Blennerhasset & Baggrow

Flood Incident Investigation Report

Blennerhasset Bridge, Cumbria

Flood Event 3rd & 5th December 2015

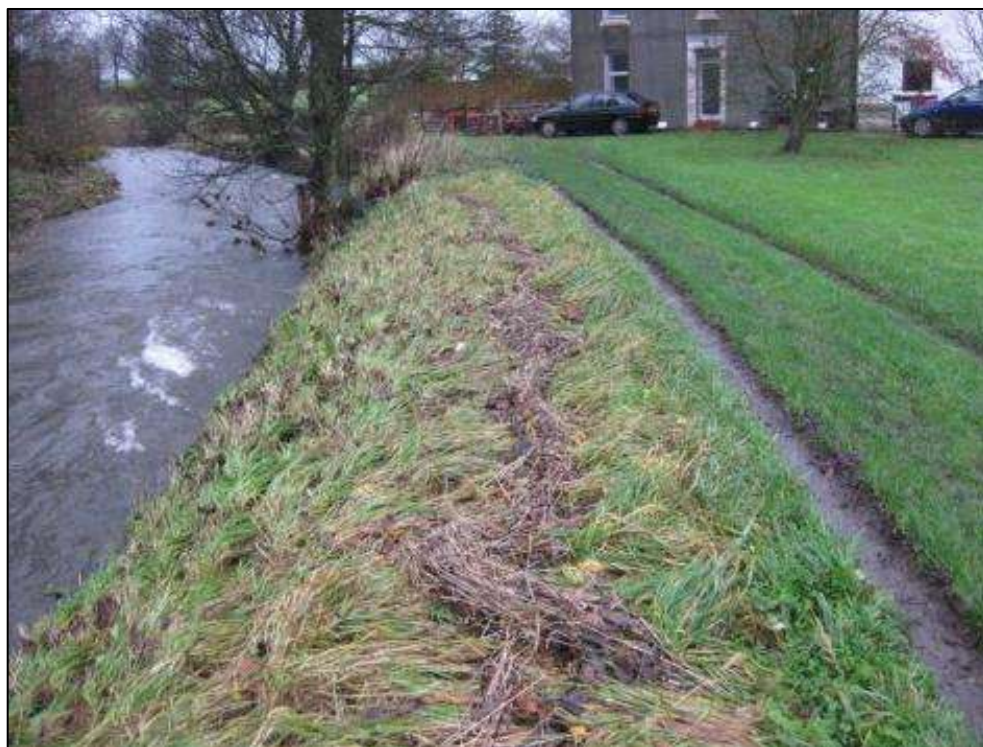
**November 2009, no timestamp,
NGR NY 17824 41682**

The November 2009 caused extensive flooding throughout Cumbria and two properties in Blennerhasset were flooded. Downstream of Blennerhasset Bridge, floodwaters overtopped the right bank of the river Ellen leading to flooding of a residential property. To the east of the village a minor watercourse runs in open channel before discharging into a culvert. During the flood event, the capacity of the culvert was exceeded and excess flows spilled onto the highway leading to flooding of another residential property.

**Photograph 1: Flood debris on the embankment on the right bank of the River Ellen
(downstream of Blennerhasset Bridge)**

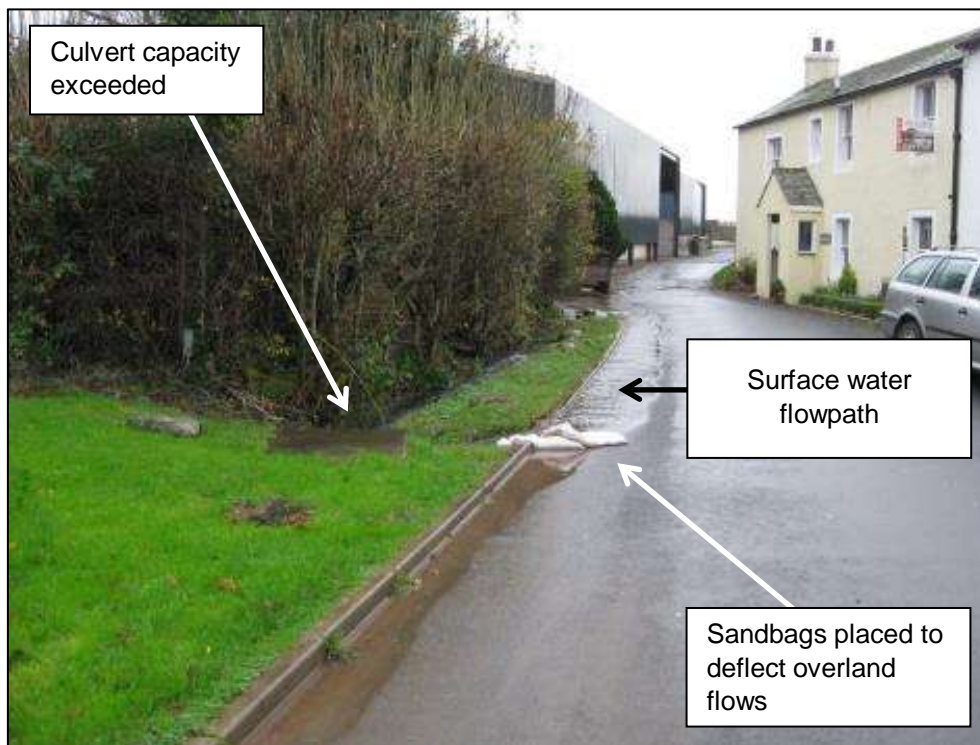
**November 2009, no timestamp,
NGR NY 18001 41589**

Photograph 2: Overland surface water flow adjacent to Ivy Cottage

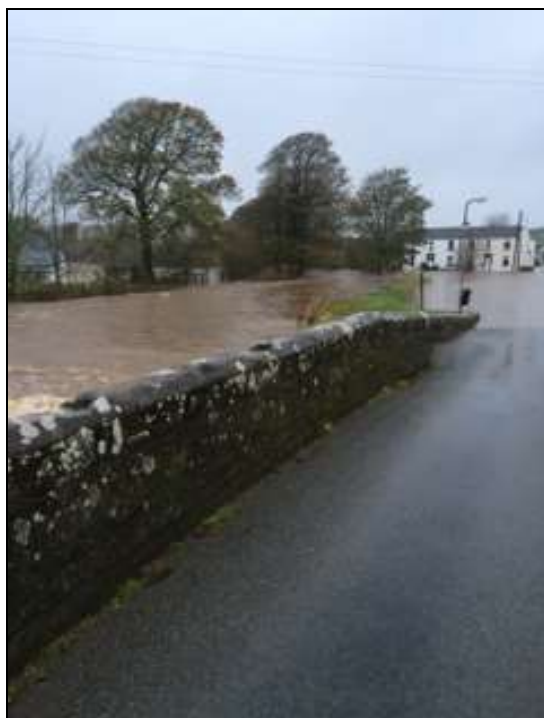
On the 3rd December 2015 the water level in the River Ellen began to rise in response to the initial period of severe rainfall that fell across the North-West region of Cumbria. The initial period of rainfall over the River Ellen catchment resulted in large volumes of floodwater laterally spilling into the adjacent floodplains between Blennerhasset and Baggrow villages as shown in **Photograph 3** and **Photograph 4**.

**Photograph 3: Photo from Blennerhasset Bridge looking towards Baggrow village
NGR NY 17853 41599**

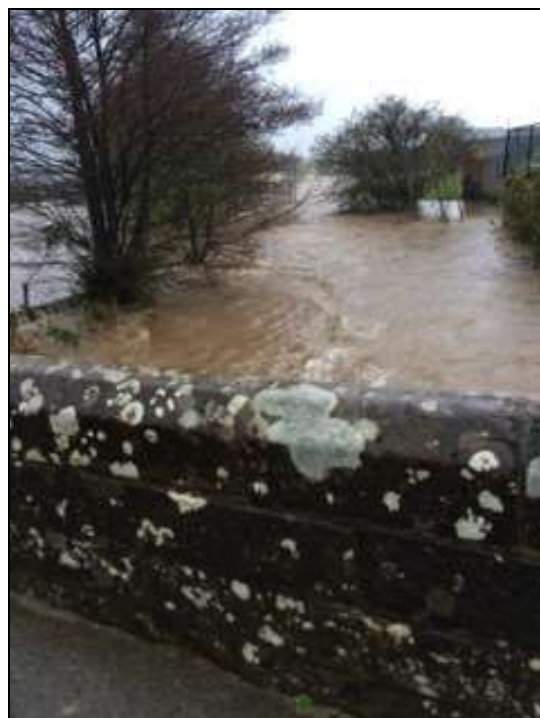
**Photograph 4: Photo from Blennerhasset Bridge looking upstream
NGR NY 17853 41599**

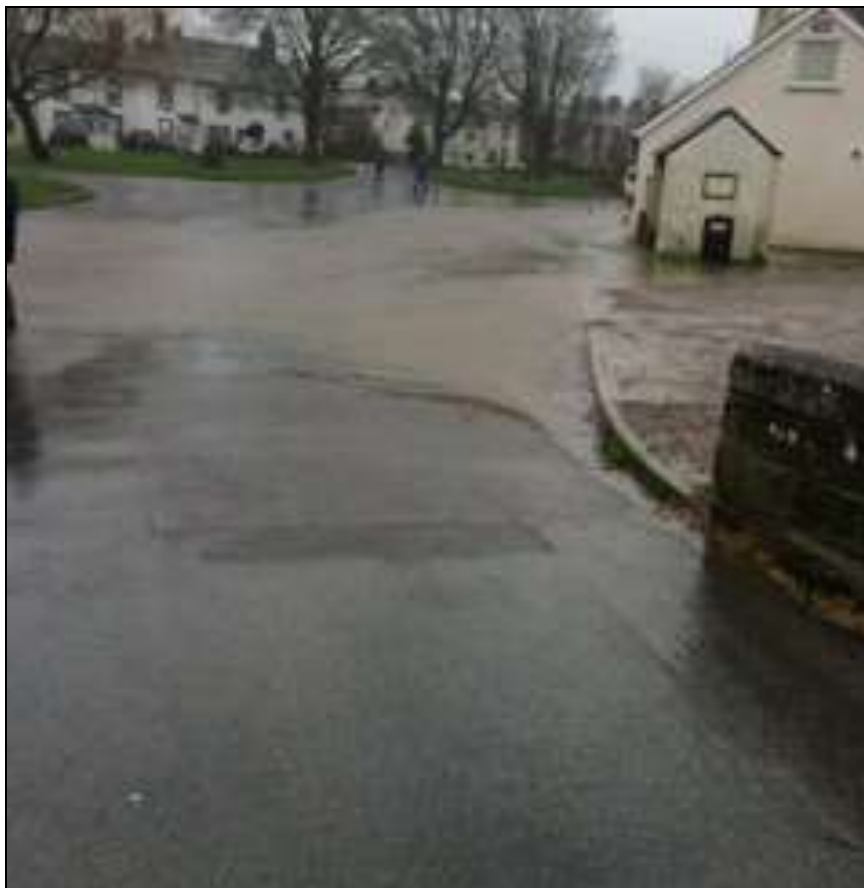
**5th December 2015, no timestamp,
NGR NY 17852 41592**

Photograph 5: Floodwater flowing down the main road towards Cross Cottages, looking west from Blennerhasset Bridge

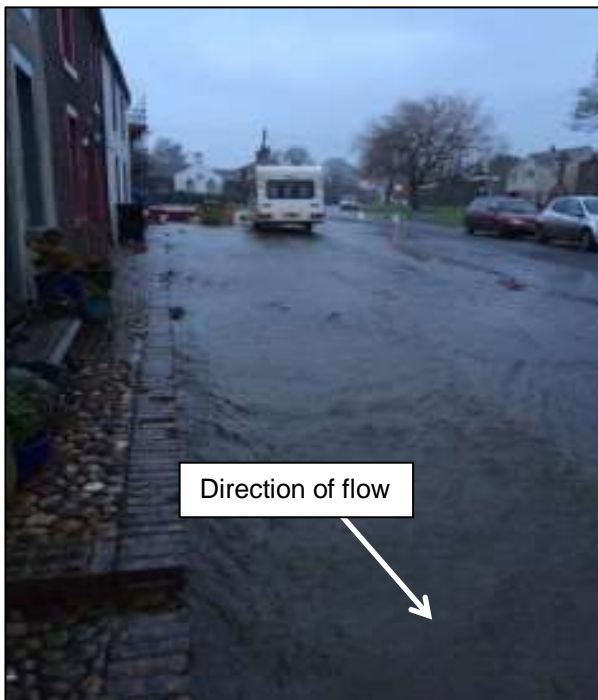
**5th December 2015, no timestamp,
NGR NY 17807 41519**

Floodwater flowed along the main road was subsequently routed towards the Low Woodnook Beck (as shown in **Photograph 6** and **Photograph 7**).

Photograph 6: Floodwater flowing down the main road, looking east

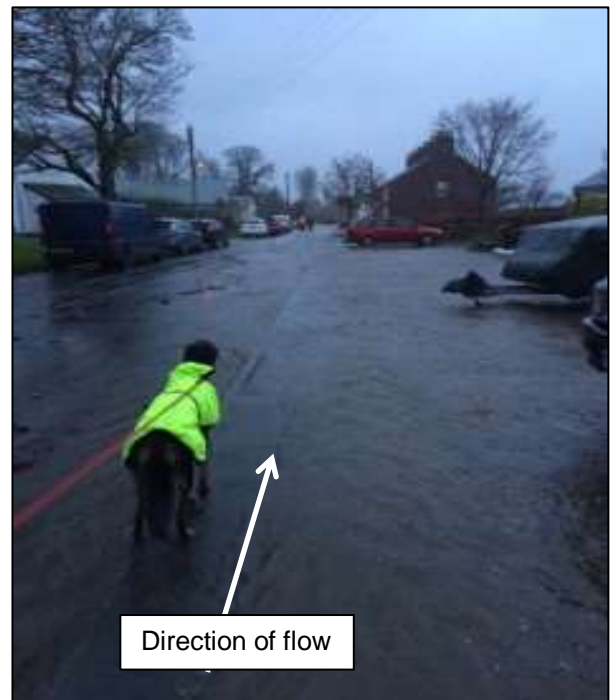
**5th December 2015, no timestamp,
NGR NY 17807 41519**

Photograph 7: Floodwater flowing down the main road, looking west

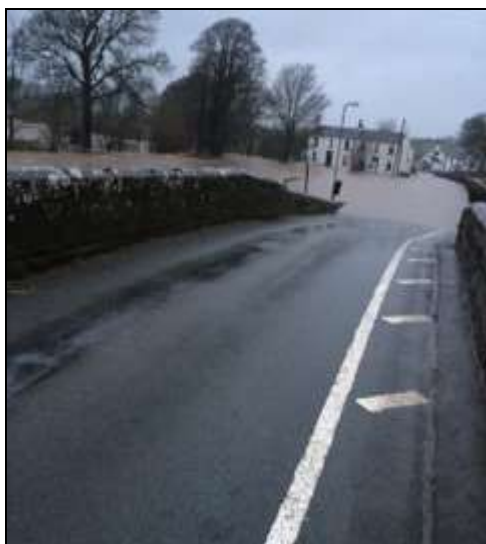
**5th December 2015, no timestamp,
NGR NY 17851 41596**

On the right bank of the River Ellen floodwater overtopped the embankments upstream of Blennerhasset Bridge, impacting on five residential properties. This floodwater flowed across the floodplain and onto the main road, flooding the lowest point in front of the residential properties located between Blennerhasset Bridge and The Grey Goat Inn. Consequently, two empty buildings including the Grey Goat Inn were flooded.

Photograph 8: Looking towards Baggrow village from Blennerhasset Bridge

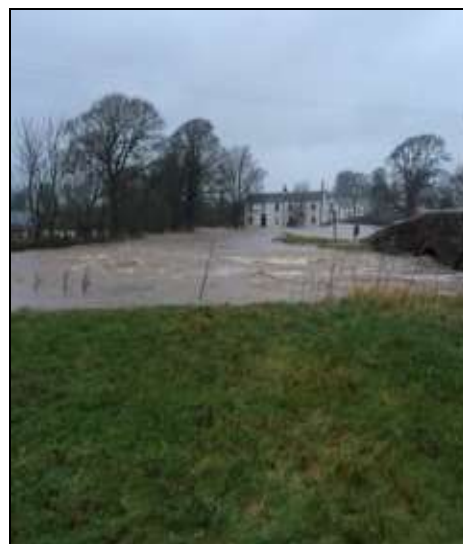
**5th December 2015, no timestamp,
NGR NY 17838 41573**

Photograph 9: Looking towards Baggrow village from Blennerhasset

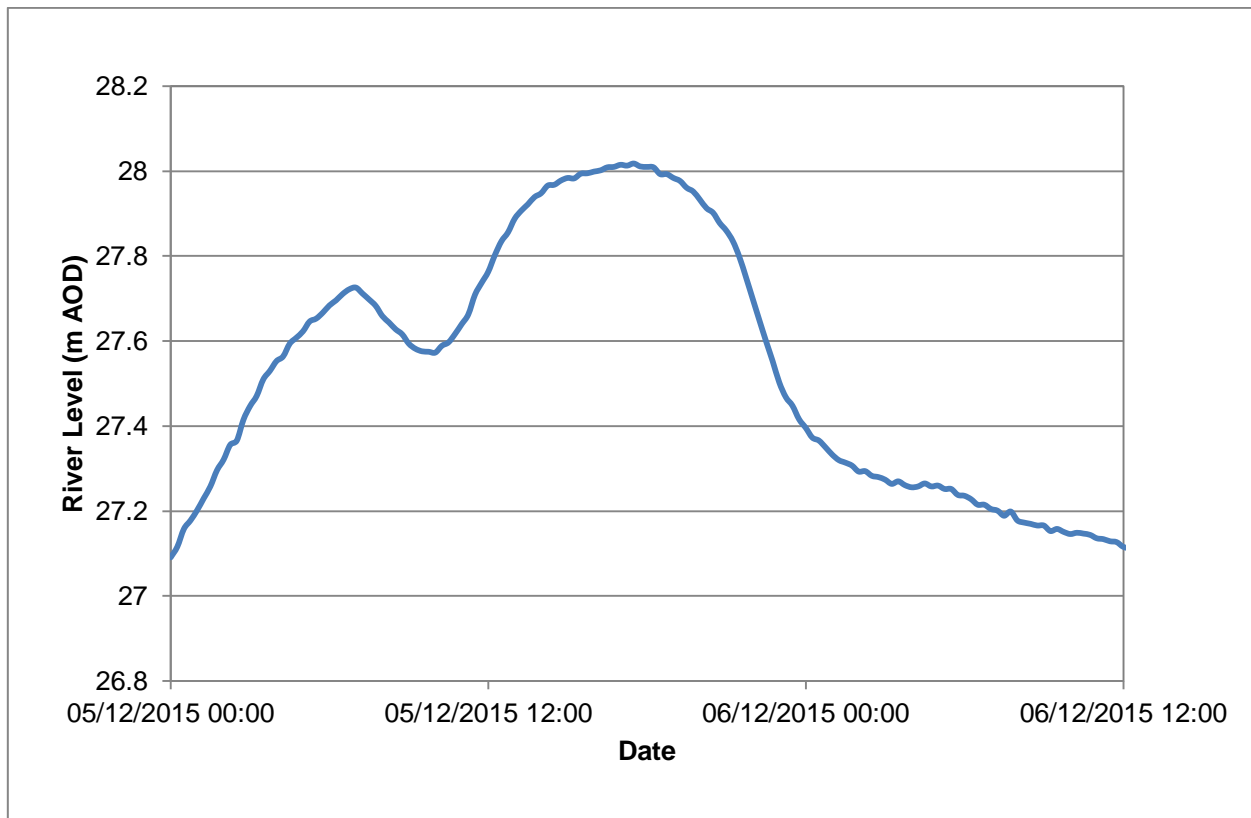
Figure 3 Recorded Water Levels on the River Ellen at the Bull Gill Gauging Station

Figure 3 shows that the water levels on the River Ellen progressively rose over a 17 hour period on the 5th December 2015. River levels initially peaked at 27.7m at 07:00 and began to temporarily subside before the secondary peak which occurred at 17:15m to a level of 28m. This is the highest recorded level at this Gauge Station since the last high level recorded in 2005.

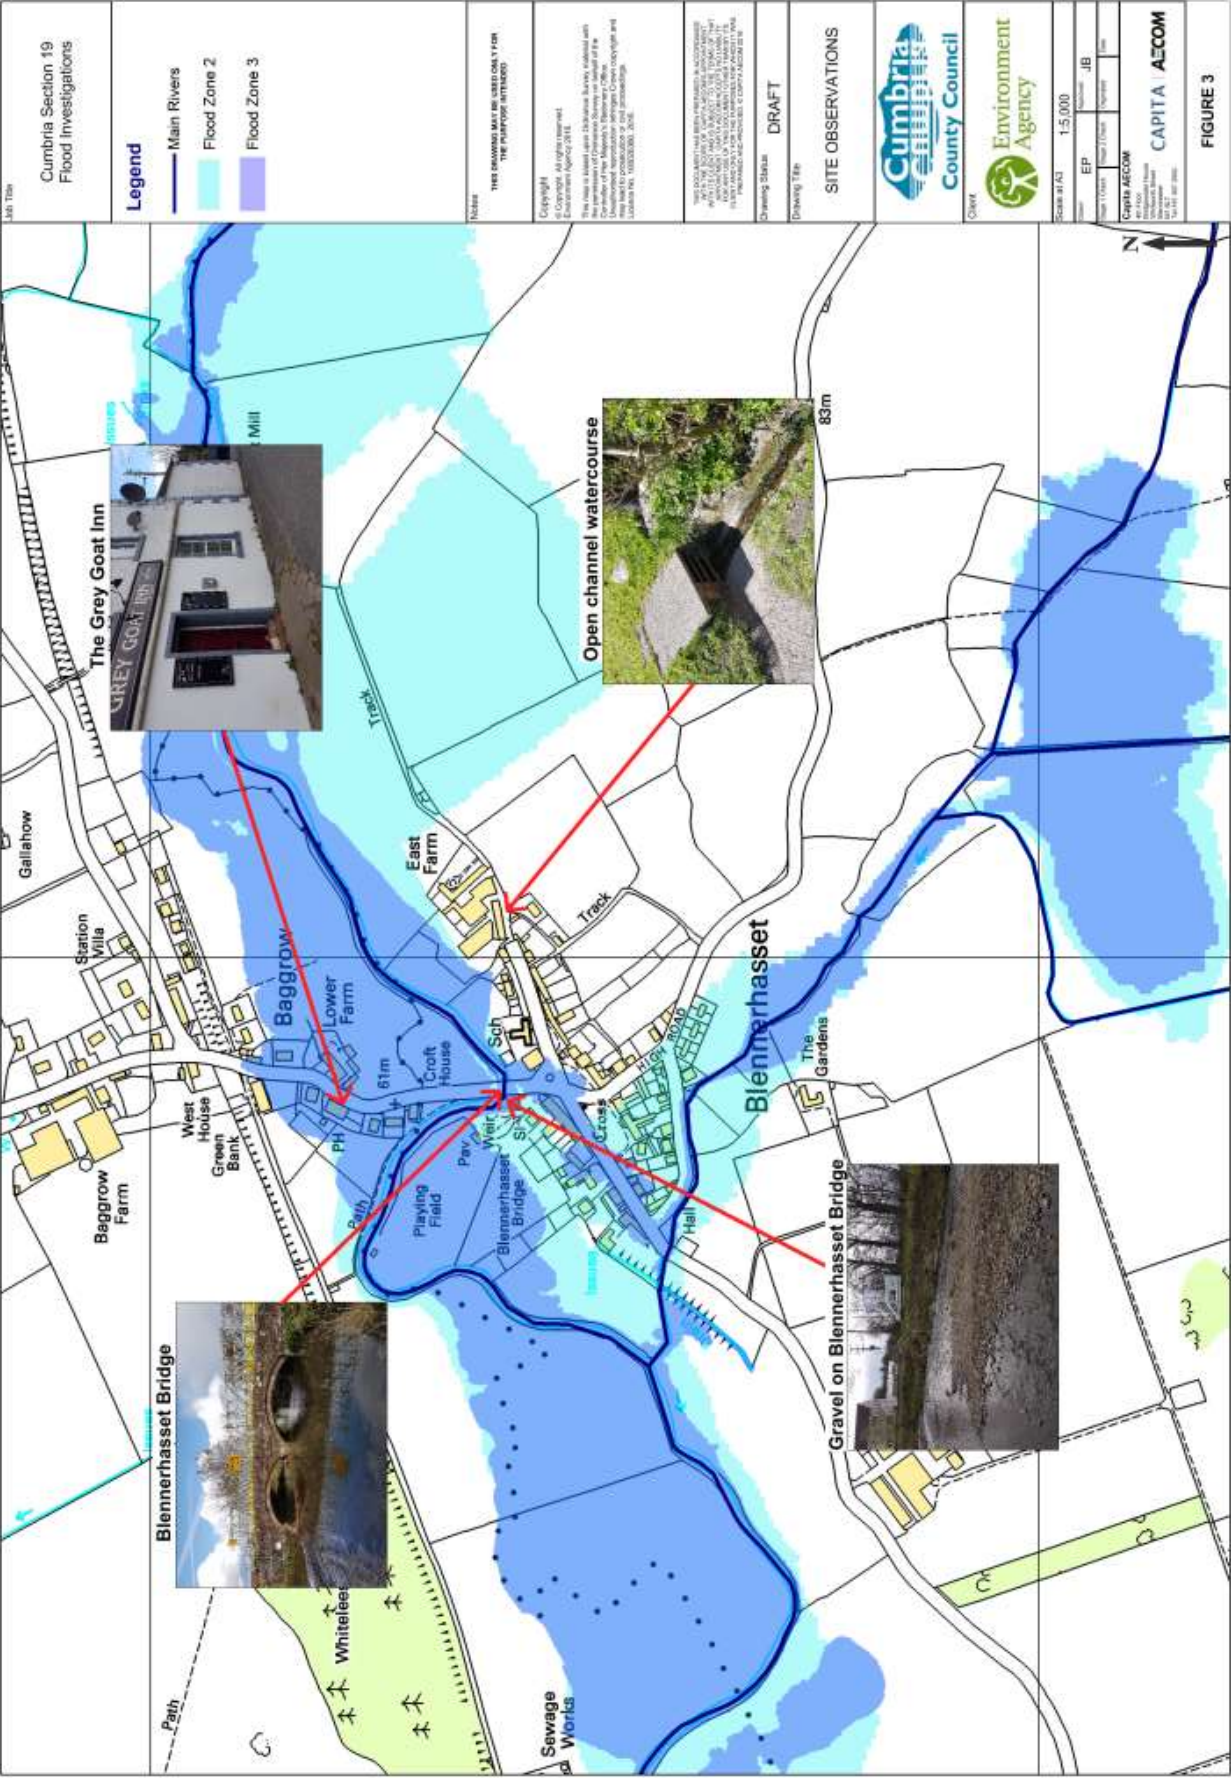
Figure 4 Key Observations

An initial site visit was undertaken by Environment Agency staff on 16th December 2015 following the flooding incident. A further site visit was undertaken on Tuesday 26/4/16 by the Capita AECOM survey team. The weather was clear and sunny. The survey team initiated the site visit with a visual inspection of Blennerhasset Bridge, the adjacent floodplain and neighbouring residential properties.

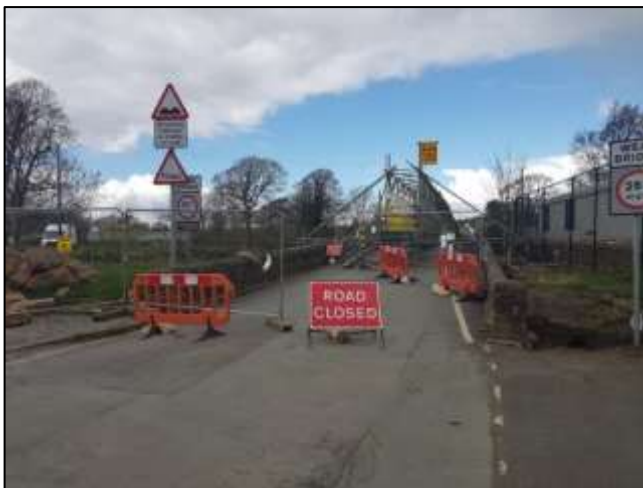
26th April 2016, no timestamp,
NGR NY 17852 41587

The survey team initiated the site visit with a visual inspection of Blennerhasset Bridge. Major remedial works on the structure were being undertaken on behalf of Cumbria County Council and the main road was closed to vehicular traffic (**Photograph 10**). Remedial work that had started in August 2015 was being extended as a result of damage that occurred during the 5th December 2015 flooding incident to address the presence of a large void (**Photograph 11**) beneath the structure and localised scour around the pier.

Photograph 10: Remedial works on Blennerhasset Bridge

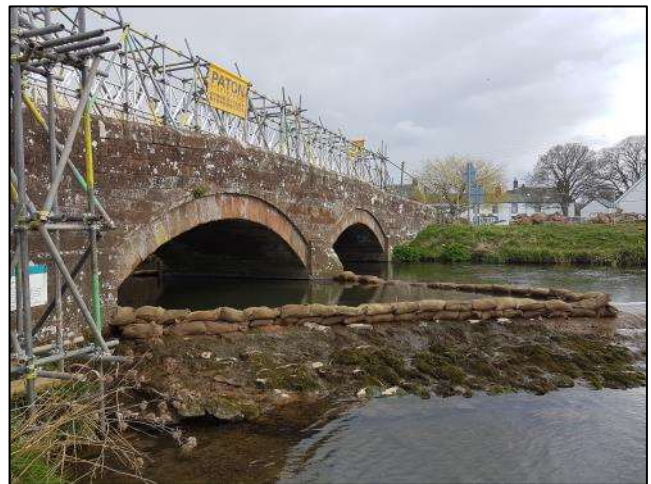
26th April 2016, no timestamp,
NGR NY 17834 41617

Photograph 11: Temporary works around the void beneath Blennerhasset Bridge

- The effects of rocks under the arch of the bridge : Doug to come back and investigate
 - Additional diver repairs carried out (after one failed attempt) and majority of rip rap removed from invert and rock rolls placed under arch in dished configuration resulting in bed depth under arch being lower than both u/s and d/s river bed level.

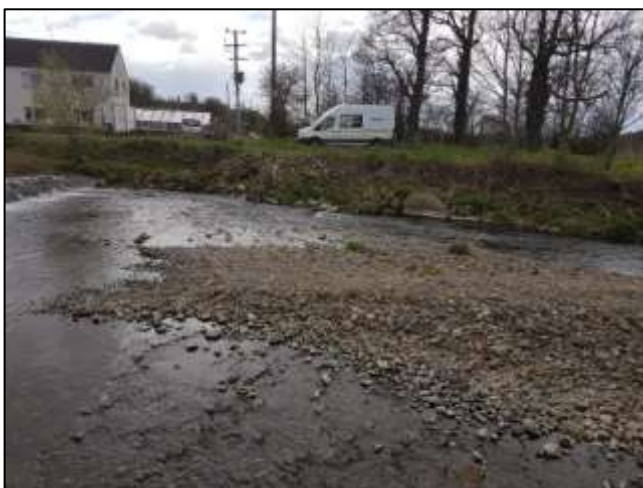
**26th April 2016, no timestamp,
NGR NY 17831 41624**

A moderate gravel shoal was observed in the river bed downstream of Blennerhasset Bridge (**Photograph 12**). This feature has been established within the watercourse for over a decade and has varied in size with seasonal variations in river flow and sediment load. The gravel shoal was previously assessed by the Environment Agency to determine if it increases flood risk locally. Our assessment from the 2010 study revealed that the gravel shoal did not increase flood risk. The assessment also recommended that we should continue to manage vegetation growth which is in the current maintenance programme. (River maintenance records from Ellen)

Photograph 12: Gravel shoal (Erosion evident)

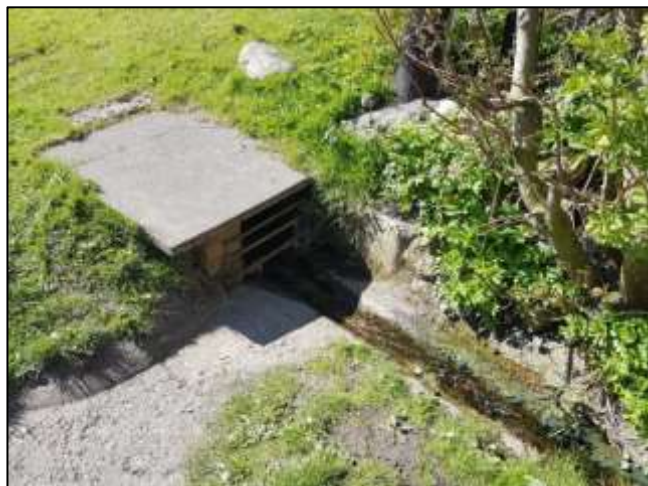
**26th April 2016, no timestamp,
NGR NY 18001 41589**

A visual inspection of the unnamed ordinary watercourse on the main road next to East Farm was undertaken. The watercourse was observed to have a small amount of flow, though the preceding weather had been dry. The watercourse is culverted from OS NGR NY 18001 41589 and the culvert inlet has restricted capacity (**Photograph 13**). The capacity structure has been exceeded historically (**Photograph 2**) and resulted in overland flow routing down the road towards the centre of Blennerhasset (**Photograph 14**). There is limited highways drainage at this location.

Photograph 13: Culvert inlet on the unnamed ordinary watercourse

- Highways are to carry out works at Gowrie cross roads and cctv has found a blocked culvert in this vicinity. There are also works planned between Gowrie and the old railway line. The culvert at East farm has been checked and tonnes of gravel removed from the pipework. The issues at Low wood nook are being worked on and there is already a smoot hole in the hedgerow so the water cannot build up to previous depths, this can hopefully become formalised.

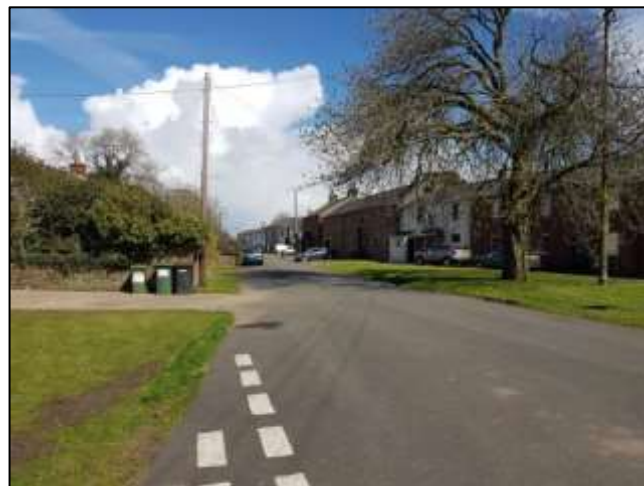
**26th April 2016, no timestamp,
NGR NY 17884 41557**

Photograph 134: Looking east on the main road towards East Farm

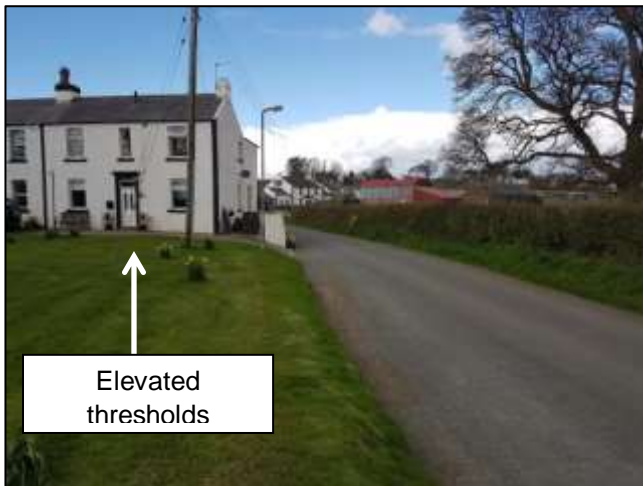
26th April 2016, no timestamp,
NGR NY 17842 41680

The team undertook a visual inspection of the main road and the adjacent residential properties north of Blennerhasset Bridge. The topography is relatively flat, with a slight uphill gradient towards the Grey Goat Public House. The properties nearest the River Ellen are well above the road level (**Photograph 15**) and still flooded despite local resilience measures being taken at one of the houses. A wrack line was observed on the easterly boundary wall that is adjacent to the properties (**Photograph 136**). Some of these properties were flooded internally while others were protected by floodgates and other measures of property level protection by the 5th December 2015 flooding event.

Photograph 145: Looking north towards residential properties in Baggrow

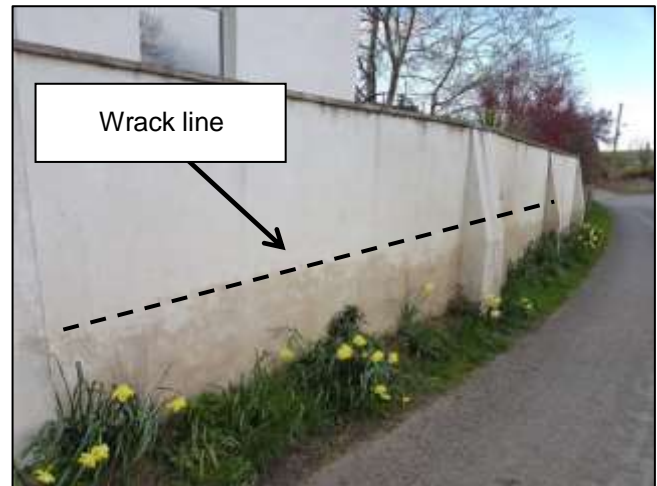
26th April 2016, no timestamp,
NGR NY 17840 41707

Photograph 156: Wrack line from fluvial flooding on the main road through Baggrow

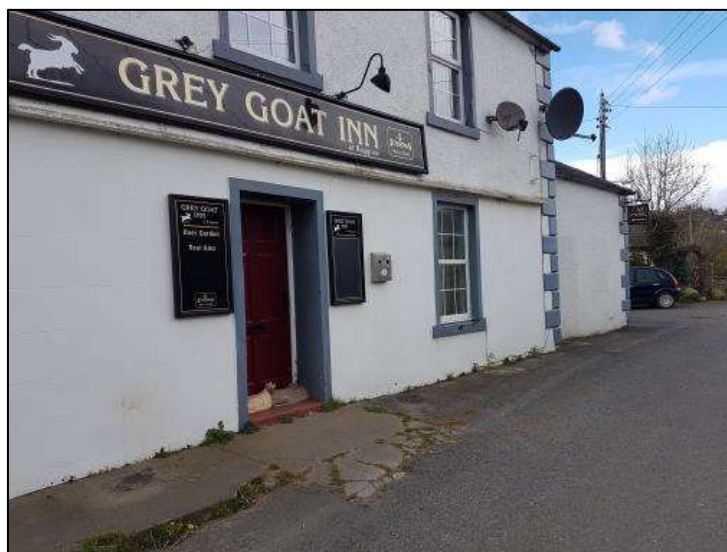
26th April 2016, no timestamp,
NGR NY 17840 41785

The Grey Goat Public House showed signs of flood damage (with sandbags still installed), as did a number of other residential properties at this location (**Photograph 17**).

Photograph 17: Sandbags at the entrance of the Grey Goat Inn

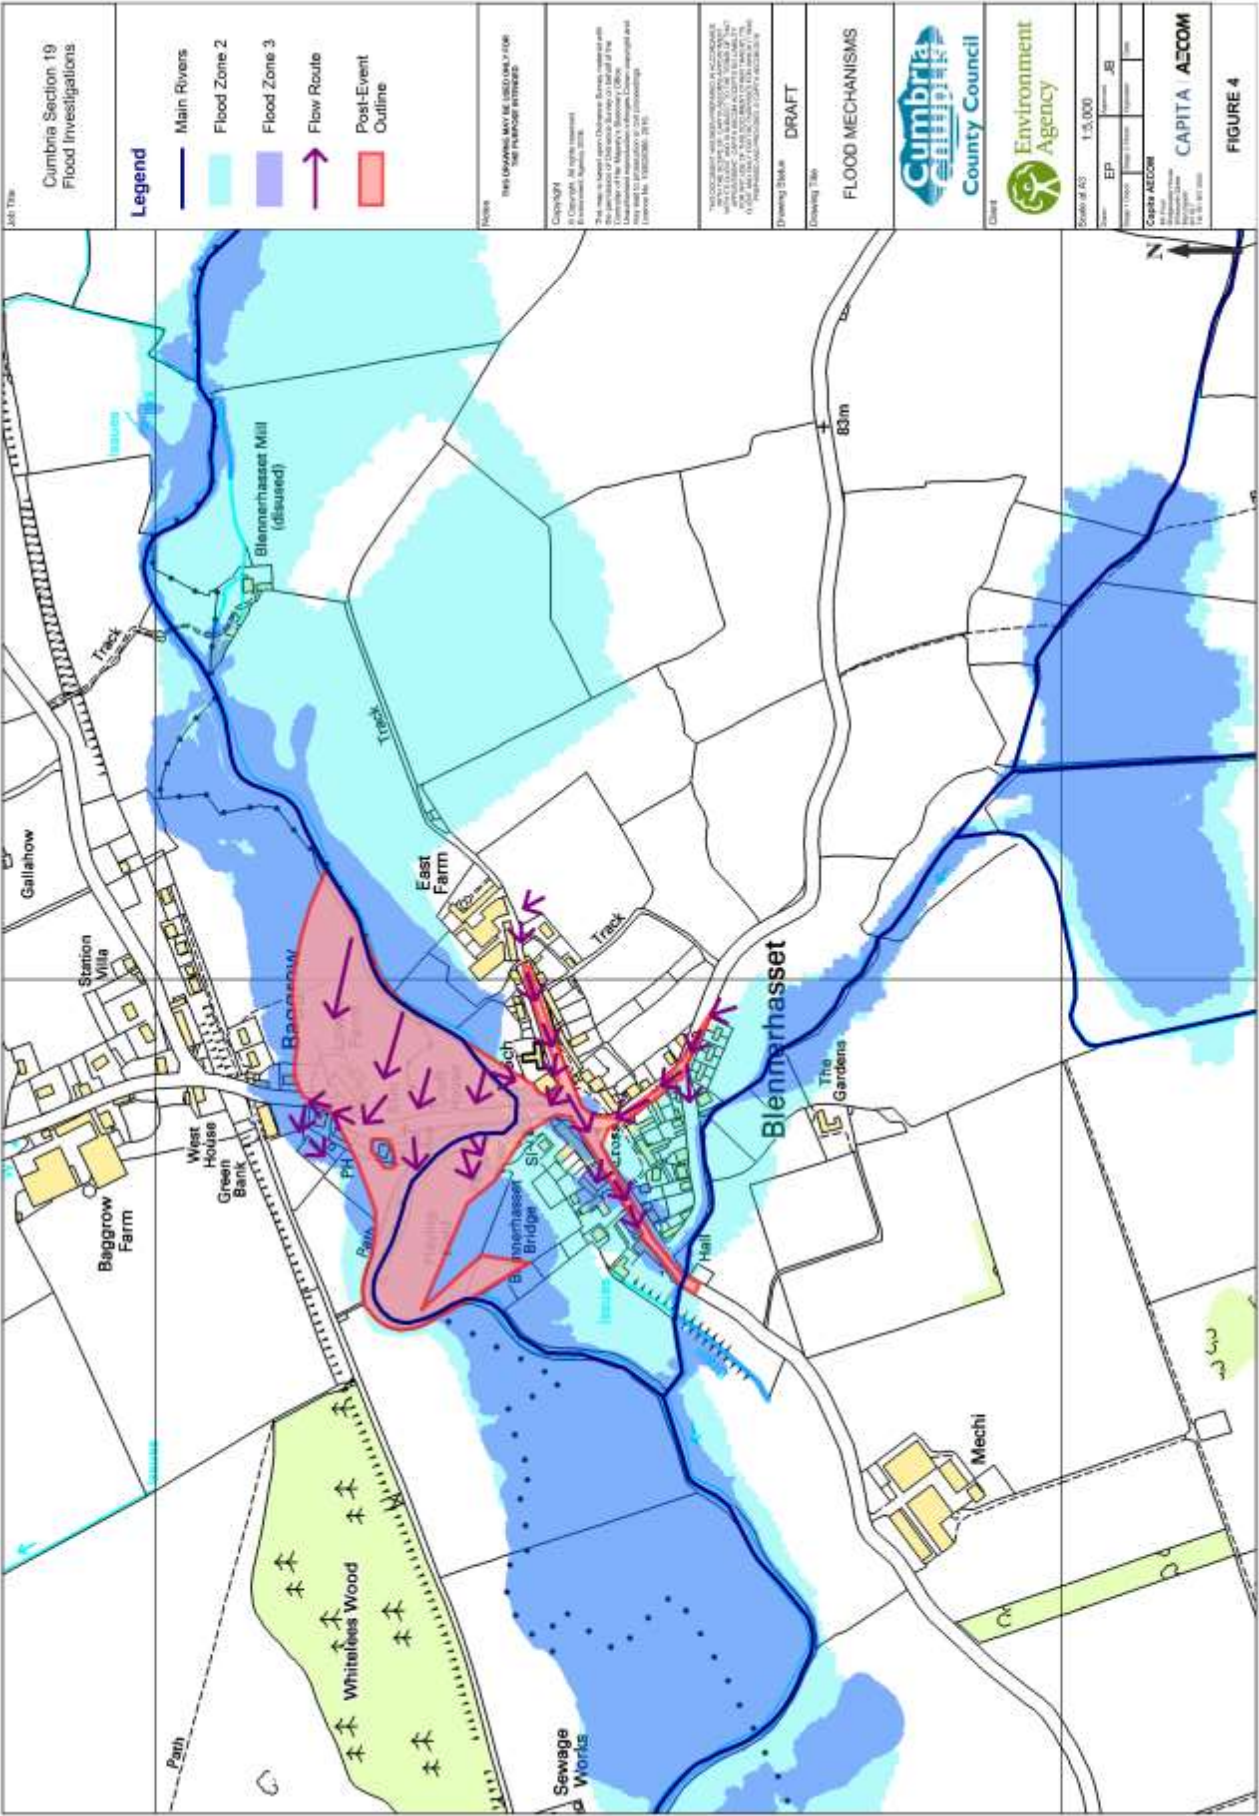
Figure 5 Flooding Mechanisms

High water levels in the River Ellen overtopped the short reach of flood embankments near the Blennerhasset Primary School. These flows were subsequently routed towards the central roundabout and combined with floodwater from the unnamed ordinary watercourse near East Farm. This feature resulted in the generation of a large amount of overland flow as the culvert capacity was exceeded and excess flows routed down along the road towards the centre of the village.

Run off from agricultural land to the south of East End Cottages flowed down the road, contributing to the build-up of surface water flow along the main road. This overland flow continued to flow along roads before finding its way back into the River Ellen. Overland flow also continued to flow along roads in a westerly direction, past Village Green, before discharging into the watercourse Low Woodnook Beck.

High water levels in the River Ellen overtopped a significant length of the flood embankments on the right bank of the River Ellen upstream of Blennerhasset Bridge. Floodwater inundated this area of agricultural floodplain, before being routed by the topography towards the Lower Farm and residential properties on the main road. Flow was then routed around the properties, flooding several of them before ultimately re-joining the River Ellen downstream of Blennerhasset Bridge. Ground water flooding also occurred in this location
