Seascale

Flood Investigation Report 31

Flood Event 30/8/2012

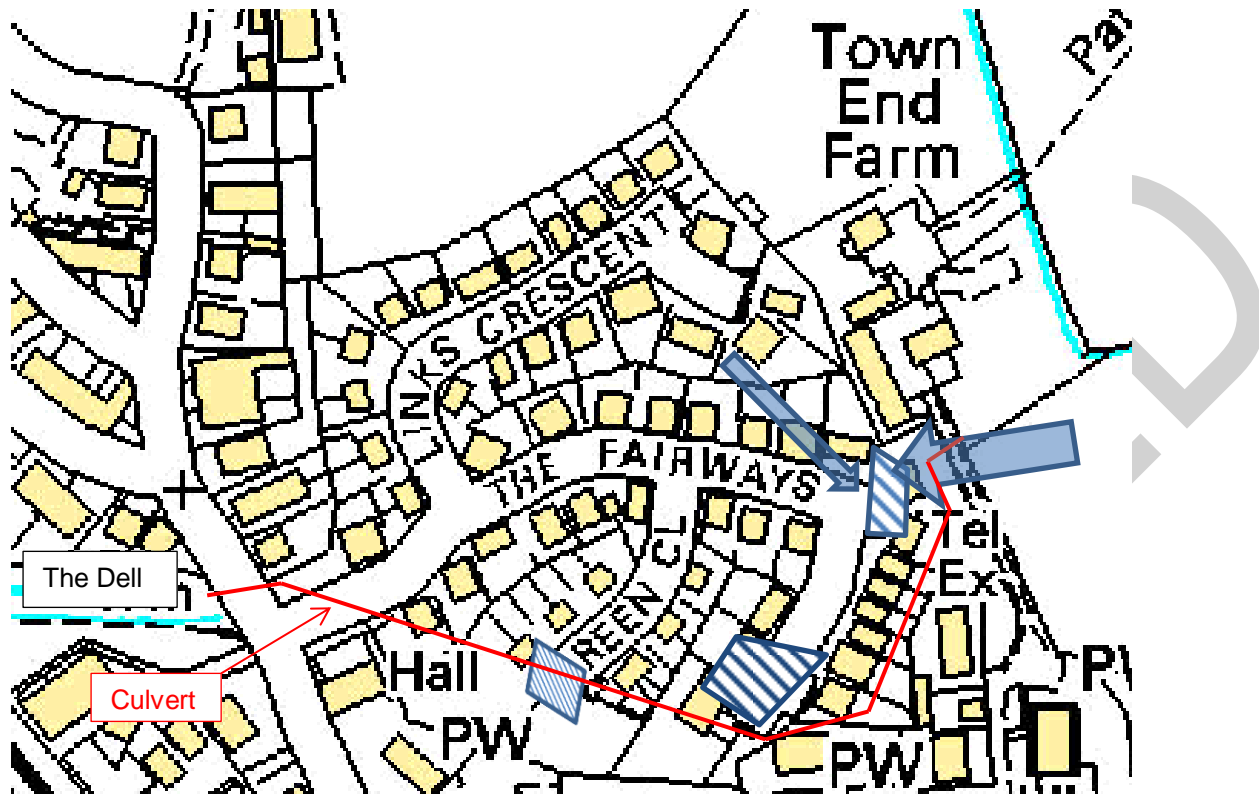
Figure 4 Plan of The Fairways and Green Close showing the location of the culvert, the main surface water flow routes and the areas that flooded.

An un-named natural watercourse flows through a culvert under the estate and outfalls at a piece of open land known as ‘The Dell’. The source of this culvert is unknown but it is likely that it takes water from the How Farm area 1km to the north. The ground levels have been altered in the building of the development. There are significant dips at the end of the roads and the flood waters gathered in these low areas flooding adjacent properties. 21, 23, 29, 33 & 35 The Fairways were flooded internally and no. 25 suffered external flooding.

UU attended the flood incident and found that the flood water was flowing through no. 21 The Fairways from pooled flood water in the field behind the property. UU advised that the sewers were operating satisfactorily, but the culvert, which is not in UU ownership, required investigation. Surface water was also reported to have been flowing from the direction of Links Crescent.

The outfall of the culvert is in ‘The Dell’, a small area of open space on the west side of The Banks (a road) at the entrance to The Fairways. ‘The Dell’ is surrounded on all four sides by steep slopes with another culvert taking the beck under the railway to the sea and regularly holds flood water because of restrictions within the railway culvert.

At the upstream end of the culvert, the first manhole is in the back garden of number 21. It has two inlets, one of which takes surface water from the field south of Town End Farm. The other inlet carries base flow even in dry conditions but the source could not be found. This is thought to be the stream which starts 1km away at How Farm.

Surface water collecting in the field behind 21 'The Fairways' discharges into the culvert via an old stone culvert located under an access track leading to Town End Farm. There is no formalised headwall to the culvert on the edge of the field.

Near no. 24 The Fairways the 900mm diameter culvert splits, with a 400mm diameter pipe taking normal flows, and a high level 600mm diameter pipe for overflows. If the 900mm diameter pipe was running at full bore (which is very likely) the water would be forced to back up and flood out of the system at any openings, such as manhole covers. Residents reported that the culvert manhole outside 24 The Fairways surcharged during the flood event.

The two branches of the culvert recombine close to no.2 in a 700mm x 1080mm box culvert with a section of disused pipe running inside this section, reducing the cross section by approximately 15%. The culvert discharges as an open watercourse in 'The Dell'.

From a CCTV survey, the 900mm diameter section of the culvert proved to be in very good condition with some large debris. This is not unexpected as a culvert carries the bed load of the watercourse as well as the water. During the surveying, stones were taken out of the manhole near no.35 but they had built up again after rain on the weekend of 21/10/12.

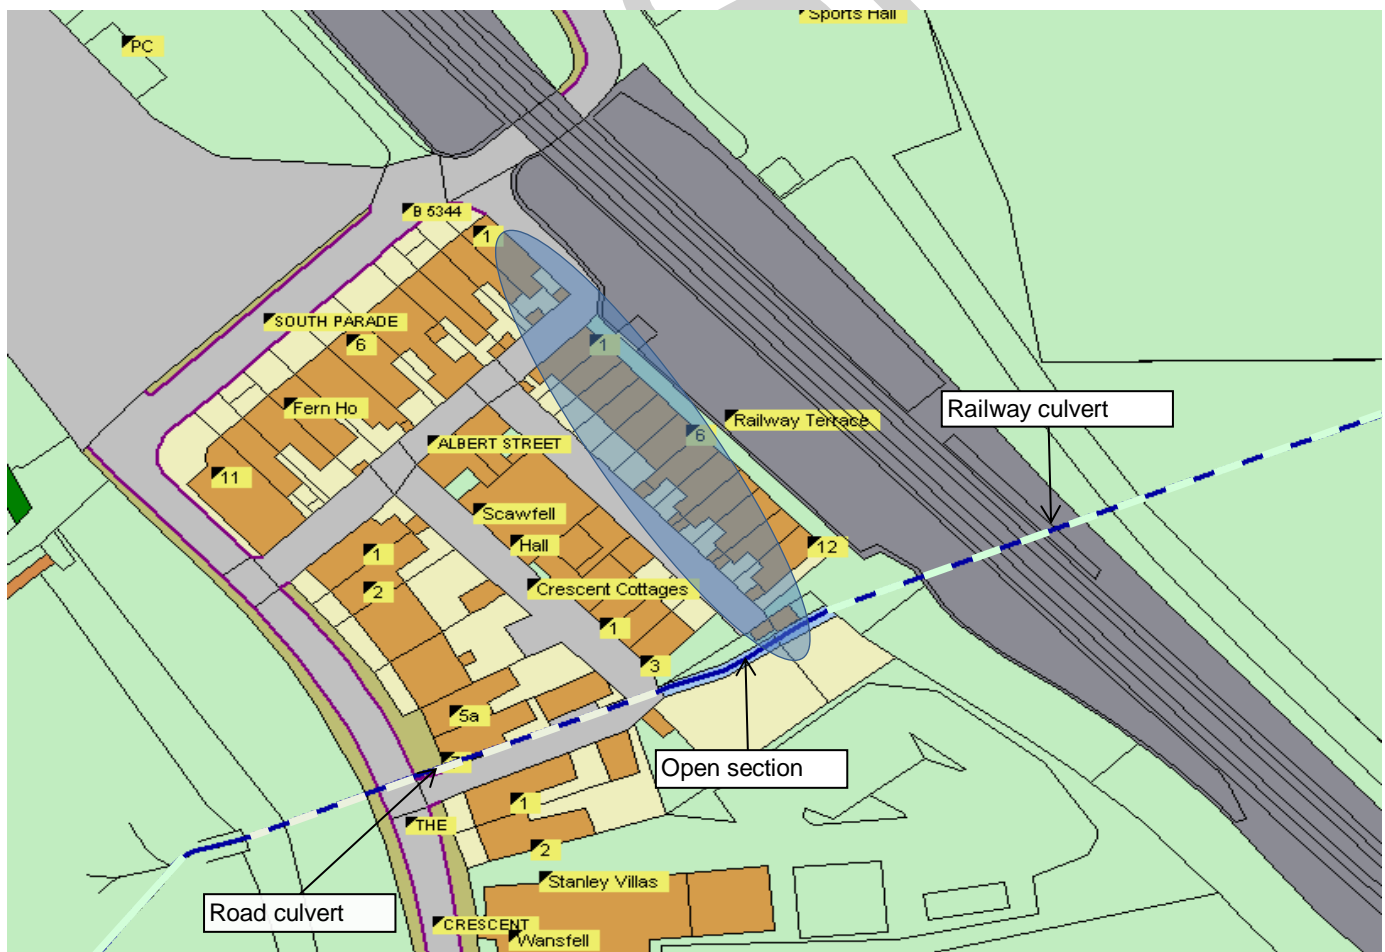
Figure 5 Plan of the Railway Terrace and Albert Street area showing the line of the culverts and the location of the flooding.

through an extended culvert under a BMX track and under the railway embankment. In the yard of 12 Railway Terrace, the beck is partly in culvert but also in open channel bounded by a wall. The wall has drainage holes made by residents to drain highway areas in normal rainfall conditions. This arrangement was reversed during the flood event. The beck surcharged and water came through holes, over the small wall and flooded adjacent properties. Whittriggs Beck then runs through a further culvert under Drigg Road and outfalling into the sea 80m downstream.

The road culvert is an arch 1.59m high x 1.28m wide while the railway culvert is a 1m high x 1.16m wide box (at the other side of the embankment it is a 1.2m diameter pipe so it is smaller at the outlet than at the inlet). Residents have concerns that it is not cleared on a regular basis. A CCTV survey was carried out to check the condition of the road culvert. While there is some rock in the culvert, it must carry bedload as well as water.

Some observations made by residents suggest that the water rose out of drainage holes in the yard and at the downstream portal of the railway culvert. There are a number of scenarios which describe how water flows through a culvert with an open channel at both ends. These behaviours are affected by the channel and culvert gradients, cross-section and resulting flow depth. Such factors would have an impact on the nature of the flood water flow at both ends of the culvert. Observations made by residents are consistent with a number of these scenarios as the flood flows altered over time covered by the event.

The flood water is said to have flashed up and down. This is consistent with a pulse of water coming through caused by a short but intense burst of heavy rain but it is more likely to be explained by the changing behaviour of the flow through the culvert as the volume of water changed with time.

The culvert below the roads was surveyed and no restrictions to the flow were found. Cobbles and small boulders within the channel are to be expected as the culvert must carry the stream's bedload as well as the water. The MSfWG partners have no authority to survey the culvert owned by Network Rail who make a full internal inspection of the culvert every six years. This was unavailable at the time of publication of this report. Network Rail's most recent external inspection, in May 2012, revealed no indications of failure.

As well as the flood water being delivered by the culvert, some of the flooding was caused by the rain falling directly on the area, especially during the 29mm/hr peak rainfall. All of the road gullies have been cleaned and the pipes between them jetted clear following the flooding. Most of the road gullies drop into the combined sewer system. The combined sewers in the area are 250mm diameter and it was reported that when the manhole cover outside no.12 was lifted, flood water was able to get away. This indicates that the combined sewers had spare capacity in them. Possibly this occurred after the peak flows had passed but the surface flood water remained. There have never been any reports of flooding from the combined sewers in this area but UU surveyed and jetted them after the flooding as a precautionary measure.

There is one road gully that flows into the open section of Whittriggs Beck rather than the combined sewer. This is located outside no.12 and could be a key mechanism to reduce flood water. It is not effective during flooding because the outfall is below the stream level in normal flow conditions. It should be noted that if the stream level is higher than the gully it will not work and will only be effective in reducing flood water levels after the stream level has subsided. Nevertheless, if the fall allows, it would be more efficient with a higher outfall, and with a flap valve on the outfall. On 22/11/2012 there was heavy rainfall and, again, this drain appeared unable to operate, resulting in surface water in the street, although there was no report of flooded properties from this event. This is a new problem that has not previously occurred.

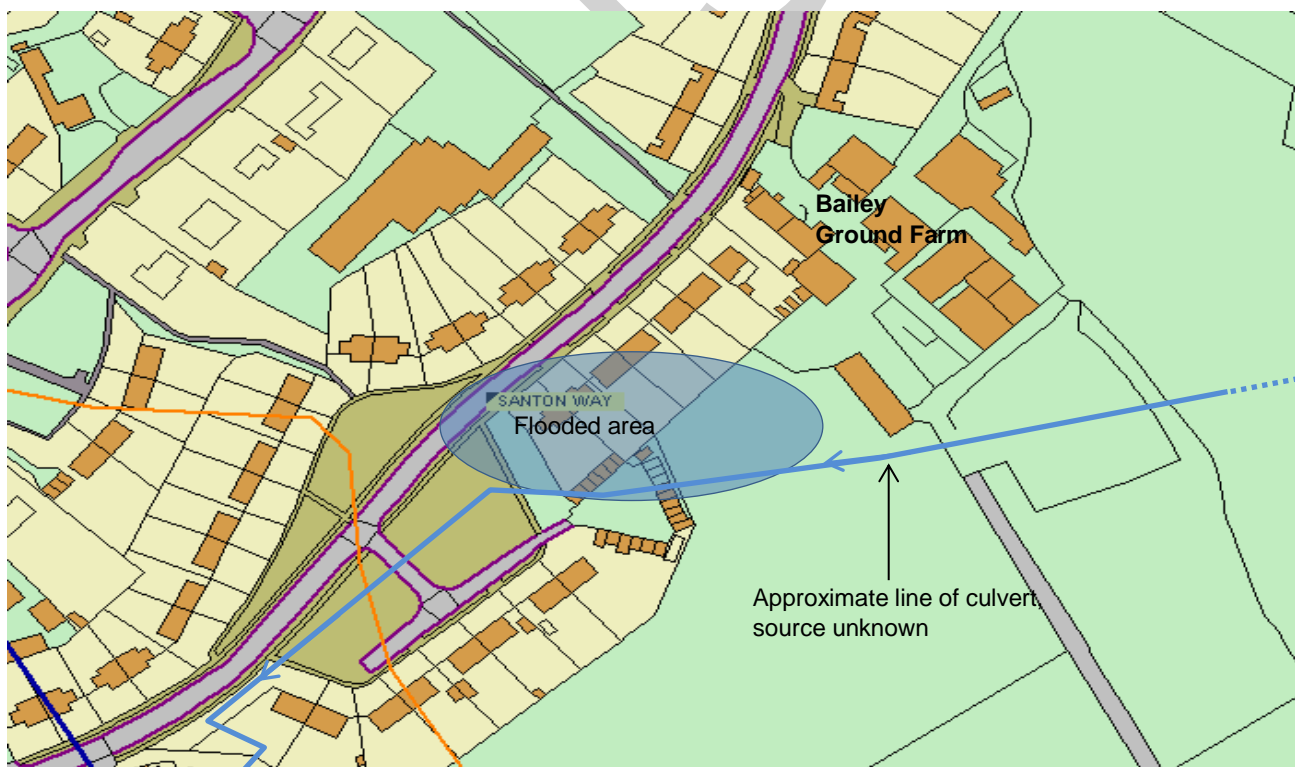
Figure 6 Plan of the Santon Way area showing the location of the flooding and the approximate line of the culvert

The fields behind 50 Santon Way are very wet, even in dry weather. Land falls towards the houses and these properties are the only route for flood water and it appears that the houses were flooded because of this topography. The water passed through the rear garden of 50 Santon Way and flooded the properties at 46 and 48 Santon Way.

There is a culvert carrying a natural watercourse which runs around the edge of the area. It comes from the direction of Black How, crossing the agricultural land surrounding Bailey Ground Farm, but its source is unknown.

The culvert runs behind 46 and 48 Santon Way and continues through the open space in front of the houses where a depression has formed in the grass indicating that the culvert has collapsed. There is also subsidence above the culvert on the site of the garages. It appears to be flowing satisfactorily in normal conditions. Owners of these areas of land are responsible for maintaining the culvert as riparian landowners; it is very deep at 2-4m. The source of the culvert is unknown. Copeland Borough Council attempted to carry out a CCTV survey after the flooding in June 2012 but could only get 26m upstream from the furthest known manhole on the upstream end of the culvert.

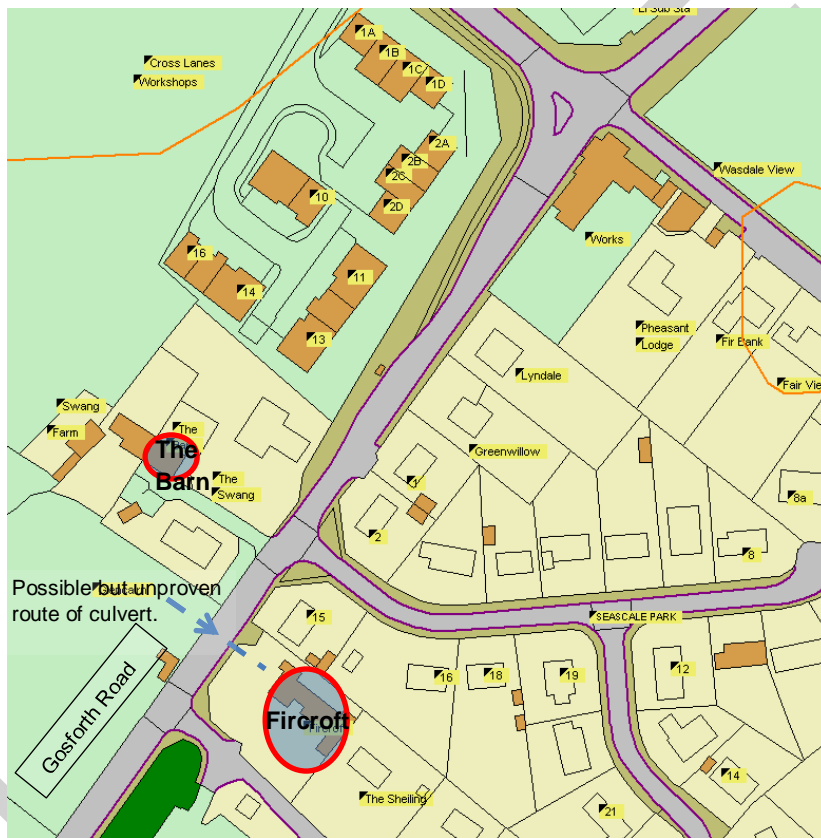
Figure 7 Location of the two properties reported to have suffered flooding in the Swang Farm area

Two properties at the northern end of the village were reported to have suffered from flooding. There are no mapped watercourses in this area, although there is a suspected culvert near ‘Fircroft’. The general slope direction, and therefore the route surface water, is from the fields to the northwest of Gosforth Road towards the southeast.

‘The Barn’, was surrounded by water but did not flood internally. ‘Fircroft’ also had surface water flooding as water ran off the highway causing damage to the garage but not flooding inside the house. The drive of ‘Fircroft’ slopes downwards from Gosforth Road.

The problems in this area became known to the LLFA too late to be fully investigated in this report. United Utilities continue to carry out extensive investigations in this area and believe

some of the flooding is related to problems with road drainage. Separate reports have been prepared by the LLFA for flooding in this area.

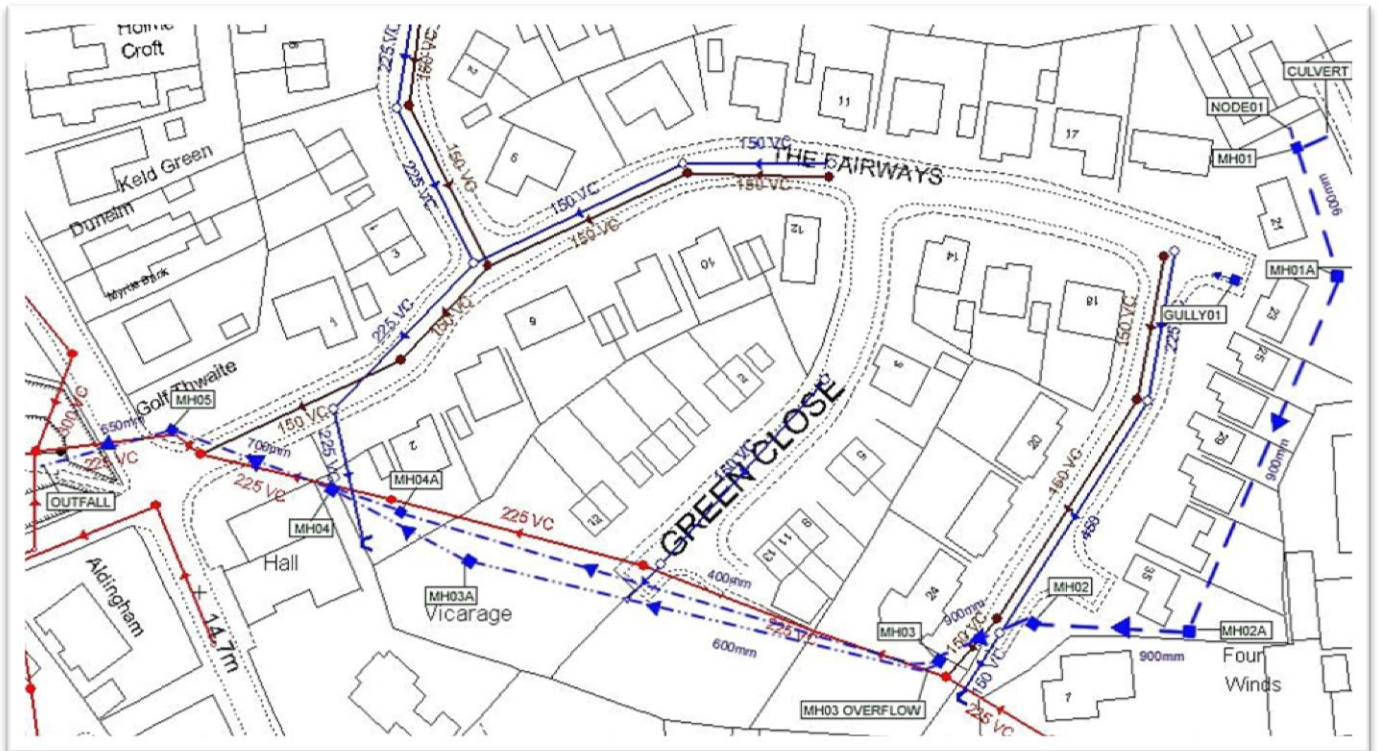
Drainage layout plan for 'The Fairways'

The dashed blue line is the culvert which splits in two outside no.24 and recombines outside no.2. Blue lines are surface water sewers. Brown lines are foul sewers. Red lines are combined, foul and surface water sewers. The numbers indicate the diameter of the pipes in millimetres.
