St Bees

Flood Investigation Report 37

Flood Event 30/8/2012

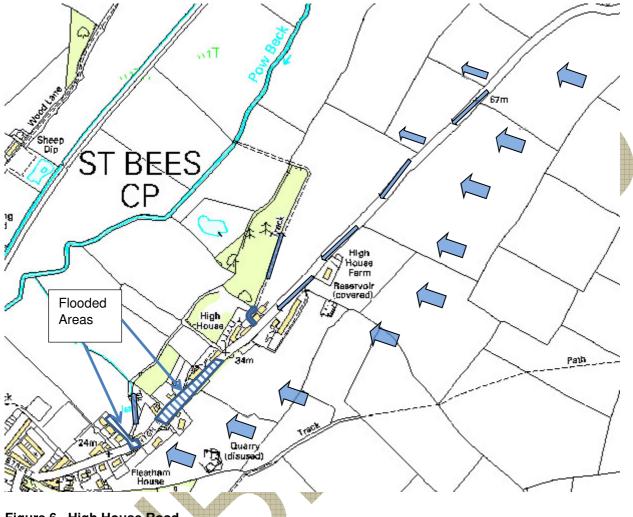
Figure 6. High House Road

High House Road cuts across the slope, descending gradually towards the village. It is easier for the water to follow the road rather than continue on its natural course straight down the slope. This is because the verge on the lower side of the road is raised above the road surface along most of the length. This has the effect of concentrating the water on the road surface. If the road was not there then the water would travel straight down the slope to Pow Beck.

A significant amount of water was discharged through a field access from the road at 'The Barn' where the driveway is lower and a lane leads downhill towards Pow Beck. The water appears to have done little damage on the driveway and did not enter the properties but it caused damage to land below. It is clear from the agricultural damage that the flows must have been significant. It has been reported that there was a 225-300mm diameter pipe system connecting road gullies in this area to Pow Beck. It is now abandoned and performs no drainage function.

Highway drainage starts at the St Bees road sign, opposite High House Farm, (2 gullies connected to a small soakaway in the field on the lower side of the road). It recommences at 'The Barn' with gullies on both sides of the road to a dip outside 'The Stables'. See Appendix 4. Two outlets from the drains then flow left and right of 'The Stables' buildings. A combination of leaves, debris and quantity of water overwhelmed the highway drains causing the dip to fill.

Water spilled down 'The Stables' driveway and overtopped front door flood boards, leaving the property uninhabitable; the flood depth exceeded 600mm. Floodwater continued down the road flooding 'The Retreat' internally and flowing into to the access track behind the property. Flood waters crossed the access track into the garden of 'Seathwaite', surrounding the property, flooding the garage, but the majority of the flows passed between the house and the garage.

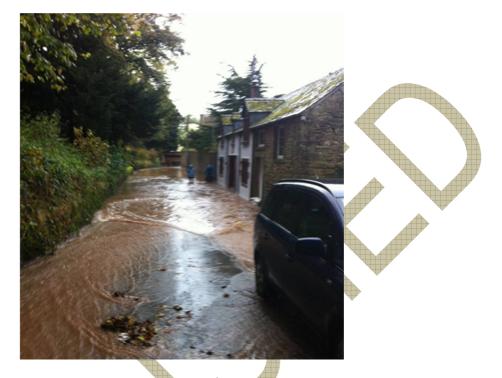
Figure 7. High House Road during the 17/10/12 flood event

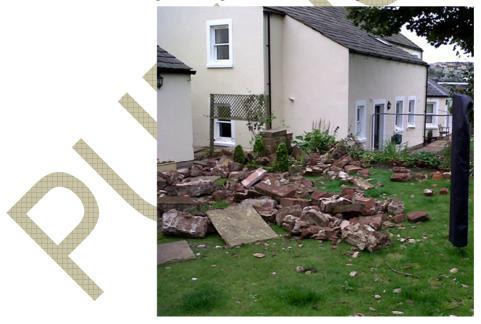
Figure 8. Devastation in the garden of Orchard House after the 30/8/12 flood knocked over walls

Flows descended into the back gardens of the 'Orchard House' and 'Brocklebank'. On route the force of the waters demolished walls and fences. 'Orchard House' was surrounded by water and 'Brocklebank' suffered internal flooding.

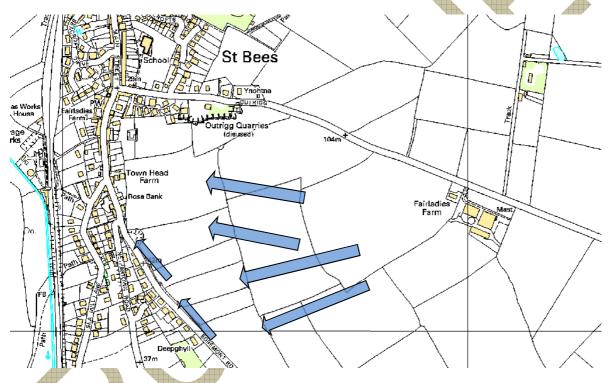
Flooding mechanisms at this location were the same as those at High House Road. Intense rainfall caused runoff from the saturated fields on Loughrigg Hill, onto the roads. The highway

Figure 9. Surface water runoff from above Egremont Road

drainage system was unable to cope with the volume of water and debris. Another source of water at this junction was a manhole, the cover of which was lifted by the force of the water.

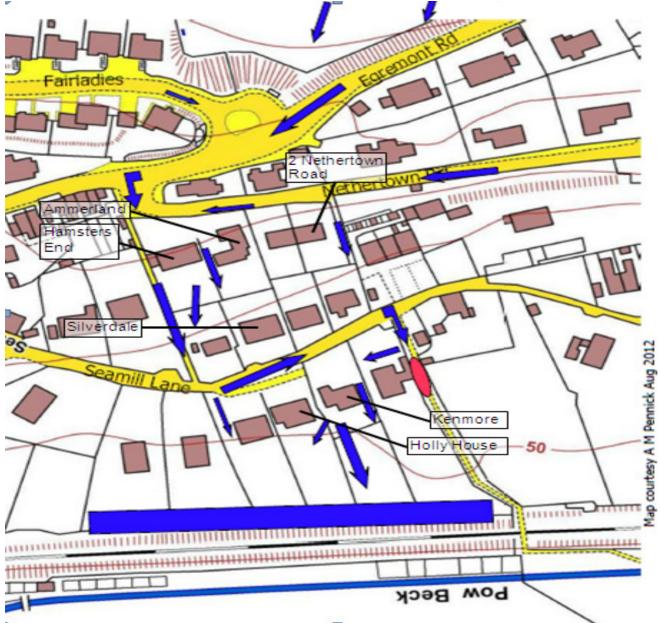
Surface water runoff deposited significant amounts of silt on the Fairladies roundabout. The roads run across the slope in this area and the water was channelled along them but escaped down the slope where there were gaps at road junctions, footpaths, hedges and garden gates.

Figure 10. Flood flow routes, Egremont Road/Seamill Lane

Flow routes through gardens caused extensive damage demolishing walls at 'Silverdale' and 'Holly House', flooding garages moving soil and paths away from gardens at 'Ammerland', 'Hamster's End', 'Silverdale', and 'Kenmore', and depositing debris in others. Water entered 'Silverdale'. The water flooded the bottom of the gardens on Seamill Lane and could not discharge into Pow Beck as the railway embankment acted as a dam.

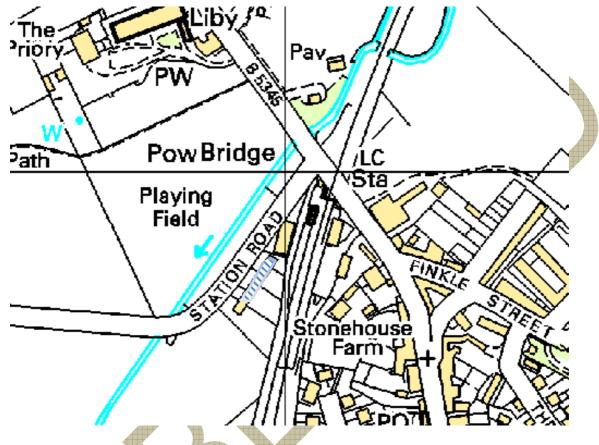
The source of the water that flooded these properties is unclear. Reports say that the water rose out of the skirting boards in numbers 1 and 2 indicating groundwater flooding associated with a rising Pow Beck. If the floor is suspended, it could have been surface water flooding that collected under the floor.

Figure 11. Flooded properties in Station Road

There are also claims that an underground stream passes under the properties. There is no record of a culvert in this area. Surface water would follow the topography but higher ground is cut off from Station Road by the railway embankment. Anecdotal evidence suggests there was an old well in the garden of number 2 and this has been filled in.

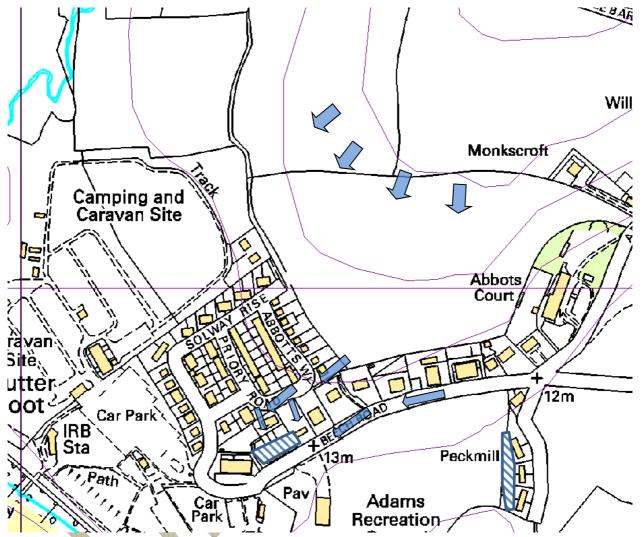
Flood water ran down the driveways and paths from Priory Road which is above the property and followed the fall of Beach Road towards 'Tomlin House'. Road gullies along Beach Road were found to be blocked. The pipe which takes water from the gullies outside 1 Abbotts Cottages appeared to have collapsed. The garden of 'Tomlin House' is lower than the road and

Figure 12, Flow routes and flooded properties, Tomlin House and Peckmill

water flooded the lower floor causing extensive damage. Ground water may also have been a factor as it has been an issue in the past resulting in the resident installing a pump, permanently in the cellar. There were no issues found with the sewers.

'Peckmill' was flooded by surface water which gathered in the Adams Recreation Ground. Anecdotal evidence suggested that the land drainage in the recreation ground is blocked. The floodwater overflowed into the neighbouring gardens on 'Peckmill' where the surface water drainage was unable to cope with the volume of water. These drains are reported to run to Pow Beck although there is a watercourse closer than this and a combined sewer runs under 'Peckmill' as well. There were no issues found in the combined sewer or the lateral surface water system that runs into it. There are concerns that outfalls into Pow Beck may not be working as it is holds significant gravel and silt deposits.

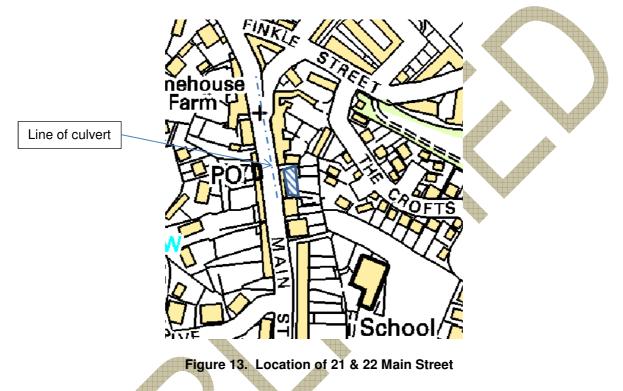
A culvert runs in front of 21 and 22 Main Street and water rose up through the ground and the flagged stone paving above it, to a depth of 75mm. The properties were flooded internally as the water rose through the floors.

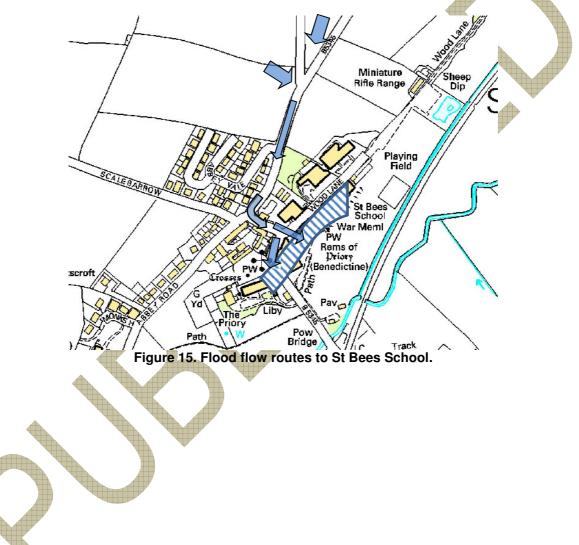
Intense rainfall caused runoff from the saturated fields on Scalebarrow Hill onto the roads. The highway drainage system was unable to cope with the volume of water. A drain on the B5345 above the school takes highway drainage in normal rainfall conditions but during the flooding water was discharged from the drain into Wood Lane.
