Millom and Haverigg

Flood Investigation Report

30th September 2017

This flood investigation report has been produced by Cumbria County Council as a Lead Local Flood Authority under Section 19 of the Flood and Water Management Act 2010.

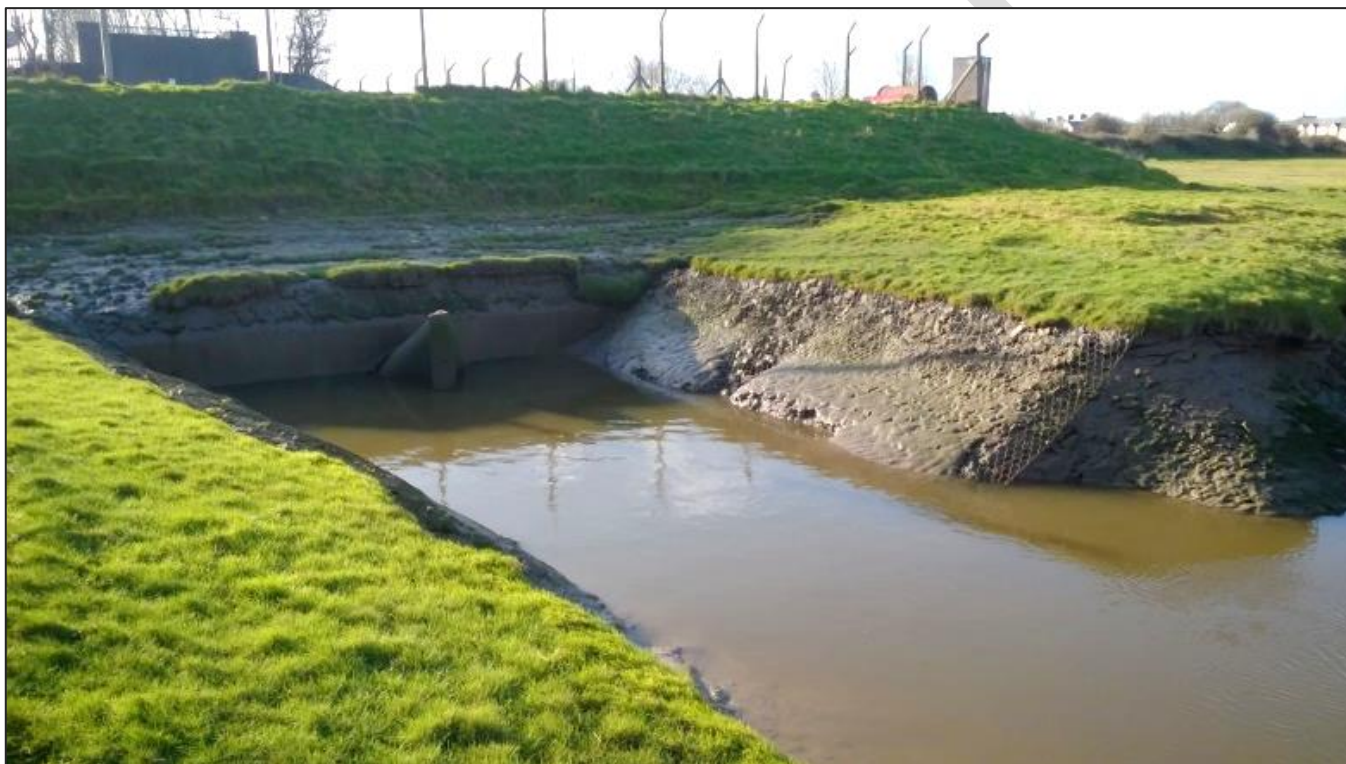
Photograph 1: Duckbill valve at King Street Pumping Station

Several residents refer to this valve as a tidal gate and were concerned that it was not open during the event. The graph under figure 20, demonstrates this was not the case.

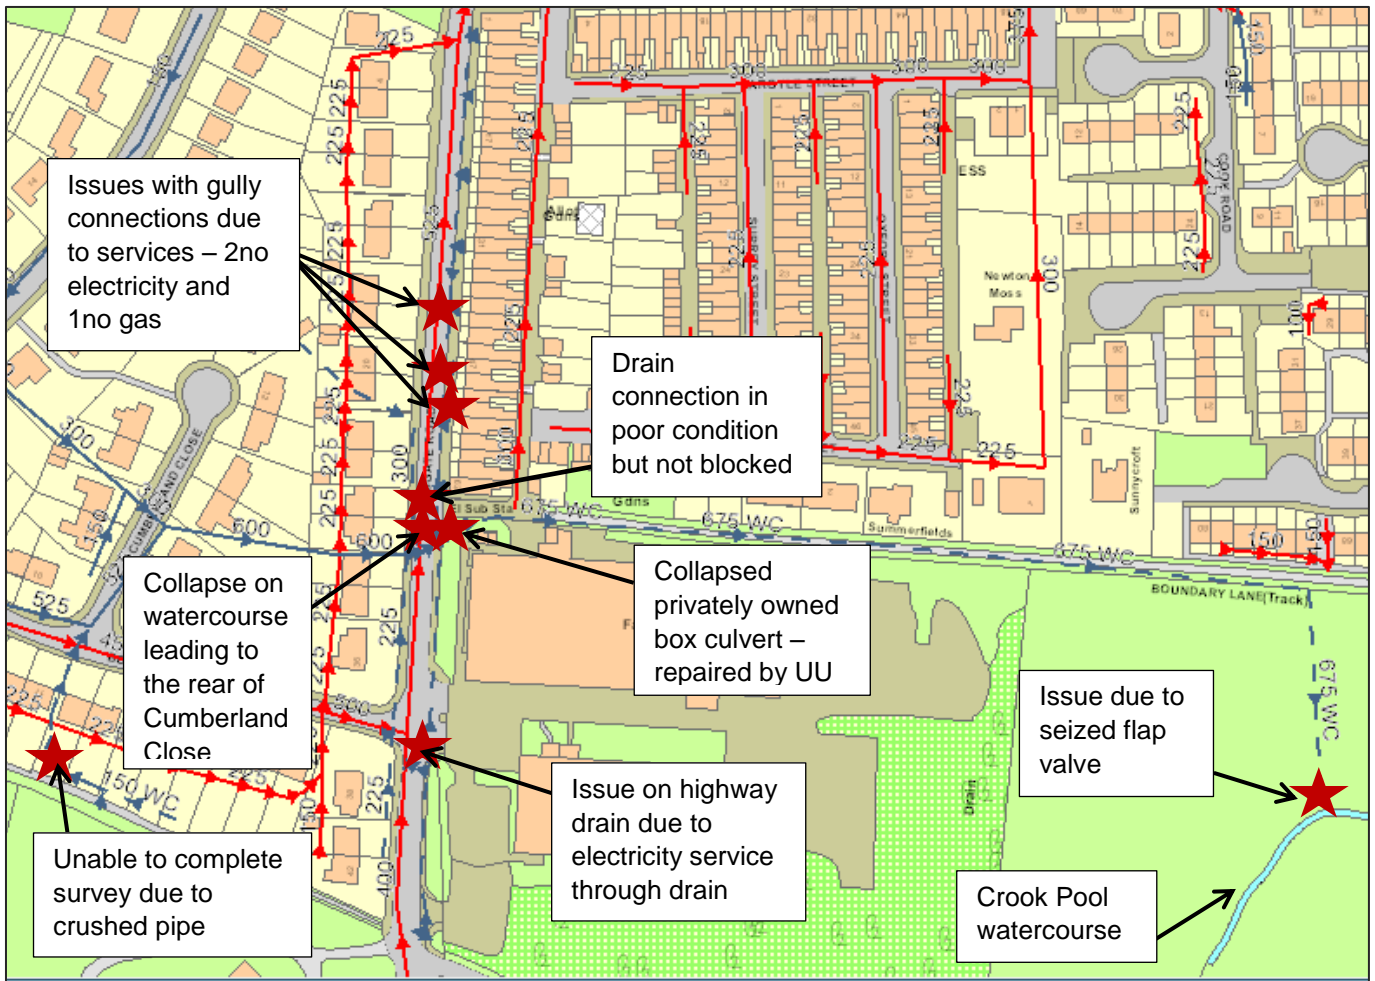
Figure 23: Location of issues on the surface water drainage systems in Mainsgate Road and Bowness Road

During the investigations as detailed in Figure 23 several issues were found on the drainage systems which are summarised as follows –

- Seized flap valve – now removed
- Collapse on the watercourse from Cumberland Close – to be programmed for repair in the near future
- Collapse on the culvert through the grounds of the factory – now repaired by United Utilities
- Badly damaged highway drain connection – now repaired by Cumbria County Council
- 4no damaged drains due to service installation – 1no gas and 3no electricity have now been repaired, see **photograph 2**.
- Crushed pipe rear of Bowness Road – the pipe is still operating but camera is unable to progress – it has been established that this transfers surface water from fields to the rear, to the public surface water system.

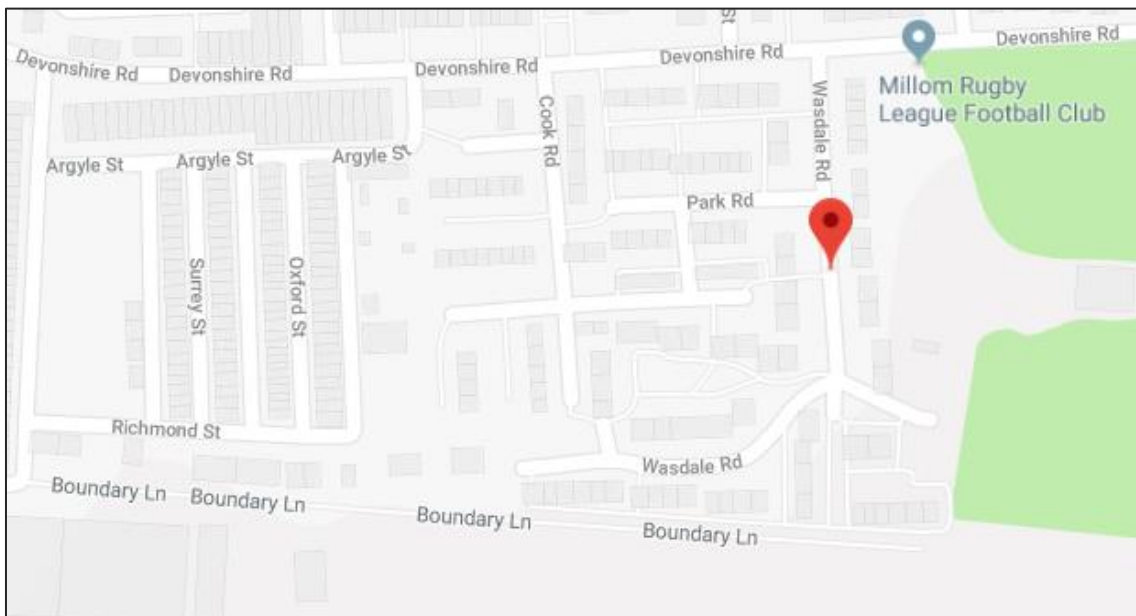
Figure 24: Surrey Street / Oxford Street / Richmond Street / Wasdale Road

It is also noted that downspouts from the roofs of these properties discharge direct to the footway and into the highway drainage system. Due to the age of the properties it is unclear what design standards the gully system will have been designed to and it is unlikely that it would have been designed to accommodate a rainfall event such as this. It can also be noted that the surface water that did drain through the gully system also overloaded the combined public sewer system contributing to the capacity issues and surcharging from the public combined sewer.

From information gathered regarding this area it is concluded that the likely cause of the flooding is the extreme rainfall event exceeding the design capacity of the drainage systems available.

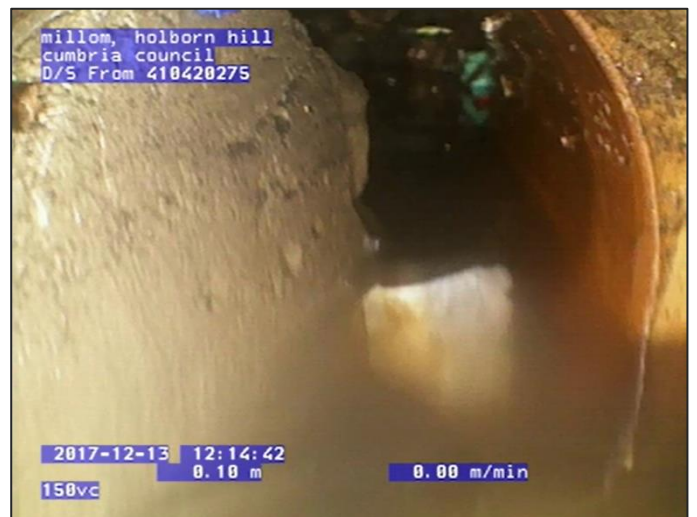
Figure 27: Standing water in damaged highway gully

The photograph below shows a block of concrete restricting the size of the pipe. It should be noted that this is a single arm connecting only to a gully; however this does cause an area of the highway to flood during downpours.

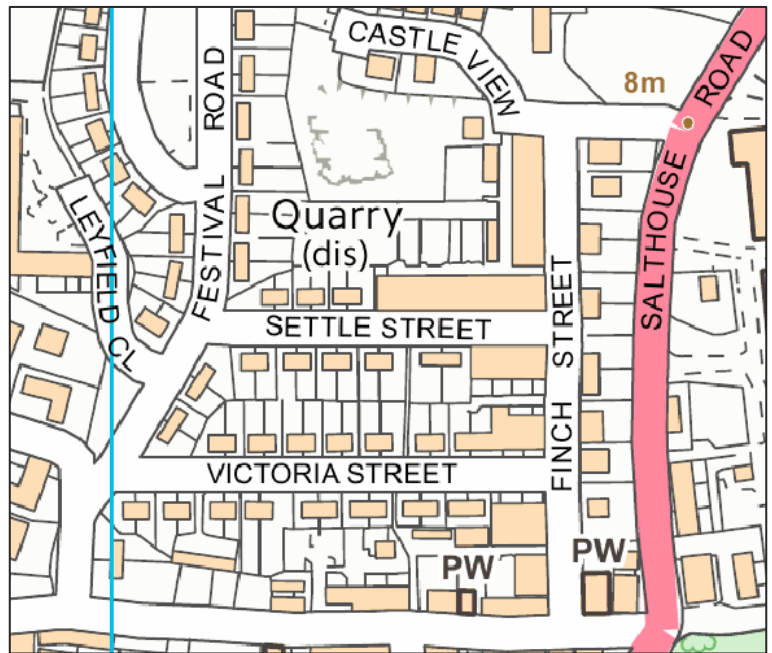
Figure 28: Finch Street / Settle Street

Investigations suggest that the cause of the flooding in this location was due to the extreme rainfall event causing extensive runoff from the Quarry which flowed into Settle Street and Finch Street.

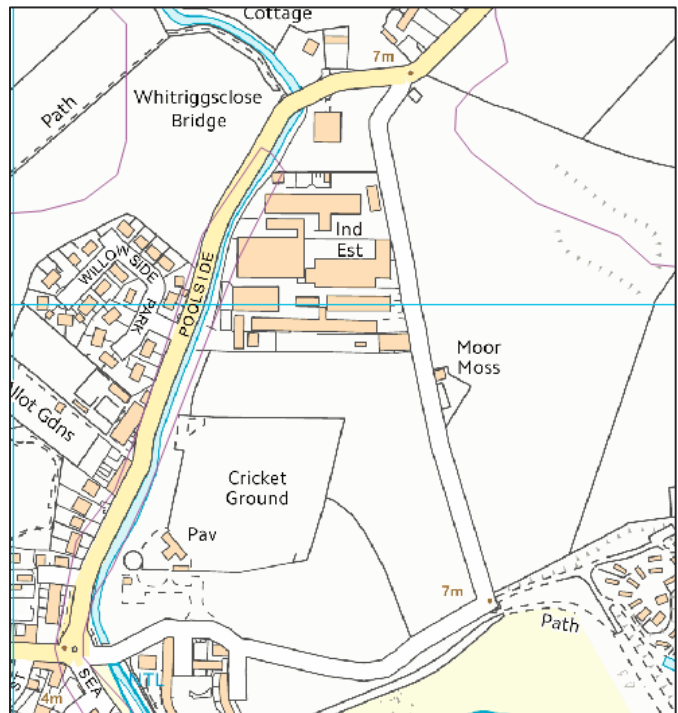
Figure 29: The Old Tannery / Moor Moss

The only drains found for surface water in this area were highway gullies. These all link into a combined sewer beneath the highway that runs toward the sea, falling west half way down the field to the pumping station.

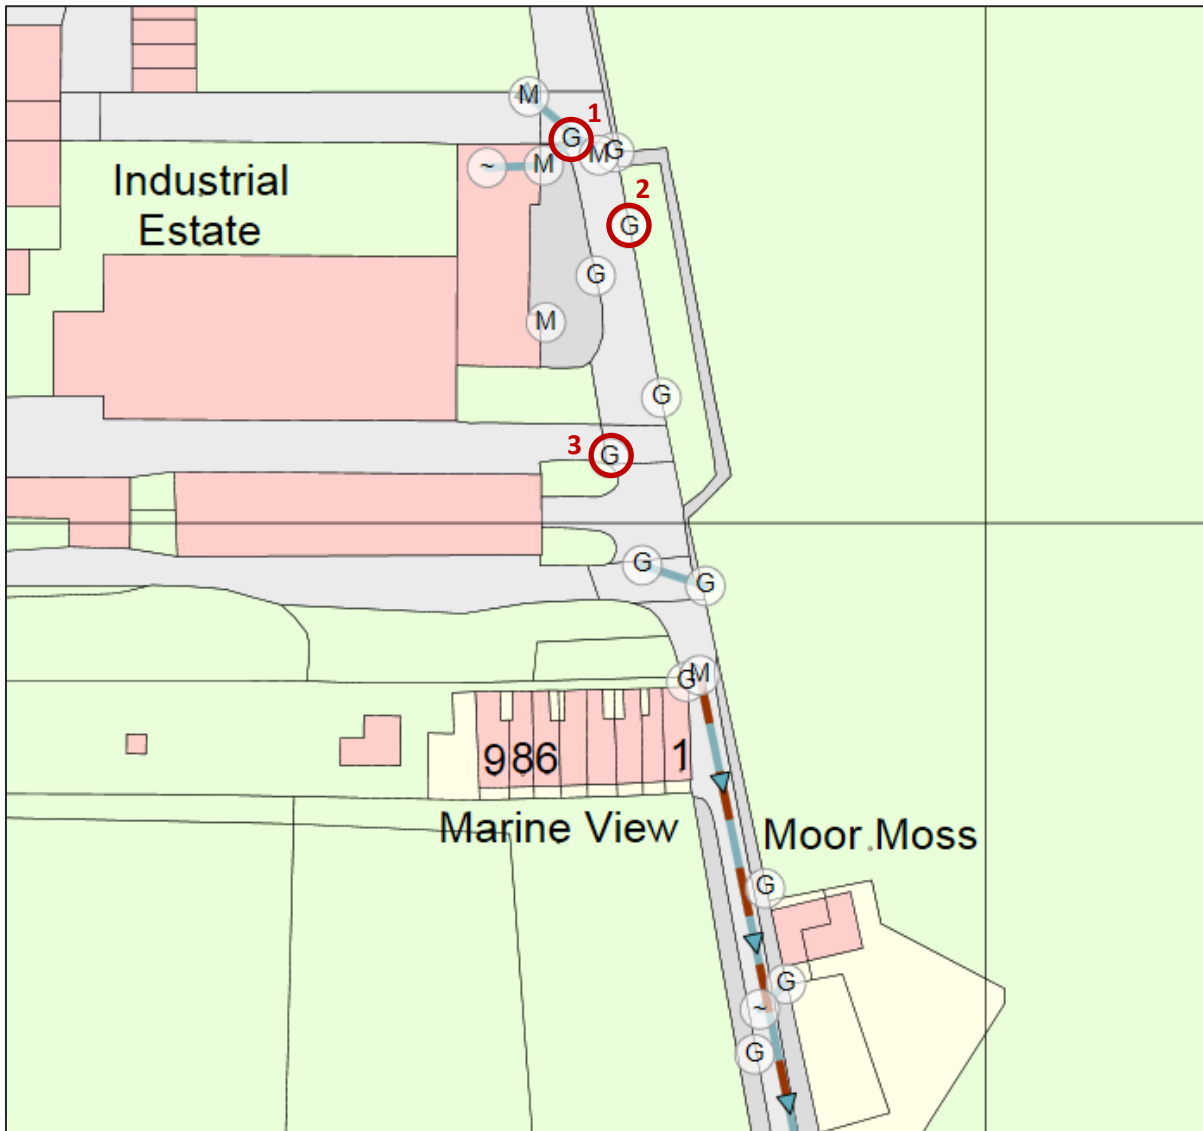
Figure 30: Obstructed Highway Gullies

Three of these highway drains were found to be defective (see **figure 30** for reference):-

- Number 1 was heavily silted. This has since been cleared and is now in full working order.
- Number 2 was covered by a sheet, presumably to protect the drain from gravel (see **photograph 11**). The sheet has been removed and the gully is fully functional.
- Number 3 has partially collapsed, severing the link between the gully and the combined sewer. This has now been repaired and reconnected.

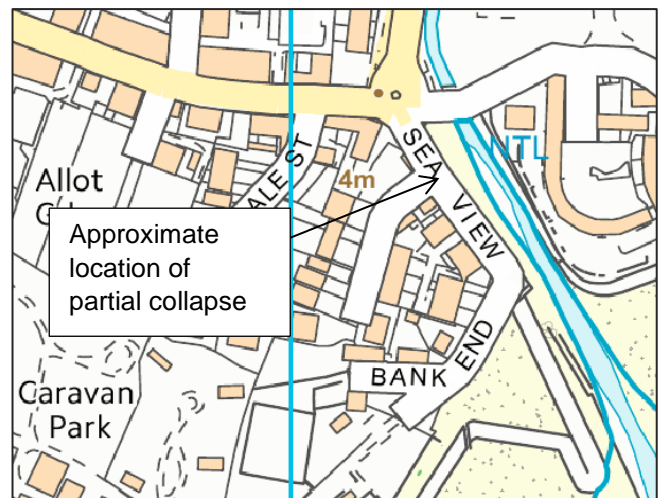
Figure 31: Bank End area

It is believed that the flooding is caused due to the properties location at low point in the land. The only drainage we were able to locate was the combined system, however during the event this exceeded its design capacity and ultimately caused flooding at the low point.

Cumbria County Council has since surveyed the highway gully systems and confirmed by dye testing that many gullies discharge direct to the public sewer system. However, on Sea View the highway system discharges direct to Haverigg Pool where a partial collapse had been located and repaired.

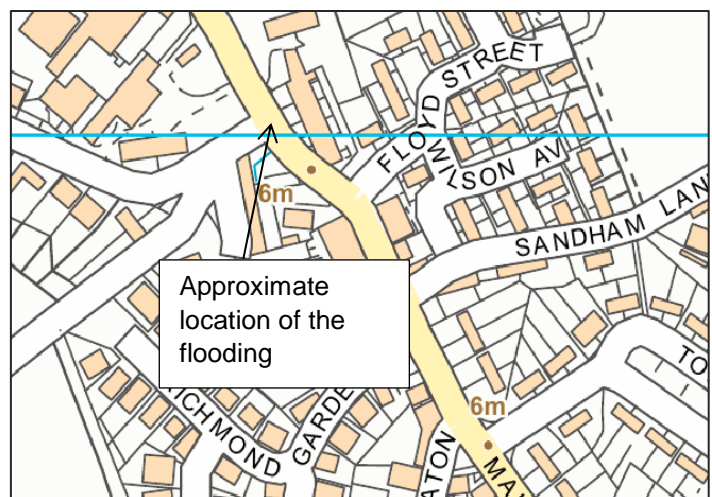
Figure 32: Main Street / North Lane

Five properties were reported as internally flooded at this point. Since the event Cumbria county Council has conducted surveys in and around the area in an attempt to determine the cause. Similar to Millom the surface water around this area all falls into highway drains which are subsequently linked to the combined sewer system.

It was discovered that the highway system is in full working order, as is the combined sewer. It is therefore believed that the design capacity for the system reached its limit due to the event.

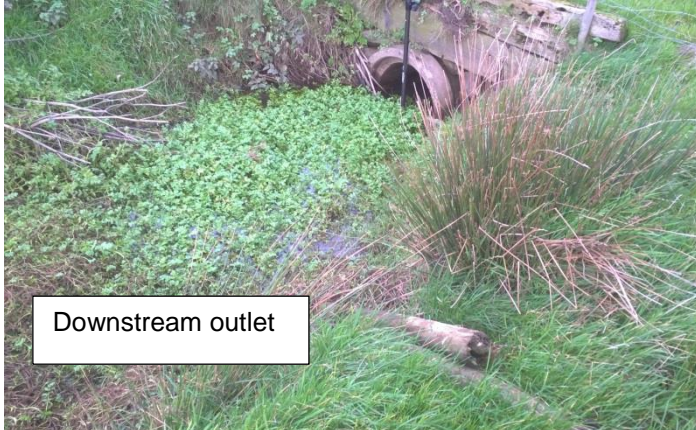
<p data-bbox="847 1173 1123 1234">Downstream outlet</p>
Outfall 1	IL 3.275	Concrete pipe 675mm dia.	Flap valve corroded and fixed in one position – needs attention

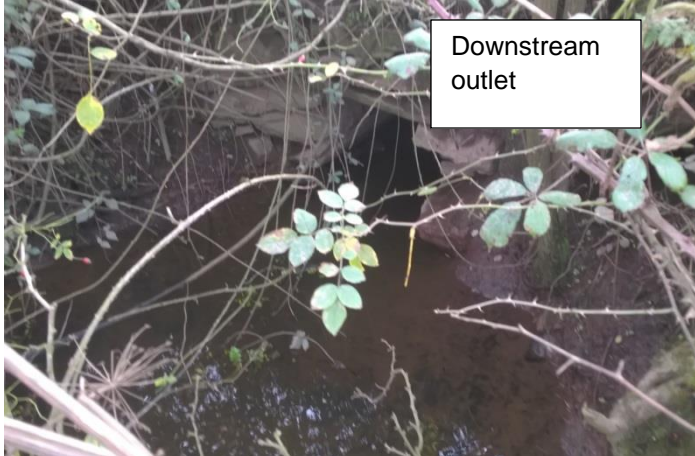
<p>Downstream outlet</p>
<p>Crossing 5</p>	<p>U/S IL 2.859 D/S IL 2.837</p>	<p>Stone culvert U/S 600mm high x 950mm wide D/S 650mm high x 550mm wide</p>	<p>Minor collapse at side of culvert – preliminary discussion with landowner regarding repair during inspection</p>

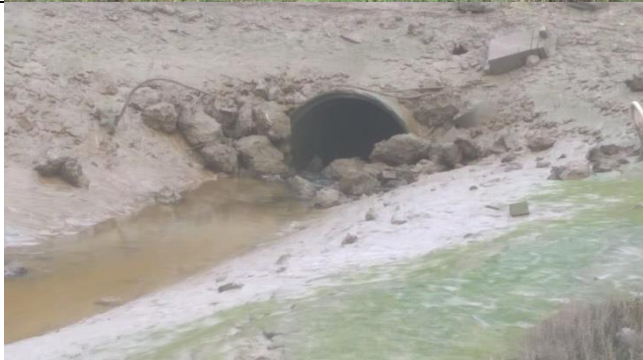
Inlet 2	IL 1.113	Concrete pipe 1700mm dia	Some stones at entrance – would benefit from removal

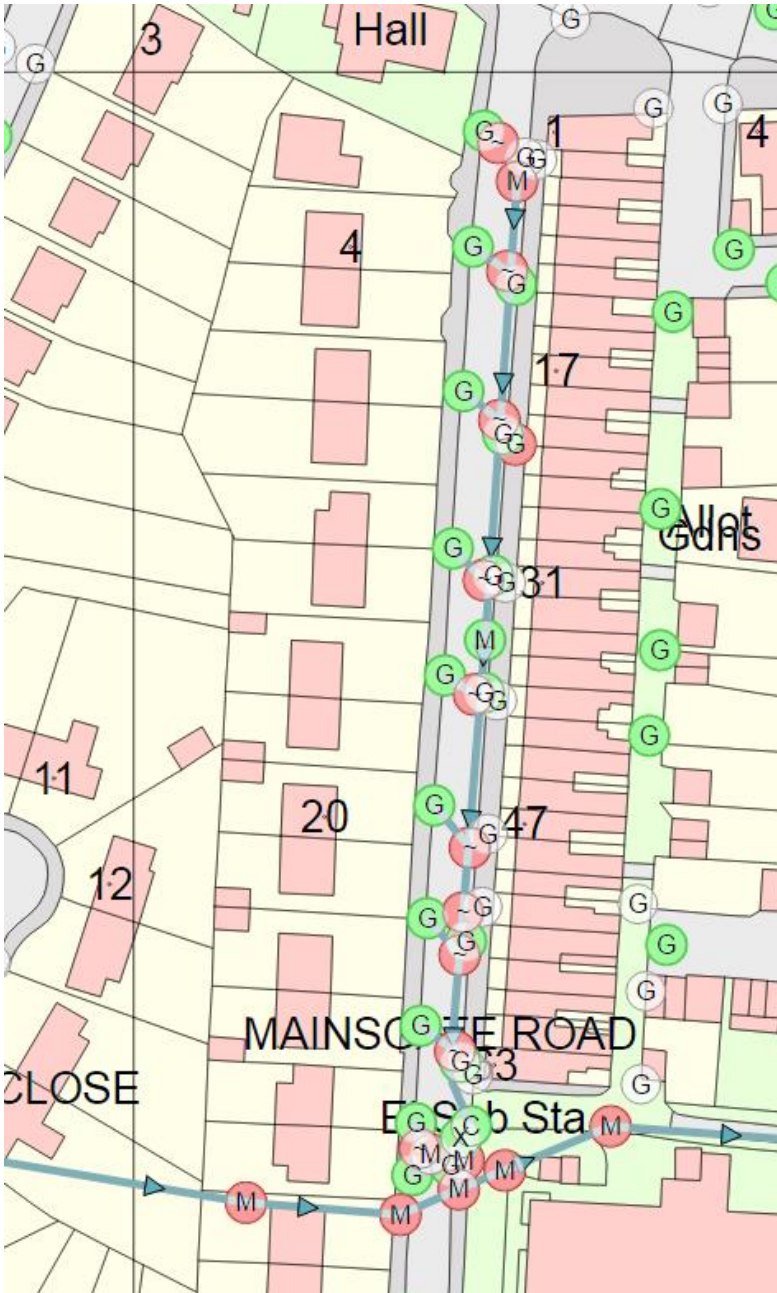
Damaged Highway Drainage in Mainsgate Road by ENW cabling work from no 1 to 63

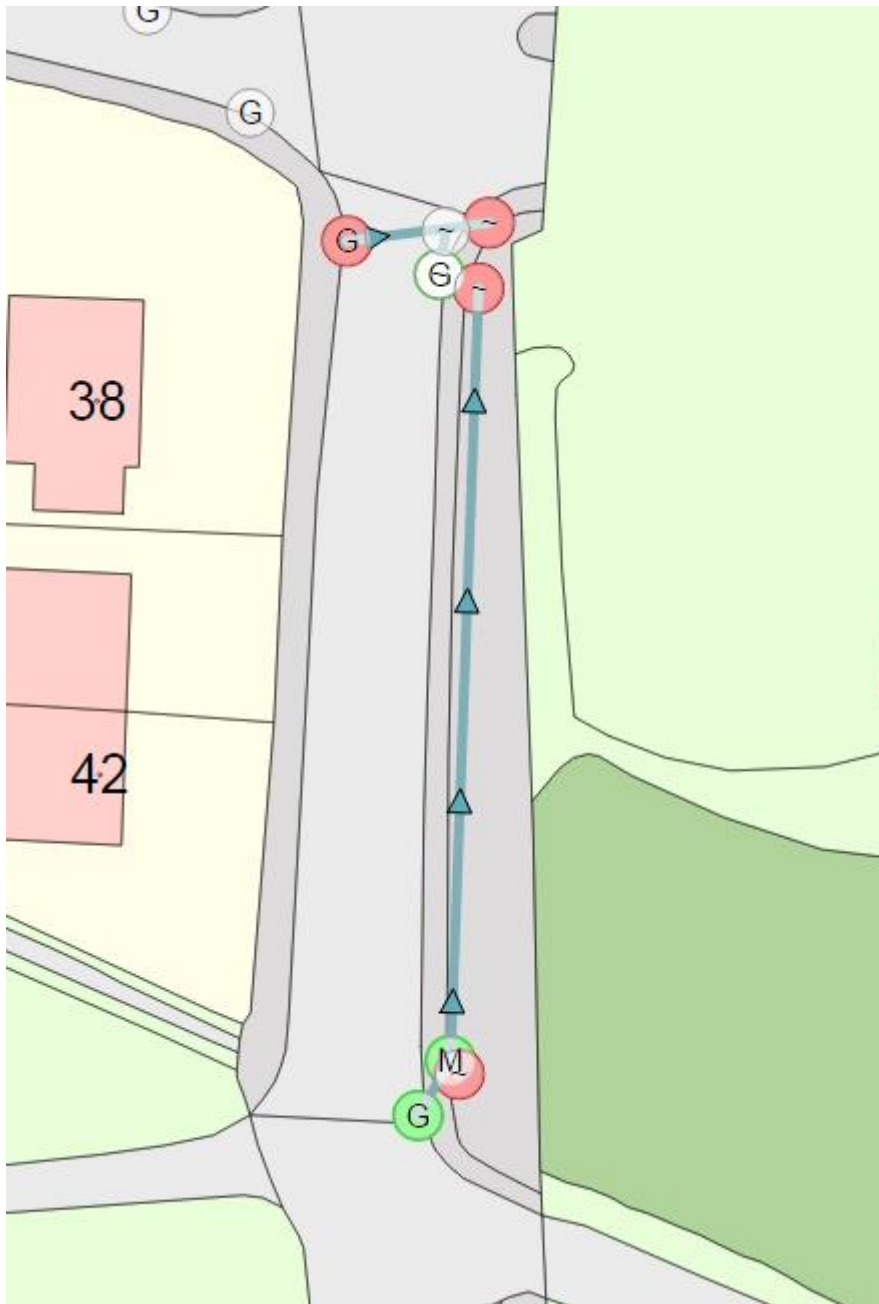
**Damaged Highway Drainage
in Mainsgate Road by ENW
cabling work next to CPG
Factory**
