Gamblesby

Flood Investigation Report No 62

Flood Events:
28th June 2012
26th November 2012
18th May 2013

This flood investigation report has been produced by Cumbria County Council as a Lead Local Flood Authority under Section 19 of the Flood and Water Management Act 2010.

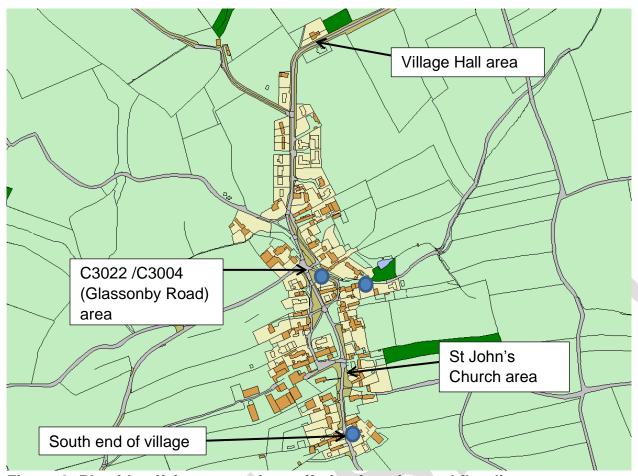
Figure 2: Plan identifying properties suffering from internal flooding

The four main areas affected by the flooding include the C3022 / C3004 (Glassonby Road) area, Village Hall area, St John's Church area and an area at the south end of the village.

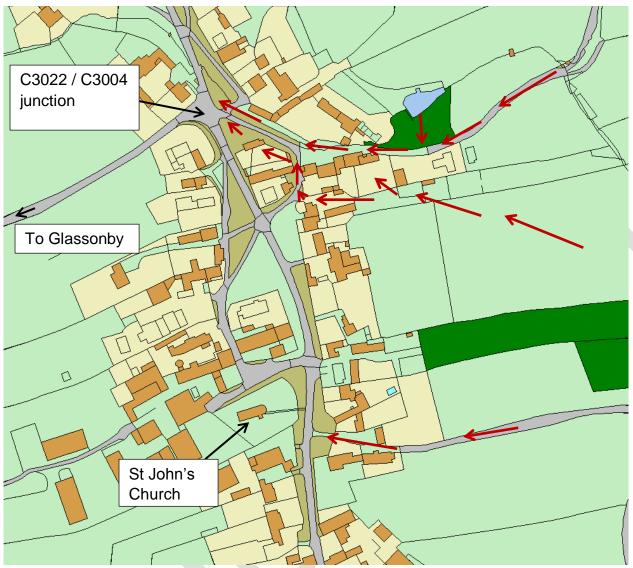
Figure 5: Plan showing the flow routes experienced during the flooding events at C3022/C3004 junction and St John's Church area

Flooding in the area of the C3022 / C3004 Junction (Glassonby road)

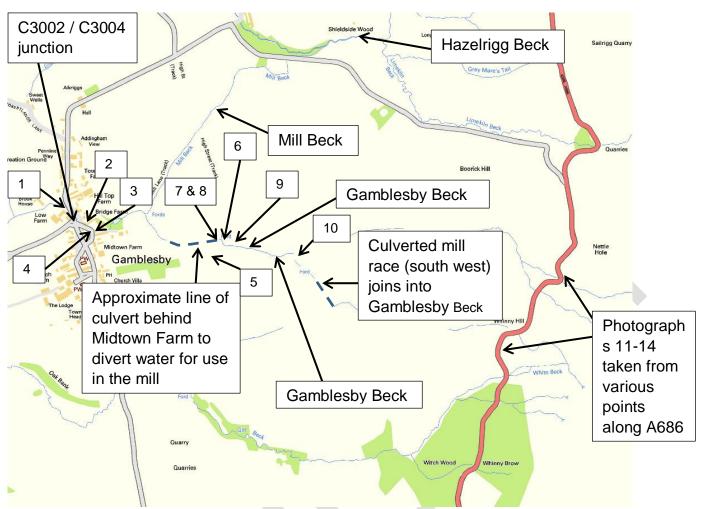
Figure 6: Plan indicating watercourses and drainage issues related to flooding around the C3002 / C3004 junction including location of photographs

There have been various changes made to the watercourses flowing towards Gamblesby generally connected to the supply of water to the Mill in the village. It is understood from residents that the original watercourse in this area has also been diverted through a culvert to provide a water supply for the Old Mill. This has included the extensive culverting through land behind Midtown Farm, and the creation of a channel to form Mill Beck from Hazelrigg Beck to connect to Gamblesby Beck. The culverting works were carried out pre 1867 as the 1867-68 1:10,560 Cumberland series maps indicate the culverting has already taken place.

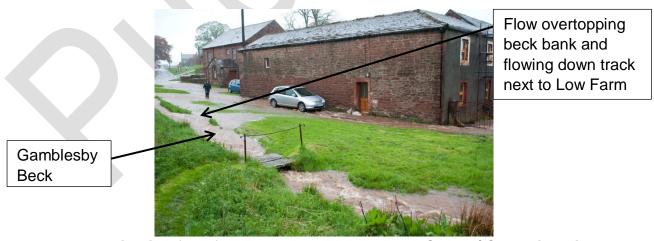
Photograph 1: Indicating flow from Gamblesby Beck near C3022 / C3044 junction

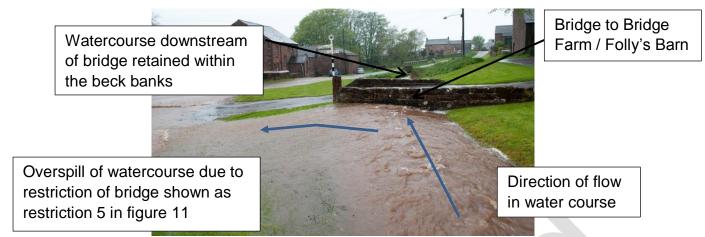
Photograph 2: Upstream of Bridge Farm / Follys Barn access bridge

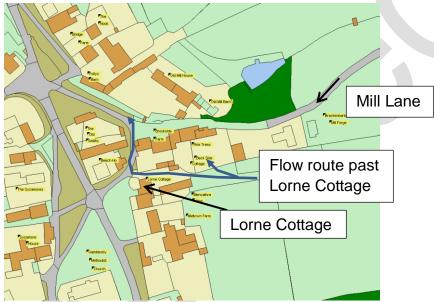
Figure 7: Plan identifying flow route past Lorne Cottage and down Mill Lane

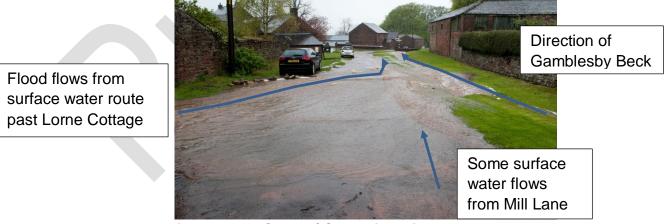
Photograph 3: Looking toward C3022 / C3004 junction

The above photograph highlights the surface water flows that cause the flooding from Lorne Cottage try to find their way back to Gamblesby Beck. Lesser flows also contribute to the flooding from Mill Lane. Residents have used sandbags where possible to divert floodwaters back into Gamblesby Beck.

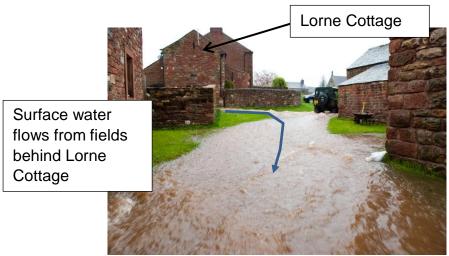
Photograph 4: Flood waters flowing past Lorne Cottage

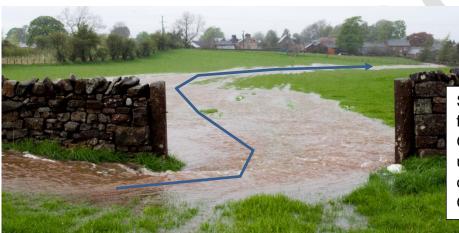
Surface water flow towards Gamblesby due to under capacity of culvert on Gamblesby Beck

Photograph 5: Showing surface water flowing down field towards Gamblesby

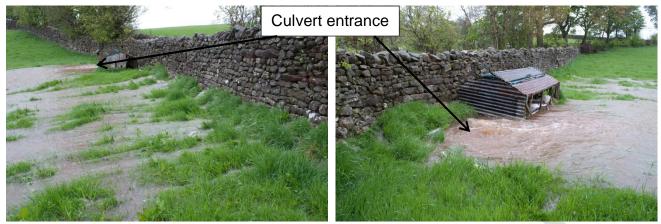
Photographs 7 & 8: Floodwater flowing through wall from bridleway shown in photograph 6.

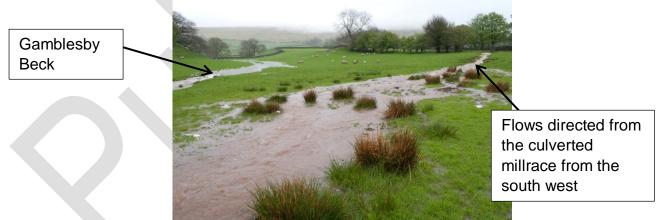
Photograph 10: Upstream of Gamblesby indicating volumes of water from Gamblesby Beck and the culverted mill race from the south west.

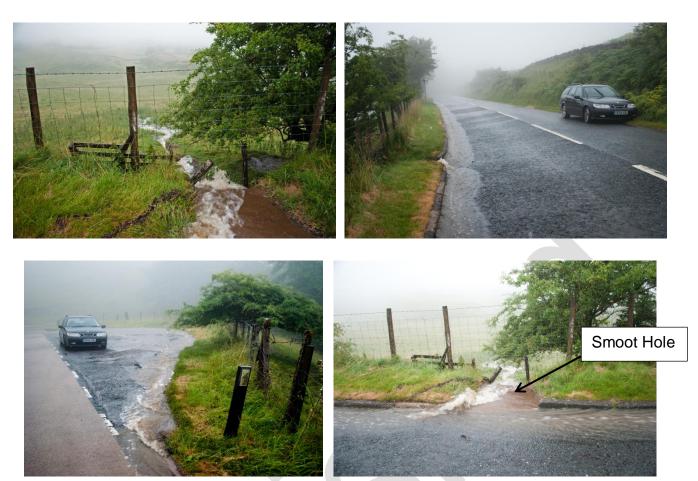
The Parish Council have also carried out investigation work to assist in identifying the sources of the surface water from above Gamblesby and provided photographs indicating the volume of water channelled along the A686. The following photographs indicate the volumes of water flowing along the A686 that finds its way into Gamblesby Beck.

Photographs 11-14: Examples of surface water flow on A686 above Gamblesby

| Action by | Recommended Action | How | |
|---|--|--|--|
| CCC Highways | Investigate possible sources of surface water flow on to A686. | Site visits during wet weather to identify sources. Surface water flow already identified from Twotop Hill track. Maintenance works carried out to restore surface water from Twotop Hill flows to Howgill Beck. COMPLETED | |

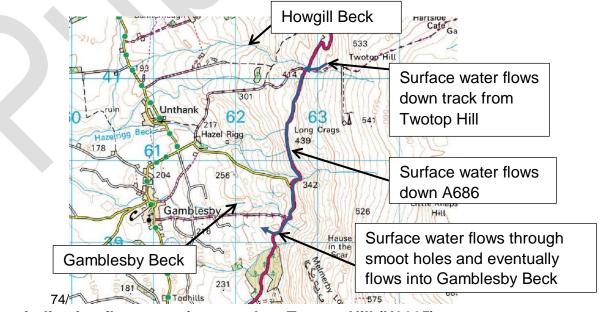
Figure 8: Plan indicating flow route from track to Twotop Hill (U3665)

Further investigations carried out by CCC Highways have identified issues with drainage on the track (U3665) to Twotop Hill. This has caused surface water to run from the track on to the A686 and to find its way into Gamblesby Beck. CCC Highways have carried out works in October 2013 to ensure that flows from the track (U3665) flow in to Howgill Beck which reduces the flow into Gamblesby Beck. The following plan indicates the location of the track and the watercourses.

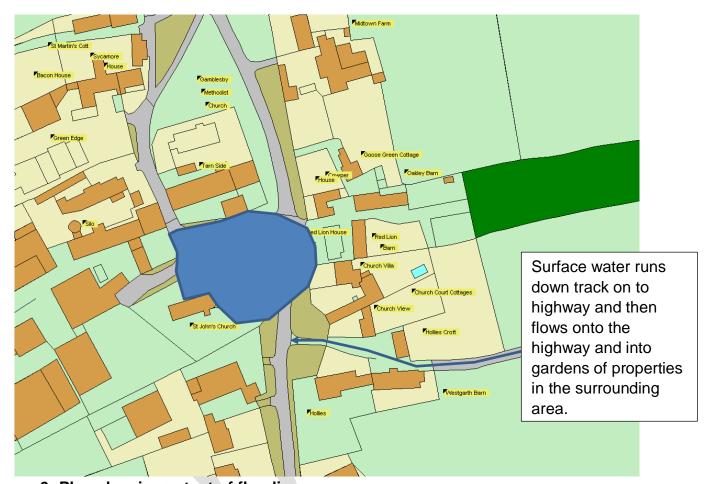
Figure 9: Plan showing extent of flooding

During the 28th June 2013 event flooding of one property and the highway occurred. Flooding of a further property was avoided by the prompt action of the resident. The following plan indicates the extent of the flooding and the direction of the surface water flow into Gamblesby.

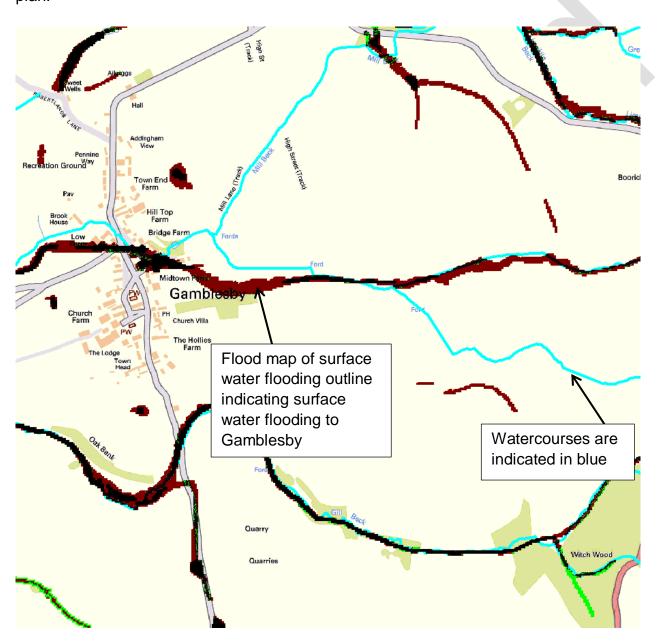
Figure 4: Plan indicating surface water flow as predicted by the Flood Map of Surface Water

There are several areas of flooding in Gamblesby, however, the area around the C3022/ C3004 is affected by flood water running from the east of the village from the direction of the Pennines. The water appears to be as a result of minor watercourses reaching capacity and overflowing following flow routes towards the village. Surface water mapping carried out by the Environment Agency clearly indicates the line of one of these routes as shown in the following plan.

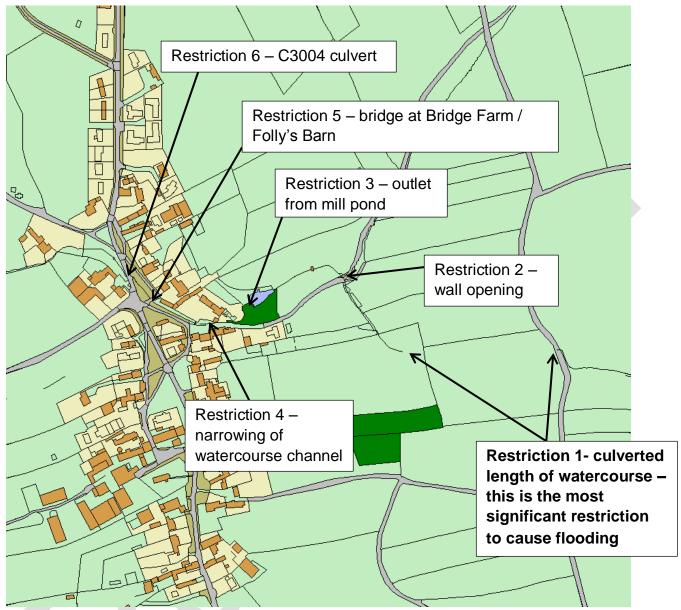
Figure 11 – Restrictions on the watercourse contributing to the flooding in the 'Mill Lane' area.

The most significant restriction on the watercourse in the plan above is the culvert indicated as number 1. This has the effect of both (to some extent) protecting the watercourse downstream and causing flooding by diverting surface water towards properties. The other restrictions have a minimal effect on flooding as the amount of overspill from the watercourse at these points appears to be a more manageable quantity except at restriction 5 where photograph 5 shows that the bridge is causing an overspill onto the C3004.

| Action by | Recommended Action | How | |
|---|--|--|--|
| CCC LFRM | Apply to Defra (through the Environment Agency) for Flood Defence Grant in Aid to carry out a study to identify solutions to mitigate flooding. Possible solutions are upland storage combined with watercourse redirection. | Application to be submitted to Defra June 2013 for funding in 2014/15. Resubmission March 2014 | |
