# Old Tebay

## Flood Investigation Report

**Flood Event 5 December 2015**

This flood investigation report has been produced by Cumbria County Council as a Lead Local Flood Authority under Section 19 of the Flood and Water Management Act 2010.

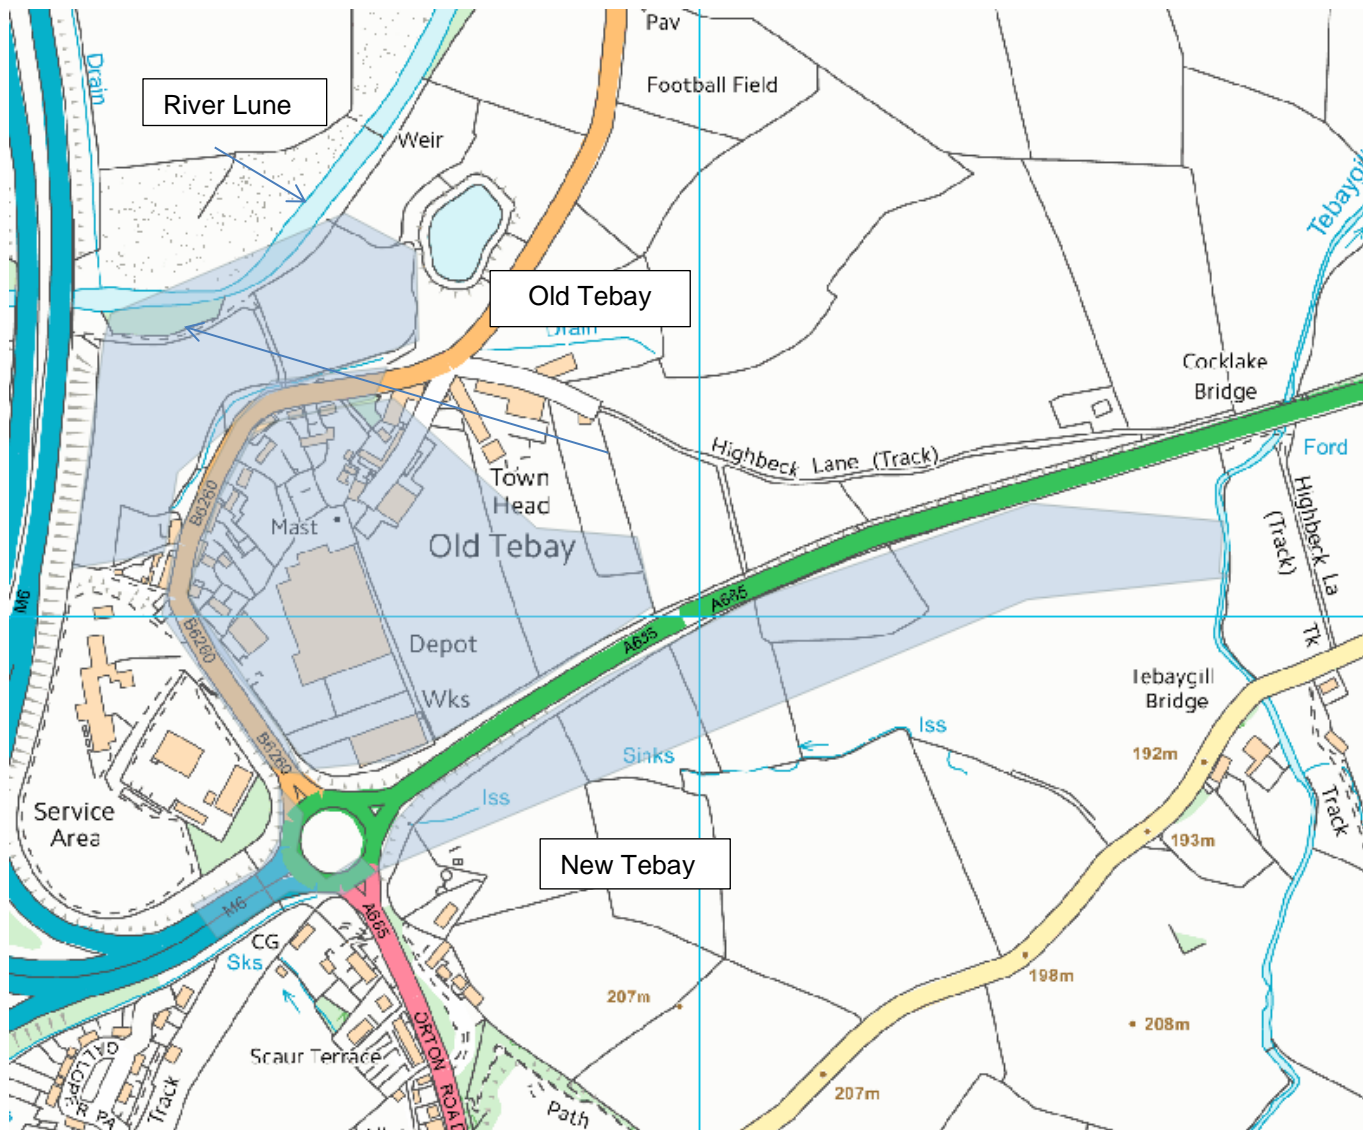
Thirteen properties were flooded internally from water seeping slowly under floors. The local sewage pumping station run by United Utilities was also affected by the flooding.

Figure 2: Flooding extent in Tebay

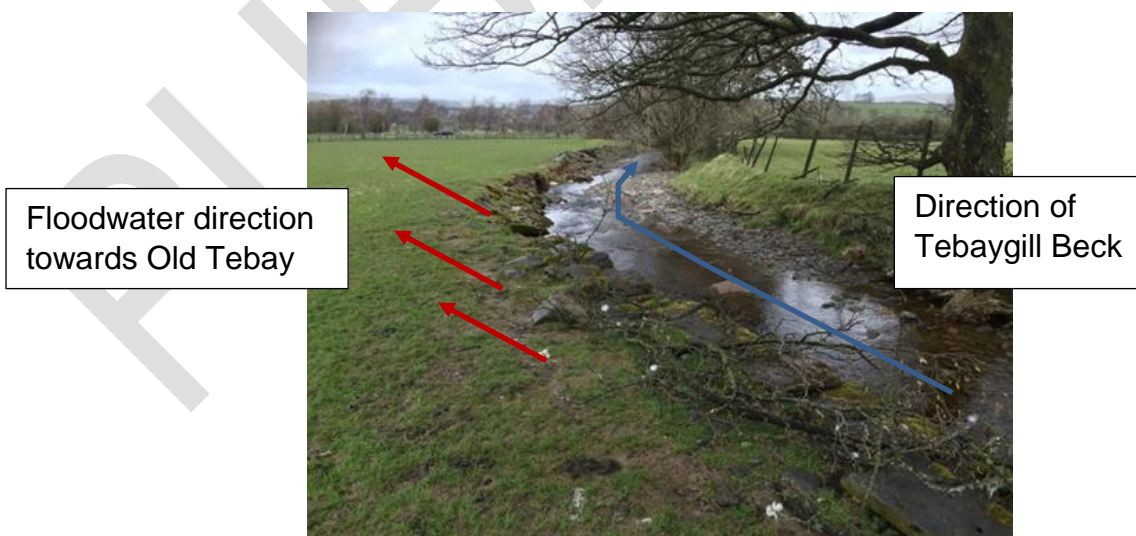
**Photograph 1: Flow route from Tebaygill Beck**

It is understood that floodwater overtopped the bank of Tebaygill Beck and flowed across the fields in the direction as indicated in the following photograph.

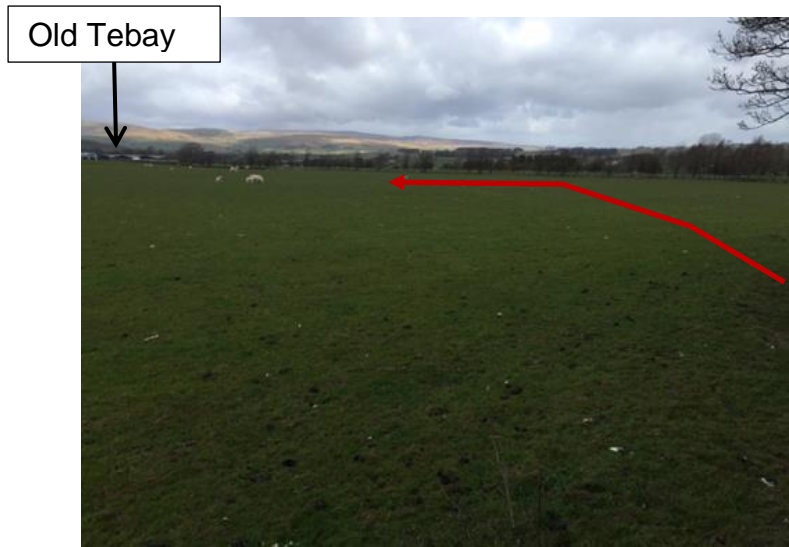
The floodwater is understood to flow down the edge of the A685 embankment to the underpass and then towards Old Tebay

**Photograph 2: Flow route of flood water towards Old Tebay from Tebaygill Beck**

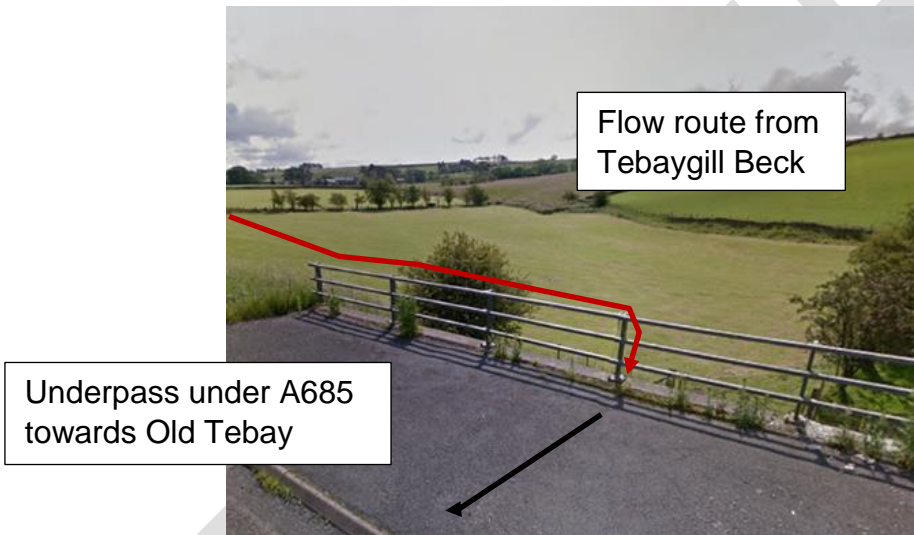
**Photograph 3: Flow route of flood water from Tebaygill Beck to underpass under A685**

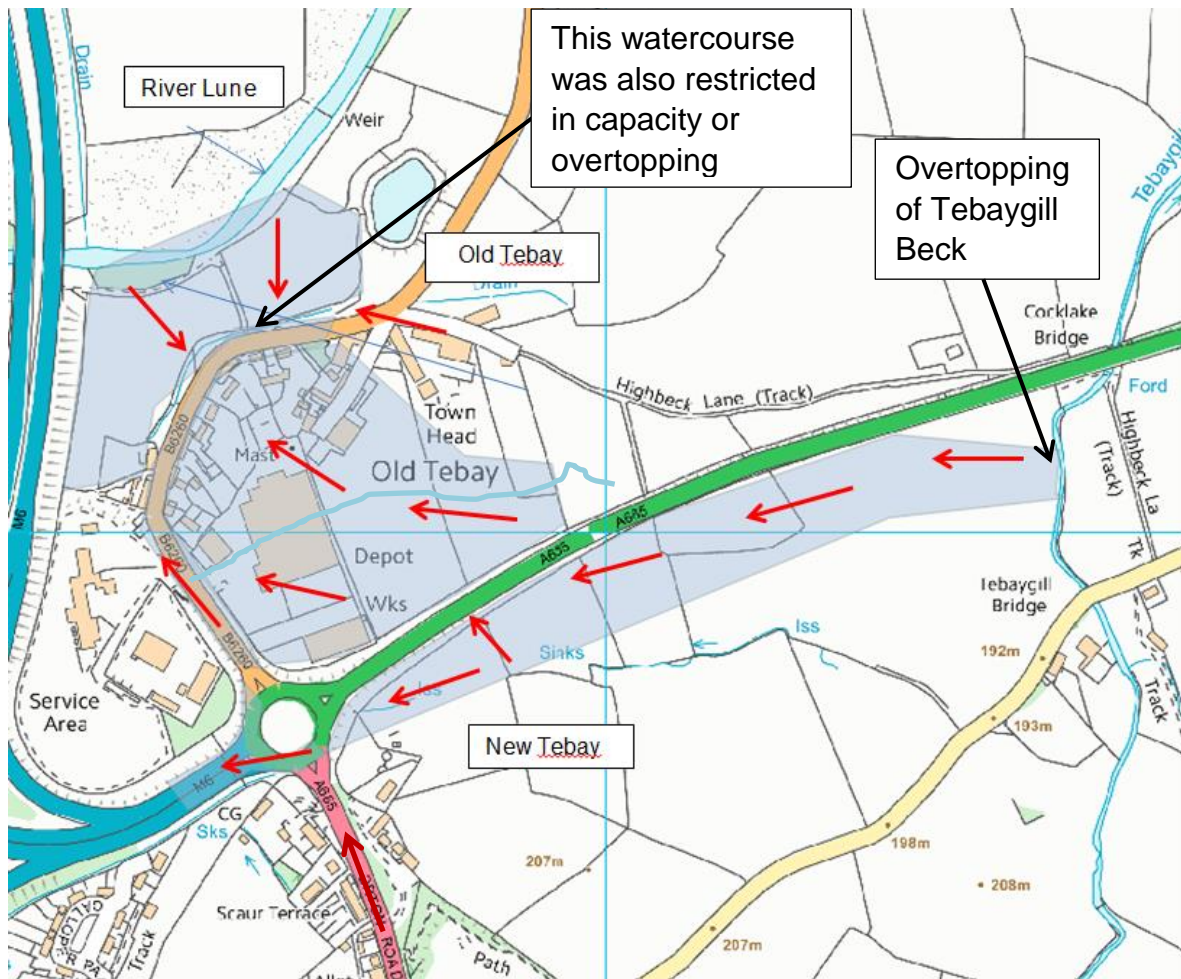
It is unclear from the evidence provided if downstream structures played a significant role in causing Tebaygill Beck to back up and spill over the embankment between Tebaygill Bridge and Cocklake Bridge. An initial assessment of the watercourse structures has been made and included as Appendix D as part of this report. It is also understood that the Lune Rivers Trust have also carried out an assessment of Tebaygill Beck, however, their report is not yet available.

**Figure 9: Surface water flow routes in Old Tebay**

The most significant flow route was that from the overtopping of Tebaygill Beck which flowed through the field adjacent to the A685 along the bottom of the road embankment, underneath the A685 carriageway via an agricultural underpass and then through the field and into Old Tebay.

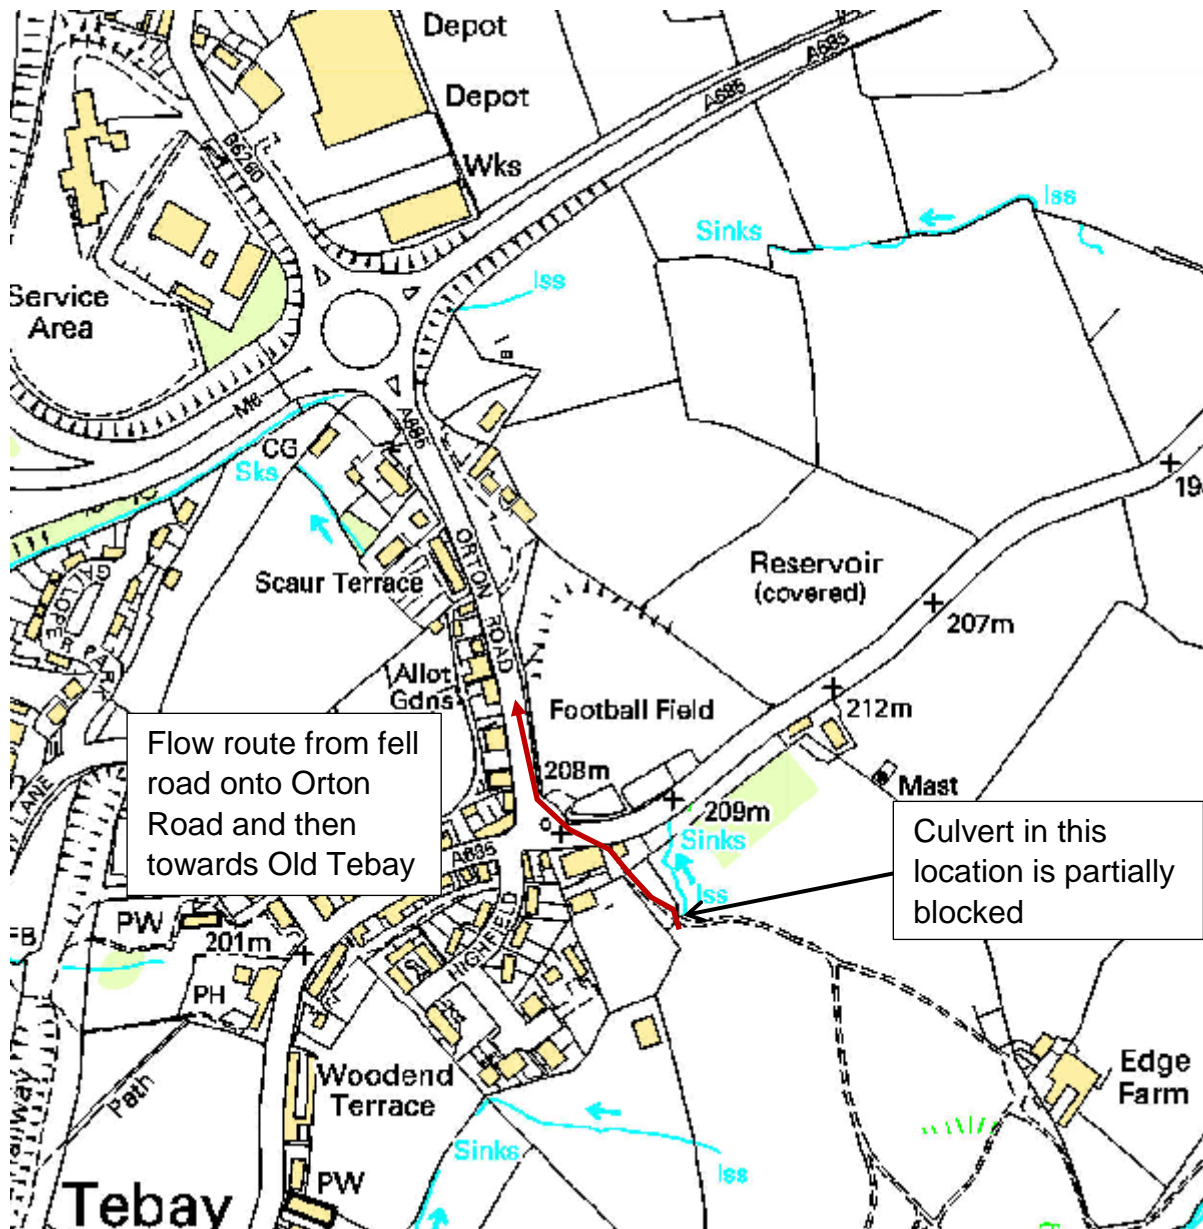
A secondary flow route was also identified from the fell road leading on to Orton Road and then flowing towards Old Tebay. Upon further investigation it was discovered that the watercourse was partially blocked and unable to work at full capacity. The following plan shows the location of the watercourse that is partially blocked.

**Figure 10: Flow route from Fell road towards Orton Road**

During this event and other times of particularly high rainfall events it has been noted that surface water flows from this area along Orton Road and into Old Tebay. Upon further inspection it is noted that the watercourse above a culverted section as indicated in the photograph 4 requires some maintenance to ensure it does not overtop during heavy rainfall events. The Lead Local Flood Authority (LLFA) will be working with the land owner to ensure the watercourse is maintained to reduce the risk of overtopping during heavy rainfall events.

A further source of flood water was from the fell road as it is considered that the partially blocked culvert in that location caused surface water to flow onto the highway and then down Orton Road and into Old Tebay.

LLFA	Work with landowner to maintain watercourse on fell road	Late autumn /early winter 2016

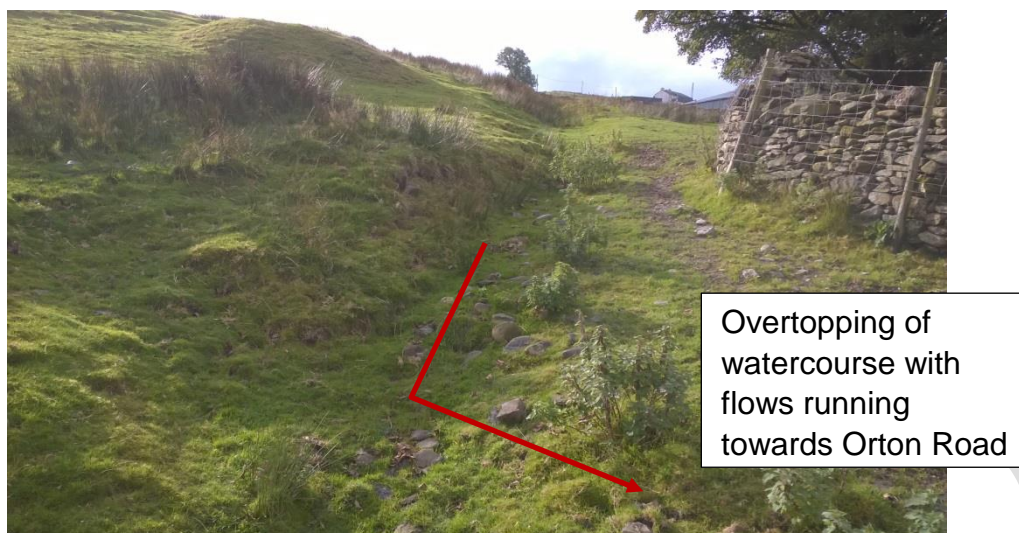
**Photograph 4: Watercourse above fell road**

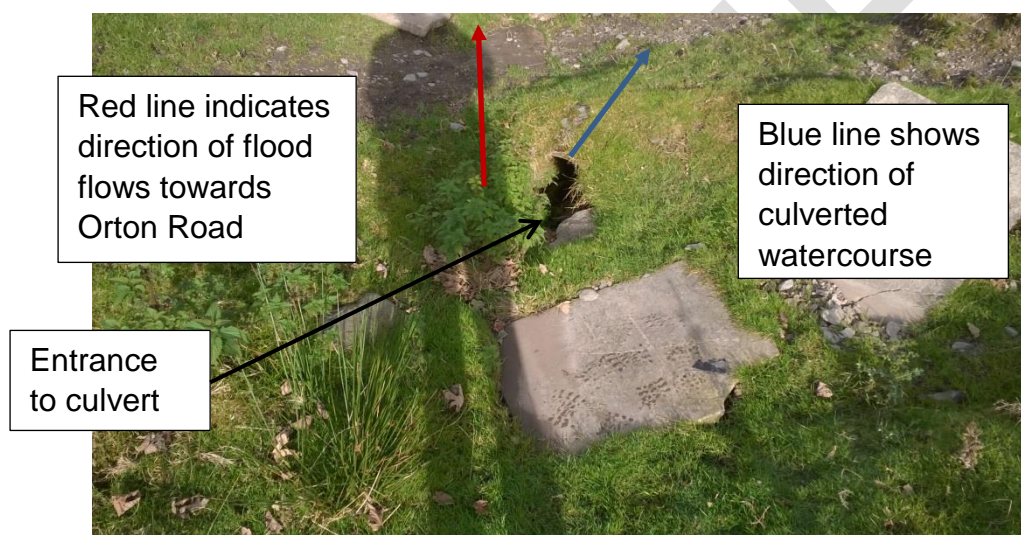
This watercourse also enters a section of culvert as it flows under the U3282/road to the fell which also appears to be partially blocked. The LLFA will also be ensuring that the culvert is cleaned and functioning to its full capacity. Photograph 5 shows the entrance to the culvert.

**Photograph 5: Entrance to culverted section of watercourse**

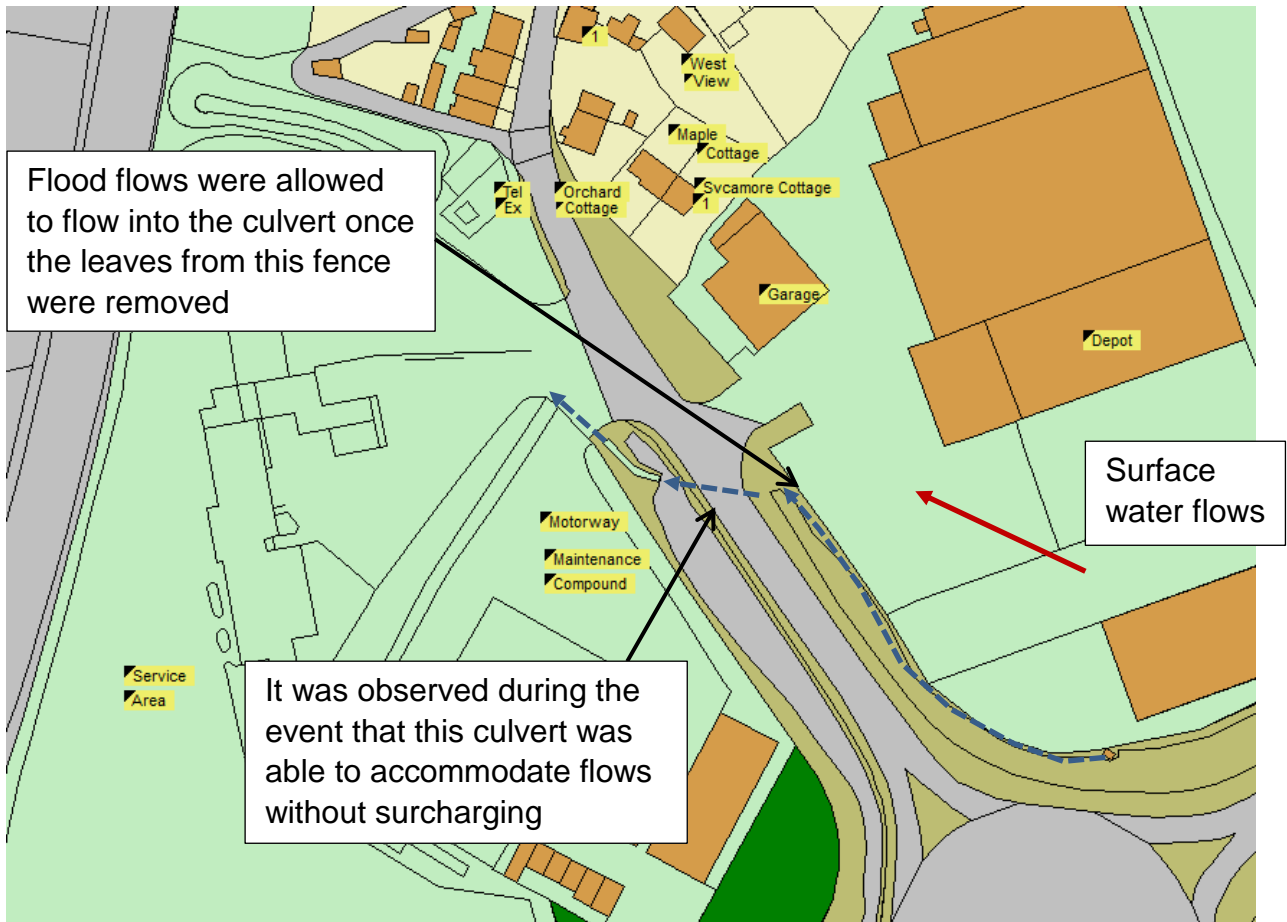
It was observed during the flood event that the culvert that runs underneath the Service area was not running at full capacity and that once leaves were cleared from the adjoining fence was able to accommodate some of the surface water flows into the area. The following plan shows the location of the culvert.

**Figure 11: Location of culvert entrance under B6260**

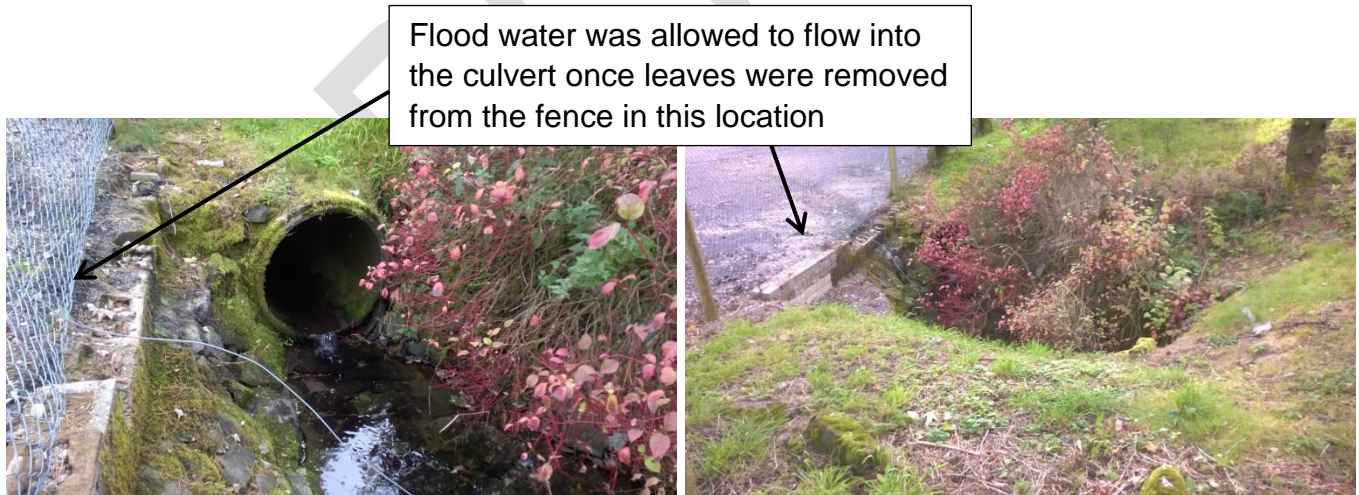
The following photographs indicate the open section of the culvert next to the depot.

**Photographs 6 & 7: Opening between culverts outside the depot, Old Tebay**

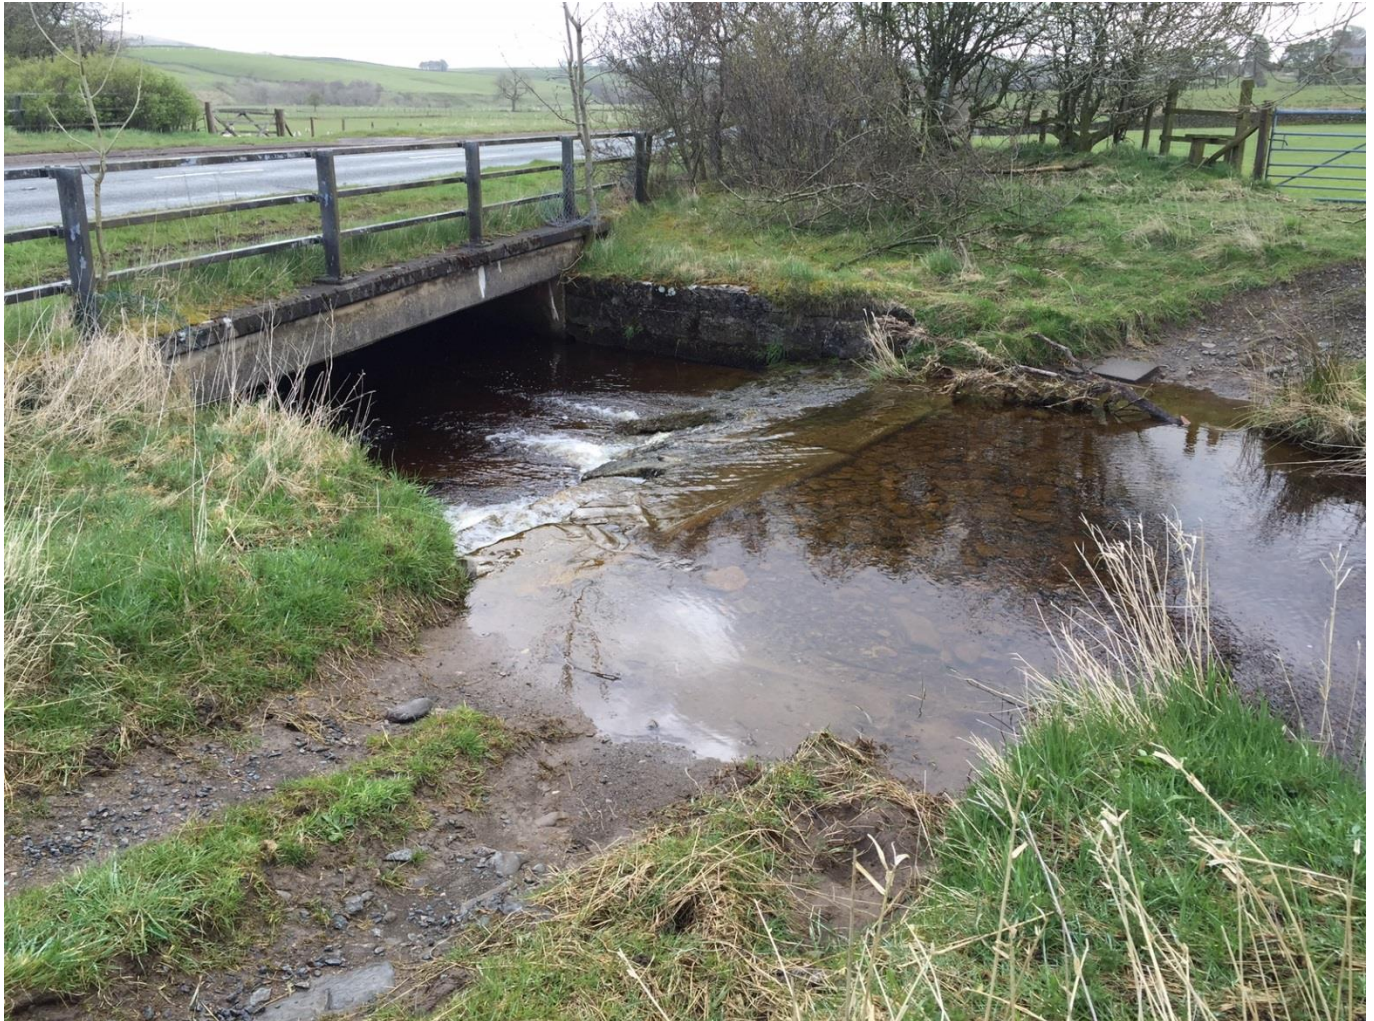
**Photograph 8: Entrance of Tebay Gill Beck under the A685 carriageway**

Photograph 8 above depicts the entrance of Tebay Gill Beck into a culvert beneath the A685 carriageway via a weir. The photograph was taken on 3 May 2016 and was during a period of low water flows through the watercourse. In light of this, the height between the surface of the watercourse and the bottom edge of the culvert beneath the carriageway is approximately 1 metre. This has the potential to cause a restriction to the watercourse during extreme precipitation events and could cause water to back up from the restriction and increase the height of the watercourse upstream. The banks of the watercourse are of equal height either side of the watercourse (1 metre) and at the entrance to the weir is a ford for farm machinery. The access tracks either side of the ford appear to direct flood water away from the carriageway and into neighbouring fields. The only evidence of a severe flood at this location is that the vegetation on the western bank of the watercourse is flattened and pointing downstream of the watercourse. The carriageway at this location is not known to have flooded during the event, but it is a severe restriction of the watercourse.

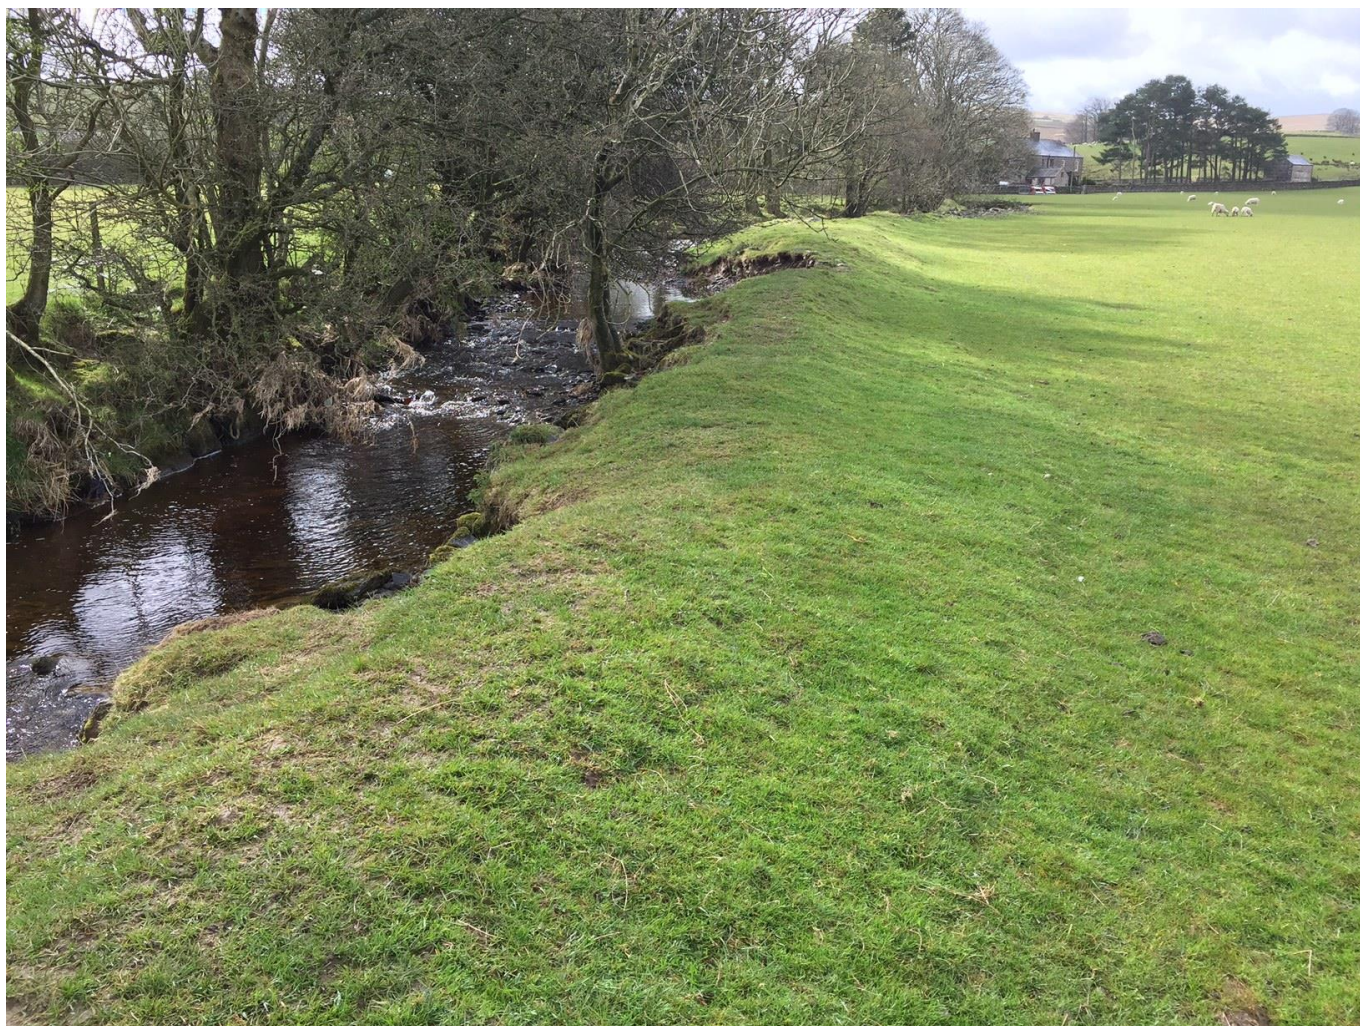
### **Photograph 9: Earth embankment on the western bank of Tebay Gill Beck**

Photograph 9 above depicts an earth embankment which is located on the watercourse meander upstream approximately 20metres from the location of Photograph 8. The earth embankment on the western bank of Tebay Gill Beck is 1.2 metres above the surface level of the watercourse in low flow conditions, as shown in the photograph. The height of this earth embankment is approximately the same height, if not fractionally higher than the eastern bank of the watercourse. This feature acts as a funnel for the watercourse, which during storm conditions will increase water velocity and could increase flood risk at the restriction pinpointed in Photograph 8. The watercourse at this location is not known to have burst its banks, but further upstream of this point where the western earth embankment is appears to be lower.

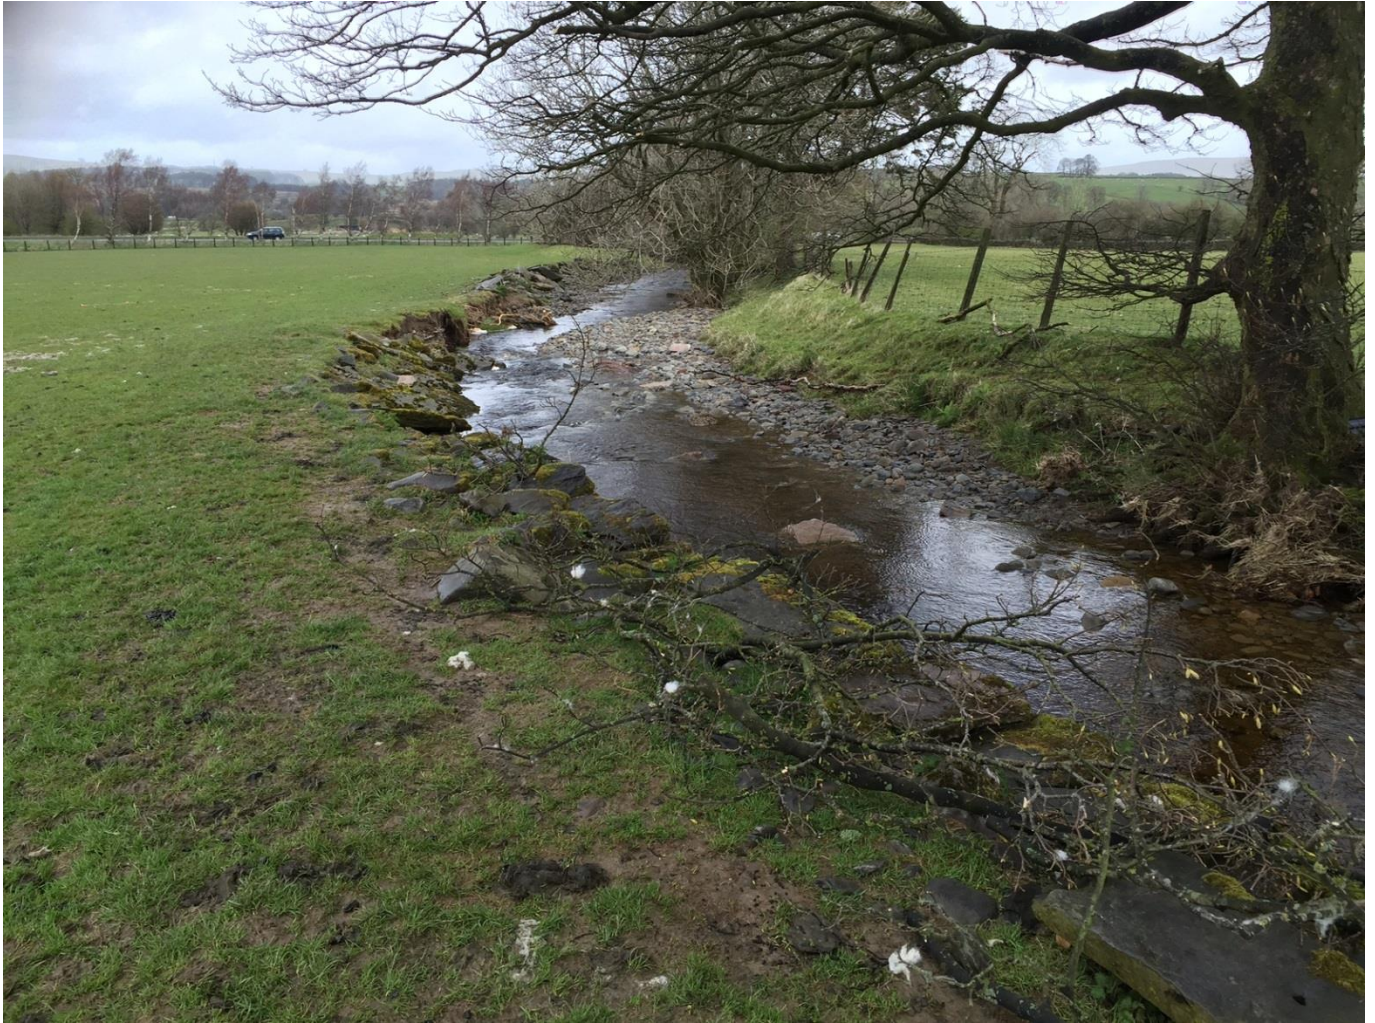
**Photograph 10: Raised embankment on the eastern bank of Tebay Gill Beck downstream of the minor road bridge**

Photograph 10 above depicts Tebay Gill Beck downstream of the second major restriction of the road bridge facing towards the A685. It can be seen that the western bank is approximately 0.5m below the level of the eastern bank. This will mean that during watercourse bank full conditions that any flooding is likely to spill out of the watercourse and into the flood plain to the west. This section, prior to the earth embankment on the western bank, spans approximately 40m of the watercourse and is the likely source of flooding which affects Old Tebay.

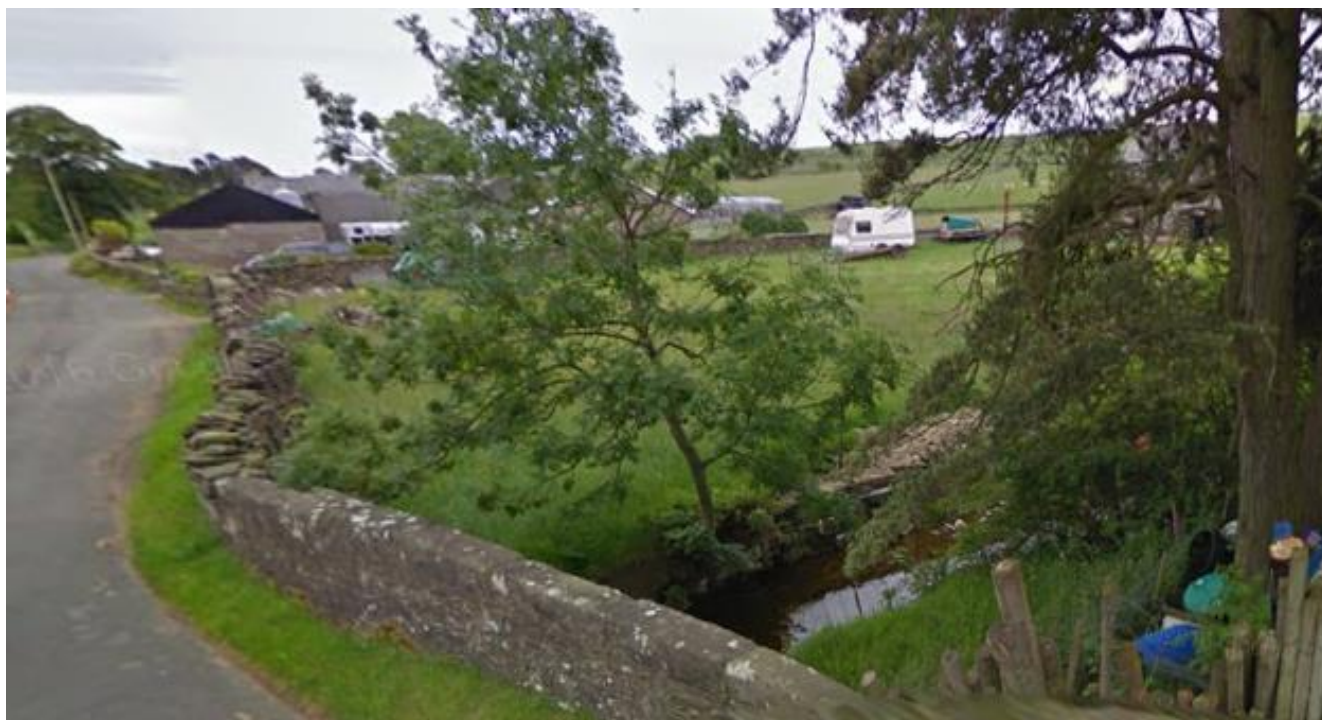
**Photograph 11: Minor Road Bridge over Tebay Gill Beck (taken from Google Maps)**

Photograph 11 depicts the road crossing of Tebay Gill Beck. It can be seen that the road is approximately 1.3m above the surface level of the watercourse during a period of 'normal' water flows. This represents a major restriction of the watercourse and will act as a throttle during flooding events. Water will back up behind the bridge and flood the eastern bank of the watercourse which is approximately 0.4m below the level of the western bank. This structure will also act as a funnel which increases the velocity of the watercourse downstream and will exacerbate flooding and erosion.
