Kirkby Stephen

Flood Investigation Report

Flood Event 5th December 2015

This flood investigation report has been produced by Cumbria County Council (CCC) as the Lead Local Flood Authority under Section 19 of the Flood and Water Management Act 2010.

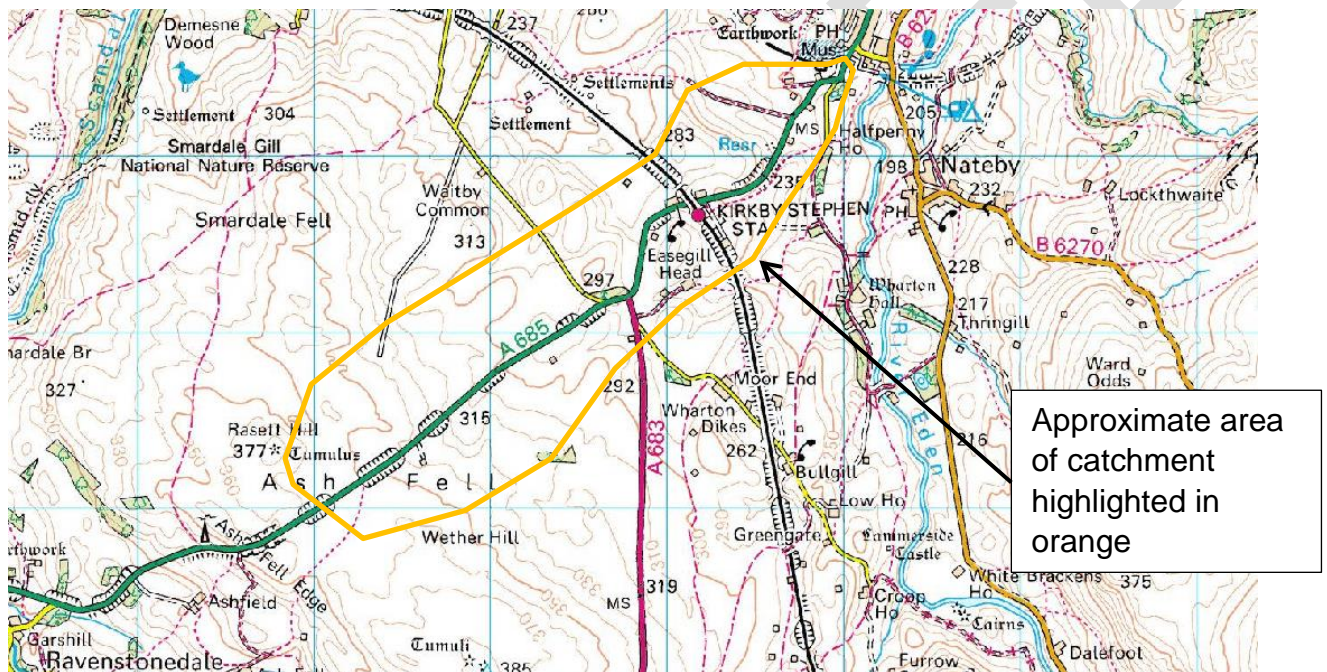
Investigations following the flood event have identified the main cause of flooding is due to the surcharge of the unnamed watercourse that flows underneath the A685 at the south end of South Road and discharges into the River Eden. The catchment for this area of approximately 35-40ha originates on Waitby Common and Rasett Hill.

Figure 3: Catchment area of unnamed watercourse

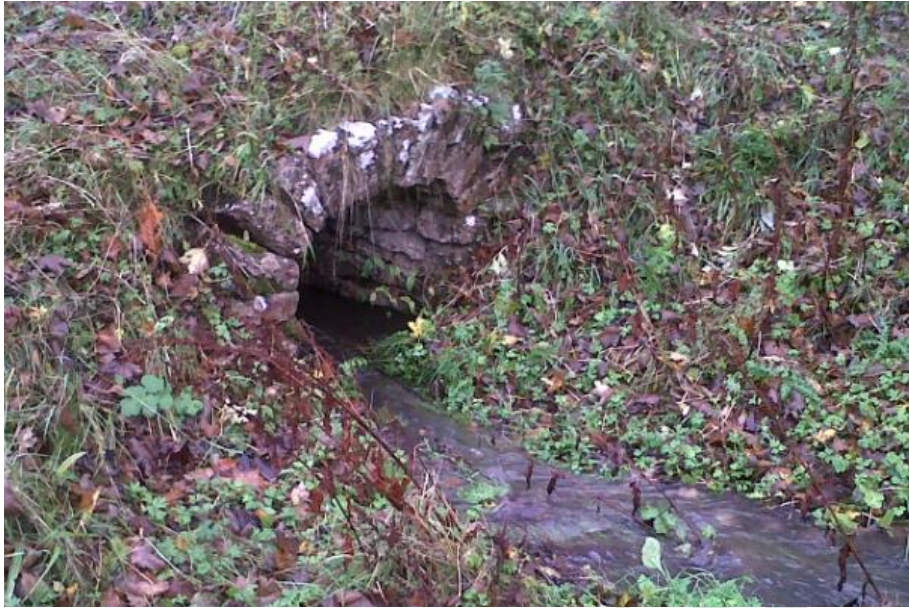
Photograph 1: Culvert entrance upstream of A685

As the unnamed watercourse nears Kirkby Stephen it flows parallel to the A685 before entering a culvert to pass under the A685. The culvert is approximately 1m in diameter at its entrance and after passing under the A685 flows through Pennine View Caravan Park.

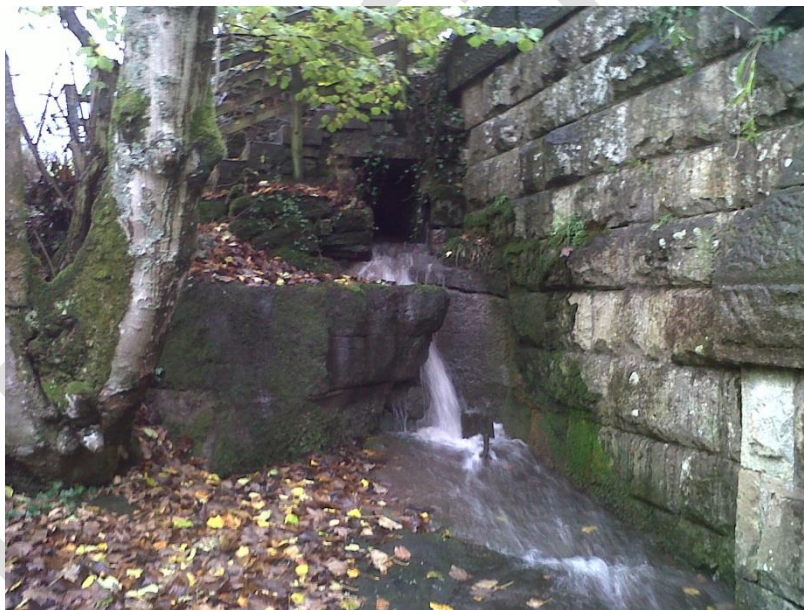
Photograph 2: Culvert discharge at River Eden

The culverted sections through the caravan park are constructed of stone and discharge into the River Eden at High Stenkrith.

Attempts were made to survey the culvert in March 2015 but it was not possible to survey the full culvert due to the stone construction of the culvert which makes it difficult for the equipment to travel. There is also an open section of watercourse in the caravan park and it is this section that allows flood water to leave the watercourse and flow through the caravan park towards Quarry Close and Birkbeck Gardens. However, it is known that the culvert inlet in the caravan park is 800/1300mm and the outlet at the River Eden is 800/575mm.

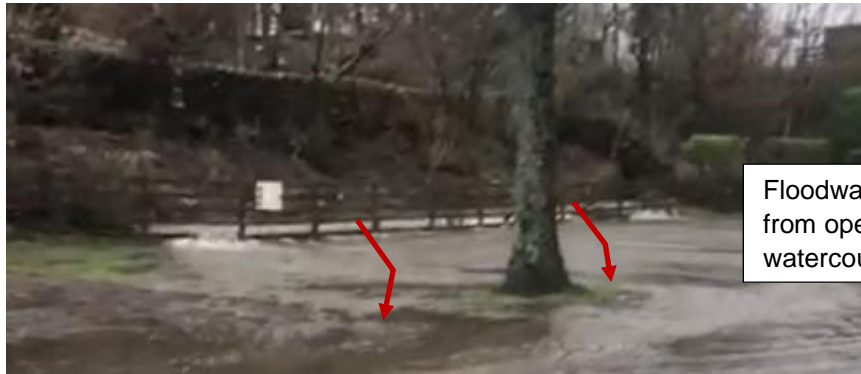
Floodwaters flowing from open section of watercourse

Photograph 3: Open watercourse through Caravan Park during heavy rainfall on 27th January 2016

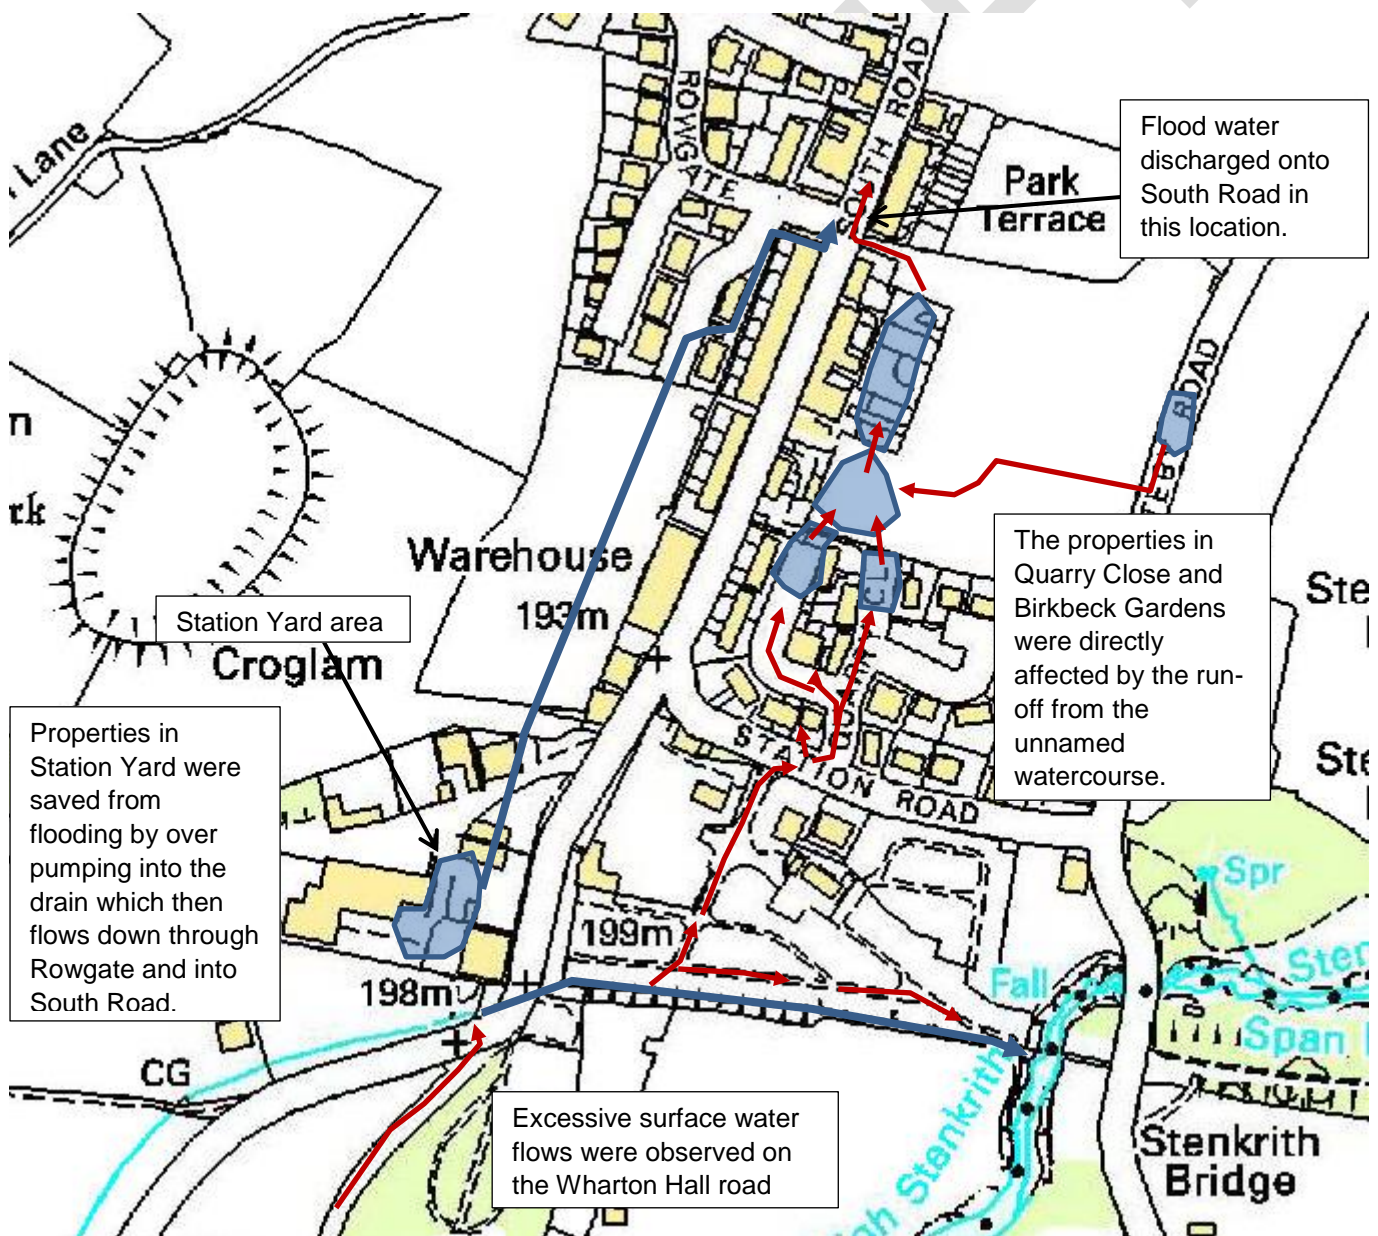
Figure 4: Plan of flow routes through Quarry Close, Birkbeck Gardens to South Road

As the flood flows left the caravan park and flowed into Quarry Close the flood water overwhelmed both the highway drainage and public sewer systems. In one property the resident reported that flood water had surcharged through the combined sewer system to cause flooding in the conservatory of the house.

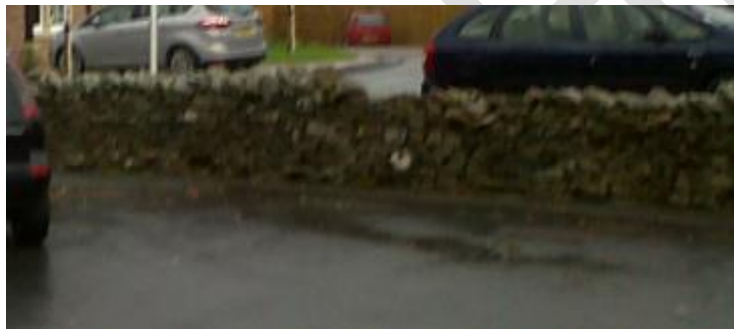
The flood water flowed through Quarry Close to gather in the ends of the cul-de-sacs where it was restricted from flowing into Birkbeck Gardens by a stone wall.

Photograph 4: Wall between Quarry Close and Birkbeck Gardens

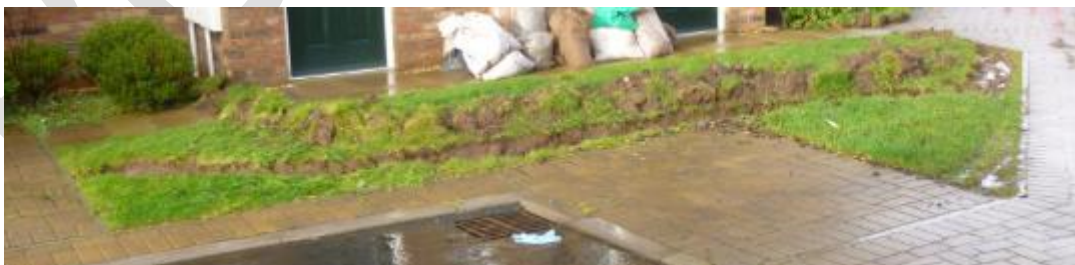
During the event parts of the stone wall were demolished in order to allow the flood water to dissipate from the Quarry Close area, however, this caused the flood water to flow into the Birkbeck Gardens area and cause internal flooding to 4 properties. It was clear from evidence that the property owners in Birkbeck Gardens had tried to take action to prevent flooding to their properties, as demonstrated in the photograph below:

Photograph 5: Evidence of flood diversion works in Birkbeck Gardens

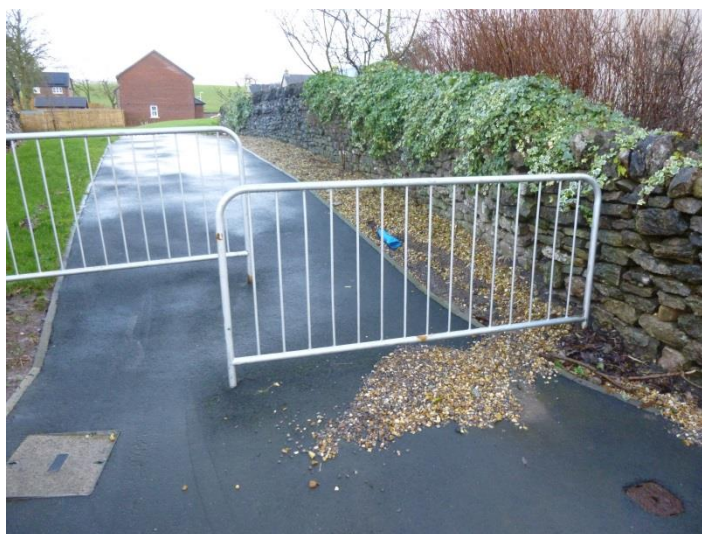
The flood water then flowed through the gardens of properties in South Road towards the footpath where a drainage system had been installed by the developer during the construction of Birkbeck Gardens. The drainage system was installed when during the construction of the site flood water had overwhelmed the site. A representative of the developer informed CCC that a drain had been installed following this incident to help prevent further flooding but at the

time they were not aware that the extensive amount of flood water had been from the overtopping of the unnamed watercourse. This drain caused washout of chippings at the side of the footpath as shown in the photograph below:

Photograph 6: Damage caused by overwhelming of drainage system through Birkbeck Gardens

The developer is currently working with CCC to establish a way to resolve this situation. The surface water drainage system (roof and road drainage) of Birkbeck Gardens also included a storage tank in the design to accommodate large rainfall events but again this storage system would not have been designed to accommodate the large volume of flood water that flowed into this area from the unnamed watercourse.

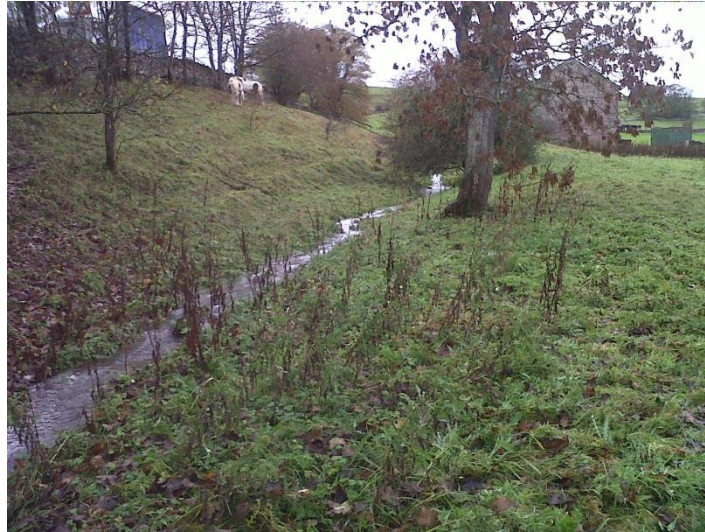
Although Station Yard is upstream of the caravan park the flooding in the Station Yard area was most apparent on the afternoon of 5th December. It has been reported by business owners that the unnamed watercourse in the location just upstream of Station Yard was able to cope with flows. In the previous event in 2013 flood flows had overtopped the watercourse bank and flooded into 1 of the businesses. Investigations by CCC following this event had identified large branches were wedged in the culvert underneath the A685. These were removed during the survey of the culvert and it appears that this has helped to reduce the risk of flooding within Station Yard. The following photograph shows the watercourse above station yard in normal flow:

Photograph 7: Unnamed watercourse upstream of Station Yard

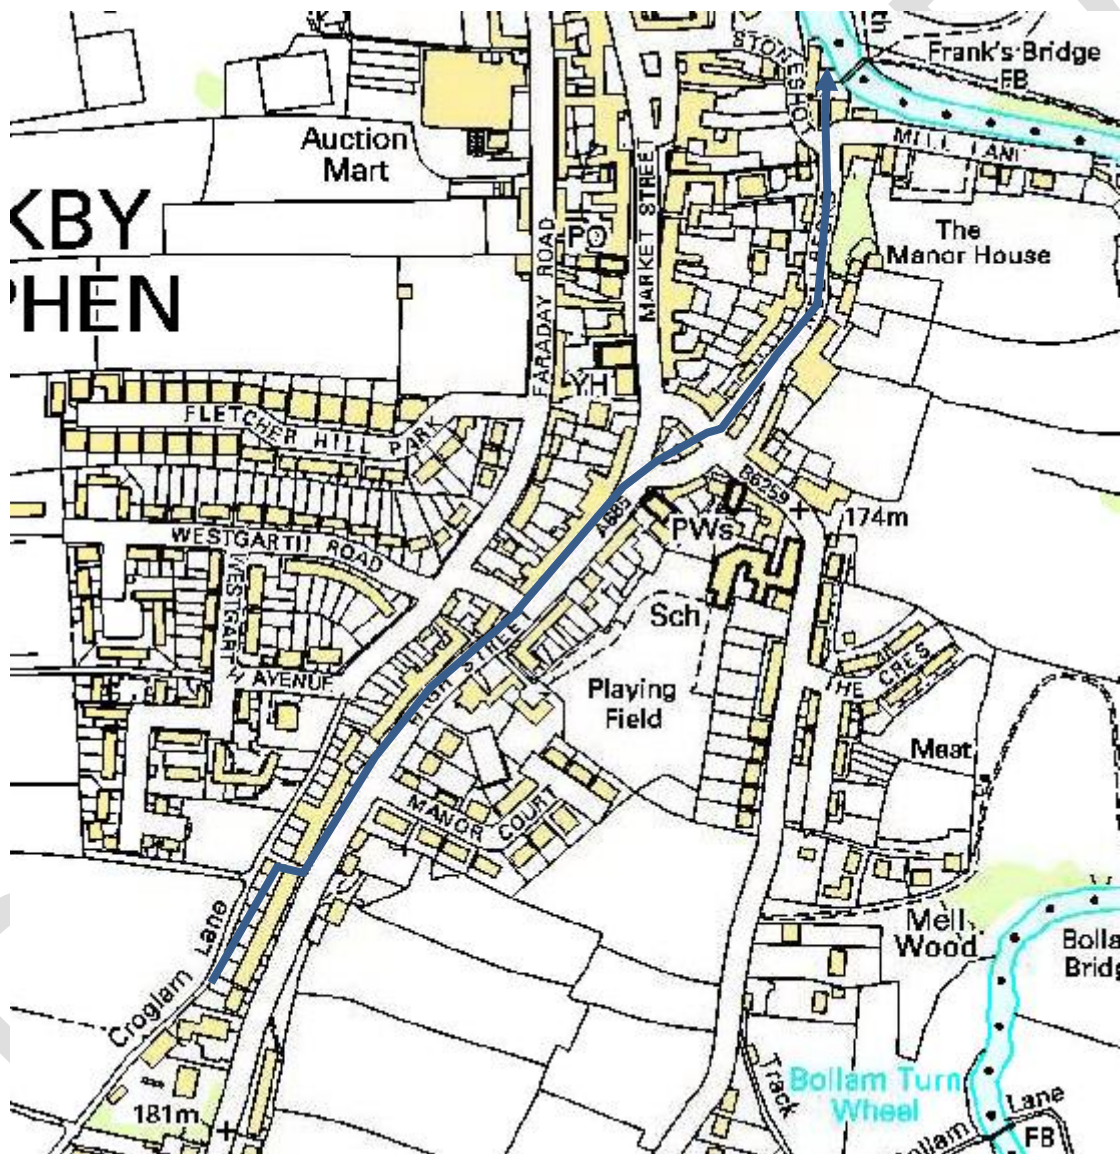
Croglam Beck Culvert, which drains the High Street and Victoria Square area towards the River Eden, was unable to convey the combined flows from Quarry Close, its native upstream catchment towards Croglam Castle, and the additional surface water of the immediate area.

Figure 6: Approximate location of Croglam Beck culvert shown in blue

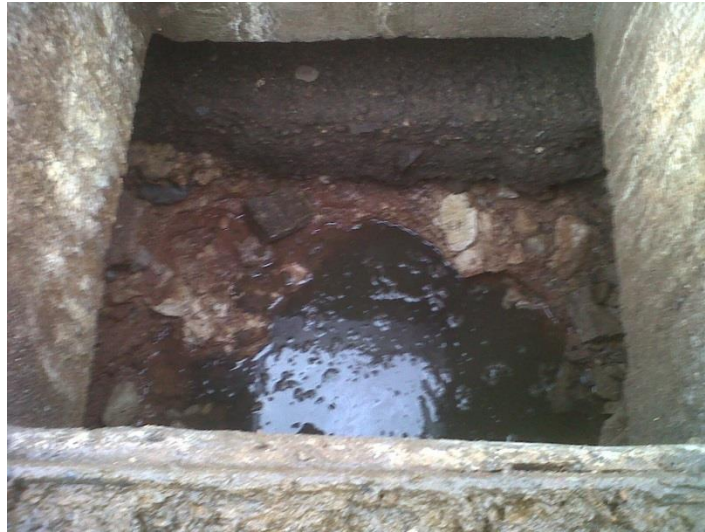
and clean. During the survey carried out in early 2015 it was identified that there was a significant amount of silt in the bed of the culvert. The following photograph demonstrates the depth of silt within the stone construction section of the culvert.

Photograph 8: Indication of silt build up within the Croglam Beck culvert

The MSfWG are currently investigating the capacity of the culvert as normal cleaning using high pressure jets would potentially increase the risk of damage to the stone culvert. Parts of the stone culvert are also located under houses which could make the identification of possible options difficult.

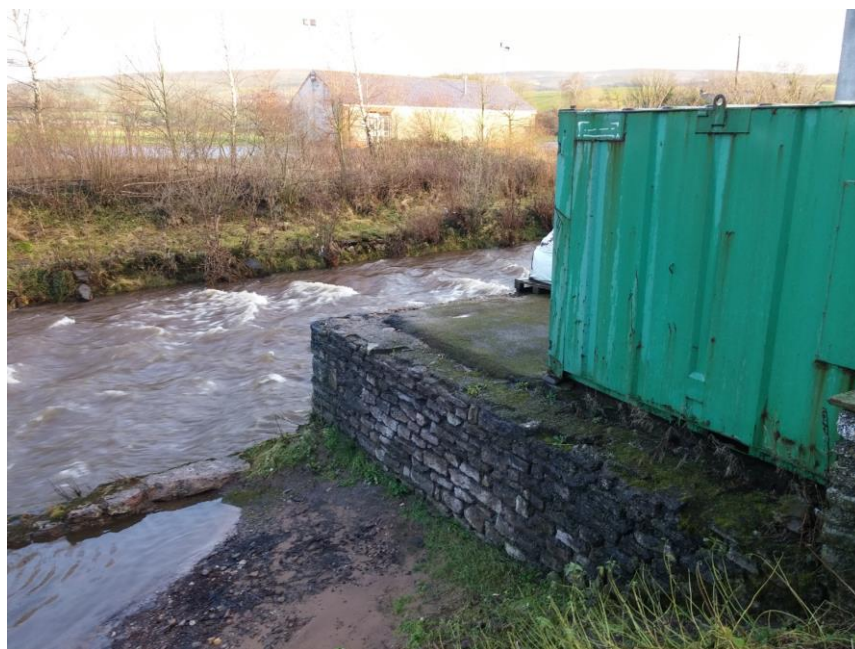
The properties that flooded are approximately 90m from the River Eden and following the flood event Environment Agency employees were informed that the River Eden did not overtop its banks at this locality. However, residents along the bank confirmed that the river wall at the Timber Yard along Hartley Road was almost over-topped.

Photograph 9: River wall that was almost over-topped.

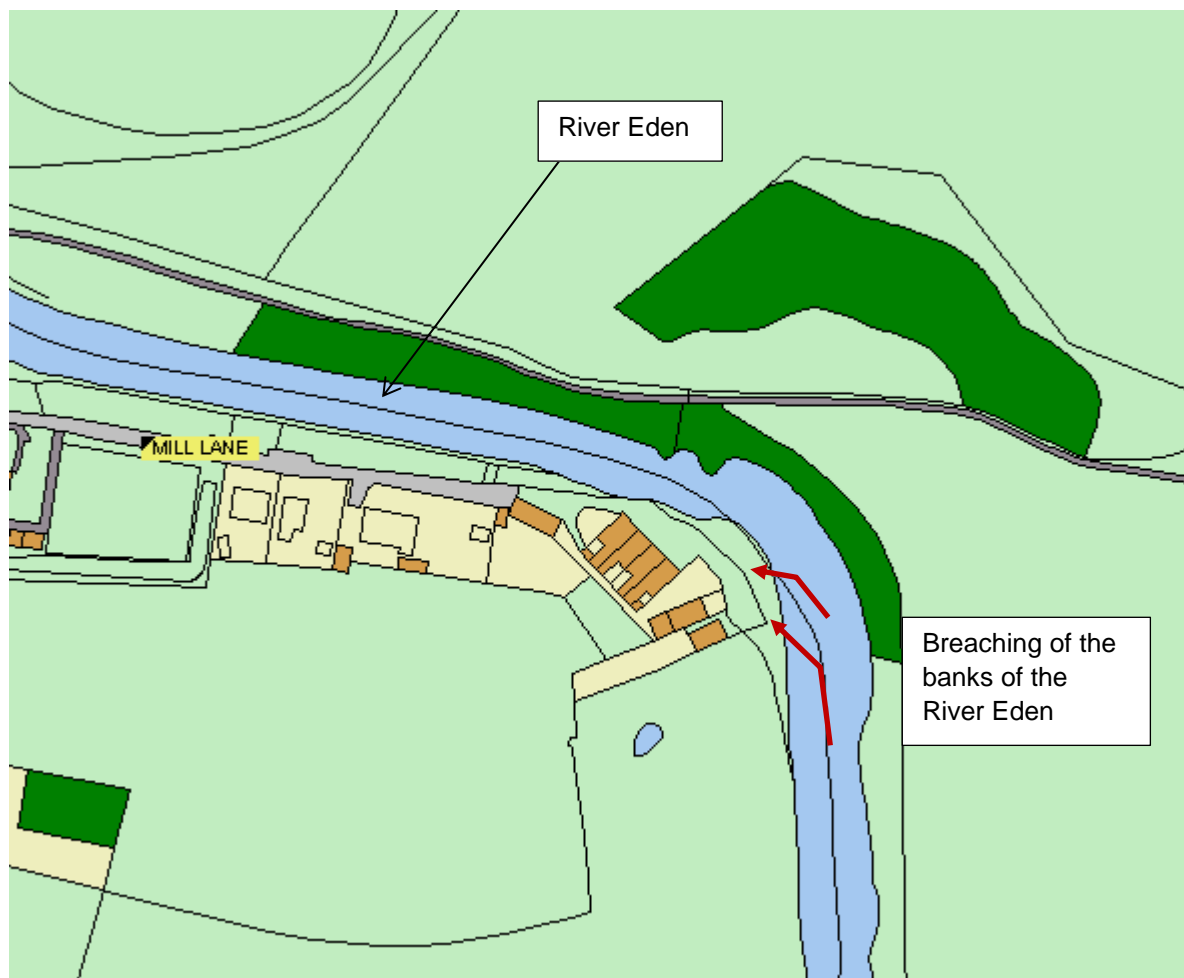
The flooding to five of the properties was caused by the River Eden when it breached its banks following the heavy rainfall and then overtopped at low garden/retaining wall to affect the properties. The following plan indicates the proximity to the River Eden.

Figure 9: Plan illustrating the breaching of the banks of the River Eden

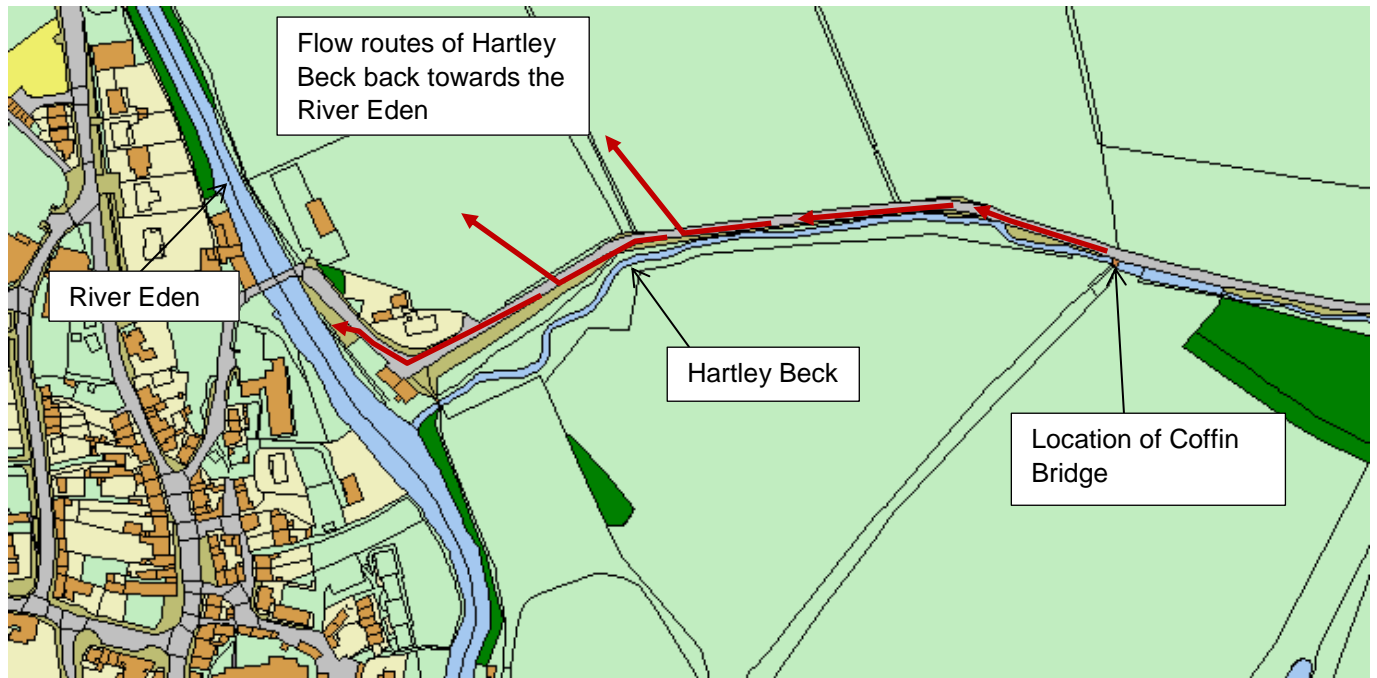
Reports from residents in the area have confirmed that Coffin Bridge caused a restriction to the flow of Hartley Beck. This caused flood water to flow onto Hartley Road at this location which then travelled along the road towards Kirkby Stephen. Locals also confirmed that someone had dug out gravel within the water course around the bridge to try to keep the flow in the watercourse (see photograph 11). Residents in two properties erected a temporary flood defence to divert the flood water flowing towards their properties, saving their properties from flooding. The following plan demonstrates the flow routes from Hartley Beck.

Figure 11: Flow Routes from Hartley Beck towards Low Mill

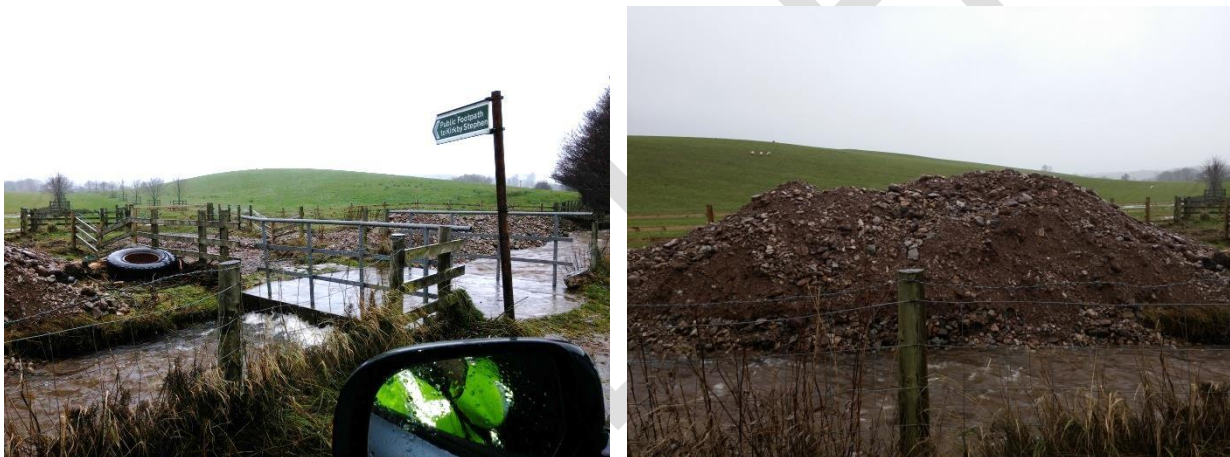
Photographs 10 & 11: Coffin Bridge and gravel that has been removed from Hartley Beck (taken on 10/12/2015).
