Kendal

Flood Investigation Report

Sandylands and Mintsfeet on the 6th December 2015

Flood Event 5-6th December 2015

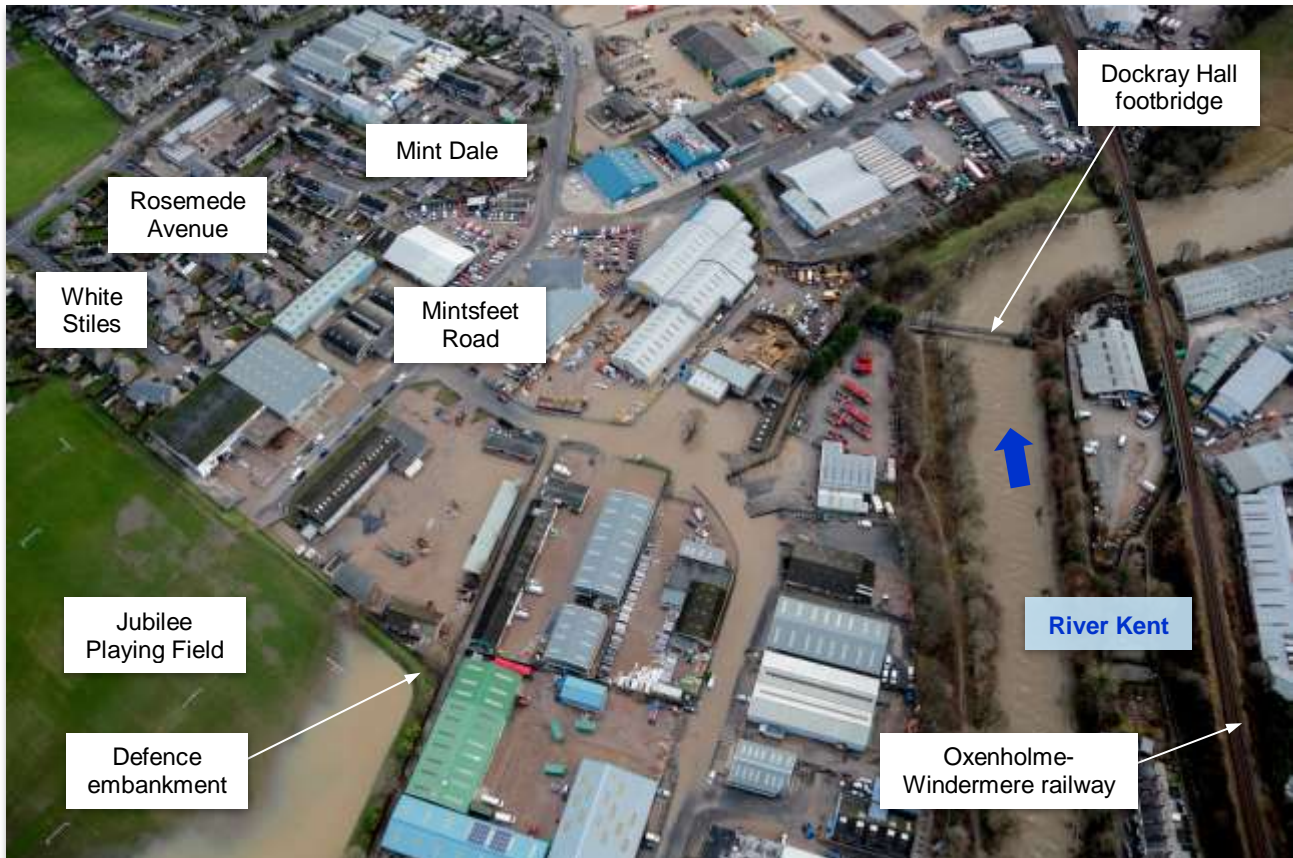
Floodwater from these sources was then able to flow through the business park and across the Jubilee Playing Fields to the south, where it was initially impounded against the existing flood defence embankment highlighted on Figure 12 and shown in Figure 13.

Figure 13: Aerial photograph from 6th December showing the flooding in Mintsfeet and the existing flood defence embankment along the south and western boundaries of the Jubilee Playing Fields

Whilst the embankment in the Jubilee Playing Fields impounded floodwater initially, the sheer magnitude of the flood event meant that it was overwhelmed. This caused flooding to residential properties on Finley Close, Finley Drive, White Stiles, Rosemede Avenue and Mintsfeet Road, with internal flood depths reported to reach 1.2m (see Figure 14). Commercial properties on Mintsfeet Road, including those in the Mintsfeet Industrial Estate were also affected. In addition to the damage caused by internal flooding to property, the combined depth and velocity of the floodwater resulted in widespread structural damage, with a number of boundary walls destroyed in the area.

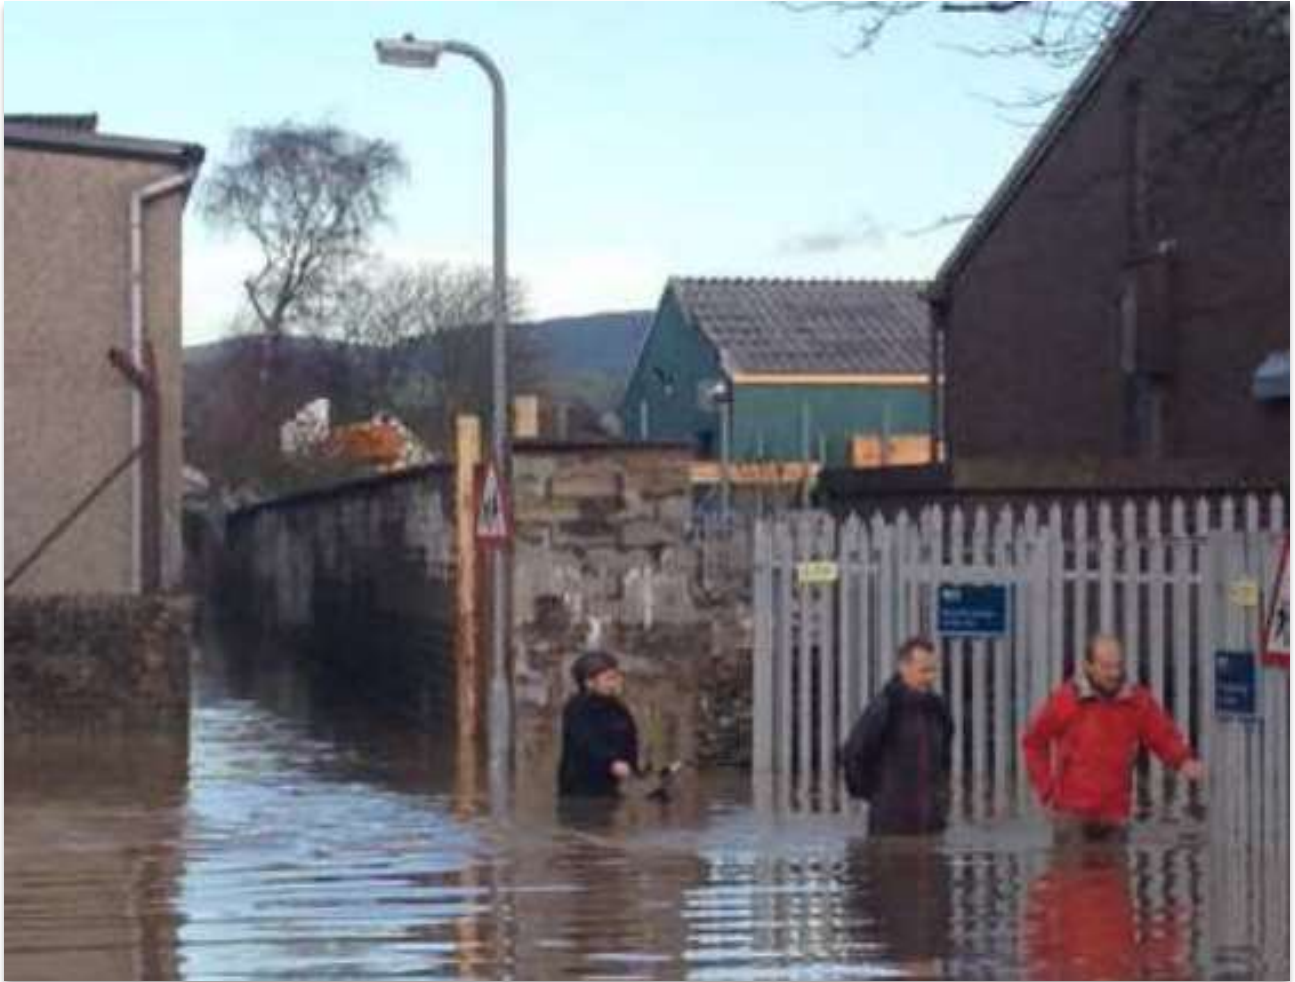
Flooding in the Mintsfeet area took days to drain away. This is due to there being a limited number of surface water outfalls. The combined sewer network in the Mintsfeet area is pumped and the pumping station was damaged during the flooding. This essentially meant that a small Combined Sewer Overflow (CSO) was the only available outlet for the flood water, which drained over a period of days.

Figure 14: Flooding in the Mintsfeet area

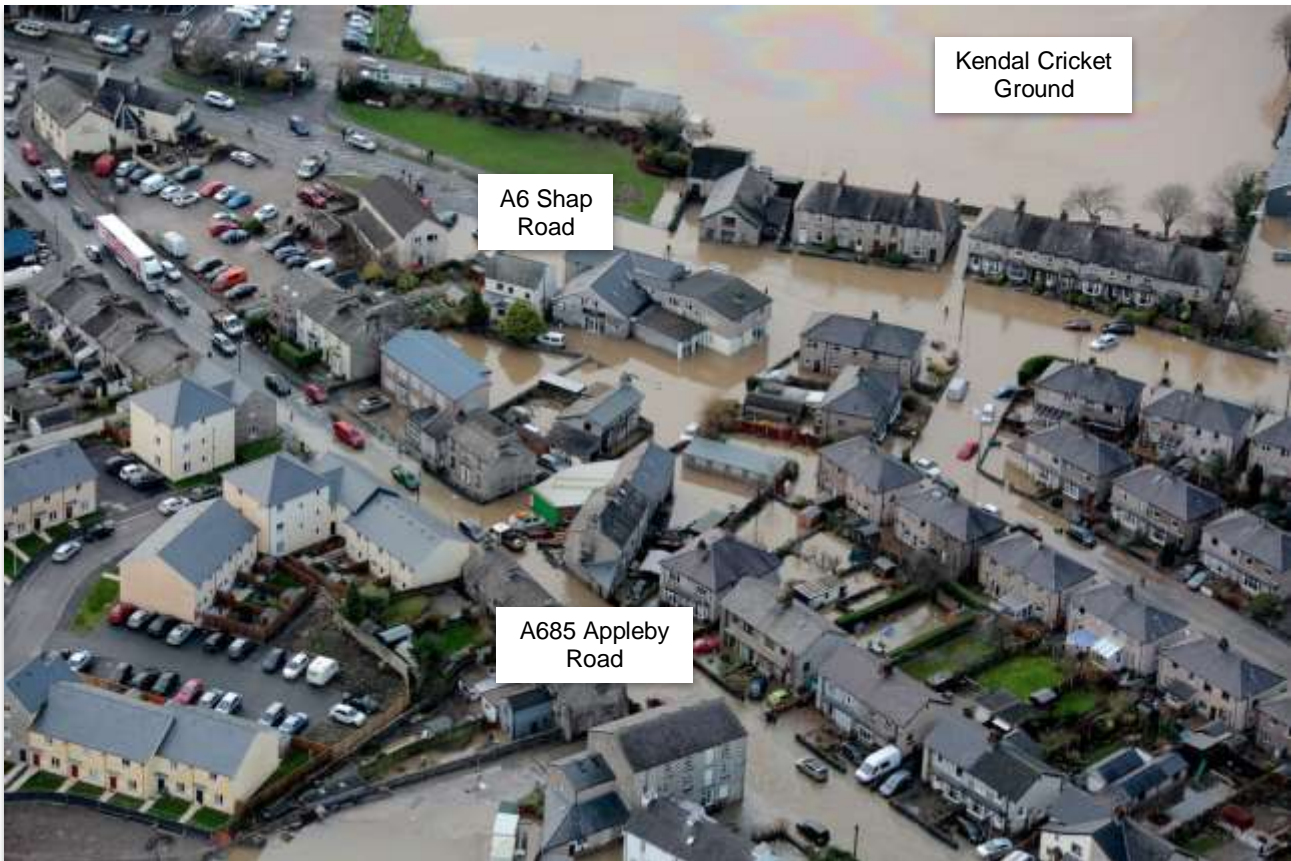
Flooding from the Rivers Mint and Kent affected properties as flood water travelled eastwards across the A6 Shap Road and inundated streets including Mint Street and Dale Avenue. In addition to the damage caused by internal flooding to property, the combined depth and velocity of the floodwater caused structural damage to a number of boundary walls in the area.

Figure 16: Aerial photograph of Shap Road and Appleby Road area on 6th December 2015

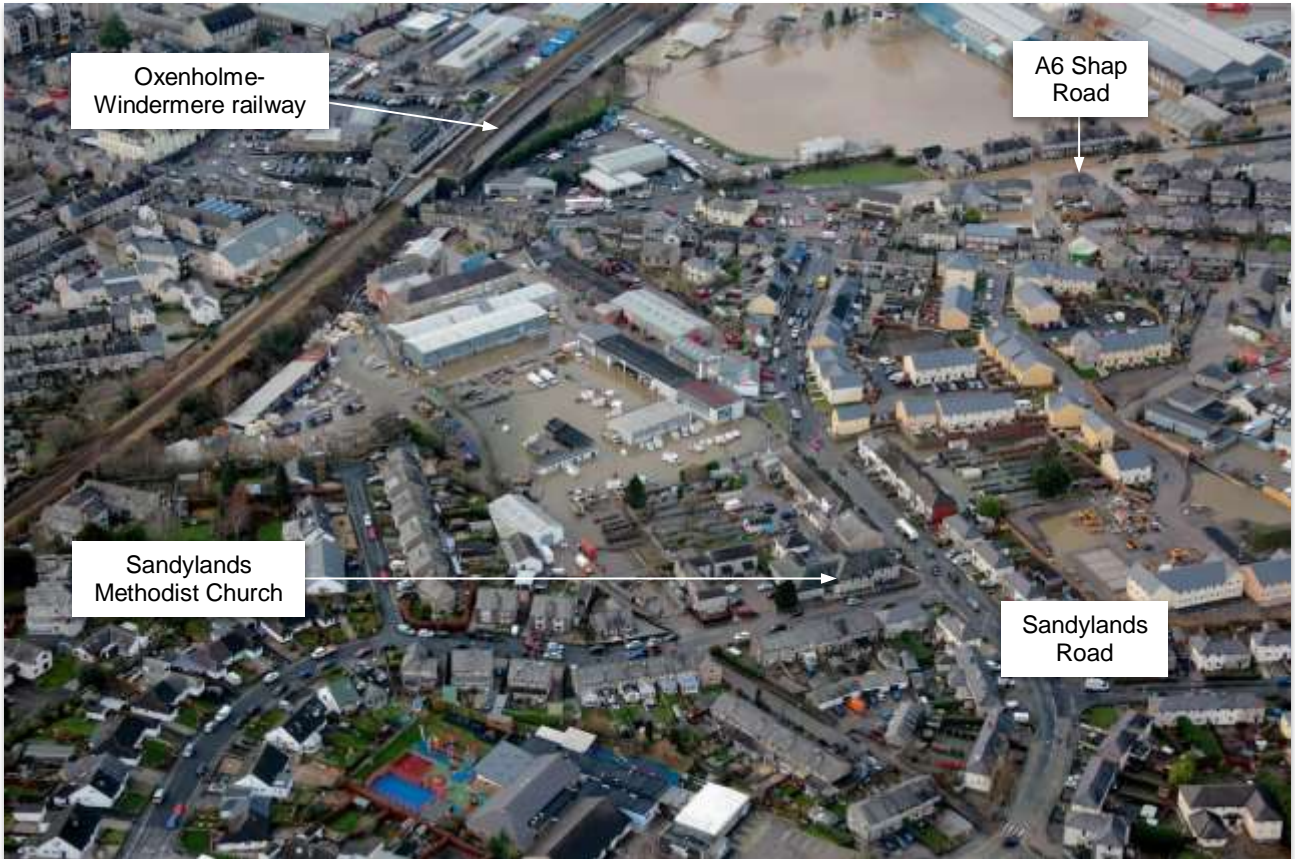
Figure 18: Aerial photograph of the Sandylands area on 6th December 2015

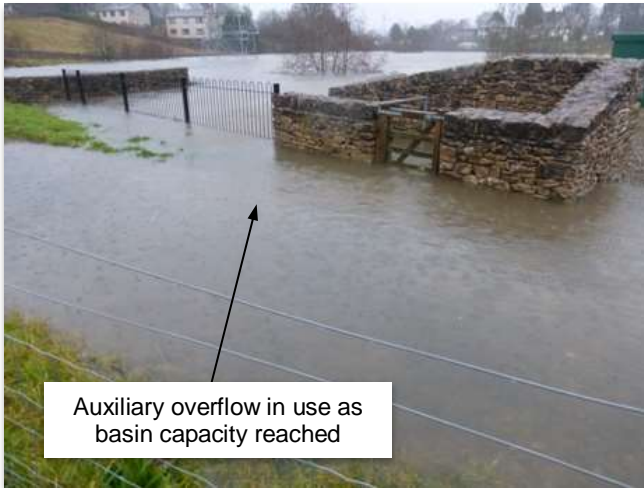
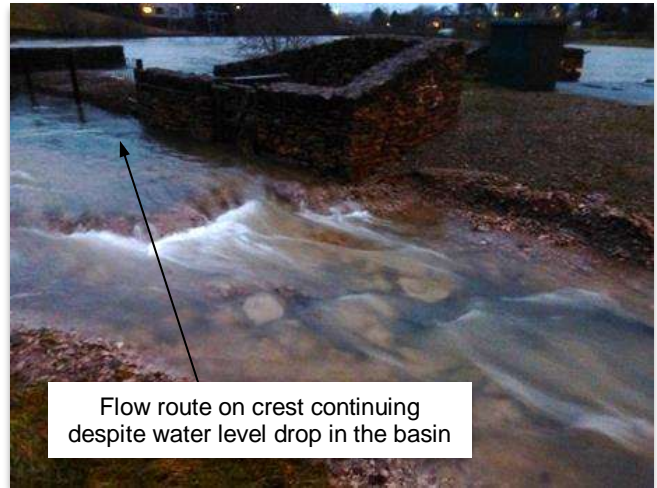
Environment Agency telemetry, which monitors water levels at the FSB, indicates that the basin spillway level was reached around 12:45. The telemetry indicates that levels within the FSB continued to rise through the afternoon, before peaking around 18:00 and slowly receding through the late evening and into 6th December. During the Storm Desmond event, it is apparent from photographs taken on the afternoon of 5th December that the capacity of the storage basin was reached. In Figure 19, the photograph on the left clearly shows that at 16:00, the basin is full and the auxiliary overflow (a protected section of embankment shown in the foreground of the photograph) is in use.

Figure 19: Stock Beck FSB at 16:00 05/12/2015 (left) and at 08:57 06/12/2015 (right)

Furthermore, the photograph on the right in Figure 19 shows water flowing along the crest of the water-retaining embankment after water levels in the main storage basin have started to recede. This water was able to by-pass the storage basin and flow down Calder Drive, causing further internal flooding to a number of properties. The source of the overland flows in this particular case was one of the tributaries of Stock Beck, which drains a steep catchment off the fells due east of Sandylands. At the point of entry into the basin, the watercourse is in open channel and the bed level of the channel is close to the level of the embankment crest. As it meets the embankment, the watercourse then enters into culvert via a trash screen and drop structure as shown in Figure 20.

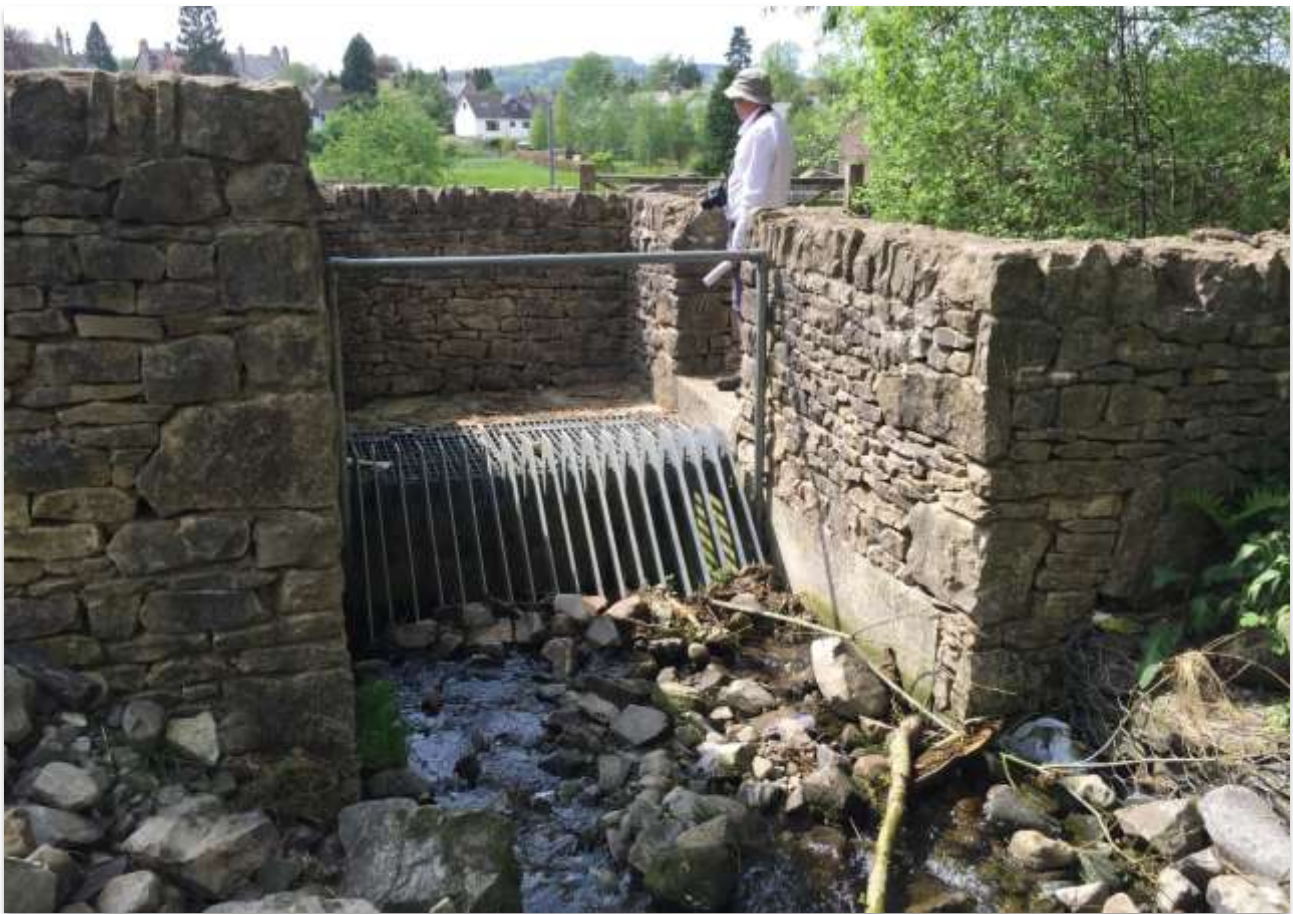
Figure 20: Stock Beck tributary culvert inlet to Stock Beck FSB

During the event, the trash screen was blocked by debris and the inlet capacity of the culvert exceeded, causing water levels to back up. A significant amount of debris was washed down onto the screen from

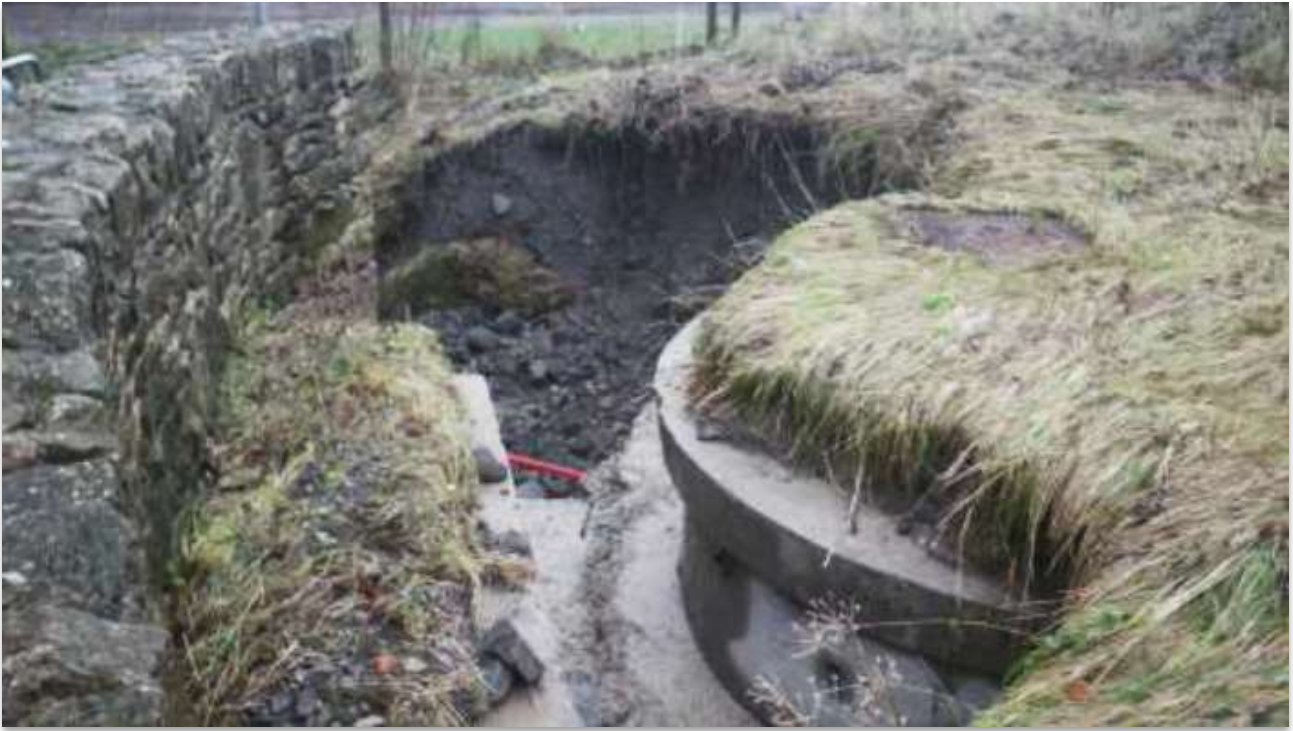
a damaged outfall structure immediately upstream. Material was scoured from behind the structure due to discharge from an outfall pipe on the right bank flowing into the discharge from the outfall, with the subsequent turbulence causing the extensive scour illustrated in Figure 21. Unfortunately, the design of the inlet structure is such that the access provided to allow the screen to be cleared also provided the pathway for the water to escape. Flows passed through the gated opening as opposed to entering the culvert and spilled onto the basin embankment crest. The topography of the crest is such that these flows were then channelled along the crest (as opposed to spilling back into the basin) before continuing into Calder Drive.

Figure 21: Scour damage to rear of outfall structure upstream of Stock Beck FSB

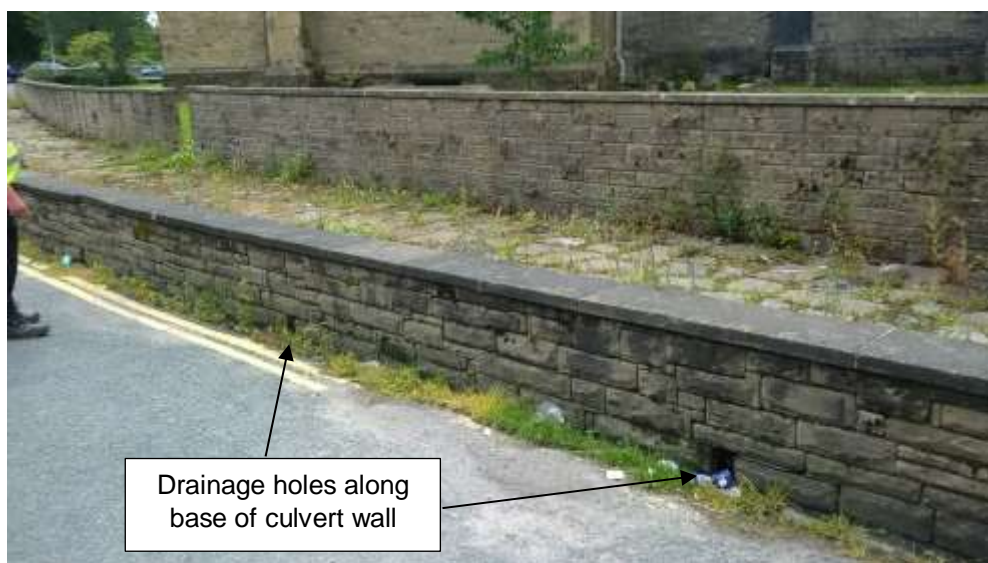
Residents on Castle Crescent reported that post-flood water drained away from the area via the redundant Stock Beck culvert. The redundant culvert has drainage holes along the base of its raised wall (see Figure 23), allowing water to enter the culvert, and runs along Castle Crescent to the rear of St George's Church, before passing under Gooseholme and discharging to the River Kent via a small pipe. This arrangement provides surface water drainage to the area during and after periods of prolonged rainfall.

Figure 23: Redundant Stock Beck culvert on Castle Crescent

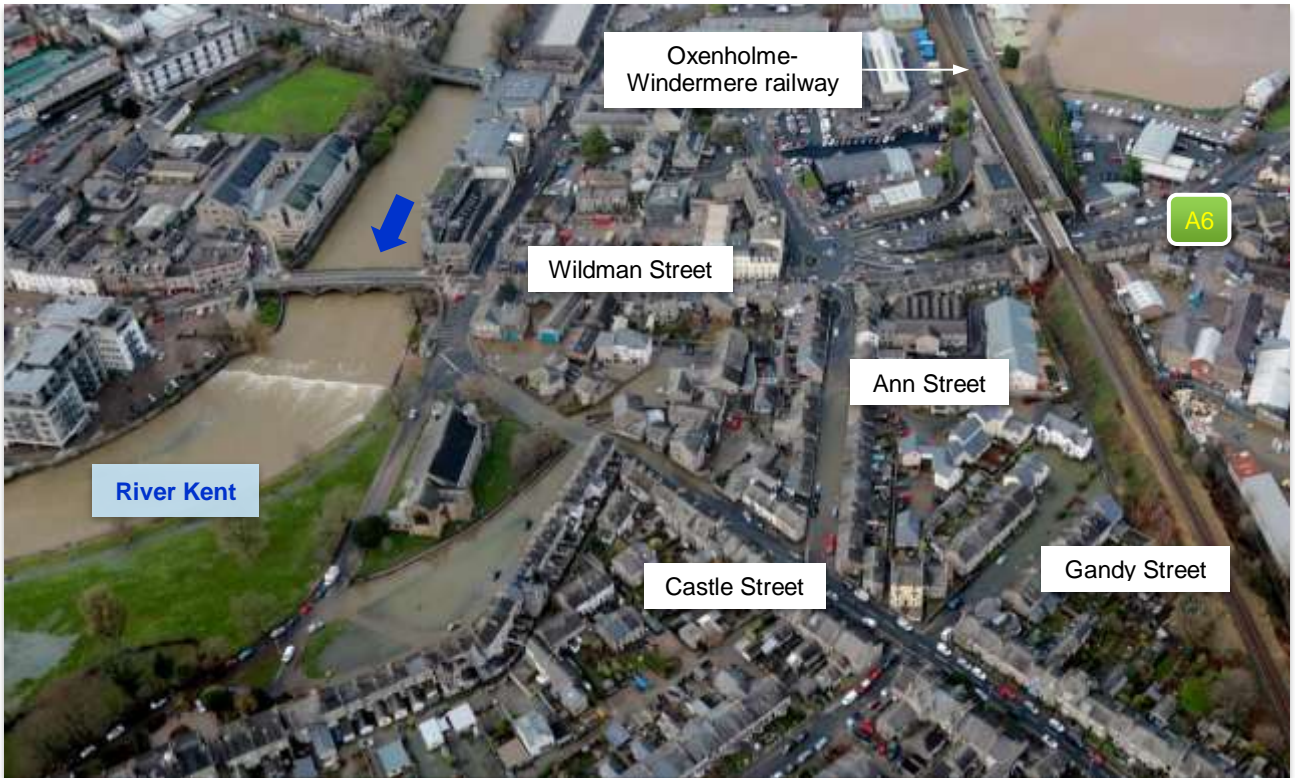
Figure 24: Aerial photograph of the Ann Street and Castle Street area on 6th December 2015

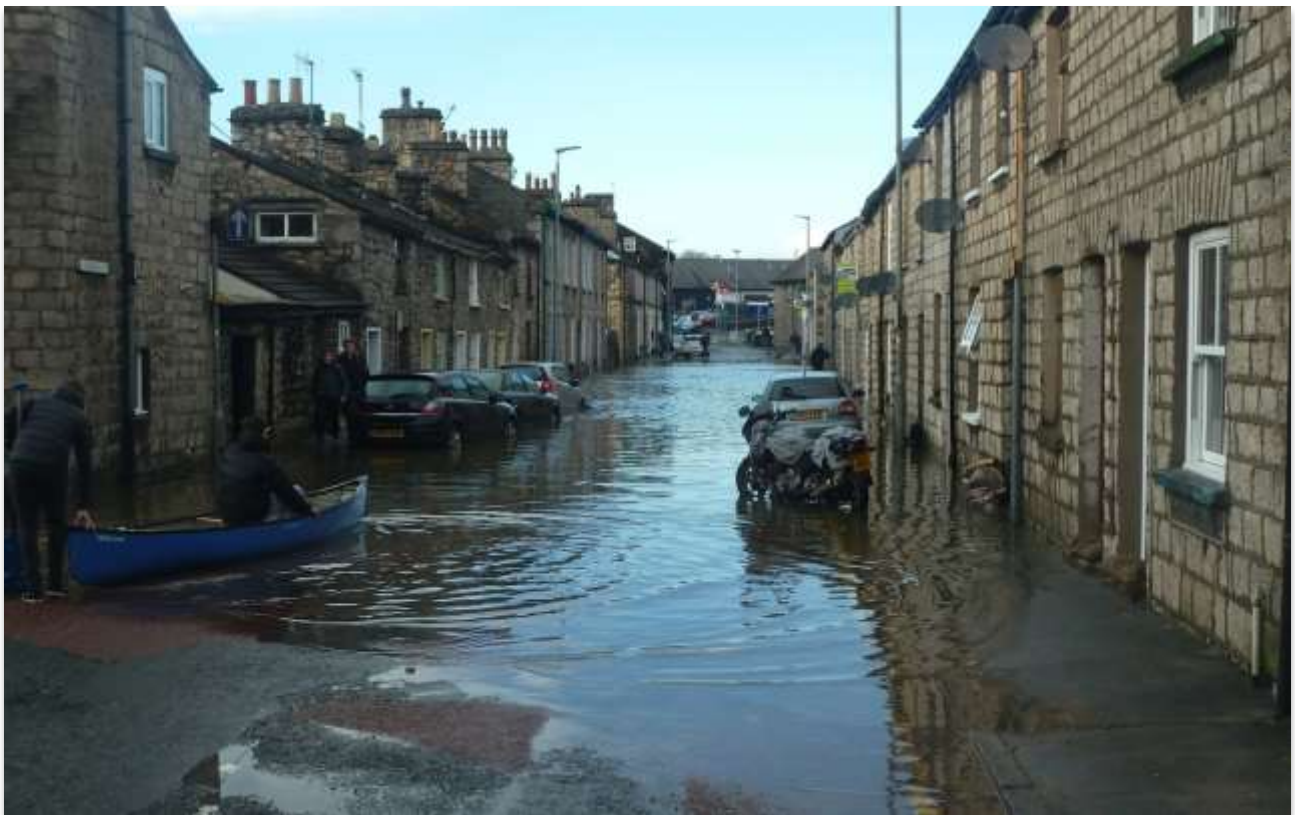
Figure 25: Ann Street in the aftermath of the event on 6th December 2015

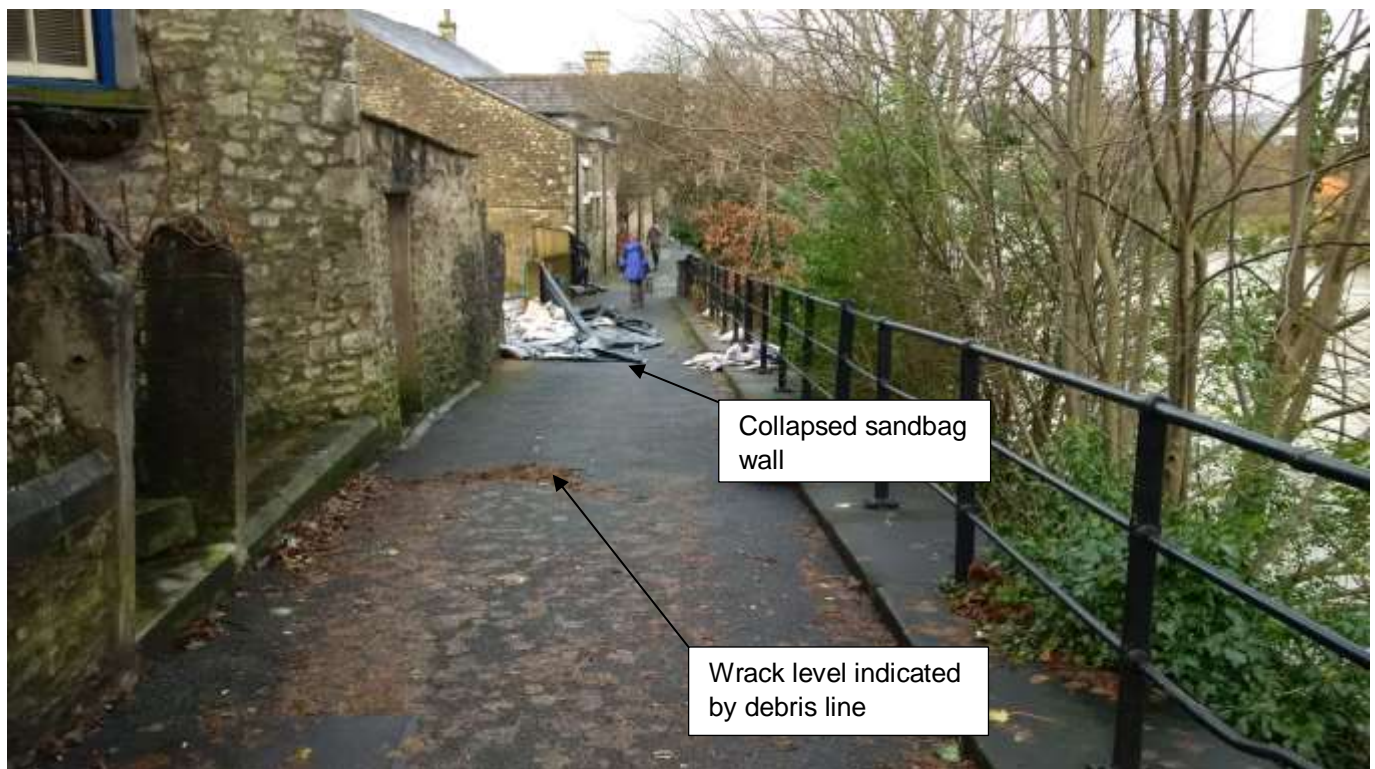
Residents of Benson Green raised concerns that Victoria Bridge reached capacity, and therefore acted as an obstruction to flow during the flood event, raising flood levels at their properties situated upstream of the bridge. Figure 26 shows the wrack level (marking the peak water level) on the riverside path on the right bank of the River Kent adjacent to Victoria Bridge. This level has been surveyed as 45.30mAOD, which, when compared to the Victoria Bridge soffit level of 45.12mAOD, shows that Victoria Bridge did reach capacity during the flood event by around 0.18m. Figure 26 also shows a collapsed sandbag wall, which has collapsed towards the river, illustrating the force of water flowing towards the river from the rear of properties in Benson Green.

Figure 26: Wrack level on the riverside path at Benson Green, adjacent to Victoria Bridge. Note the sandbag wall which has collapsed towards the river.

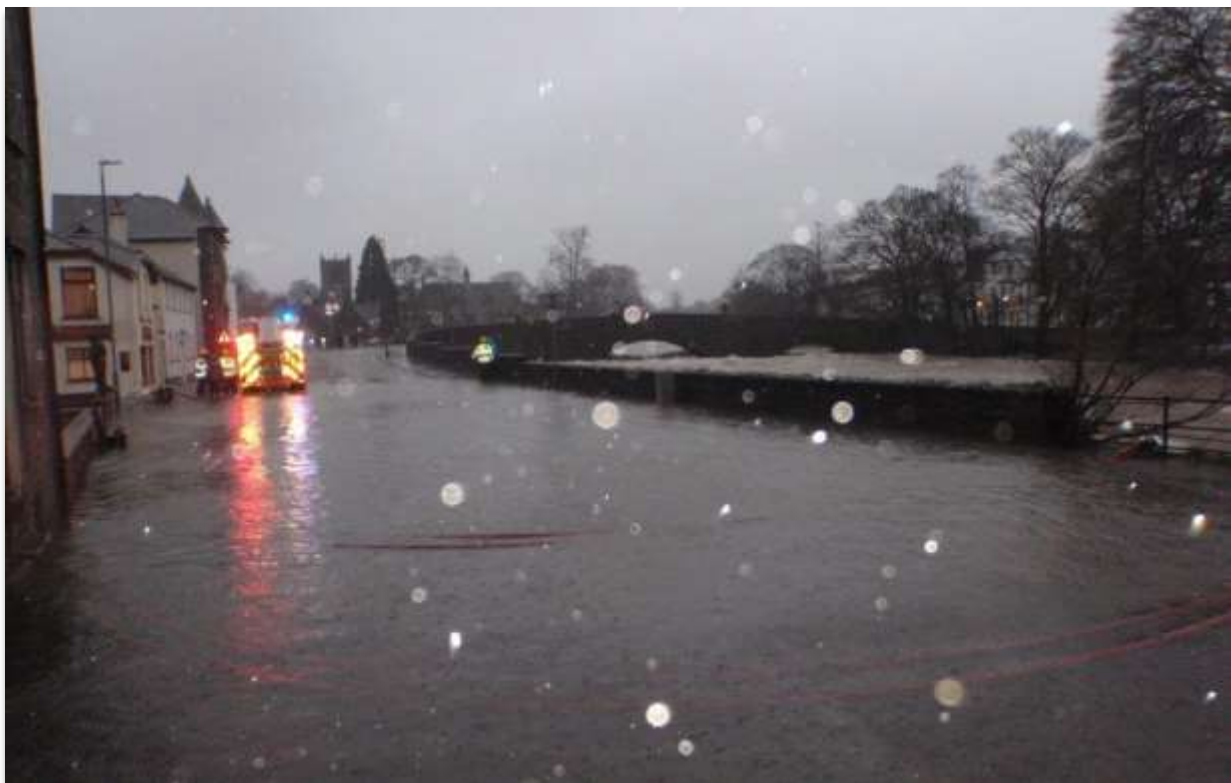
The east and west sides of Kendal are connected by a series of bridges over the River Kent and these have varying ages and construction types. The bridges include road bridges, pedestrian footbridges, and a railway viaduct, and are thought to have exacerbated the flooding along the banks of the River Kent. Evidence suggests that these bridges reached their capacity during the event and Figure 29 shows the water level in the River Kent approaching the soffit of the eastern arch of Nether Bridge. The railway viaduct is also thought to have had a role in diverting flow in the River Kent into the Mintsfeet area. Further investigatory work is required to fully assess the role of the bridges and to identify where conveyancing improvements can be made.

Figure 259: Nether Bridge, taken on the right bank of the River Kent looking north

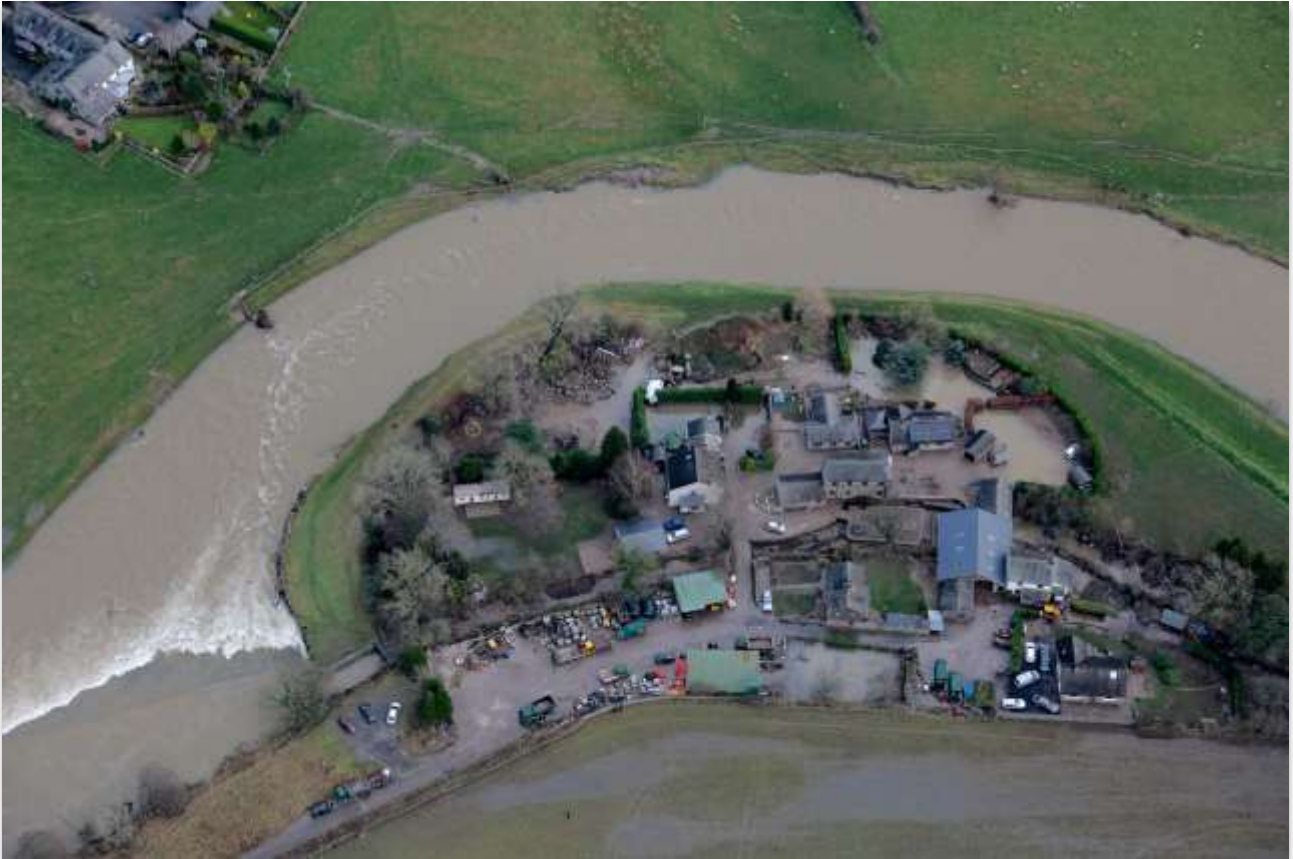
Figure 32: Aerial photograph of Helsington Mills on 6th December 2015
