# Sedbergh

## Flood Investigation Report

**Flood Event 5-6<sup>th</sup> December 2015**

This Flood Investigation Report has been produced by Cumbria County Council as a key Risk Management Authority under Section 19 of the Flood and Water Management Act 2010 in partnership with Cumbria County Council as Lead Local Flood Authority.

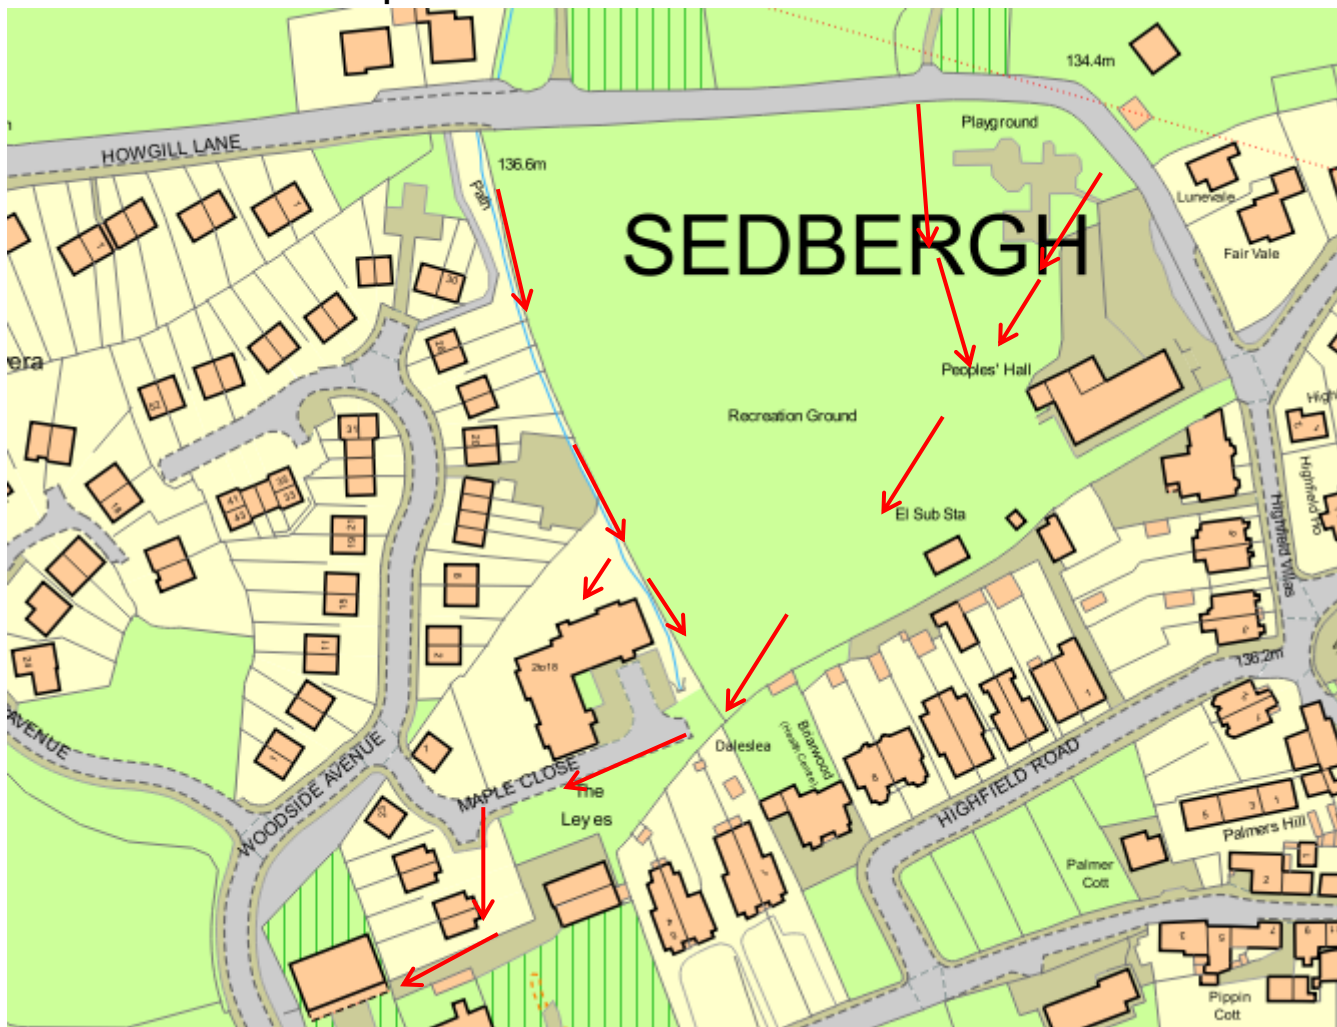
**Figure 8- Flows across Recreation Ground exceeded across Howgill road**

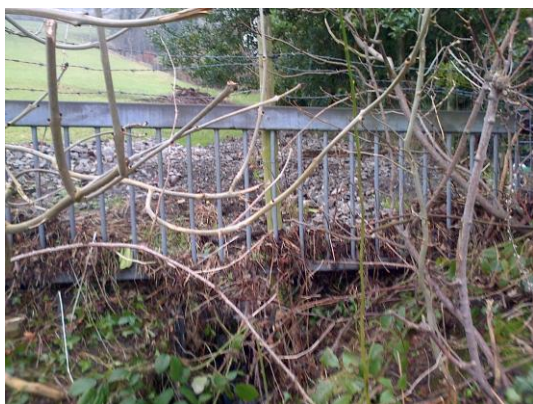
Fell side flood water was channelled into 3 sections of open watercourse to the North of Howgill Lane in Sedbergh. The watercourse carried a vast amount of debris and sediment which led to the clogging up of the culvert entrances and blocking of the catcher screens see image 1 below.

**Image 1: Shows the amount of debris trapped on debris screens upstream of Howgill Road**

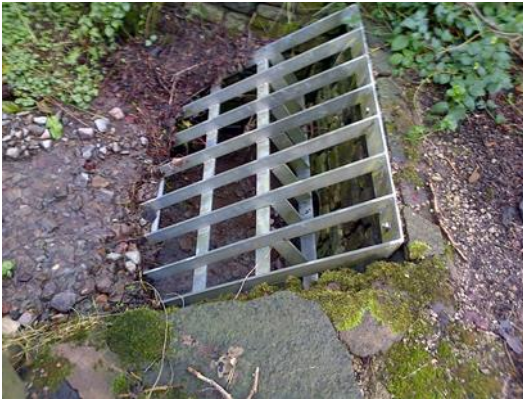
flood water made it into the south east corner of the football field the flood water was unable to re-join the due to capacity and some flood water due to the levels passed the culvert catcher shown in image 2 below.

**Image 2: Shows the debris screen on the east boundary in Maple Close.**

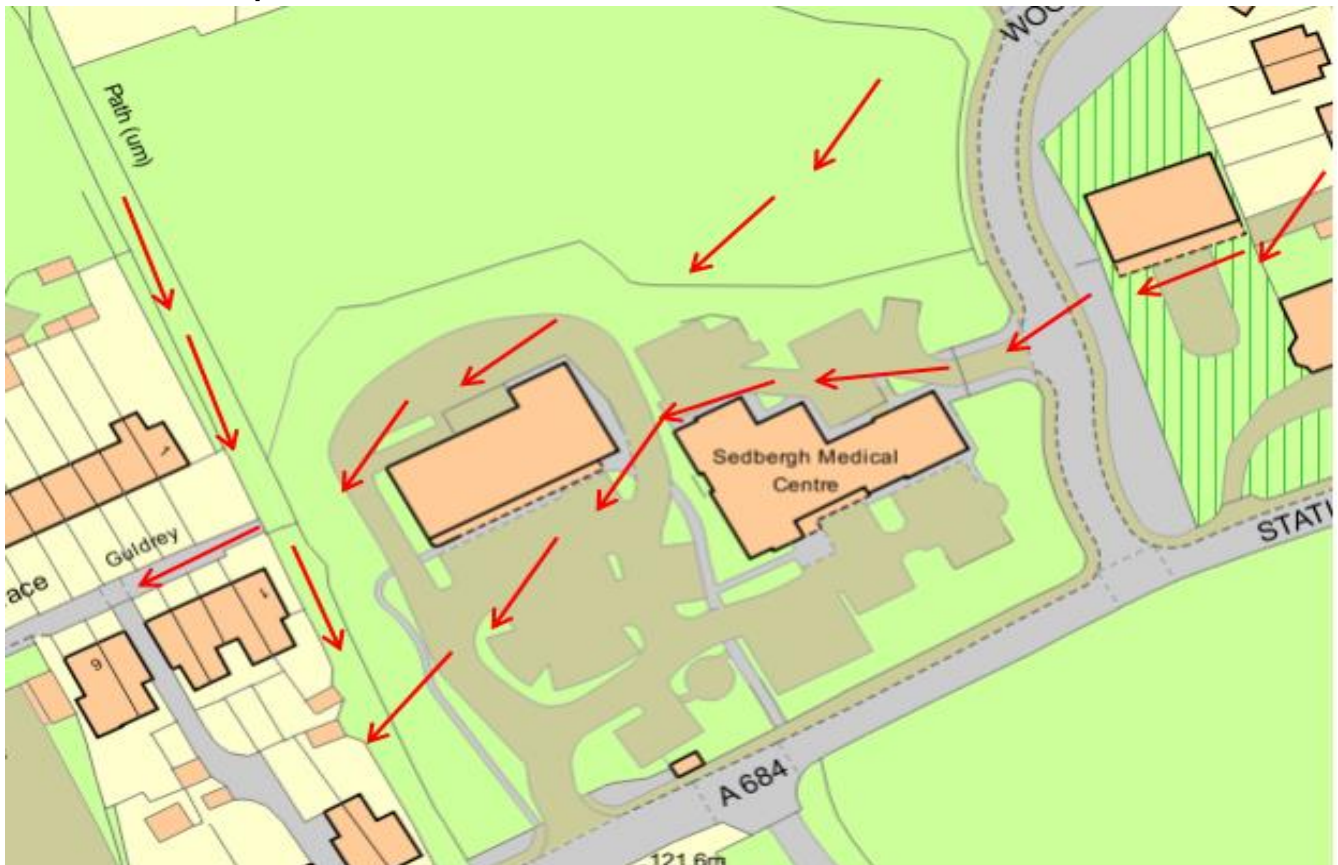
**Figure 9- Shows the flow route through the new build development**

Rehearsal Hall was flooded as the watercourse exceedance was unable to re-enter the culvert. The flood water built up against the side of the public highway which is higher than the ground levels around the music hall. The School made efforts to prevent flood water ingress by placing sandbags against the music hall doors and windows. Once the flood water built up it then flowed over the top of the public highway and then down the access road to rear of the Sedbergh medical centre and towards the rear of the Spar where the flows where met with surface water runoff from the fell which had travelled overland and came down the path from Howgill Lane.

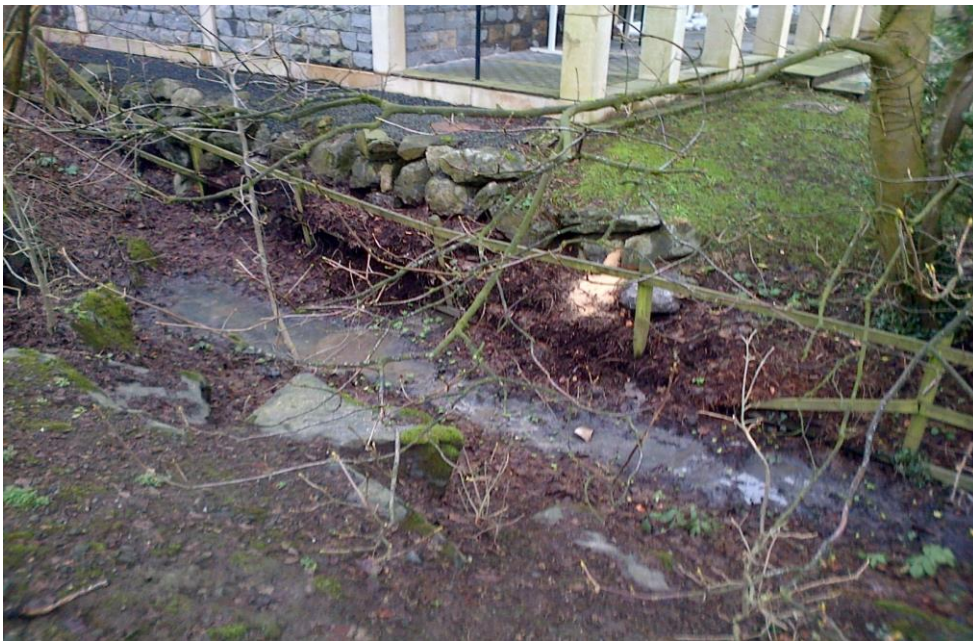
**Image 3 – Shows the ditch at the side of the music Hall where the watercourse exceedence built up, Image was taken from the public Highway and indicate the change in levels**

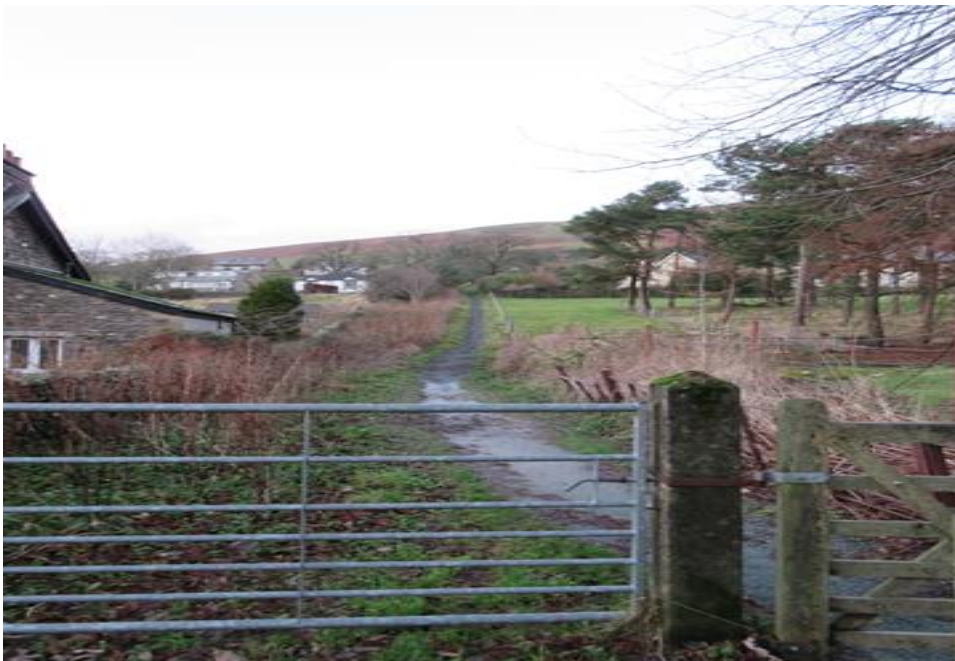
**Image 4 – Shows the footpath which overland flow channelled down from Howgill Lane and converged on the watercourse exceedence route**

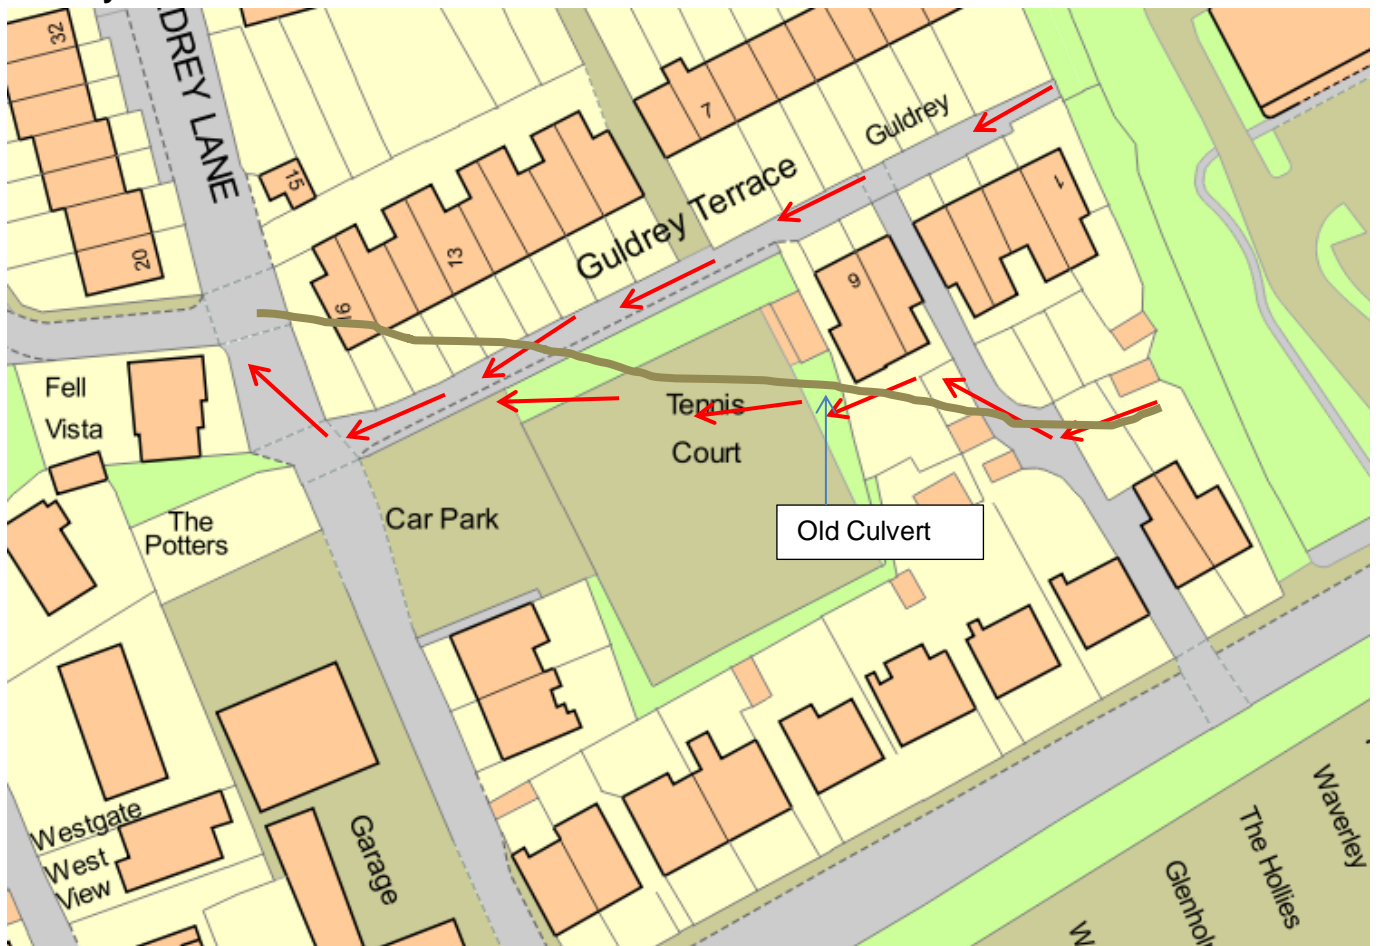
**Figure 10– Shows an overlay of the surface water exceedance rout in relation to the old stone culvert**

Old culvert exceeded in the back garden of the Nook house the flows then passed through a number of gardens and across on to the tennis courts. The flood water then joined with flow routes coming down the footway/ access track at the front of Guldrey Terrace. The two flow routes then joined and flooded the lane and then flowing west down Guldrey Terrace and towards Guldrey Lane.

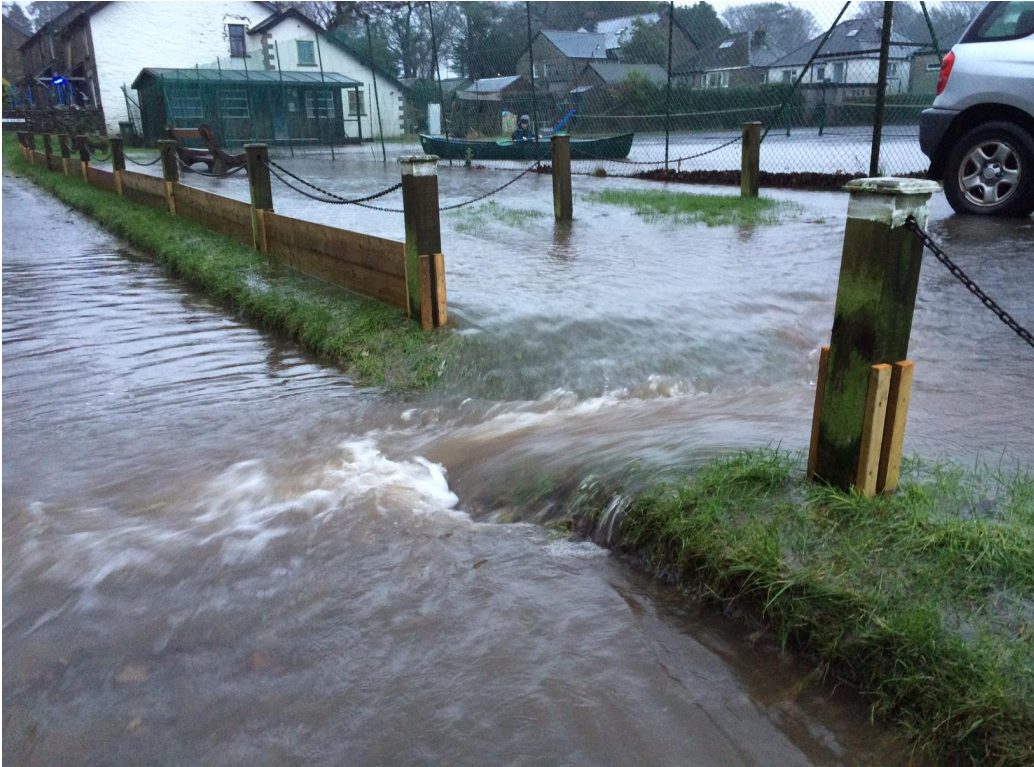
**Image 5 – Shows the location where the watercourse exceedance from The Nook joins the overland flows from the footpath.**

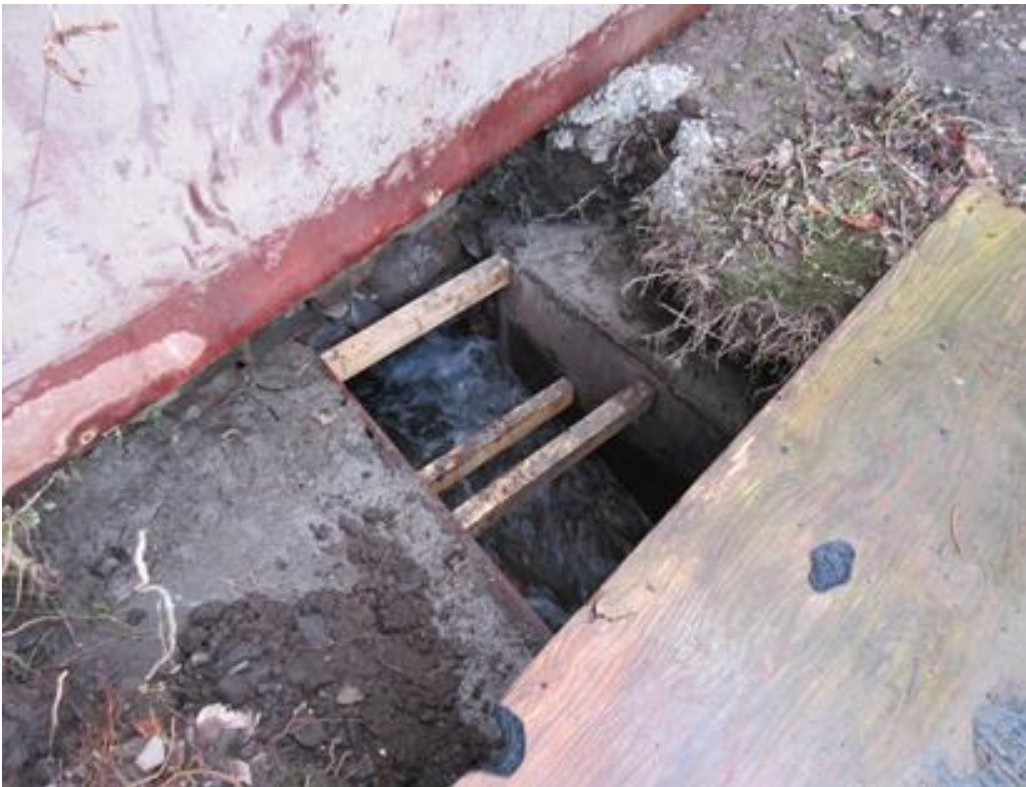
**Image 6 – Indicates the location in the rear of The Nook where the watercourse had forced its way out of the old stone culvert. The image was taken by residents after the event and after works had been done to repair the culvert wall collapse.**

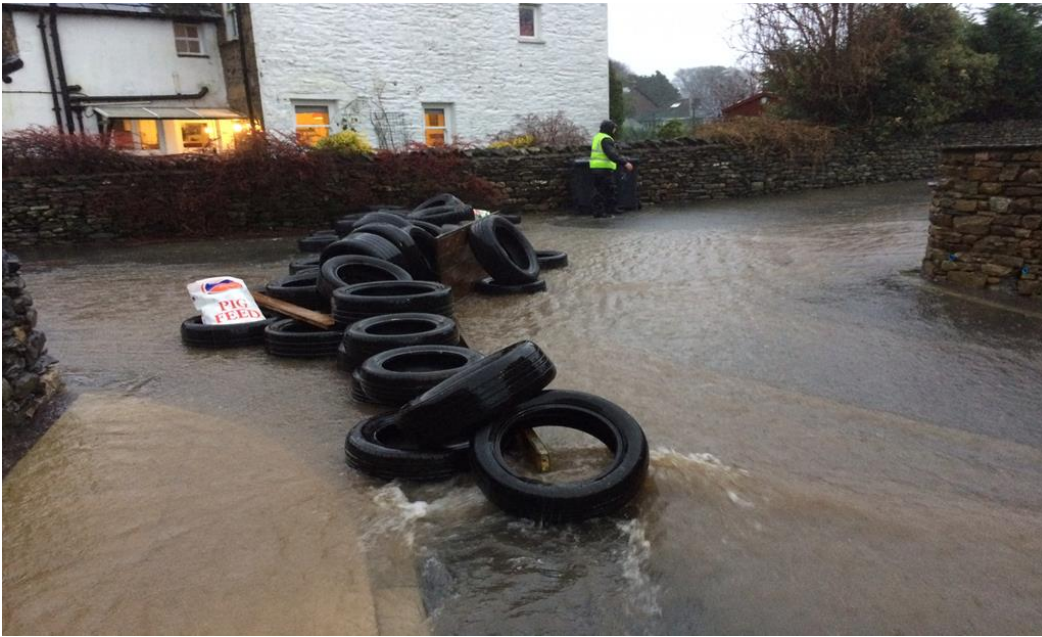
The flood water ponded outside the properties and the into a number of properties on Guldrey Lane, residents took action to further protect the properties by placing a temporary barrier in the highway to direct the flooding onto the car park area at the rear of the development see image 7 below.

**Image 7 – Temporary barrier to protect properties on Guldrey Lane**

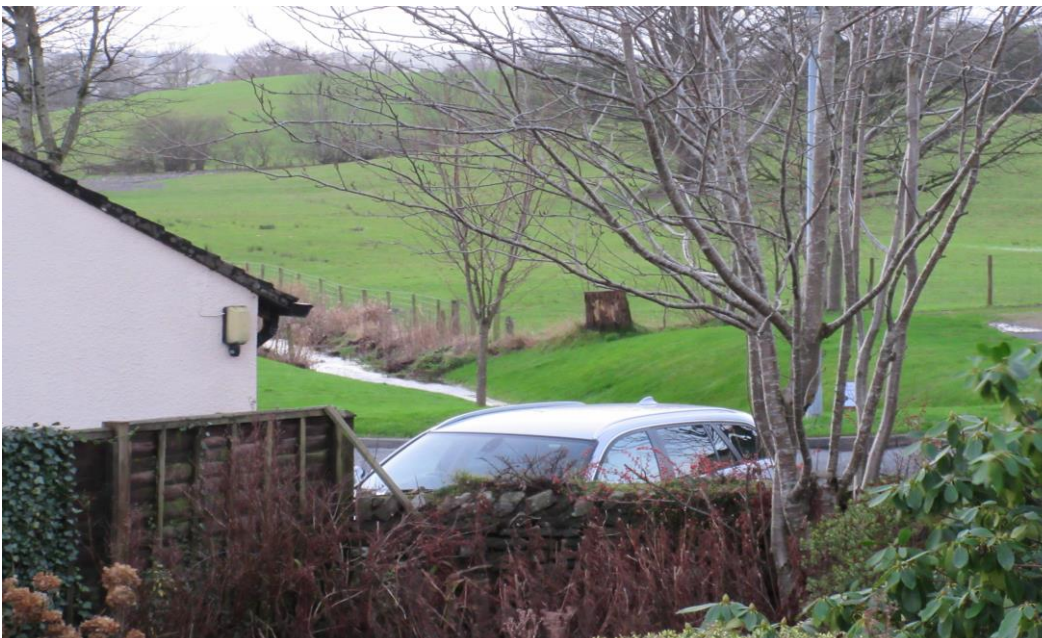
The drains were unable to bring down the flood water levels in the car park area and the boundary wall to the rear of No 7 Guldrey Fold created a barrier which the flood water built up behind. Some of the water passed through and later over the wall controlling the discharge and protecting potential flooding to No7 Guldrey Fold. See image 8 below shows the open channel of the watercourse, image was taken from the carpark to the rear of the flooded properties on Guldrey Lane and look across the rear garden of No 7 Guldrey Fold.

**Image 8 – Shows the location of the open watercourse**

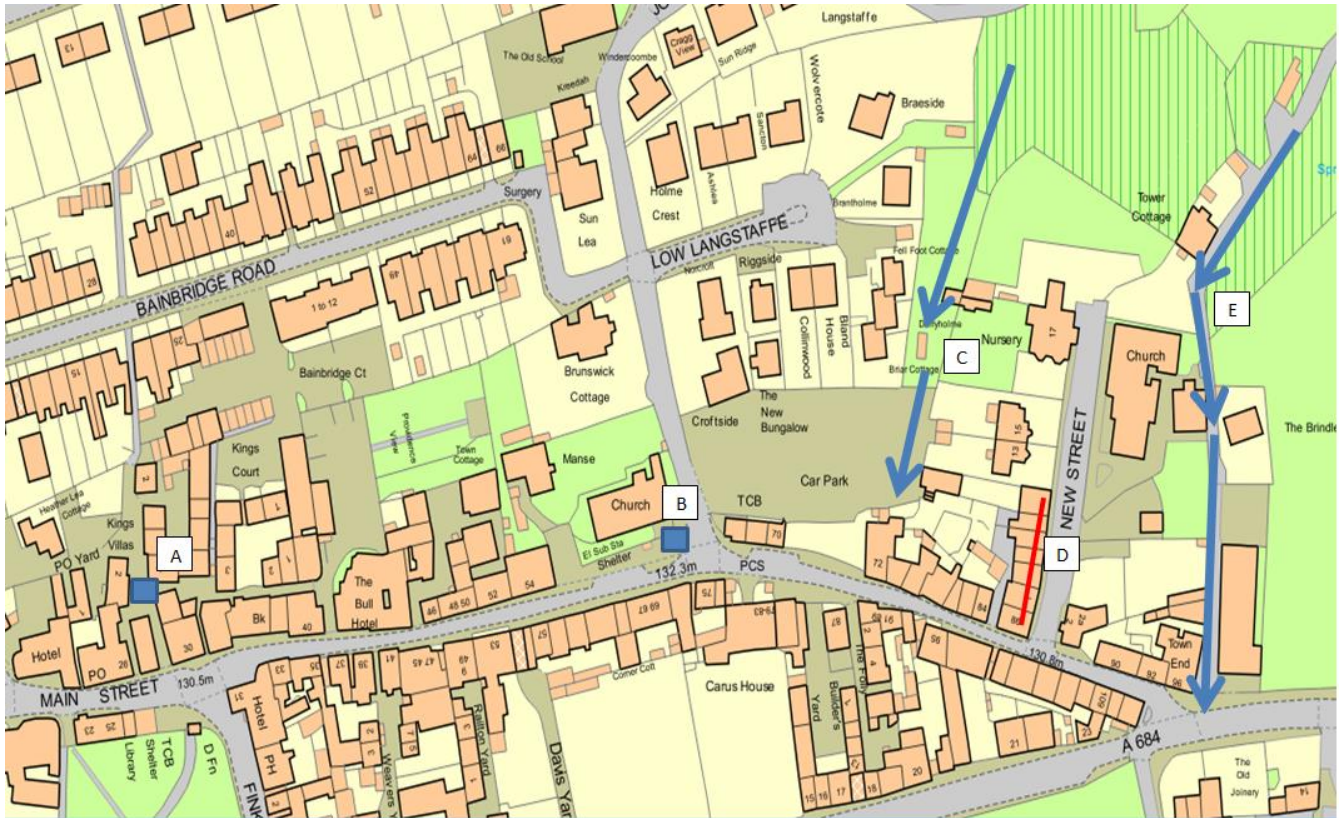
Figure 6- Indicates the location of flooding reported in the Draft flood forum which had an impact on Main Street Sedburgh

The above locations have been discussed with Cumbria County Council Highways Department and United Utilities and will be further investigated by both organisations.

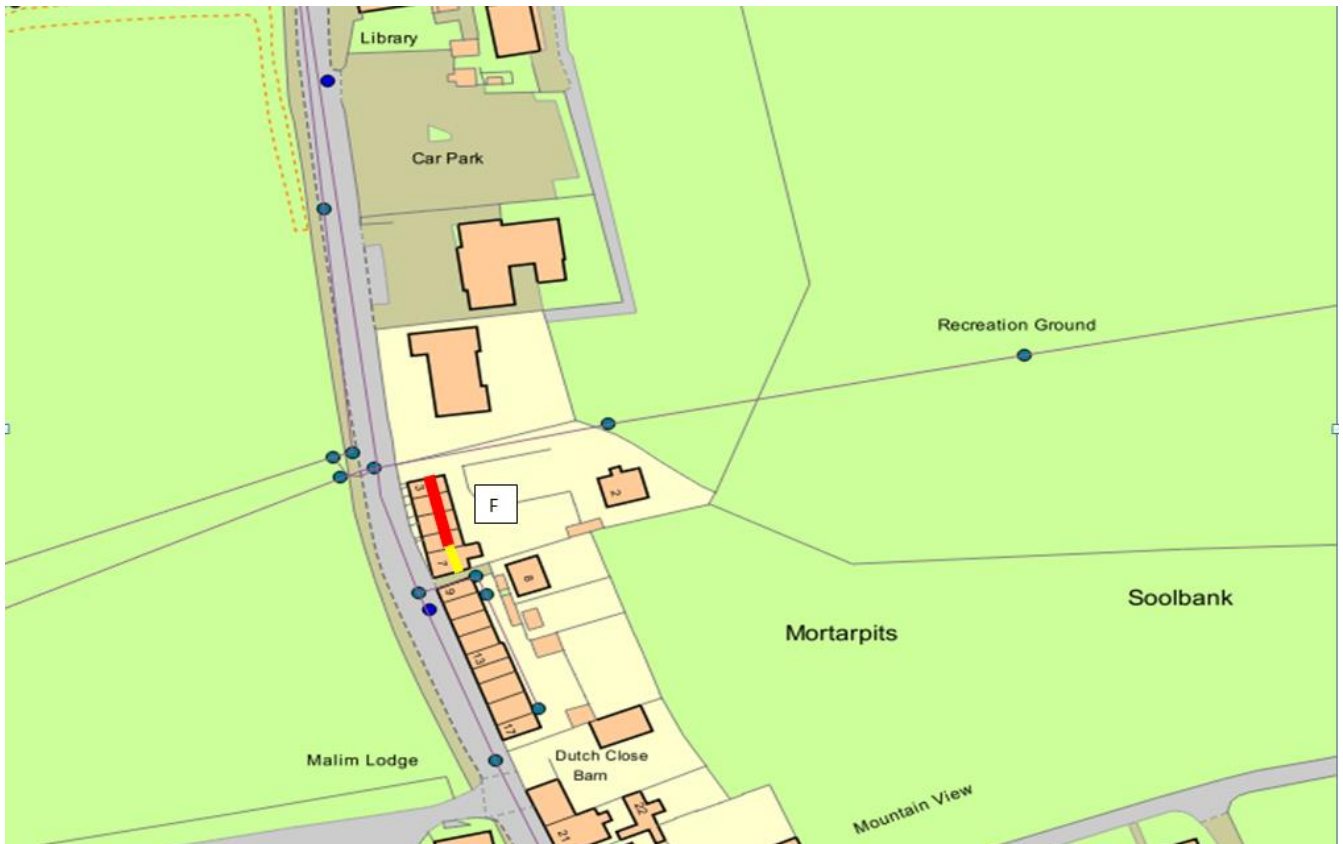
Figure 7- Loftus Hill, Sedburgh and investigation into Cumbria County Council and United Utilities surface water system

- A. Catch pit in the public footpath
- B. Underground catch pit which lifted in a flash flood in June 2016
- C. Overland flows which channelled through gardens and onto the Joss Lane pay and display car park

- D. Cellar flooding to properties at the bottom of New Street in Sedbergh
- E. Overland flows which has channelled down the public highway Castlehaw Lane in Sedbergh. The flows carried significant amounts of debris from the fell which was deposited on the public highway.
- F. Loftus Hill in Sedbergh, this location has been under investigation with United Utilities as the system is combined. UU have undertaken works to clear gullies and manholes in the area and have discovered a potentially separate surface water system which is under investigation with Cumbria County Council highways department. Loftus hill resulted in internal flooding to No 3, 4, 5 and 6 in December 2015 and unfortunately No 7 was flooded internally in June 2016.

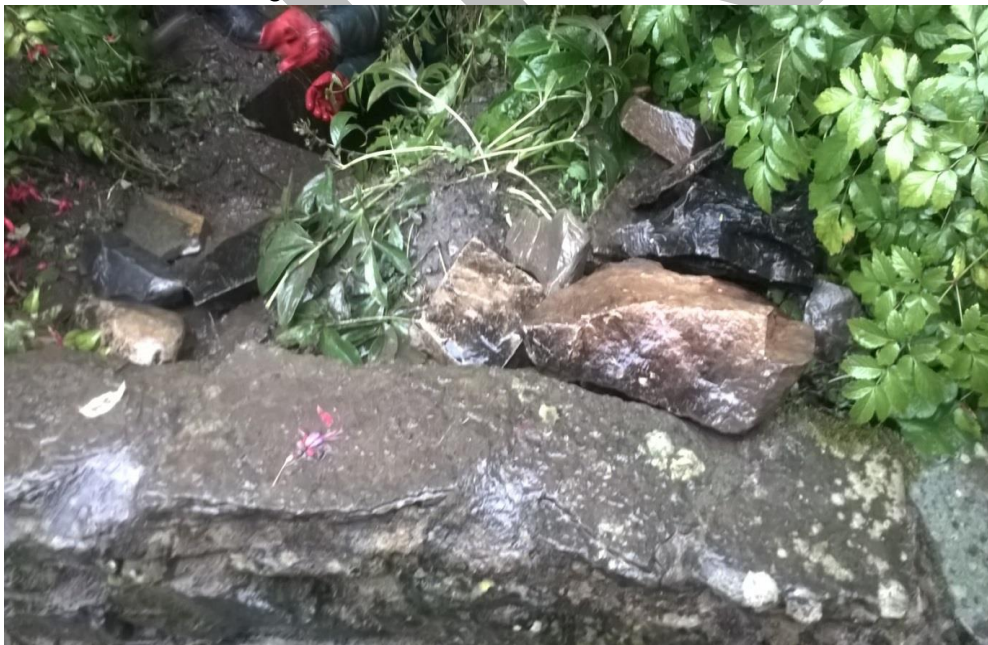
It was soon evident that although large stones had blocked the culvert and reduced the capacity to as little as 10-15% there was a significant amount of smaller sediment behind this which also reducing the capacity of the stone culvert to between 70% near Guldrey Terrace and 30% at the rear gardens of Waverley and The Nook . Image A below shows the size of stones removed by hand from the access chamber in the rear garden of The Nook.

**Image A: Debris removed from culvert by hand located in the Garden of “The Nook”**

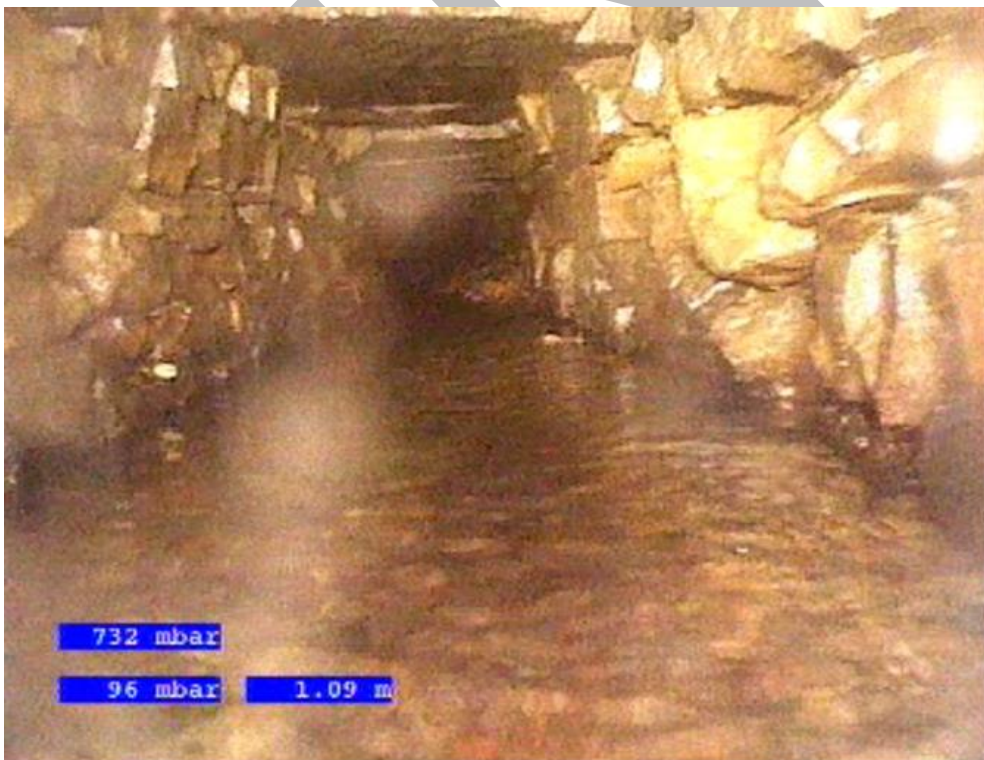
From this excavation it was evident that the stone built block culvert had more capacity in this location however there was still only 40% of capacity available. The image C below shows the condition of the culvert after jetting and loose sediment had been removed. In the distance a bank of gravel is evident which indicates the amount of material removed from the culvert

**Image C: Condition of the culvert after removal of debris, Note debris bank in the distance.**

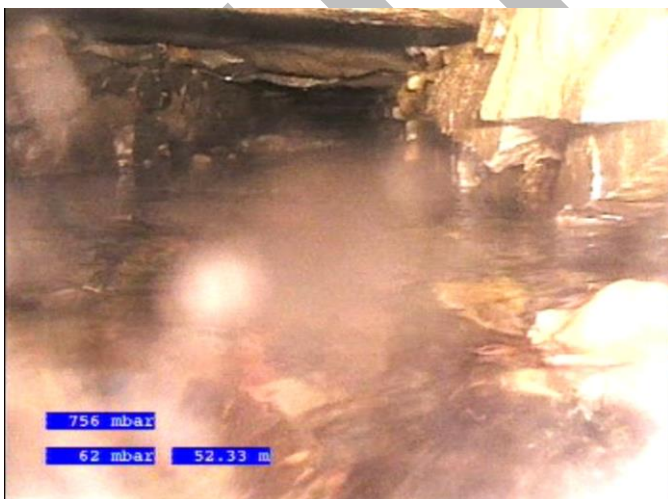
The sediment build up increased from 30% under the grass verge to 85-90% at the rear of the Nook.

The issue experienced in December 2015 seems to have been caused by sediment build up within the Stone Box Culvert, this could have led to the culvert walls and roof being under a significant hydraulic pressure that the eventually the roof of the culvert was forced off in the rear garden of The Nook. The walls of the culvert in this location also seem to have collapsed and had been washed further into the culvert becoming lodged in which meant even light rainfall events the culvert was unable to take the volume of water. Sapphire has removed in all between 7-8 tonnes of material from the culvert this doesn't include the larger boulders which had to be removed by hand. The 2 images D and E below show what the culvert looked like during the works and how the culvert had been left.

**Image D: Indication of culvert capacity loss during Sapphire works**

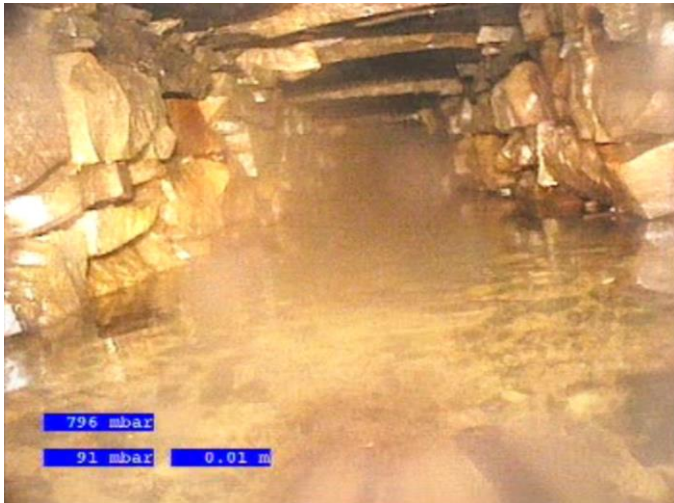
**Image E: Indication of the improved capacity following works undertaken by Sapphire**

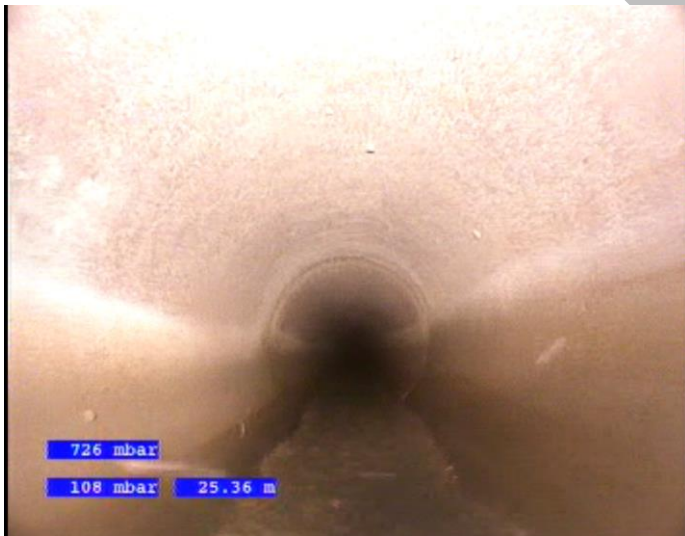
**Image F: Shows the 450mm pipe through the new build development to Guldrey Fold**

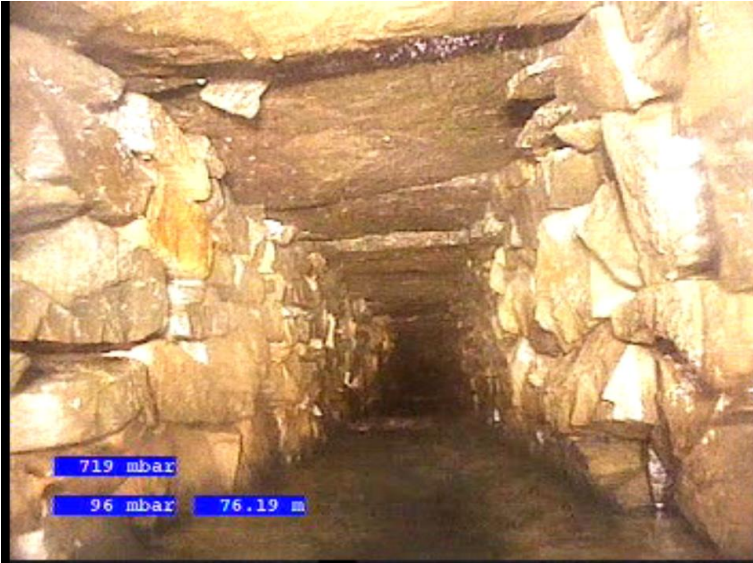
**Image G: Shows the downstream section of the box culvert at the end of Guldrey Terrace before discharge into the 450mm pipe**
