# Carlisle

## Flood Investigation Report

## Flood Event 5-6<sup>th</sup> December 2015

This flood investigation report has been produced by the Environment Agency as a key Risk Management Authority under Section 19 of the Flood and Water Management Act 2010 in partnership with Cumbria County Council as Lead Local Flood Authority.

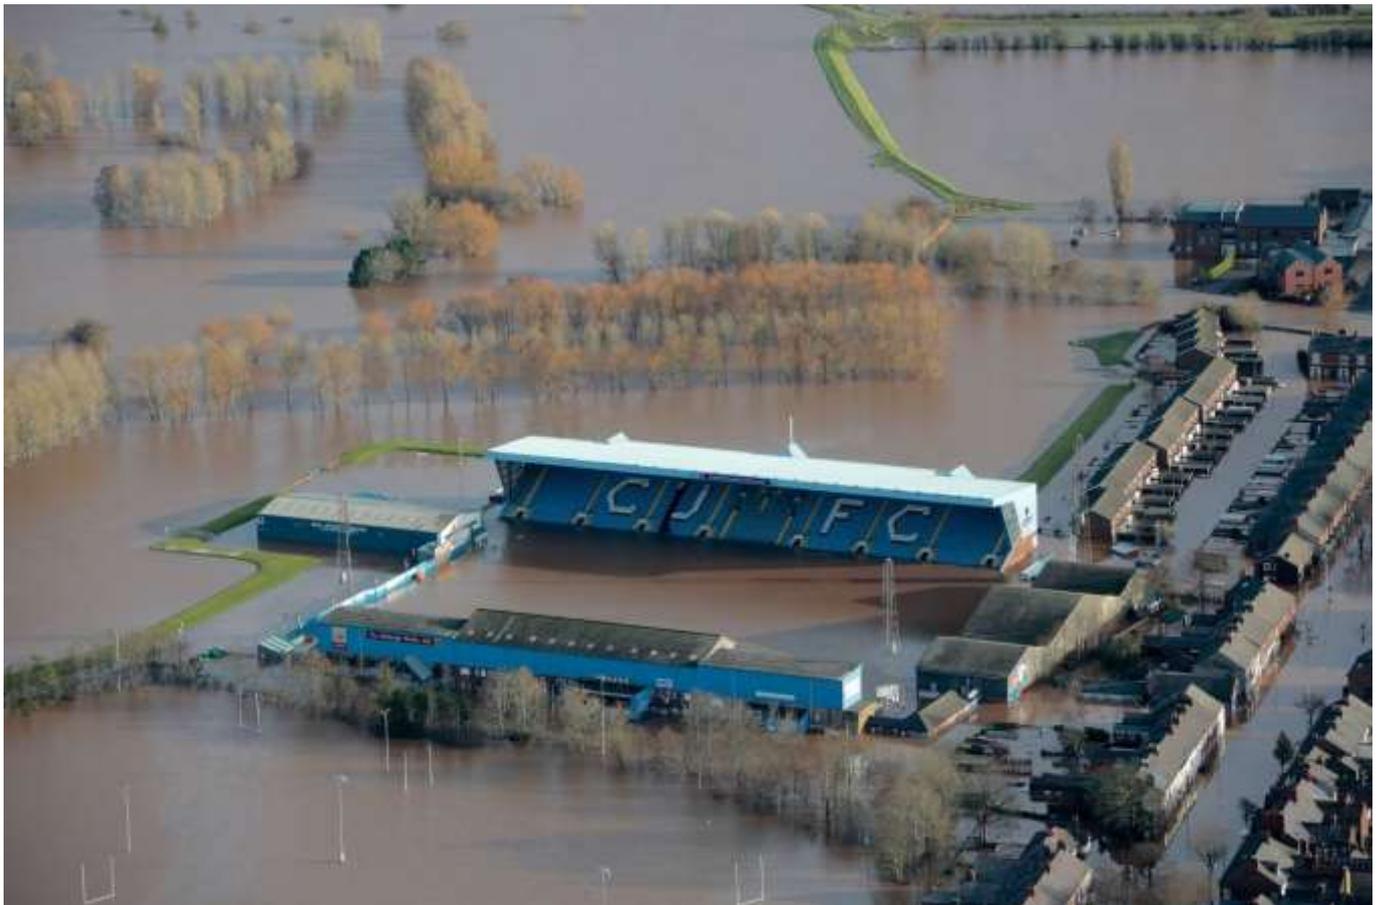
*Brunton Park football ground 6<sup>th</sup> December*

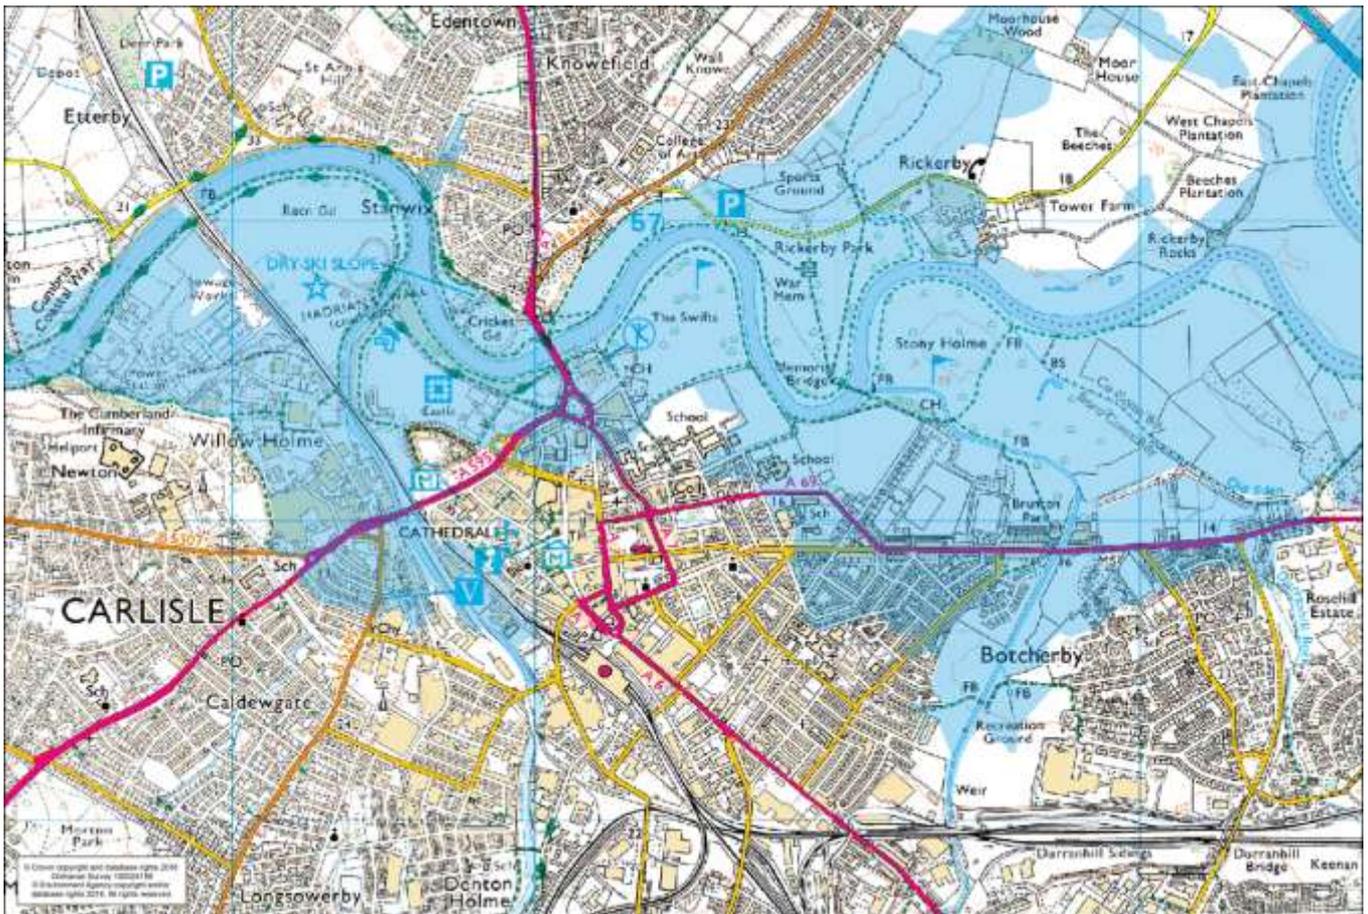
**Figure 2 Extent of Fluvial (River) Flooding in Carlisle on 5-6<sup>th</sup> December 2015**

On 5<sup>th</sup> and 6<sup>th</sup> December 2015, approximately 2,100 properties suffered flooding. This flooding can be attributed to a record-breaking rainfall event from Storm Desmond. This led to widespread flooding from the Rivers Eden, Petteril, and Caldew, plus flooding from other watercourses, surface water and drainage systems. Figure 2 shows the approximate extent of the flooding.

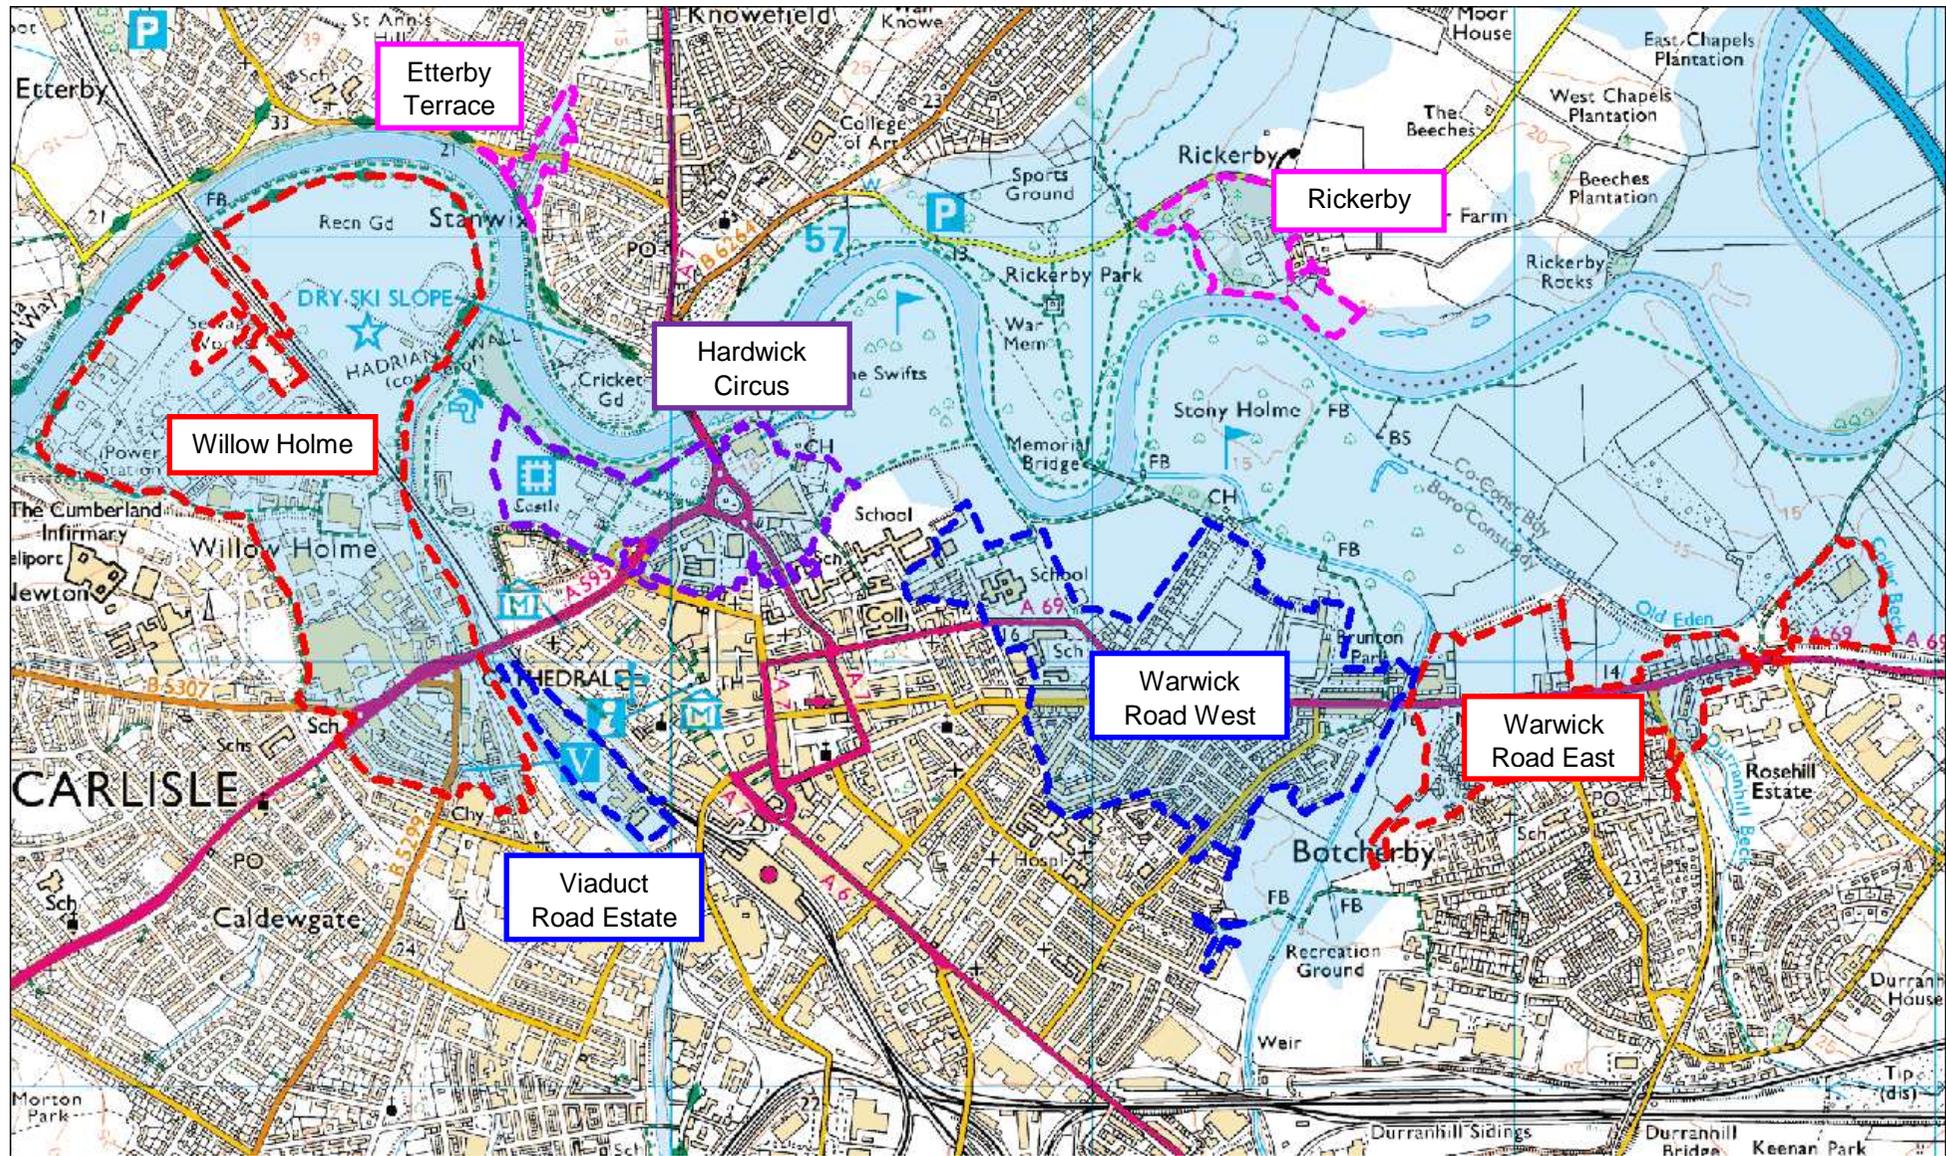
Figure 3 Identification of Areas Flooded

For this report the flooded area has been divided into 7 sub-areas for investigation. These are shown in Figure 3.

- **Warwick Road East** – Warwick Road on the right bank of the River Petteril and surrounding area
- **Warwick Road West** – Warwick Road on the left bank of the River Petteril and surrounding area
- **Hardwick Circus** – The area south of Eden Bridge
- **Rickerby** – Rickerby village north of the River Eden
- **Etterby Terrace** – The flooded area on the right bank of the River Eden located downstream of Eden Bridge
- **Viaduct Estate** – The area on the right bank of the River Caldew around Caldew Bridge
- **Willow Holme** - The left bank of the River Caldew and the left bank of the River Eden where these two rivers meet

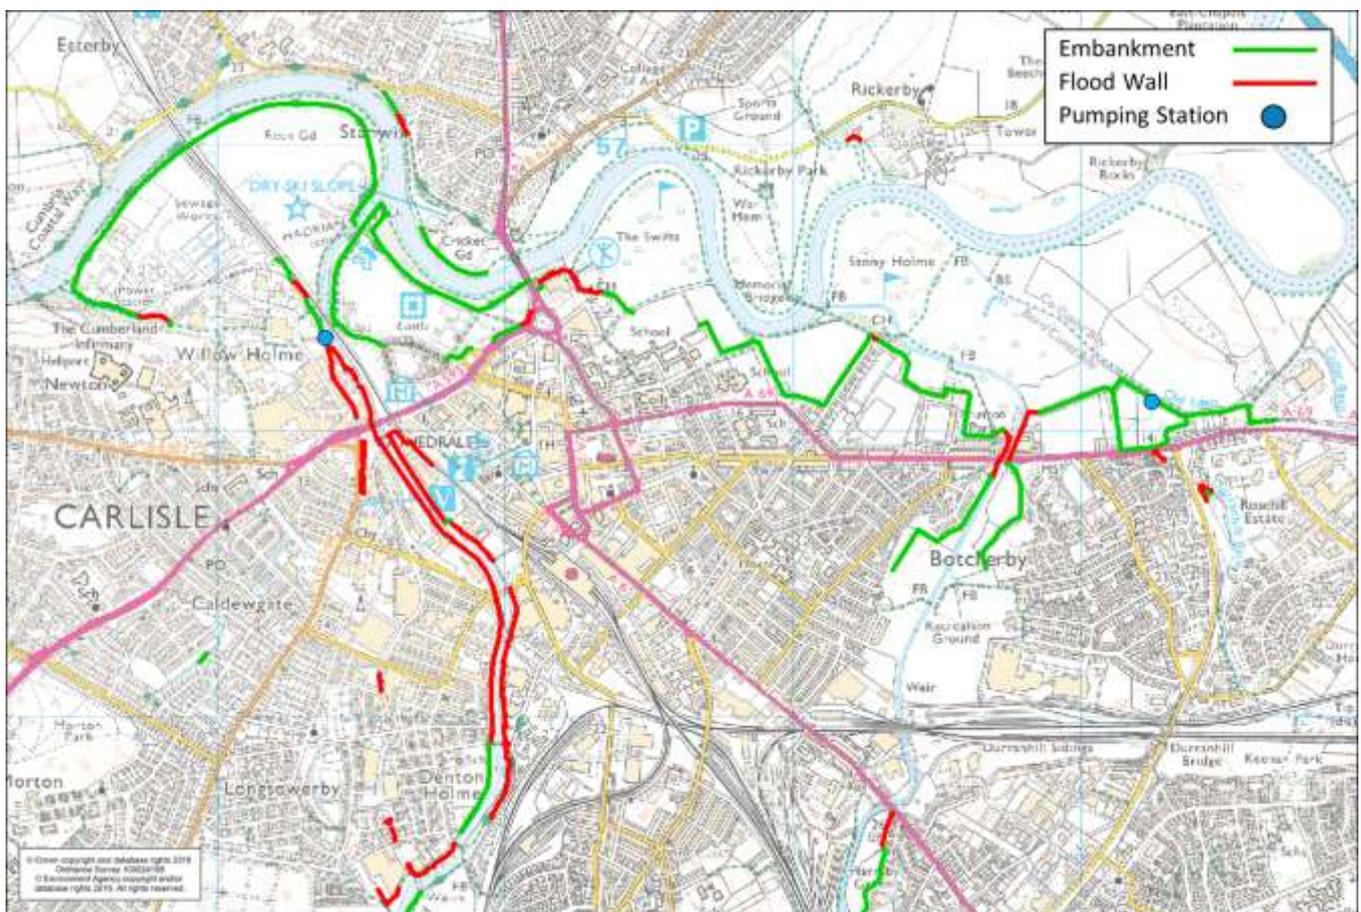
Figure 4 Flood Defences within Carlisle

The first of these was the Eden & Petheril Flood Alleviation Scheme in the east of the city (completed in 2007) and this was followed by the Caldew & Carlisle City Flood Alleviation Scheme to the west (completed in 2010). In addition to this there are smaller schemes at Etterby Terrace and Harrayb Green, which were completed before the 2009 storms.

A map of existing defences is shown in Figure 4.

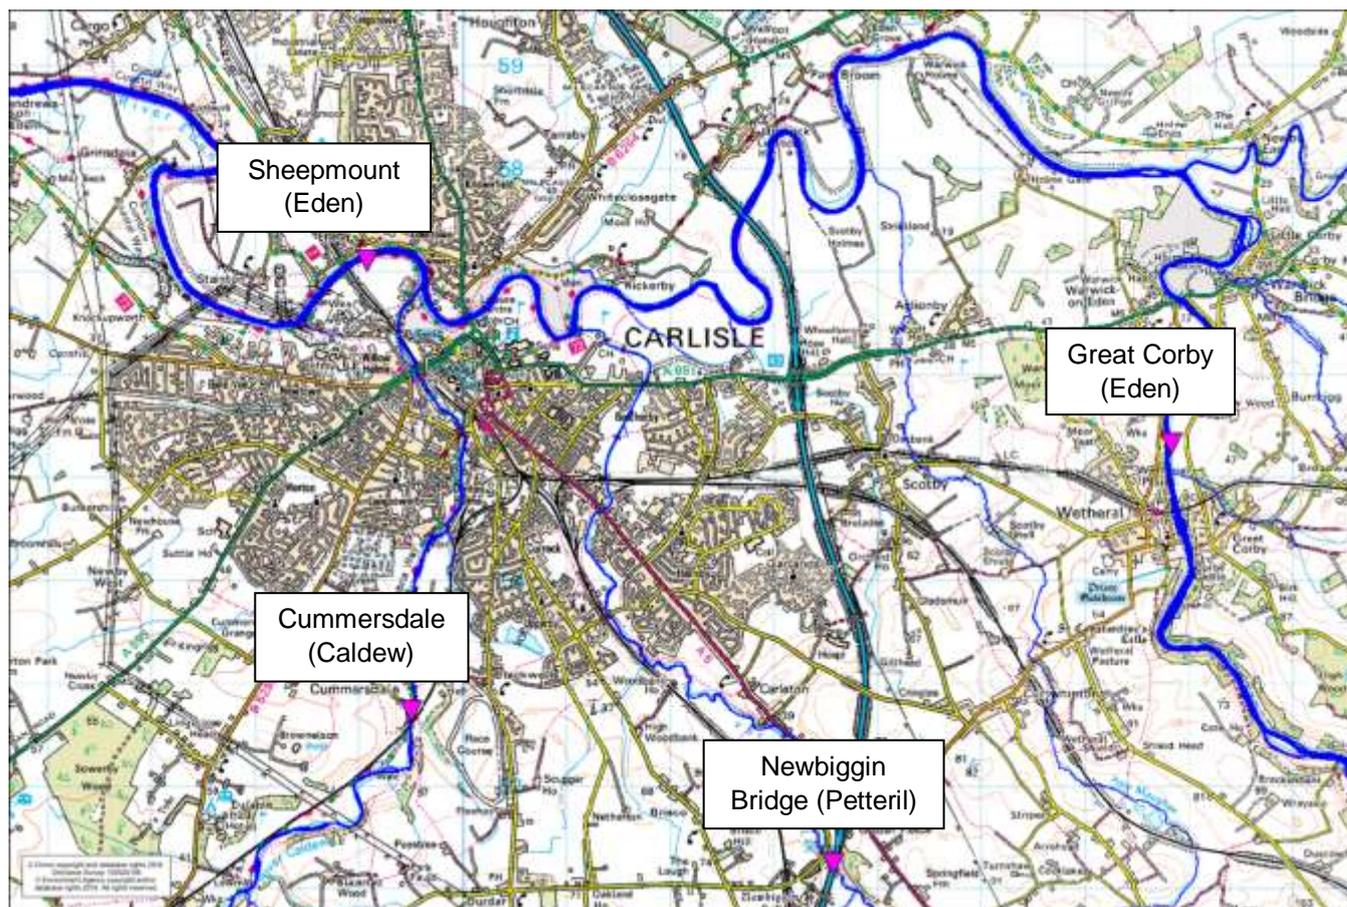
Figure 6 Location of river gauges around Carlisle

There are 4 river monitoring gauges in the Carlisle area, these are shown in Figure 6. The peak flows recorded on the Rivers Eden and Caldew are shown in Table 4, along with the flows from past flooding events.

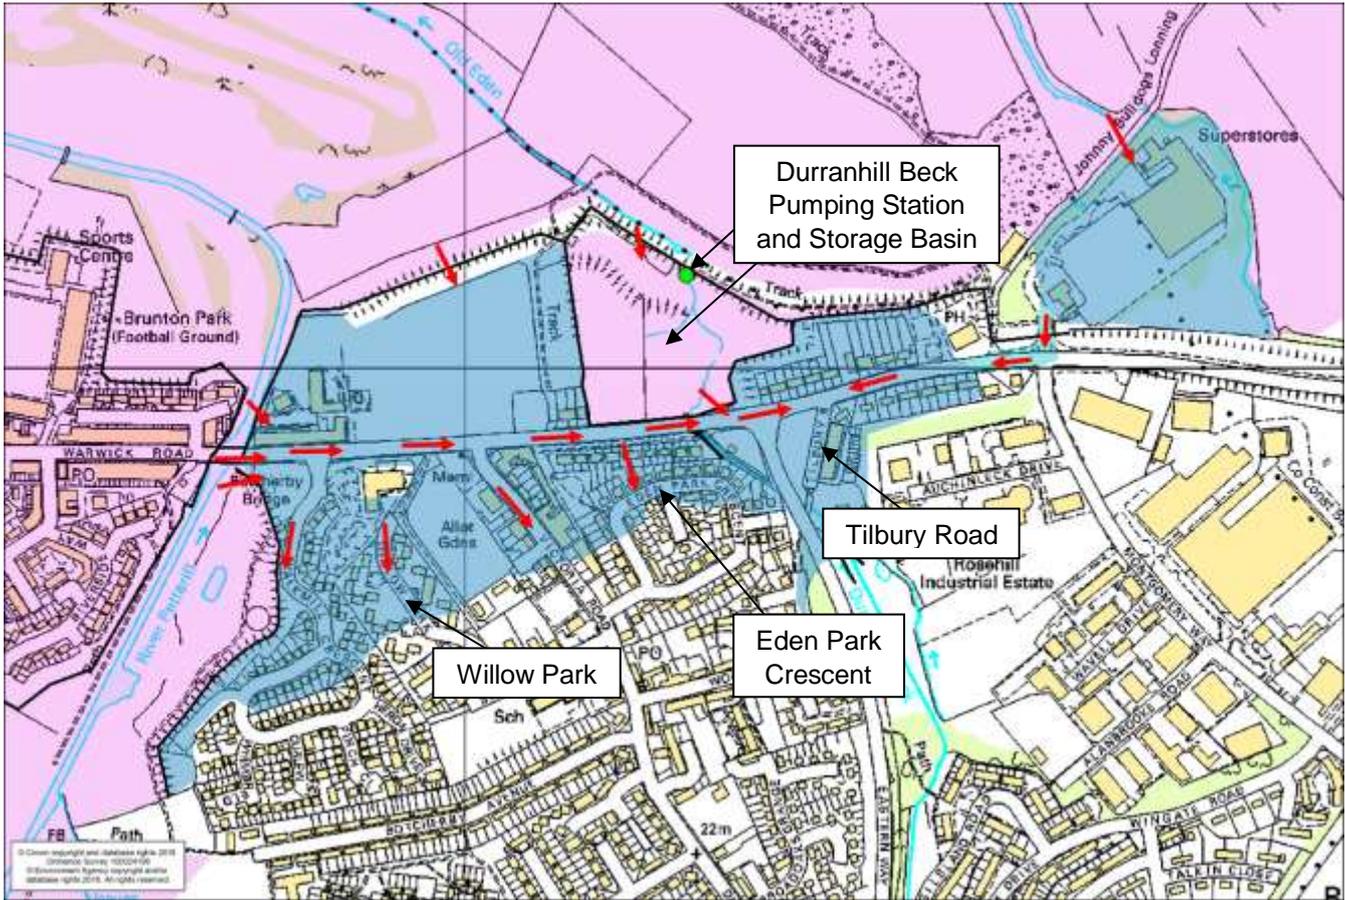
**Figure 8 Flood Flow Routes in Warwick Road East area**

This area is on the right bank of the River Petteril and left bank of the River Eden. There is also a smaller watercourse, Durranhill Beck, which flows through the area. Warwick Road crosses the River Petteril at Botcherby Bridge in this location. This area is primarily residential and was flooded from the River Petteril and also from the River Eden in the latter stages of the flood event.

Early in the event, Botcherby Bridge acted as an obstruction to flow leading to higher water levels upstream of the bridge and over topping of the left bank . However the defences on the right bank were not overtopped until high water levels in the River Eden caused flow in the River Petteril to back up.

The pumping station on Durrhill Beck pumps water stored in the storage basin when water cannot naturally flow into the River Eden during periods of high river levels. During the flood event the power supply to the area failed; following this the pumping station continued to run on an emergency generator until it exhausted its fuel and stopped pumping. This occurred in the early hours of Sunday morning, but the exact time that pumping stopped was not recorded. Whilst the pump was operational the storage basin for Durrhill Beck worked well and did not fill to capacity. Following the failure of the pumping station the basin filled and overtopped leading to additional flooding on Warwick Road.

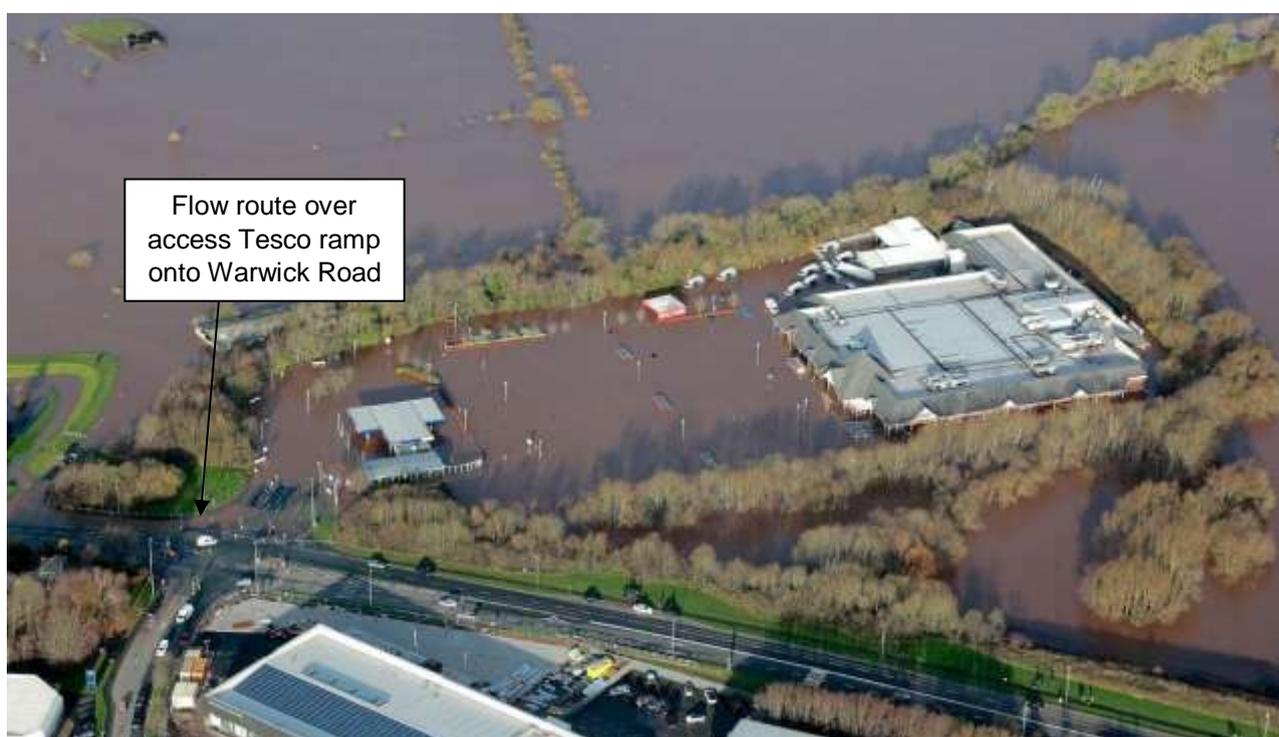
The Tesco store at the east of this area was flooded directly from the River Eden. This store is not protected by flood defences. During the latter stages of the event on Sunday morning flood water overtopped the raised access road to the store (which forms part of the flood defence scheme). The access ramp may have formed a low point in the River Eden defences in this area. This flow route will have contributed to the flooding on the eastern extent of the flooded area of Warwick Road.

**Figure 9 Flooded Tesco store with the flow route onto Warwick Road visible**

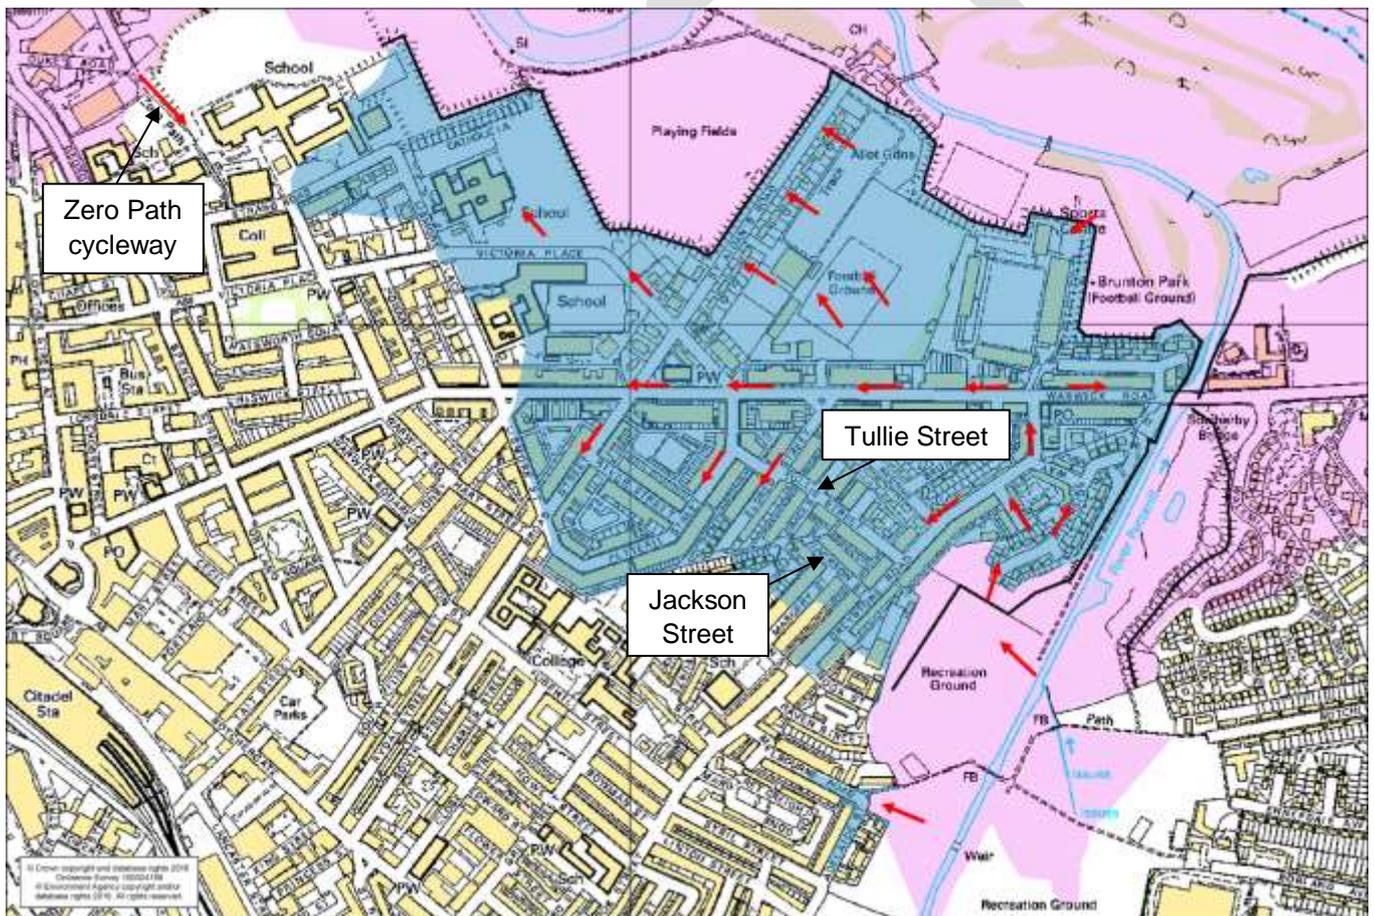
Figure 10 Flood Flow Routes in Warwick Road West area

This area is located on the left bank of the River Petteril on the opposite side of Botcherby Bridge. The flooded area is primarily residential with a number of schools also affected. There are flood defences along the banks of both rivers consisting of earth embankments and sheet piled walls. There were a number of properties that flooded during the flood event of the 5<sup>th</sup> and 6<sup>th</sup> December that had never flooded historically in this part of the city. This is a reflection of the size of the event experienced in December 2015.

There was flooding reported early on Saturday afternoon to Adelaide Street. This was from the River Petteril outflanking the flood defences at Melbourne Park via a flow route upstream of these defences. There was also flooding from drains reported in the area at this time. This was reported to have occurred at 16:00 on the 5<sup>th</sup> December, significantly before the peak river levels in the Petteril and Eden. Residents in Jackson Street and Vasey Crescent reported that the properties in these streets closest to the River Petteril had water rising through the floorboards prior to flooding from the river.

The main flow route into this area was from defences being overtopped upstream of Botcherby Bridge. Melbourne Park was also flooded with the defences here being overtopped near the end of Riverside Way. As with the Warwick Road East area, this was exacerbated by the high levels in the River Eden. The defences within Melbourne Park were also out-flanked, as the river levels were greater than the ground level upstream of these defences. In addition to this, there was some leakage through the defences immediately upstream of Botcherby Bridge; some water was seeping through the corner joint of the defence wall before properties were flooded from the Melbourne Park route.

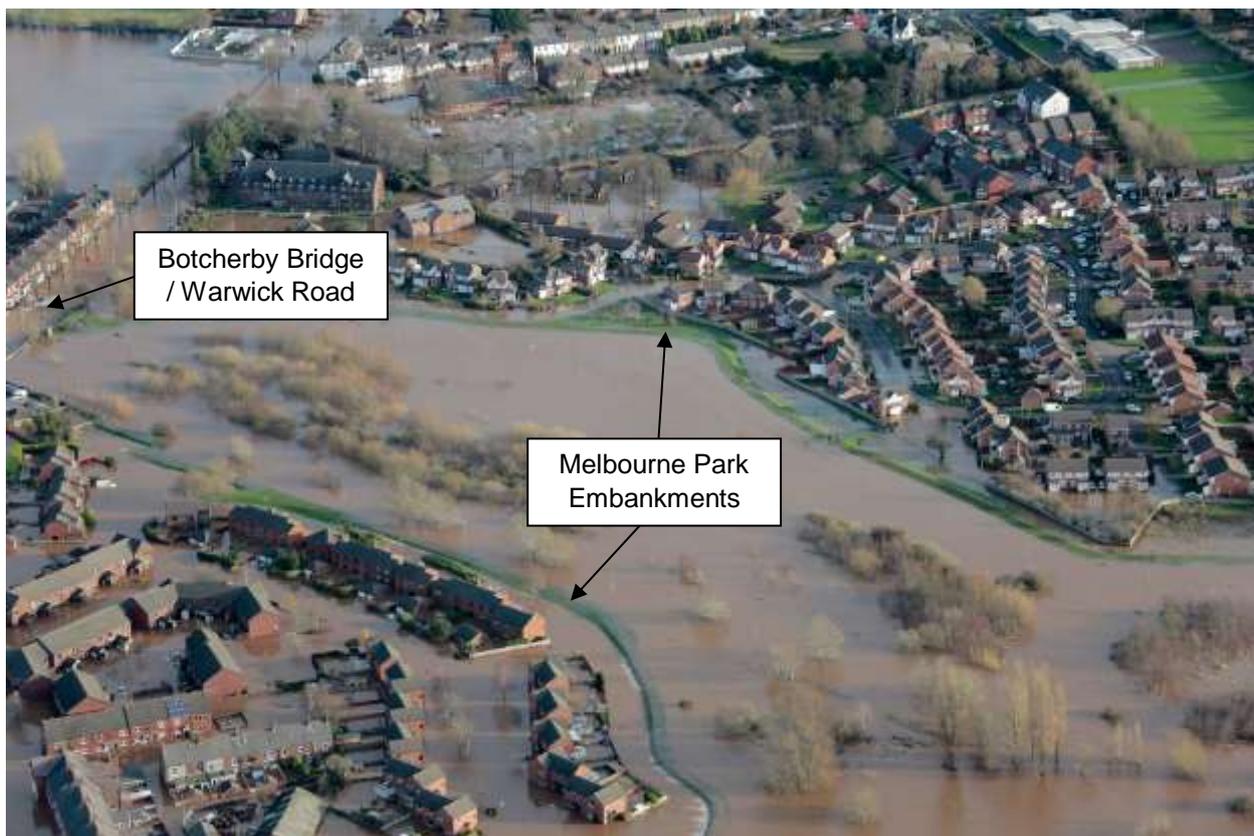
**Figure 11 Melbourne Park and River Petteril during flood event**

The overtopping of this defence led to flooding in Riverside Way, Greystone Road and Tullie Street at midnight. This flood route then continued to Warwick Road and flooded the neighbouring streets. This flooding extended as far as St Aidans Road and Newman & Trinity Schools. This also led to flood water flowing over Botcherby Bridge into the Warwick Road East area.

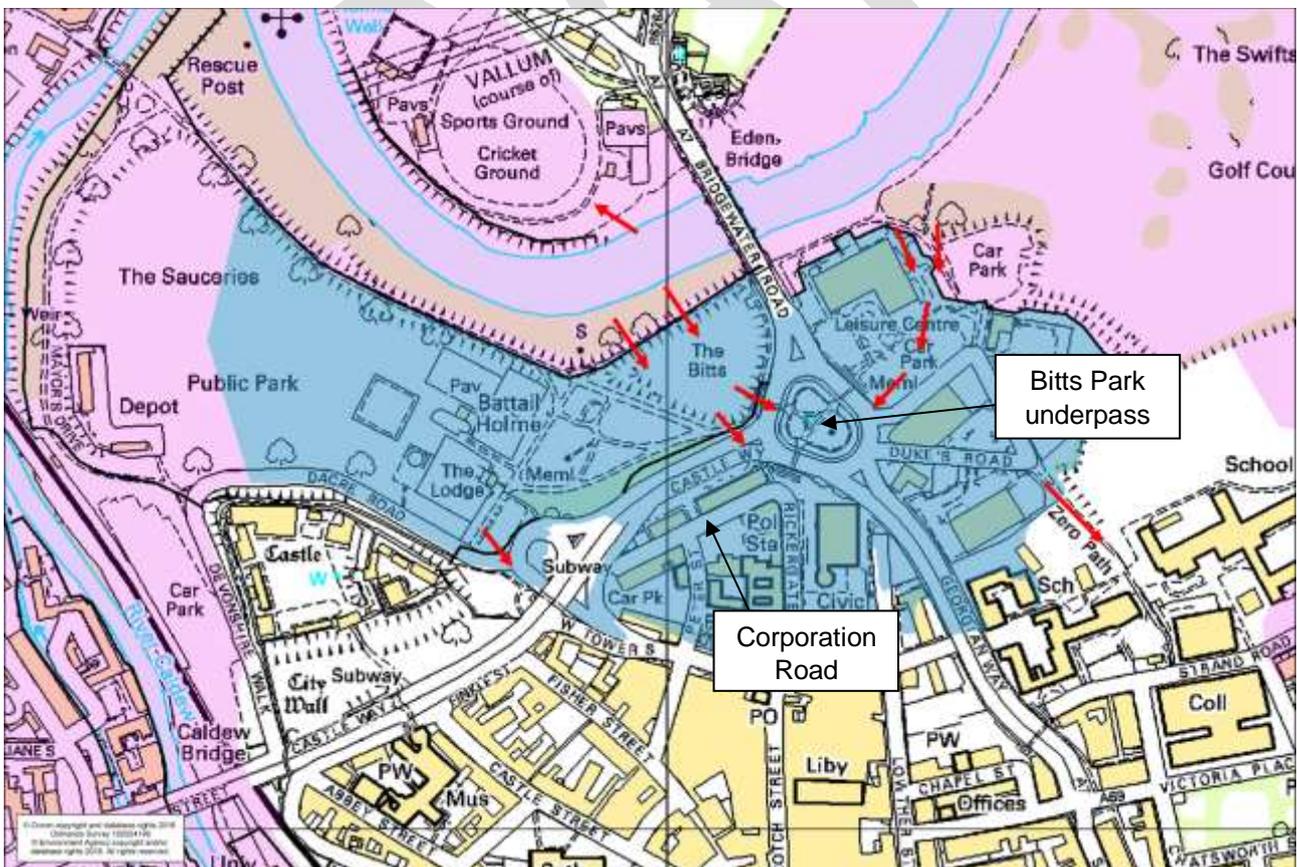
Figure 12 Flood Flow Routes in Hardwick Circus area

This is the area south of Eden Bridge and consists of commercial and retail buildings as well as Carlisle City Civic centre. To the north of the River Eden is the Cricket Ground which was badly affected during the flooding. The area is alongside the River Eden and there are flood defences along this riverbank in the form of embankments and reinforced concrete walls.

This area is adjacent to Eden Bridge, which carries the A7 trunk road. The left arch of this bridge was reported to have been blocked by debris during the flood event. This, combined with the flood flow level reaching to the top of the bridge arches will have increased river levels upstream of the bridge, and may have contributed to the overtopping of defences at the Sands Centre.

From this area there was flow down Zero Path towards Trinity School. This contributed to the flooding in the Warwick Road West area. The time of this flow was not recorded.

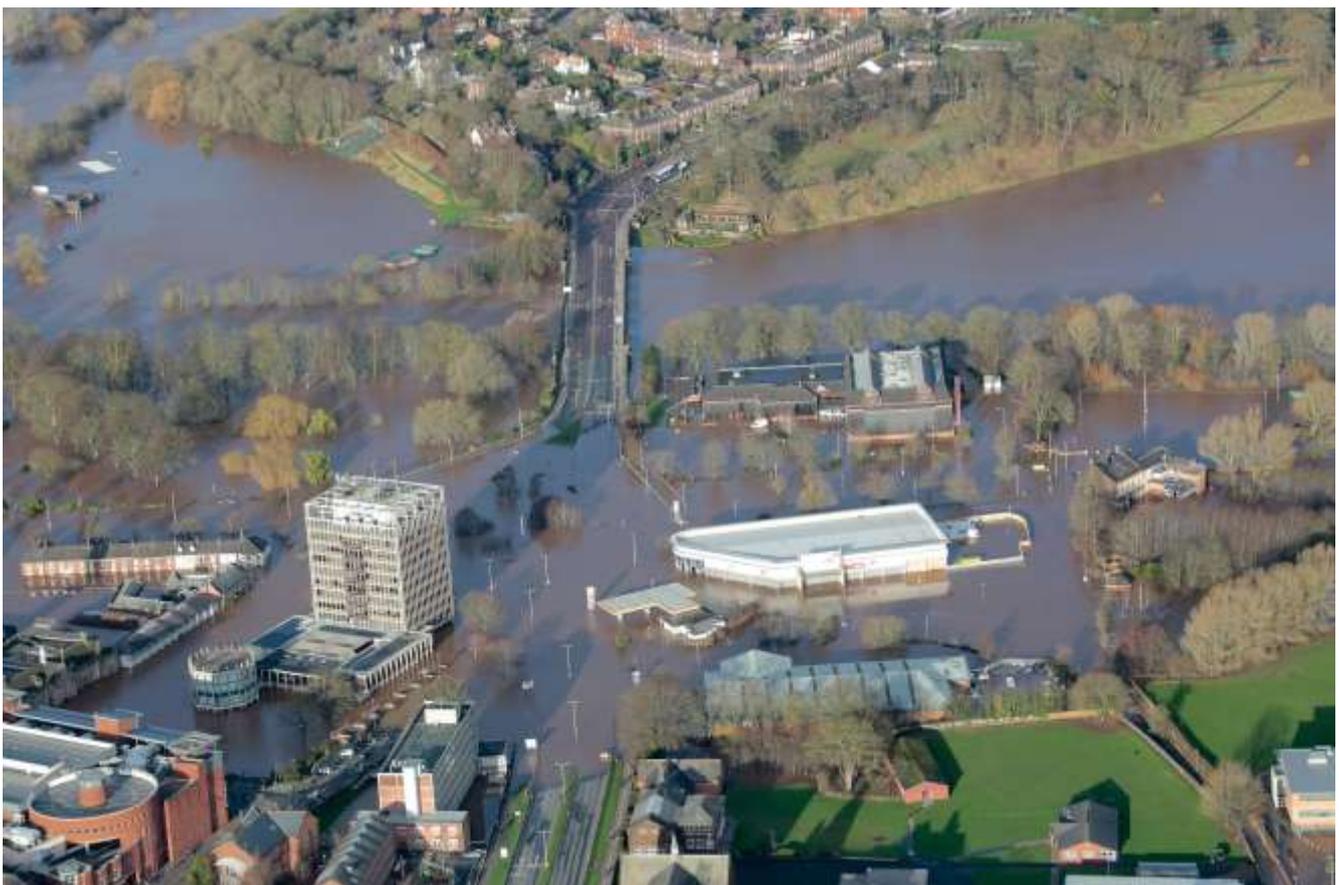
**Figure 13 Hardwick Circus area during flood event**

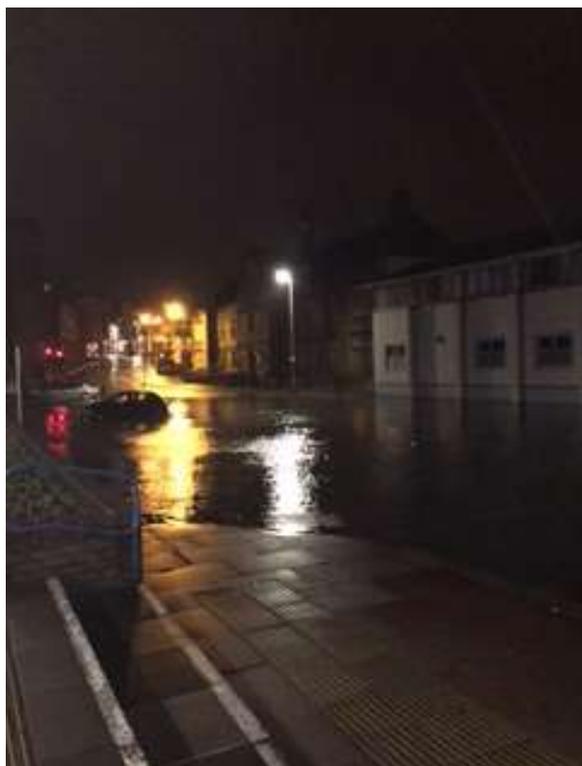
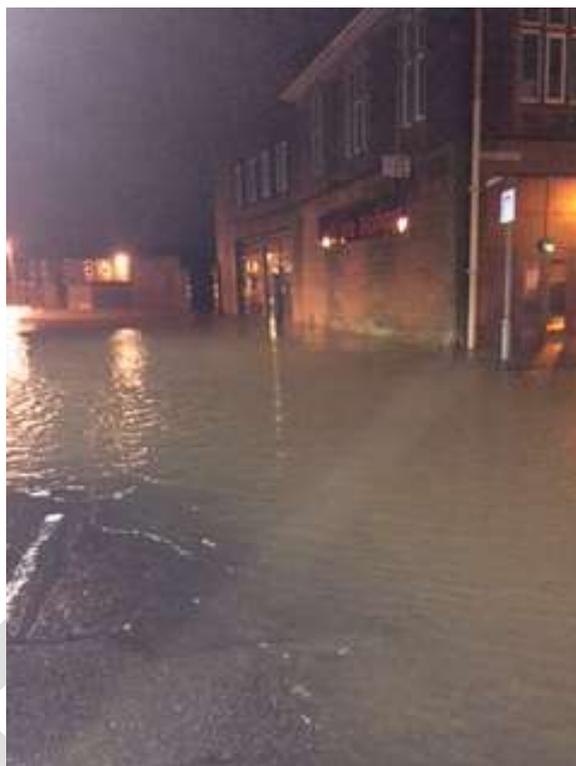
**Figure 14 Photographs of Hardwick Circus area during the flood event**

Rickergate at 23:07 on the 7<sup>th</sup> December

Peter Street facing towards Corporation Road at 03:23 on the 6<sup>th</sup> December

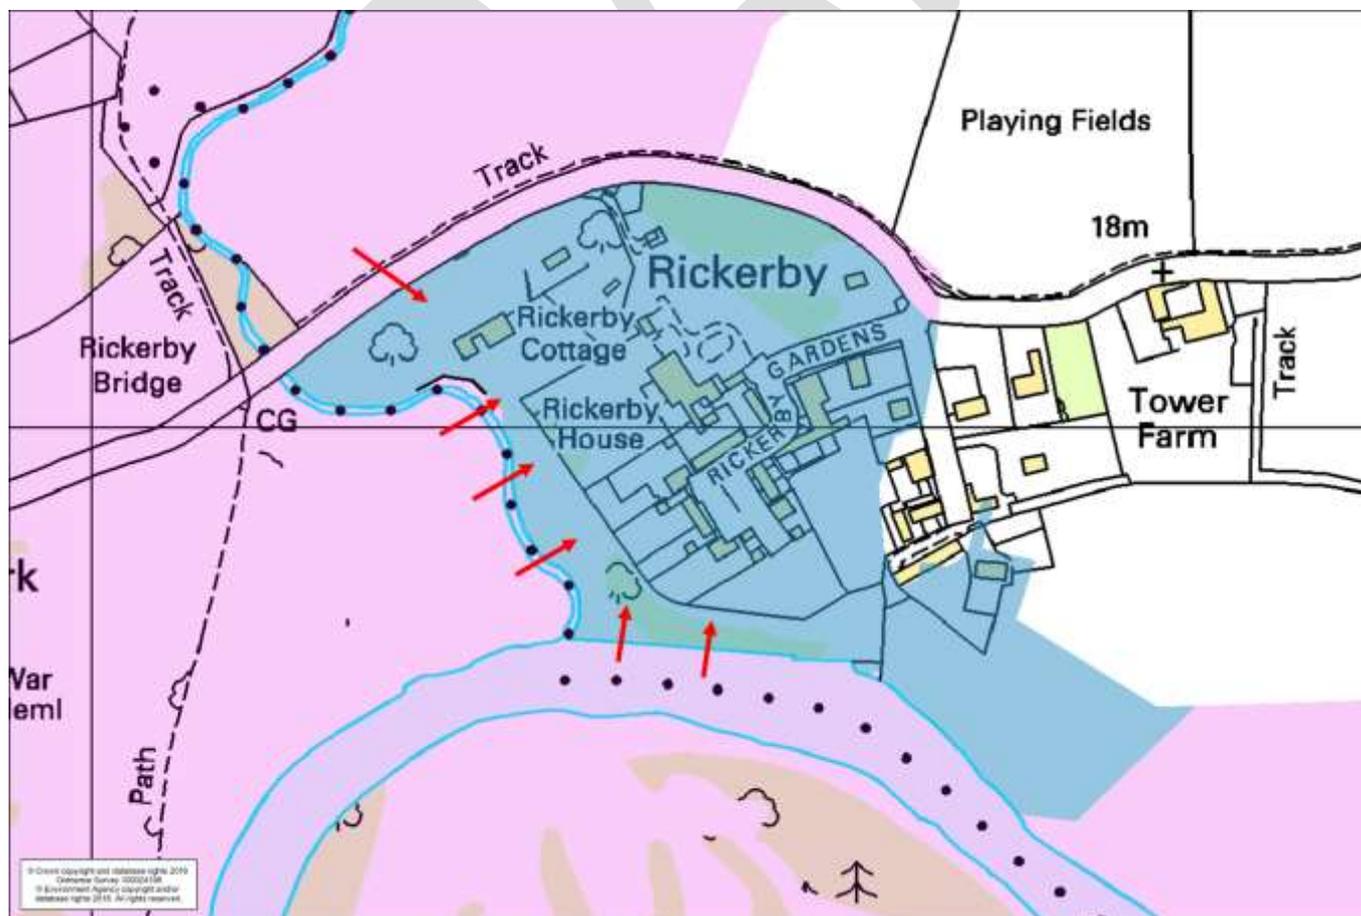
**Figure 15 Flood Flow Routes in Rickerby**

The majority of properties in Rickerby village are relatively new, and located in a residential development completed in 2004. Despite the village's close proximity to the River Eden there are limited flood defences in this area. The only raised defences consist of a small raised embankment to protect Rickerby House against minor flooding. As the area is at risk of flooding, many of the properties have property level protection.

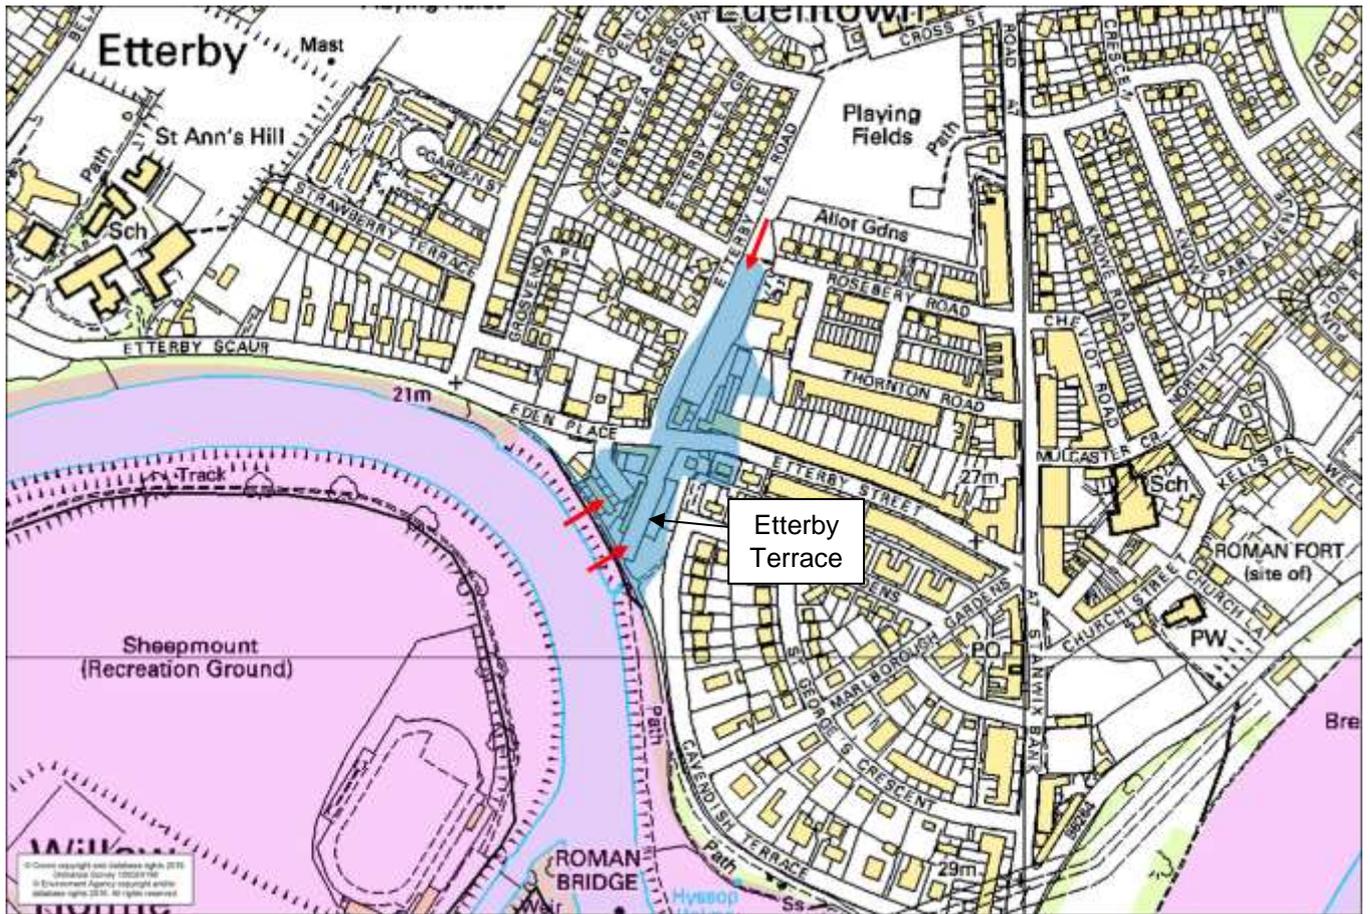
**Figure 16 Flood Flow Routes in Etterby Terrace**

This is an area of residential properties north of the River Eden. There is a flood defence wall along the River Eden at Etterby Terrace, constructed following flooding to this area in January 2005. There is also a culverted watercourse, Gosling Syke, which passes underneath this area and into the River Eden.

Prior to the overtopping of the defences the properties within this area were flooded from surcharging surface water drains and from water rising through floors. This flooding was from Gosling Syke, a watercourse which passes underneath the area that was flooded. Residents reported that the Gosling Syke outfall is often blocked. However, this flooding may have been caused by high river levels in the Eden causing Gosling Syke to back up.

Environment Agency	Etterby Terrace experienced flooding from the drainage system, Gosling Syke and latterly the River Eden. All these sources of flooding need to be investigated	Summer 2016
	Environment Agency	The Environment Agency is carrying out a series of repairs to flood defence assets that were damaged during the floods as part of a c.£10m Asset Recovery Programme which covers Cumbria & Lancashire. This programme of repairs is scheduled to be complete before winter 2016/17 and includes work such as repairing the pumping station at the confluence of the Little Caldew and the River Caldew, reinstating embankments which suffered scour damage and removing large debris and silt/gravel build up from within the river channels.	Winter 2016

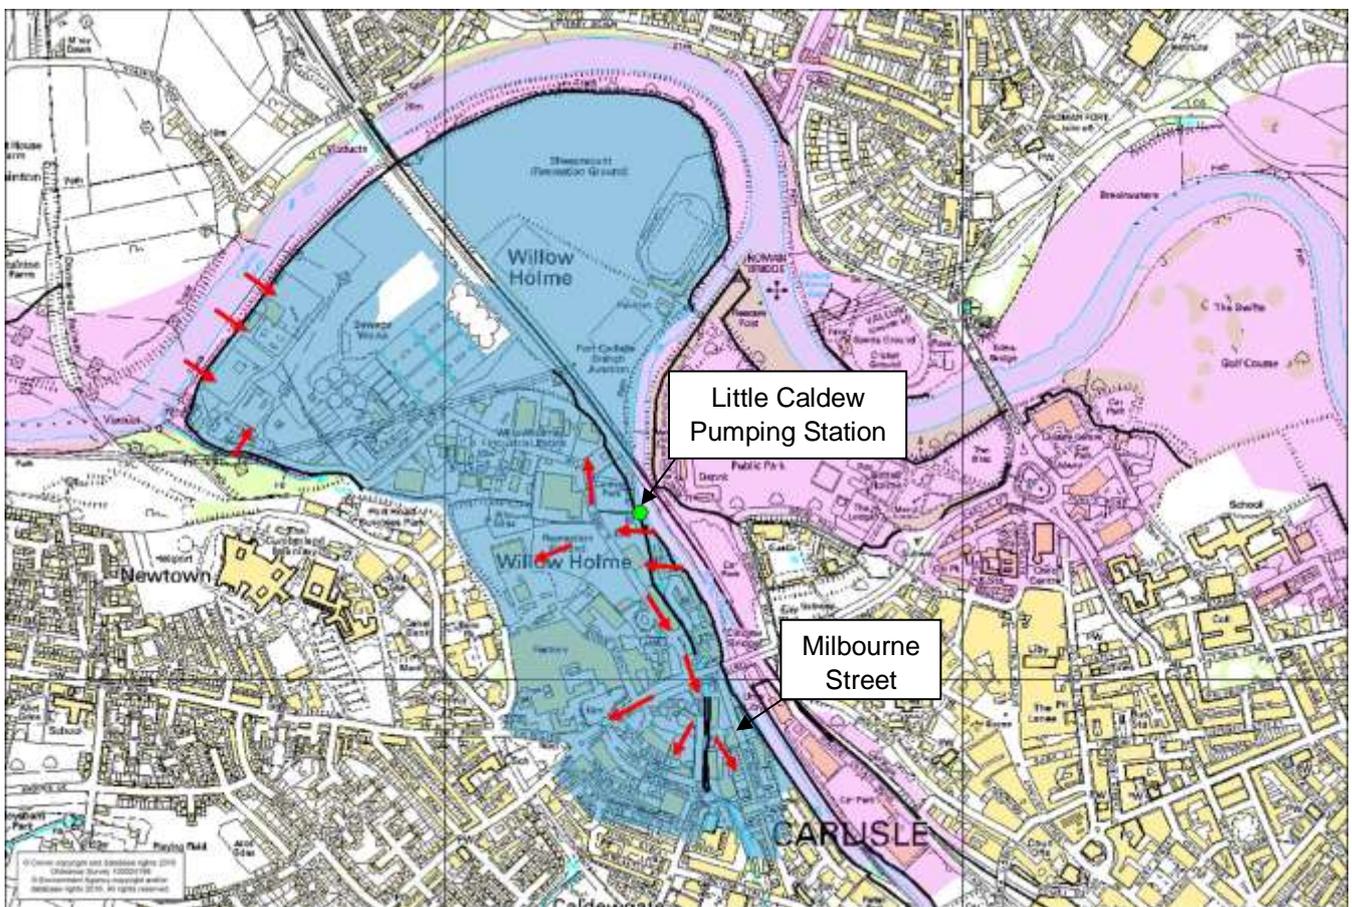
**Figure 17 Flood Flow Routes in Willow Holme**

This area is adjacent to both the River Caldew and River Eden. A large area was flooded including Carlisle sewage treatment works, Sainsbury’s, Willow Holme industrial estate, the United Biscuits factory, and some of the Caldewgate residential area. In addition to the Rivers Eden and Caldew, there are also three smaller watercourses in this area, Parham Beck, Dow Beck, and the Little Caldew.

This was one of the first areas of the city that was flooded, with flooding occurring on the 5<sup>th</sup> December. This was due to this area being at risk from the River Caldew, which peaked before the Rivers Eden and Petteril. Despite this, defences were not overtopped until after the peak flow in the River Caldew, suggesting that flooding was due to restriction of flow caused by high levels in the River Eden.

During the event, the pumping station on the Little Caldew at the Caldew Maltings stopped operating, as this was flooded. This pumping station failed due to flooding of the electrical components at 23:30 on the 5<sup>th</sup> December shortly after the defences at Caldew Maltings were overtopped. A number of properties flooded from the direction of the Little Caldew after this, and it is thought that this pumping station reduced the extent of this flooding whilst it was operational.

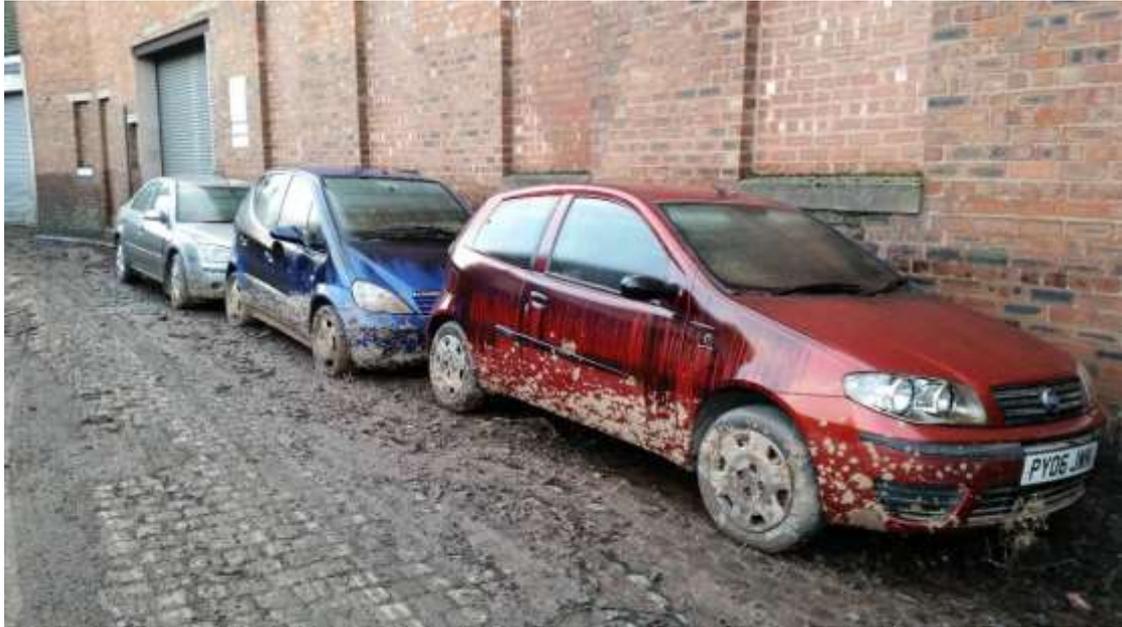
There was a large amount of oil and diesel reported in this area following the flooding. This was from flooded commercial properties dealing in motor vehicles. This created pollution within the flooded area and additional challenges for properties recovering from flooding.

Figure 18 Cars in Willow Holme area covered with oil following flooding
