# Carlisle

## Flood Investigation Report

## Flood Event 5-6<sup>th</sup> December 2015

This flood investigation report has been produced by the Environment Agency as a key Risk Management Authority under Section 19 of the Flood and Water Management Act 2010 in partnership with Cumbria County Council as Lead Local Flood Authority.

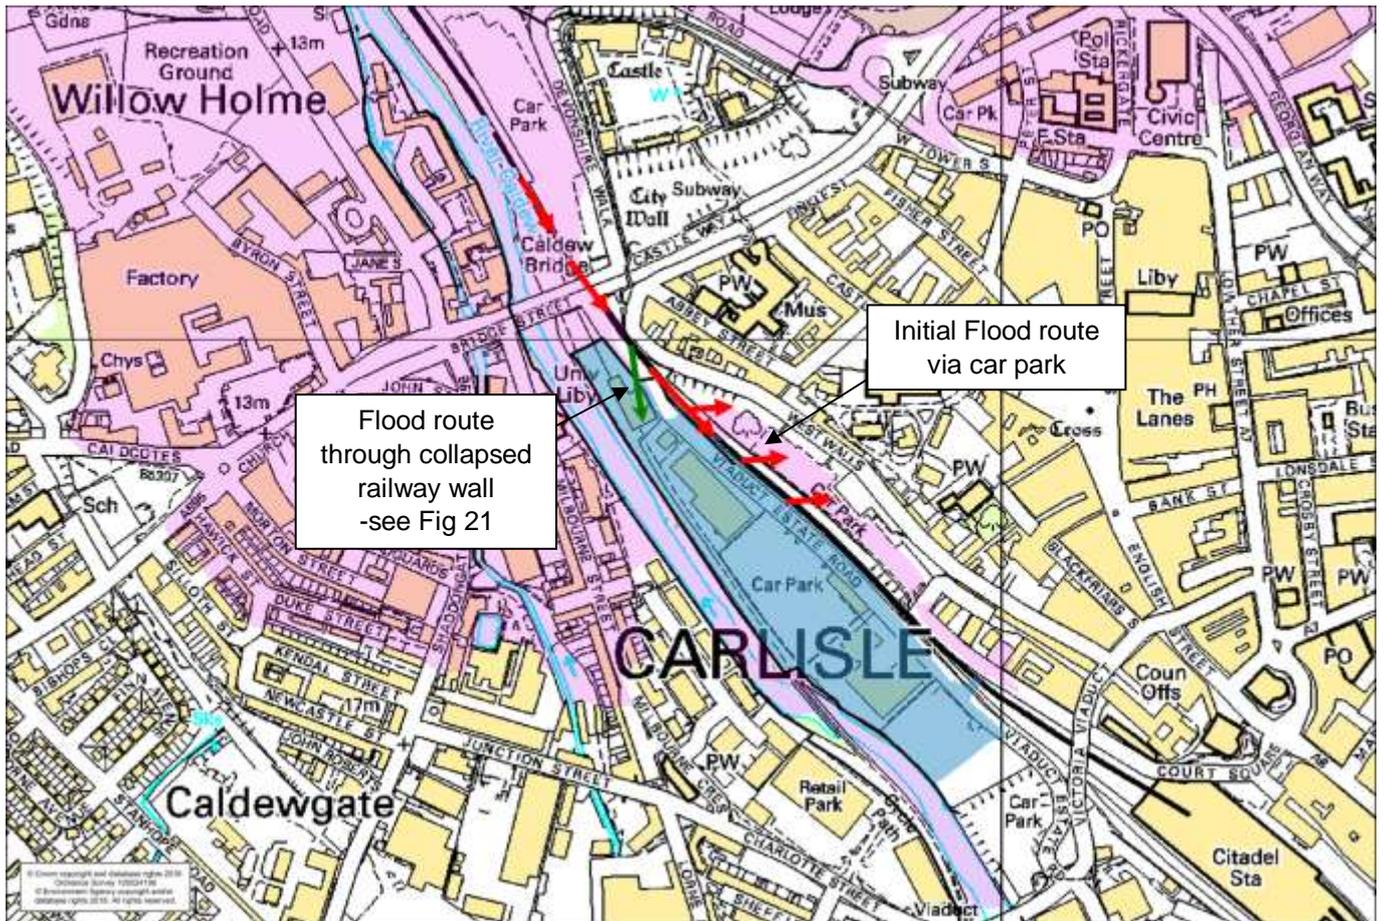
Figure 19 Flood flow routes into Viaduct Estate

The Viaduct Estate is a retail and leisure area located between the River Caldew and the West Coast Main Line railway. The area is protected from direct flooding from the River Caldew by a flood defence wall along the right bank (when looking downstream) of the River Caldew.

Later in the flood event, a section of the railway wall was breached at this location. The wall collapsed onto the footpath indicating that the breach was caused by the water on the railway line. Following this, the flow path into the viaduct estate would be directly from the railway line through this breach. This is the route shown in green on Figure 19.

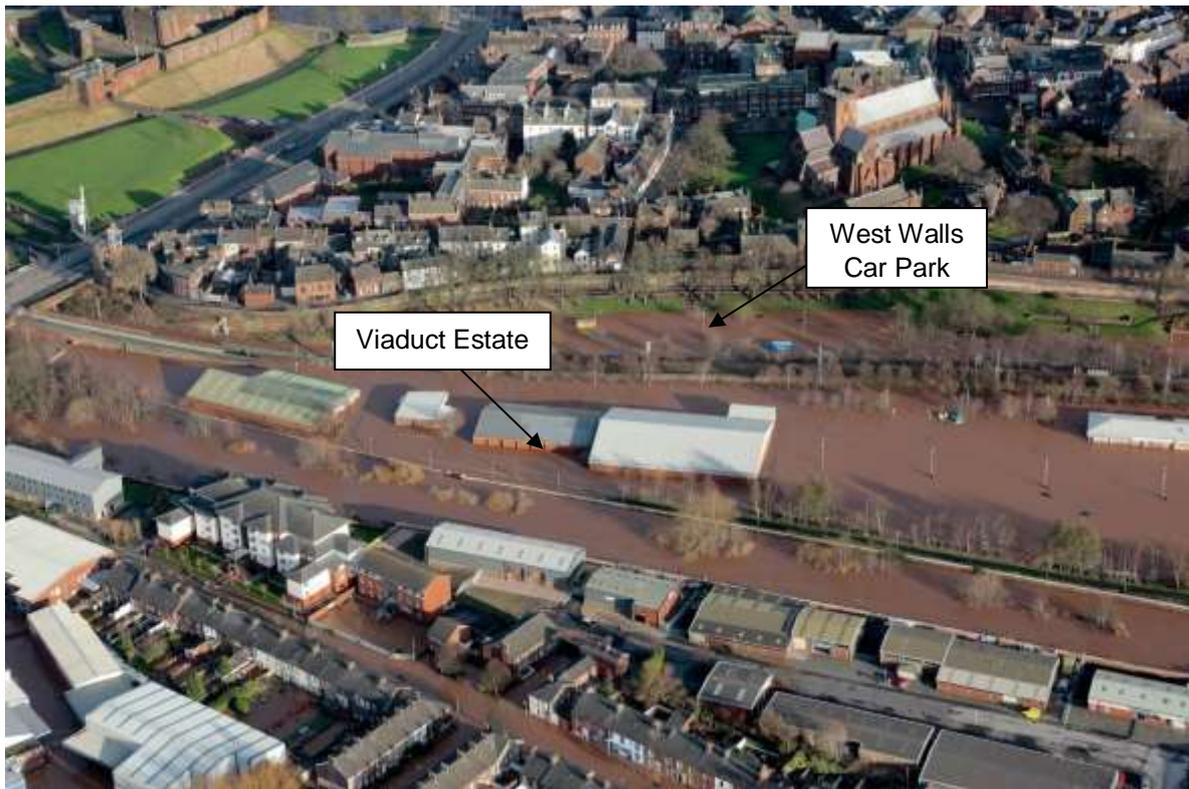
**Figure 20 Viaduct Estate during flood event**

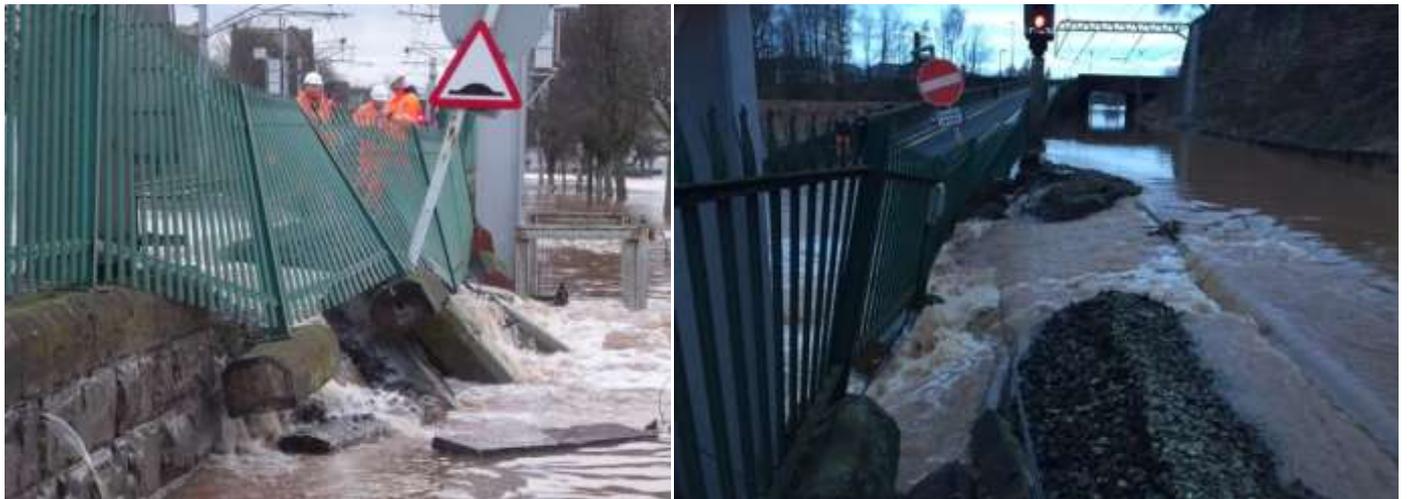
**Figure 21 Wall along railway at entrance to Viaduct Estate that collapsed during the flood event**

ensure all outfalls are sealed with flap valves or non-return valves to prevent the defence scheme being compromised.	
	Environment Agency, United Utilities and Cumbria County Council	Complete on-going inspections and repairs to assets which may have been damaged during the flood event	2016
Strengthening Defences	Environment Agency	Review modelling data to ensure that models for Carlisle reflect real conditions as accurately as possible and use this information to make any improvements to the flood warnings service. This will be used to inform future investment plans.	July 2016
	Environment Agency	Review scheme performance and consider what worked well, and where improvements to defences are required	July 2016
	Environment Agency	Investigate potential to improve defences upstream of Botcherby Bridge to prevent overtopping and outflanking of defences in Melbourne Park.	July 2016
	Environment Agency in consultation with Network Rail	Investigate potential to extend the defences at Viaduct Road Estate to prevent flooding from the railway line. This could potentially consist of defence walls along the railway line or temporary barriers across the archways between the car park and viaduct road estate.	July 2016
