# Wigton

## Flood Investigation Report

Burnfoot, Wigton, Cumbria

## Flood Event 3<sup>rd</sup> – 5<sup>th</sup> December 2015

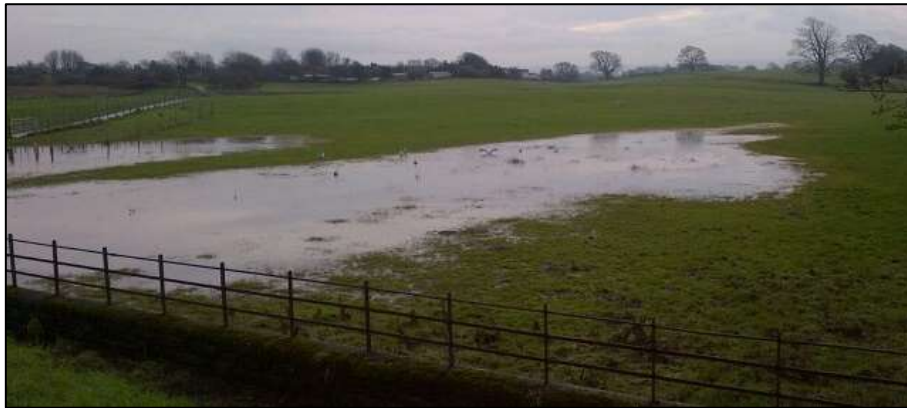
A number of the fields near the Flosch Beck and Wiza Beck were flooded during the December 2015 flooding (**Photograph 1**). This did not impact on residential property, although the playing fields and changing room facilities were affected by the flooding. The flood flows also resulted in bank erosion, scour and damage to a kissing gate near the sports pitches (**Photograph 2**).

**Photograph 1: Flooding from the Flosch Beck (15<sup>th</sup> December 2015)**

- Flood flows in the Wiza Beck exceeding the capacity of the channel in the area upstream of the B5032, resulting in lateral flooding of the sports pitch. This also resulted in bank erosion and collapse of a kissing gate and footpath.
- Flood flows on the Flosh Beck being throttled by the capacity of the culvert which outfalls into the Wiza Beck downstream of the B5302. This issue may have also been compounded by elevated water levels within the Wiza Beck causing a backwater effect on the Flosh Beck. This resulted in the flooding of the fields adjacent to the Wigton Bowling Green.
- Flood flows on the Black Beck exceeding the capacity of the culverted reach beneath the Innovia Films Factory. This resulted in widespread internal flooding within the factory as flows continued in a north-easterly direction towards Station Road.

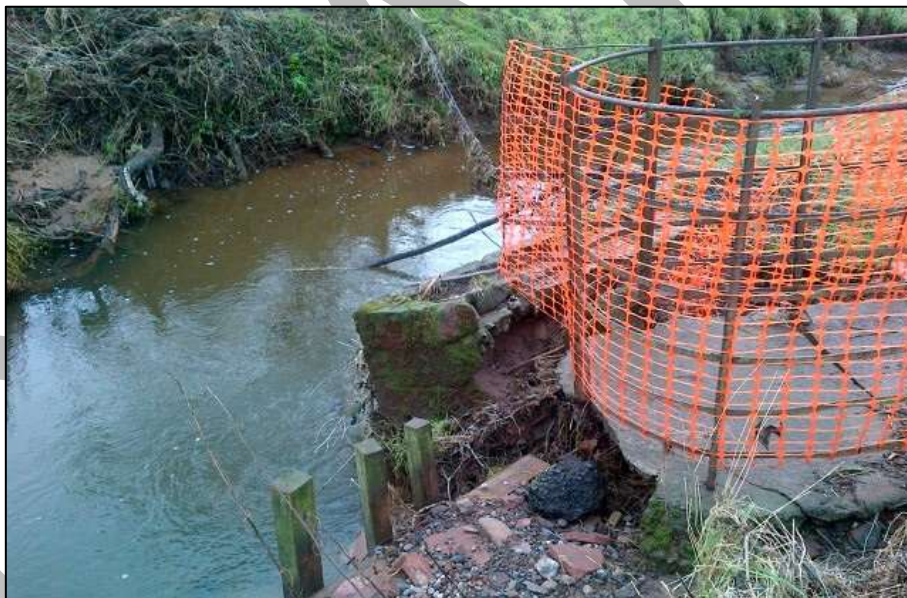
**Photograph 2: Bank damage near the Sports Pitches (15<sup>th</sup> December 2015)**

The Wiza Beck is a main river that flows south to north along the sports pitches south of the B5032. Significant gravel deposition was observed in the watercourse upstream of the B5032. Bank erosion on the Wiza Beck near the sports field had resulted in a kissing gate collapsing into the watercourse.

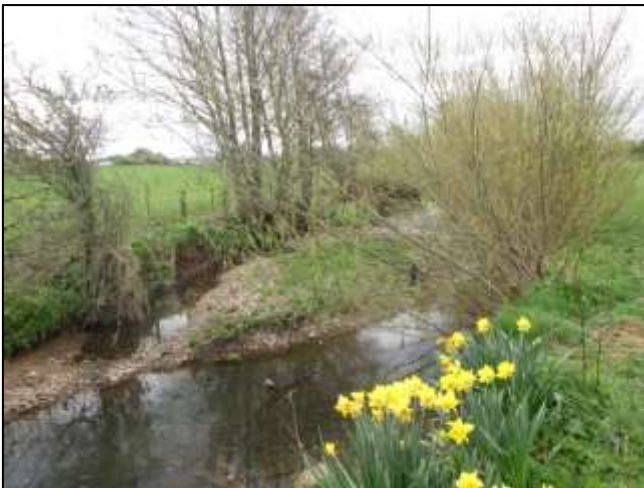
The Flosh Beck is a main river that flows east to west alongside the Wigton Bowling Club (**Photograph 4**). This watercourse forms a tributary of the Wiza Beck (**Photograph 3**) via a large box culvert beneath the B5032. The confluence is throttled at the downstream end by a circular conduit that discharges into the Wiza Beck at the 90 degree bend at the entrance to the Innovia Films Factory.

**Photograph 3: Wiza Beck, Looking Upstream**

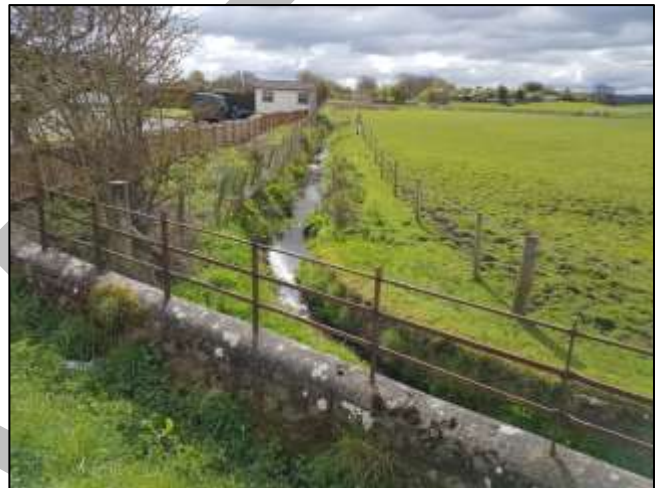
**Photograph 4: Flosh Beck, Looking Upstream**

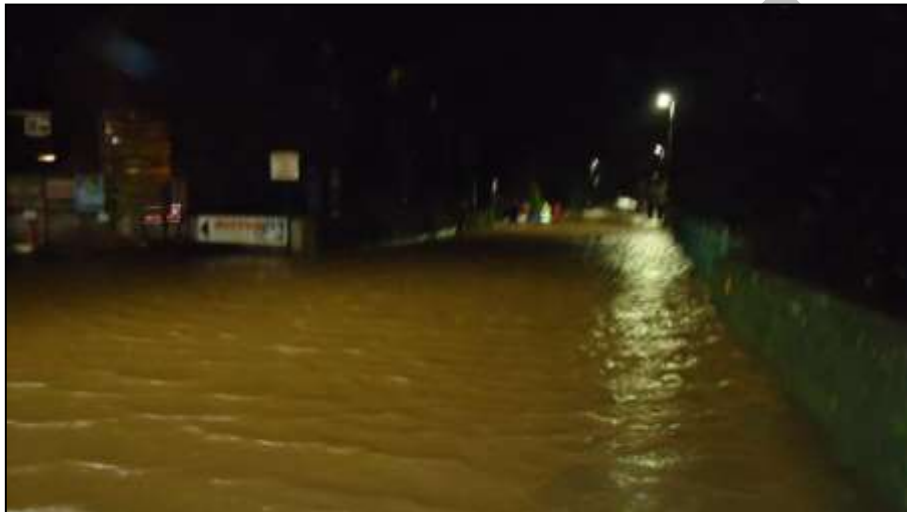
A number of residents on Station Road use flood gates and other resilience measures to defend their properties from flooding. On the 3<sup>rd</sup> and 5<sup>th</sup> December 2015 floodwater is reported to have reached approximately half a metre up the streetside floodgates, although this did not result in residential property flooding as resilience measures had been put in place.

**Photograph 5: Flooding on Station Road (3<sup>rd</sup> Dec 2015)**

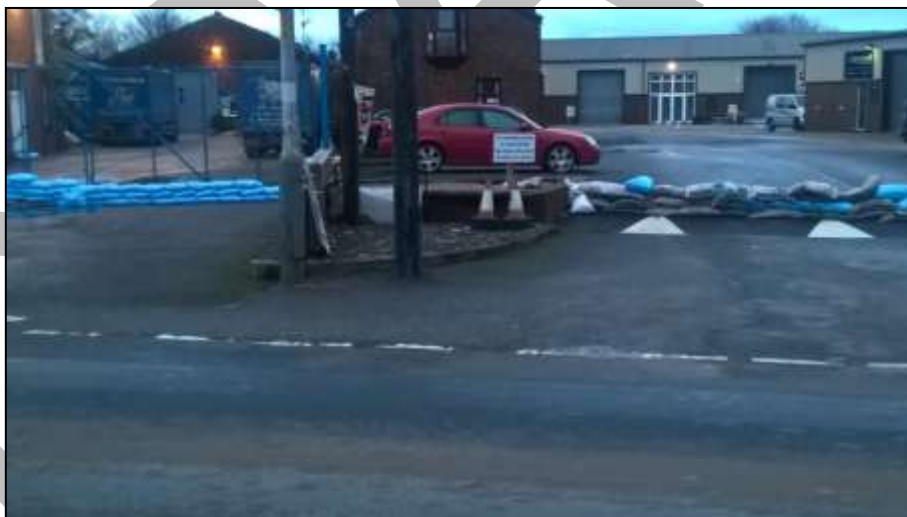
The Station Road Business Park was protected by sandbags and bags of salt (stock) provided by a local business which diverted the water (**Photograph 6**). The area was also helped by the Fire & Rescue Service pumping water away from property. The Post Office was flooded during the December 2015 event and also on two other previous occasions.

**Photograph 6: Temporary Sandbags and bags of salt on Station Road (7<sup>th</sup> Dec 2015)**

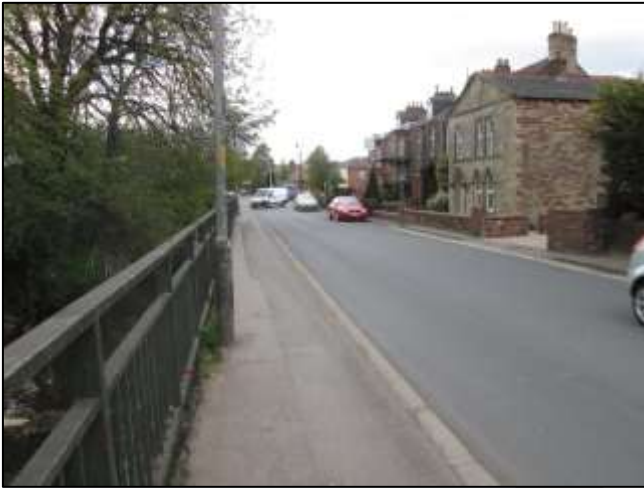
The Wiza Becks passes west to east beneath Station Road via a brick arch conduit (**Photograph 7**). The watercourse continues in an easterly direction before later passing beneath the A596. The Black Beck discharges into the Wiza Beck via a pair of large concrete conduits immediately upstream of the Station Road Bridge. An Environment Agency level gauge is located on the Wiza Beck and there is Environment Agency telemetry at this location.

**Photograph 7: Wiza Beck and Station Road**

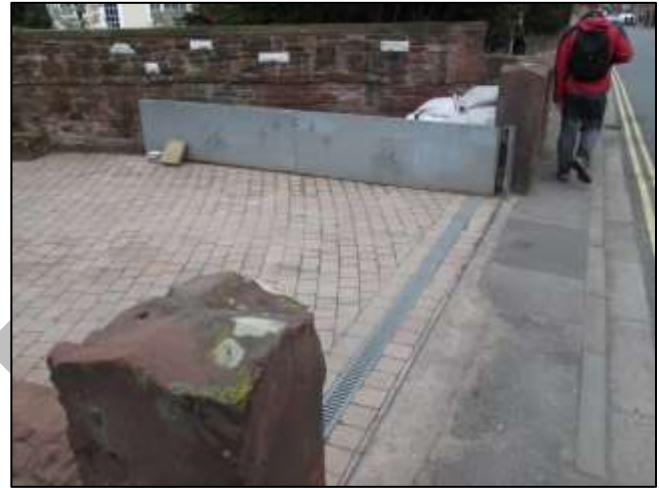
Property-level resilience measures (i.e. flood gates and doors) were observed at multiple properties on Station Road and evidence of post-flood refurbishment works was observed. Sandbags were present at the entrance to the small business trading estate on Station Road.

**Photograph 8: Flood Gates on Station Road**

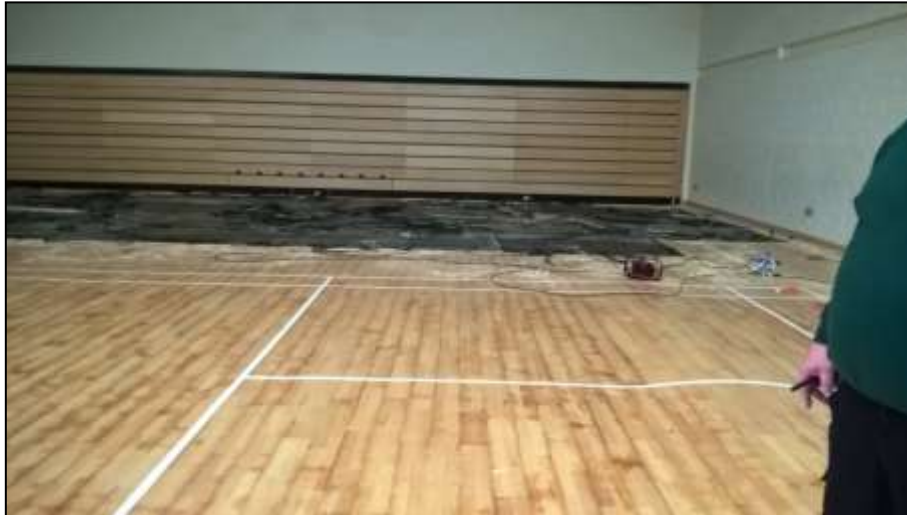
The Nelson Thomlinson Secondary School was also affected during the event. The boiler room and the sports hall were flooded resulting in extensive damages (**Photograph 9**). Consequently the school was closed for the day and the sports hall was closed until further repairs and refurbishment could be undertaken. Flooding is likely to have resulted from surface water sources rather than floodwater from Speet Gill or the Floss Beck.

**Photograph 9: Nelson Thomlinson School – Sports Hall Flood Damage**

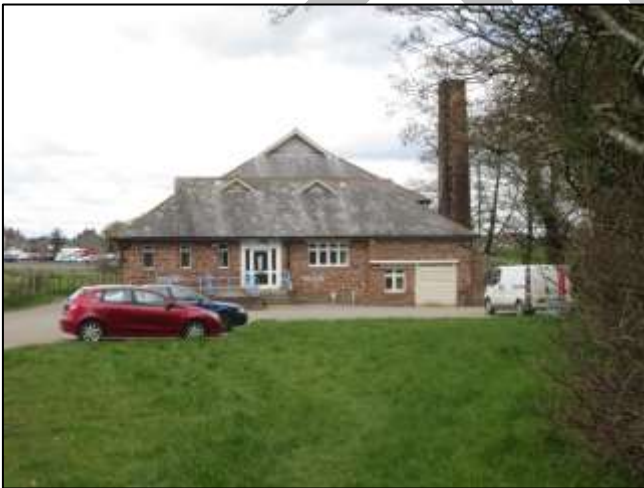
The Wigton Swimming Baths (**Photograph 10**) were observed to be closed and a number of sandbags were observed as partially covering the airbricks and access points to the basement.

**Photograph 10: Wigton Swimming Baths**

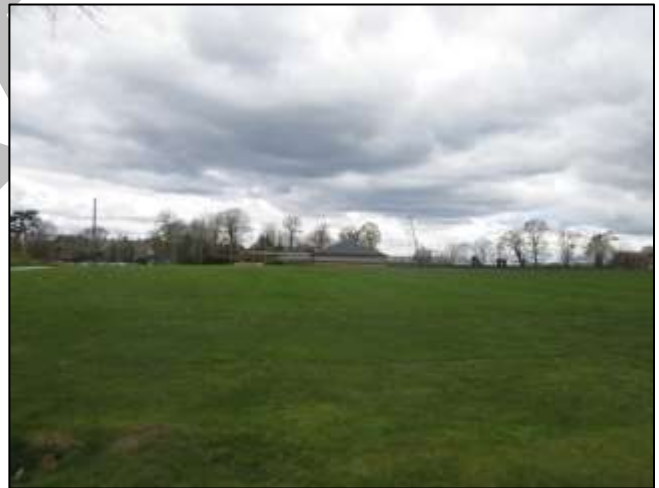
The Nelson Thomlinson School is, for the most part, located at the crest of a hill between Lowmoor Road and the Speet Gill. The gradient of the site slopes away from the main facility towards its south-west corner where the Sports Hall is located (**Photograph 11**).

**Photograph 11: Nelson Thomlinson School**

- The Sports Hall is also located at the bottom of a hill in a topographic hollow. Given the wet antecedent conditions rainfall would have been unable to effectively infiltrate into the ground and would have resulted in the generation of surface water. This would have consequently been routed across the playing fields, along the topographic gradient, and would have compounded the ponding around the Sports Hall.

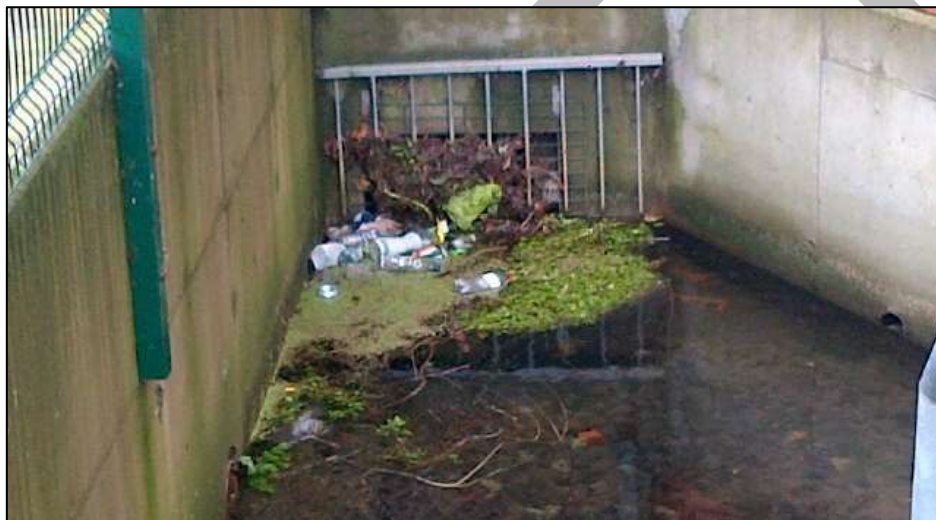
On the east side of Wigton, the ATS Garage and 9 residential properties were affected by flooding from the Speet Gill and an unnamed ordinary watercourse due to a blocked trash screen on a non-main river and severe volumes of flow (**Photograph 12**). This resulted in flooding of the public highway (**Photograph 13**) and ingress to residential properties via air-bricks and other similar openings to property basements. Although water reached Lidl, no ingress occurred.

Photograph 12: Trash Screen on the Tributary Next to Lidl

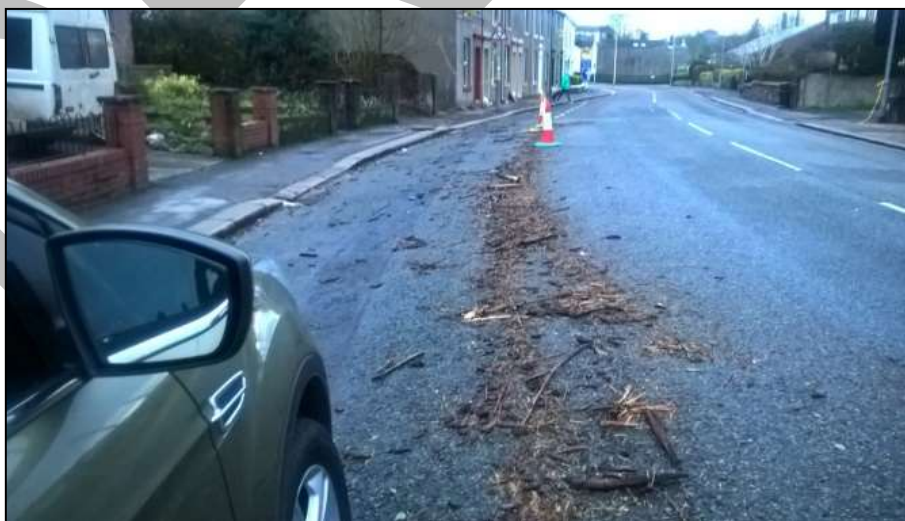
Photograph 13: Wreck Marks on Burnfoot (7<sup>th</sup> Dec 2015)

Evidence of historic flooding was observed around the residential properties on the right bank of the Speet Gill (i.e. silt wrack marks and mortar loss). It was observed that residents had previously attempted to prevent water from entering into basements by covering airbricks and other access points into the property.

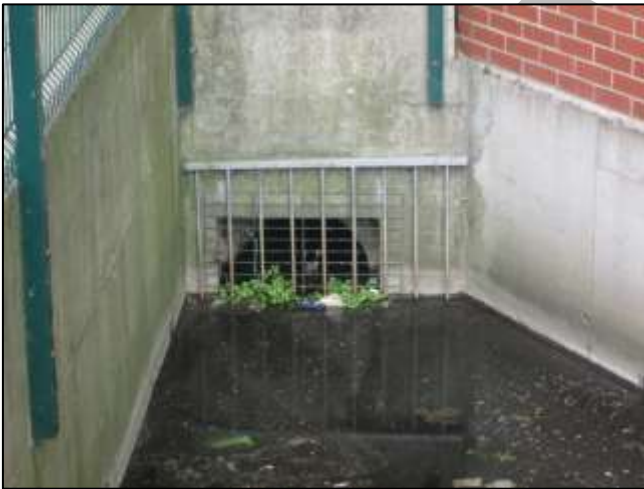
The unnamed ordinary watercourse is culverted beneath Burnfoot and discharges into the Speet Gill via a circular culvert that is covered by a basic trash screen (of a non-standard Environment Agency design as shown in **Photograph 14**). This design results in difficulty removing debris build up and consequently may lead to a backwater effect from the culvert inlet.

**Photograph 14: Lidl Trash Screen**

- Floodwater would have been routed over Burnfoot as a result of the throttled capacity on both watercourses. This issue would have been compounded by surface water runoff following the gradient of the topography west of Lidl and adjacent to the residential properties.
- The public highway sits in a topographic hollow at this location and is likely to have resulted in localised ponding that consequently impacted on flooding at the ATS Garage.

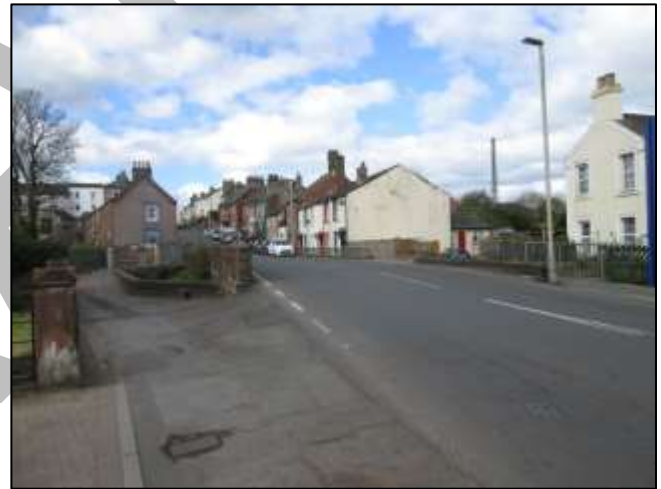
The Speet Gill is bounded on the right bank by a small dwarf wall that may act as a defence but is not considered a formal Environment Agency asset. The Speet Gill passes beneath Burnfoot via a brick arch conduit with a low invert level. This capacity issue may constrain flow conveyance during times of flood and result in a local backwater effect from the structure.

**Photograph 15: Burnfoot Bridge**

- High water levels in the Speet Gill overtopping the de facto defences on the right bank of the watercourse due to capacity issues beneath the Burnfoot road bridge (**Photograph 15**). This would have subsequently resulted in residential property flooding and inundation of basements via unprotected airbrick covers and other openings.
- The trash screen on the unnamed watercourse at the Lidl car park becoming blocked with debris and resulting in a localised backwater effect and potential overtopping of the culvert into the Lidl car park.

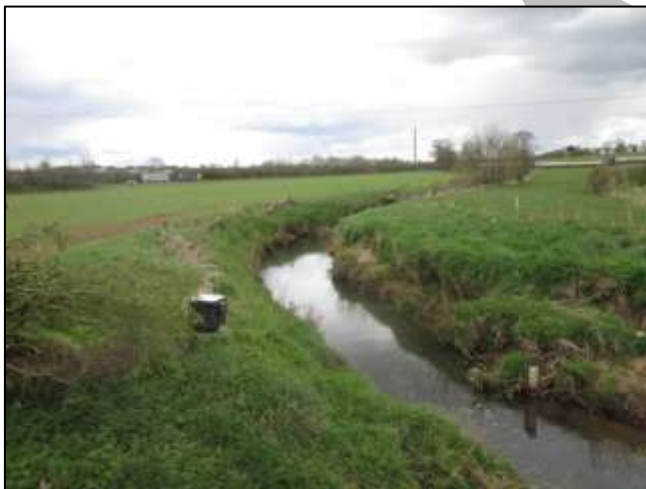
Spittal Farm is located immediately north of the A596. Spittal Farm has been developed into private accommodation, providing approximately 10 homes. The Farm is bounded on its western side by a drainage ditch from the A596 that subsequently discharges into the Wiza Beck (**Photograph 16 and 17**).

The drainage ditch adjacent to Spittal Farm discharges into the Wiza Beck via a short culverted section. An Environment Agency level gauge with data logger is located immediately upstream of the confluence of the Wiza Beck with the drainage ditch.

**Photograph 16: Wiza Beck near Spittal Farm**

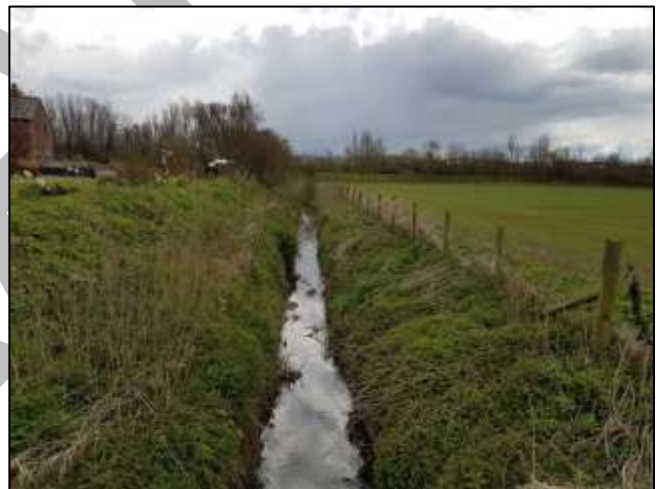
**Photograph 17: Spittal Farm Drainage Channel**
