# Patterdale and neighbouring valleys

## Flood Investigation Report

## Flood Event 5-6<sup>th</sup> December 2015

This flood investigation report has been produced by the Environment Agency as a key Risk Management Authority under Section 19 of the Flood and Water Management Act 2010 in partnership with Eden District Council as Lead Local Flood Authority.

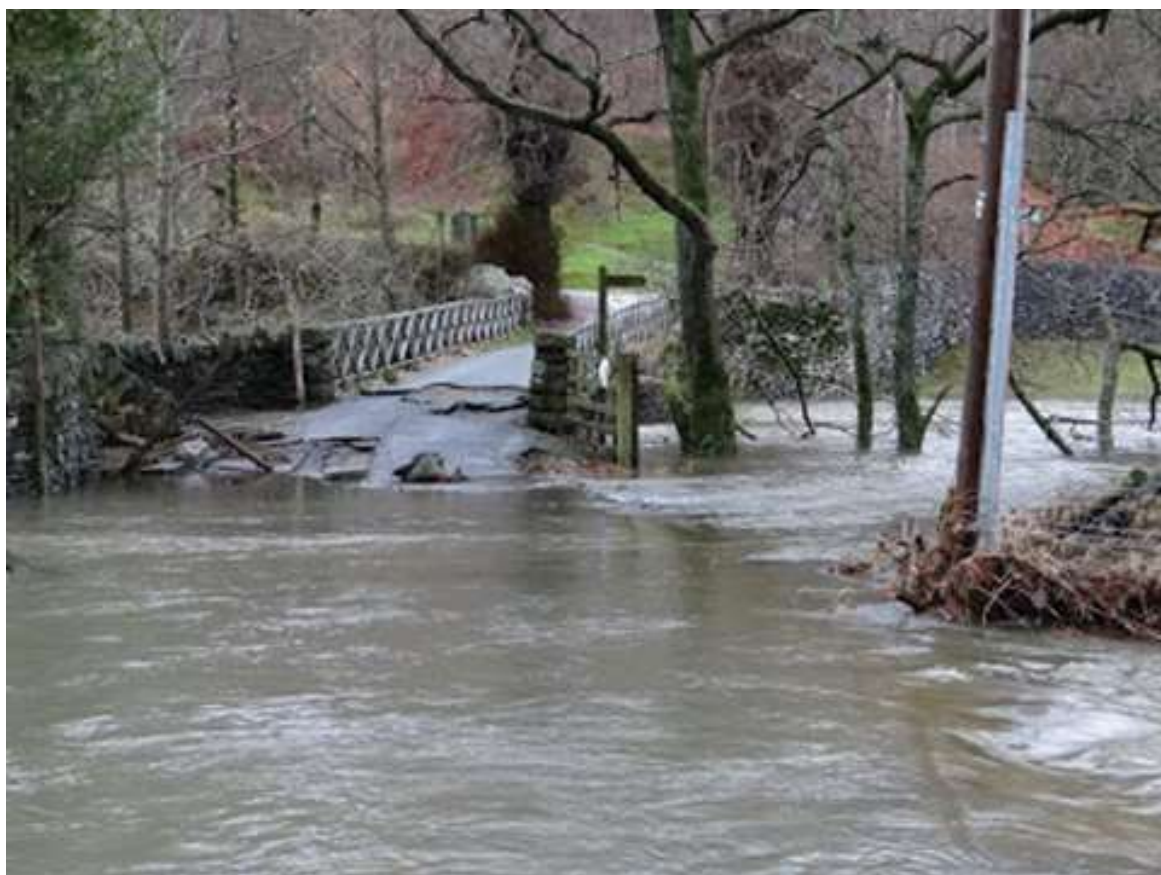
*Goldrill Bridge on 6<sup>th</sup> December 2015*

On the right bank, the level of the beck was above the road level and bypassed the Bridge and flowed towards the downstream field. The stone boundary wall and fence line on the right bank field collapsed due to the flooding. The road surface on the bridge was damaged by the flow. It was reported that Goldrill Bridge was flooded at approximately 23:00hrs on 5<sup>th</sup> December 2015.

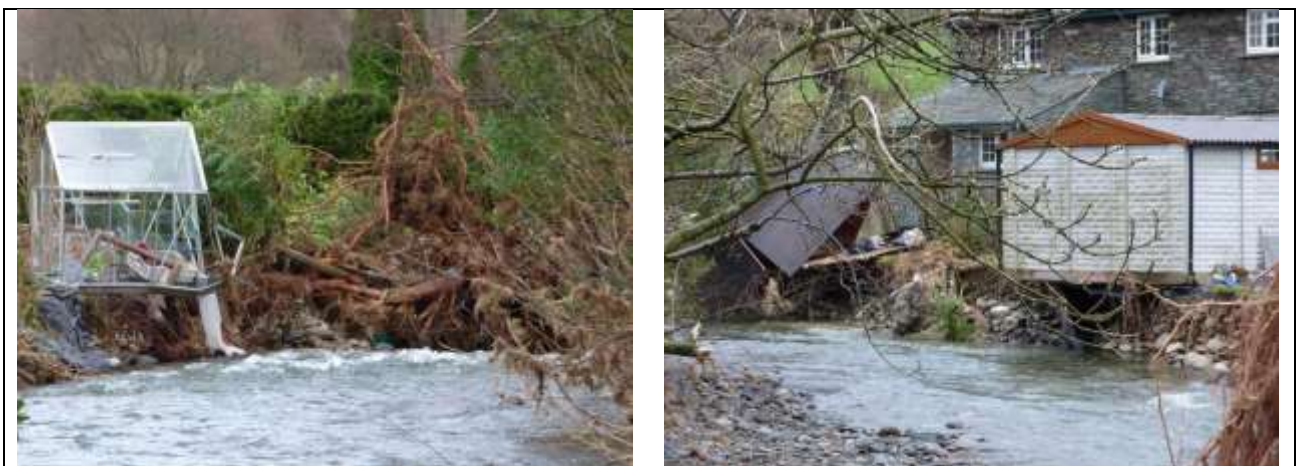
**Figure 7-Rear of Lane Foot Cottages**

On the downstream side of Deepdale Bridge, the wall to the rear of Lane Foot Cottages collapsed into the channel. The high flow in the beck caused scouring of the channel banks and damage to garden sheds and garages as shown in the Figure 7.

During the flood event, a large amount of gravel was deposited within the channel and the surrounding fields. There was also woody debris within the channel from fallen trees.

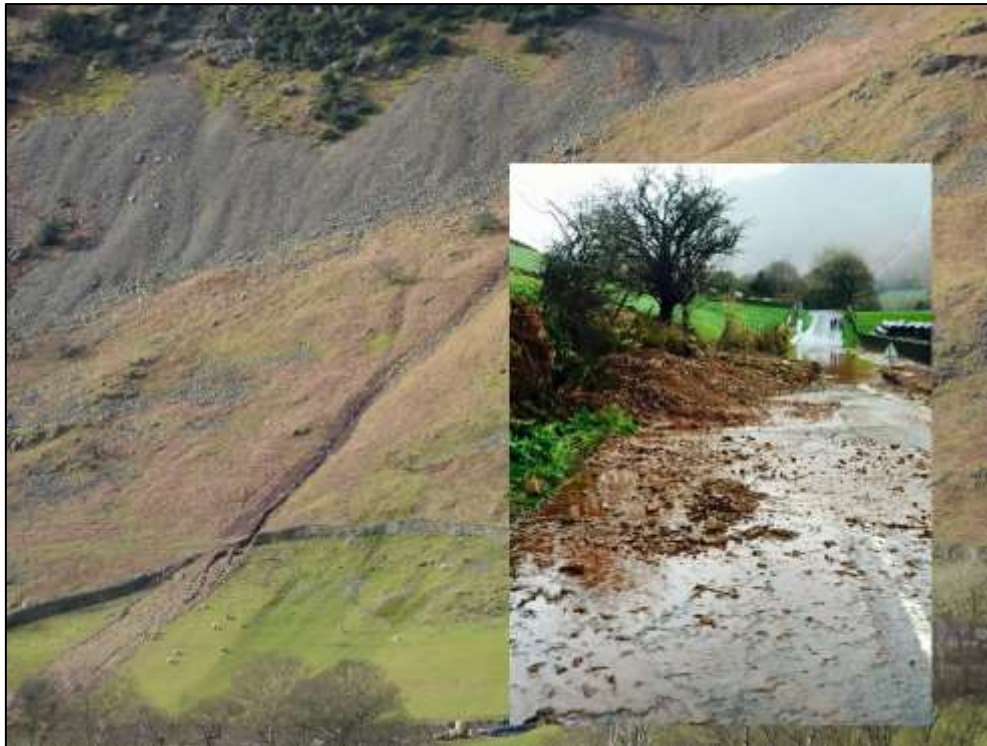
**Figure 8-Landslip between Noran Bank and Green Bank**

The intense rainfall caused a landslide between Noranbank and Greenbank north of Deepdale Beck. The material from this landslide was deposited on the A592 and blocked the road drainage. The effects of this landslide are shown in Figure 8. Following the event the debris was cleared and CCC Highways have installed new road drainage.

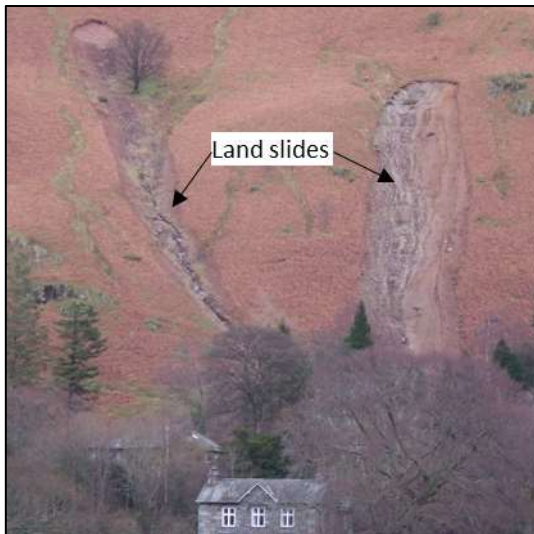
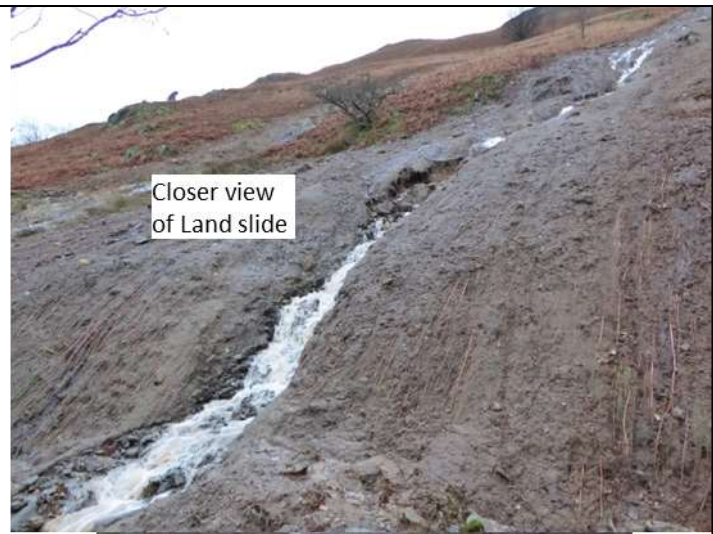
**Figure 14-Landslides on Place Fell**

Extreme rainfall over a prolonged duration generated high-velocity runoff from the fells. Two major landslides were recorded at Place Fell that caused significant gravel and mud deposition on the road. This material blocked the road to Rooking and access to the gardens of Fell Place Cottage, Green Rigg and Broad How.

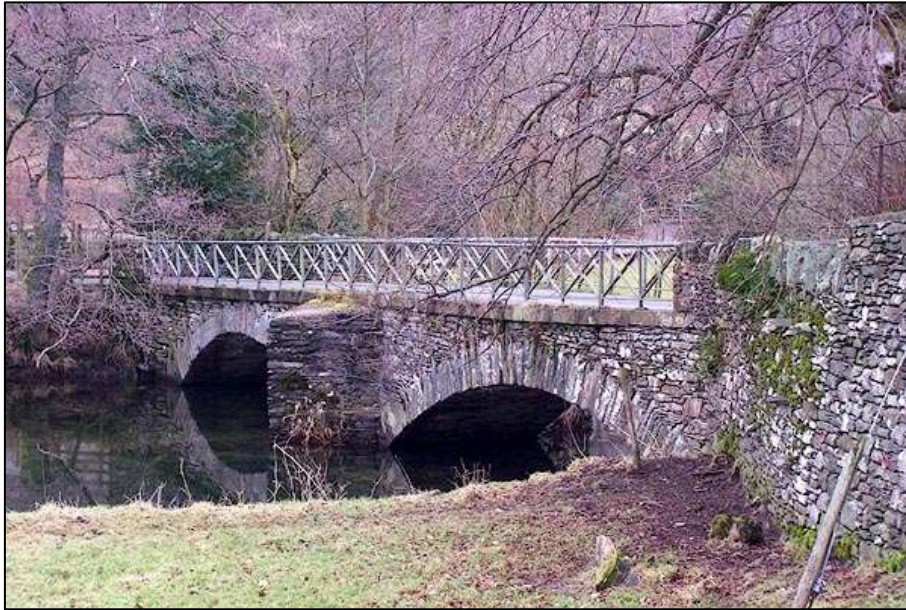
**Figure 17-Goldrill Bridge**

Figure 16 shows the area around Goldrill Bridge. There are two bridges crossing Goldrill Beck before it flows into Ullswater; namely Cow Bridge and Goldrill Bridge. Goldrill Bridge provides access to the Cottages situated east of the A592. The bridge is a single lane stone bridge with two low arches over Goldrill Beck as shown in Figure 17.

During the December 2015 flood event due to the intense rainfall there was significant runoff from the nearby mountains transporting a large volume of debris and gravel. This collected within the beck and reduced the capacity of the beck and of Goldrill Bridge leading to the beck overflowing its banks upstream of the bridge.

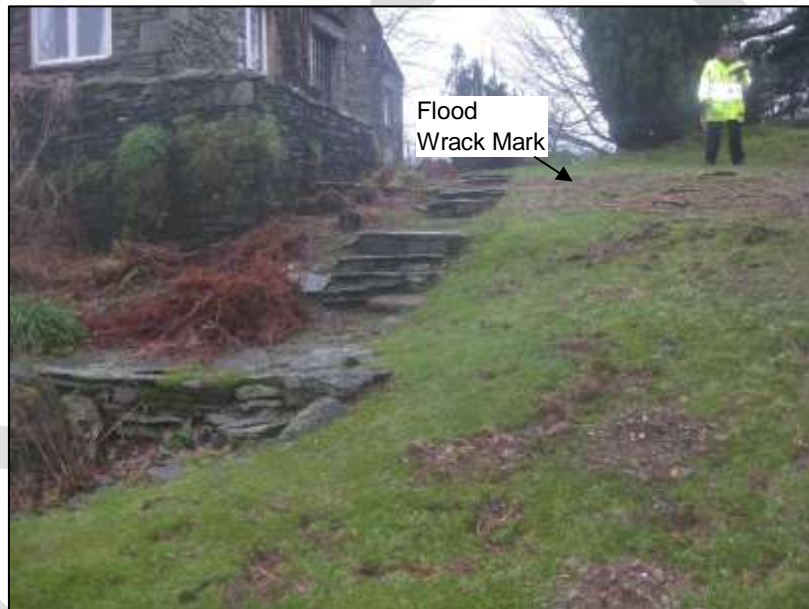
**Figure 20-Wrack Mark at Goldrill Cottage**

The level of the beck was close to the threshold level of Goldrill Cottage situated on the right bank of Goldrill Beck. The flood wrack mark recorded following the flooding was 0.2m below the Cottage's threshold level. There was also flow through the garden of this property causing damage to the garden wall.

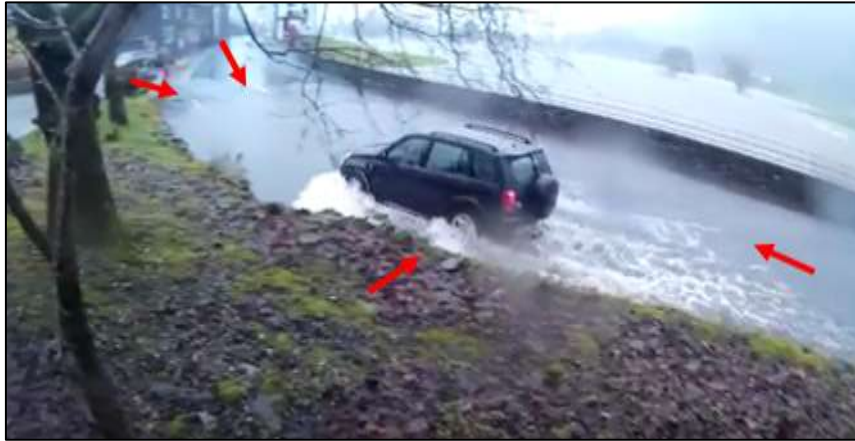
**Figure 21-Runoff collecting at low point on the A592**

Between Goldrill Bridge and the White Lion Inn the A592 is lower than the surrounding ground. As such the road drainage collects the runoff from the road and hills. During the December 2015 flood event, the road drainage was blocked by debris and the road was flooded.

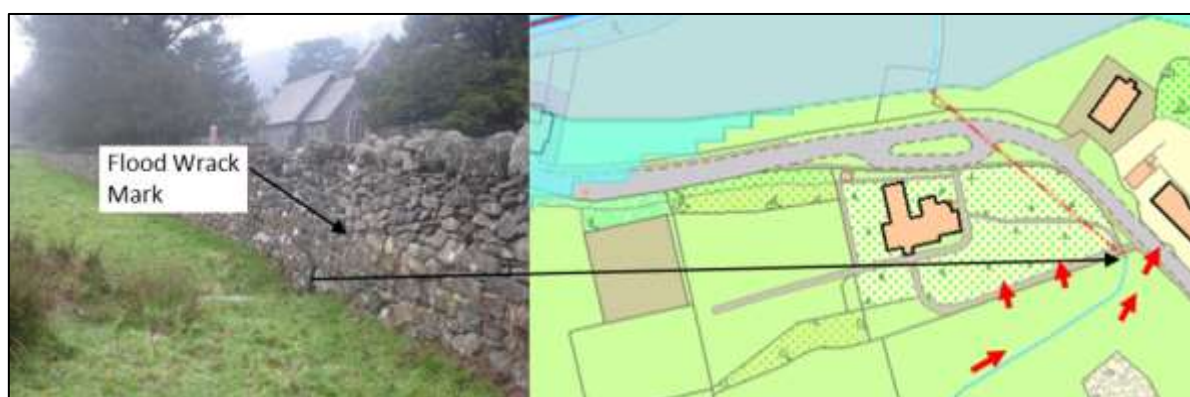
**Figure 25-Culvert inlet on south of St Patricks Church and flow route**

An additional flow route was observed from the stream located to the south of St Patrick's Church. This stream is culverted underneath the A592 and outfalls into the field on the left bank of Goldrill Beck as shown in Figure 25. The runoff collected in the field was reported to have seeped through the stone boundary wall and flooded the church (See Figures 26 and 27). The field boundary wall along the road was overtopped and flooded this area of the A592.

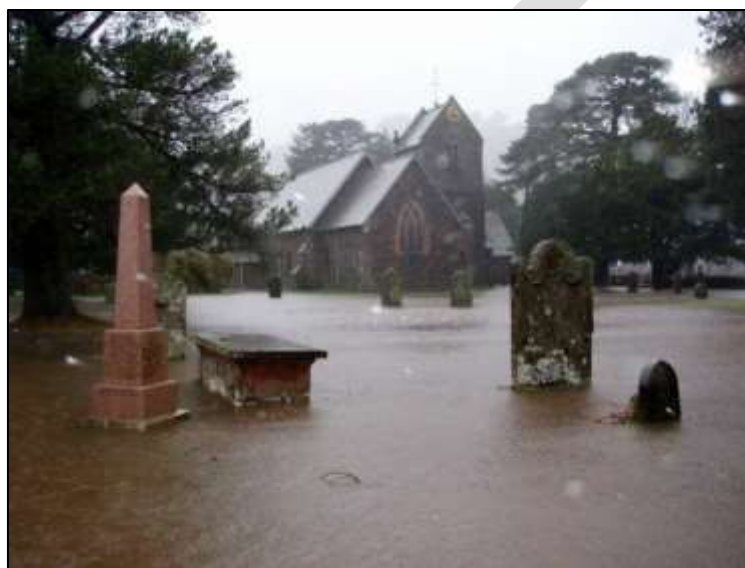
**Figure 11-St Patricks Church flooded on 5<sup>th</sup> Dec 2015**

The A592 was flooded from a combination of runoff from the left and right side fields. The flooding on the A592 also contributed to the flood level within the Church.

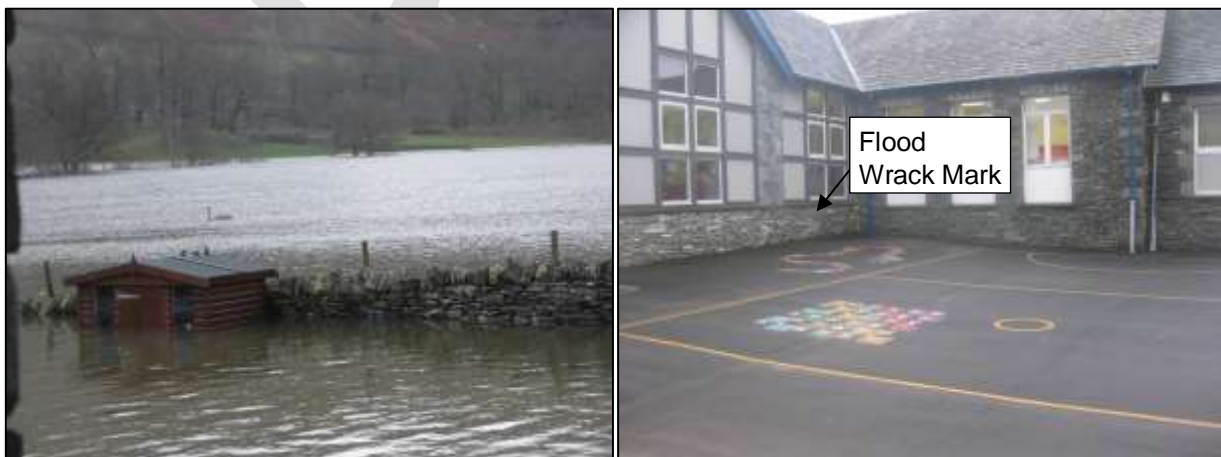
**Figure 28-Flooding on the rear of Patterdale School and around the School**

The field to the rear of Patterdale School was flooded from both Goldrill Beck and Grisedale Beck. The water level within the field rose above the boundary wall along the A592 and contributed to the road flooding. High water levels on Ullswater were compounding the problems experienced in Patterdale.

Four properties on the A592 were flooded; three internally, and one property, Patterdale C of E School flooded externally. The flood water was up to the bottom of the school's windows. However, the basement was flooded by water seeping through air bricks.

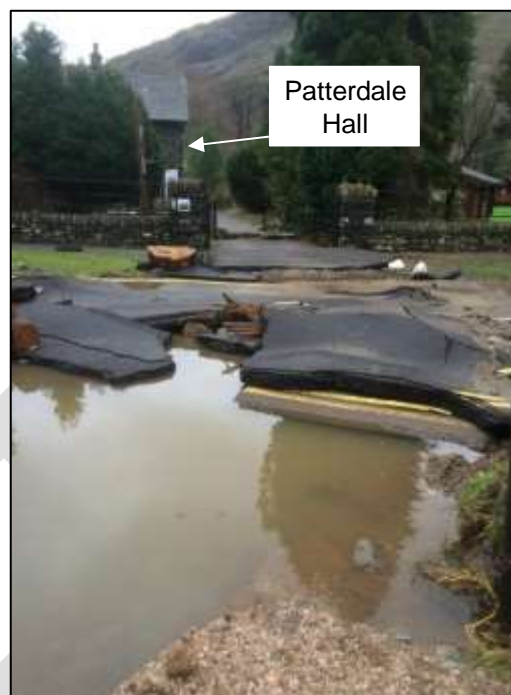
**Figure 30 - Flow route through access gate and stone wall and damage to the A592 road surface**

Grisedale Bridge formed a constriction to the stream flow and caused elevated river levels immediately upstream of the bridge. Also, debris collected on the stream's bed reduced the bridge's capacity. As a result, the beck overtopped its left bank upstream of the bridge and flowed towards the A592 through a stone boundary wall and access gate. This flow flooded the A592 and continued towards Patterdale Hall. The road surface at the entrance of Patterdale Hall was damaged due to the flood flow. Figure 30 shows the route towards Patterdale Hall and the damage to the A592.

The right bank upstream of the bridge was not overtopped. Following the event the Environment Agency have carried out dredging of Grisedale Beck in order to remove debris and increase the bridge capacity.
