Troutbeck Bridge

Flood Investigation Report

Flood Event 5-6th December 2015

This flood investigation report has been produced by the Environment Agency as a key Risk Management Authority under Section 19 of the Flood and Water Management Act 2010 in partnership with Cumbria County Council as Lead Local Flood Authority.

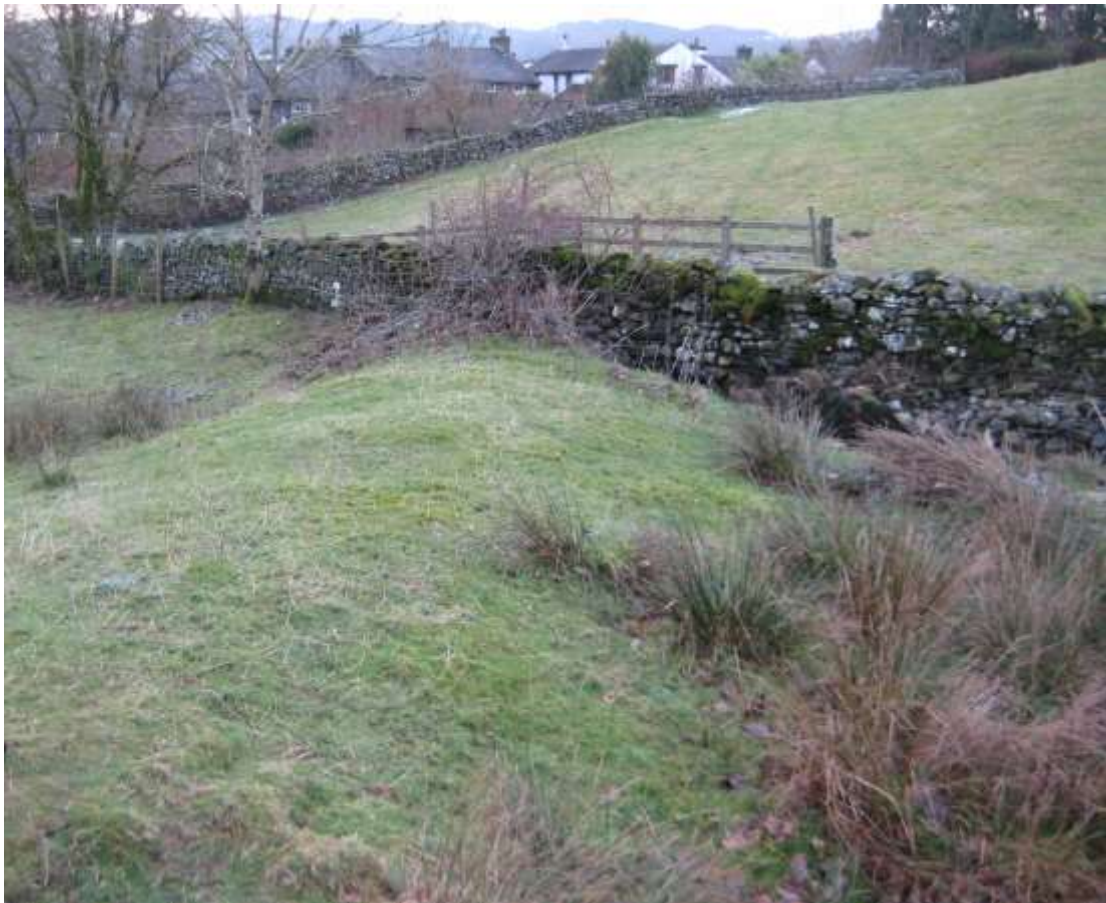
There are no formal flood defences within Troutbeck Bridge. There is a short length of raised ground upstream of Brook Street adjacent to the Bell Beck culvert inlet, as well as a flow interception trench in the field upstream of Brook Street on the left bank floodplain of Bell Beck. These are shown in Figures 5 and 6.

Figure 5 – Short length of raised ground next to the Bell Beck culvert inlet

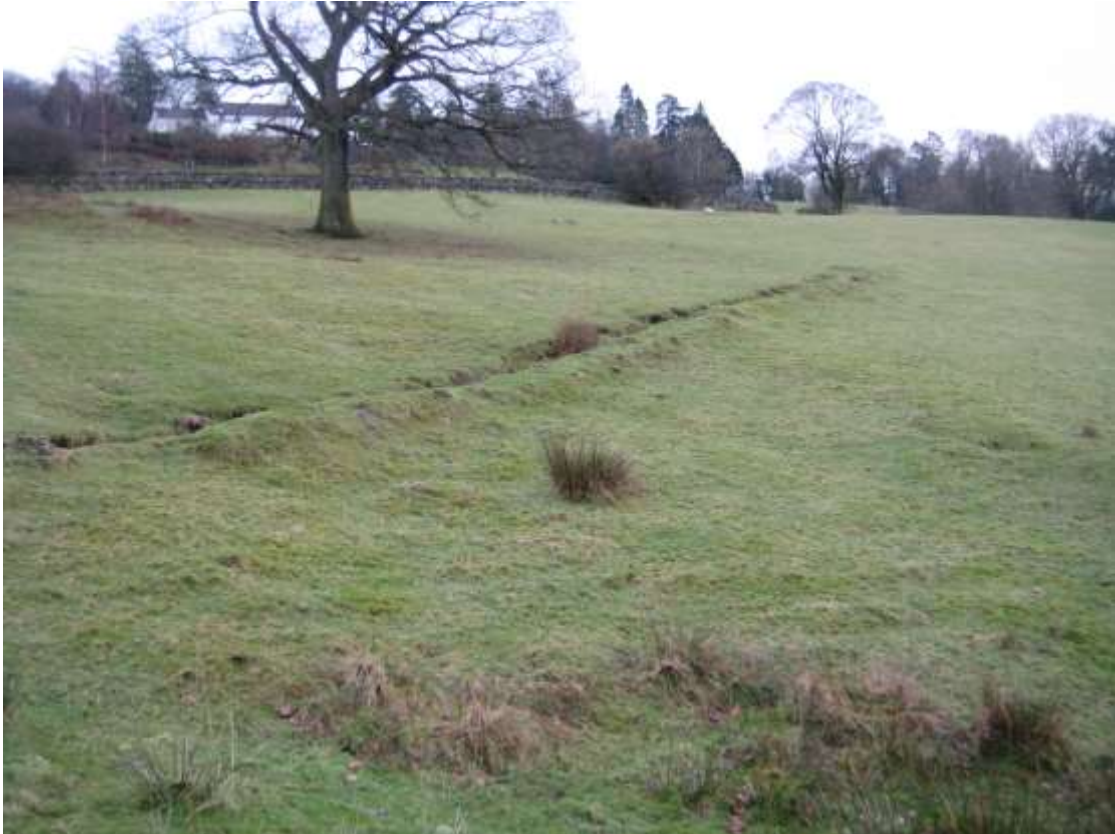
Figure 6 – Flow interception trench on the left bank floodplain of Bell Beck

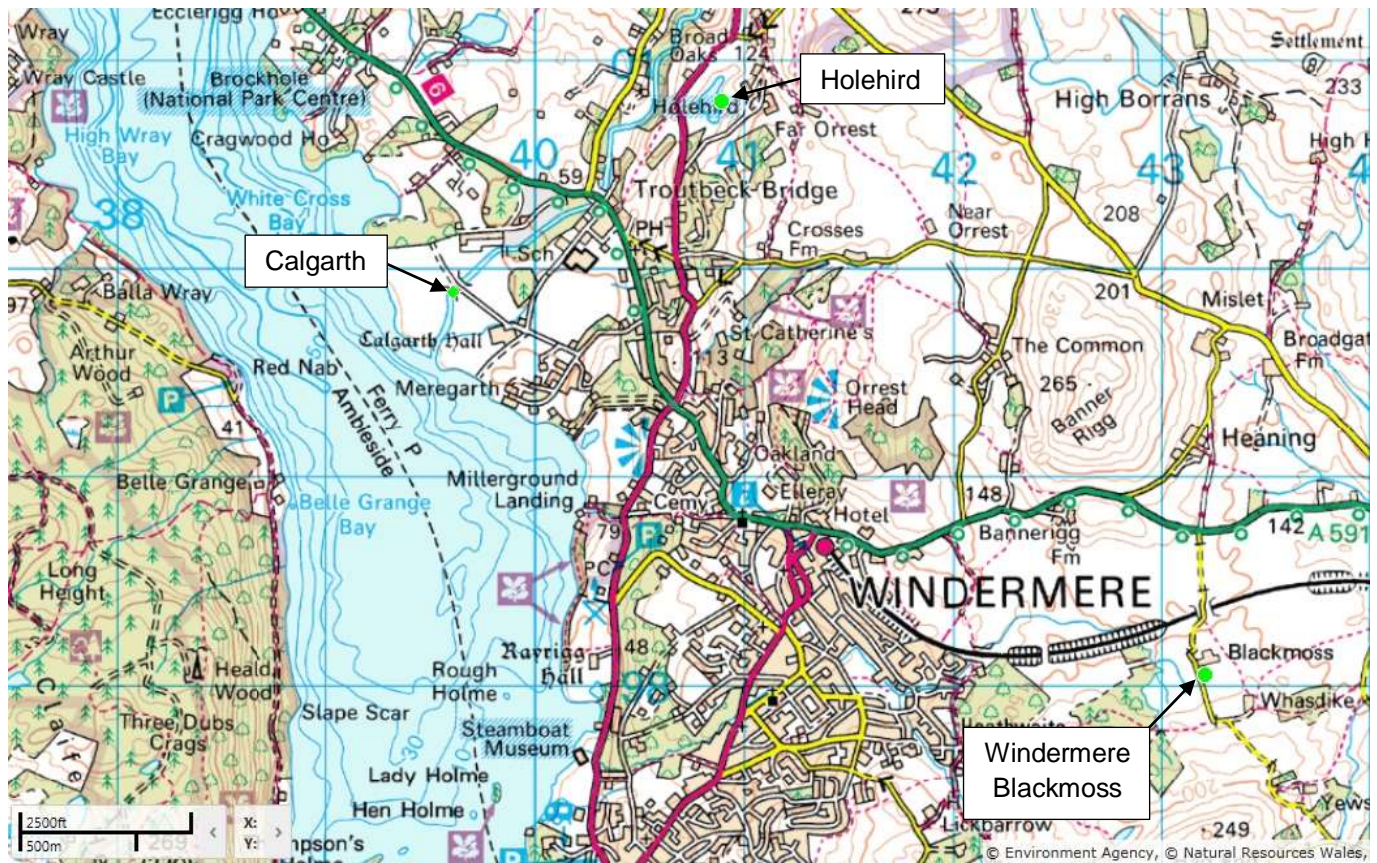
The location of the Holehird and Windermere Blackmoss rain gauges is shown in Figure 7.

The location of Calgarth river level gauge is shown in Figure 7.

Figure 7 - Location of local rainfall and river level gauges

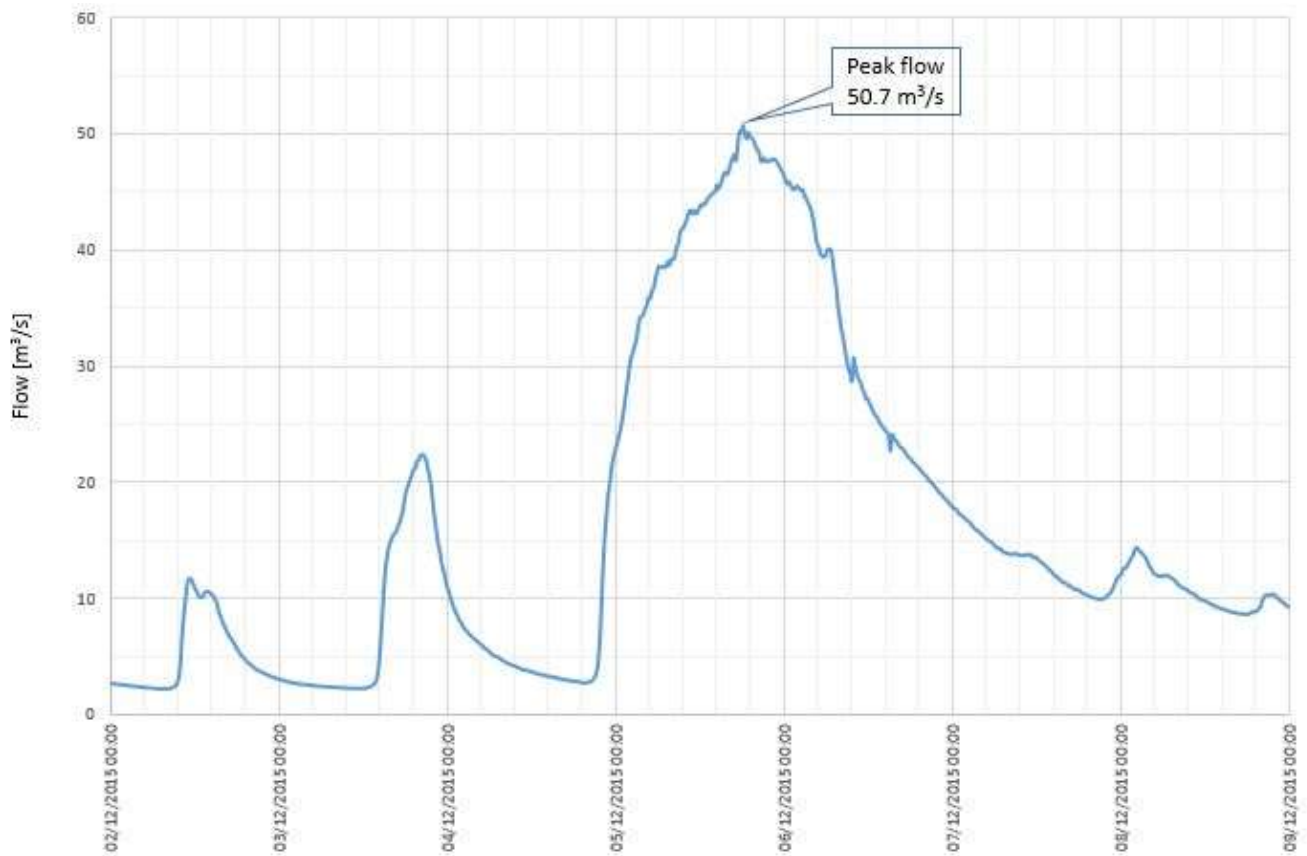
Figure 8 - Flow recorded on Trout Beck during the December flood event at Calgarth gauging station

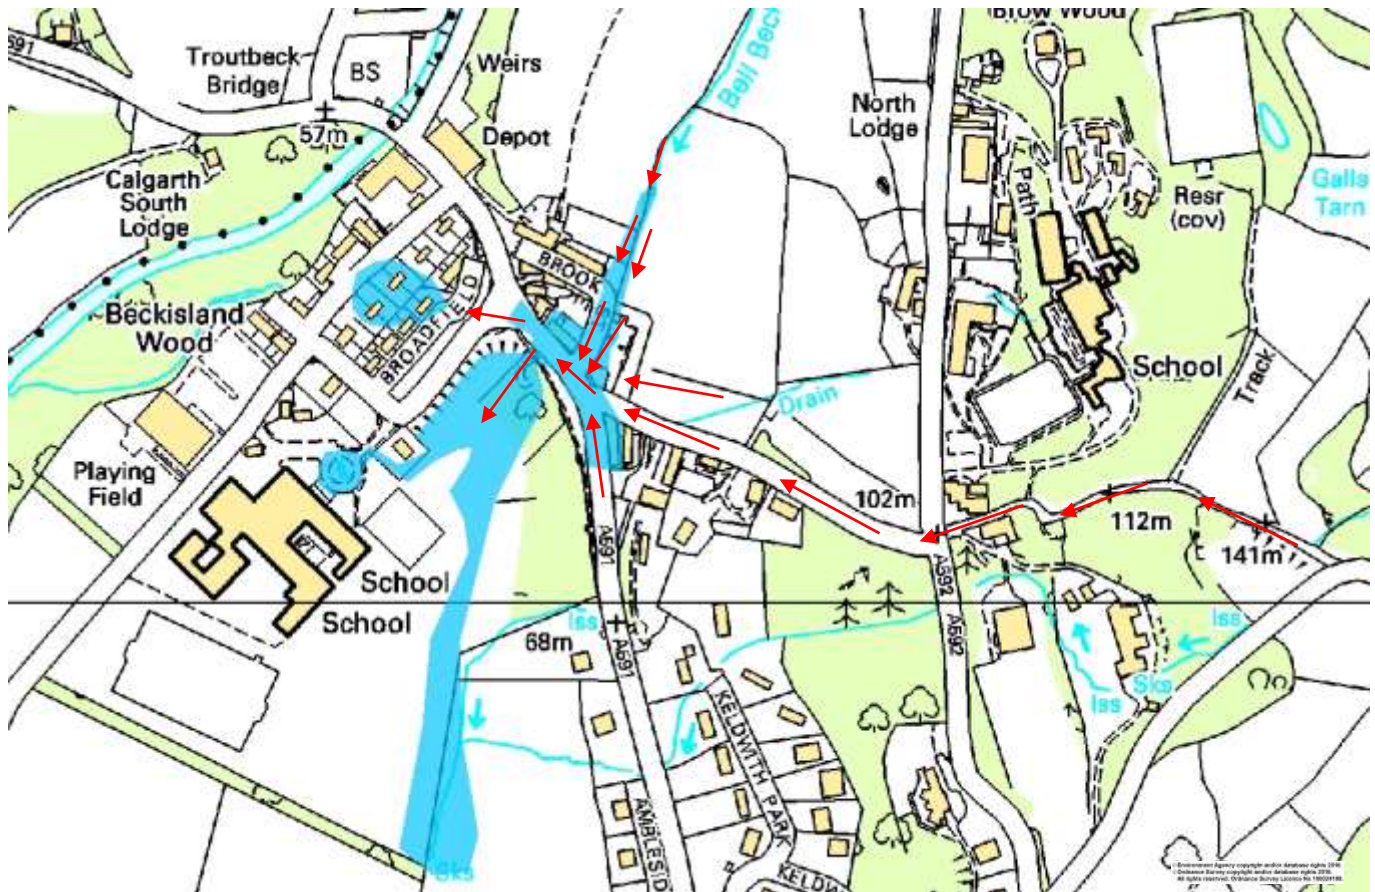
Figure 9 - Flood flow routes observed in Troutbeck Bridge during the flood event

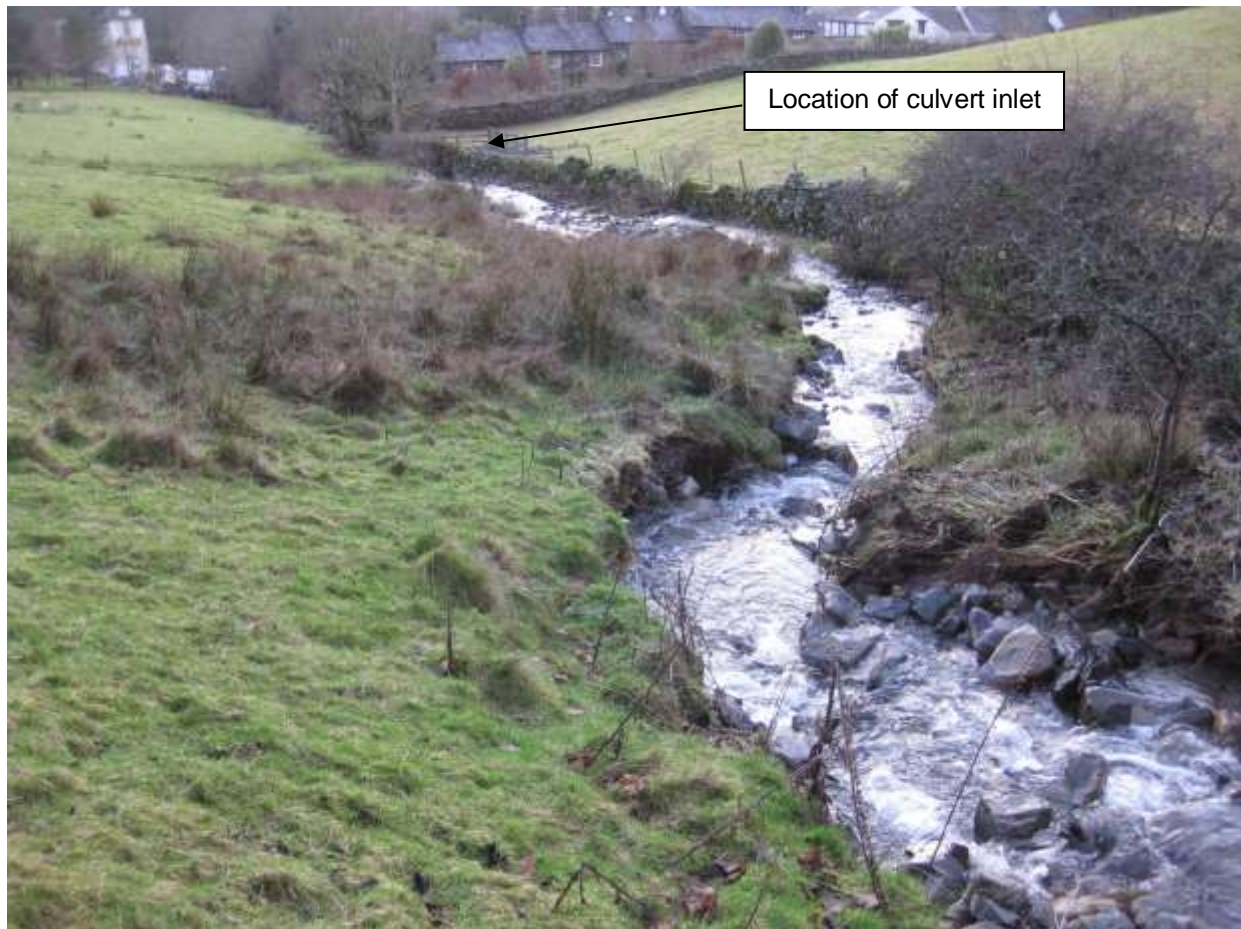
Flooding from Bell Beck occurred when it overtopped its banks after becoming overwhelmed with high volume flows. At the location of the culvert inlet upstream of Brook Street (see Figure 10), the capacity of the culvert was exceeded by the sheer volume of water flowing down the hillside. Culvert capacity was reduced by large quantities of gravel and stone, mobilised from erosion in the open channel upstream of the culvert, which had been washed downstream into the Bell Beck culvert. Once the culvert capacity had been exceeded in the field upstream of Brook Street, water flowed down Brook Street and through the adjacent fields (Back Acre), towards the Pedro's car park and properties on Calgarth View.

Reports indicate that Calgarth Cottages were inundated to the rear by overland flow from the surcharging Bell Beck culvert and surface water flows. In addition, seepage through the Bell Beck culvert walls was reported at 7 Calgarth Cottages. Due to the ground levels in the rear yards of Calgarth Cottages, which vary between each property, flood levels at each property ranged from between 100mm to 700mm.

Figure 10 - Bell Beck, looking downstream towards Brook Street (17th December 2015)

Following the flood event, the Environment Agency removed approximately 30 tonnes of gravel from the Bell Beck culvert as part of emergency recovery works. Following this, CCTV survey was undertaken to identify further remaining material within the culvert, which was subsequently removed in June 2016. Following the removal of this material, a further detailed CCTV survey of the Bell Beck culvert was undertaken to fully assess the condition of the culvert.

The CCTV culvert survey identified that the culvert section from the inlet to the manhole upstream of the A591 (adjacent to 7 Calgarth Cottages) was in poor condition. As well as being in poor condition, the existing culvert along Brook Street is extremely difficult to maintain, and is prone to blockages, all of which causes an increase in flood risk to the local community and places an ongoing financial burden on the Environment Agency to maintain the free flow of water through the culvert. As a result of the poor condition of the culvert, the Environment Agency have secured funding through their Asset Recovery Programme to return the culvert to a serviceable standard. Undertaking the proposed culvert replacement and associated works will deliver a more sustainable solution to manage flood risk going forward, and will greatly reduce the risk of blockage or collapse of the culvert.

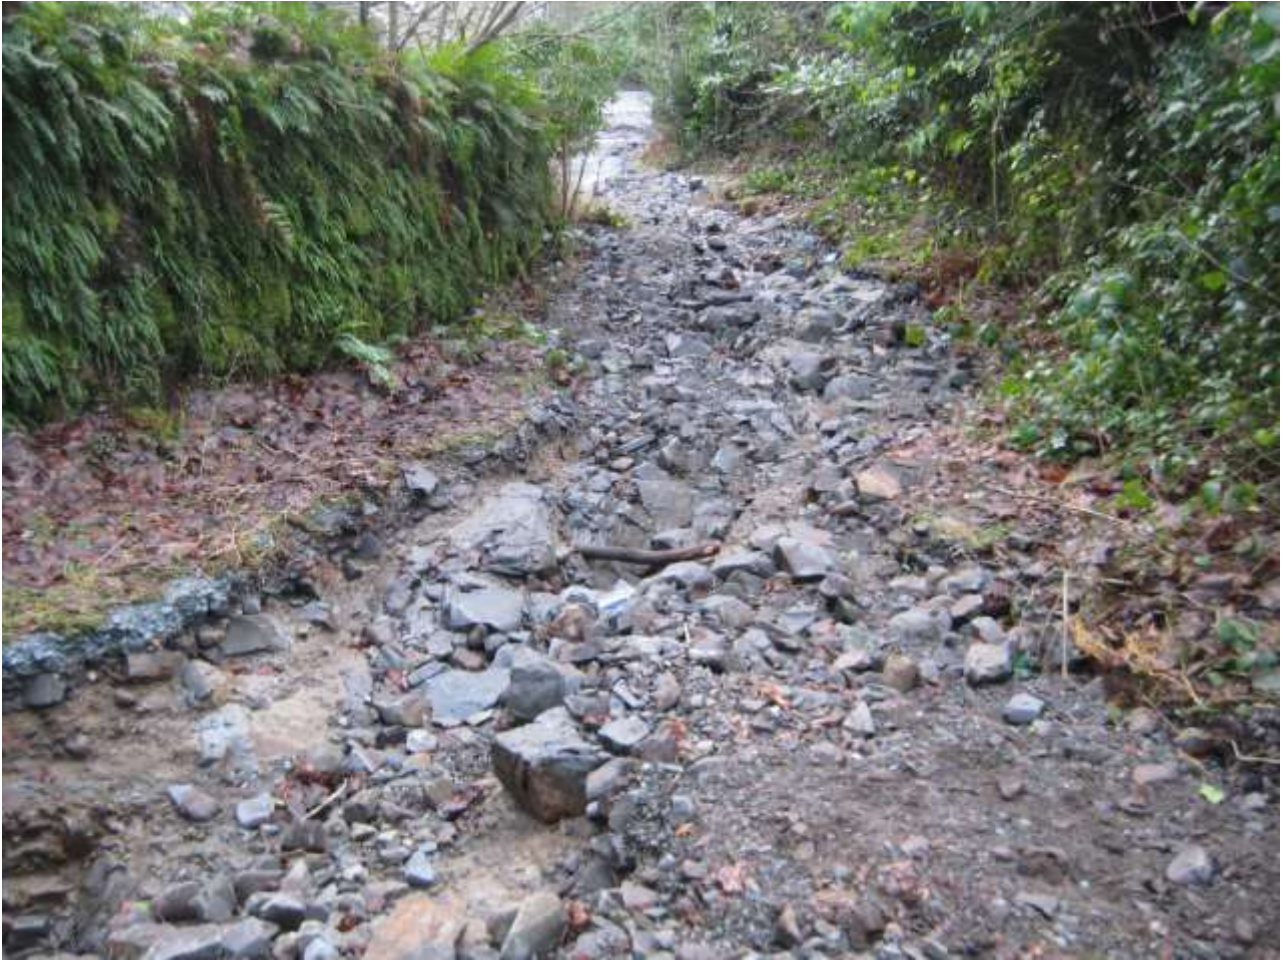
A large contributor of flow down Sun Lane also appears to have originated from an ordinary watercourse, which enters culvert at the top of Rough Lane. Rough Lane is a steep access track to the east of the A592, situated directly opposite the junction of the A592 and Sun Lane. As such, the natural topography and location of Rough Lane and Sun Lane provide a flow route for water towards the A591 and properties in Troutbeck Bridge situated adjacent to the road. The culvert inlet at the top of Rough Lane appears to have been overwhelmed by the volume of water flowing in the ordinary watercourse from Howe Hill, with the resulting flow down Rough Lane causing significant damage to the access track as illustrated in Figure 11. In addition, investigations post-event indicated that the culvert inlet and culvert downstream of Rough Lane were blocked with debris, which will have reduced the ability of the culvert to convey flow during the flood event. The damage caused to the access track on Rough Lane gives an illustration of the volume and velocity of water flowing down the lane and onwards down Sun Lane towards Troutbeck Bridge during the flood event.

Figure 11 – Damage on Rough Lane, looking downstream towards the A592

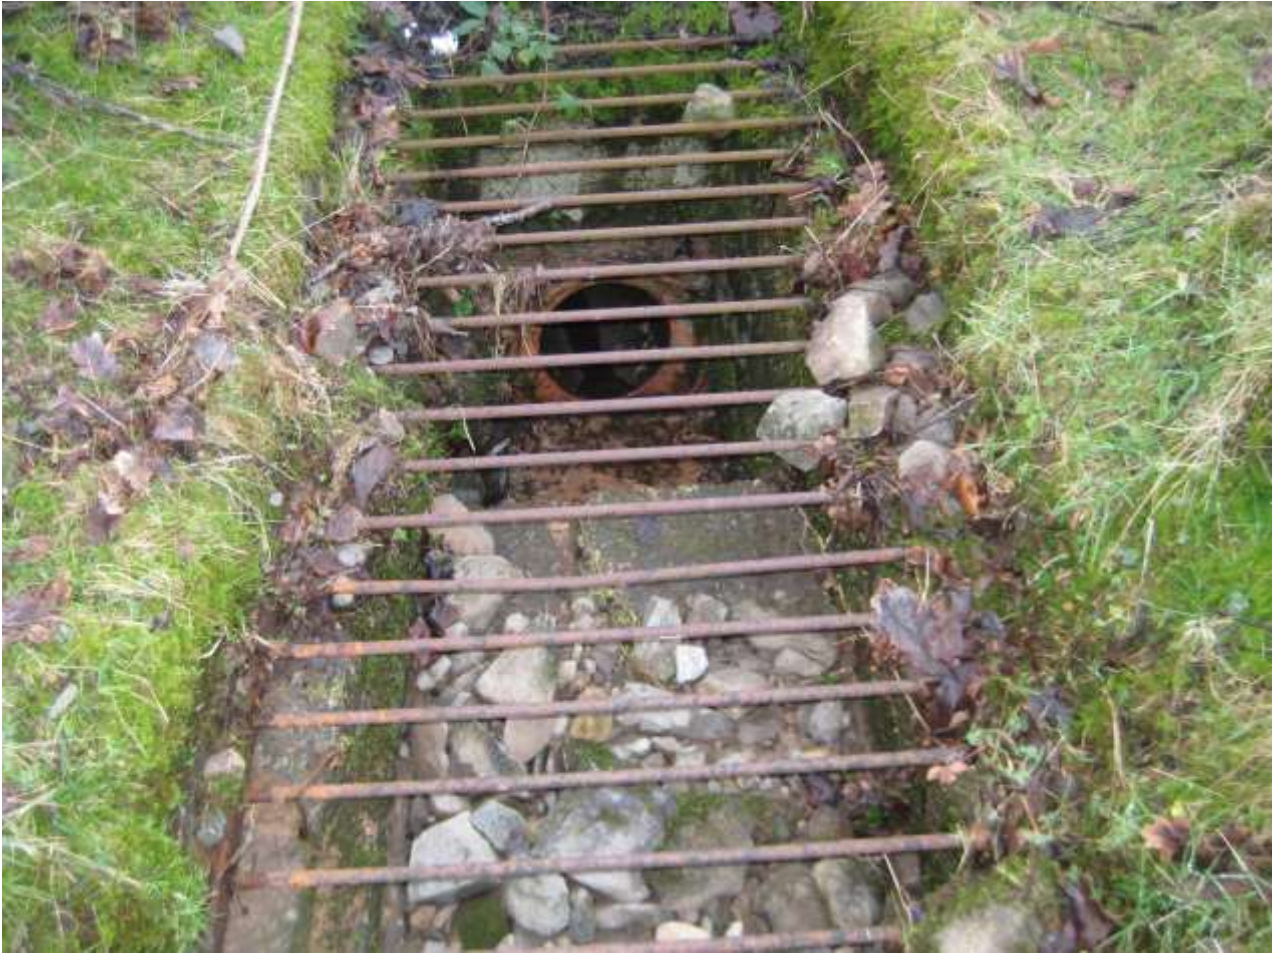
Some of the flows from the catchment upstream of the A592 flow across the fields to the north of Sun Lane, and are channelled towards a culvert inlet upstream of Pedro's. The existing culvert pipe has a limited capacity, and evidence of debris around the trash screen post-event suggests that the inlet was partially blocked during the flood event (see Figure 12). Reports from local residents suggest that when this culvert reaches capacity, flow across the fields to the north of Sun Lane is directed in a westerly direction down Sun Lane, and towards Brook Street and Calgarth View.

Figure 12 – Culvert inlet and trash screen upstream of Pedro's
