# Cockermouth

## S.19 Flood Investigation Report

## Flood Event 5-6<sup>th</sup> December 2015

This flood investigation report has been produced by the Environment Agency as a key Risk Management Authority under Section 19 of the Flood and Water Management Act 2010 in partnership with Cumbria County Council as Lead Local Flood Authority.

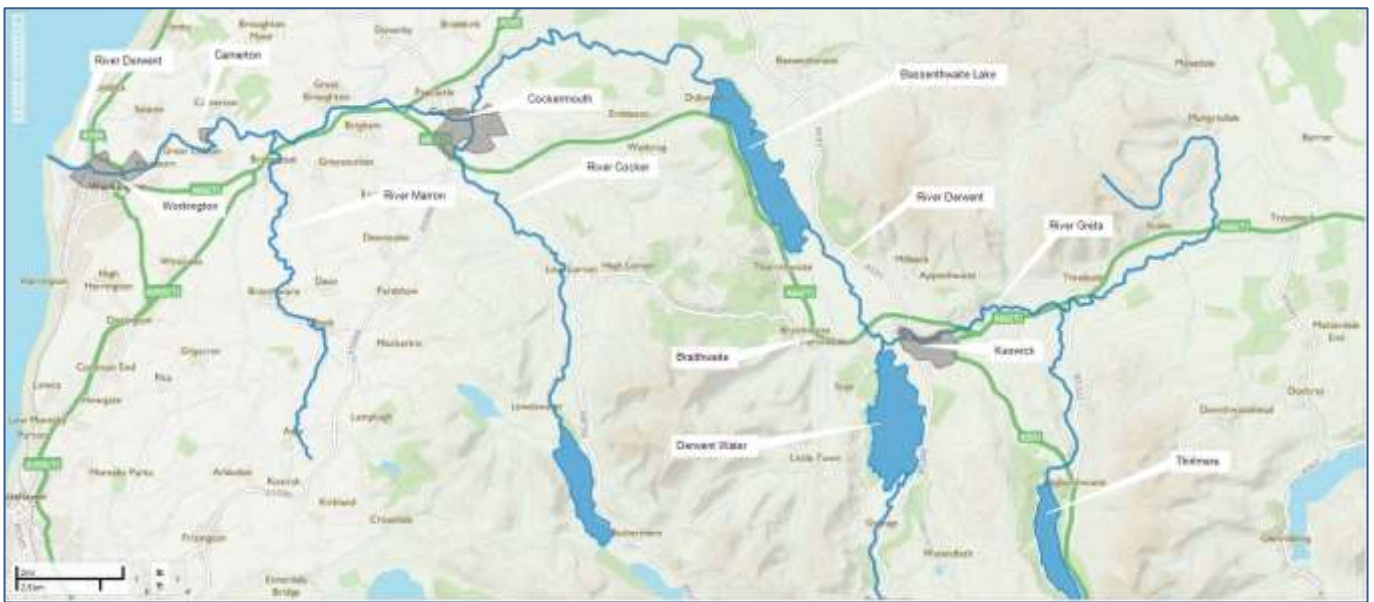
**Figure 1: Location of Cockermouth and the Wider Catchment**

Cockermouth is a town that has historically grown up around the river system with much of the industry using its water. Jennings Brewery is sited on the right bank of the River Cocker immediately upstream of the confluence. The centre of Cockermouth retains much of its historic character. It is known for its range of small specialist shops and is a popular destination for tourists. **Figure 1 provides an overview of the location of Cockermouth and the surrounding catchment.**

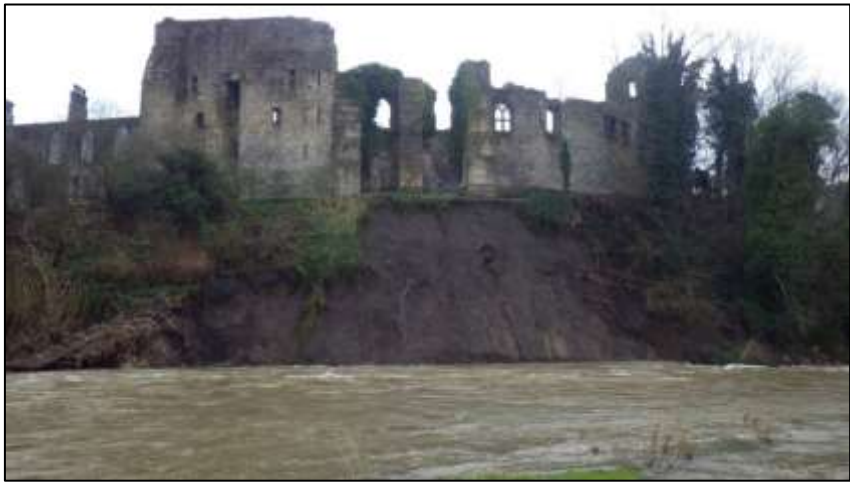
A number of areas in Cockermouth were identified to have experienced significant erosion during this flood event. In particular, the riverbank at Cockermouth Castle was severely eroded, and the castle has been identified as being at risk of damage. Damage to this bank, and fallen trees on the upstream island led to blockages at Gote Bridge. **Photograph 1** shows the riverward side of the castle and the erosion to the bank at this location. There was also significant erosion around Bitter Beck and to the playing fields and footpaths east of Gote Road.

**Photograph 1: Cockermouth Castle showing erosion to riverbank. Taken 21/12/2015**

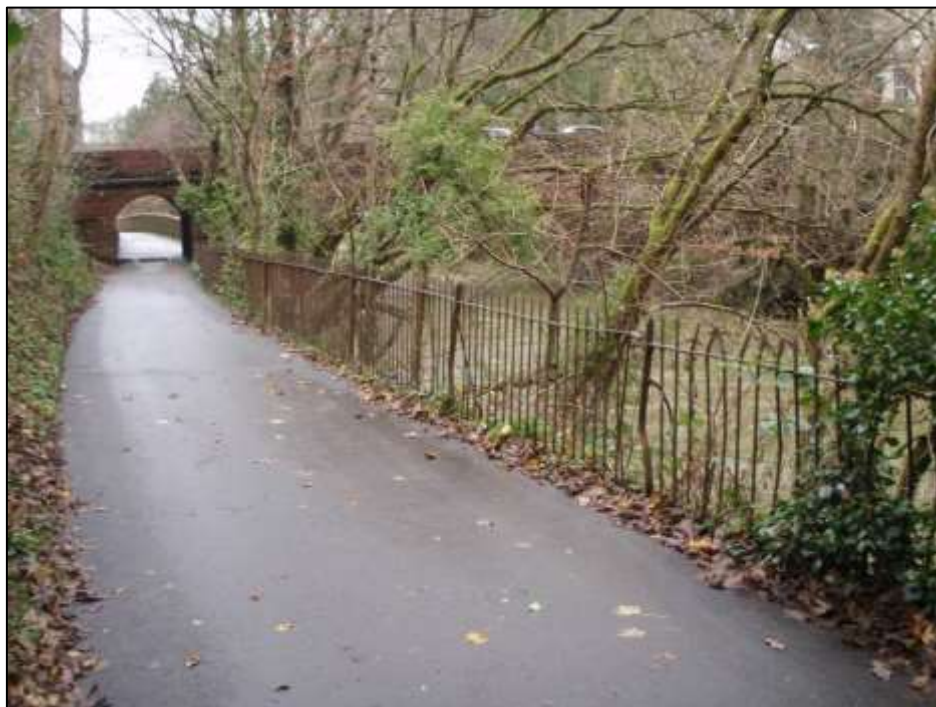
Water from the River Cocker overflowed the riverbank between the Victoria Road Bridge and Victoria Jubilee Railway Bridge. **Photograph 2** shows the riverbank which does not have any raised defences at this location. After overtopping the riverbank, the floodwater passed through the pedestrian archway. The water level was high enough to pass over the raised road hump, located at the upstream end of Rubbybanks Road. This road hump is higher than the level of the flood defence wall but was thought to be overtopped due to the Victoria Road Bridge restricting flow and raising the river level upstream of the bridge.

**Photograph 2: Riverbank between Victoria Jubilee Rail Bridge and Victoria Road Bridge (facing downstream). Taken 9/12/2015 at 11:40**

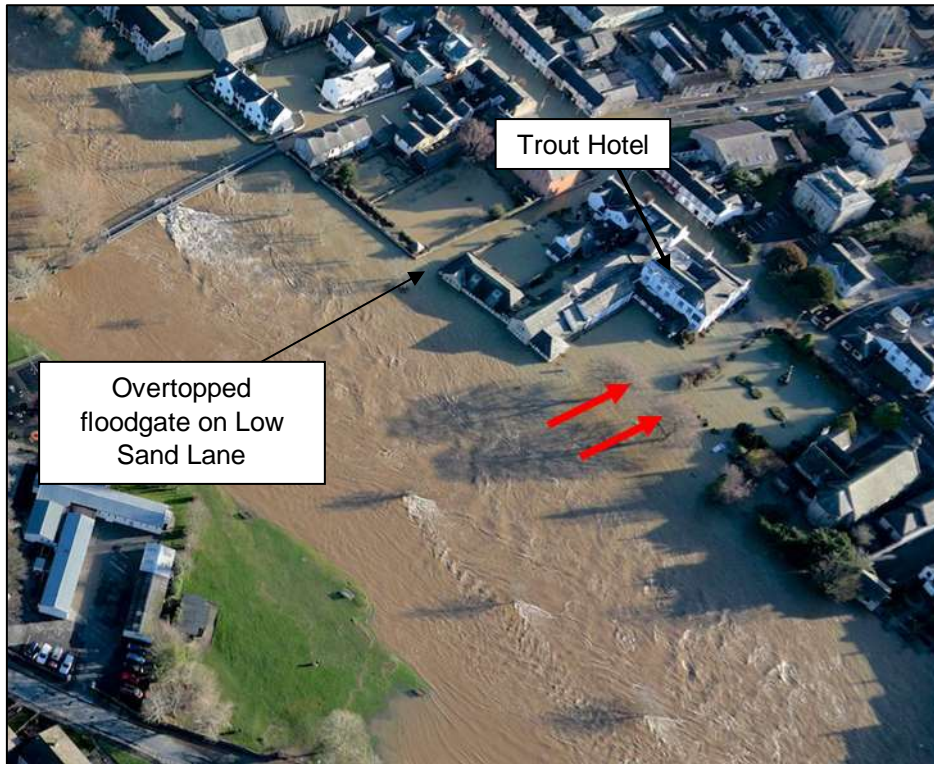
**Photograph 3: River Derwent at Main Street area highlighting flow route through the Trout Hotel car park. Photograph provided by Peter Smith Photography. Taken 06/12/2015 12:37**

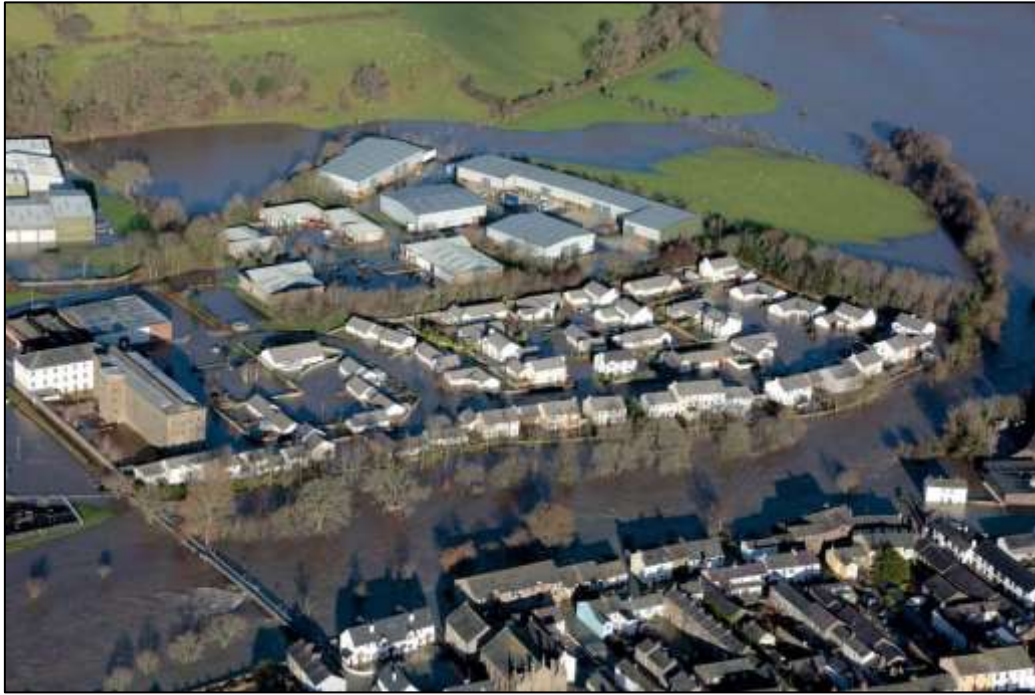
**Photograph 4: Derwentside Gardens during event showing flow route upstream of defence.  
Photograph provided by Peter Smith Photography. Taken 06/12/2015 12:37**

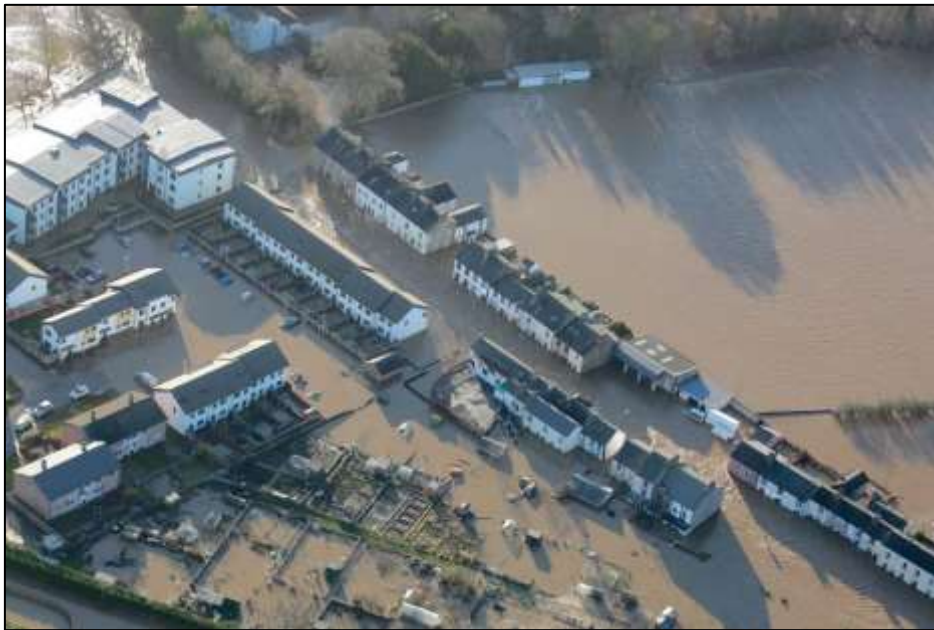
**Photograph 5: Gote Road area during event. Photograph provided by Peter Smith Photography. Taken 06/12/2015 12:35**

Gote Bridge caused an obstruction to the river leading to higher river levels upstream of the bridge. This was visible during the event where there was a significant difference in levels upstream and downstream of the bridge. A number of trees and other debris partially blocked the bridge arches at peak flows, increasing the impact of this. This exacerbated the overtopping of the defences and the flow into this area.

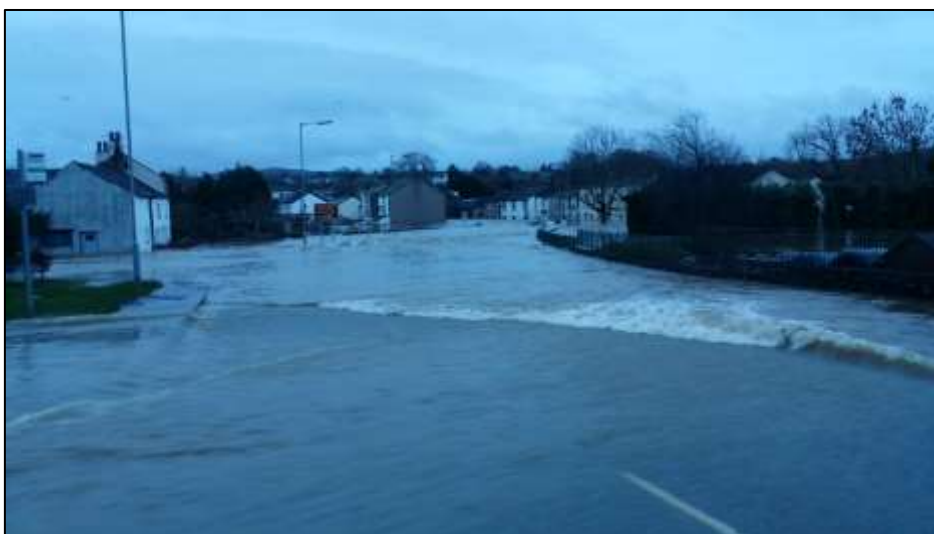
3. There was also flow through the Derwentside Gardens area and the James Walker factory, **Photograph 6**.
4. There was also reported flooding from a manhole on the old mill race which Tommy Gill Beck flows into before, discharging into the River Derwent.

**Photograph 6: Floodwater flowing from the James Walker factory along Gote Road. Photograph provided by D Dunlop. Taken 6/12/2015 08:26**
