An Historic Route in old Westmorland

Ride it only with great care and never in wet conditions.

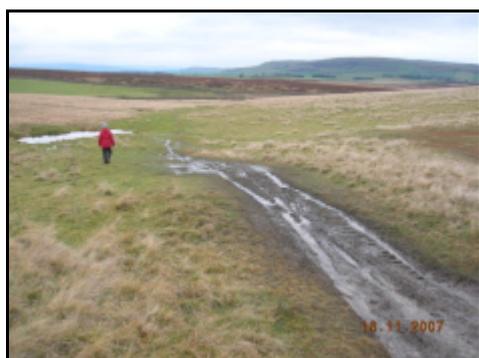
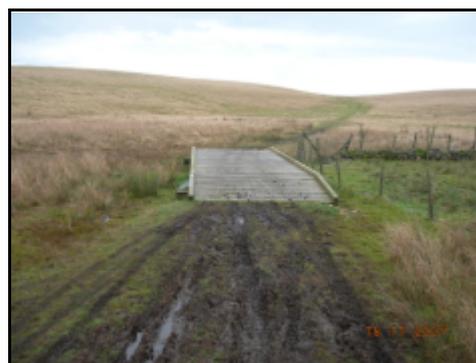
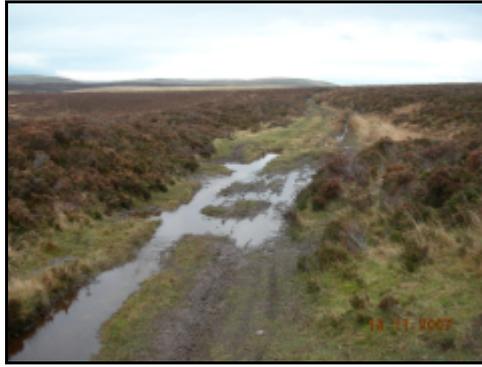
It's clear that in mid-November 2007, four or six bikes that crossed this route around that time were ridden with quite a lot of care. They stayed on the route (mainly) and on the grass-covered stretches there is little or no sign of heavy throttle use or stripped turf; though the bikes with motocross tyres moved more turf than those on trials tyres. However, on Friday 16th and Saturday 17th November there was very heavy rain in the area, the ground was waterlogged, and there were large areas of standing water. The trail-route crosses a Site of Special Scientific Interest (SSSI), mainly related to wading and water bird species; so you can tell that it's a wet area at the best of times. In these conditions careful riding across this site was not enough. Perhaps riders should have decided to not ride this route at all.

A volunteer walked this track in mid-November who took these pictures. Some of the wheel ruts made just a few hours earlier were running in water and being eroded even though the bikes were long gone. In some places instead of water running down the run-off drains it had been diverted onto the track by the wheel ruts. The old-guys in 1800 with the horses and carts would have leaped off the cart, shovel in hand, to ensure that run-off drain were still clear after their wheels had passed by.

Always take great care, and if at all in doubt please take the decision to not use the route. The accompanying photo shows the considerable impact of use in wet conditions even when trying hard to tread lightly.
