Glenridding

Flood Investigation Report

Glenridding Village Centre, 6th December

Flood Events 5th-6th, 9th-10th and 21st-22nd December 2015

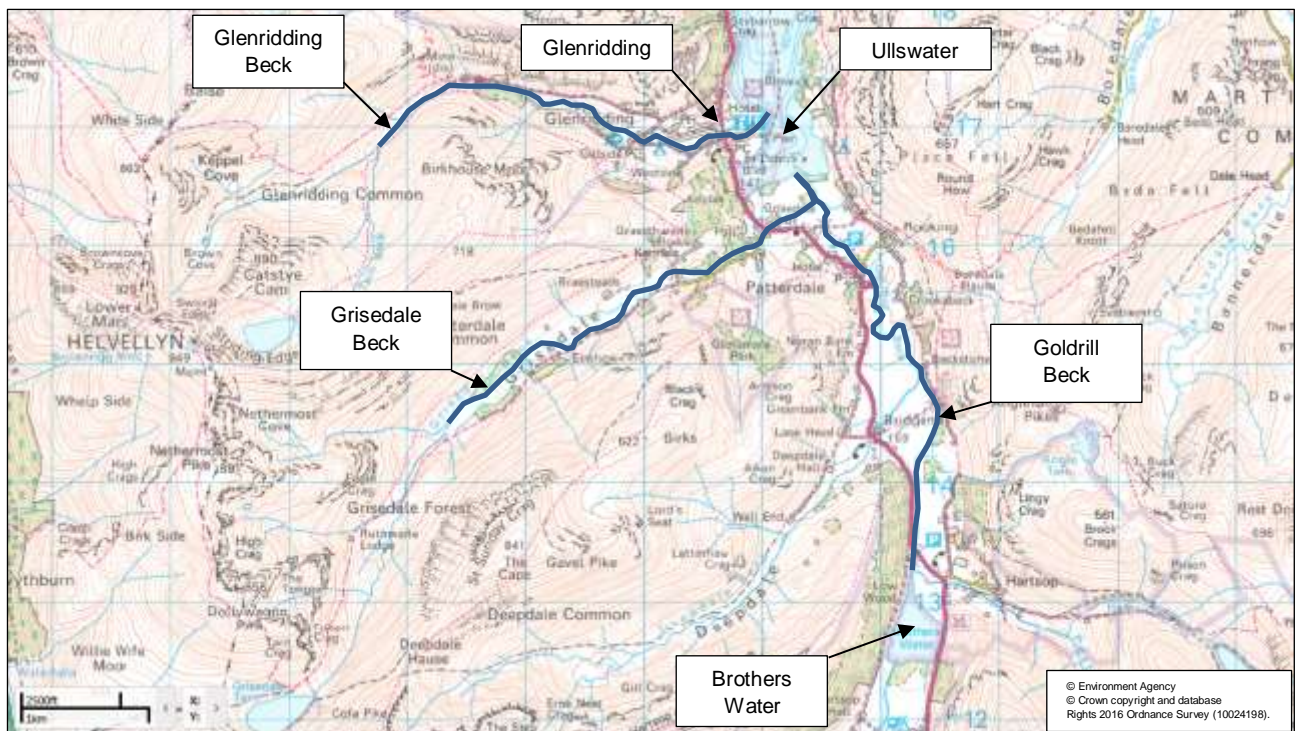
Figure 2-Location of watercourses and water bodies within the catchment

Figure 1 shows the location of Glenridding. **Figure 2** shows the route of Glenridding Beck and other watercourses in the area.

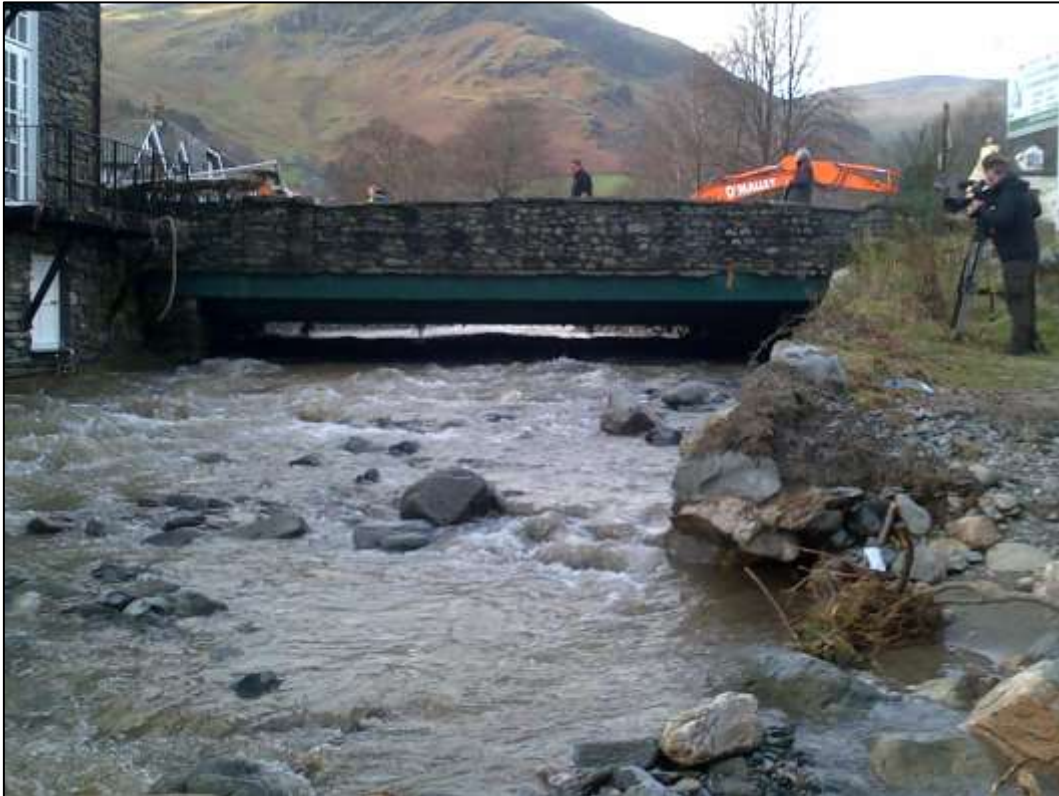
Figure 7-Glenridding Bridge 10th December 10:49

All three flood events led to large deposits of gravel and debris within the channel. This was caused by landslips in the steep slopes upstream of the village following heavy rain. This debris reduced the capacity of the channel and in particular reduced the clearance under Glenridding Bridge. **Figure 7** shows Glenridding Bridge on 10th December following the second flood event. **Figure 8** shows removal of gravel and blockages on 11th December.

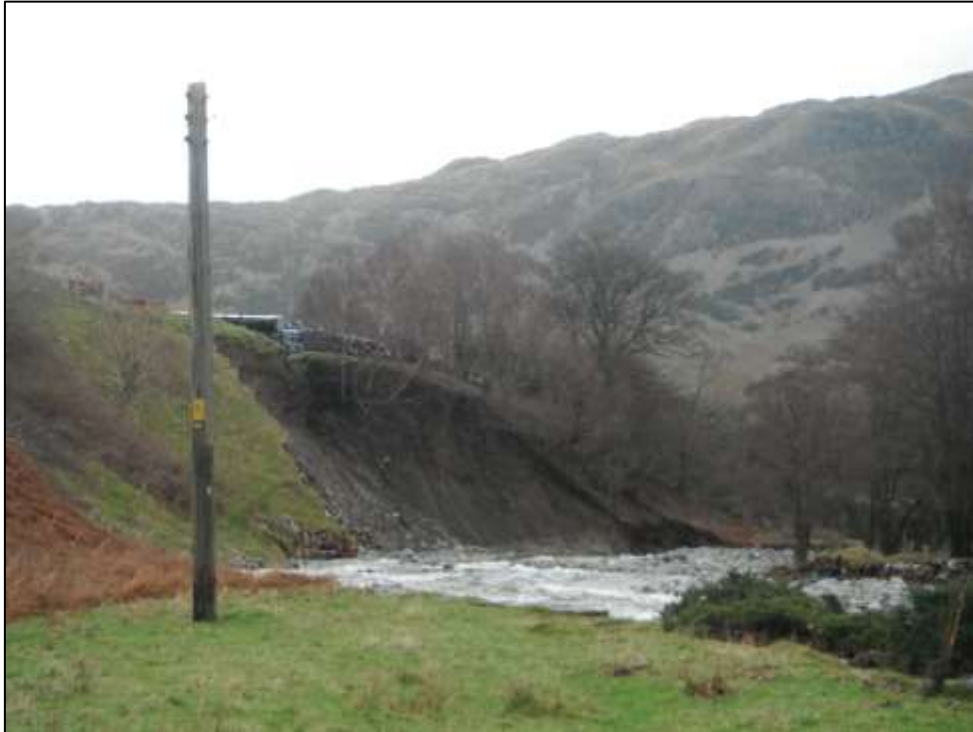
Figure 9-Bank erosion upstream of Glenridding. Date Taken XX/12/2015

There was erosion and landslips along the length of Glenridding Beck upstream of the village. **Figure 9** shows an example of this erosion. The erosion and slope failures led to gravel and fallen trees being deposited in the watercourse. Footpaths and properties close to the river were also damaged. These landslips were the source of both gravel and woody debris within the river.

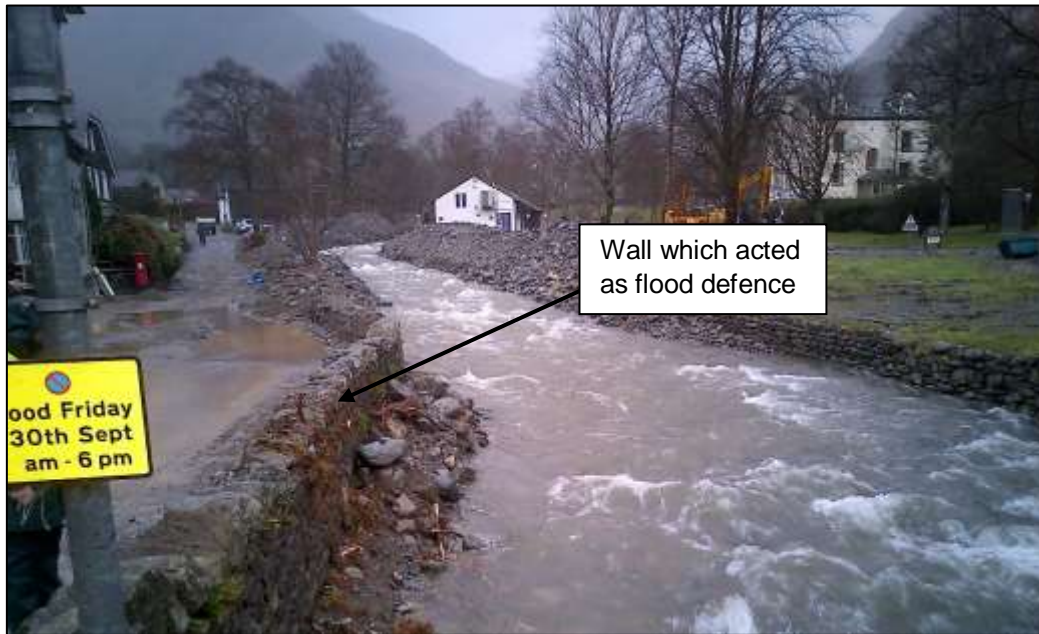
Figure 11-Wall along right bank of Glenridding Beck. Taken 9/12/2015 15:30

There are no flood defences in Glenridding. There is a wall along the river bank in front of properties on the right bank (looking downstream) that protected the properties behind it from flooding. This wall is shown in Figure 11. However, the river levels were greater than the level of this wall. As such, this wall was overtopped and the properties behind it flooded. The wall was also damaged by the flood water. Following the flooding, this wall is to be repaired and reinforced to act as a flood defence. This is discussed in the 'Environment Agency Flood Incident Response' section of this report.

The Environment Agency have begun work to replace the damaged wall in front of properties on the right bank of the beck (facing downstream) with a flood defence wall. The wall will be extended and the height increased to protect properties and reduce the risk of future flooding.

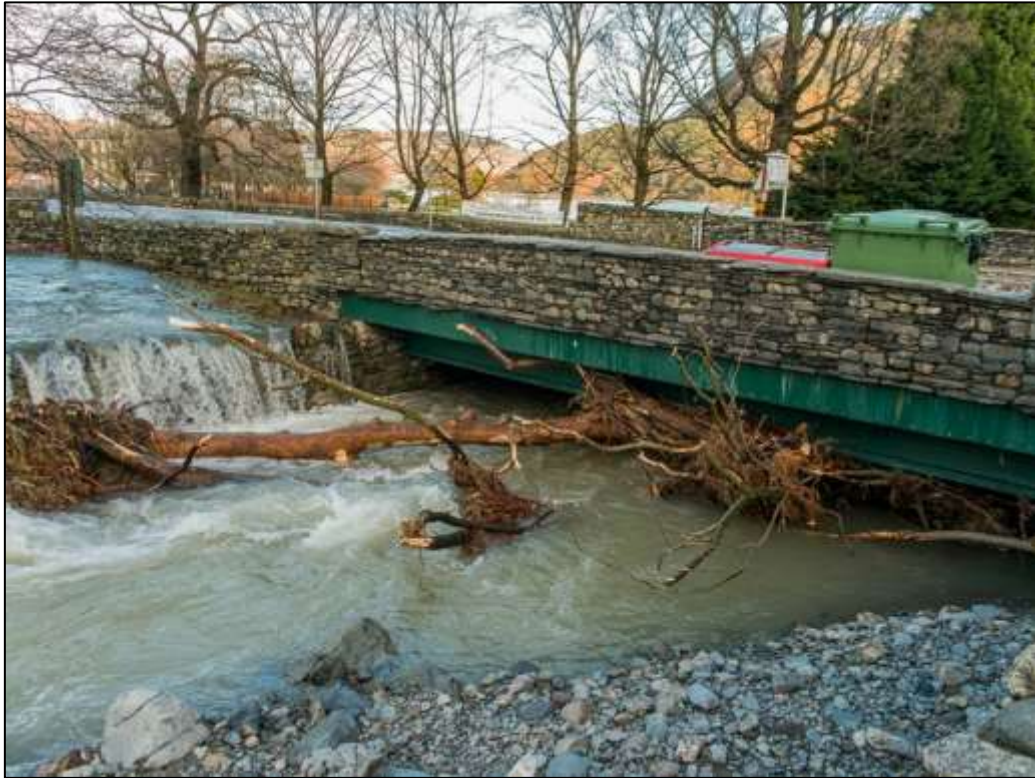
Figure 13-Glenridding Bridge Blocked by debris. Photograph provided by Patterdale Parish Flood Group. Taken **XX/12/2015**

Properties close to the bridge were flooded from Glenridding Beck. The main cause of this was large amounts of debris and gravel blocking Glenridding Bridge. **Figure 13** shows the bridge partly blocked with debris.

Blockages at the bridge caused water levels to rise on the upstream side of the structure, and water to overtop the river banks and flow onto the A592. From here the floodwater entered the hotel and neighbouring properties from the road. The Glenridding Hotel was also flooded directly from the river where the property backs onto the river bank.
