Historic Environment Addendum: assessment of impacts on Scalegill Hall (grade II listed building)

1.1.1 West Cumbria Mining Ltd instructed Headland Archaeology Ltd to carry out a review of the Heritage Chapter of the ES to ensure that its conclusions remained up-to-date and robust. As part of this review, it was identified that the significance of the identified impact on Scalegill Hall may be less than the “Moderate adverse at most” impact that had previously been identified in the ES. In light of this, West Cumbria Mining commissioned a site visit and impact assessment on the likely impacts of the scheme on Scalegill Hall (asset 184).

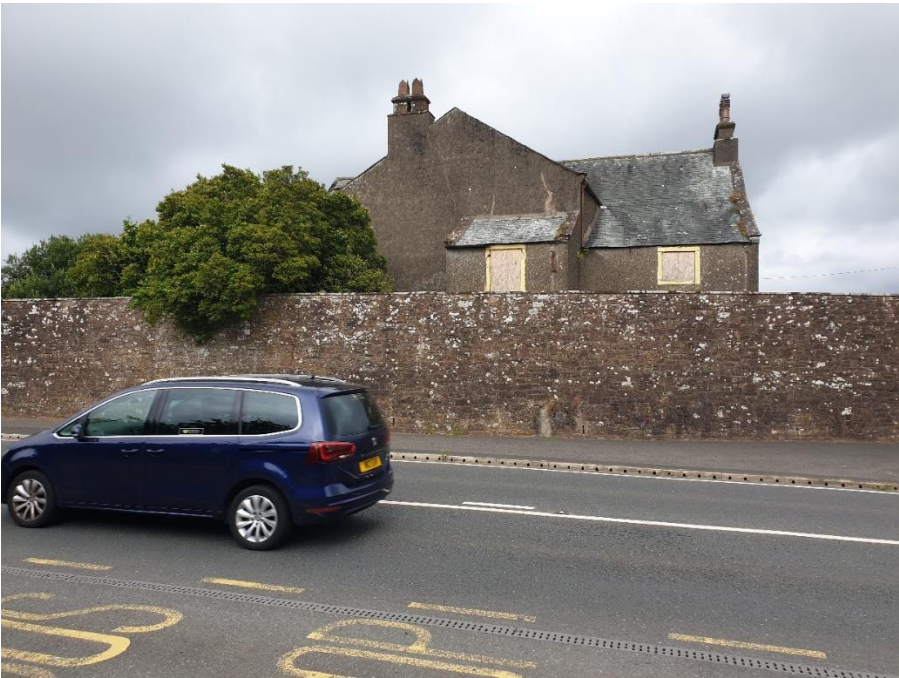
View to west of Scalegill Hall from A595

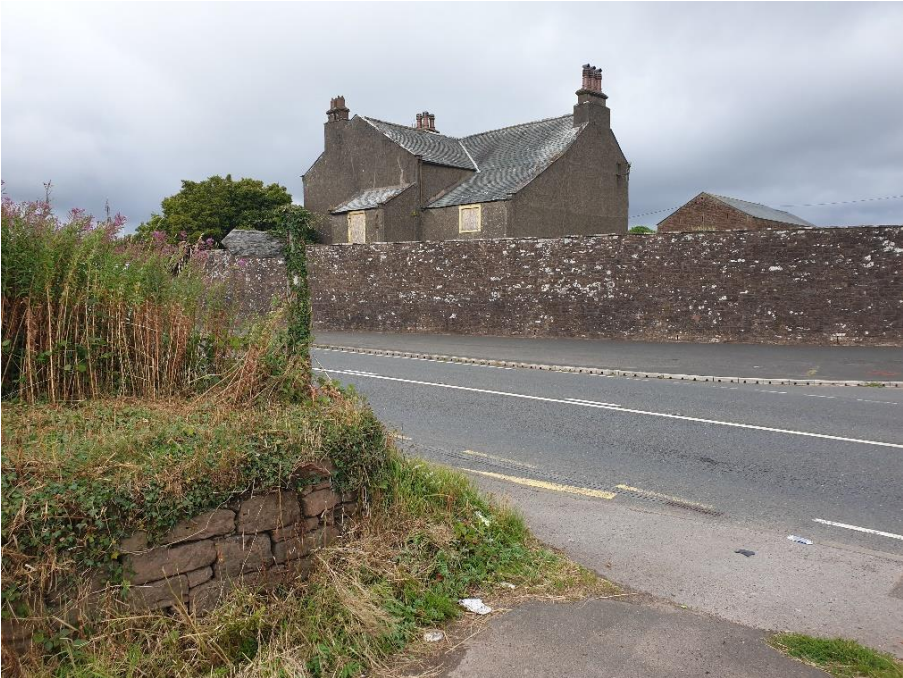
View to north west of Scalegill Hall from track and public footpath

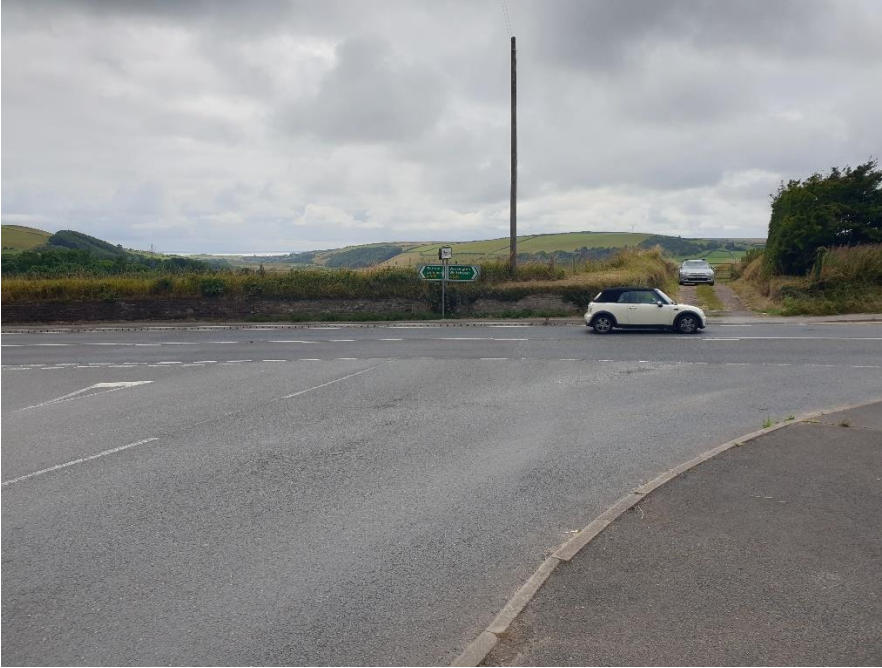
View to west from footpath adjacent to Scalegill Hall towards proposed development area

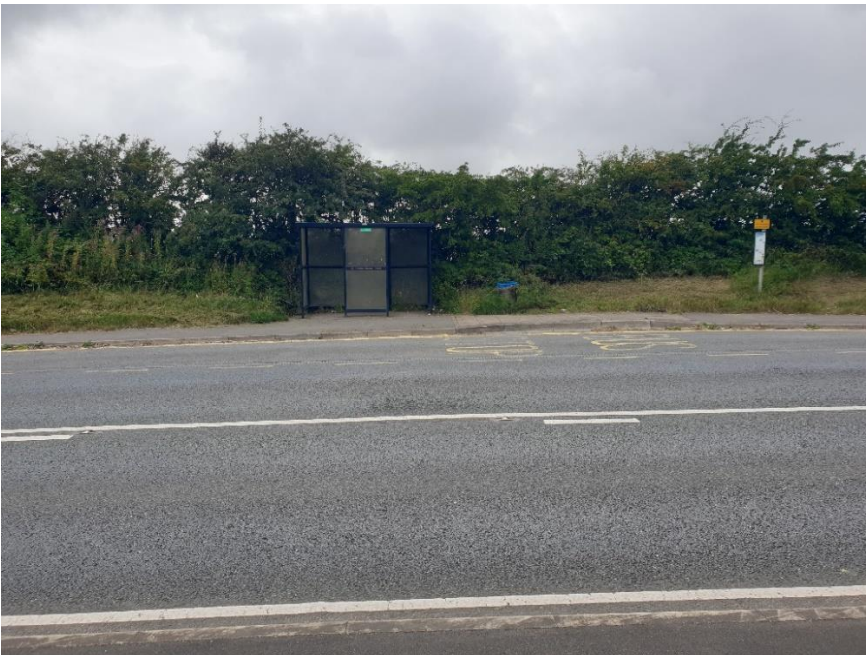
View to West from Scalegill Hall across A595 and bus stop towards development area

- 1.1.13 Scalegill Hall is primarily experienced by drivers using the A595- as a derelict farmhouse briefly glimpsed to the east whilst using the road. A bus stop opposite the farmhouse allows waiting passengers to view the rear of the building, largely obscured by the high wall separating it from the A595.

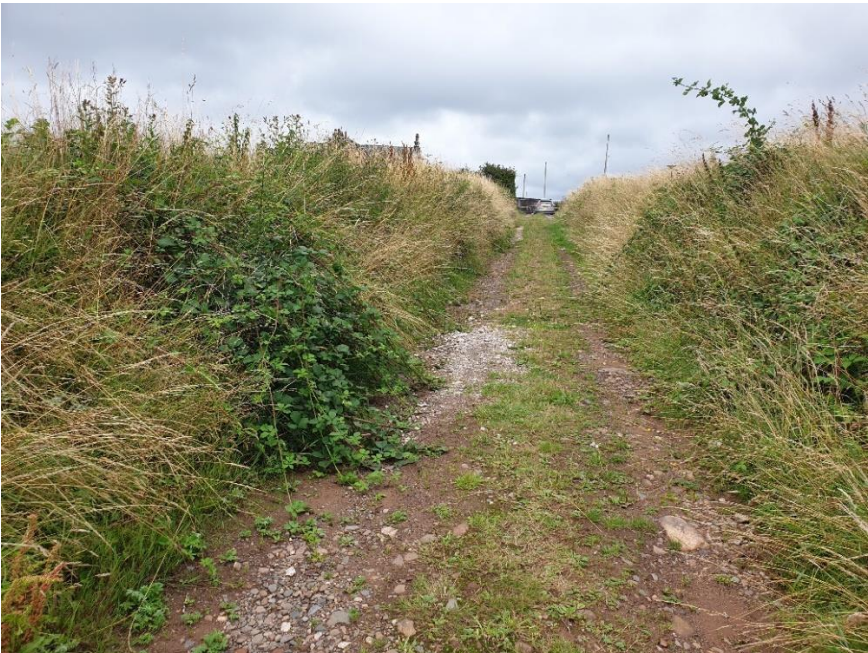
View to east along track and public footpath towards Scalegill Hall. Note it is partially obscured by both vegetation and land form.

- 1.1.14 Walkers using the public footpath which passes along the track opposite the hall and continues along Scalegill Road are able to partially view the complex of buildings and enclosing walls.
- 1.1.15 The proposed development, including the rail loading facility and main site will not intrude into any of the views of the hall from within the complex, adjacent to it or from a longer distance.
- 1.1.16 The development will not inhibit the public's capacity to experience or enjoy Scalegill Hall as pedestrians, walkers, drivers or passengers either close-up or from long range.
- 1.1.17 The proposed development will not have an impact on the components or values which constitute the heritage significance of Scalegill Hall during enabling, construction, or use of the proposed scheme.
