The poor in Victorian Carlisle

The 20th century fight against disease - problems of working class housing

Photographs taken around 1900 in Carlisle

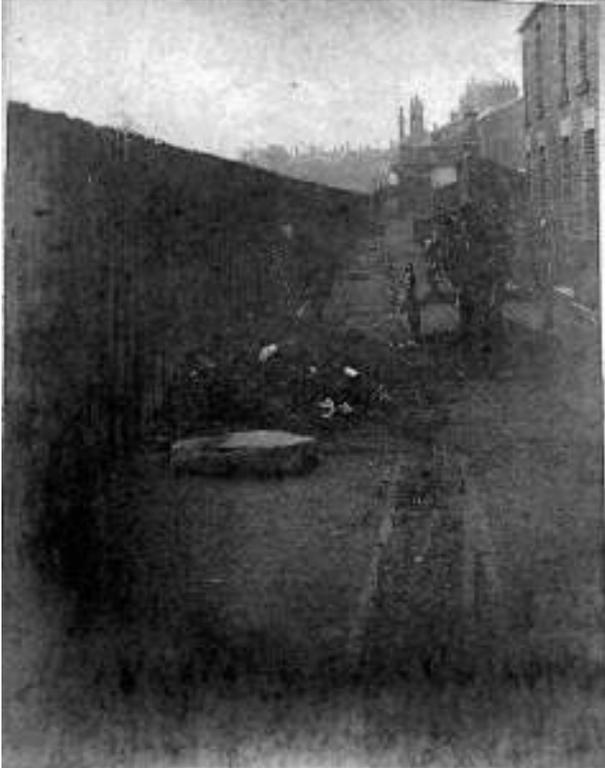
Charlotte Terrace, Botcherby, Carlisle

This shows a heap of privy midden refuse [waste collected from outside toilets] deposited in front of the terrace.

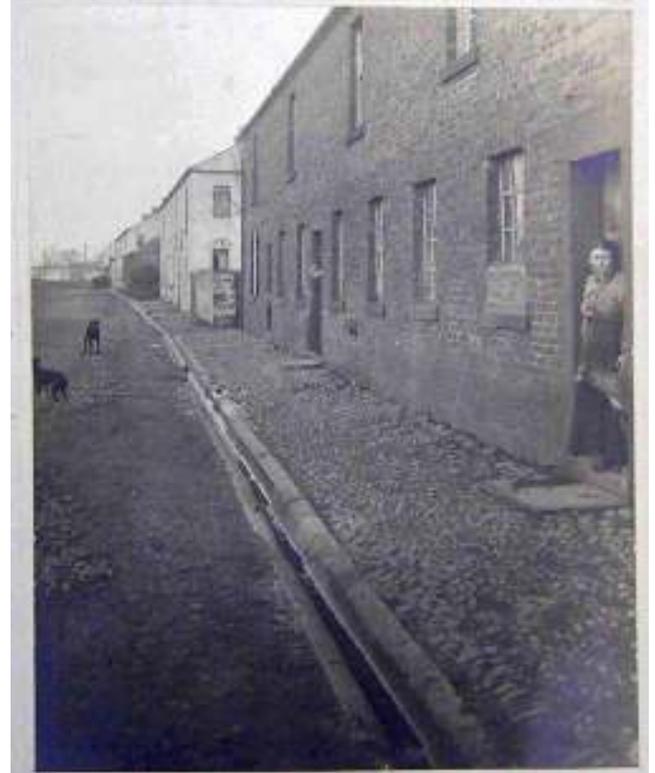
Scotland Road, Kingstown, Carlisle

For about a distance of 200 yards, there is no drainage of any description to the houses. The whole of the slop and refuse water is thrown into the channel in front of the houses. This channel is composed partly of cement, partly of earth and partly of cobbles.

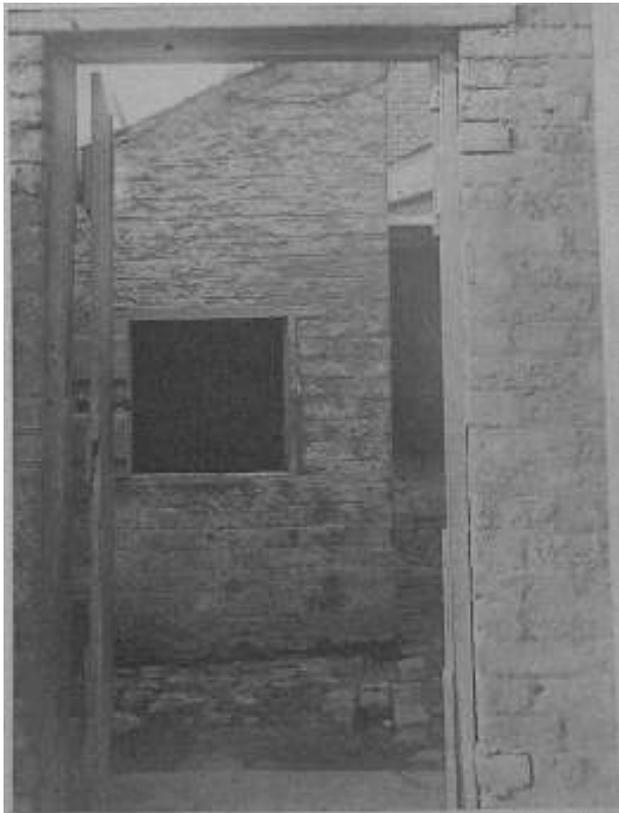
Kell's Place, Stanwix, Carlisle

A privy midden [outside toilet] is situated in a confined yard and only 3 feet distant from the doors of dwelling houses. It is used by five families.

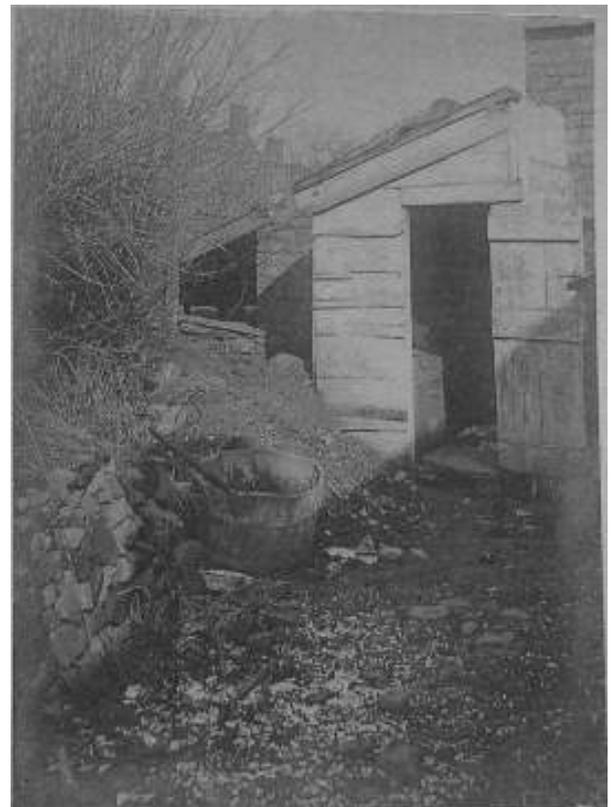
Back yard of a house in Upperby, Carlisle

A typical privy [toilet] and back yard. The wire netting is fixed to the side of a privy which belongs to the next yard. Note the heap of refuse and excrement.

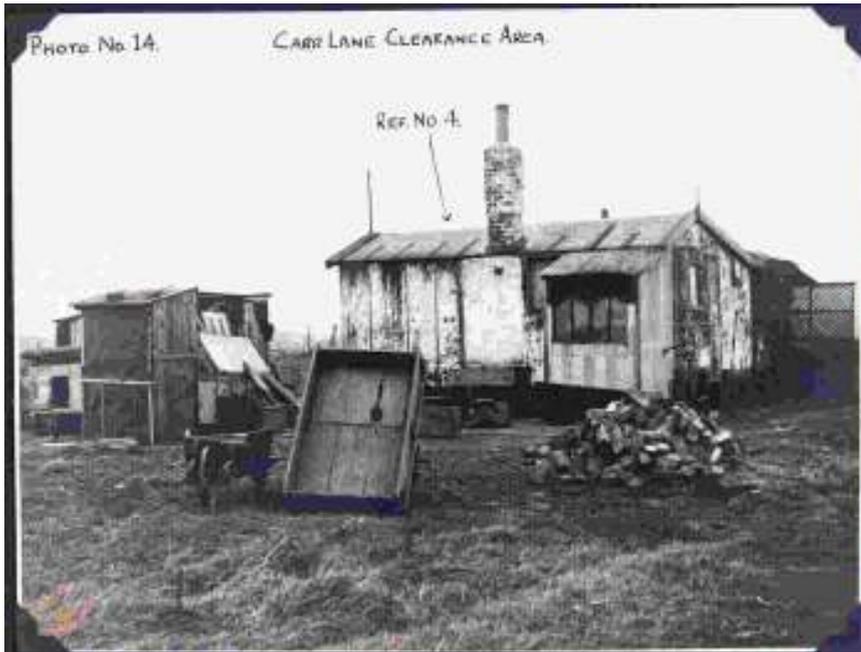
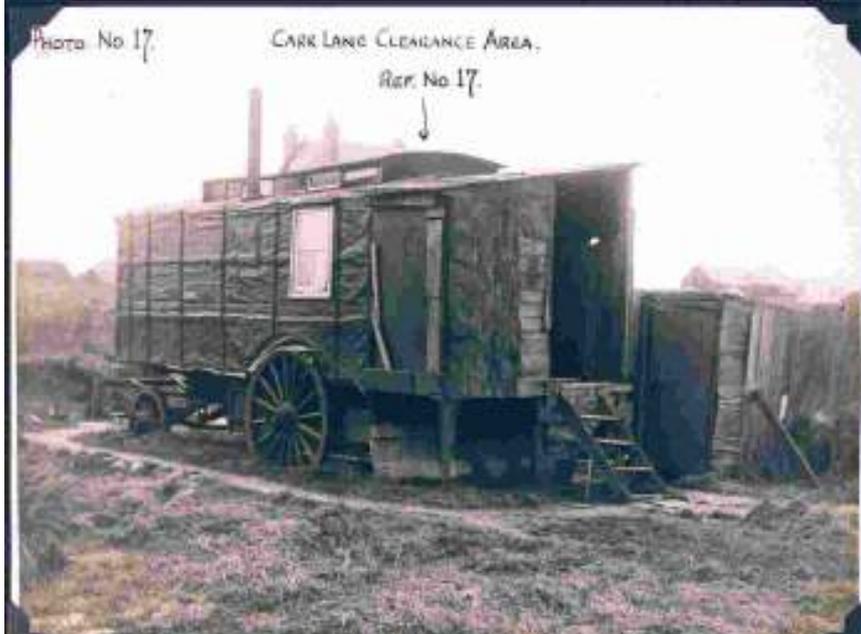
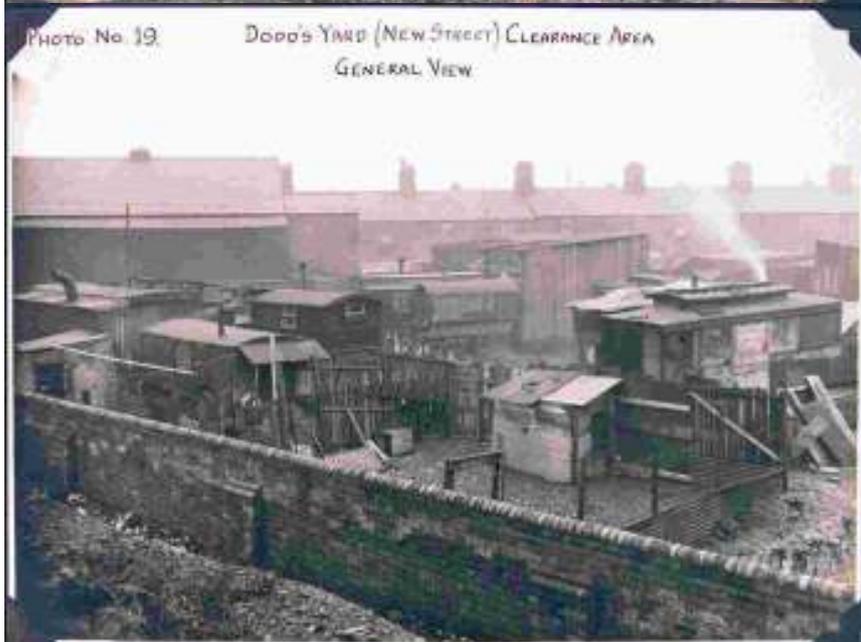
Photographs taken around 1937 in Barrow-in-Furness

The Medical Officer of Health identified 15 clearance areas throughout the borough which comprised of huts and caravans built mainly of wood, corrugated iron and tarred felt.

These evocative photographs show us clearance areas amongst the living accommodation on Carr's Lane, and Dodd's Yard on New Street.
