High and Low Lorton

Flood Investigation Report

Low Lorton, 5th December 2015, Cumbria

Flood Event 5th December 2015

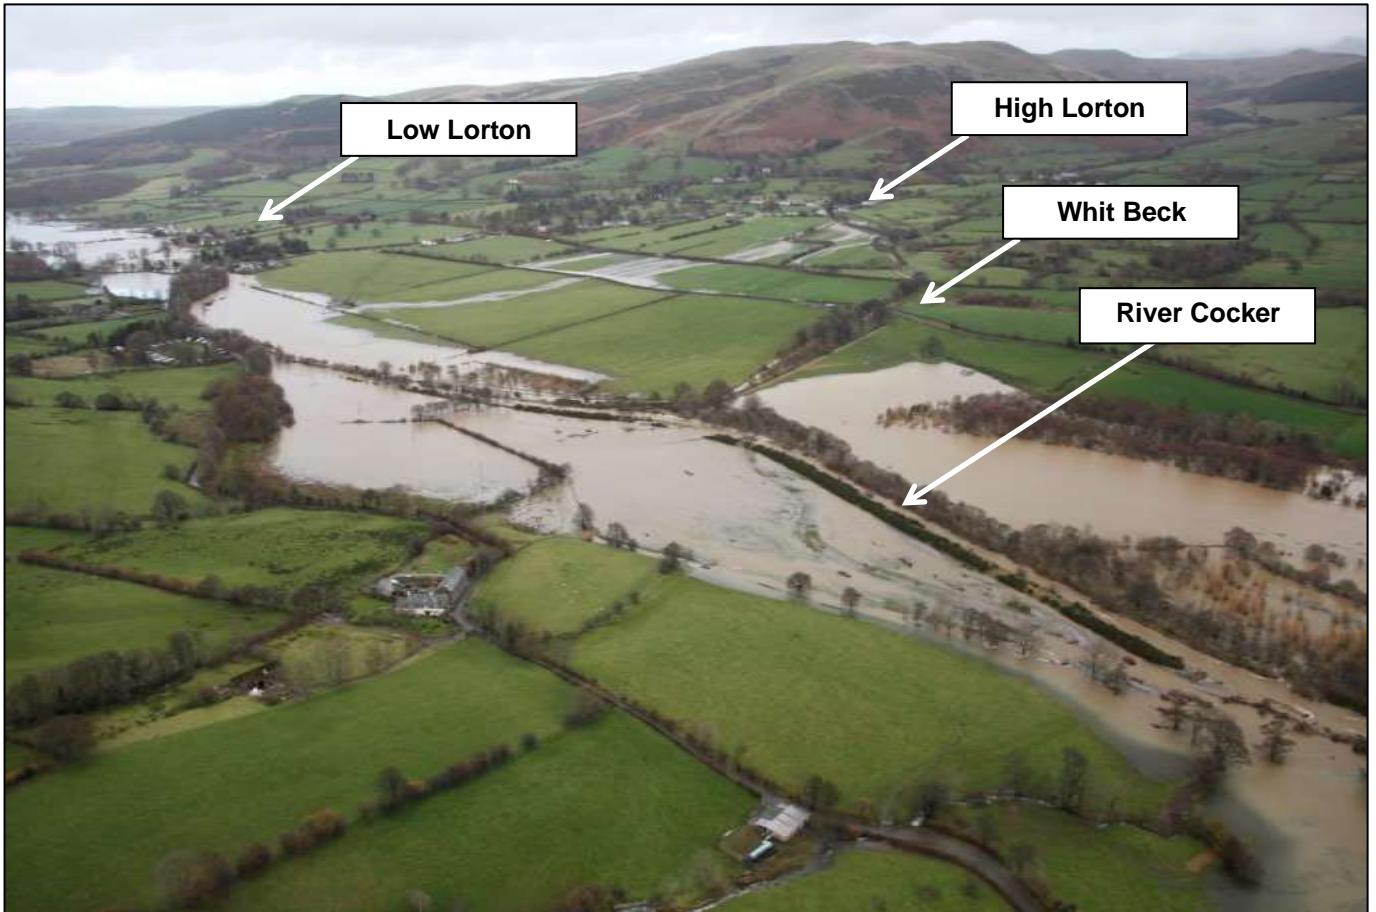
**Photograph 1: River Cocker during the November 2009 flooding
November 2009, no timestamp, NGR NY 15162 25622**

The River Cocker is another Environment Agency main river that originates at the head of the Buttermere valley, and flows south to north through High Lorton. The River Cocker is spanned by a road bridge near Lorton Low Mill. The bridge was completed in January 2010 following the destruction of the former structure during the November 2009 flooding event. Both High and Low Lorton were affected by major flooding on the 19th November 2009. Both the River Cocker and the Whit Beck flooded during this event as a result of prolonged rainfall falling over the northwest region from the 18th. An aerial photograph of the November 2009 flooding is shown in **Photograph 1**.

A significant volume of floodwater was routed along the Whit Beck from the upper river catchment in the Lorton Fells flooding Brewery House. This is not known to have caused any internal flooding within the centre of High Lorton. However, the river flows subsequently overtopped the right bank of the watercourse leading to flooding of the fields between High and Low Lorton. This flooding mechanism also occurred in November 2009 and is evident in **Photograph 1**.

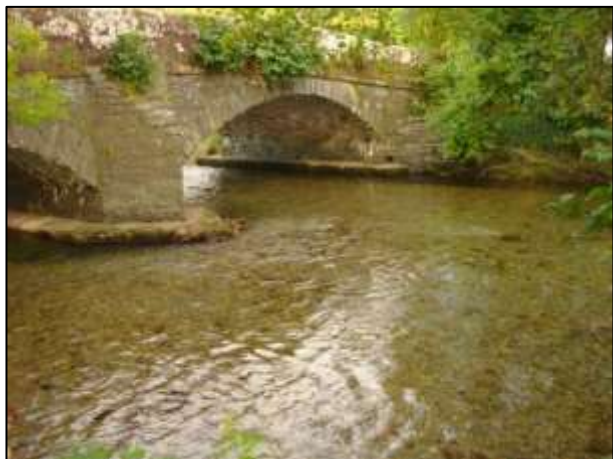
Photograph 2: Lorton Bridge (pre-destruction)

The November 2009 flood event resulted in the collapse of Lorton Bridge. The former structure was an old stone arch design with a central pier and limited capacity (**Photograph 2**). The majority of the structure and several cars were swept away during the peak of flood (**Photograph 3** and **Photograph 4**). No people were harmed by the collapse of the structure.

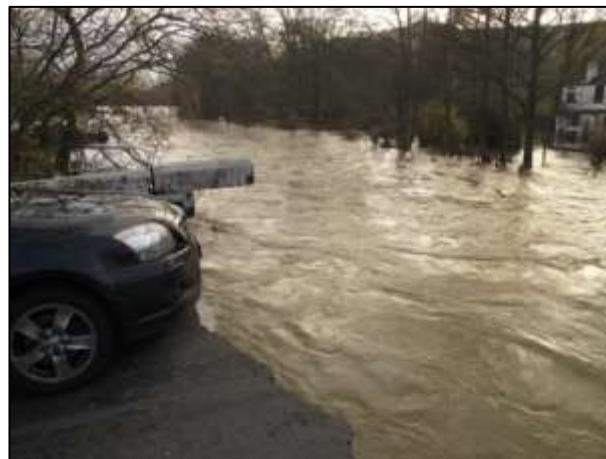
Photograph 3: Looking downstream from the destroyed Lorton Bridge

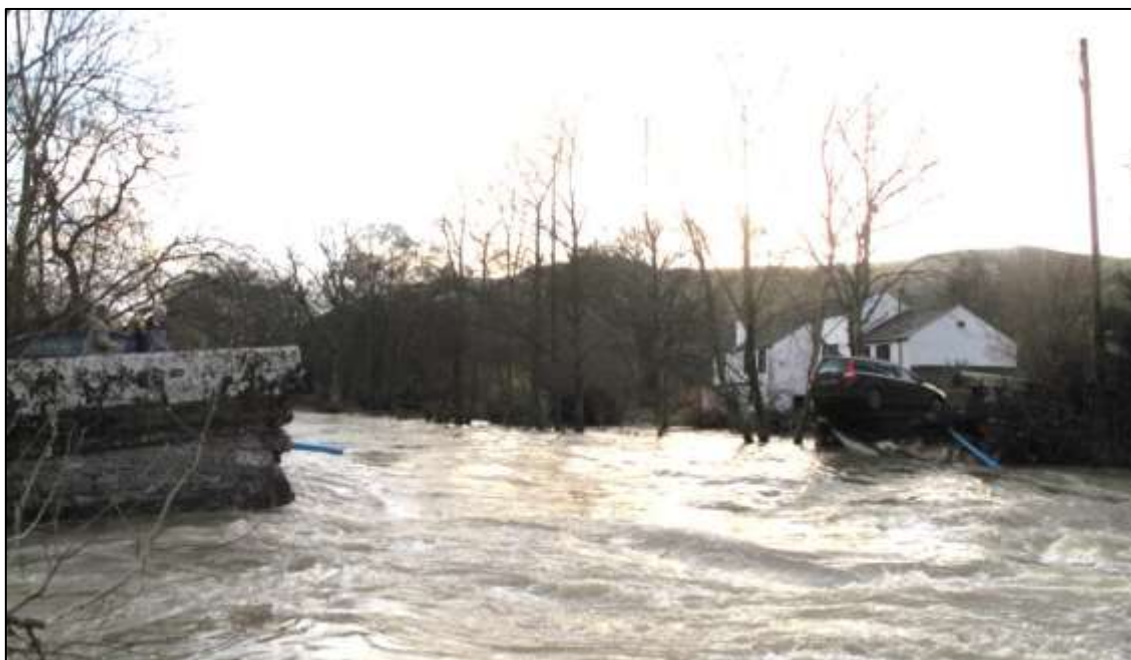
Photograph 4: Looking south towards the destroyed Lorton Bridge

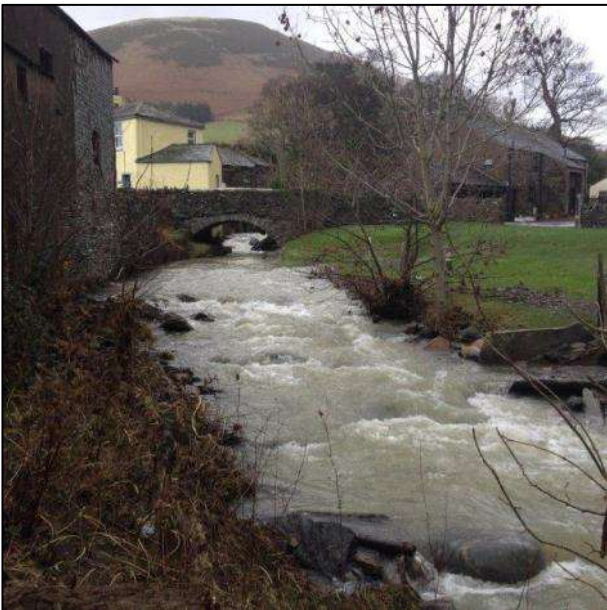
Photograph 5: Whit Beck in High Lorton, looking upstream

High Lorton was affected by localised fluvial flooding from Whit Beck (**Photograph 5** and **Photograph 6**) as high river flows resulted in scour and structural damage around residential properties at NGR NY 16182 25538. There were 10 residential properties reported to have flooded with 3 of these confirmed as having been flooded internally flooded up through the floors and in basement rooms. Other sources of flooding were the public highway surface water that flowed down the access roads connecting High Lorton with the B5292 and surface water running off fields into the rear of properties. This resulted in localised damage to walls and the public highway. The Whit Beck overtopped its banks approximately 200m downstream of High Lorton, resulting in fluvial floodwater routing across agricultural fields towards the River Cocker.

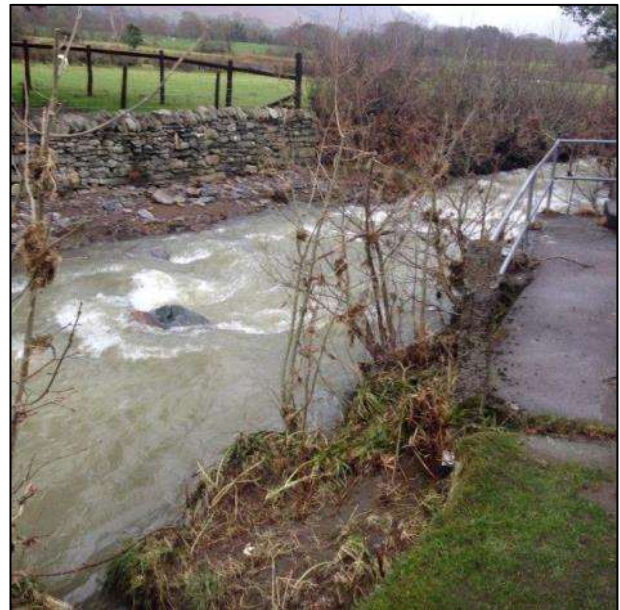
Photograph 6: Whit Beck in High Lorton, looking downstream

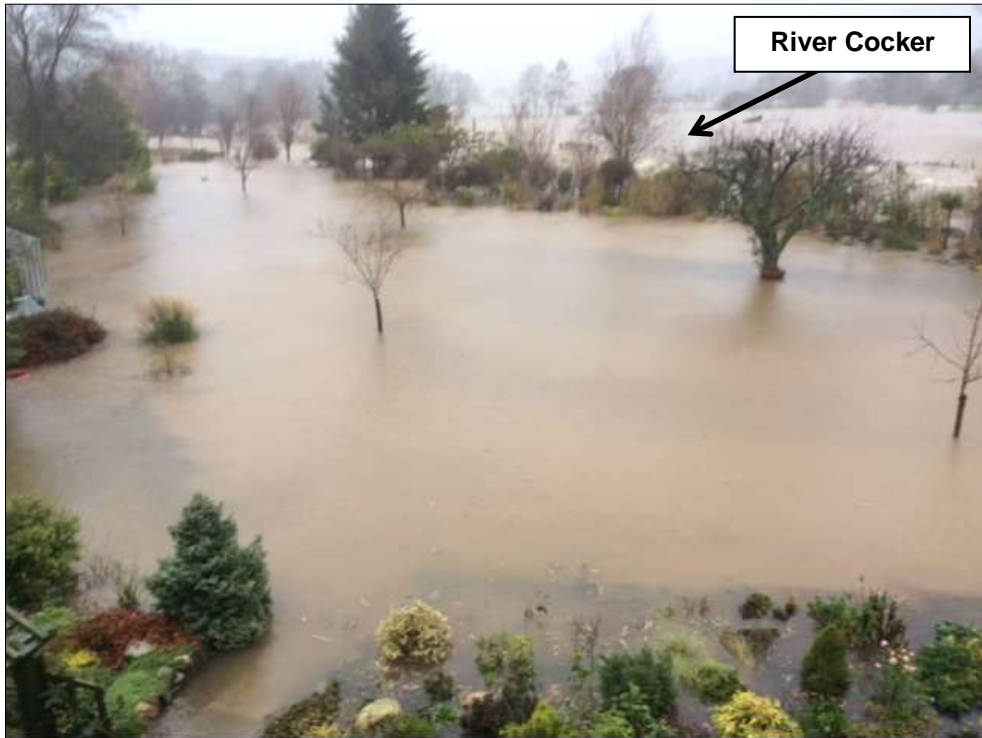
Photograph 7: Looking north towards the River Cocker from the left bank near Lorton Bridge

On the 5th December 2015 water levels within the River Cocker catchment rose in response to the prolonged and severe rainfall across the northwest region. This resulted in significant volumes of floodwater spilling into the adjacent floodplains within the Lorton Valley as shown in **Photograph 7** and **Photograph 8**.

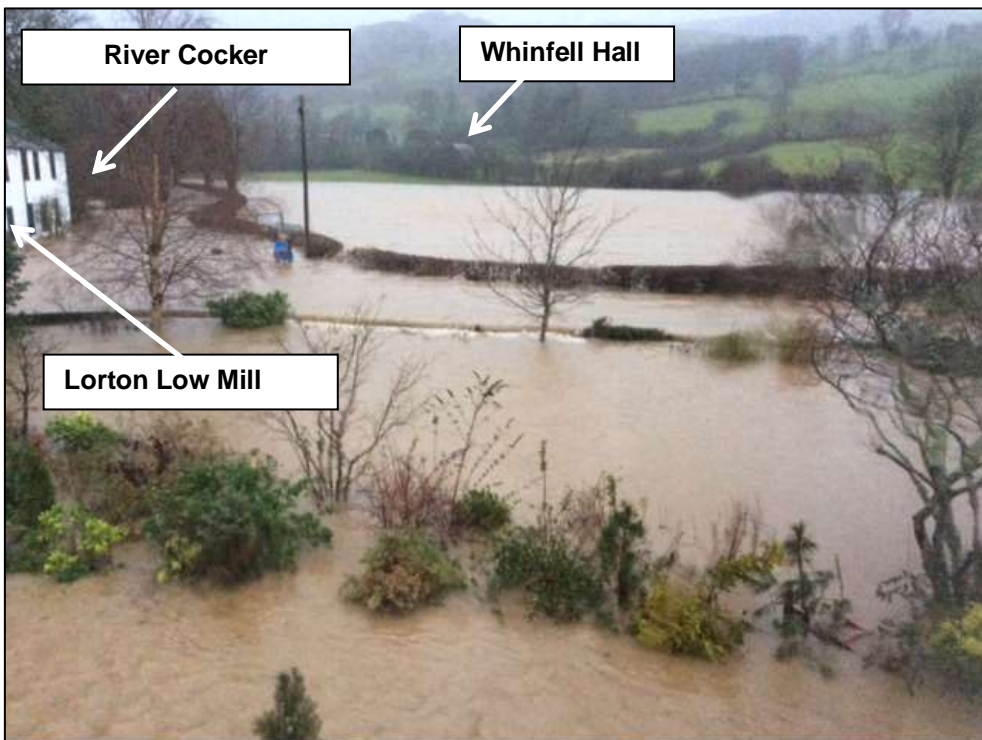
Photograph 8: Looking south from Lorton Low Bridge (Bridge End Cottage)

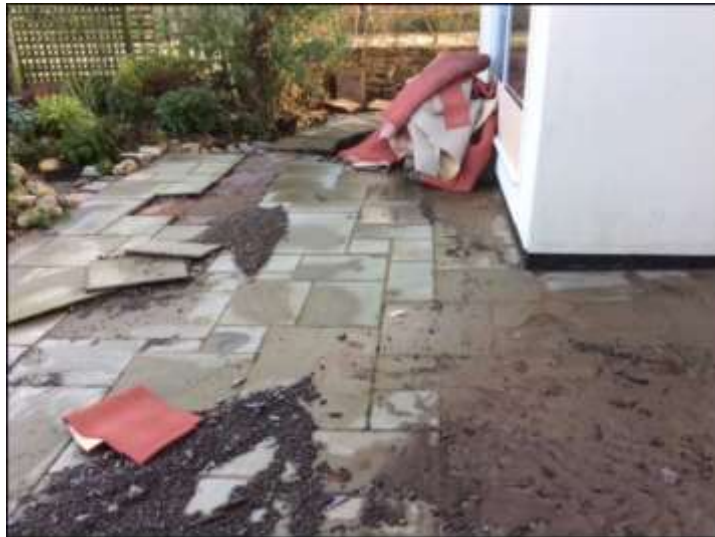
The fluvial flooding resulted in significant damage to 6 residential properties with depths of up to 30cm above the ground floor and garden areas (**Photograph 9**). All of these properties were affected by the November 2009 flooding event. Peak river flows occurred during the evening of 5th December. Lorton Bridge was overwhelmed, with significant volumes of water rising up and spilling out onto the road approaching Lorton Bridge from the east. The flooding at his location was exacerbated by surface water flooding flowing from the B5289 cross roads (**Photograph 10**). A culverted section of an ordinary watercourse collapsed approximately 30 meters north of Bridge End Cottage on the left bank of the River Cocker.

Photograph 9: Flood damage at Low Lorton

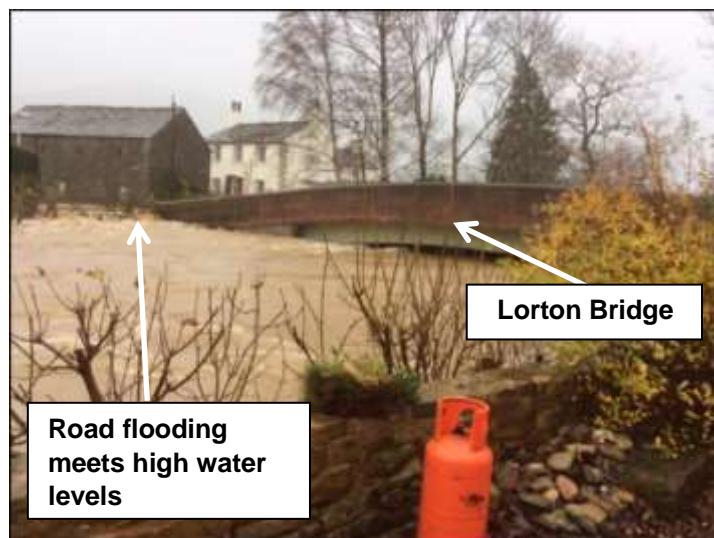
Photograph 10: Looking upstream towards Lorton Bridge on the River Cocker

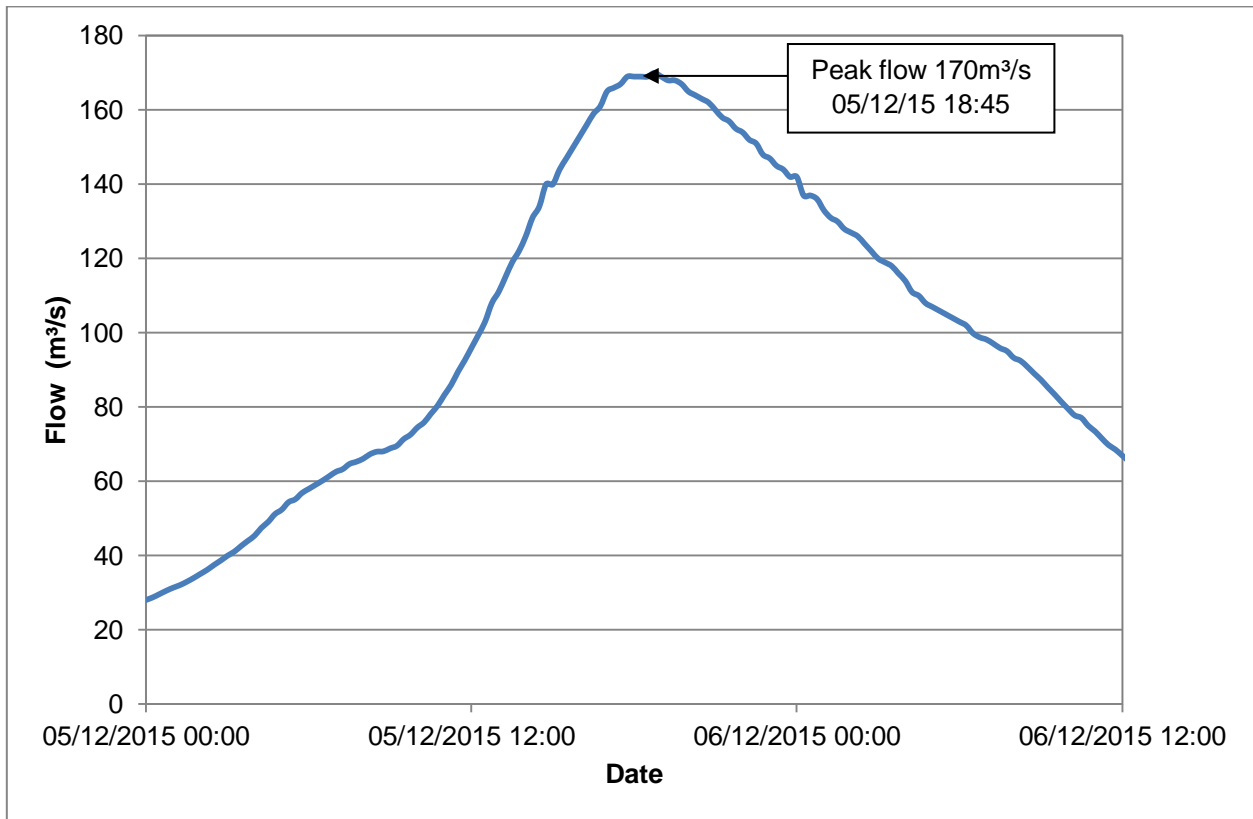
Figure 3 River Flows on the River Cocker at Southwaite Bridge, 5th December 2015

Figure 3 shows that the river flow at Southwaite Bridge peaked at 170m³/s at 18:30 on the 5th December 2015. By comparison, the 19th November 2009 flood event peaked at 201 m³/s at the same gauging station (**Table 4**).

The Environment Agency operates a river gauge on the River Cocker approximately 3.5km downstream of Low Lorton. This is location at NGR NY 13071 28089, and was opened in October 1967. River gauges are used to provide an assessment of river flow and are often used by the Environment Agency to determine when Flood Warnings and Flood Alerts should be issued to communities at risk of flooding. **Figure 3** shows the river flows and levels recorded at Southwaite Bridge during the 5th December 2015 flooding event.

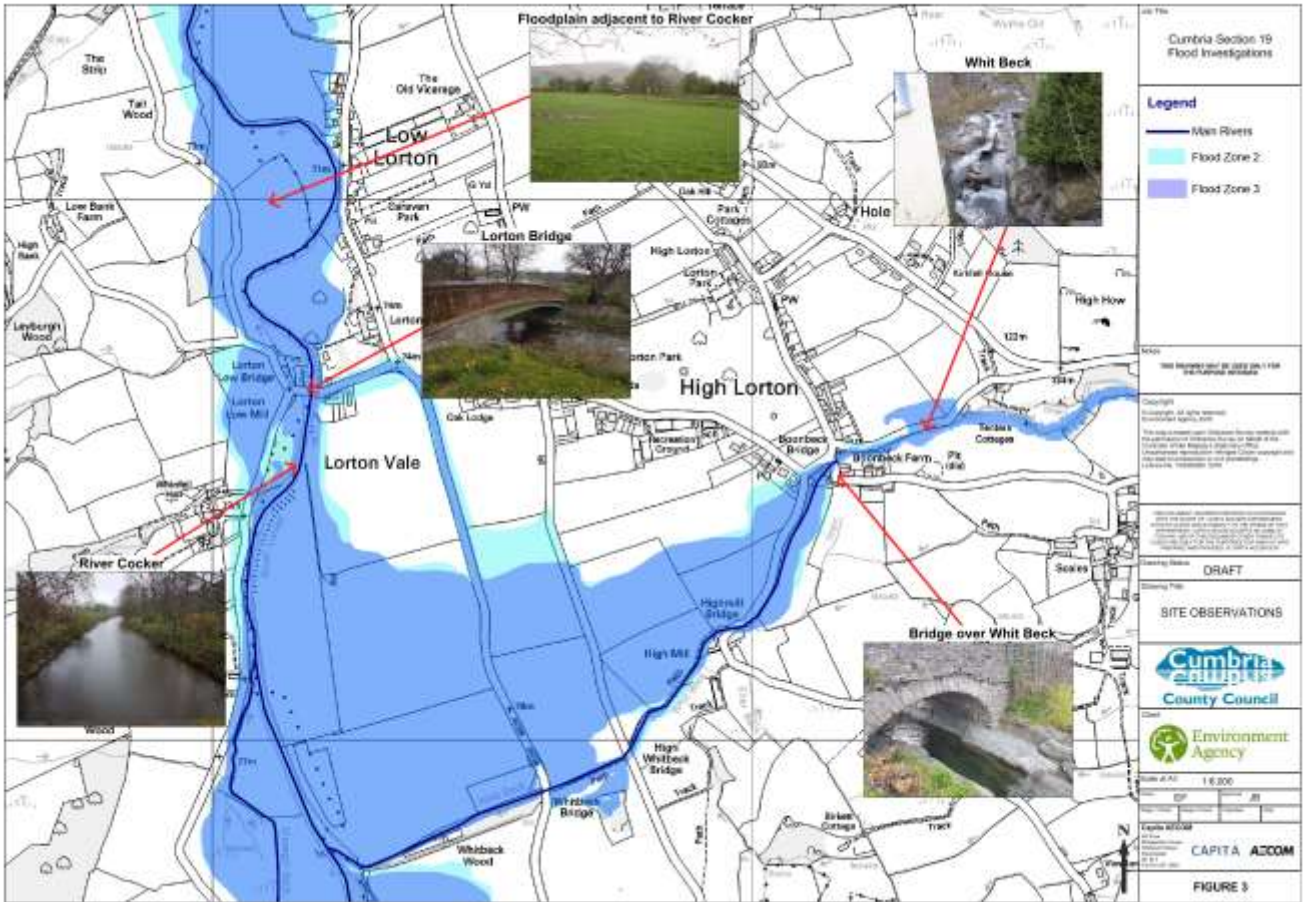
Figure 6 Key Observations

An initial post-event site visit was undertaken on the 9th December 2015 by Environment Agency staff. A secondary site visit was undertaken on the 28th April 2016 by the Capita AECOM survey team. Key features, observations and photographs from the site visit are presented in **Figure 6**.

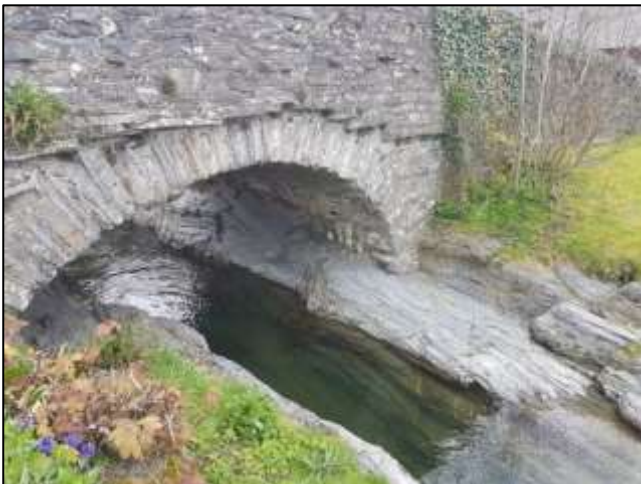
Photograph 11: Bridge over the Whit Beck in High Lorton

The survey team initiated the site visit of High Lorton with a visual inspection for signs of property damage and other evidence of flooding. The majority of the village showed no visible signs of damage from fluvial flooding, although a number of sandbags were present outside residential properties on the main road through the village. The bridge over the Whit Beck was observed as being in good condition (**Photograph 11**), with no visible signs of flood damage. Channel scour and some structural damage was observed outside the properties upstream of the bridge over the Whit Beck (**Photograph 12**). It is anticipated that this was the result of the high velocities within the river channel during the flooding on the 5th December 2015.

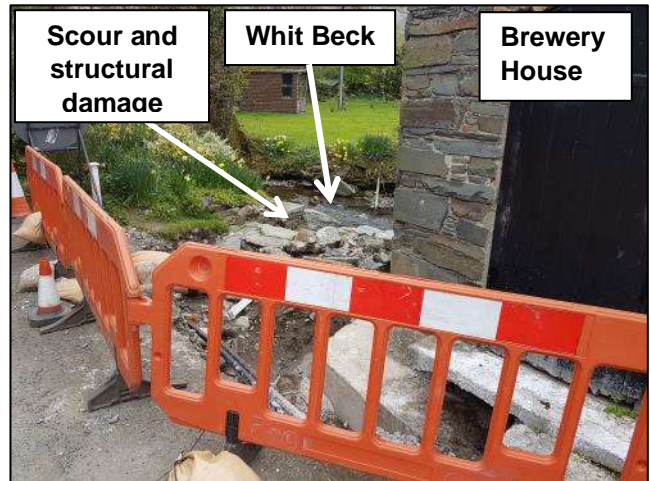
Photograph 12: Scour around properties on the westerly access road to the B5292

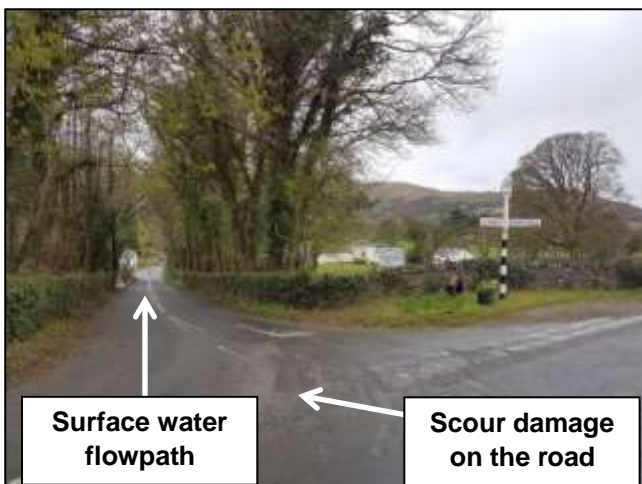
The surface of the second access road into High Lorton (located NGR NY 16083 25902) showed visible signs of flood damage and scour which was likely as a result of surface water from the steep valley sides (**Photograph 13**). The adjacent wall on the southern side of the road also showed signs of damage (**Photograph 14**) and improvised flow barriers to route surface water into the adjacent gullies were observed.

Photograph 13: Scoured tarmac leading into High Lorton from Hole Mire

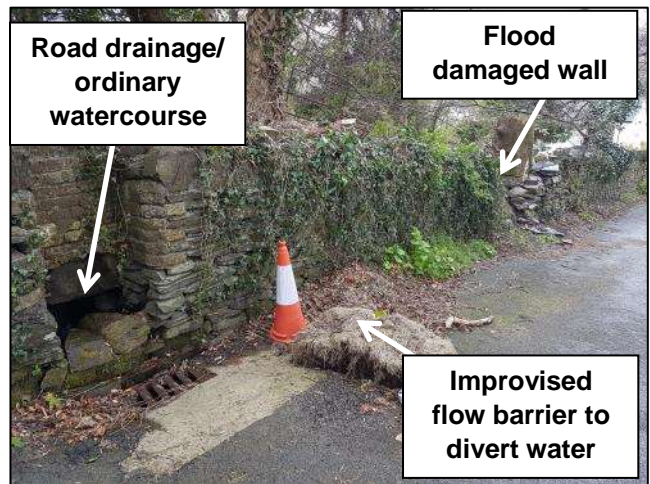
Photograph 14: Flood damaged wall and improvised surface water flow barriers

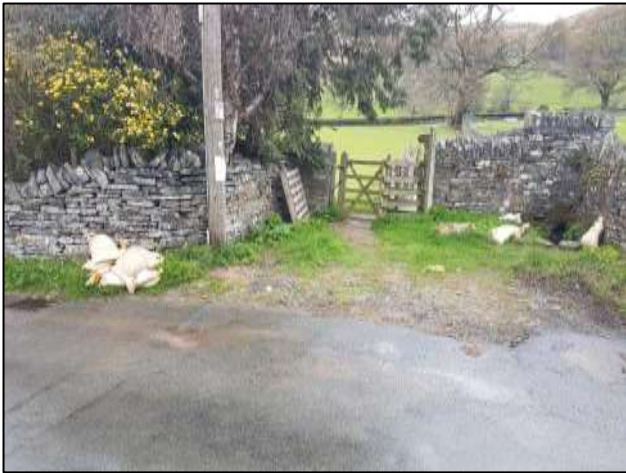
Additional sandbags and other improvised resilience measures were observed around High Lorton and appear to have been employed to route surface water from the steep valley hillsides into the highways drainage system (**Photograph 15** and **Photograph 16**).

Photograph 15: Sandbags in High Lorton

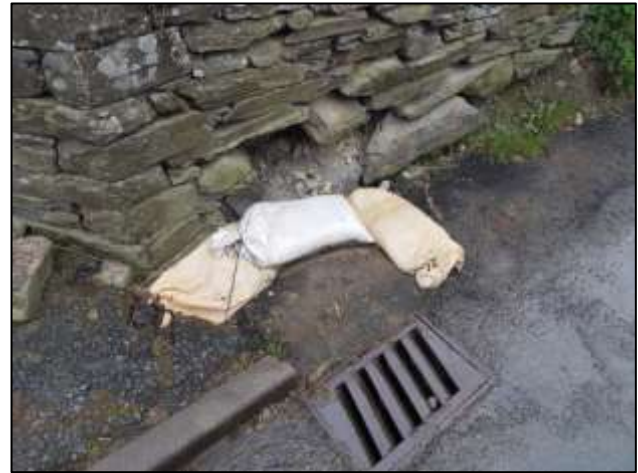
Photograph 16: Improvised surface water flow barrier

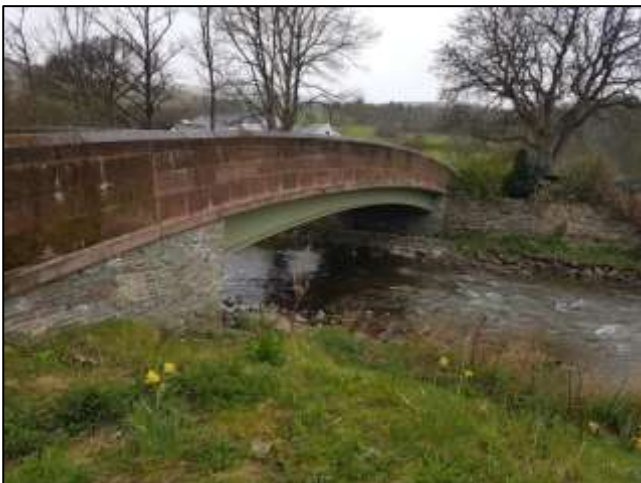
The survey team initiated the site visit at Low Lorton with a visual inspection of Lorton Bridge. Work on this structure was completed in January 2010 following the destruction of the original stone arch in the November 2009 flooding event (**Photograph 17**). The structure was in good condition, with no visible signs of flood damage. A minor amount of gravel deposition was present beneath the span of the bridge. The channel immediately downstream of the structure was free-flowing with lightly-vegetated river banks (**Photograph 18**).

Photograph 17: Looking upstream towards Lorton Bridge from the right bank of the River Cocker

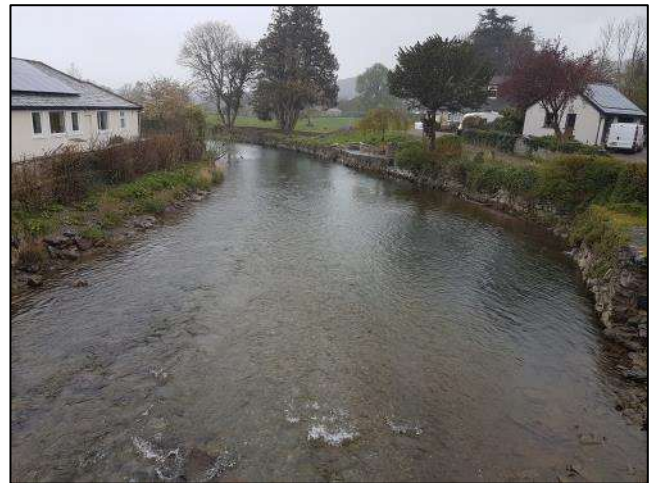
Photograph 18: Looking downstream on the River Cocker from Lorton Bridge

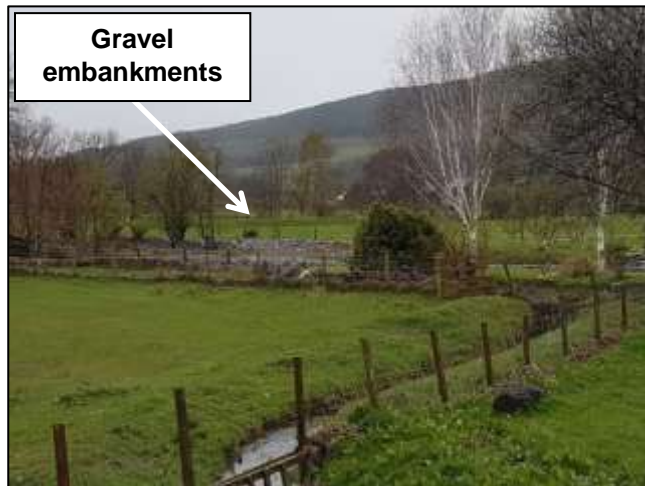
A series of stone embankments and bunds were observed further downstream of Lorton Bridge on the River Cocker (**Photograph 19**). These features are a result of historic gravel deposition and the excavation of dredged material from the River Cocker.

Photograph 19: Gravel embankments on either side of the River Cocker

In 2009 the Environment Agency undertook a hydraulic modelling study which sought to quantify the potential flood risk impacts associated with the growth of the stone bunds on either side of the River Cocker. This study concluded that the removal of the embankments may provide potential flood risk benefits around Low Lorton as these features may result in increased water levels upstream in area of Low Lorton Bridge. Whilst this was the overarching conclusion, the technical approach was strategic in scope, stated a number of modelling limitations and made a number of broad assumptions about the representation of the bunds along the River Cocker.

Given the limitations outlined above and changing morphology of the stone bunds since 2009 it is therefore recommended that additional detailed appraisal is undertaken with new topography survey of the bunds and hydraulic modelling for a range of different river flow scenarios. This study would provide a quantifiable evidence base which, if proven to increase flood risk upstream, could be used in the development of a strategic outline business case to remove the stone bunds in this area.

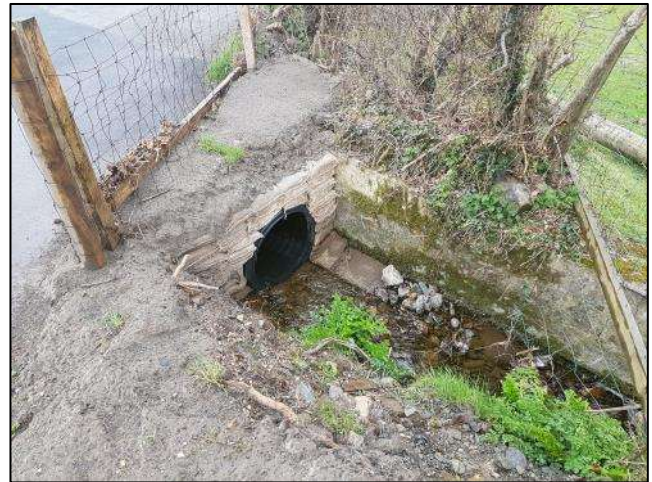
An ordinary watercourse is culverted beneath the Thackthwaite Road approximately 100m north of Lorton Bridge (**Photograph 20**). This was free-flowing and in good condition at the time of the site visit, though is understood to have become blocked and collapsed during the 5th December 2015 flood event.

Photograph 20: Culverted ordinary watercourse
