# Wigton

## S.19 Flood Investigation Report

Burnfoot, Wigton, Cumbria

## Flood Event 3<sup>rd</sup> – 5<sup>th</sup> December 2015

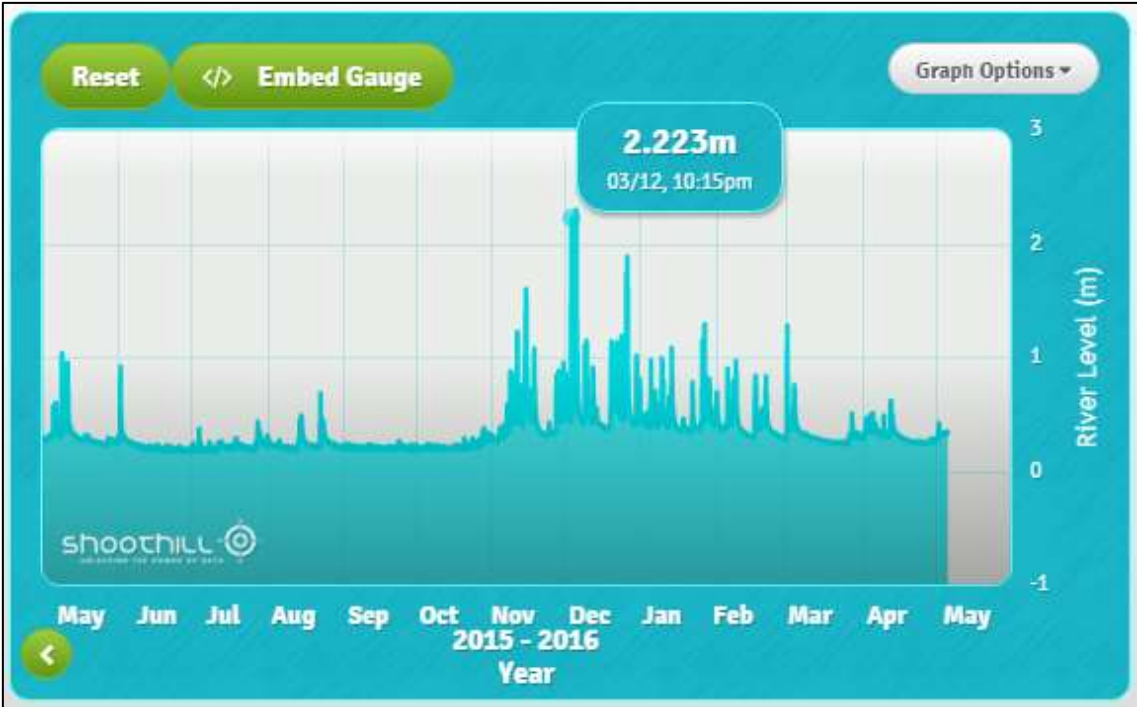
Figure 2: Recorded Levels at the Wiza Beck Storage Basin

These level gauges are used to deliver flood warning services to the community at Wigton. Both river gauges recorded levels that were more than 2m above gauge datum on the 3<sup>rd</sup> and 5<sup>th</sup> of December 2015, as shown in **Figure 2** and **Figure 3**.

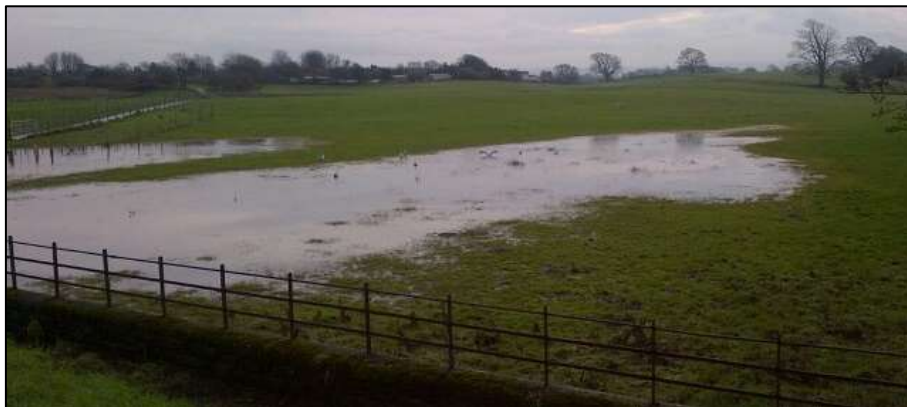
A number of the fields near the Flosch Beck and Wiza Beck were flooded during the December 2015 flooding (**Photograph 1**). This did not impact on residential property, although the playing fields and changing room facilities were affected by the flooding. The flood flows also resulted in bank erosion, scour and damage to a kissing gate near the sports pitches (**Photograph 2**).

Photograph 1: Flooding from the Flosch Beck (15<sup>th</sup> December 2015)

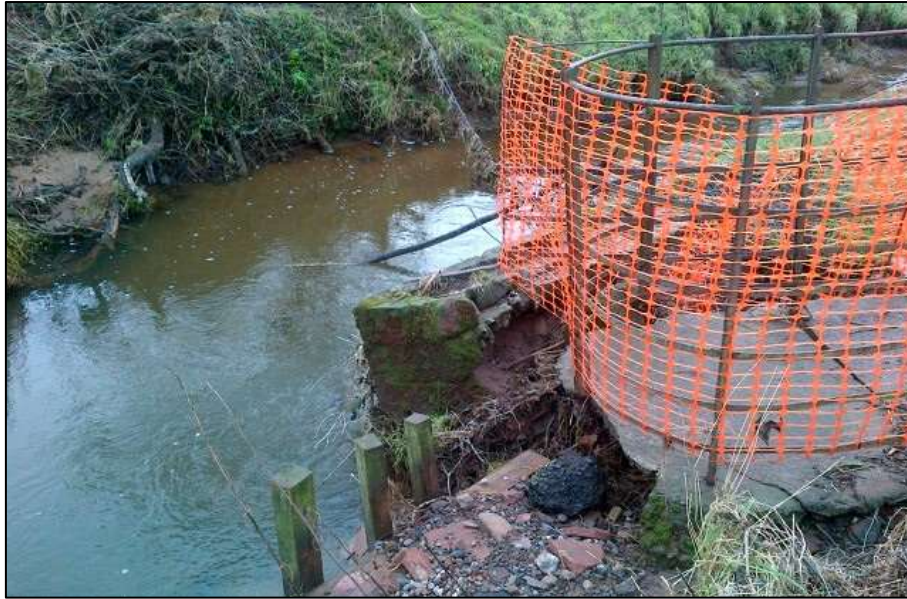
**Photograph 2: Bank damage near the Sports Pitches (15<sup>th</sup> December 2015)**

The Wiza Beck is a main river that flows south to north along the sports pitches south of the B5032. Significant gravel deposition was observed in the watercourse upstream of the B5032. Bank erosion on the Wiza Beck near the sports field had resulted in a kissing gate collapsing into the watercourse.

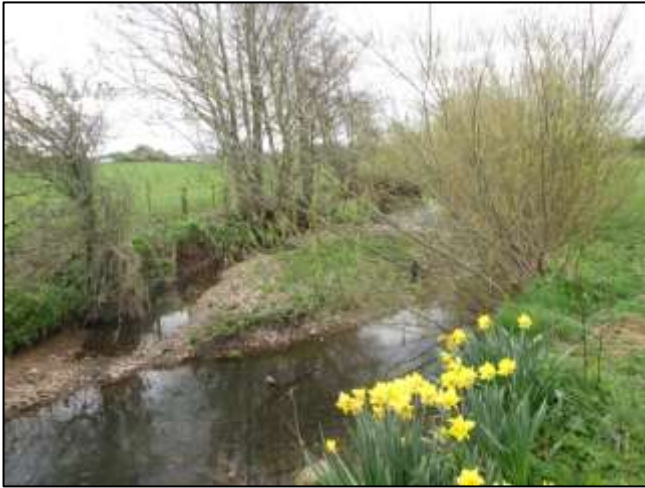
**Photograph 3: Wiza Beck, Looking Upstream**

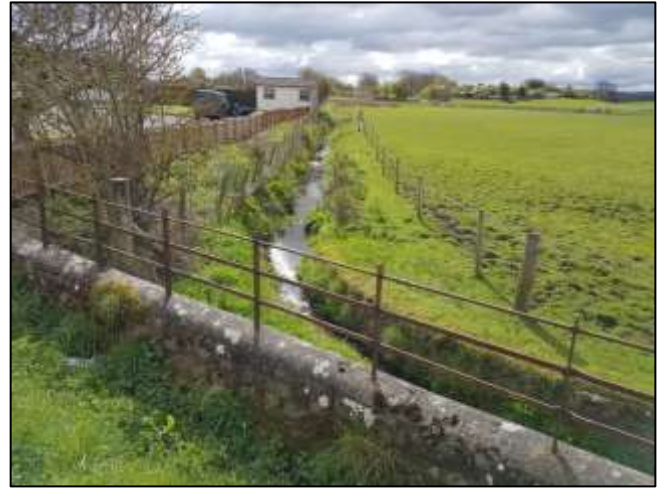
**Photograph 4: Flosch Beck, Looking Upstream**

The Flosh Beck is a main river that flows east to west alongside the Wigton Bowling Club (**Photograph 4**). This watercourse forms a tributary of the Wiza Beck (**Photograph 3**) via a large box culvert beneath the B5032. The confluence is throttled at the downstream end by a circular conduit that discharges into the Wiza Beck at the 90 degree bend at the entrance to the Innovia Films Factory.

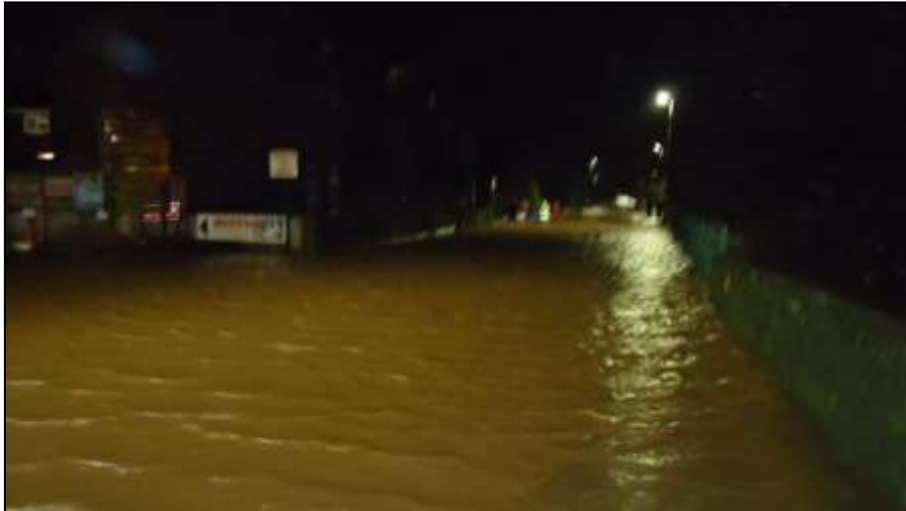
The Station Road area is occupied by one of the main roads through Wigton, local businesses and homes including a residential static caravan park. Station Road was flooded from Wiza Beck on the 3<sup>rd</sup> December 2015 (**Photograph 5**).

**Photograph 5: Flooding on Station Road (3<sup>rd</sup> Dec 2015)**

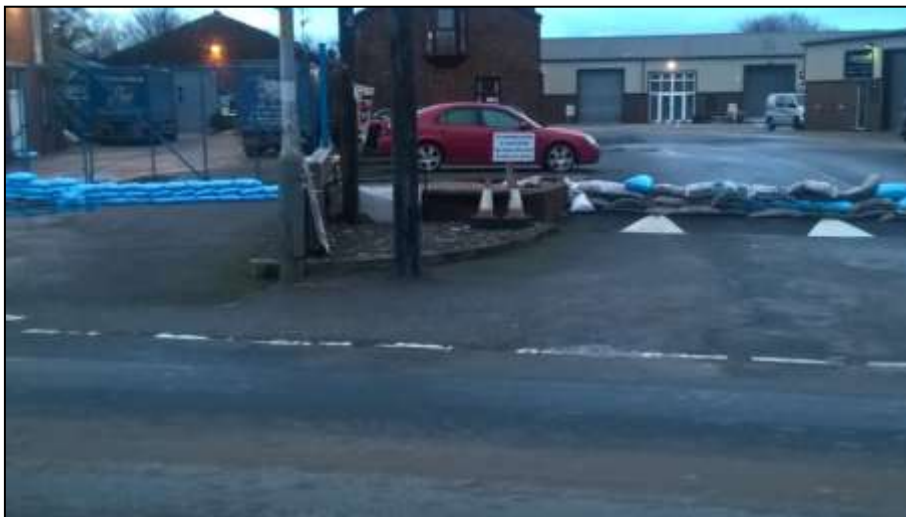
The Station Road Business Park was protected by sandbags and bags of salt (stock) provided by a local business which diverted the water (**Photograph 6**). The area was also helped by the Fire & Rescue Service pumping water away from property. The Post Office was flooded during the December 2015 event and also on two other previous occasions.

**Photograph 6: Temporary Sandbags and bags of salt on Station Road (7<sup>th</sup> Dec 2015)**

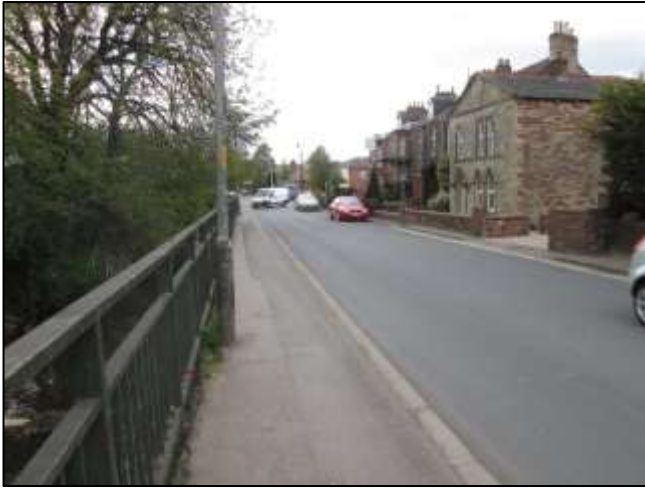
The Wiza Beck passes west to east beneath Station Road via a brick arch conduit (**Photograph 7**). The watercourse continues in an easterly direction before later passing beneath the A596. The Black Beck discharges into the Wiza Beck via a pair of large concrete conduits immediately upstream of the Station Road Bridge. An Environment Agency level gauge is located on the Wiza Beck and there is Environment Agency telemetry at this location.

**Photograph 7: Wiza Beck and Station Road**

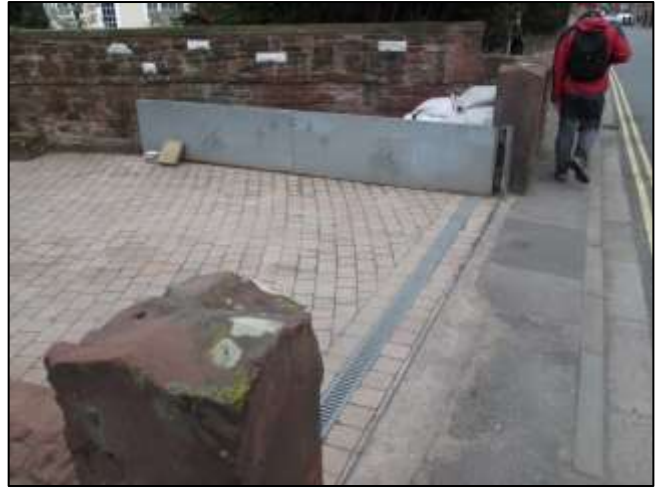
Property-level resilience measures (i.e. flood gates and doors) were observed at multiple properties on Station Road and evidence of post-flood refurbishment works was observed. Sandbags were present at the entrance to the small business trading estate on Station Road.

**Photograph 8: Flood Gates on Station Road**

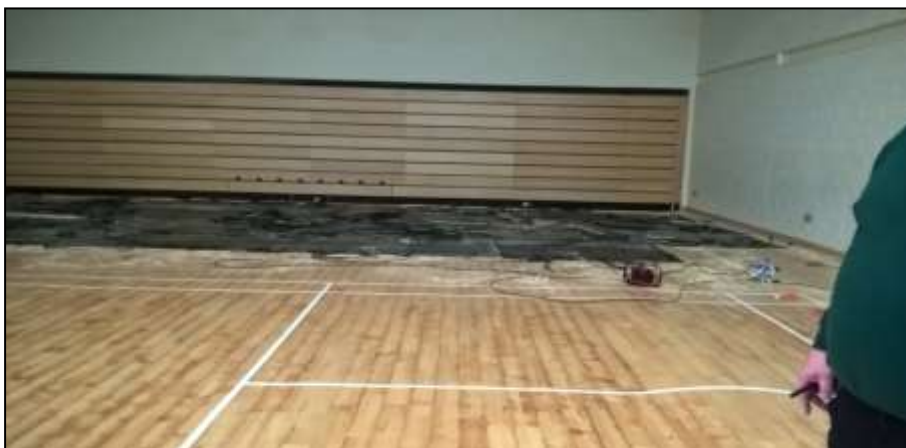
The Nelson Thomlinson Secondary School was also affected during the event. The boiler room and the sports hall were flooded resulting in extensive damages (**Photograph 9**). Consequently the school was closed for the day and the sports hall was closed until further repairs and refurbishment could be undertaken. Flooding is likely to have resulted from surface water sources rather than floodwater from Speet Gill or the Floss Beck.

Photograph 9: Nelson Thomlinson School – Sports Hall Flood Damage

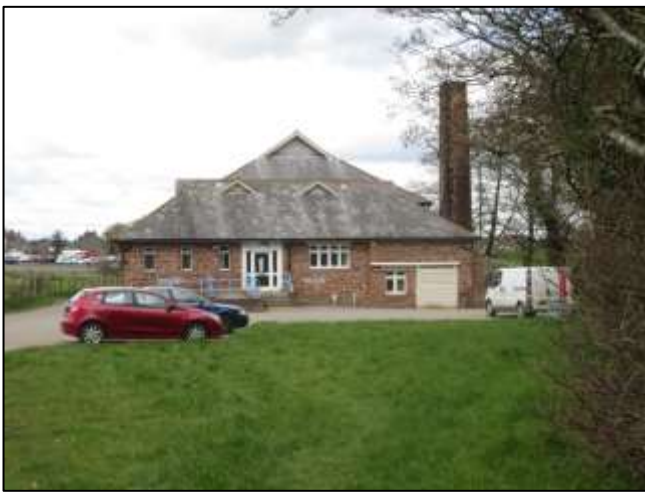
The Wigton Swimming Baths (**Photograph 10**) were observed to be closed and a number of sandbags were observed as partially covering the airbricks and access points to the basement.

**Photograph 10: Wigton Swimming Baths**

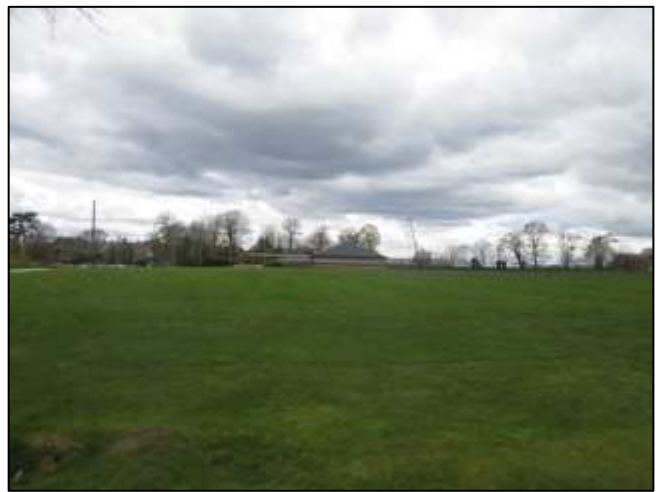
The Nelson Thomlinson School is, for the most part, located at the crest of a hill between Lowmoor Road and the Speet Gill. The gradient of the site slopes away from the main facility towards its south-west corner where the Sports Hall is located (**Photograph 11**).

**Photograph 11: Nelson Thomlinson School**

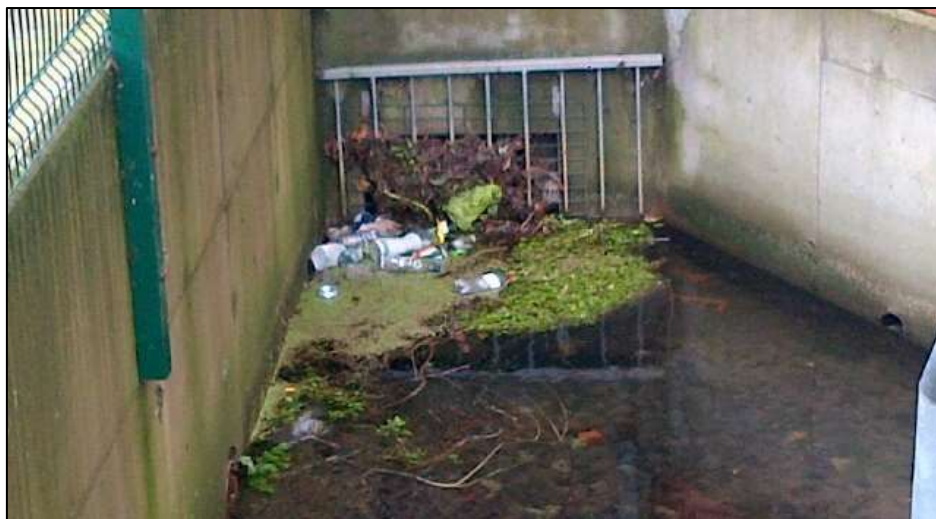
On the east side of Wigton, the ATS Garage and 9 residential properties were affected by flooding from the Speet Gill and an unnamed ordinary watercourse due to a blocked trash screen on a non-main river and severe volumes of flow (**Photograph 12**). This resulted in flooding of the public highway (**Photograph 13**) and ingress to residential properties via air-bricks and other similar openings to property basements. Although water reached Lidl, no ingress occurred.

Photograph 12: Trash Screen on the Tributary Next to Lidl

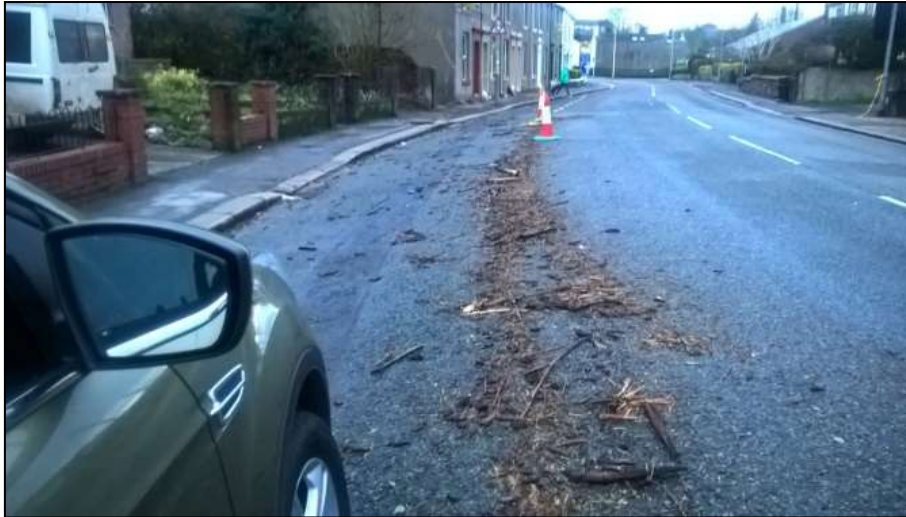
**Photograph 13: Wrack Marks on Burnfoot (7<sup>th</sup> Dec 2015)**

Evidence of historic flooding was observed around the residential properties on the right bank of the Speet Gill (i.e. silt wrack marks and mortar loss). It was observed that residents had previously attempted to prevent water from entering into basements by covering airbricks and other access points into the property.

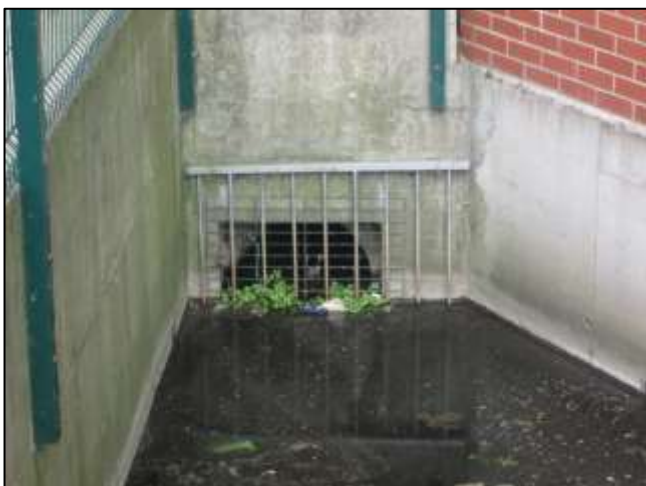
The unnamed ordinary watercourse is culverted beneath Burnfoot and discharges into the Speet Gill via a circular culvert that is covered by a basic trash screen (of a non-standard Environment Agency design as shown in **Photograph 14**). This design results in difficulty removing debris build up and consequently may lead to a backwater effect from the culvert inlet.

**Photograph 14: Lidl Trash Screen****Photograph 15: Burnfoot Bridge****Summary of observations**

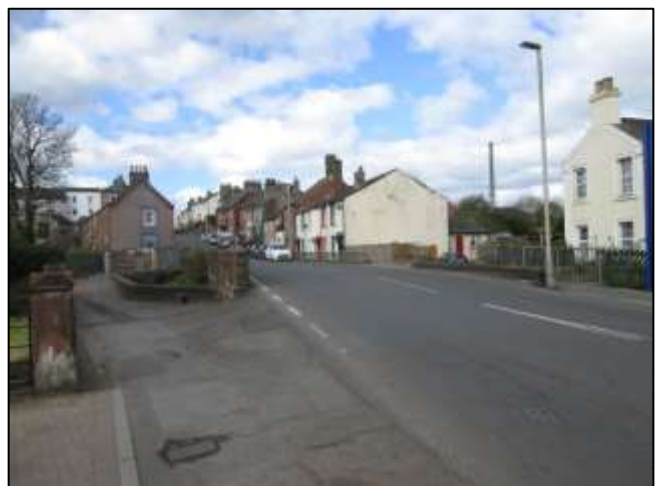
The Speet Gill is bounded on the right bank by a small dwarf wall that may act as a defence but is not considered a formal Environment Agency asset. The Speet Gill passes beneath Burnfoot via a brick arch conduit with a low invert level. This capacity issue may constrain flow conveyance during times of flood and result in a local backwater effect from the structure.

- High water levels in the Speet Gill overtopping the de facto defences on the right bank of the watercourse due to capacity issues beneath the Burnfoot road bridge (**Photograph 15**). This would have subsequently resulted in residential property flooding and inundation of basements via unprotected airbrick covers and other openings.

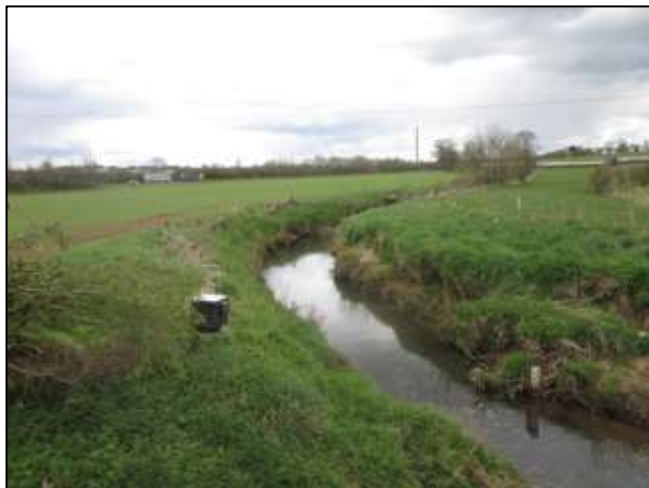
Spittal Farm is located immediately north of the A596. Spittal Farm has been developed into private accommodation, providing approximately 10 homes. The Farm is bounded on its western side by a drainage ditch from the A596 that subsequently discharges into the Wiza Beck (**Photograph 16** and **17**).

**Photograph 16: Wiza Beck near Spittal Farm**

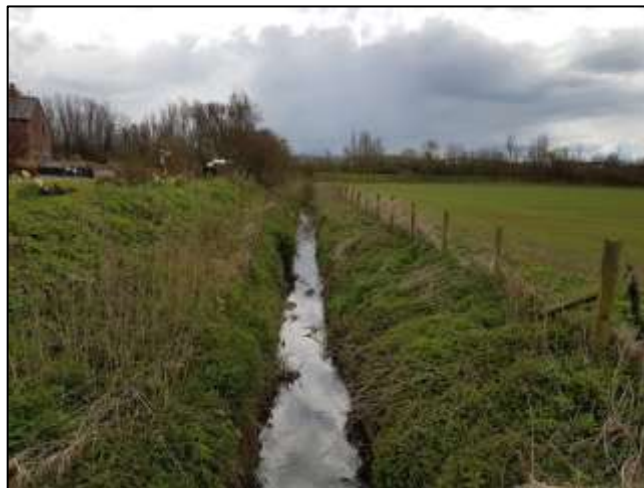
The drainage ditch adjacent to Spittal Farm discharges into the Wiza Beck via a short culverted section. An Environment Agency level gauge with data logger is located immediately upstream of the confluence of the Wiza Beck with the drainage ditch.

**Photograph 17: Spittal Farm Drainage Channel**
