# Workington including Barepot

## Flood Investigation Report

## Flood Event 5-7<sup>th</sup> December 2015

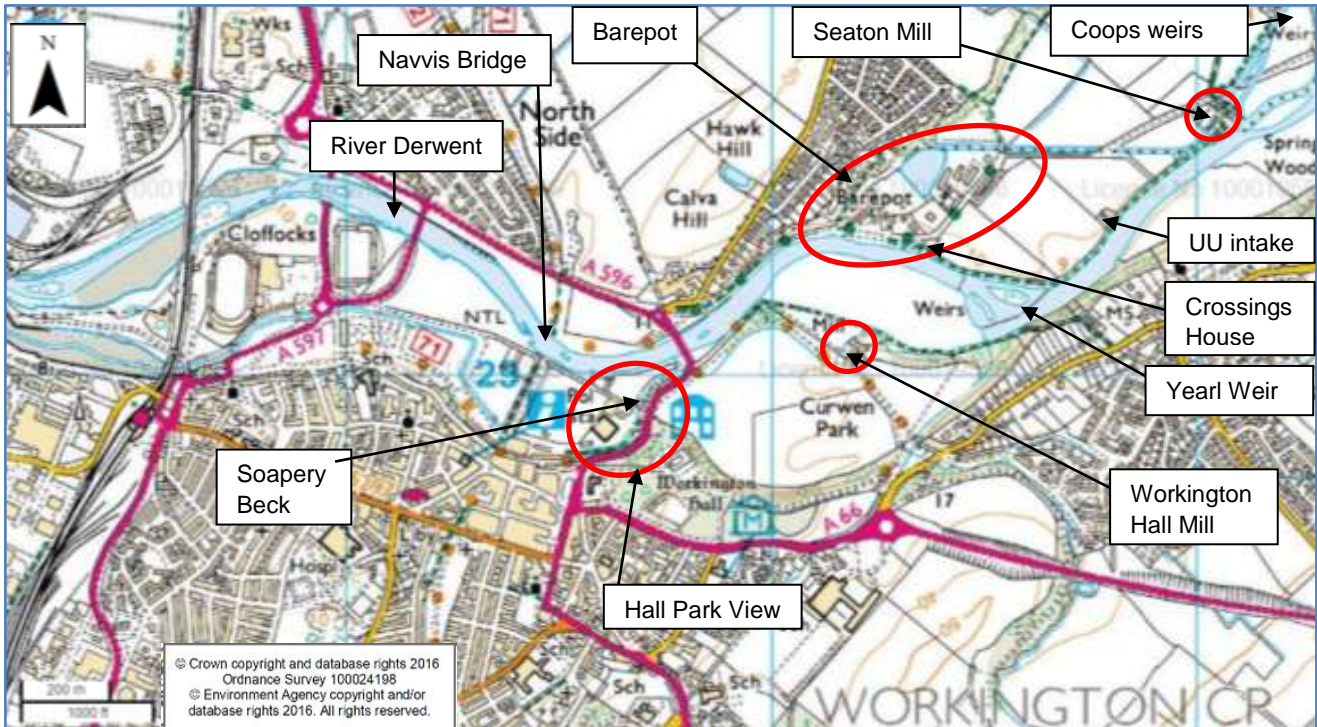
Figure 2- Identification of Areas Flooded (and key features)

For this report, the flooded area has been divided into 5 sub-areas for investigation. These are based on flood flow routes. These sub-areas are shown in Figure 2:

- **Hall Park View** – The area on the left bank of the River Derwent and road to Workington Bridge.
- **Cricket Ground & Cumbria Constabulary** – The area around Soapary Beck flow route.
- **Workington Hall Mill** – The area on the left bank of the River Derwent downstream of the Yearl.
- **Barepot** – The right bank of the River Derwent upstream of Workington Bridge.
- **Seaton Mill** – Upstream of Barepot, downstream of the Coops Weirs.

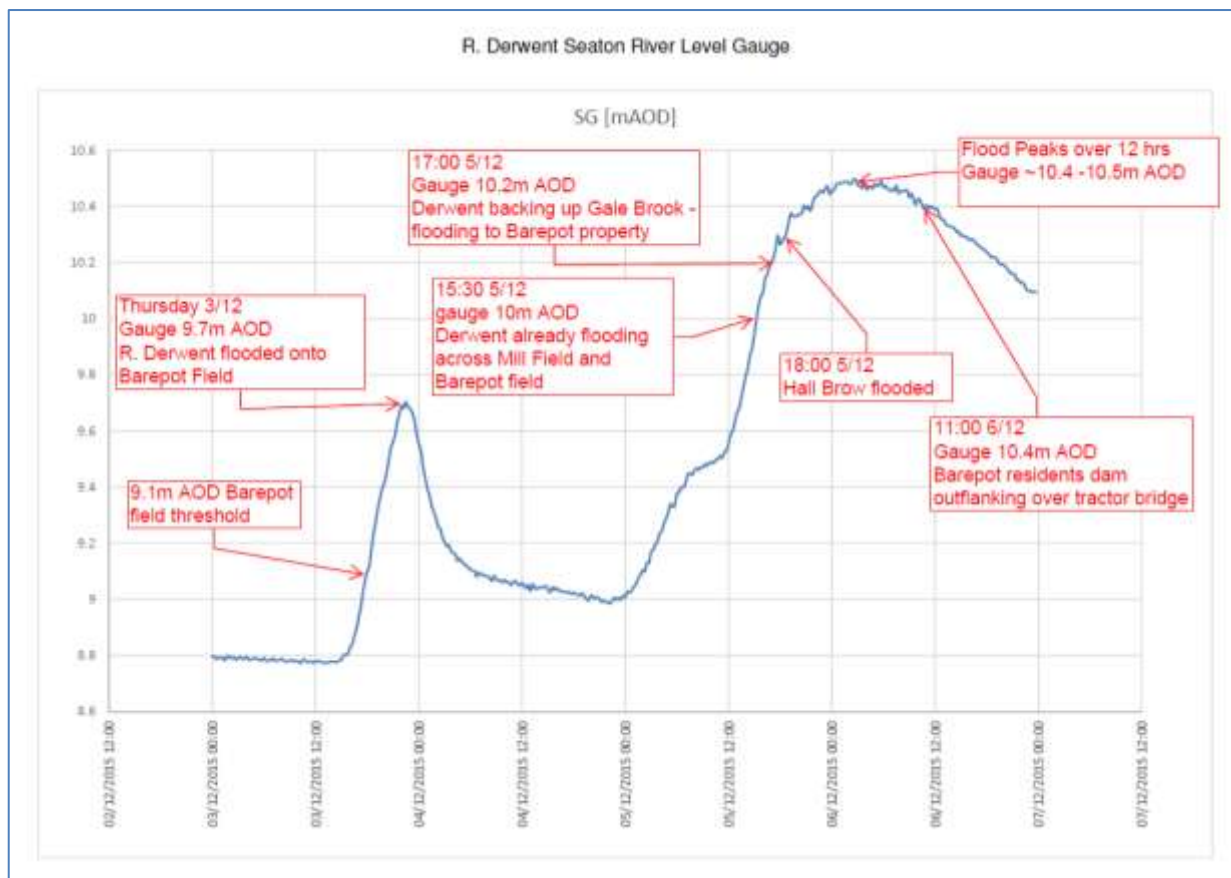
Figure 6- Seaton Mill River gauge 3-7<sup>th</sup> December 2015

NB Camerton gauge was destroyed during the 2009 flooding, Seaton Mill is the replacement.

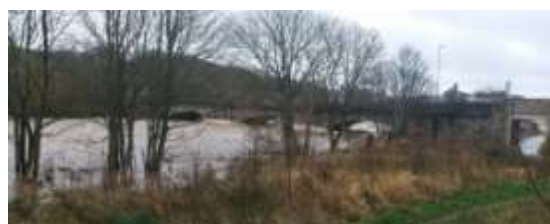
Figure 12- Workington Bridge during the flooding

During the 2009 flood event, erosion under Workington Bridge (Calva Bridge) almost caused the bridge to collapse. Extensive works were carried out to rebuild the bridge pier rather than demolish the historic bridge. Without modelling, the influence of the bridge on flood levels is difficult to determine as Hall Park View threshold levels are below the level of the bridge arches. On this occasion (see figure 12), the bridge still had capacity whilst at the same time flood waters were flowing through Hall Park View.

Flood flows returning to the river have caused substantial erosion to the river bank both upstream and downstream of Workington Bridge. Downstream of the bridge, on the left bank between the allotments and the river, a strip of land is owned by Iggesund for access to their pumping station intake. Upstream of the bridge, the land is owned by Allerdale Borough Council with the road access to Mill Field and Workington Hall Mill on the edge of the riverbank.

Environment Agency	Complete repairs to flood defence assets that were damaged during the floods as part of the c.£10m Asset Recovery Programme which covers Cumbria and Lancashire.	Winter 2016/17
	Environment Agency / Allerdale Borough Council / Iggesund	Investigate low flow and flood flow mechanisms/problems of mill race/ Soapery Beck at old Intake, under Hall Brow and through allotments.	2016/17
	Environment Agency	Carry out a Flood Risk Assessment /Review Study (see table 6) for Hall Park View area and Barepot including partnership funding scoring and AEP.	2016/17
	Residents	Review effectiveness and improve flood resilience/ resistance measures for properties to reduce impacts of future flooding.	
	United Utilities	Carry out work to prevent flows from eroding around the Yearl – consider permanent access track from Pumping station.	TBC
	Landowners	Review issues caused by river bank erosion up and downstream of Workington Bridge	2016

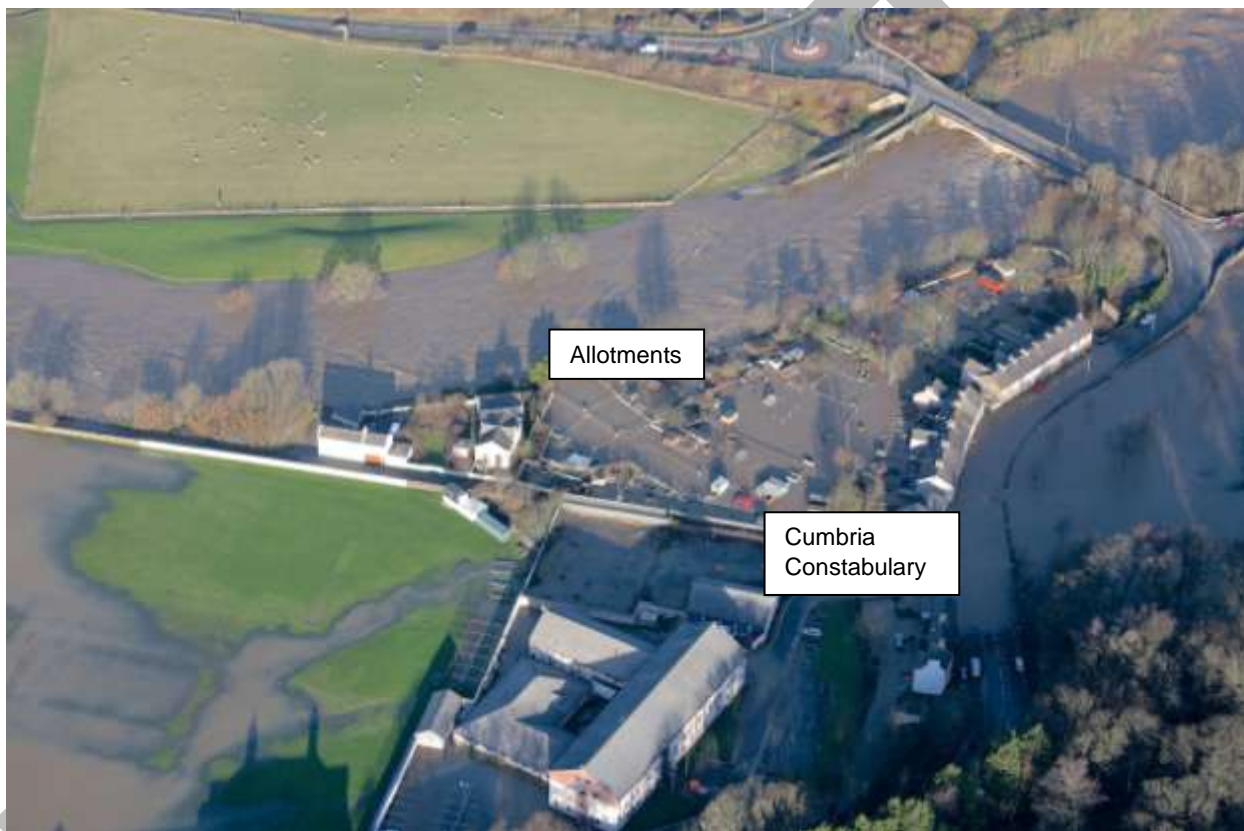
**Figure 13- Aerial Photo Hall Park View**

Property numbers 1-5 Hall Brow, are built into the hillside with their basements at ground level at the rear, and first floor at ground level at the front. In these properties the basements flooded from Soapery Beck at the rear. Additionally, property numbers 1 & 2 were reported to have flooded prior to the main flooding event, on the night of the 3<sup>rd</sup>/4<sup>th</sup> December due to the intense rainfall impacting surface water drains.

The wrack mark surveyed post December 2015 at Hall Park View was 7m AOD.

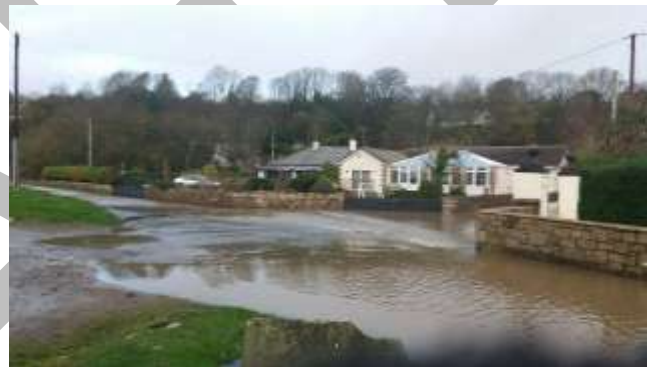
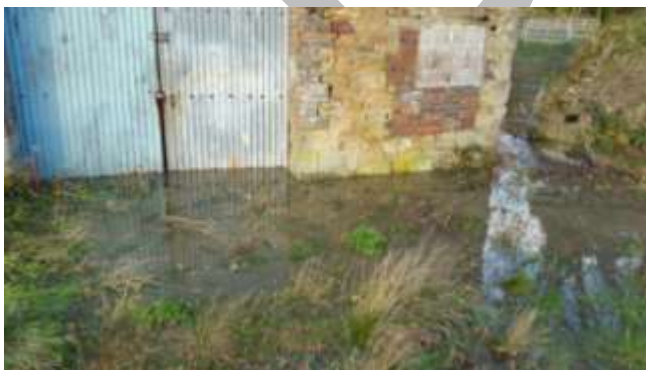
- The flow across the fields to the North of Barepot entered the reservoir and mill race. The work to deculvert, carried out below Barepot Reservoir in 2014, contained the majority of this flow although some flow overtopped, again adding to the flooding impact in Barepot, see Figures 19 and 20. Flood waters also leaked through the reservoir wall. See Figure 21

**Figure 19 Flooding outside Bryn Tiron**

**Figure 20 Overland flow from Barepot Reservoir**

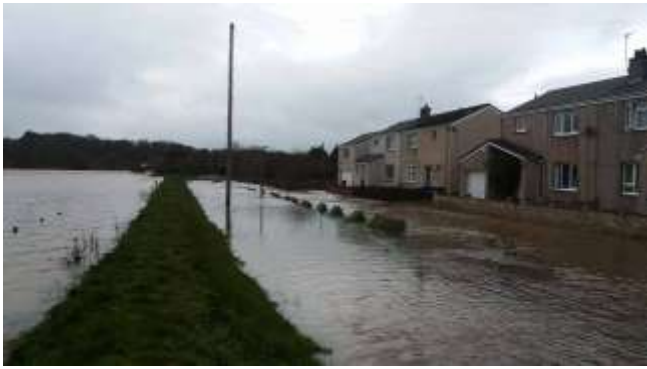
Figure 22 Meadow View and Flood Bank

- The overland flows from the fields also crossed over the mill race at the tractor crossing, see Figure 22, and flowed down the road past Glenfield Terrace. The quick actions of residents constructing a bund across the tractor crossing prevented more serious flooding.

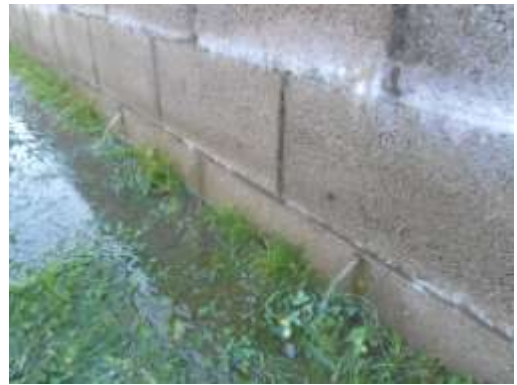
Figure 23 Wall to rear of Glenfield Place

During the 2009 flood event, the raised riverside track in Barepot that ran along the bank top of the River Derwent was destroyed. This ran from the United Utilities intake above the Yearl to Crossings House, offering protection from floodwater (see Figure 2). The destruction of this track, in conjunction with the passage of flows back into the river near Crossings House, reopened the floodplain East of Barepot. The protection offered by the raised track was replaced by a length of embankment in 2010, constructed opposite the Meadow View properties. This embankment was tied into a sandstone wall to the rear of Glenfield place. The wall was reinforced with a blockwork skin to the rear.
