# Upper Borrowdale Valley

Section 19 Flood Investigation Report

Flood Event 30 September 2022

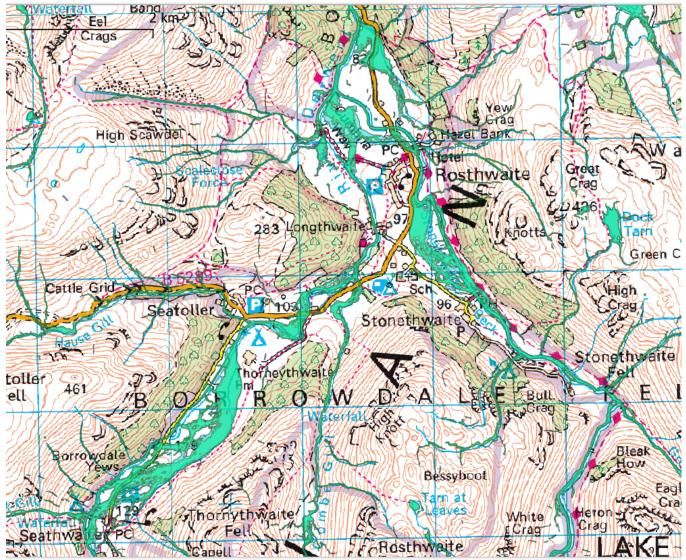
Figure 1: Location Plan & Approximate Flood Outline

The flood outline below is based on the 1:30yr Surface Water Flood Risk map from modelling.

Speaking with local residents who witnessed the flooding, the theoretical risk area, closely resembles the extent of the actual flood. The flood outline is, however, an approximation and a snapshot in time. Since every flood event is different and the depth, flow and extent vary throughout the event, it is not possible to show an exact or definitive outline.

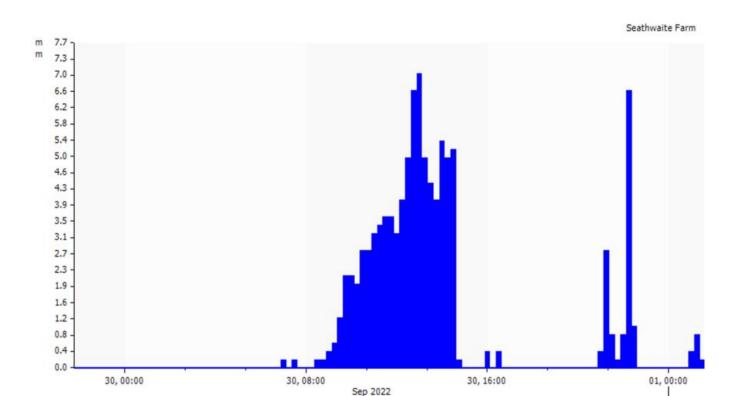
**Table 1:**Rainfall Histogram (Seathwaite Farm) showing that the storm lasted from 9am – 3pm (6 hours)

The Environment Agency has produced the table below which shows the rainfall amount at Seathwaite Farm (a significant catchment and one of the main contributors to the flood water in the valley) over the duration of the storm on 30<sup>th</sup> September 2022 alongside the equivalent data for Storm Desmond on the 4<sup>th</sup> & 5<sup>th</sup> Dec 2015.

As can be seen from the 6 hr cumulative totals, there was more rain over this period in Sept 2022 compared to Storm Desmond. Storm Desmond however, continued for two days solidly and resulted in a much higher average 24hr flow.

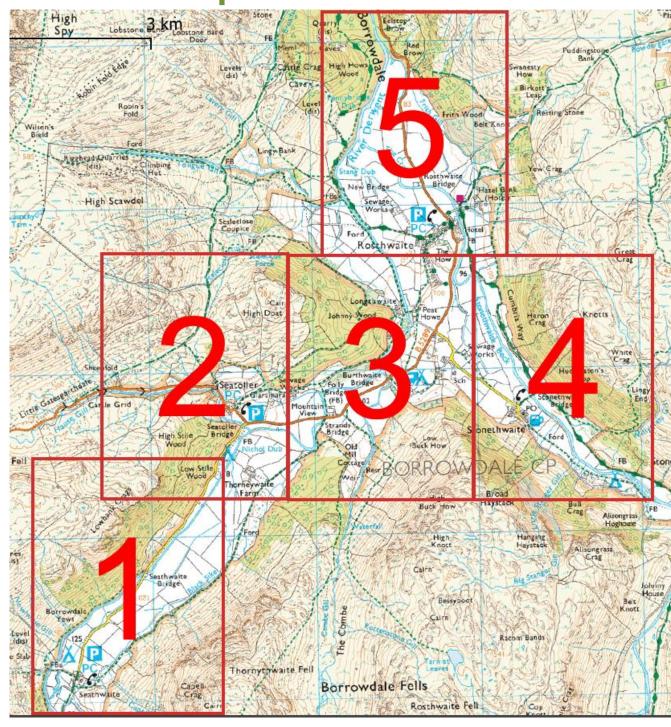
Flood Map Detail Area 1 - Seathwaite

Key: **G**ully **Ordinary Watercourse** Main River 0 100 m 13/01/2028 11:29 1.2 wall on roadside collapsing Seathwaite Right-hand side of river bank eroded and water surcharges over bank across fields as shown and onto the valley road causing flooding Borrowdale Capell

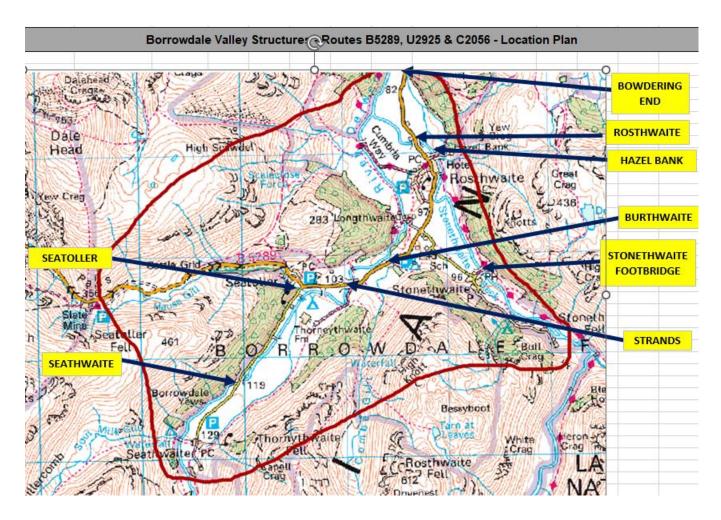
- All County bridges are inspected every two years and remedial measures programmes where necessary. Underwater surveys when necessary.
- All bridges on the valley roads (shown above) have been assessed to take full C&U Traffic Loading (in excess of quarry wagons)

- Local repair and maintenance works recently completed or programmed:
  - Hazel Bank Bridge Works completed 19/06/23. Grout bags, masonry and Rockbond used to repair undermining to East apron. Local repair.

- Strands Bridge Due to start 03/07/23. Expected to finish 04/07/23. Sapling removal from the southeast retaining wall (upstream). Grout bags, masonry and Rockbond used to reinstate wall. Local repair.

- Bowdering End Bridge Replace missing masonry in abutment. Remove tree roots and possibly some trees. General repointing and vegetation removal. Local repairs.

- o **Grange Bridge** Apron repairs. No repairs currently planned.

None of the above works would alter flow routes or affect flood risk upstream or downstream.

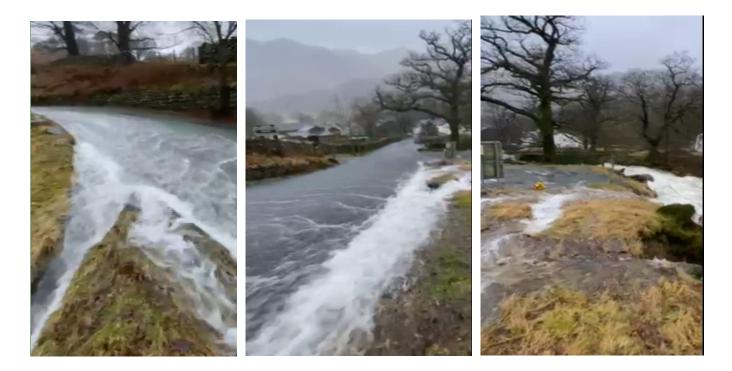
Bottom of Honister Pass, just north of Seatoller village. These photos show that during intense rainfall events, the road acts as a conduit / flow route for the excess run-off from the fellsides. The existing highway drainage infrastructure is not coping with this scale of deluge.

- 1. Drainage improvements at the bottom of Honister pass just upstream of Seatoller. Improvements / maintenance recommendations:
  - Cleaning gullies and drains under road out falling into Hause Gill.
  - Modifying roadside dished channel to direct more water into roadside streams.
  - Cutting 'grips' into the southern verge to allow more water to flow from road into Hause Gill

These minor interventions and better maintenance will ensure that flood exceedance water from the fellsides will be more likely to be routed to the river than using the road as a flow route and thus will reduce the volume of water entering the village on the road which increase flood risk to the properties. It will also reduce the likelihood of damage to the road itself and gravel and silt blocking of gullies.

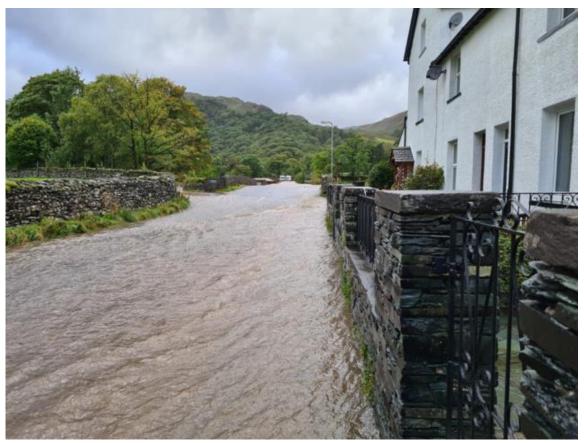
Downstream of Strands Bridge at Mountain View Cottages showing flood water at property thresholds

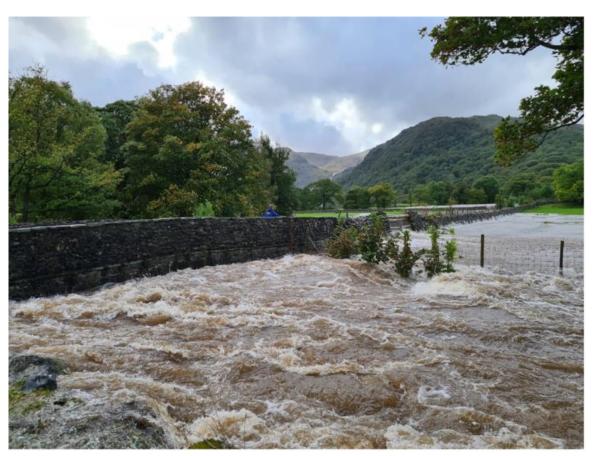
Downstream of Strands Bridge at Mountain View Cottages looking up the valley road with 'heck' in wall on the right-hand side of the road

Investigate the possible removal of a section of field boundary wall on the northern side of the road upstream of Mountain View cottages and replace with a longer heck or railing type fence. This will allow flood exceedance water to flow across fields not down the road which endangers Mountain View Cottages and increases flood water level in the field adjacent to the river.

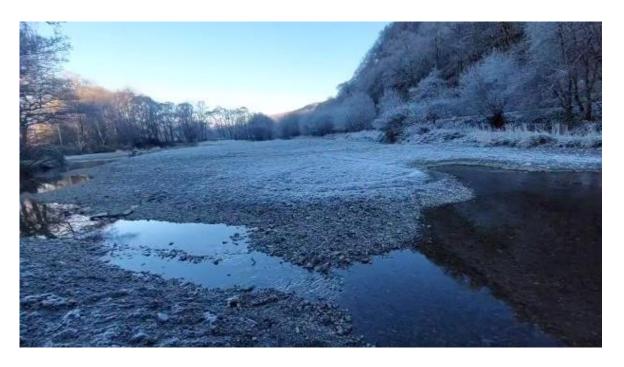
**Downstream of Grange Bridge showing gravel bar looking towards Derwentwater**

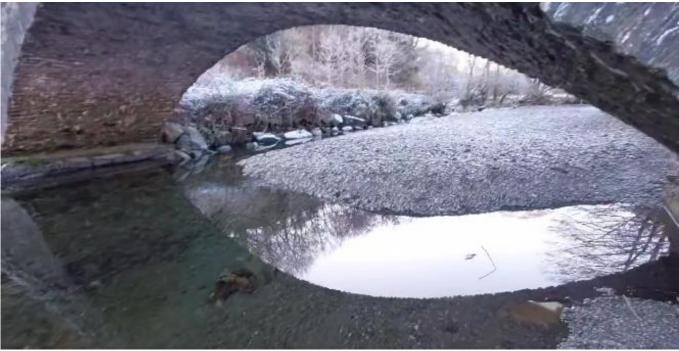
**Under Grange Bridge showing gravel deposits**

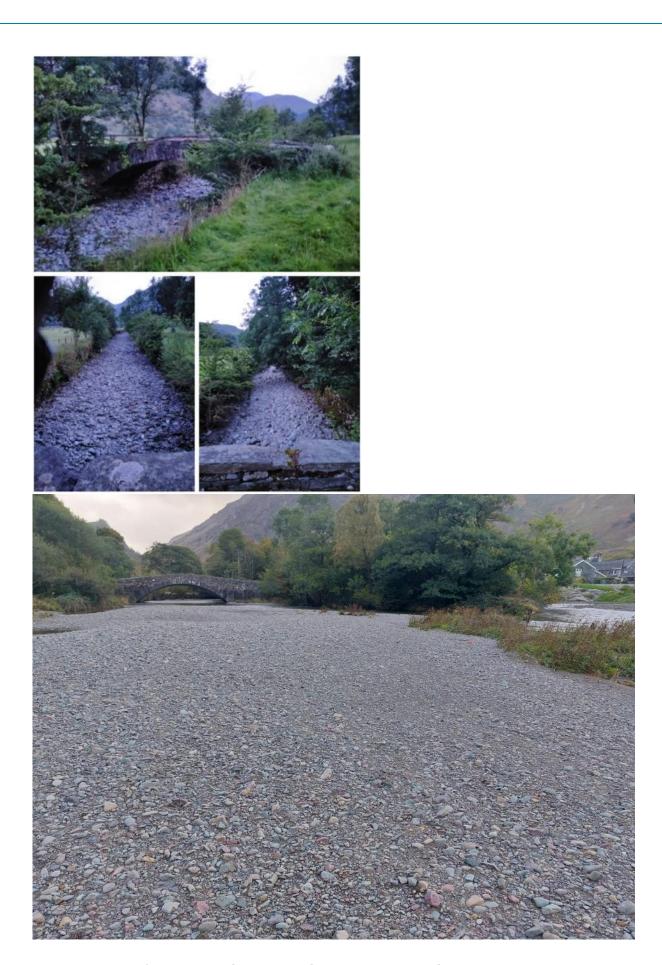
**Downstream of Grange Bridge showing gravel deposits**

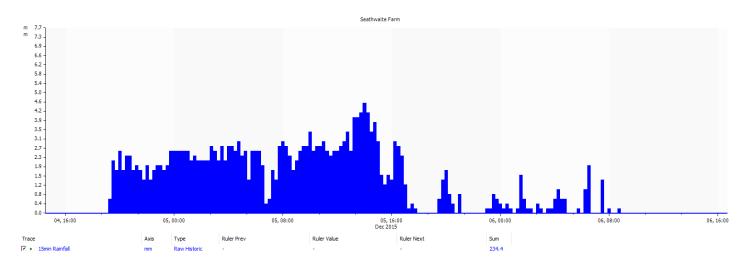
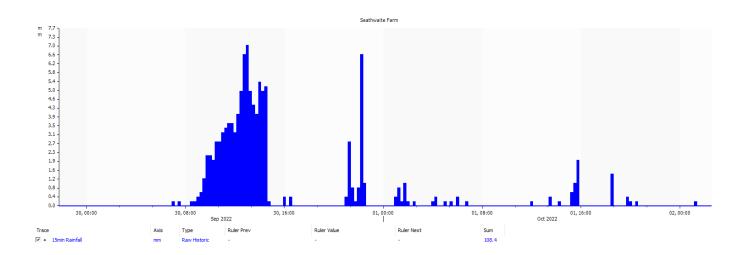
# Storm Desmond Dec 2015 & 30 Sep 2022 Event Borrowdale Rainfall Gauge Trace @ Seathwaite Farm

Note: The peak rainfall intensity on 30.09.22 of 7mm/hr was higher than during Storm Desmond

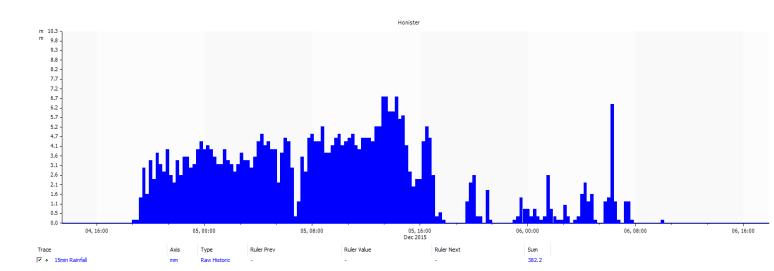
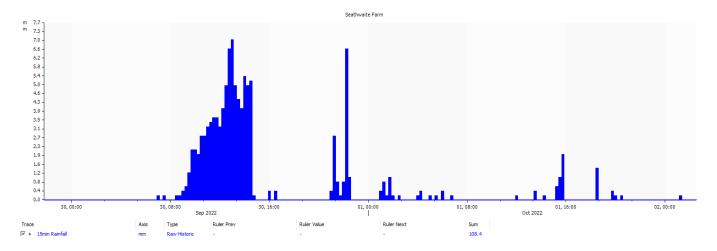
# Storm Desmond Dec 2015 & 30 Sept 2022 Event Borrowdale Rainfall Gauge Trace @ Honister Pass

Note: The peak rainfall intensity on 30.09.22 of 7.3mm/hr was higher than during Storm Desmond

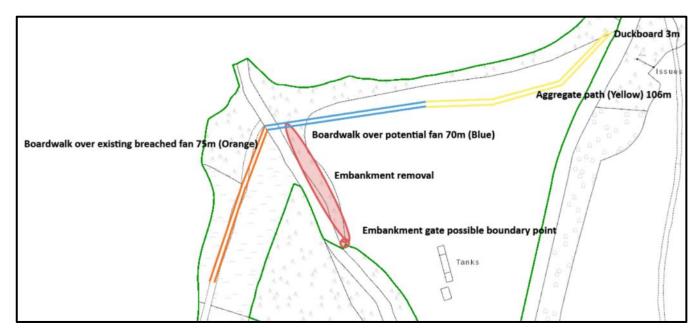
This year we will be restoring a section of Barrow Beck and improving access around Barrow Bay. Contractors will start on site in late July, conducting works to remove a section of embankment on the left bank of Barrow Beck and install a raised boardwalk around Barrow Bay.

The removal of the right-hand embankment will allow the restoration of the alluvial fan which the channel currently sits on top of. Naturally, these systems would be very dynamic, with a primary channel moving seasonally across a fanned area of gravel and pebbles, which have deposited at the bottom of a slope over time. The embankments on Barrow Beck mean the channel has become elevated above the surrounding land, impacting on land drainage, requiring bigger and bigger flood banks, and causing a significant accumulation of gravel in the mouth of the channel, where the waters energy drops when it meets the lake. This cuts off the channel from the lake in summer months. Removing the embankment will restore natural processes across this fan, allowing the deposition of sediment and dynamic movement of channels in high flow events.

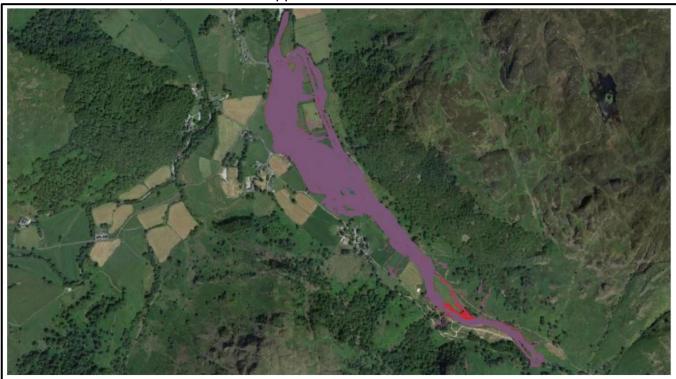
Figure 2.7 1 in 2yr flood extent change, blue = baseline, red = restored (where red is visible indicates flood extent increase, purple indicates no change and blue indicates reduction in flood extent).

This work included lowering sections of embankment to various levels to encourage water onto the floodplain at different flows. The lowering furthest upstream was the smallest, to allow the larger flows to access the floodplain, whilst the lowering furthest downstream was to floodplain level, which has encouraged a very regular flow through this area. The work also included the creation of several seepage ponds. These ponds collect water at the break of slope between fell side and valley floor, holding water in the landscape, creating valuable habitat, and providing a sustainable drinking source for stock.

There have been several floods since the works were completed and the river has responded as expected. It was anticipated that the fields on the right bank would flood more rapidly and earlier in a flood event, and this has happened in the events we have seen.

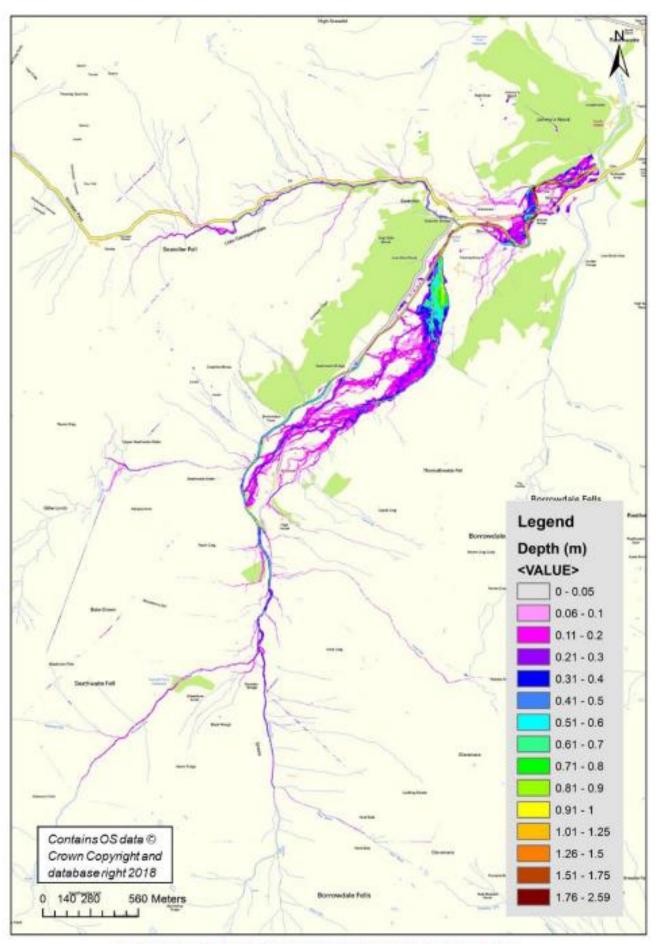
Figure 4.2 Depth output of the TUFLOW direct rainfall model.

The model data above shows how the current channel of the river Derwent does not occupy the lowest part of the floodplain; therefore, flood flows focus on the opposite side of the valley.

The modified channel, through the valley bottom, is confined to the left-hand side of the valley and is significantly embanked. Because of the significant forces on this channel there is a continuous threat of the channel breaking through these embankments, seeking the lowest part of the floodplain (this is highlighted on Flood Map Detail Area 1 – Seathwaite). The effects of this straightening and the embankments mean the riverbed has become perched above the valley, impacting drainage, and making the channel itself unsustainable in the long term, especially when climate change projections for rainfall volume and intensity are considered.

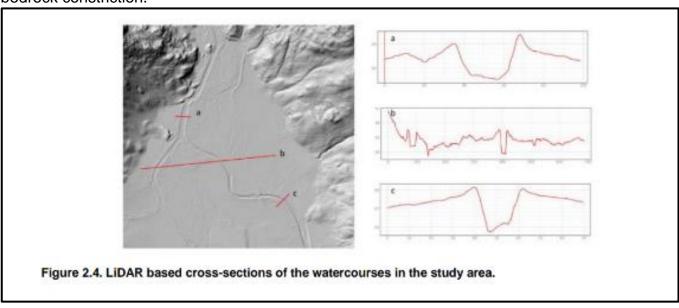
The LiDAR shows the river Derwent, through the centre of the valley, to be perched above the valley bottom, putting significant pressure on the right-hand bank, increasing the risk of failure. The embankments shown on the LiDAR, disconnect the river from the floodplain, pushing water and sediment downstream at a faster rate compared to a natural system. Because of the natural bedrock restriction downstream, this puts additional pressure on Grange, where the valley widens again, and flow energy dissipates.

The LiDAR shows the river Derwent, through the centre of the Rosthwaite valley, to be perched above the valley bottom, putting significant pressure on the right-hand bank, increasing the risk of failure. The embankments shown on the LiDAR, disconnect the river from the floodplain, pushing water and sediment downstream at a faster rate compared to a natural system. Because of the natural bedrock restriction downstream, this puts additional pressure on Grange, where the valley widens again, and flow energy dissipates.

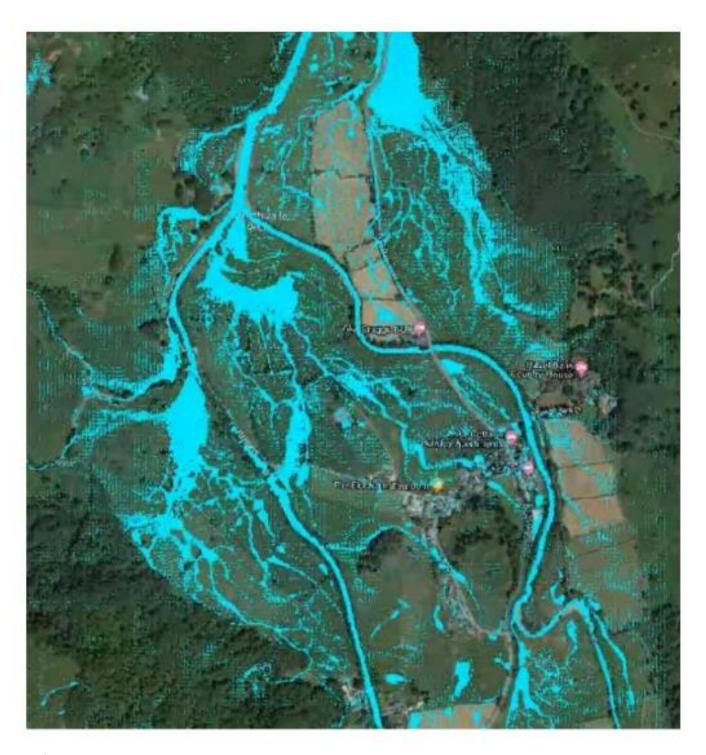
The flooding patterns shown above indicate the current areas where water is held in the landscape in flood and shows us where flood water is held behind embankments following a flood, where natural drainage is impeded.

The flooding patterns shown above indicate the current areas where water is held in the landscape in flood and shows us where flood water is held behind embankments following a flood, where natural drainage is impeded.
