# 10–38 Victoria Road, Whitehaven

## Published Flood Investigation Report No.77

**Flood Event 17<sup>th</sup> October 2012**

This flood investigation report has been produced by Cumbria County Council as a Lead Local Flood Authority under Section 19 of the Flood and Water Management Act 2010.

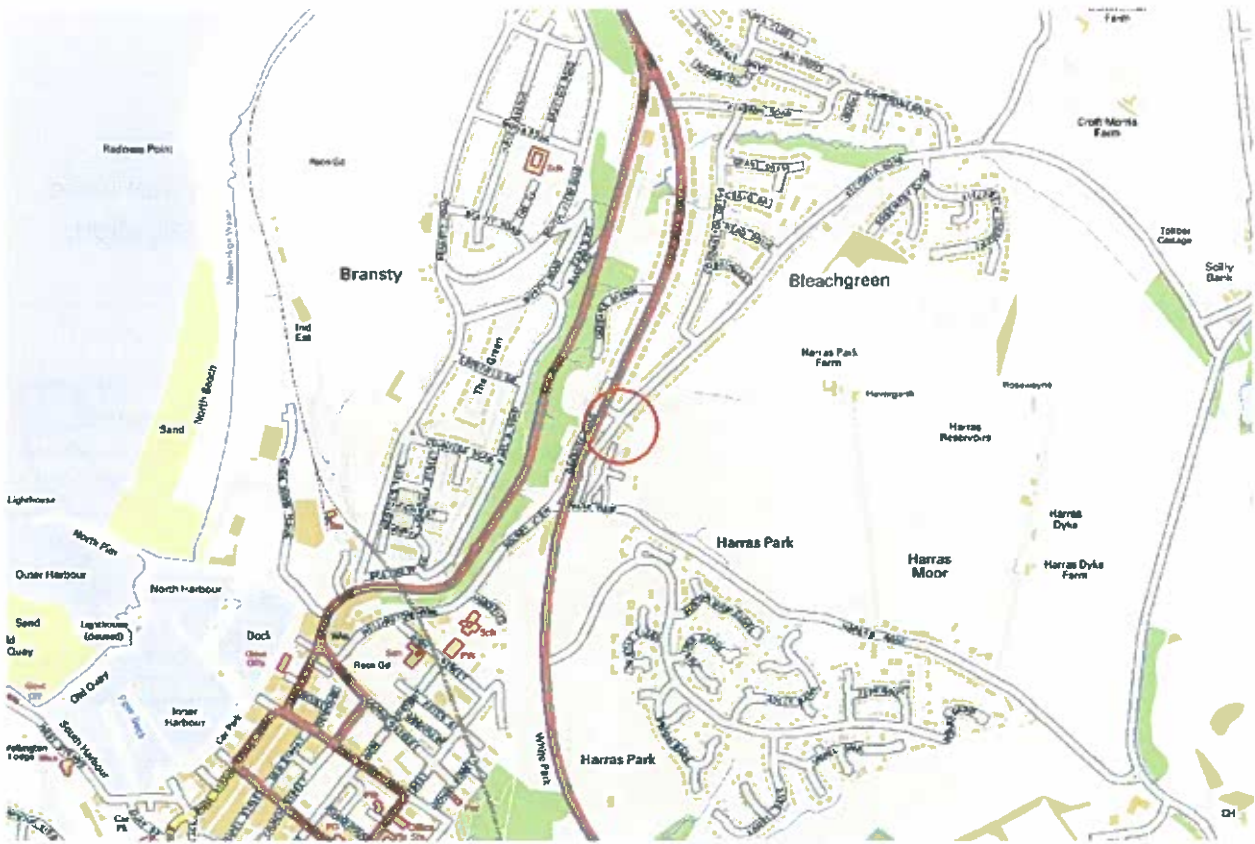
Figure 2: Location Plan Victoria Road

Victoria Road, Whitehaven is situated 760m northeast of the harbour (see Figure 1: Location Plan and Figure 2: Location Plan-Victoria Road). The locations of Nos.10-38 are shown in Figure 3 which also shows the watercourses in the vicinity as indicated on the Environment Agency (EA) records.

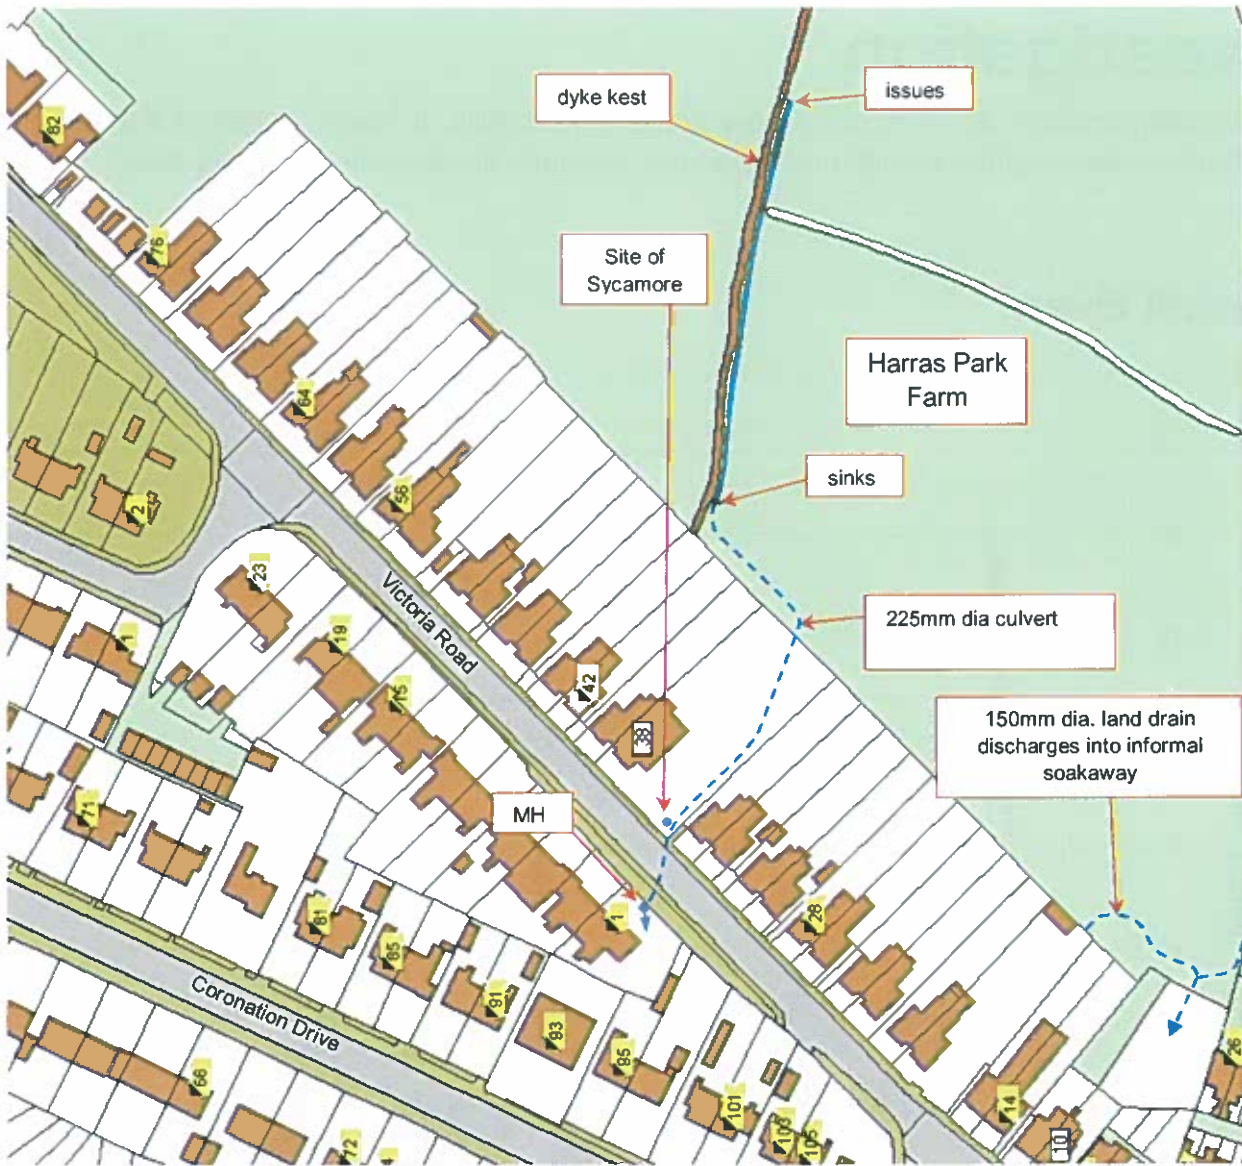
Figure 5: Route of Beck

Figure 5 shows the route of an ordinary watercourse that issues on a steep hillside behind Victoria Road on farmland belonging to Harras Park Farm. It runs on the south side of a dyke kest (earth bund) and sinks into a 225mm dia. culvert behind the backgardens of Nos. 42/44 Victoria Road. The culvert then runs parallel to the rear gardens before turning and running through the garden of No.38. The culvert then crosses Victoria Road and enters a manhole (MH) chamber in the front garden of No.1. A sycamore tree, protected by a TPO, stood in the front garden of No.38 (adjacent to No.36) and its roots caused problems to the culvert. There may be another culvert running down the field parallel to rear gardens in addition to that shown above but this is unconfirmed

A sycamore tree, protected by a TPO, stood in the front garden of No.38 (adjacent to No.36) and its roots caused problems to the culvert. Subsequent to the flooding of the 17<sup>th</sup> October, it was discovered that a section of the culvert pipework was missing.

The property owner of no. 36 has undertaken works to replace part of the culvert that had been damaged by the roots of the sycamore tree using 300mm dia. pipe. However the flooding continued and investigations found that it was the roots of the tree causing the problem. The tree has been taken down but and it is unclear whether the roots have been removed although surcharging water at this location seems to have abated.

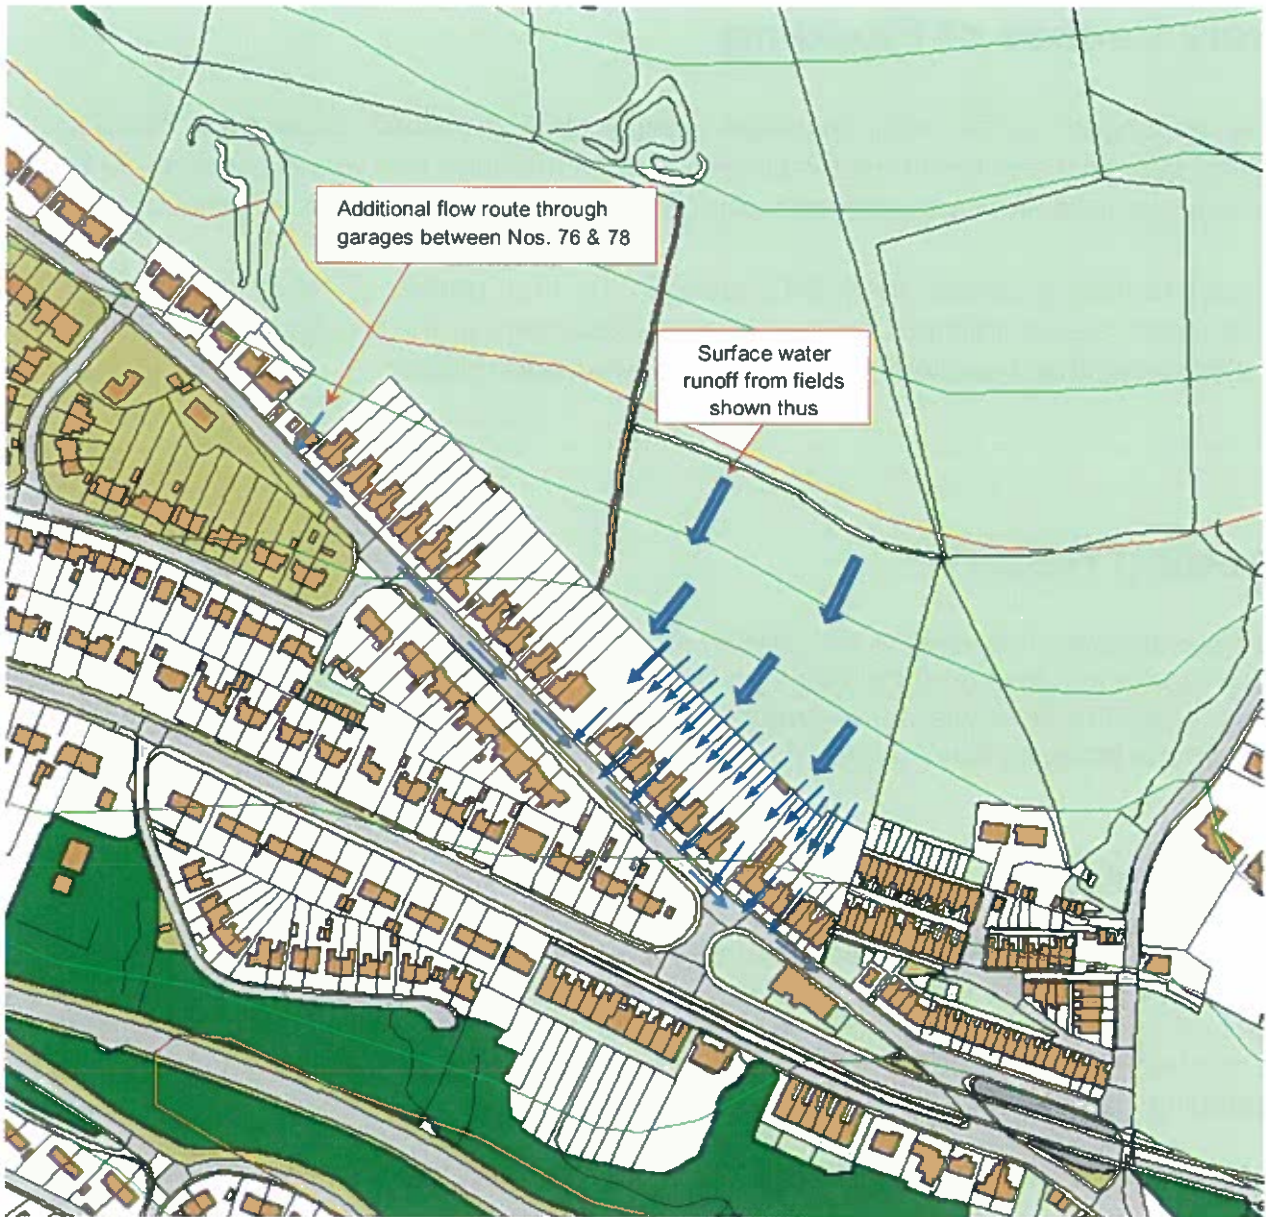
**Figure 6: Flow Routes**

Figure 6 shows the flooding flow routes of the 17<sup>th</sup> October, with floodwater flowing over the fields perpendicular to the backgardens. It is understood that the flood flowed into backgardens and between the properties into the road. It had been originally reported that about 29 properties experienced external flooding, with 4 properties having some internal flooding. However it has only been confirmed that one property was flooded internally and the number of properties that experienced external flooding has not been verified.

Heavy prolonged rainfall onto saturated steeply sloping ground caused the flooding. The resulting surface water runoff overwhelmed any land drainage that was in place at the bottom of the sloping ground and flowed through gardens and between properties onto the road.

There is a history of flooding to the garden of No.36. Before 17<sup>th</sup> October it had been reported that surface water flowed off the fields and ran along the rear of the back gardens. However on this occasion the flow was much greater and flowed over this drainage route and into all the backgardens between Nos.10 and 36.

To alleviate the flooding to rear gardens some land drainage has been laid, connecting to a pipe in the backgarden of No.10, which discharges into an informal soakaway consisting of a pipe that discharges straight into the ground.
