Cumrew

Flood Investigation Report No 60

Flood Event 28th June 2013

This flood investigation report has been produced by Cumbria County Council as a Lead Local Flood Authority under Section 19 of the Flood and Water Management Act 2010.

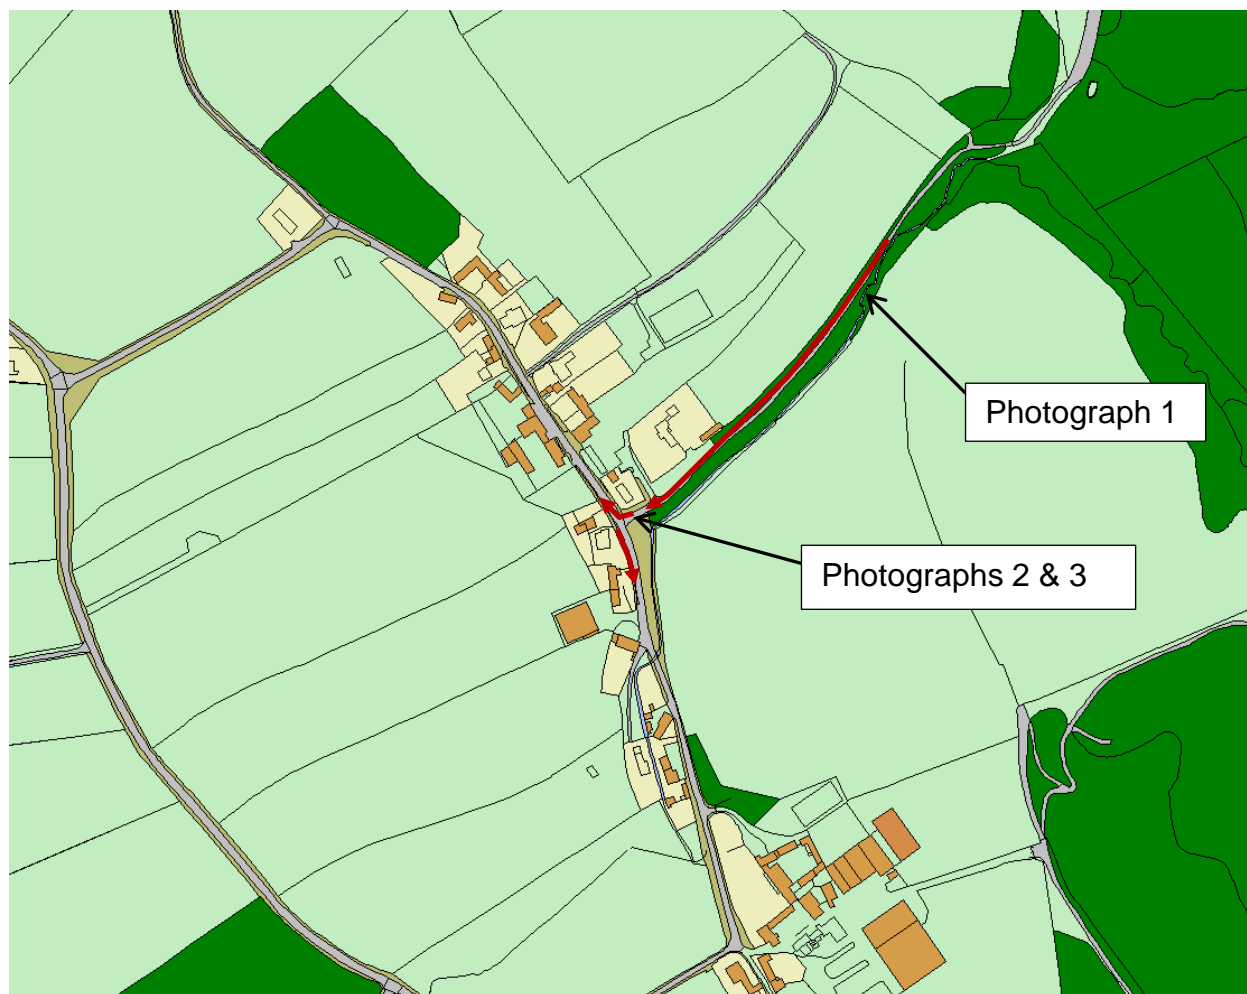
Figure 5: Initial flow route from Cumrew Beck

During the event on the 28th June 2012 Cumrew Beck was unable to take the excessive rainfall causing floodwater to overtop the watercourse banks. The overtopping occurred in several places which are indicated on the following plan. Over topping next to the track caused the flood water to run down into the village. The information on the following pages details flow routes from Cumrew Beck and other sources.

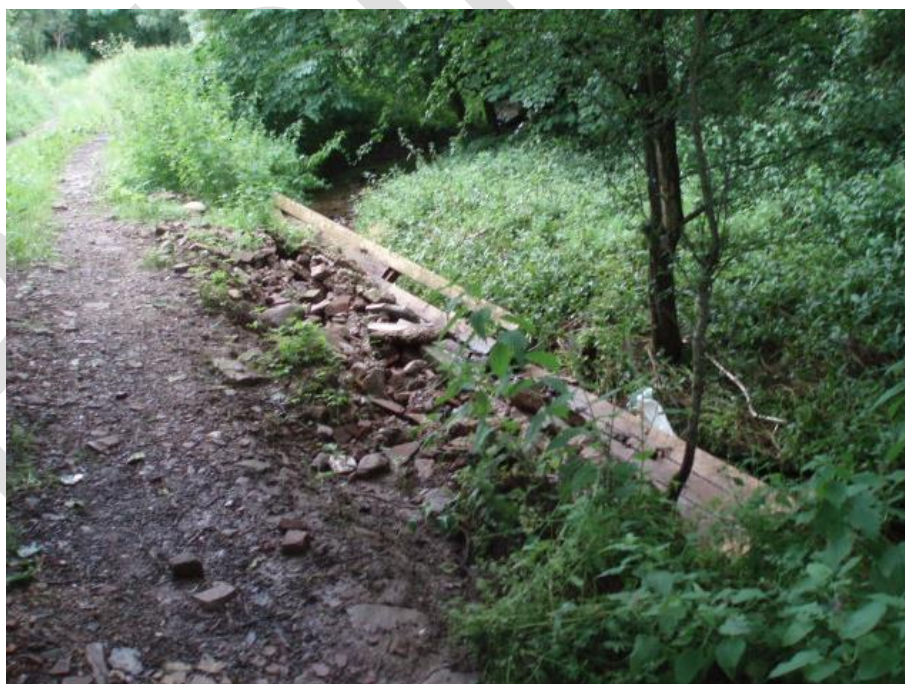
Photograph 1: Erosion and damage caused to Cumrew Beck upstream of Cumrew Village

The velocity of the flow in Cumrew Beck during the flood event will have caused an increased risk of damage and erosion particularly in the location of meanders and bends in the

watercourse. It is also likely that such issues have created areas that have allowed the watercourse to overtop its banks and allow flow to run down the track into the village.

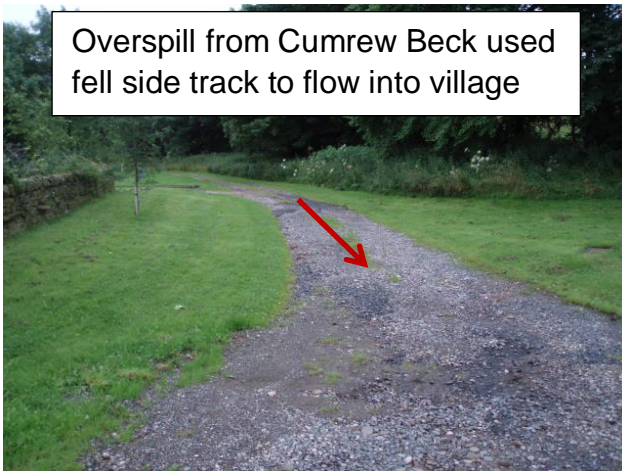
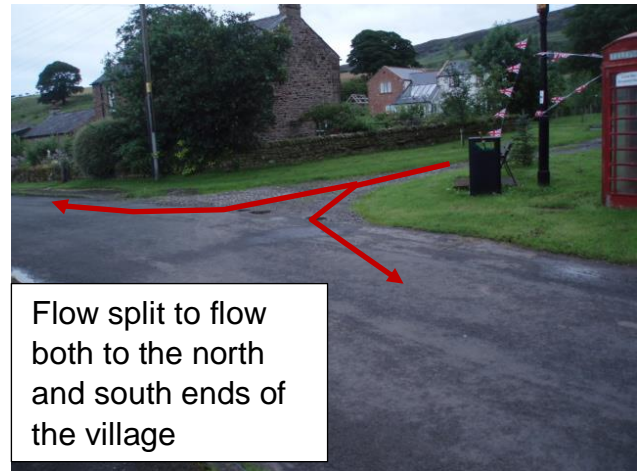
Photographs 2 & 3: Flow routes from fell side track into village

The surplus flow from Cumrew Beck reached the village where the flow split allowing the flood water to flow to either end of the village. The south flow route was also added to by over flow from Cumrew Beck upstream of the road bridge and the unnamed watercourse that flowed through the dry stone wall near Cumrew House. These flow routes are indicated in figure 6 on the following page.

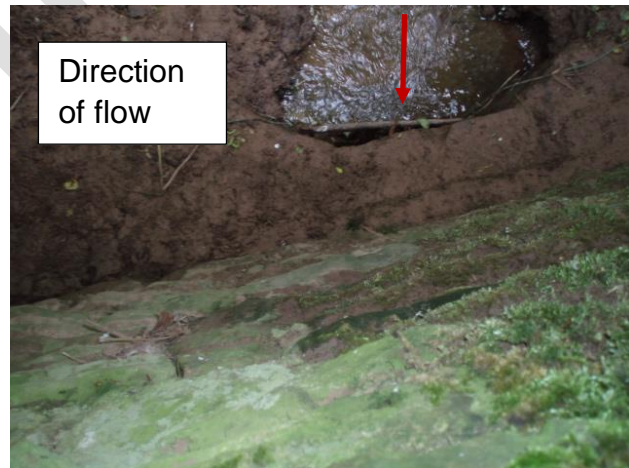
Photographs 4 & 5: flow route through wall and culvert entrance

Photograph 4 indicates the flow routes through the dry stone wall near the entrance to Cumrew House. Photograph 5 shows the entrance to the culvert that runs under the road near to Cumrew House. The photograph was taken a few weeks after the flood event and there was no indication from the rapid flow through the culvert that there were any signs of collapses or siltation within the culvert. From this it is assumed that the water flowing through the wall was caused by excessive rainfall overwhelming the culvert rather than a blockage. However, during October 2013 residents were continuing to inform CCC that there were problems with the culvert next to Cumrew House blocking. Jetting works had been carried out previously but had

not indicated any blockages. A CCTV survey was carried out in December 2013. During this operation a plastic bag was removed and it was identified that a partial obstruction remained in the culvert. An excavation into the culvert allowed the removal of 3no fence posts. The upstream land owner of this culvert continues to ensure that debris is removed to prevent future blockages.

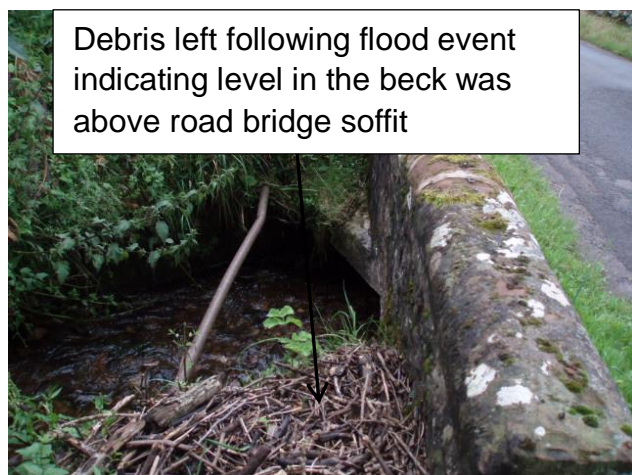
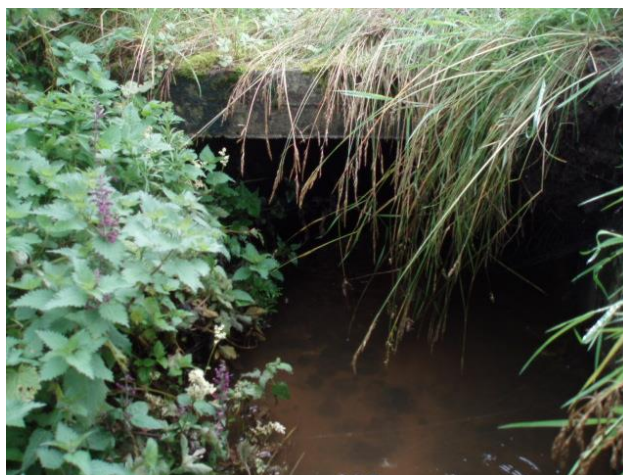
Photographs 6 & 7: Debris left next to the culvert near Rivendell and downstream culvert structure

Residents have raised concern regarding the capacity of the culvert under the road near to Rivendell. The culvert did cause a restriction and did contribute to the overtopping of the watercourse upstream of the bridge. CCC are proposing to remove silt from the culvert near to Rivendell in early 2014. The downstream sections of Cumrew Beck after the culvert are the responsibility of the landowners. As such each land owner should monitor and maintain the bed and banks of the watercourse. Particular attention should be paid to the reaches from the culvert next to Rivendell to the point where it crosses the B6413. Information of a riparian land owner's rights and responsibilities are detailed in the Environment Agency's leaflet 'Living on the Edge'.

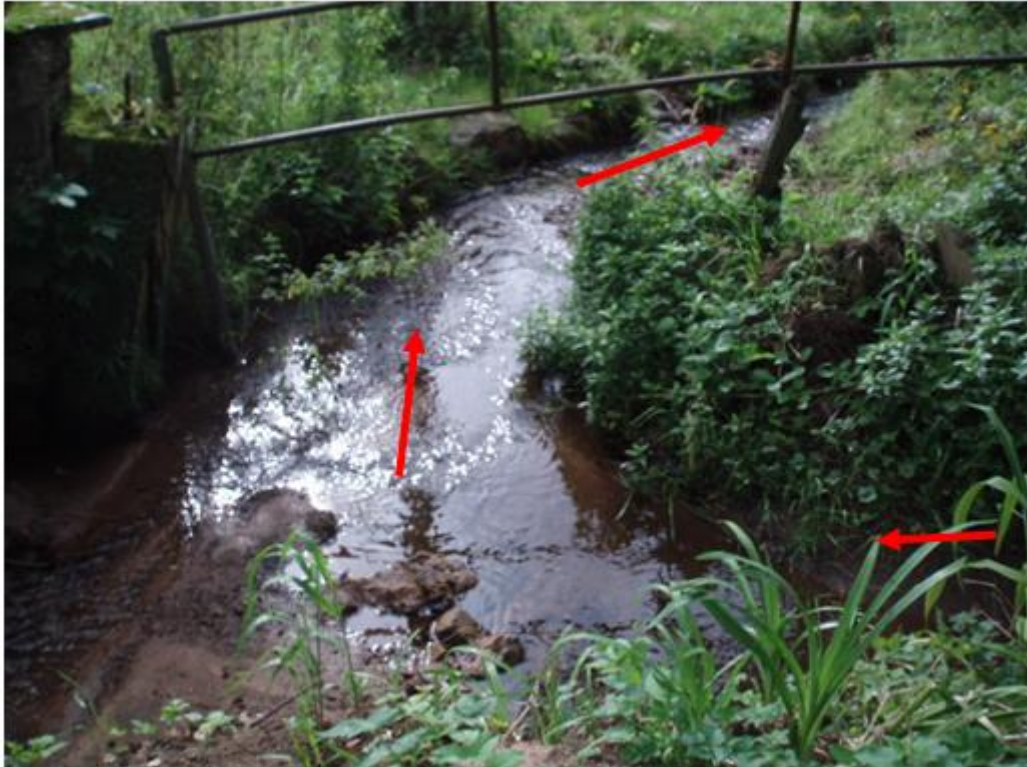
Photograph 8: Bend in Cumrew Beck as it exits Cumrew Village

Once Cumrew Beck has flowed through the village of Cumrew it exits the village by means of a sharp bend which may cause a restriction by the slowing of the water course above this point. However, old maps show that the watercourse has followed this bend for many years and is shown on the present course on plans dating from the 1861-1895 Cumberland Series. The latter part of the beck flows down an adjacent field where Cumrew Beck was diverted to accommodate works to Electricity Northwest apparatus. The diversion has had no impact on the flooding that took place. The diversion of Cumrew Beck is shown in Figure 6.

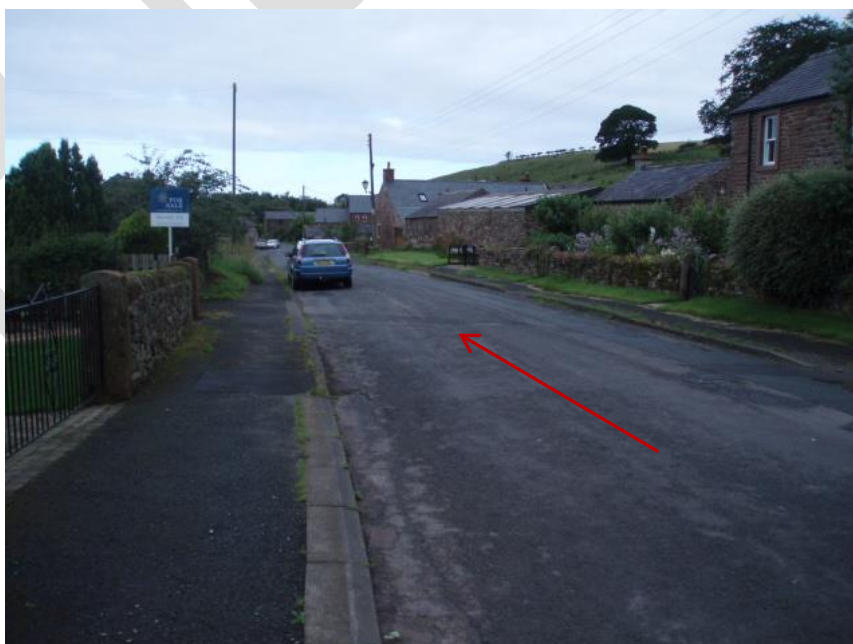
The flow from the fell side track also made its way towards the north end of the village along the highway. Where properties had dropped kerbs for driveways then water overtopped the kerbs as it travelled down the road causing internal flooding to some properties. Following the June 2012 event investigations by County Highways staff identified blockages on the highway drain outside The Hollies which were repaired soon after the June 2012 event.

Photograph 9: Flow route towards north end of Cumrew Village

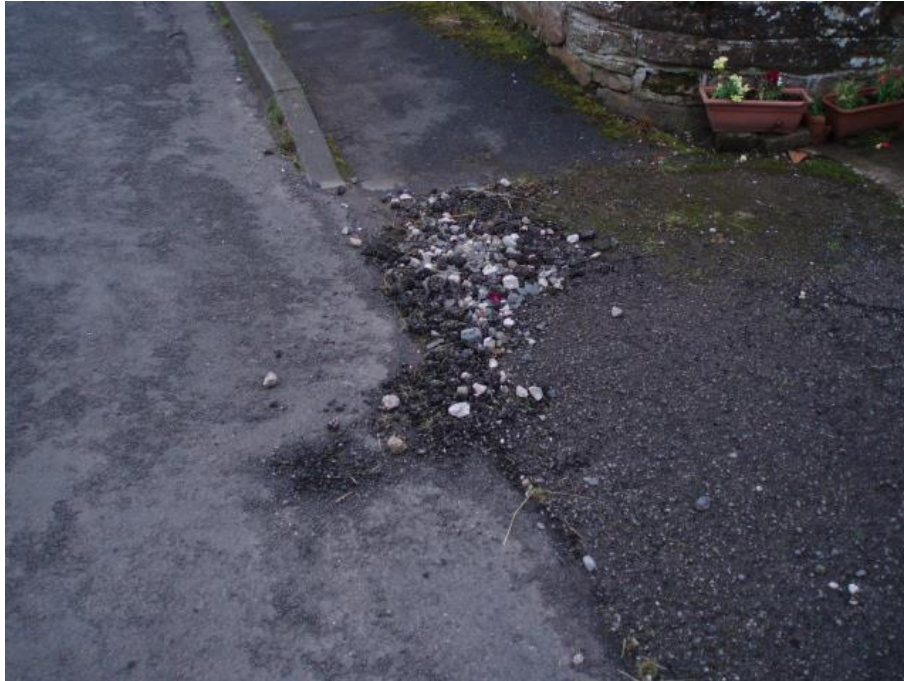
Photograph 10: Remains of gravel left by flood event

Information gathered from residents on the flood event not only provided details on the flow routes that the flood water had taken but also indicated the issues they had experienced with the volume of gravel that the flood water had deposited in the village. The deposition of gravel in the village can also cause blockages on the highway drainage systems as it can leave the gullies blocked. CCC highways clean gullies once per year but rely on reports from the public if a gully is blocked in the interim time. The gullies were last cleaned in January 2014. Residents have reported that gullies appeared blocked during the event. However, it should be noted that gullies and highway drainage systems are only designed to transfer surface water from the highway and not the volumes of water that was produced during the event on 28th June 2012.
