# Viaduct Estate, Carlisle

## Flood Investigation Report

**Flood Event**  
**24/25<sup>th</sup> September 2012**  
**and**  
**22<sup>nd</sup> November 2012**

This flood investigation report has been produced by Cumbria County Council as a Lead Local Flood Authority under Section 19 of the Flood and Water Management Act 2010.

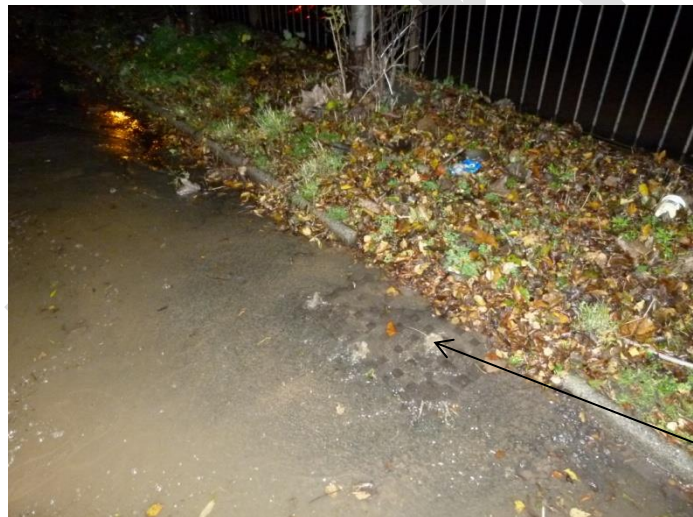
**Photographs 1 & 2: Flood water surcharging from gullies and manholes**  
Photographs provided courtesy of Cumbria Indoor Bowling Club 22<sup>nd</sup> November 2012.

Information gathered from business owners suggests that surface water surcharged from the gullies and manholes in both events. Property owners have also provided information to indicate the height of the flooding which has helped to confirm flood levels. There were no clear flood routes as the flooding was caused by surcharge from the surface water sewer systems rather than surface water being unable to enter the sewer systems.

The following photographs taken during the event on 22<sup>nd</sup> November 2012 indicate that the flooding occurred by surface water surcharging through the drainage systems.

Flood water surcharging from gullies and manholes

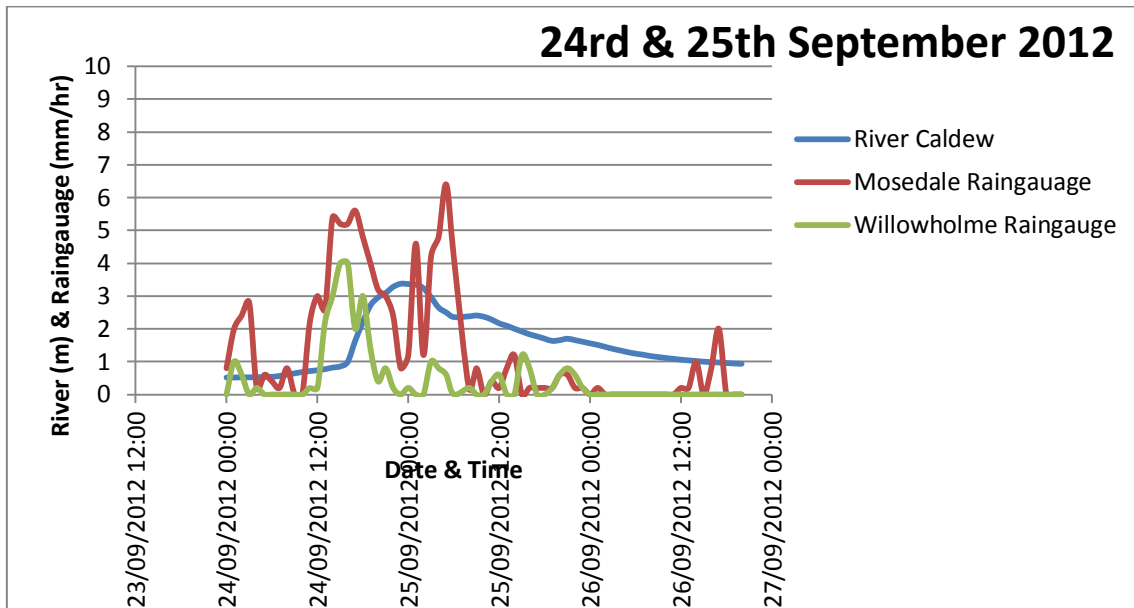
**Figure 3b: Hydrograph and Hyetographs showing river and rainfall data on 24<sup>th</sup> & 25<sup>th</sup> September 2012**

The event on the 24<sup>th</sup>/25<sup>th</sup> September and 22<sup>nd</sup> November 2012 caused flooding to the Viaduct Estate area, even though river levels were lower than June 2012.

The graphs below and on the following page show recorded river levels and rainfall from the EA’s river gauging station at Skew Bridge (behind Dunelm) and rain gauges at Mosedale (upper reaches of Caldew catchment) and Willowholme, Carlisle. The river gauging station at Skew Bridge records the river levels in the River Caldew in metres above a datum height at the station which can then be converted to metres above ordnance datum (mAOD). This can then be used to make comparisons between the river levels and the height of flooding in the Viaduct Estate area as is indicated in figure 2. The rain gauges at Mosedale and Willowholme record the actual depth of rainfall in mm per hour.

The information in the graphs has been used to determine if there was a significant difference in the amount of rainfall in Carlisle that may have caused the flooding in September and November 2012 but not caused flooding in June 2012. The rainfall graphs show that there was heavy rainfall in Carlisle (recorded on the Willowholme rain gauge) for all three events prior to the peak river level in the river Caldew. This would rule out the likelihood of the flooding being caused by incapacity of the drainage system because flooding would have occurred during the June 2012 event as well as during the events in September and November 2012.

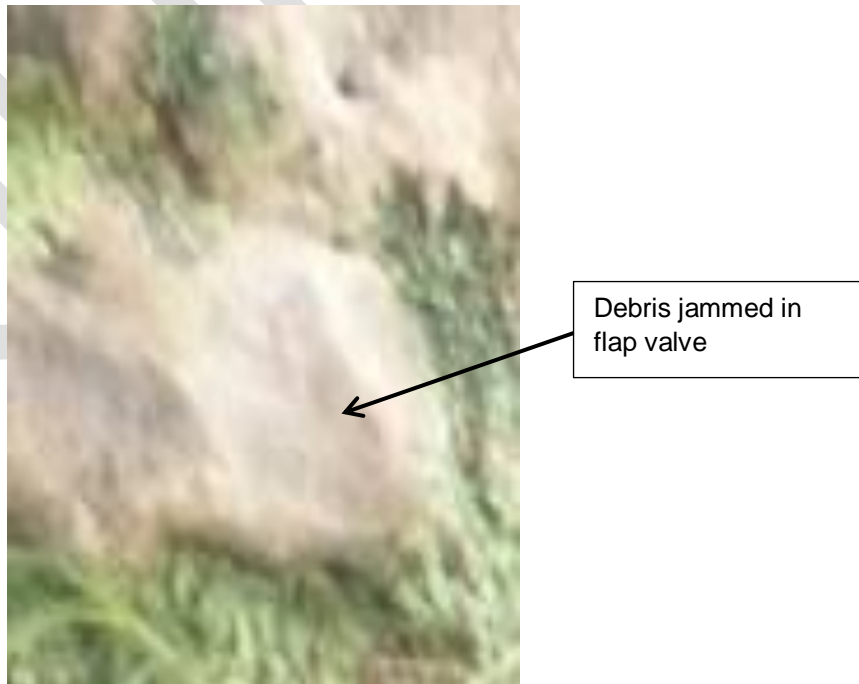
**Photograph 3: Debris jammed in flap valve on surface water outfall**  
Photograph courtesy of the EA

The flooding was identified to be caused by debris lodged in the flap valve on a United Utilities (UU) surface water outfall close to the upstream end of the Lower Viaduct car park. This allowed river water to flow through the drainage systems into the Viaduct Estate area.

Following routine inspections by the EA it was identified that the flap valve on the surface water sewer discharging to the River Caldew upstream of the Lower Viaduct car park was jammed open by debris. It is unclear how long the debris had been in place but the EA inspection sheets identify the flap valve to be clear from debris on 25<sup>th</sup> May 2012 but not on 30<sup>th</sup> November 2012.

From the information available the most likely cause of the flooding is due to the surface water outfall being jammed open allowing river water to flow back through the drainage systems to flood the Viaduct Estate area. The following photograph shows the surface water flap valve.

Debris in the flap valve has been cleared by the Environment Agency (EA). This report recommends that the asset owner carries out routine inspections to ensure that the flap valve remains free from debris.

Action by	Recommended Action	How
EA	Clear debris from surface water drainage flap valve	Remove debris to allow flap valve to close correctly. COMPLETED
UU	Continue to monitor build up in the flap valve.	Inspect periodically to ensure no build-up of debris. ON-GOING
UU	Review suitability of existing flap valve structure	Use current best practice guidelines to ensure flap valve operates with minimum risk of blockages
Business owners and users of the Viaduct Estate	Continue to report any flooding that occurs in the future	Use the contact details provided for UU, EA and CCC in Appendix 3 of this report
Business owners and users of the Viaduct Estate	Remain vigilant and report any debris build up in the location of the surface water outfall near Skew Bridge	Report debris in the surface water flap valve to UU on 0845 746 2200.

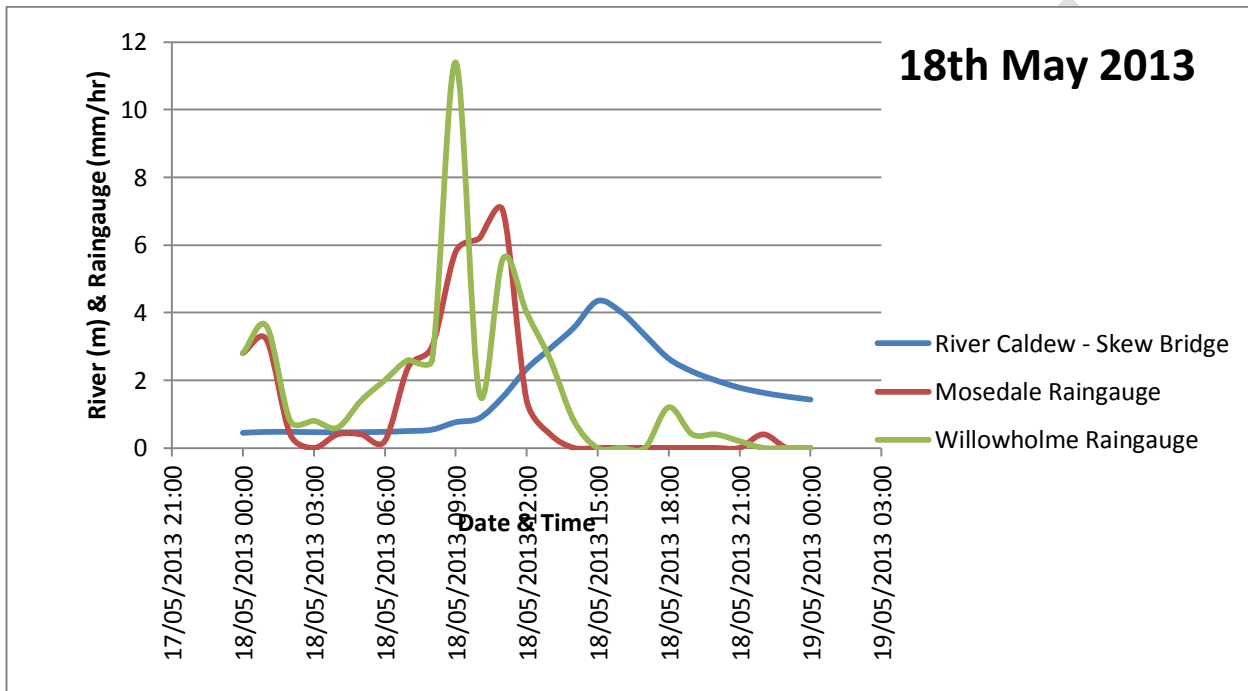
**Figure 6: Hydrograph and Hyetographs showing river and rainfall data on 18<sup>th</sup> May 2013**

This update provides information on the significant event that occurred on the 18<sup>th</sup> May 2013 and provides a hydrograph / hyetograph graph which demonstrates that similar or higher levels of rainfall and river levels were reached to the previous events on 23<sup>rd</sup> June 2013, 24<sup>th</sup>/25<sup>th</sup> September 2013 and 22<sup>nd</sup> November 2012.

CCC has not received any reports from the public or other Risk Management Authorities to suggest that flooding occurred on 18<sup>th</sup> May 2013. From this it can be concluded that the clearing of the flap valve on the surface water system has helped to prevent flooding during this event.
