Low Crosby

Flood Investigation Report

Flood Event 5th and 6th December 2015

This Flood Investigation Report has been produced by Cumbria County Council as the Lead Local Flood Authority under Section 19 of the Flood and Water Management Act 2010 in partnership with the Environment Agency as a key Risk Management Authority.

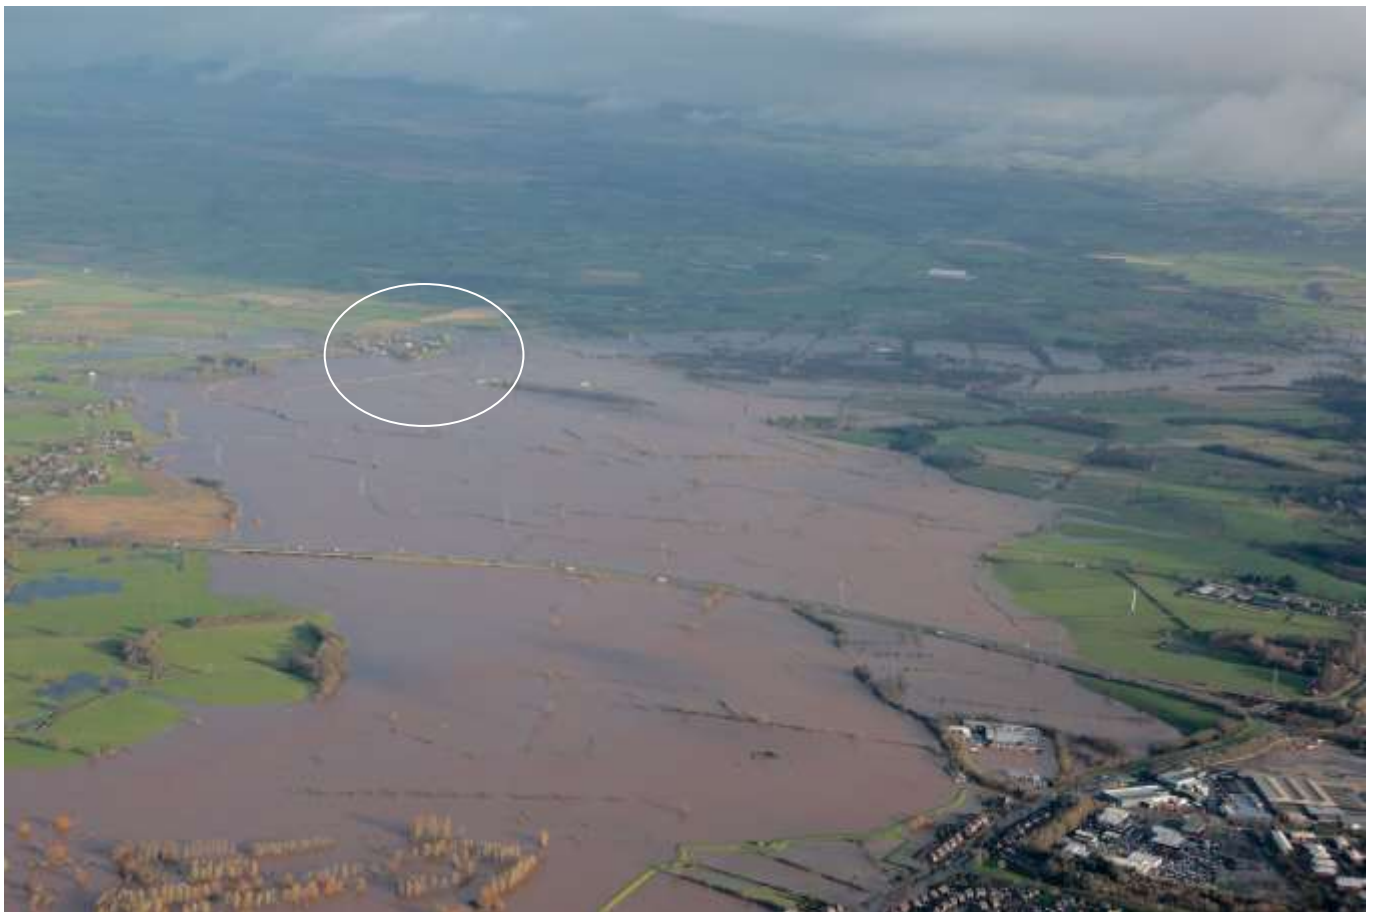
Aerial photograph taken looking east from Carlisle

Photograph provided by Peter Smith. Taken 06/12/2015 11:00hrs

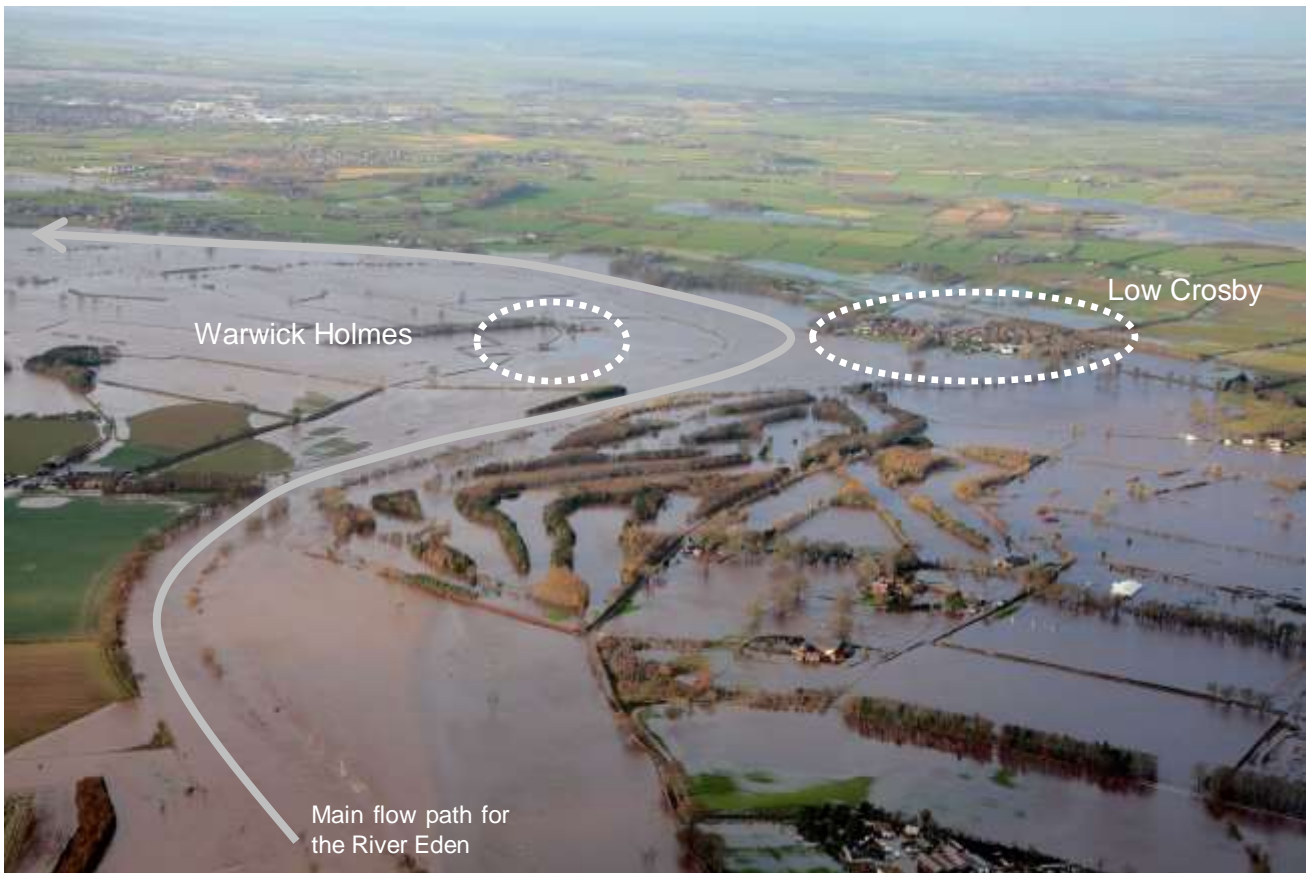
Photograph 1 - Aerial View of the Flood Extent at Low Crosby and Warwick Holmes (view looking west)

On 6th December 2015, approximately 60 properties in Low Crosby suffered internal flooding as a result of Storm Desmond. Further flooding of property also occurred in surrounding rural areas (e.g. Warwick Holmes and Newby Grange). This storm caused 36 hours of intense rainfall leading to high river levels that overtopped and outflanked flood defences. The main source of the local flooding is attributed to the River Eden, rather than Willow Beck. The River Eden flowed up the course of Willow Beck, entering the western side of the village along Willow Beck's left hand bank. The area affected by the flooding is shown in Photograph 1.

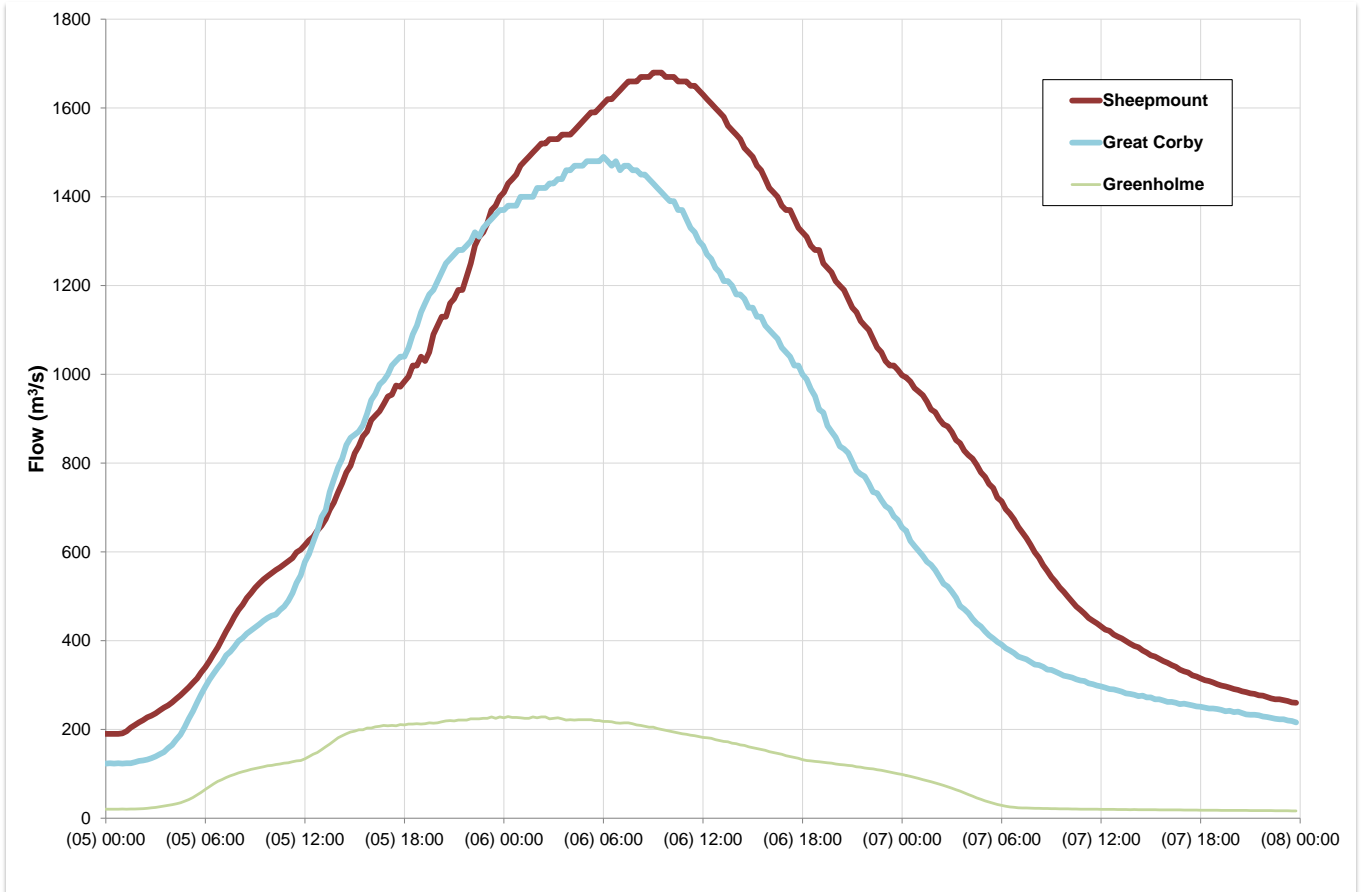
Figure 5 – River Flows near Low Crosby

Figure 5 shows the recorded river flows at the three “live” monitoring gauges from the 5th to the 7th of December 2015. This illustrates the relative size of the two rivers and the times of peak flow during the flood event.

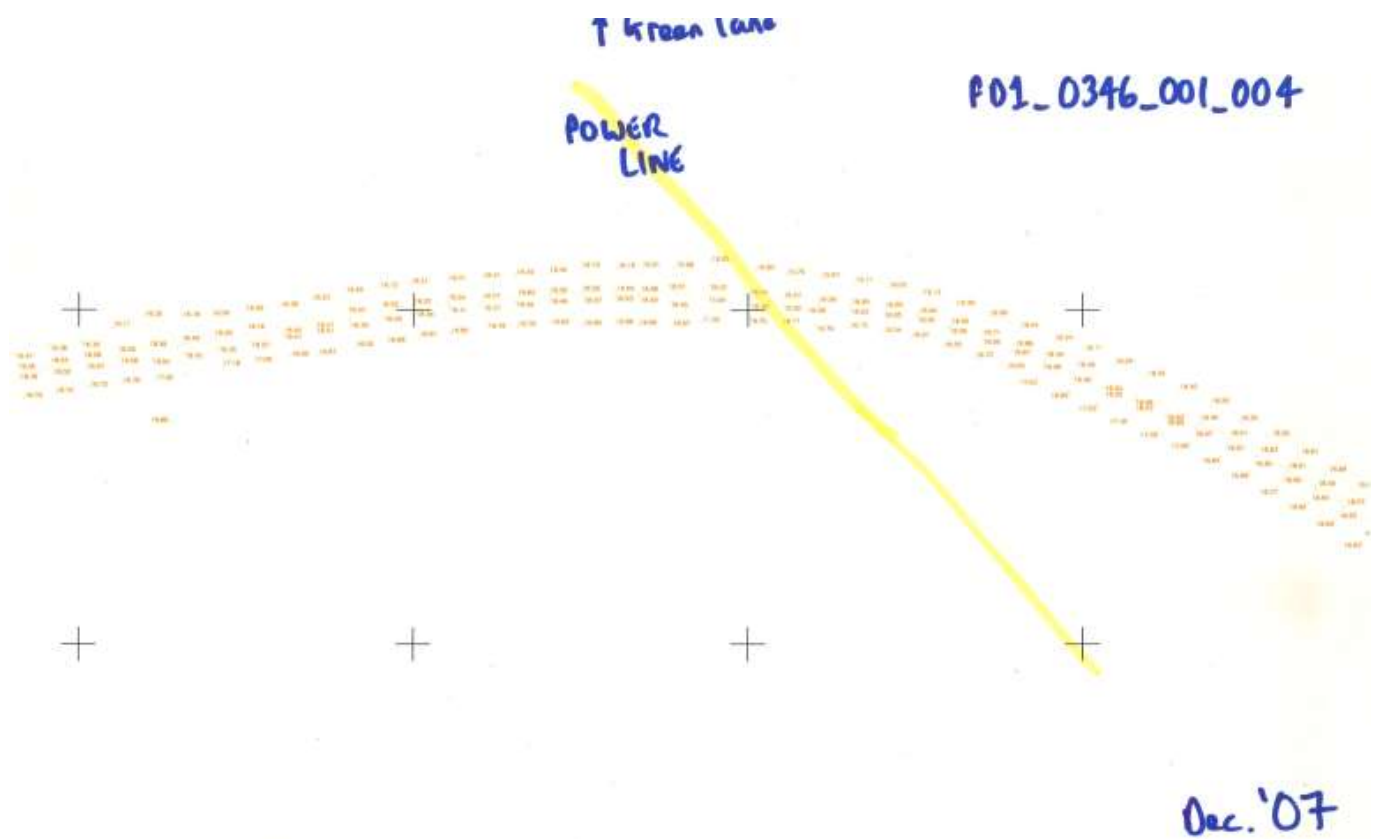
Appendix 4: Survey details Warwick Holmes Embankment

Please see excerpts from two pieces of survey work. One is dated December 2007 and the other June '16. We have the drawings for the entire length of the defence but they are large files and in a format that you may not be able to open (Autocad). The defence levels recorded in the 2007 survey, showed the variability in crest levels which were indicative of the general condition of this bank.

June '16
