Oaklands Drive Carlisle

Flood Investigation Report

**Flood Event 22 November 2017
and 10 February 2018**

This flood investigation report has been produced by Cumbria County Council as a Lead Local Flood Authority under Section 19 of the Flood and Water Management Act 2010.

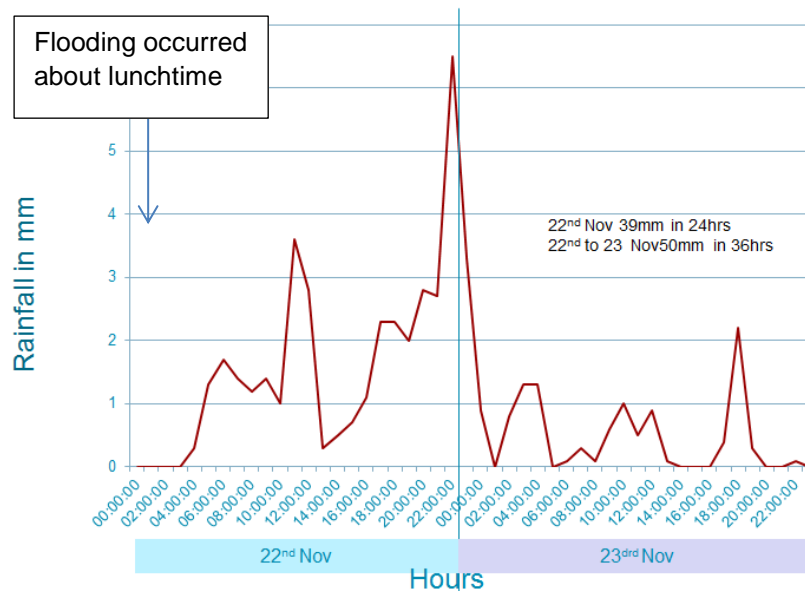
Figure 5: Rainfall totals 22nd to 23rd November 2017

Rainfall intensity on the 22nd November at Oaklands Drive is shown below. The rainfall totals on the 22nd November 2017 were 39mm in 24 hours and 50mm for 36 hours from 22nd into 23rd of November.

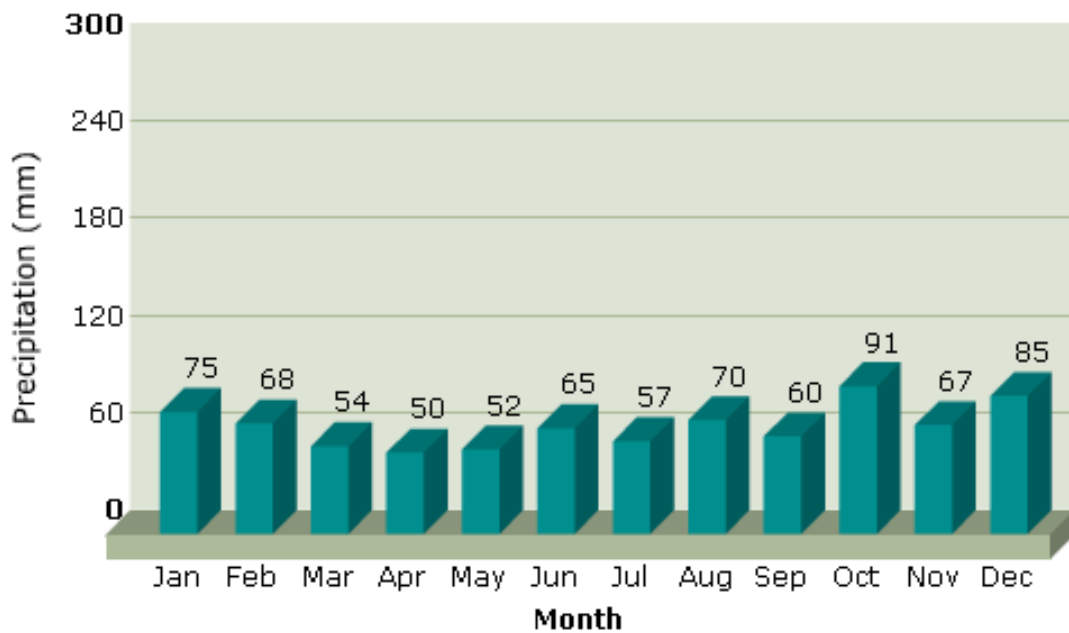
Figure 6: Average annual rainfall for the Carlisle area

In comparing the rainfall over the 24hr period with then average rainfall for the Carlisle area in November it would appear that over half a **month's** rainfall fell in **24 hours**.

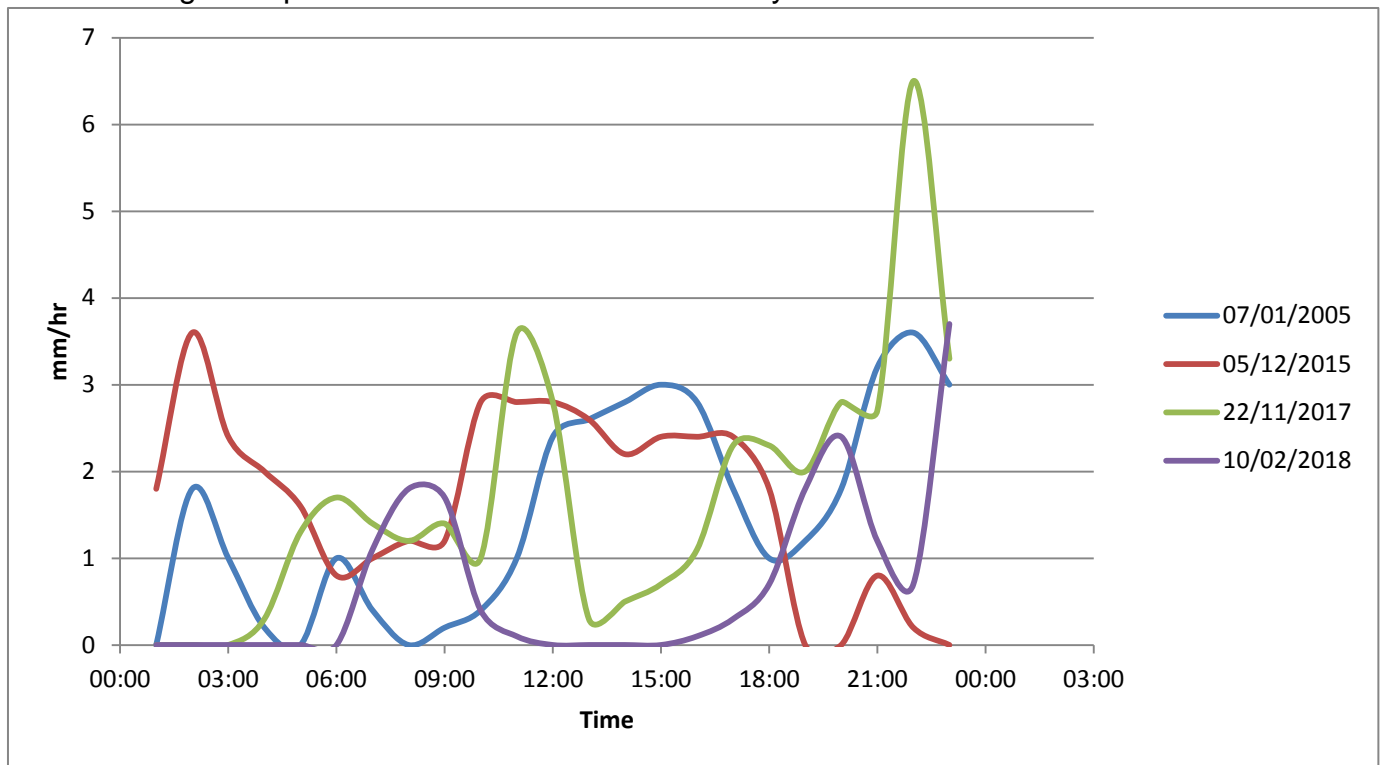
Figure 7: Comparison of rainfall events

This rainfall event was then compared with previous heavy rainfall events of 7th January 2005, 5th December 2015 and the event that occurred on 10 February 2018. It can be seen that similar peak rainfall was recorded for all of the events except for the 6.5mm peak which occurred late on the 22nd November 2017 but much later than the flooding occurred.

On the 10 February 2018 the rainfall peaked at 3.7mm at 23:00 which coincided with the timing of the internal flooding occurring. The overall volume of rainfall was considerably less than the previous 3 flood events in comparison by a minimum of 14mm over the 24 hour period. It is likely that due to the cold weather preceding the event that the soils were still frozen. This resulted in little percolation into the soil strata and the vast volumes of runoff which flooded 3 dwellings. The following graph indicates these events.

Rainfall event	Total rainfall
5/12/2005	30.8mm
5/12/2015	38.8mm
22/11/2017	39.2mm
10/02/2018	16mm

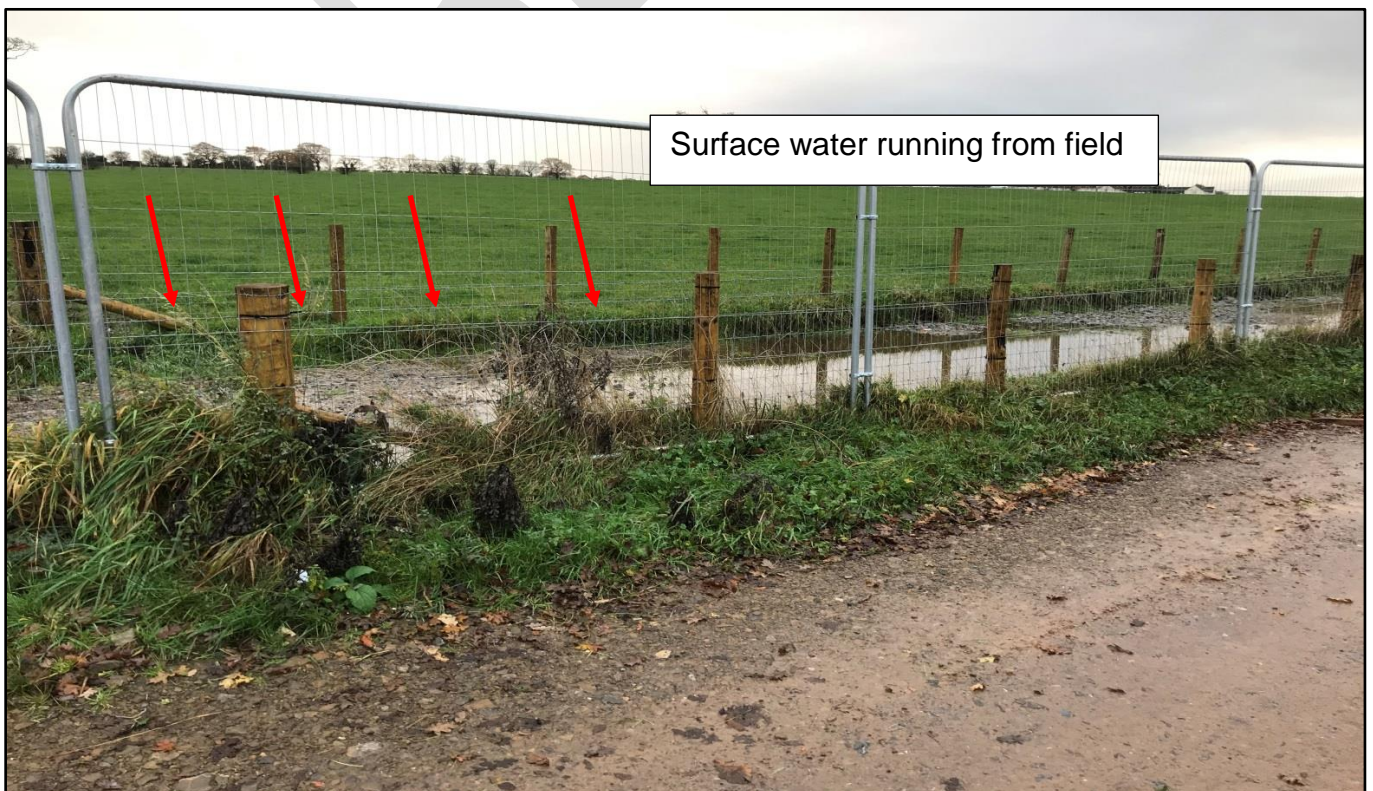
Photograph 1: Surface water flowing from field behind houses

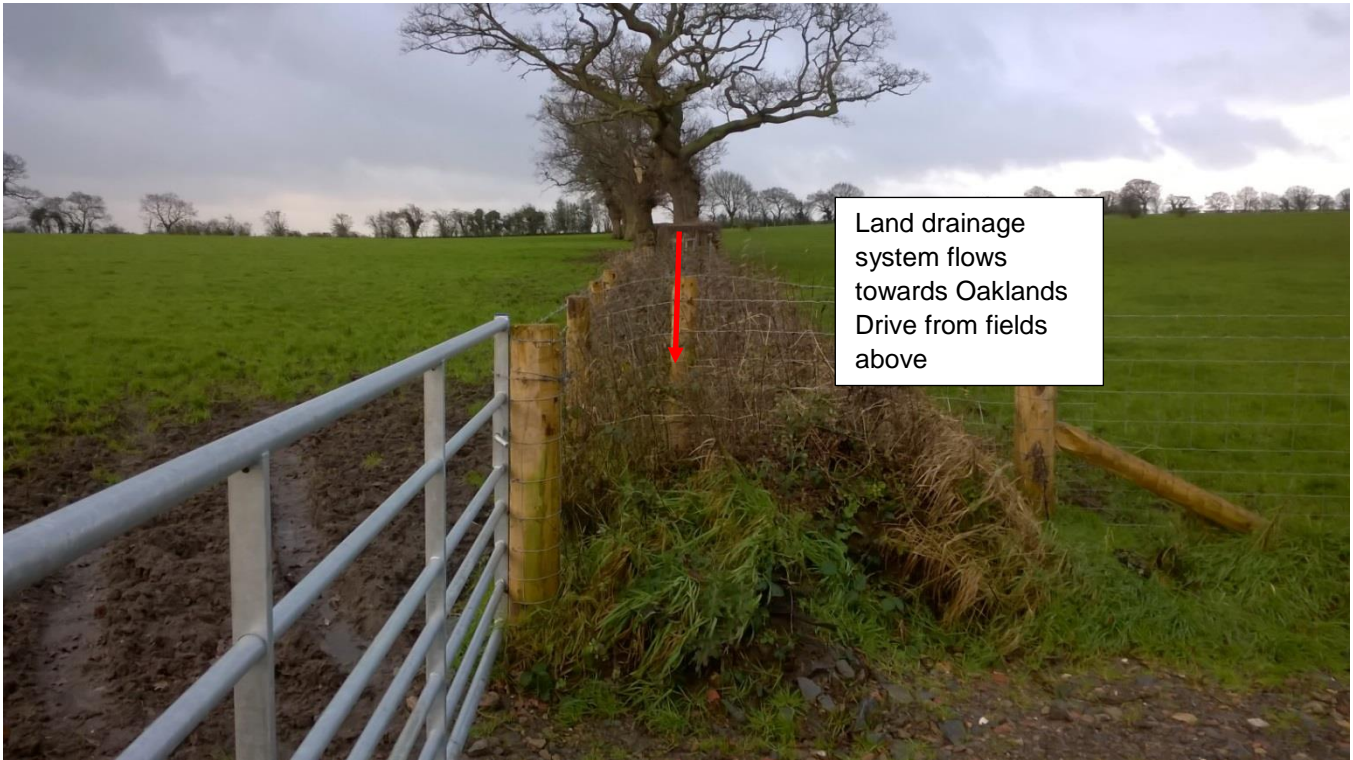
Photograph 2: Land Drainage route from fields above

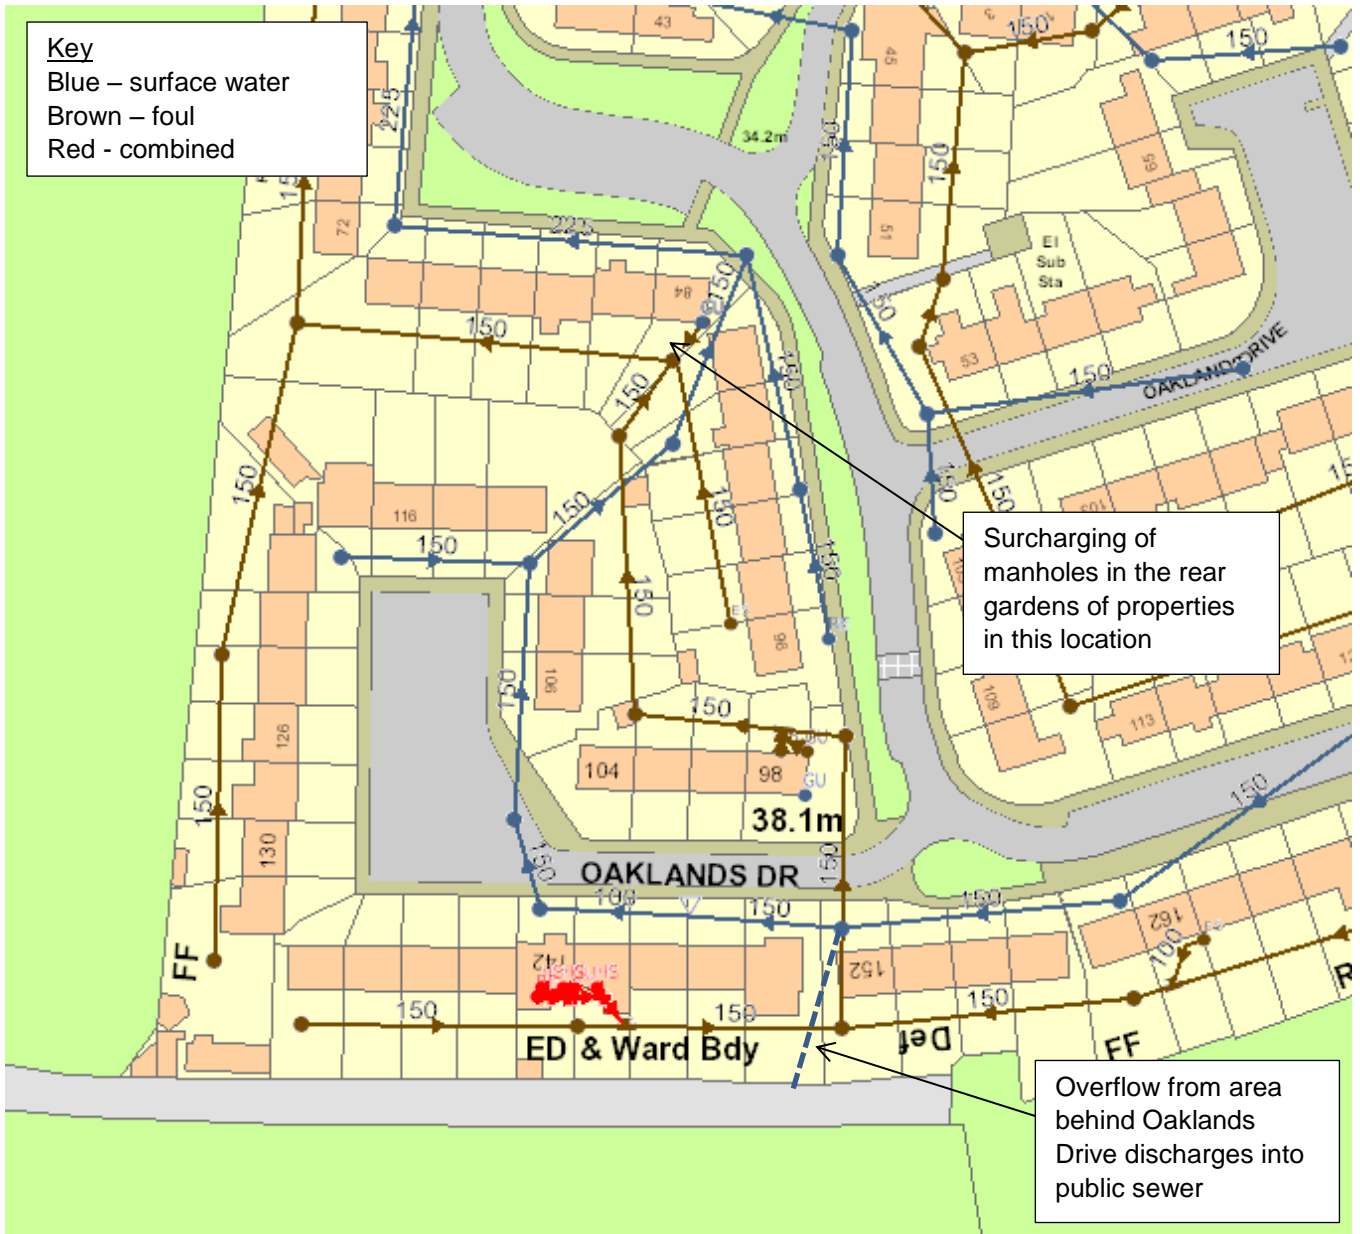
Figure 9: Plan of public sewers in Oaklands Drive

As well as the above land drainage system there is also a small overflow from the low area at the rear of the flooded properties which connects into the public surface water sewer within the Oaklands Drive estate. Figure 9 indicates the public sewer within the estate.

Also located in the lane behind Oaklands Drive is an 'overflow' drain which discharges to the public sewer (surface water) in Oaklands Drive. It is unclear when this structure was constructed, whether this was before or after the culvert but unfortunately it flows to the 150mm diameter sewer which during a heavy rainfall event may already be close to its capacity. It is understood that the surface water that flowed through the small overflow in this event overwhelmed the public sewer system that in turn caused surcharging from the public sewer system in other parts of the estate. The overflow is indicated in figure 9 and shown in photograph 3.

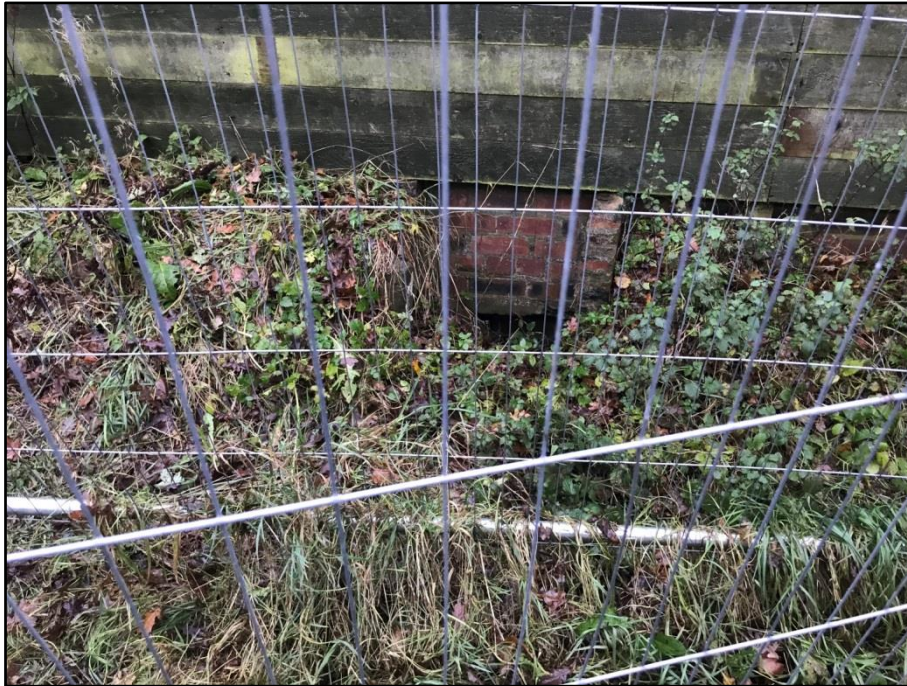
Photograph 3: Overflow drain to public sewer

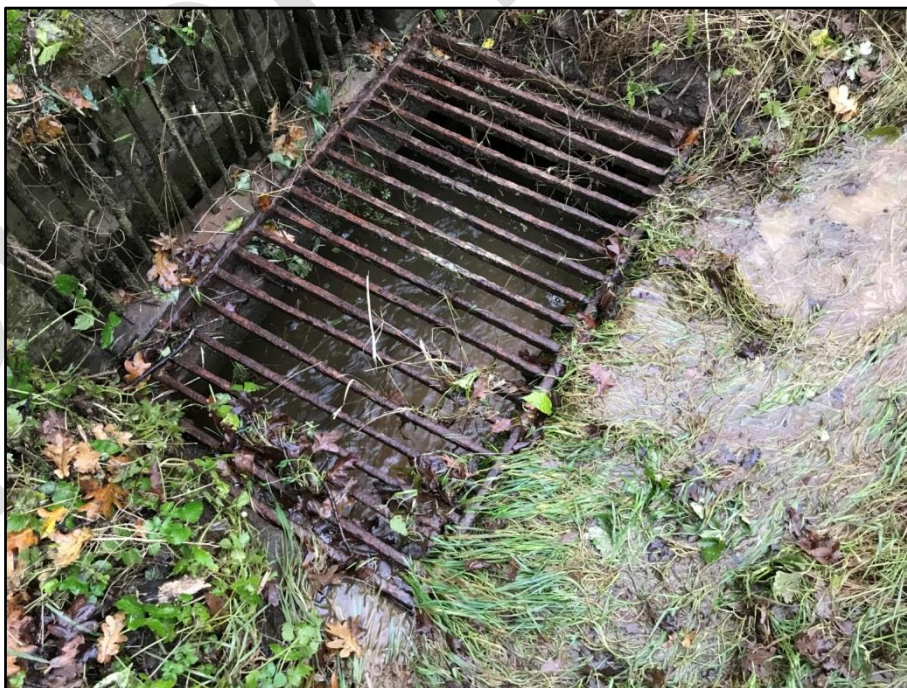
It has been known that the surface water sometimes runs around the first stretch of culvert and falls into the next section through an opening covered by a grid as shown in photograph 4. In normal circumstances this is sufficient to accommodate the surface water flows. However, there are several large trees in the area which can create debris to build up on the grid causing it to block. It is understood that residents do monitor the grid and remove debris as and when required. However, since the start of the new development and construction of the temporary access this has been difficult as the grid has been enclosed within the site barriers

Photograph 4: Grid over culvert

It is understood that during the event on 22nd November that the large volume of leaf fall was a contributing factor to the blockage of the grid.

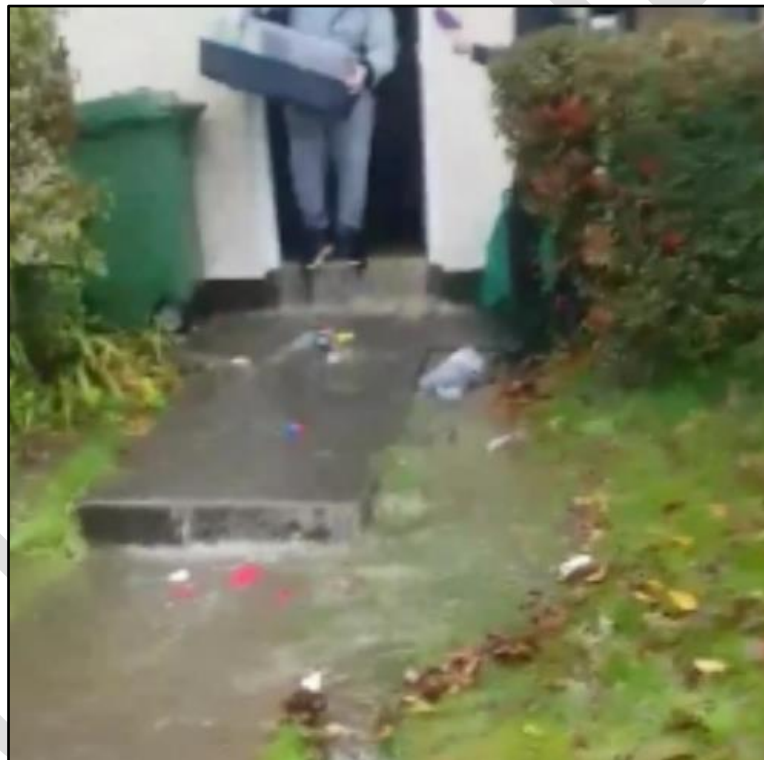
The following photograph shows the flood water flowing from the front door of the property. The flood water had entered at the rear of the property.

Photograph 5: Image of flooding shared on social media

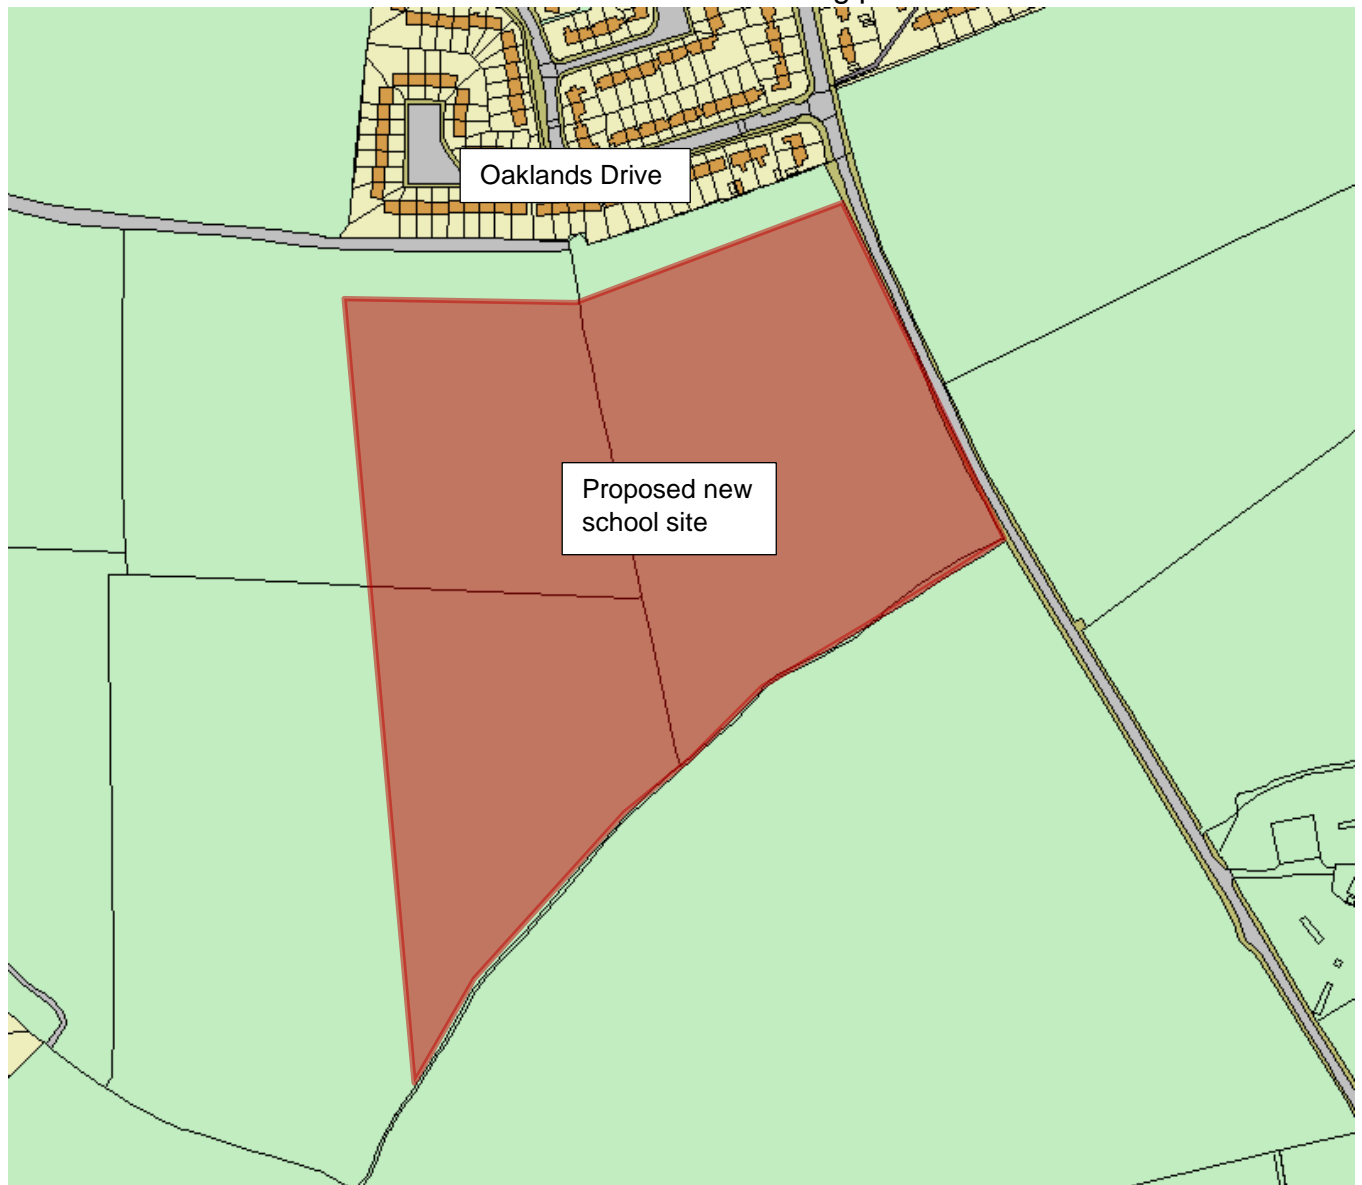
Figure 10: Location of proposed new school site

It is also known that it is proposed that the site for the new Newman School is to be located on land above Oaklands Drive as indicated within the following plan.

It is anticipated that the drainage design for the new school will also help to reduce the risk of flooding as attenuation of rainfall and surface water can be incorporated on the site.

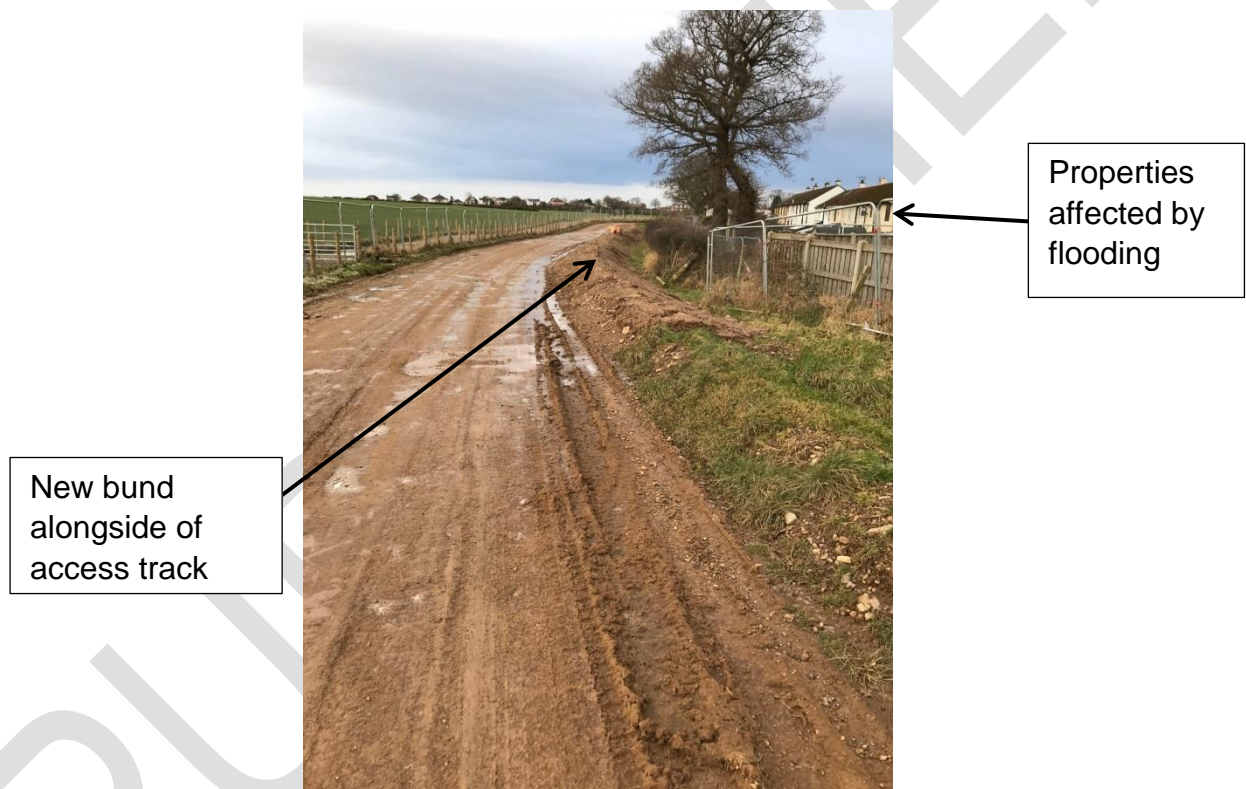
The flooding which occurred on 10th February 2018 was following the CCTV survey by Cumbria County Council (14/12/17) when blockages from the soft toy and leaves had been removed. Improvement works had also been carried out to the bund along the temporary access track. Observations during and shortly after the event suggested that surface water has gathered behind the bund but had then breached and overtopped the bund. This had then overwhelmed the existing drainage system (drainage system indicated in figures 8 & 11). The breach appeared to have occurred where a section of the bund had been stoned up to allow slow seepage of flow from the bunded area. The following photographs were taken on the 14th February 2018.

Photograph 6: Bund along new access track

With regard to the second event on 10 th February 2018 it was observed by residents that the bund erected by Story Homes was breeched as well as overtopped.	The report has been amended to reflect this.
It had been observed that the breach in the bund erected by Story Homes had been filled with stones to try to control the flow but when the second event occurred the stones were washed out and water then discharged into the gardens causing flooding.	The report has been amended to reflect this.
The pump that was in place over Christmas holidays should be reinstalled until a permanent solution is in place.	This has been considered as an action.

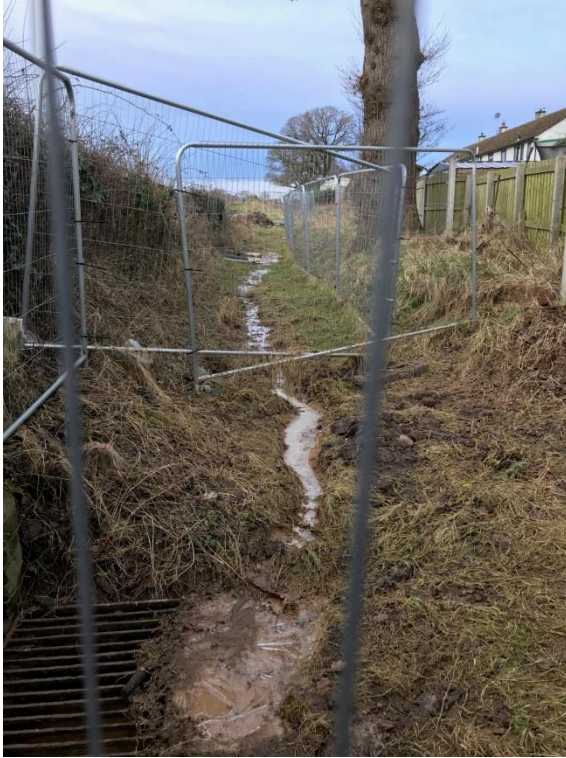
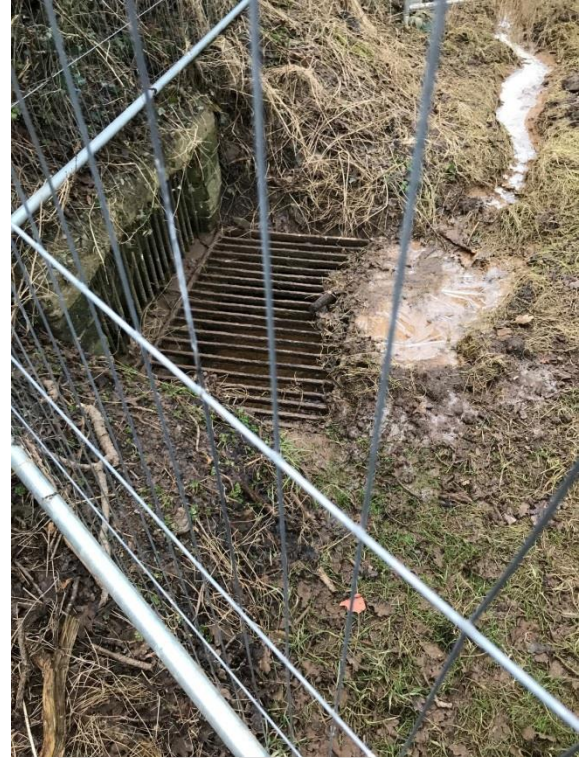
Photographs 7 & 8: Runoff of surface water from the bund in the grid on the drainage system
