Rockcliffe

Flood Investigation Report

Flood Event 2 January 2018

This flood investigation report has been produced by Cumbria County Council as a Lead Local Flood Authority under Section 19 of the Flood and Water Management Act 2010.

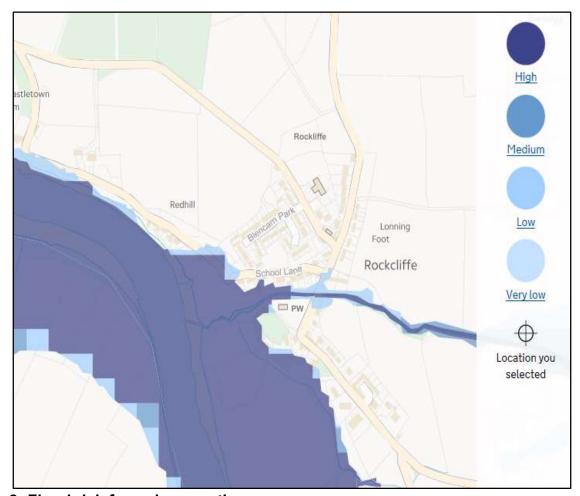
Figure 2: Flood risk from rivers or the sea

This section provides information on areas of flood risk from the Environment Agency mapping that is available. The following information is publically available and can be viewed at the following website - https://flood-warning-information.service.gov.uk/long-term-flood-risk/map. As can be viewed from the extract within Figure 2 below, the properties along Rockcliffe Coast Road and School Lane that were affected by the flooding on 2 January 2018 were already identified as being in a high / medium flood risk area.

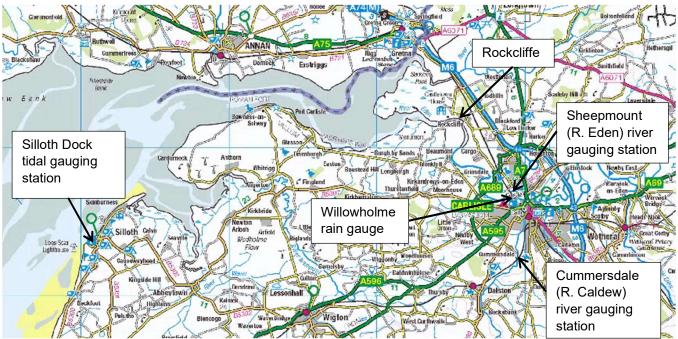
Figure 3: Location of Environment Agency Gauging Stations

The Environment Agency collect information from various gauging stations including tidal, river and rainfall gauges. This report has considered information from several such gauging stations as identified at the locations in the following plan –

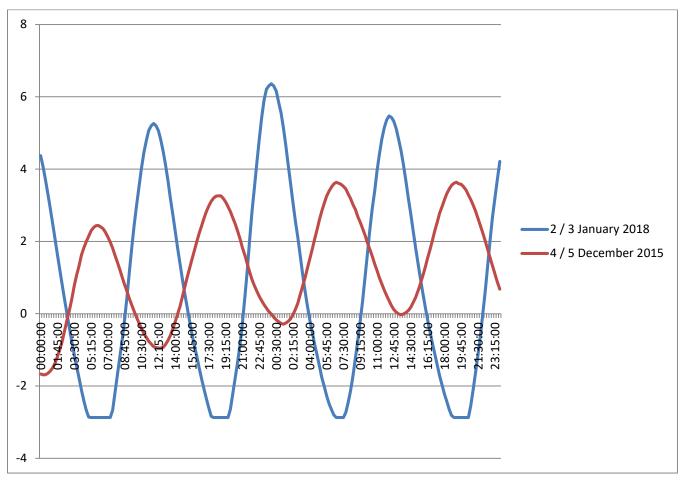
Figure 4: Comparisons of tidal Levels (m) at Silloth Docks

The event of the 2nd January 2018 (Storm Eleanor) was compared against the tidal information from the event of 5th December 2015 (Storm Desmond) to demonstrate the difference in tidal levels during the 2 events. It can be seen that during Storm Eleanor the tides were approximately 2.6m higher than during Storm Desmond. See figure 4

As can be seen there are two peaks in the tidal levels on the 2 January 2018; one at 11:45 (5.26m) and one at 23:45 (6.3m). The peak in the tidal level at 23:45 is considerably higher than that of the other peak at 11:45 by 1.04m. The 23:45 peak coincides with the anecdotal information provided by local residents as to the timing that the flooding began. It is understood that the flooding lasted approximately 6 hours.

As can be seen from the tidal information shown within Figure 5, the tidal fluctuations experienced within January 2018 were considerably more exaggerated and extreme than during the flooding of December 2015. It is considered that the high tide was a contributing factor to the flooding.

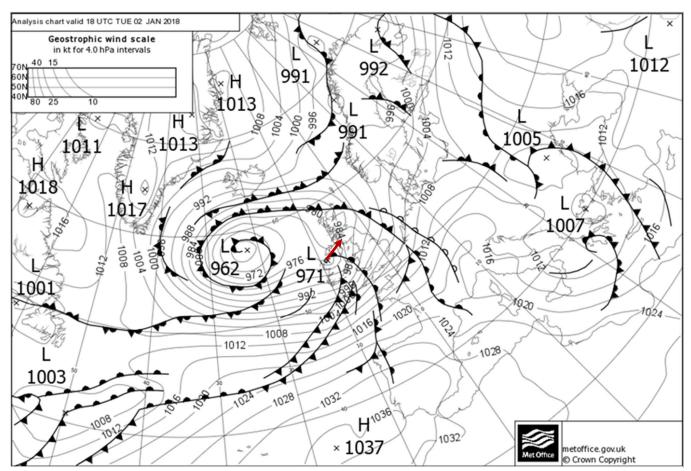
Figure 5: Low pressure system at 18:00 on 2nd January 2018 (red arrow indicates direct of travel)

The Met Office have provided details of the pressure systems in the location of Rockcliffe and from the diagrams below it can be seen how the low pressure moved north-easterly which would have had the effect of funnelling the winds up the Solway Firth and the River Eden at a similar time to the high tide.

Sea levels vary depending on the weather conditions being experienced as air pressure has a direct influence on the river / sea level. High air pressure exerts a force on the surroundings and results in water movement. So high air pressure over a sea area corresponds to low sea level and conversely low air pressure (a depression) results in higher sea levels. This is called the inverse barometer effect (storm surge). Therefore, with the storm event which occurred, the associated low pressure will have increased the water height within the Solway Firth and River Eden and contributed towards the flooding which occurred.

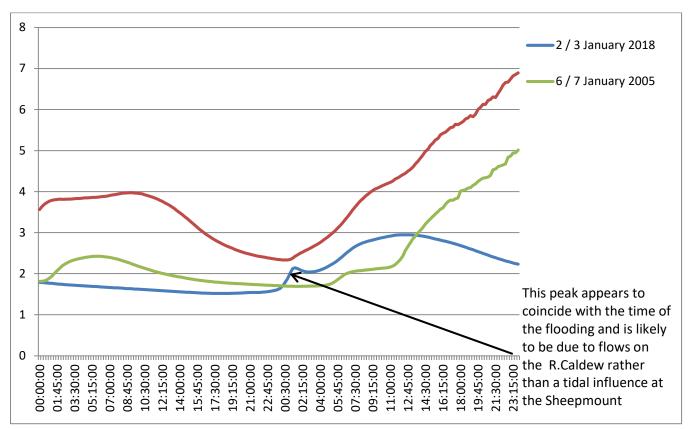
Figure 7: Comparison of the levels of the River Eden (m)

In order to ascertain as to whether or not the flooding was due to a fluvial event within the River Eden, the Environment Agency supplied river gauging data at the Sheepmount, Carlisle. Figure 6 below is a graphical representation of the river levels (m) on the 2 and 3 January 2018 compared with January 2005 and December 2015 fluvial events.

The river levels at the Sheepmount gauging station, approximately 4 miles upstream of Rockcliffe, illustrate that river levels fell from 1.788m at 00:00 on the 2 January 2018 to a point of 1.518m at 18:30. From 18:30 onwards the river levels rose rapidly to 1.61m at 23:45 and continued to rise into the 3 January 2018 with a peak of 2.947m at 12:00. In comparison with the historic flood events in January 2005 and December 2015 where river levels raised to in excess of 7.2m the event in January 2018 showed levels at least 4m less than this.

As can be seen from the comparison of the river levels from other flooding events in Rockcliffe and the vicinity, the levels experienced in January 2018 were considerably lower than those in 2005 and 2015. It is therefore considered that the flooding at Rockcliffe was not caused by a fluvial event.

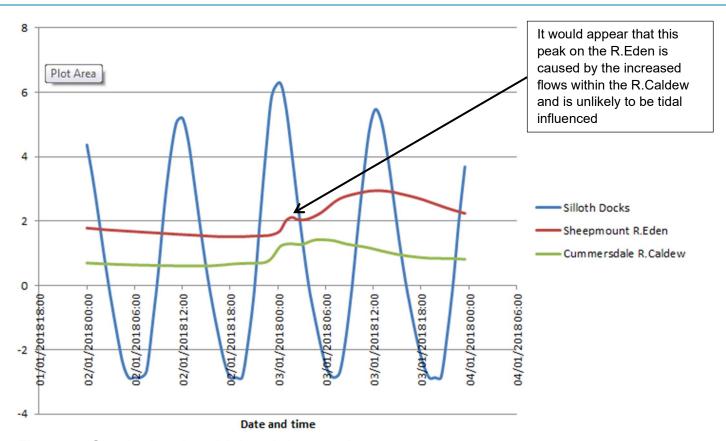
Figure 8: Graph showing tidal and river peaks

However, it was noted when considering the river levels on the 2nd and 3rd of January 2018 that a small increase in levels occurred at approximately 00:30 on 3rd January which appeared to coincide with the timing of the tidal event. It was considered unusual as it had always been considered that a tidal event would not reach as far up the catchment as Carlisle. Further investigations were made which considered river levels on the River Caldew which feed into the River Eden upstream of the Sheepmount. It was discovered that there had been a peak in the river level on the River Caldew which coincided with the small increase on the River Eden at approximately 00:30 on 3rd of January. It was therefore concluded that the initial river level peak on the River Eden was not due to the tidal event. The following graph indicates this.

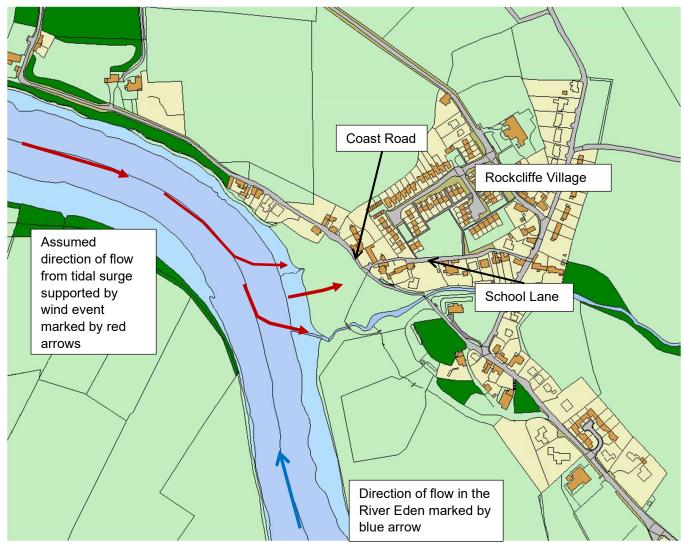
Figure 9: Likely flow routes during the Storm Eleanor flooding event on 2nd January (It is possible that the different routes were observed at different times)

The following diagram indicates the route of the flood water from the River Eden towards Rockcliffe

As is shown within Figure 9 above, the source of water which flooded Rockcliffe Coast Road / School Lane is reported to have entered from the River Eden via the flood plain. It is understood that the tidal surge supported by the strong winds were funnelled up the Solway Firth Estuary and forced across the flood plain in the location of Rockcliffe. The flow in the River Eden from the Carlisle direction, although not close to record levels, also would contribute to the volume of flood water in the Rockcliffe area. No reports of any flooding from Rockcliffe Beck or surface water were reported on the 2 January 2018.

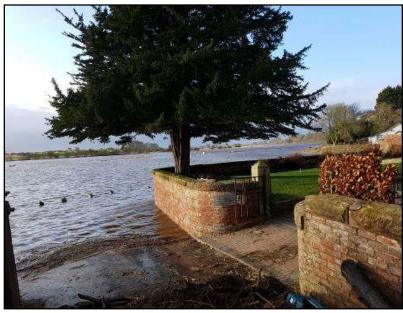
Photograph 1: During the second high tide on 3rd January 2018 looking towards the River Eden.

No significant waves during the second high tide on 3rd January but it shows the edge of the trash line in the bottom of the image. The coast road is also flooded during this high tide.

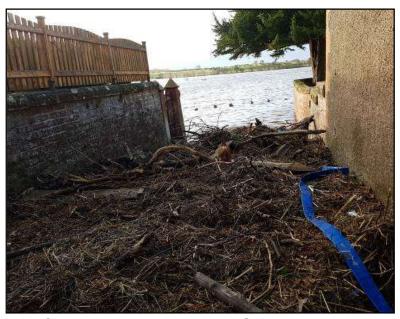
Photograph 2: Post the flood event looking down School Lane at the debris.

The volume of debris suggests that wave action has played a part in this, pushing the debris into the narrow road known as School Lane.
