# Croglin

## Flood Investigation Report No 66

**Flood Event 28<sup>th</sup> June 2012  
And  
23<sup>rd</sup> July 2013**

This flood investigation report has been produced by Cumbria County Council as a Lead Local Flood Authority under Section 19 of the Flood and Water Management Act 2010.

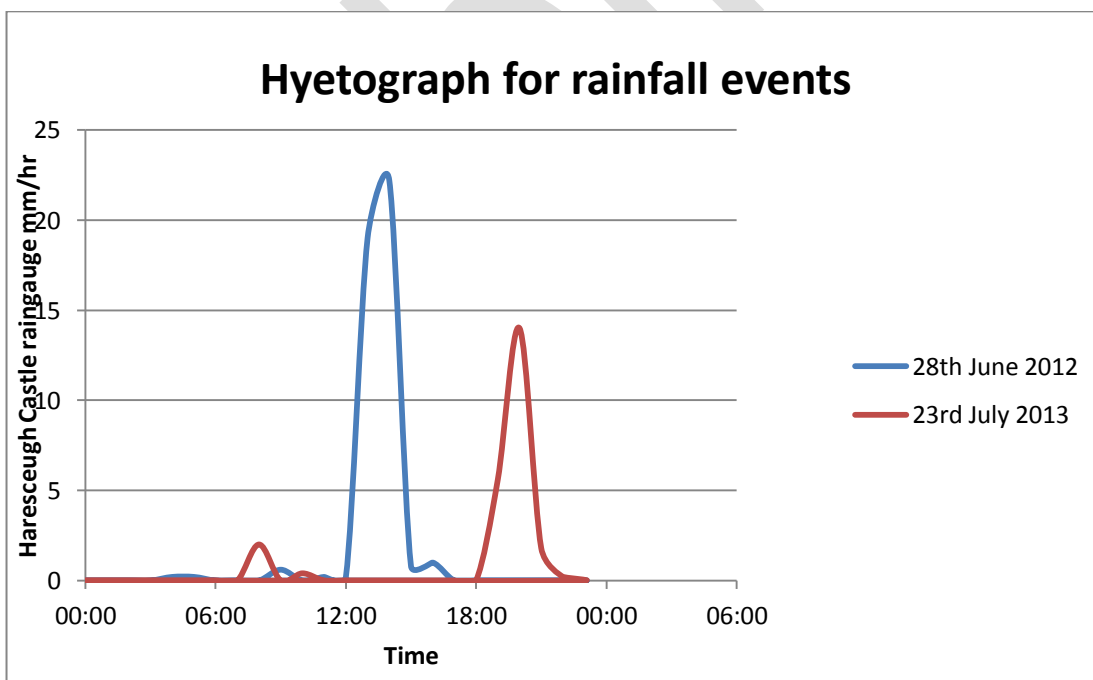
**Figure 2: Rainfall hyetograph for 28<sup>th</sup> June 2012 and 23<sup>rd</sup> July 2013.**

On 28<sup>th</sup> June 2012 a total of 44.2mm of rainfall was recorded at Haresceugh Castle with 42.2mm of the rainfall occurring between 12.00 and 14.15hrs.

During the 23<sup>rd</sup> July 2013 event a total of 21.4mm rainfall occurred within 3 hours.

The rainfall total recorded at Haresceugh Castle for June 2012 was 237% of the long term average. The long term averages used are provided by the Met office and are calculated using their 1961-1990 datasets.

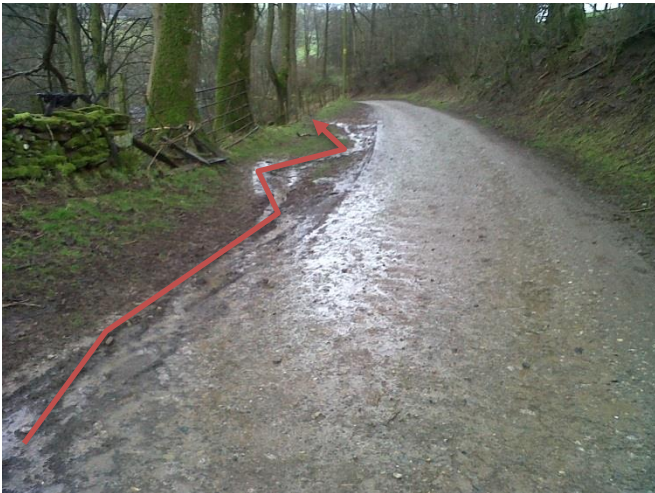
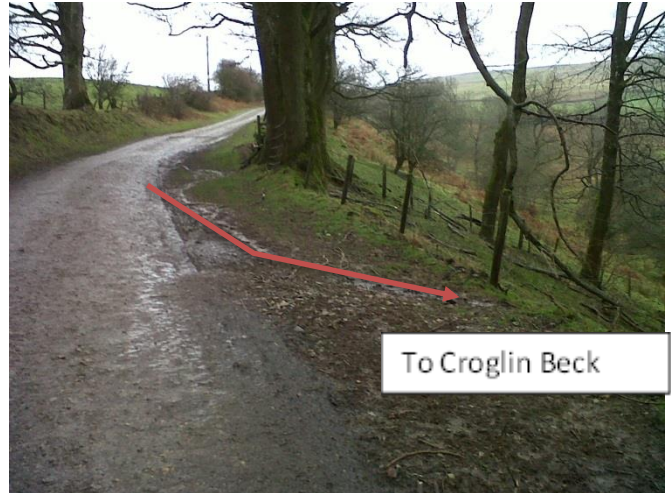
**Photographs 1 & 2: Surface water running towards Croglin Beck after the higher cross ditch**

The upstream cross ditch and the track profile are deflecting water towards Croglin Beck on the higher part of the track.

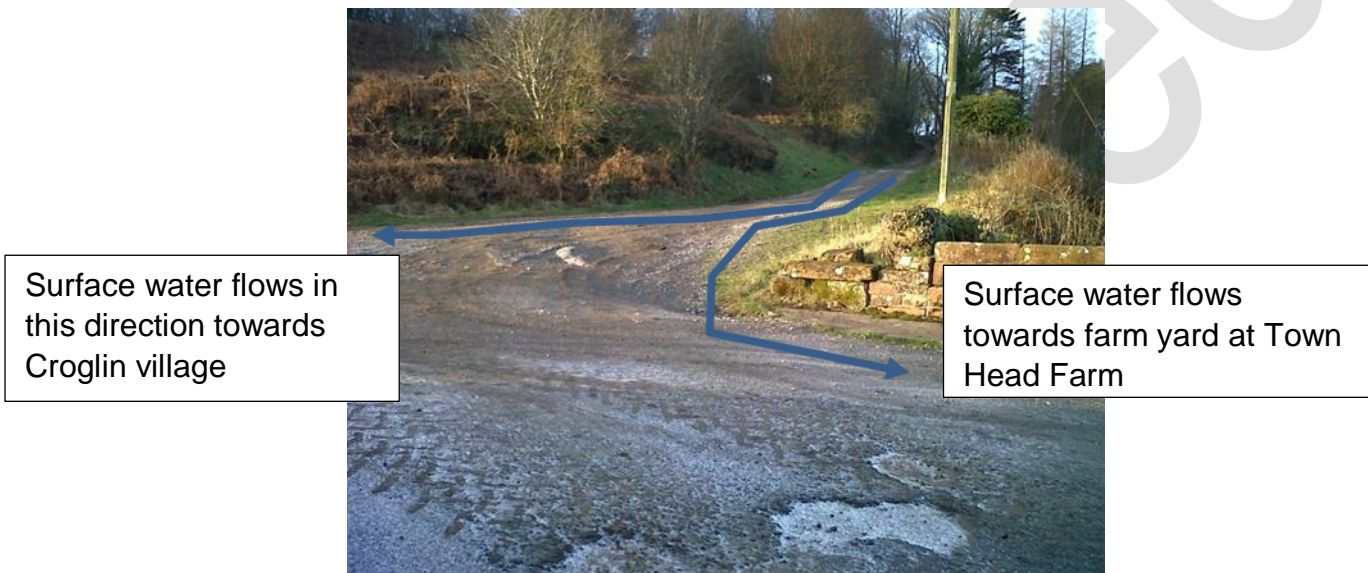
**Photograph 5: Track leading up fell side near Town Head Farm**

At Town Head farm the track meets the tarmac surfaced road. Here some of the surface water flow runs through one of the yards at Town Head Farm with the remainder running on down into the village and ultimately the B road.

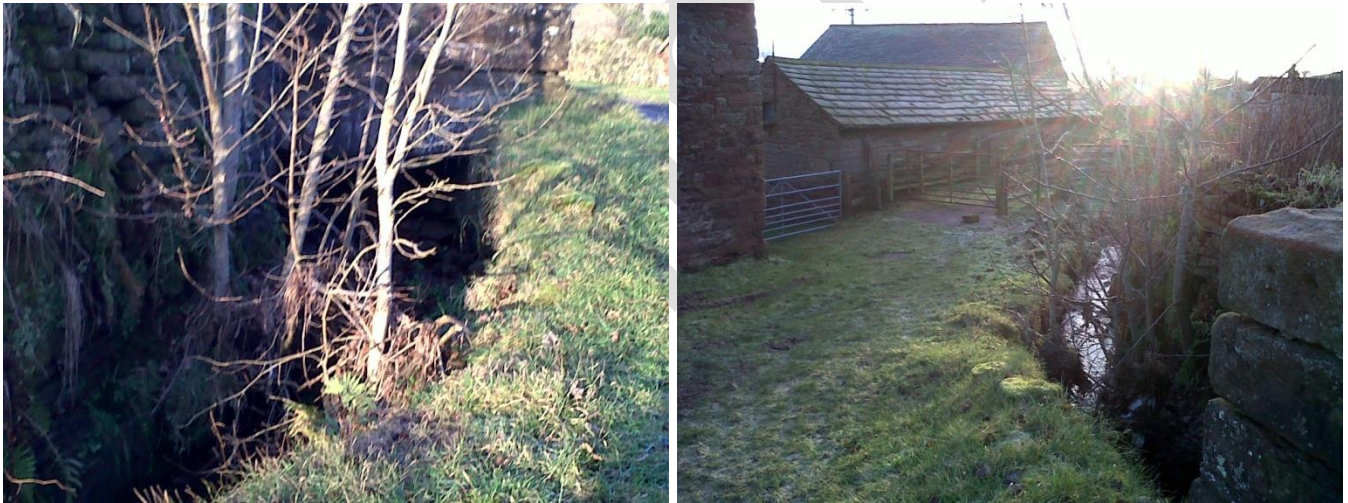
**Photograph 7 & 8: Tree in Croglin Beck near the bridge at Town Head Farm**

Photographs 7 & 8 show the trees in Croglin Beck, which caused water to flow from the watercourse and run between buildings at Town Head Farm. After flowing between the buildings the flood water flowed back towards Croglin Beck. Residents have commented that the trees used to be cleared on an annual basis and burned on the village bonfire

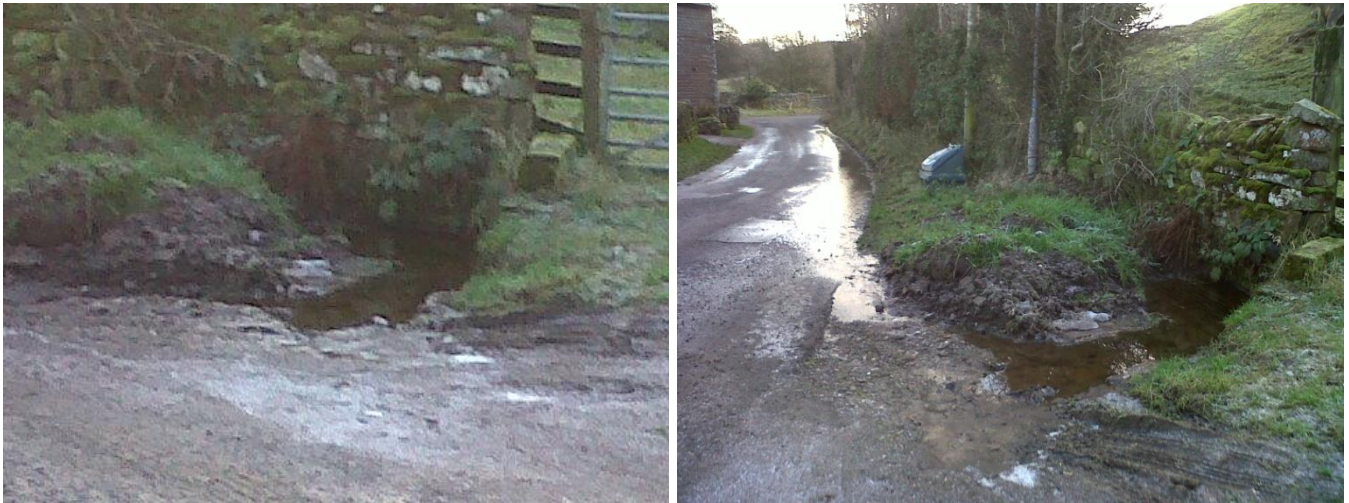
**Photograph 9 & 10: Evidence of blocked drainage pipe near Quarry Farm**

The blocked drain outside Quarry Farm has also been identified as a drainage issue as it creates a situation where water is at present constantly running on to the road as shown in photographs 9 & 10. During heavy rainfall events these flows are increased and create a significant flow of water towards the village.

Riparian Landowner	Improvements to Croglin Beck banks to prevent flows escaping downstream from Holme View	Increase height of watercourse bank to prevent overspill. COMPLETED
CCC LFRM	Identify ownership of blocked drainage pipe near Quarry Farm	Request riparian owners to clear their section of the blocked culvert. (part under highway) - ONGOING
CCC LFRM	Consider options to prevent future flooding.	CCC LFRM to review possible options and where appropriate apply for FCRM GiA funding. Next FCRM GiA submission date is March 2014.
Natural England	Catchment Management Officer to liaise with landowner to investigate runoff from fell side and farm buildings	Support land owner to identify best methods to deal with surface water
Residents	Continue to report flooding issues to the relevant authorities	Use contact details in Appendix 3 to report any future flooding

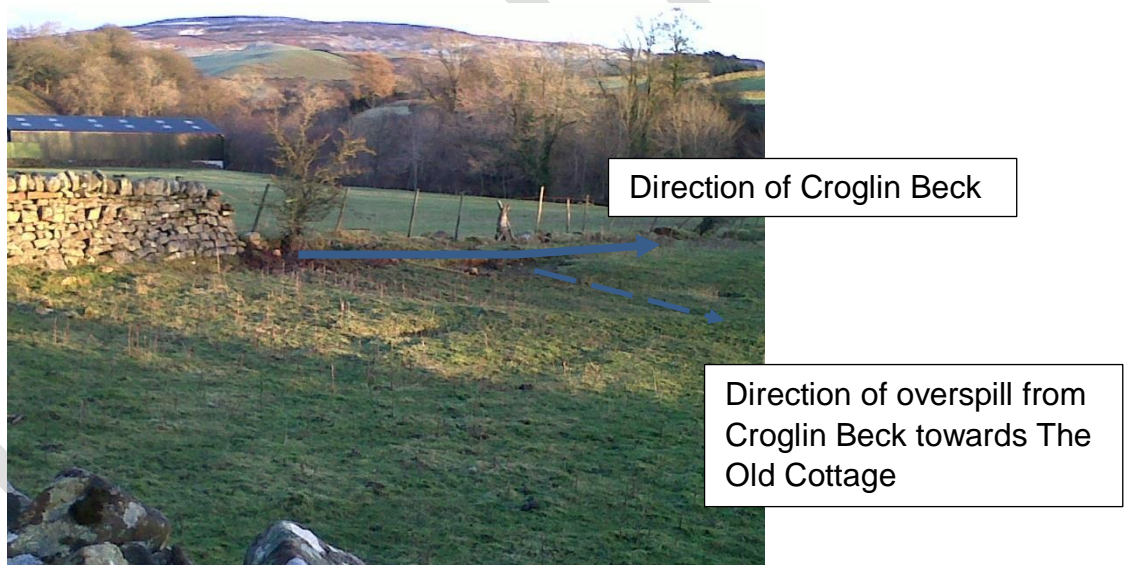
**Photograph 11: Croglin Beck downstream of Holme View / Clint View**

During the 28<sup>th</sup> June 2012 event flood waters escaped from Croglin Beck at the location shown in photograph 11 and flowed towards The Old Cottage where it entered the cottage causing internal damage. The flow route is also indicated in figure 3. Works have now been carried out by residents to prevent flows escaping from Croglin Beck at this section.
