Glassonby

Flood Investigation Report No 64

Flood Event 28th June 2012

This flood investigation report has been produced by Cumbria County Council as a Lead Local Flood Authority under Section 19 of the Flood and Water Management Act 2010.

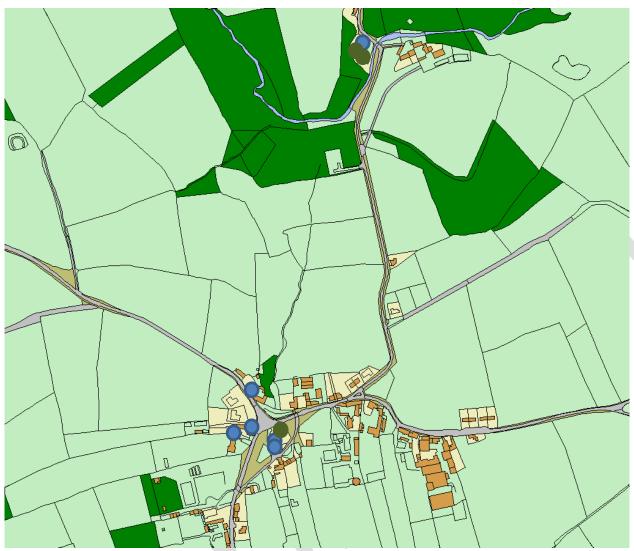
Figure 2: Internally flooded properties indicated by blue dots / Externally flooded properties indicated by green dots

CCC have received reports indicating that 6 properties were flooded internally during the flooding on 28th June 2012 with 3 further properties being flooded externally to either driveways or gardens.

The following plan indicates the locations of the flooded properties.

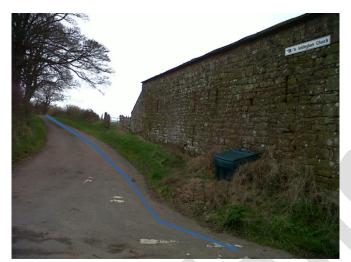
Photograph 2: U3093 towards Adlingham Church

Surface water will run from the side road and flow towards Glassonby

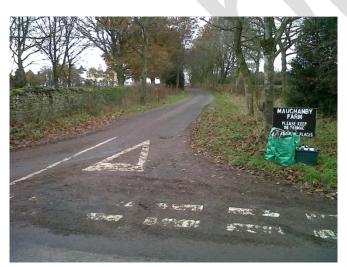
Photograph 3: Road towards Maughanby Farm

along the surface of the road towards Glassonby

Again surface water will run
