Renwick

Flood Investigation Report No 61

**Flood Event 28th June 2012
And
18th May 2013**

This flood investigation report has been produced by Cumbria County Council as a Lead Local Flood Authority under Section 19 of the Flood and Water Management Act 2010.

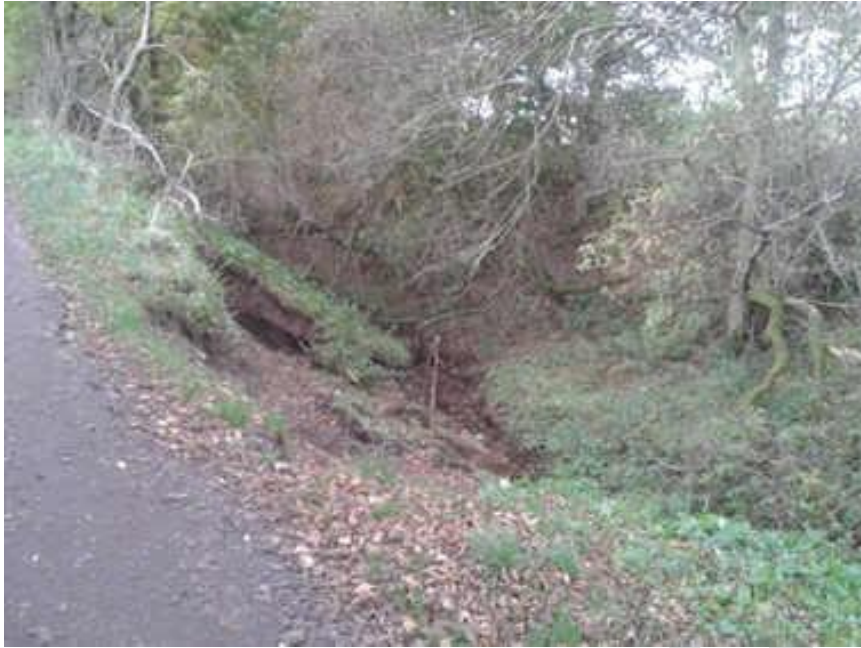
Flows from the Green Rigg track are diverted into the beck in an uncontrolled manner which contributed to the significant damage to the watercourse embankments illustrated in photograph 1. The embankment slippage added to the mud and debris already within the watercourse causing significant blockages on the open slabbed watercourse clogging grills above and prior to the culverted section close to Lilac House.

Photograph 1: Landslip near the junction of Green Rigg track and Ormthwaite Road

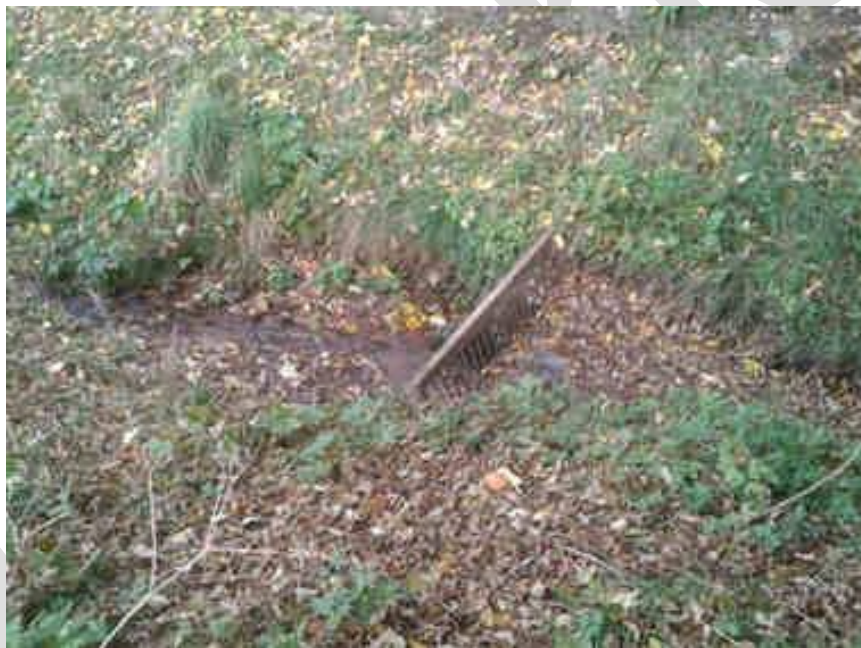
Photograph 2: Grill in watercourse to capture leaves and debris

Grills as shown in photograph 2 have been installed along the watercourse to capture leaves and debris to try to prevent blockages in the culverted section through the village. However, during the events detailed, these grills become overwhelmed. Photograph 3 shows the actual flows experienced on 28th June 2012 and photograph 4 shows the watercourse channel in normal conditions.

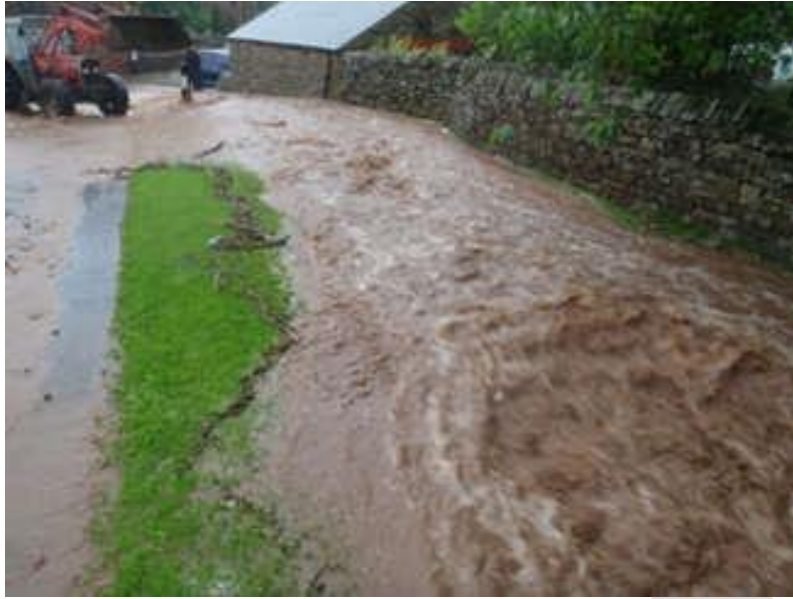
Photograph 3: Flow on 28th June 2012 overwhelming culvert entrance

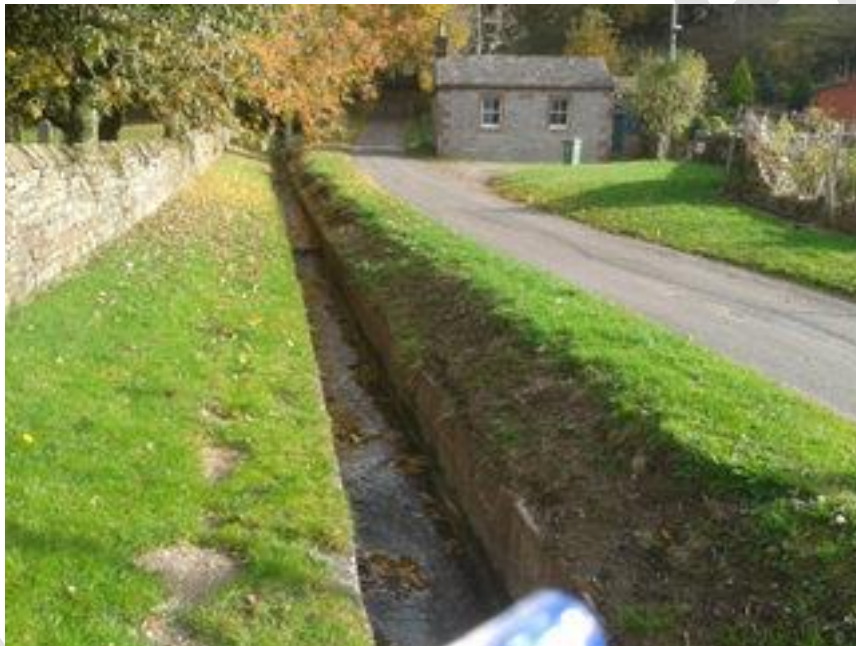
Photograph 4: Watercourse channel in normal circumstances parallel to Outhwaite Road

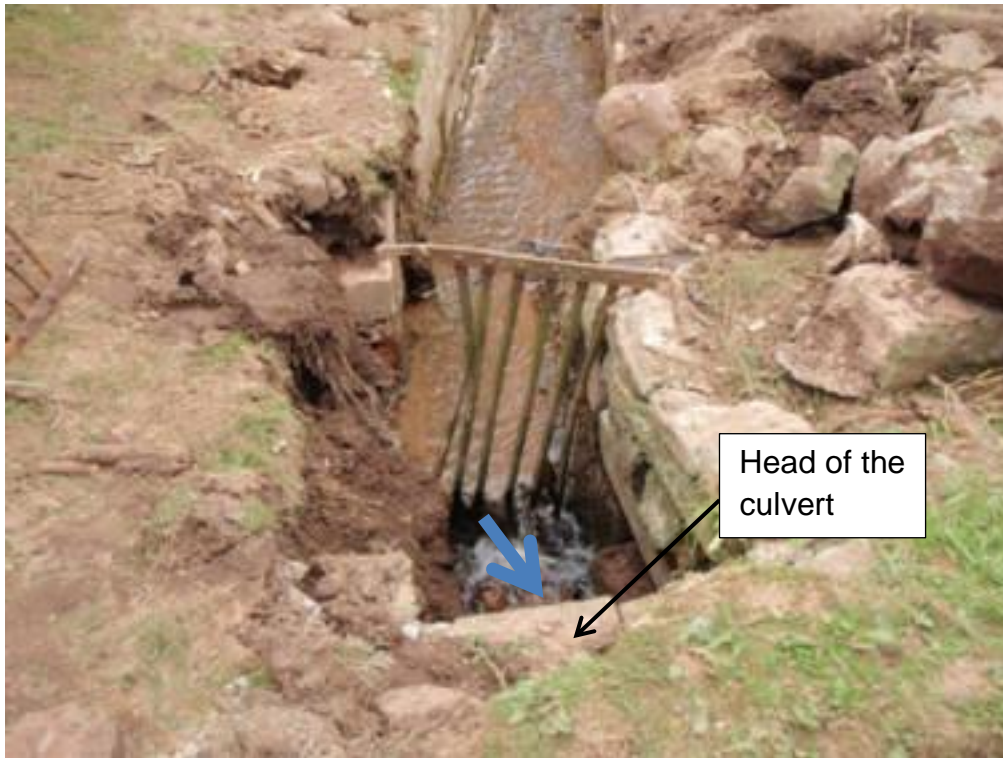
The following photograph taken after the channel was cleaned out shows the damage caused by the event on 28th June 2012 and highlights the damage caused by the force of the water.

Photograph 5: Damage to culvert entrance following 28th June 2012 event

Once the watercourse reaches the village it enters the culvert shown in photograph 5. In normal circumstances the flow enters a 300mm diameter culvert which runs along the main road, turning at approximately 90 degrees into Kirkoswald Road. The culvert flows down Kirkoswald Road and discharges into Harberry Beck.

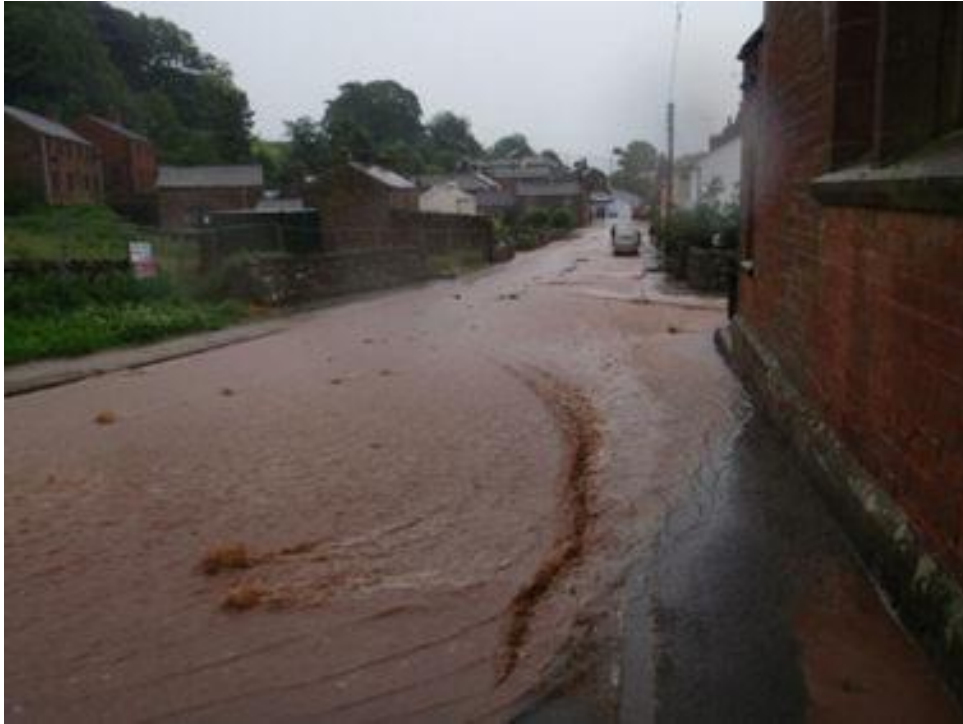
Photograph 6 indicates the volumes of water that was not able to enter the main culvert into the village and proceeded through the middle of the village via the main road.

Photograph 6: Surface water flows on C3004 on 28th June 2012

Flood water flowed down the main road towards Kirkoswald Road topping over dropped kerbs provided at access points to drive ways into properties. This in turn led to internal flooding of the 9 properties as indicated previously in figure 3.

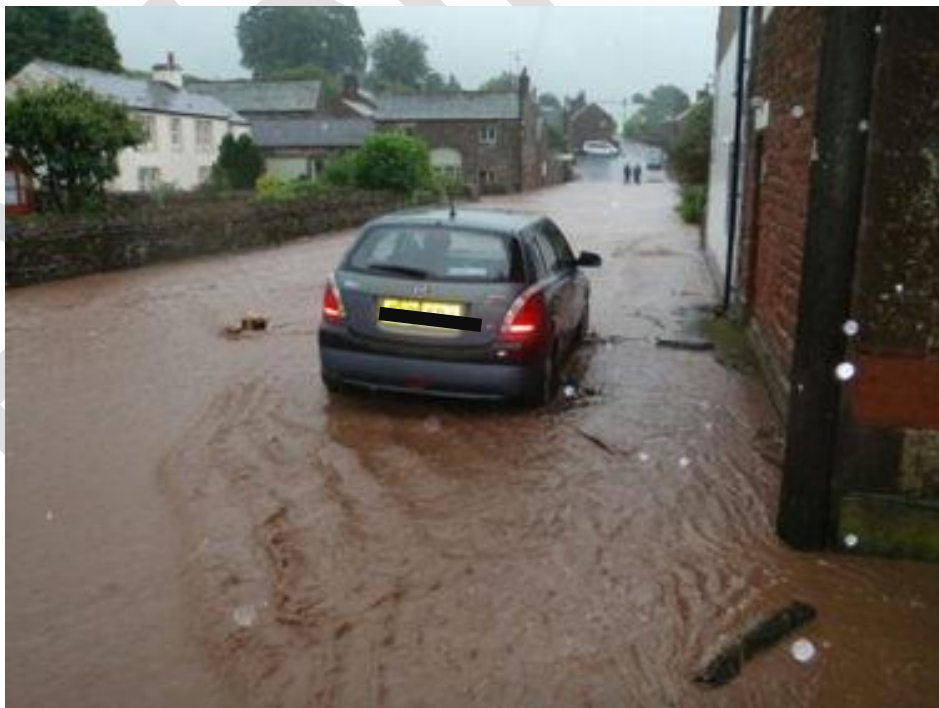
Flood water overwhelmed the existing gullies, which were also blocked by mud and debris. Photograph 7 indicates the extent of flooding on the main road.

Photograph 7: Area where surface water collected causing flooding

Action by	Recommended Action	How
CCC Highways	Clear debris from highway and ensure gully pots and connecting pipework are clean	Use excavators and street sweepers to clean debris from the highway – COMPLETED Use jetting equipment to clear silt and debris from gully pots and connecting pipework - COMPLETED
CCC Highways	Maintain gully pots and pipework of highway gullies	Continue to maintain gully cleaning schedules. ONGOING
Riparian Owners	Establish who owns the watercourse as it enters the village	LFRM ordered Land Registry search. COMPLETED but no details on ownership.
Riparian Owners with 'overflow system' (original watercourse) running through their land	Ensure the watercourse running through their land is running freely as required.	Work with CCC to identify blockages and arrange suitable repairs.
CCC LFRM	CCTV survey of culvert and associated connections	Use survey cameras to obtain information on the condition of the culvert. Partially completed 26 th /27 th February 2014 and 28 th March 2014. ONGOING
