Appleby-in- Westmorland

Flood Investigation Report

Flood Event 5-6th December 2015

This Flood Investigation Report has been produced by Cumbria County Council as the Lead Local Flood Authority under Section 19 of the Flood and Water Management Act 2010 in partnership with the Environment Agency as a key Risk Management Authority.

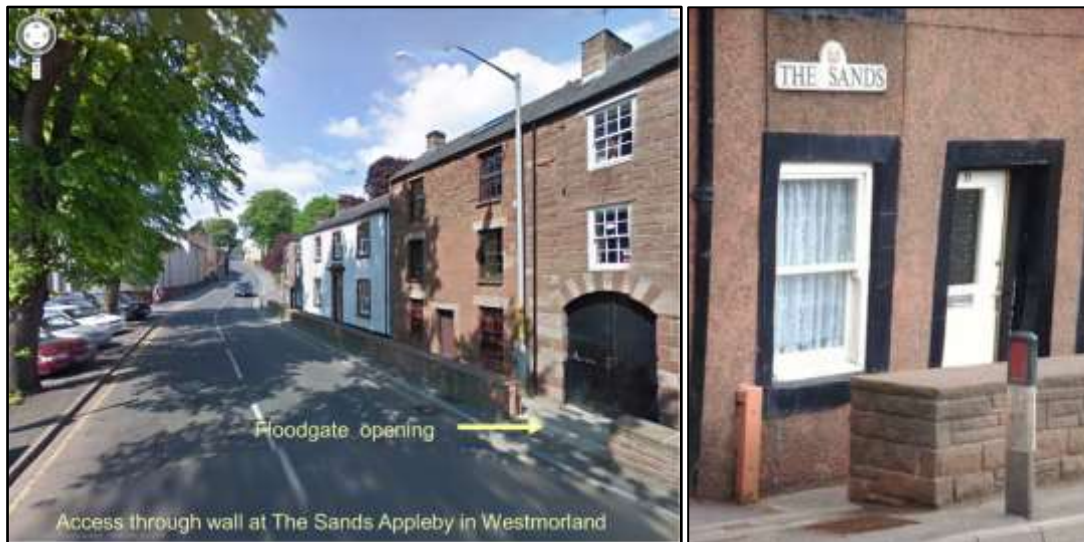
In 2007, Defra launched a pilot grant scheme in Appleby that provided property level flood protection. This included demountable flood barriers, pumps, new drains, water resistance external render and floodwalls, Photographs 1 & 2.

Photographs 1 & 2: Property level flood defence measures introduced. Wall in photo on right is a CCC highways wall not part of DEFRA pilot

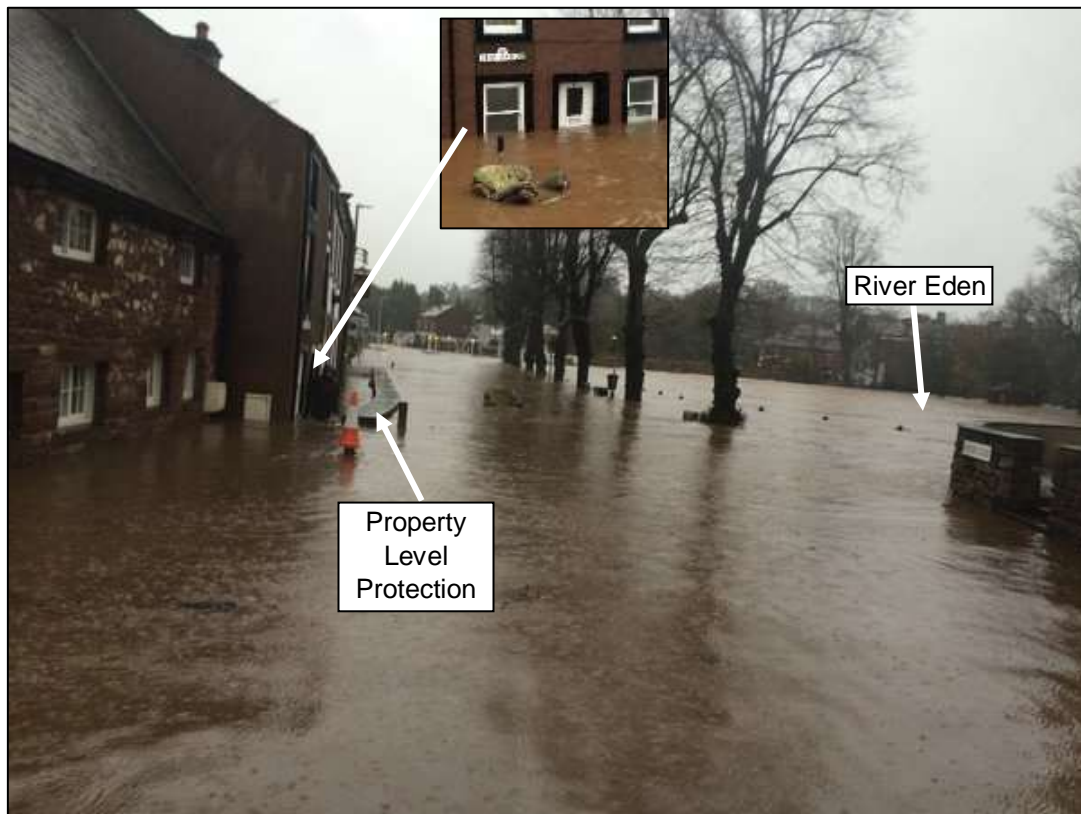
Photograph 3: Flooding at The Sands, Appleby

In 2007, as part of the Pilot Property Level Protection Grant Scheme, a short section of wall was constructed in front of the terrace of properties along The Sands adjoining The Grapes Inn, to provide additional protection from out of bank flows. Flood gates were installed in the access gaps. Residents reported that given the magnitude of the event, all installed property level protection measures were overwhelmed, Photograph 3. At its peak the flood water level on The Sands was recorded up to 1.8m above ground level and several of the lowest lying properties were flooded up to mid window height.

The Environment Agency has investigated the feasibility of constructing a flood defence scheme to protect The Sands area on several occasions over recent years, however this has proven to be technically difficult due to the constraints of the Bridge and would also result in unfavourable aesthetic impacts to this area of the town which have previously been deemed unacceptable to the local community.

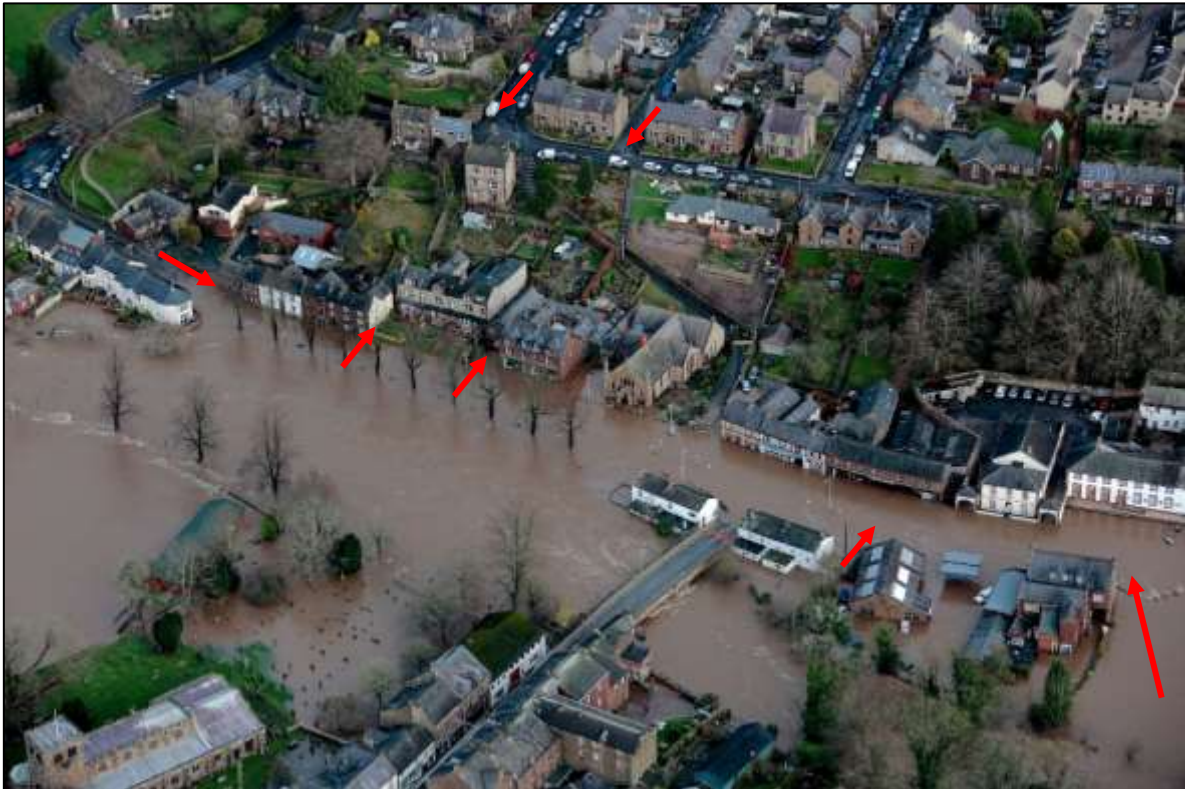
It was reported that surface water runoff from Clifford Road, to the rear of The Sands properties also contributed to flooding of properties in this location. See Photograph 4.

Photograph 4: Flood at the Sands, Appleby

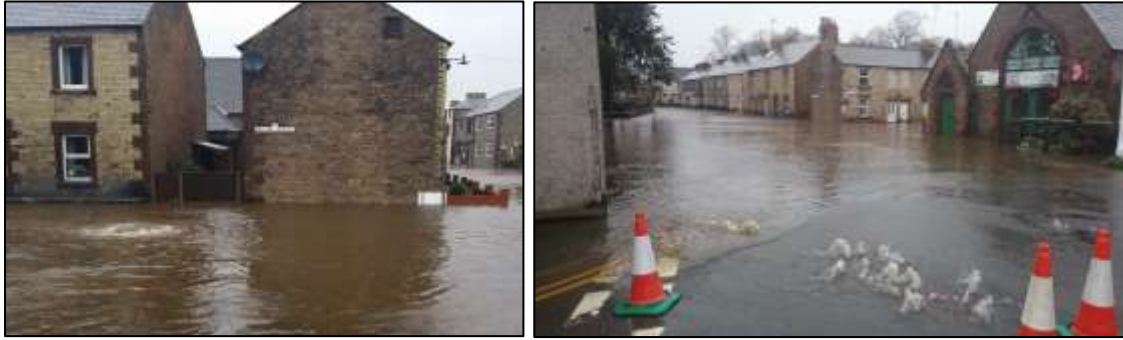
During the flood event, due to the high river level, the flap valve on the outfall closed to prevent the River Eden backing up into the town. This resulted in the Doomgate Fluvial Flows and local surface water runoff backing up the drainage system and surcharging the pipes and manhole covers on the culvert at Doomgate. Initial flooding was observed from manholes at the Doomgate and Holme Street junction and the continued surcharging flooded properties on both Holme Street and Chapel Street. See Photographs 5 and 6.

Photographs 5 and 6: Doomgate Culvert Manhole Surcharged, 11:00hrs (left) and 13:30 (right) on 5th December

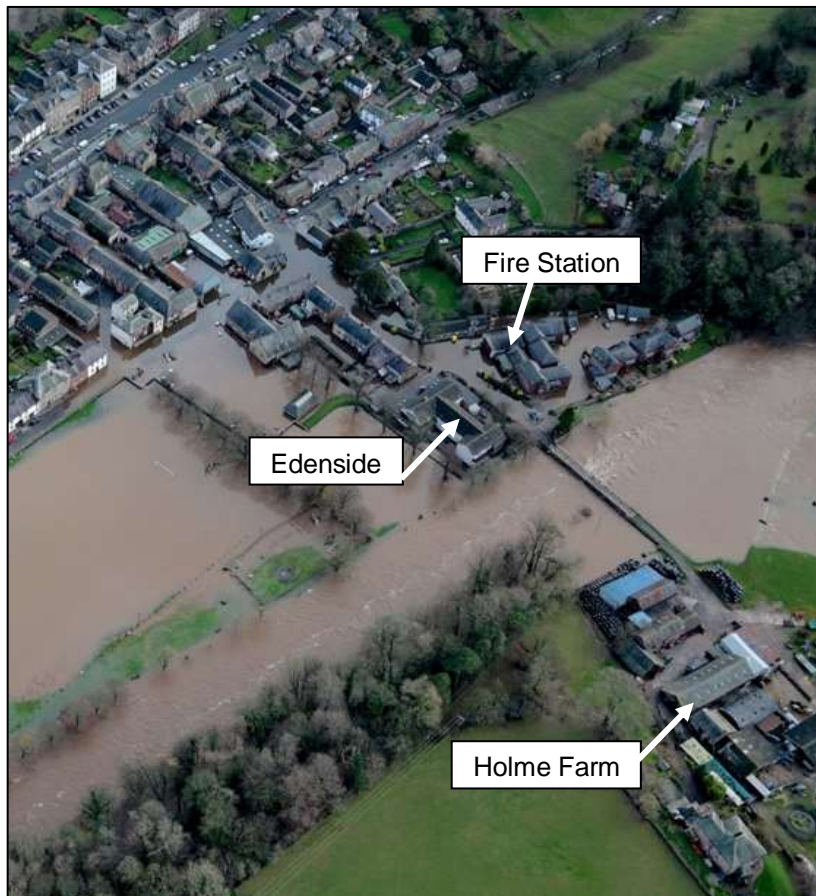
Photograph 7: Flood Extent on Holme Street

Holme Street was flooded due to a combination of surcharged surface water drainage systems, as described above from Doomgate, runoff from Chapel Street and surface water ponding at the low point

on Holme Street. At the peak of the event flood water also overtopped the flood defences at the Broad Close car park - an additional flooding mechanism which will be discussed in the following section of the report. It was reported that runoff from Holme Street collected in Holme Court.

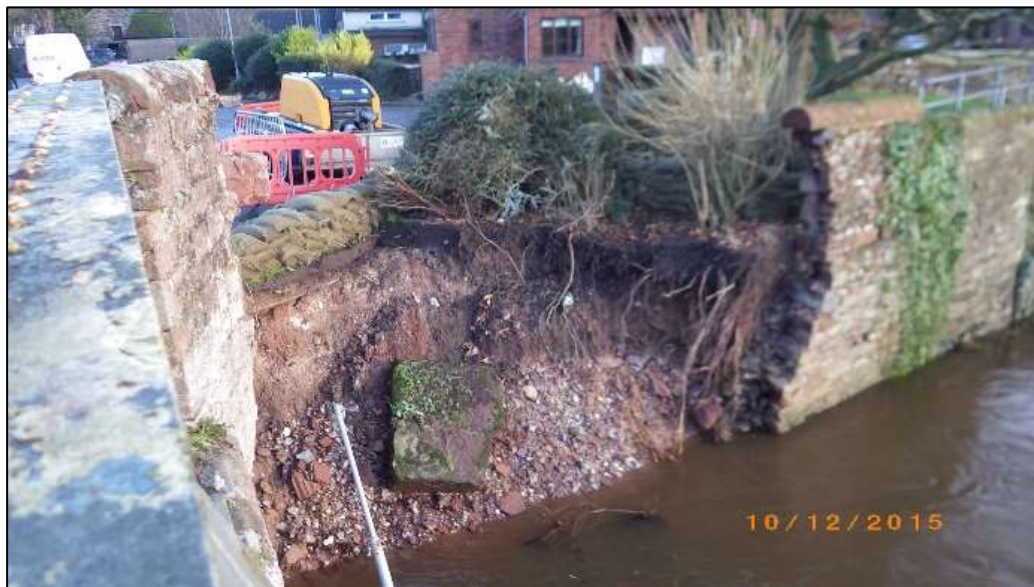
A local resident confirmed that the river wall, on the left bank, immediately downstream of Holme Farm Bridge did not overtop. A section of this retaining wall however collapsed outwards into the river, after the peak of the flood event, in the early hours of 6th December 2015. See Photograph 9.

Photograph 9: Left bank retaining wall collapsed

Following the flood event, the collapsed section of the retaining wall was protected by sand bags and barriers were erected for public safety. The necessary repair works to the wall are now complete.

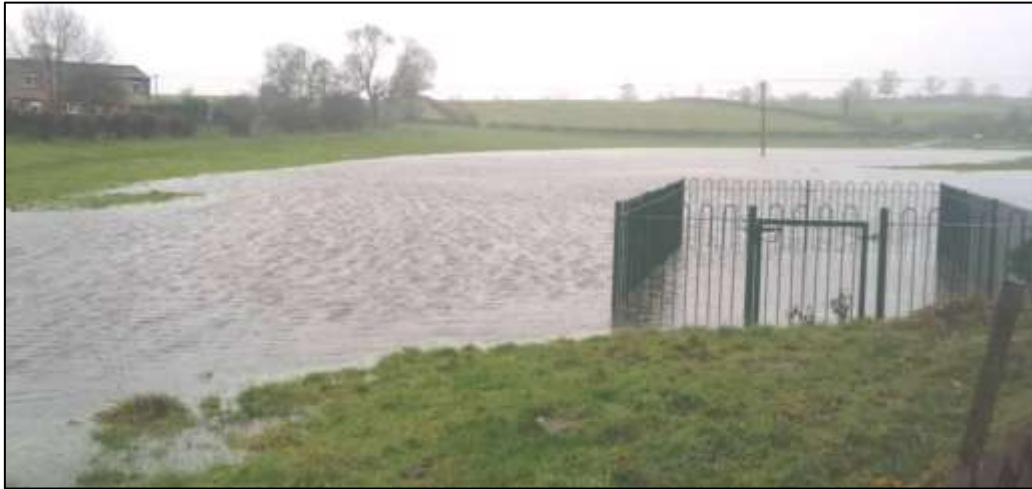
At the upstream end of the Doomgate culvert inlet on Colby Lane, a field acts as a flood plain and contributes runoff to the culvert. Photograph 10 below is from a previous flood event however demonstrates the likely ponding effect experienced in this location during the December 2015 event.

Photograph 10: Doomgate culvert inlet at Colby Lane (2005)

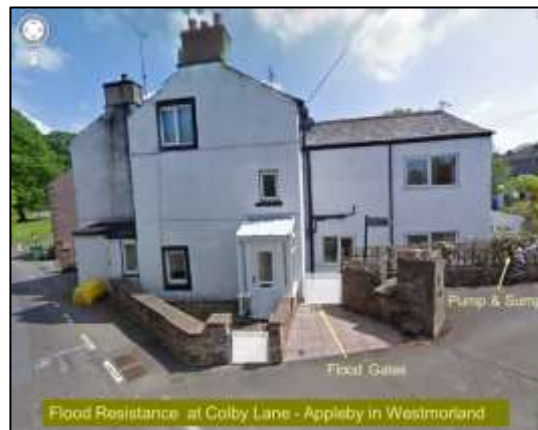
Three properties at the upstream end of the Doomgate culvert have fitted property level flood protection measures including flood gates and pumps, see Photograph 11. These three properties did not flood during the 2015 event.

Photograph 11: Properties on Colby Lane - Property level measures

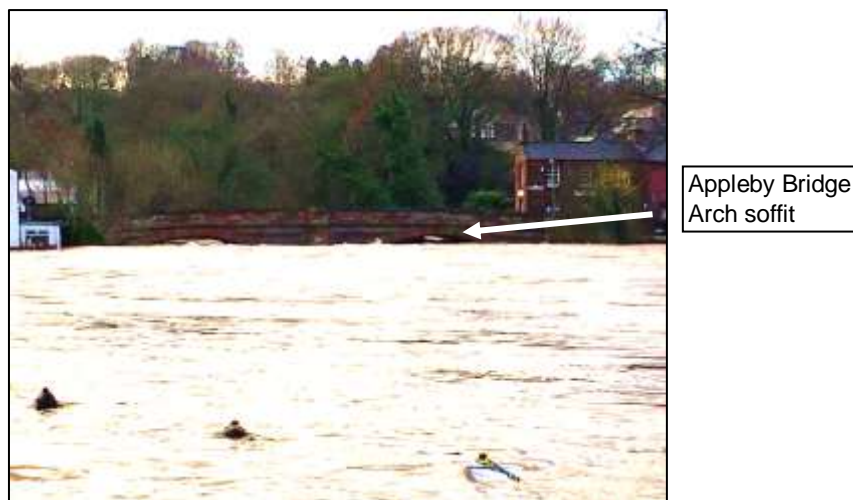
Rebuilt in 1889, St Lawrence's Bridge is a Grade II listed road bridge over the River Eden linking the east and west sides of the town and consists of two wide stone arches. The bridge along with the narrowed channel upstream of the bridge form a constriction to river flows and often cause elevated river levels immediately upstream. The December 2015 event was so severe that river levels reached the bridge soffit level, Photograph 12.

Photograph 12: River level just below the bridge soffit level before the event peak

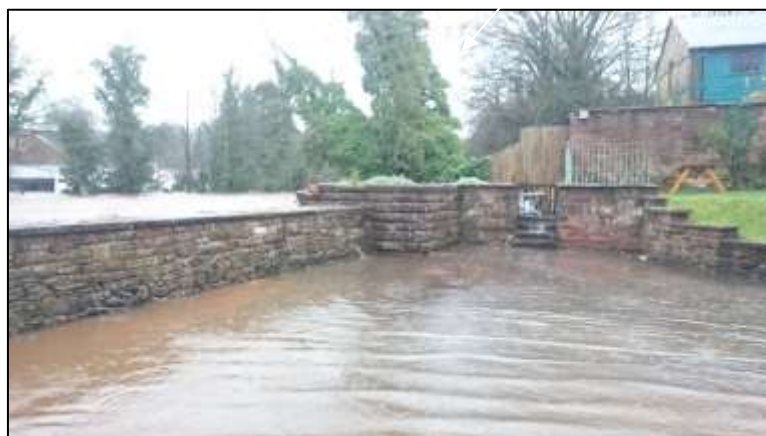
Initially, on 5th December 2015, the river water started seeping through the left bank stone wall immediately upstream of the bridge, Photograph 13. Flood water also surcharged in large quantities from the surface water drainage manhole behind the defences on the downstream side.

Photograph 13: Stone wall on the left bank - water seeping through 13:22 hrs 5th Dec. '16

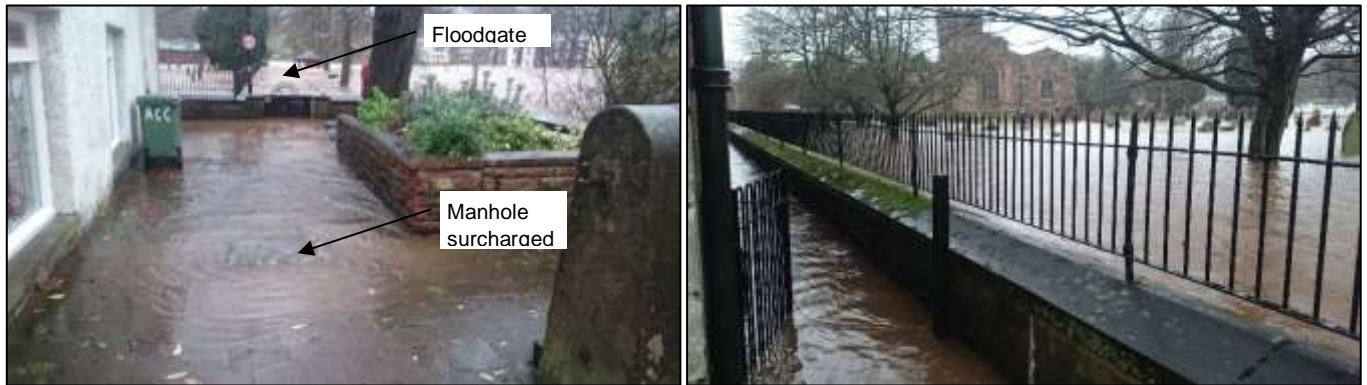
The surface water manhole, located behind the floodwall, surcharged at Factory 33 on Bridge Street. This was due to the surcharging of the surface water drainage system caused by the failure of a flap valve on the outfall to the River Eden. See Photographs 14 and 15.

Photographs 14 and 15: Surcharged manhole behind the flood defence 13:40 5th Dec. '15

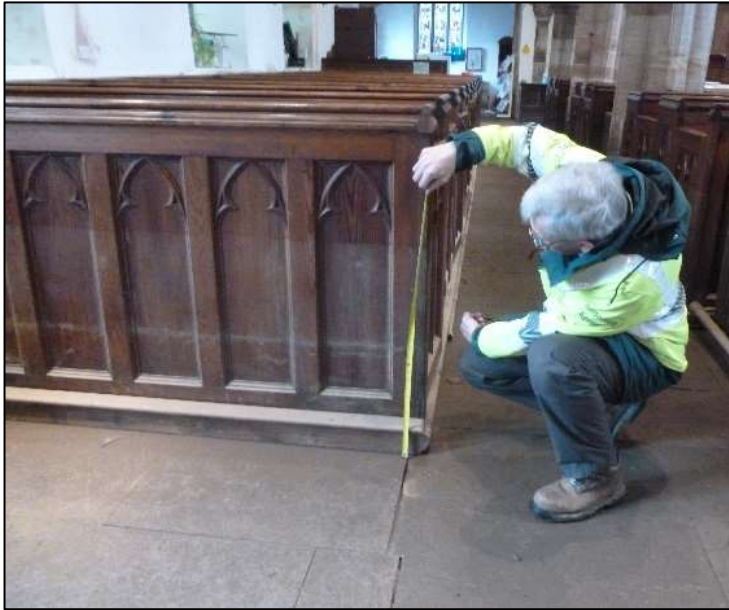
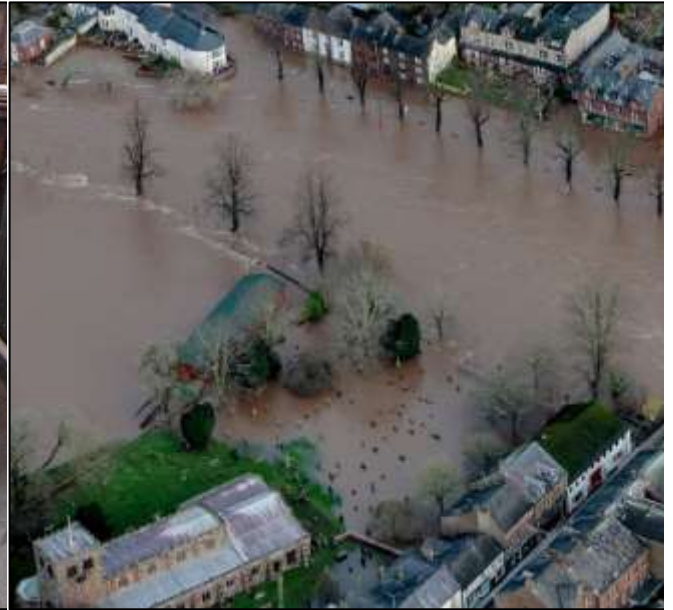
During the December 2015 flood event, the river water rose and overtopped the embankment which resulted in water ponding in the crypt of St Lawrence church, see Photograph 17. The church's flood defences are dependent upon two sump pumps installed on top of the flood embankment, which are triggered when water enters the crypt up to a depth of 50mm. Due to a wider power failure in the town, these pumps failed to operate and thus the impact of the flood was heightened.

The church was reported to have flooded to approximately 700mm deep (Photograph 16) within 15 minutes via the doors and the crypt. The flood level recorded at the entrance of the church was 2.0m above existing ground level. Flood waters were reported to have receded by 04:00 on 6th December although water was still present in the churchyard.

Photographs 16 & 17: Flood data collection inside St Lawrence Church & Flood Extent

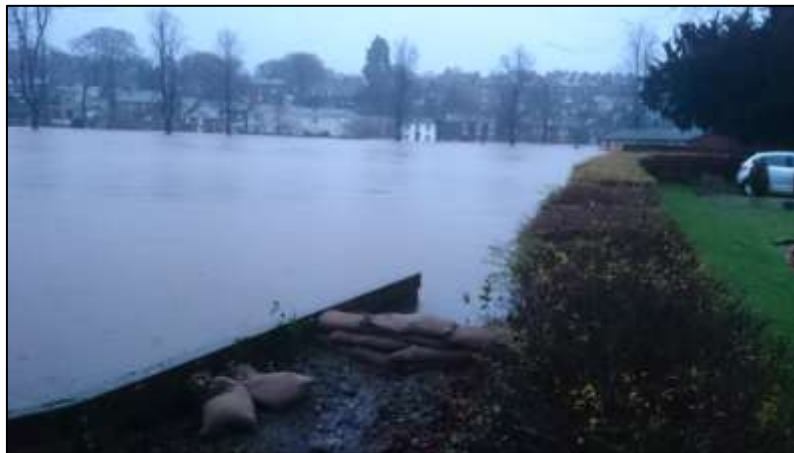
The flood embankment at the end of the flood wall surrounding the cricket ground was reported to have settled and had created a low point along the flood defence. Sand bags were placed at the low point in an attempt to bolster the defences as a temporary measure during the event (shown in Photograph 18).

Photograph 18: Embankment Settled at Cricket Ground – 15:44hrs on 5th December 2015

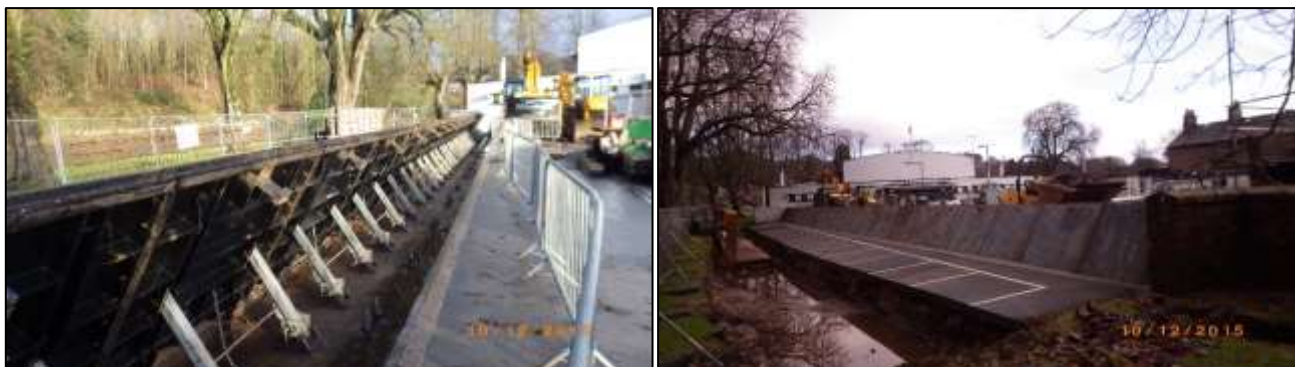
During December 2015, construction works to replace the existing flood defence barrier with a new floodwall were in progress, see Photographs 19 and 20. During the flood event, the flood barrier was operated/installed by the contractor Breheny who reported that the barrier was not overtopped. The area was however subsequently flooded due to the overtopping of the defences at Bridge Street resulting in water flowing towards Appleby Leisure Centre. Appleby Health Centre although located adjacent to the Leisure Centre is situated on slightly higher ground and as a result did not flood.

Photographs 19 and 20: After flood peak - Flood Barrier in Operation at Appleby Leisure Centre

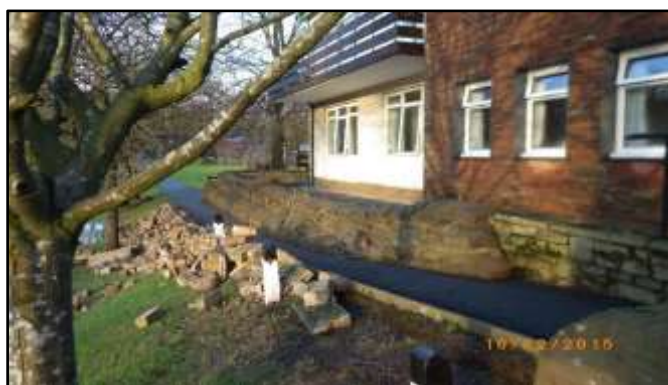
The wall on the left bank that protects the care home collapsed outwards towards the river (Photograph 23), evidence shows that it failed after the peak of the event when water levels were higher inside the defences than outside. The care home's entrances were protected by sand bags however it was reported that the home was flooded internally with flood water entering the property initially via the drains, water outlets and through the walls.

Photograph 23: Collapsed flood wall at Edenside Care Home

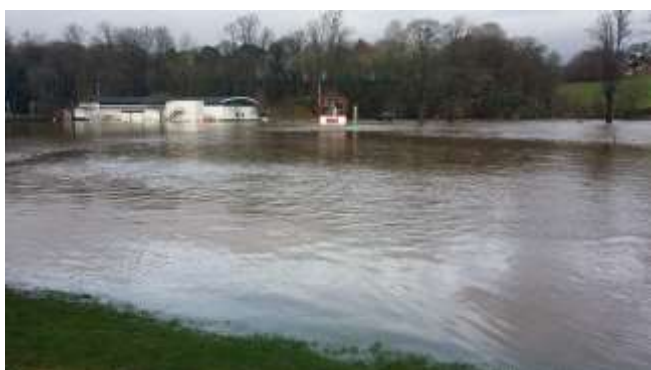
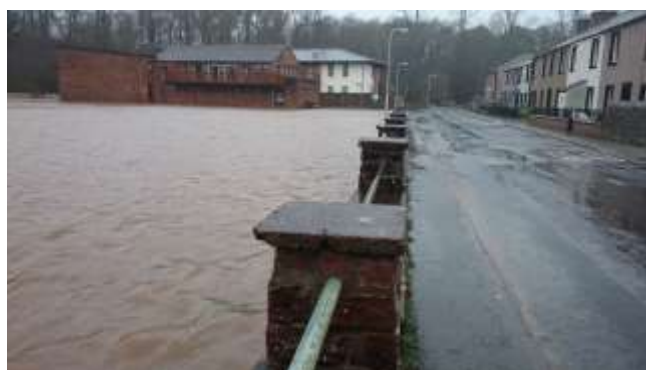
The Cricket Ground and King George's field on the left bank of the River Eden are not defended and are intended to be used as flood plain storage during a flood event, Figure 13 and Photographs 24 and 25. The floodwater deposited silt and debris across both the cricket and football pitch and caused significant damage to the park facilities, including the cricket clubhouse, Scout Hut and children's playarea. Both the cricket pitch and football pitch had to be relaid.

Photographs 24 and 25: Flood water Cricket Ground (left) and King George's Field (right)

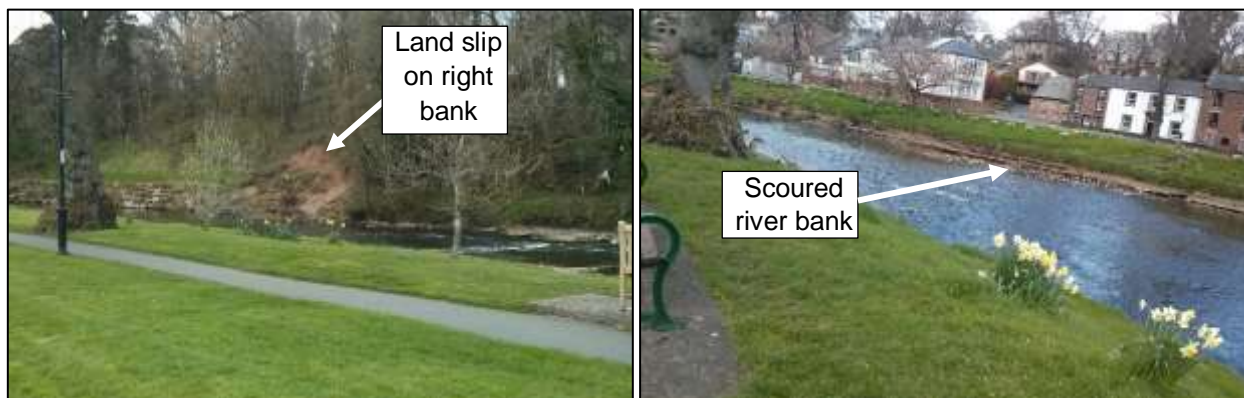
A land slip was observed upstream of the stone revetment on the right bank opposite King George's field, see Photograph 26. Also, scouring of the riverbank was observed on the right bank, opposite the Cricket Ground, see Photograph 27.

Photographs 26 (left) and 27 (right): Land Slip and Scour on Right Bank

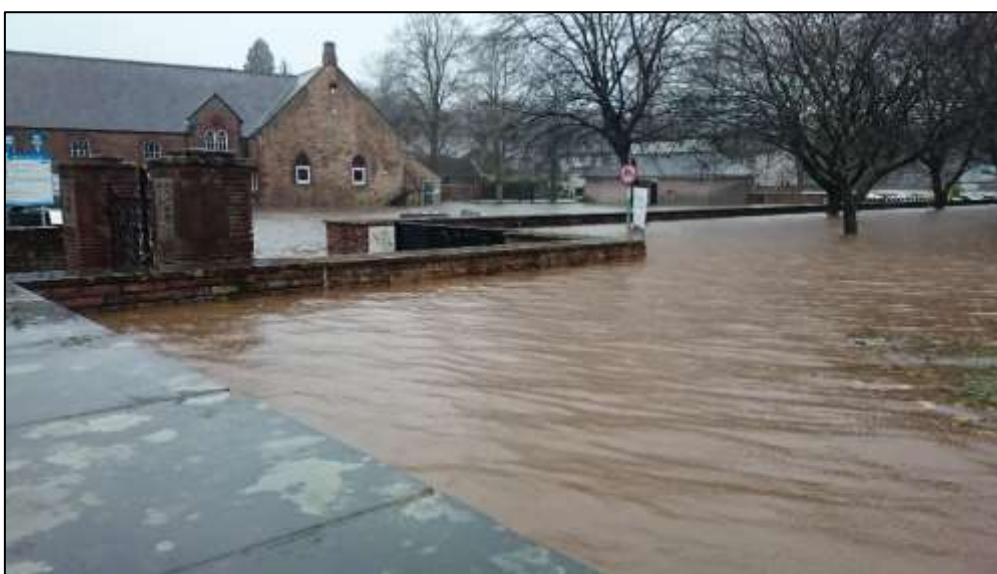
Photograph 29: Water ponding behind floodwall on Chapel Street

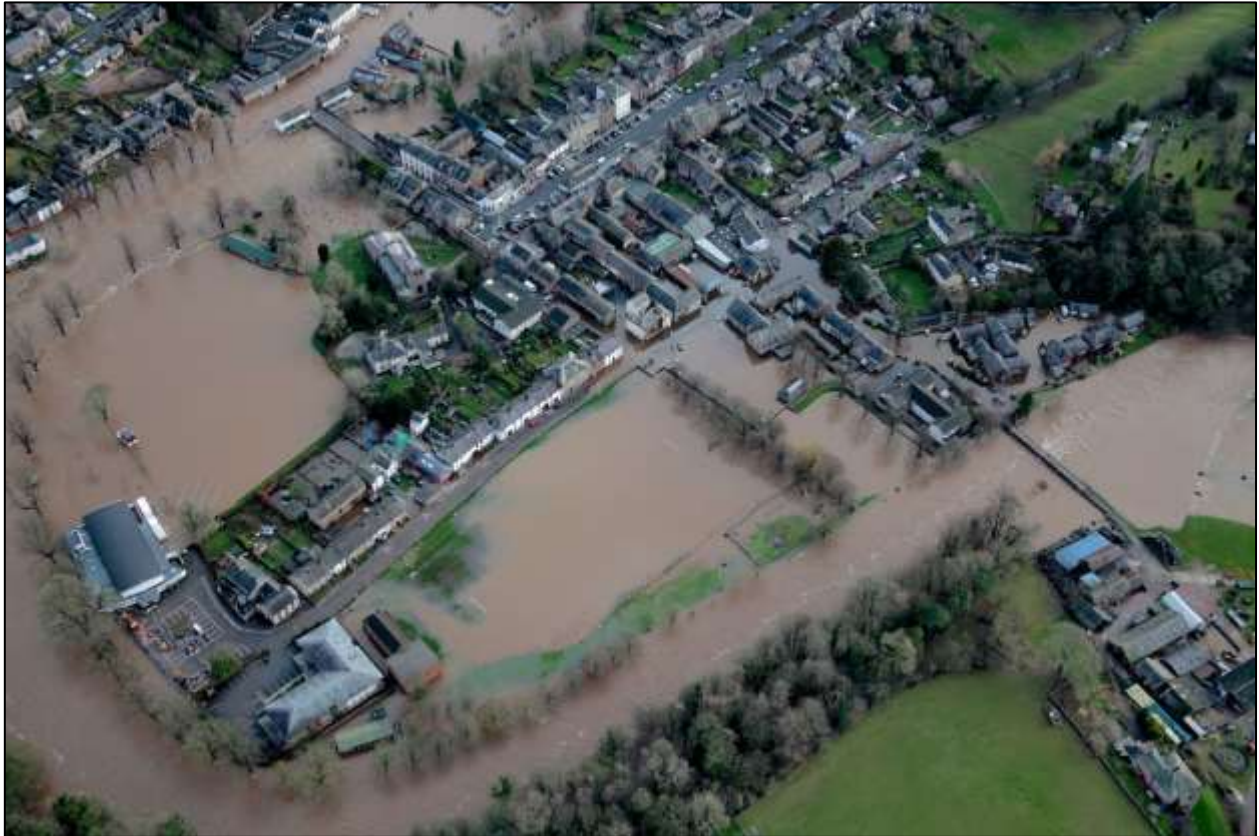
Photograph 30: Flood water from the Eden being held back by the defences. Water ponding behind floodwall on Chapel Street is from Doomgate culvert.
