Greystoke

Flood Investigation Report

**Flood Events 15th November 2015
and 5th December 2015**

This flood investigation report has been produced by Cumbria County Council as a Lead Local Flood Authority under Section 19 of the Flood and Water Management Act 2010.

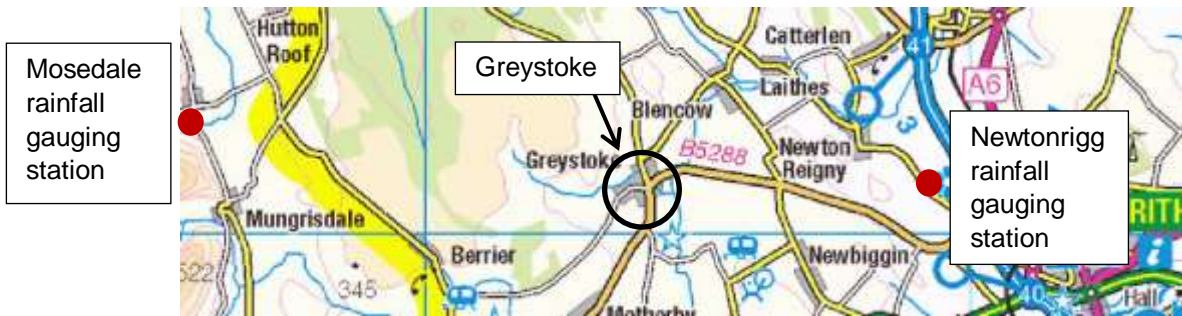
Figure 3: Location of rain gauges

Specifically for Greystoke, the two nearest rainfall gauging stations are Newton Rigg (NY 49286 30833) and Mosedale (NY 35642 32149) which recorded rainfall totals of 55.8mm and 138mm respectively on 5 December 2015. The locations of the rain gauges are indicated on the plan below.

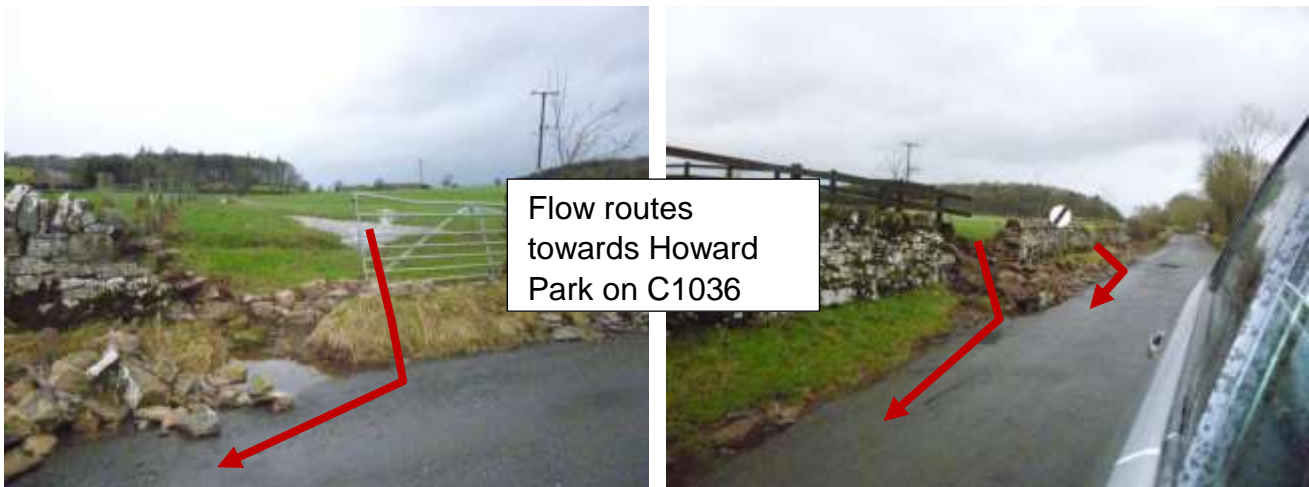
Photographs 1 & 2: Damage to wall caused by excessive flood water

Flood water overwhelmed the culverted section as it left the field and flooded on to the C1036 (Blencowe road). This caused damage to the boundary wall as shown in the above photographs.

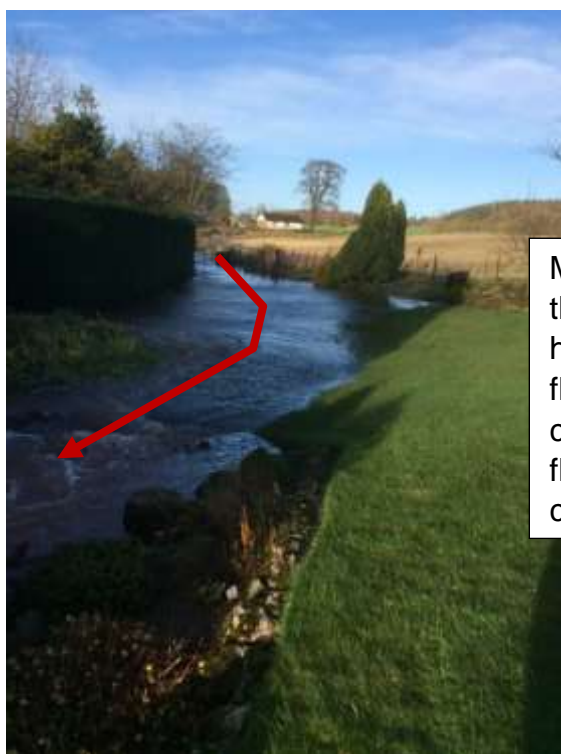
Photograph 6: Flood water flowing over the culverted section through Howard Park

Much of the watercourse in this photograph is culverted, however, due to the volume of floodwater overwhelming the culvert the watercourse is flowing over the top of the culvert.

7. Investigations. Map of Flow routes. - Page 12. Photo 6. - Needs turned through 90°clockwise. IT should be noted that the main reason for the culvert not coping (other than the ridiculous pipes under the road) is that there is a grid which blocks easily. I have a photo of the culvert grid as it is was before I cleared it yesterday because of the threats of flash floods, partly blocked (about 45 -60 cm) and the stream flow has been minimal for weeks. *CCC response – photograph amended. Likely causes of flooding section updated.*

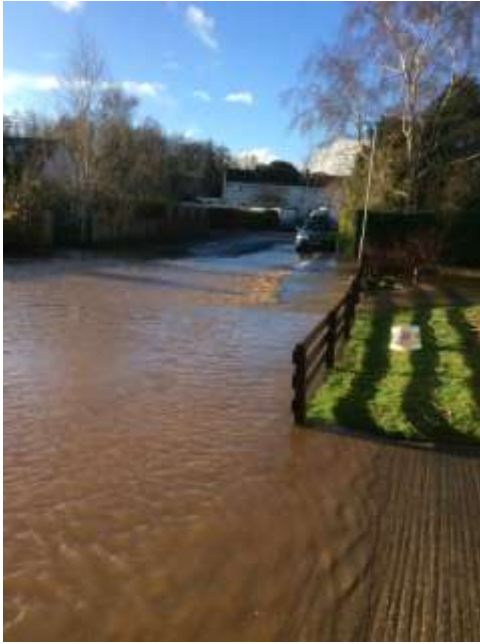
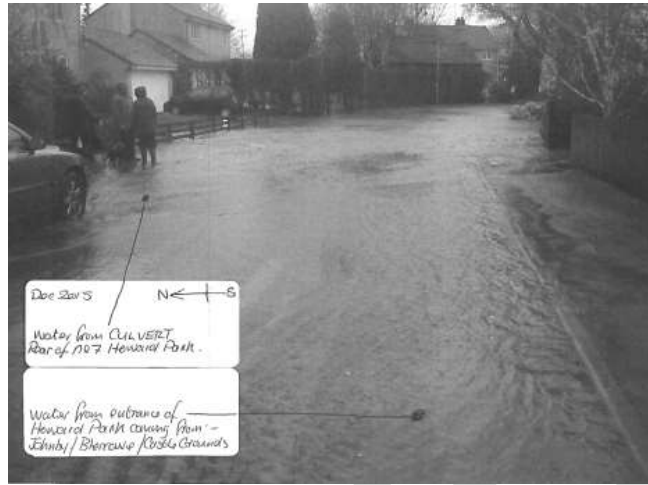
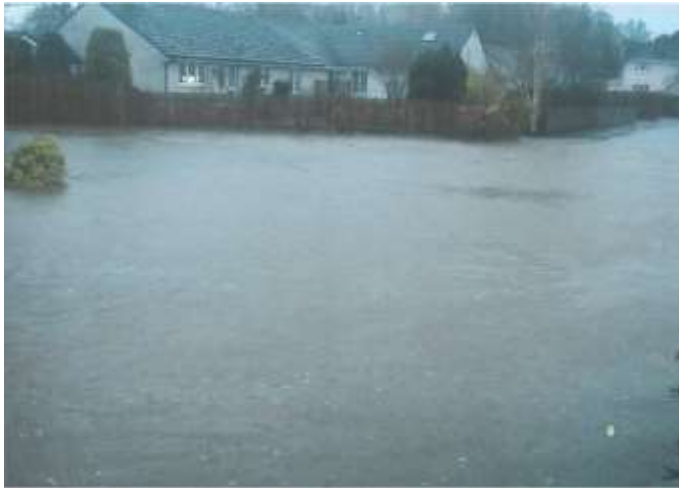
Photographs 7, 8 & 9: Flood water within Howard Park during the December 2015 event

Although the above photographs were not taken at the height of the flooding they do give a good indication of the extent and volume of the flood water that gathers in Howard Park.

8. Page 11. Photos 7 needs turning through 90°clockwise. *CCC response - amended*
9. Photo 10. It should be noted that the gully does not work properly as it slopes up to the path at the end of the right hand arrow. This along with the school boy mathematical error of having two pipes under the road which combined do not carry the volume of the main pipe suggests much money has been wasted over the years due to ineffective work. *CCC response – comments noted and will be considered in any future redesign.*

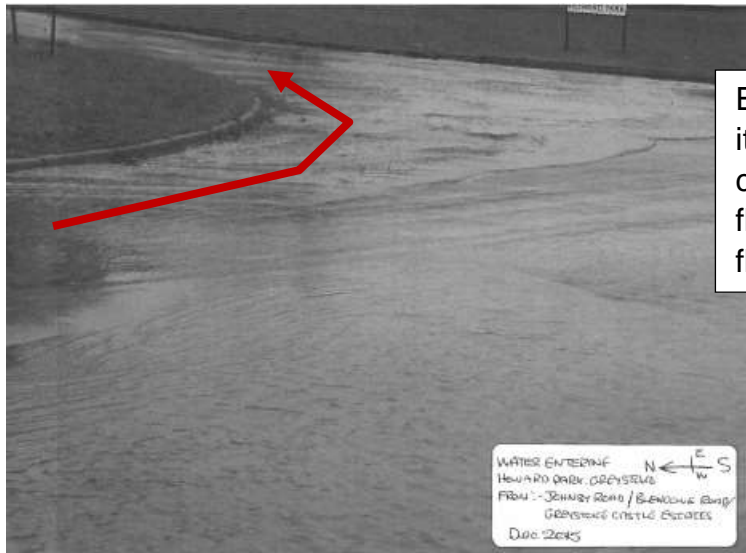
Photograph 12: Flood water flowing into Howard Park from the Johnby and Blencowe road

Excessive surface water that finds its way on to the Johnby road is conveyed towards Greystoke and flows into Howard Park to join the flood water from Poplin Beck

10. Page 14. Photo 12. This situation could be alleviated by some form of “speed hump” sleeping policeman speed table preventing water flowing down the road to Howard park. There would then need to be work done to direct this excess water along the grass/roadside to join the Pettril. Obviously this would not be a total solution as the drains would still carry water into Howard Park possibly overflowing but it would greatly reduce the volume. *CCC response – comments are again noted and will be considered through the MSfW process in identifying flood risk reduction measures*

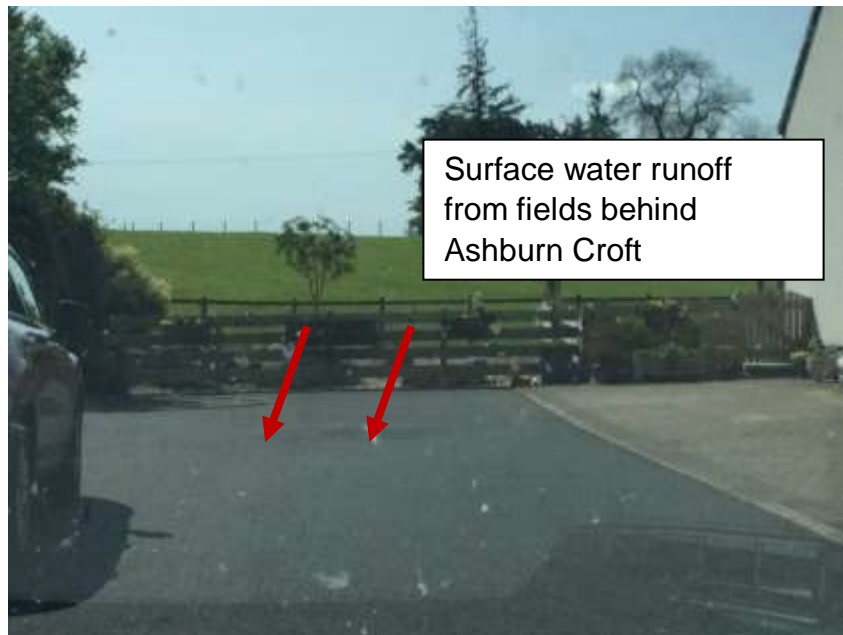
Photograph 13: End of cul-de-sac at Ashburn Croft, Greystoke

Photograph 13 above depicts a pre-planned flood route through Ashburn Croft in Greystoke. The end of the highway has deliberately been left without development to allow the flow of water through the development from the fields to the south.

13. Page 16. Photo 13. I am not terribly familiar with Ashburner Croft (again the title of the picture needs changed to Ashburner) but it appears to suggest the water is being directed off the fields into the development where it then flows either on to the Berrier Road or down past the school into the centre of the village. If this is correct I would suggest it makes the situation worse for those down hill. *CCC response – comments noted*

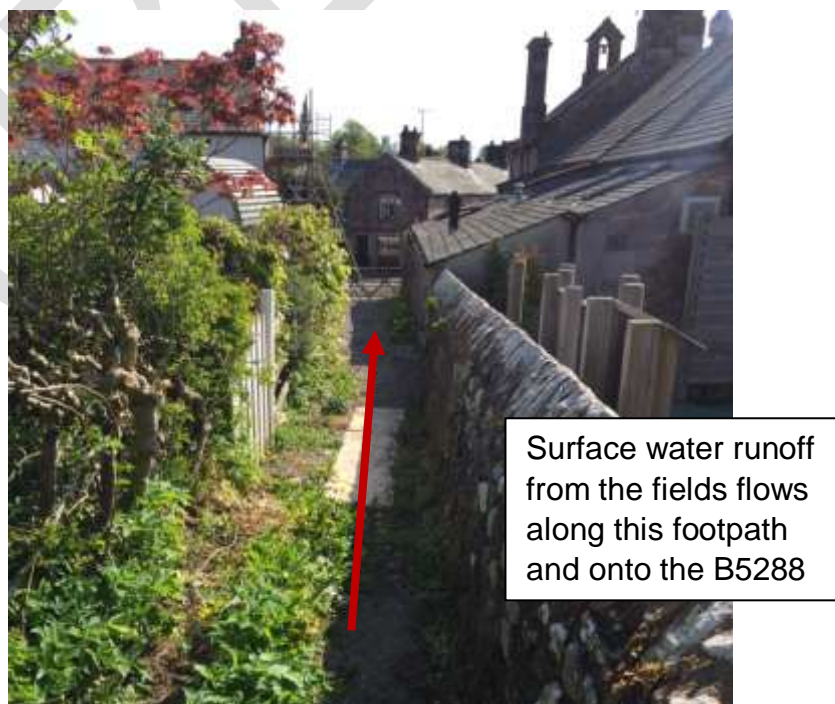
Photograph 14: Footpath which runs parallel to Greystoke School and onto the B5288

Photograph 14 above depicts a footpath which runs parallel to Greystoke School and exits onto the B5288. This route acts as a funnel and a flow route for the surface water runoff from the fields.

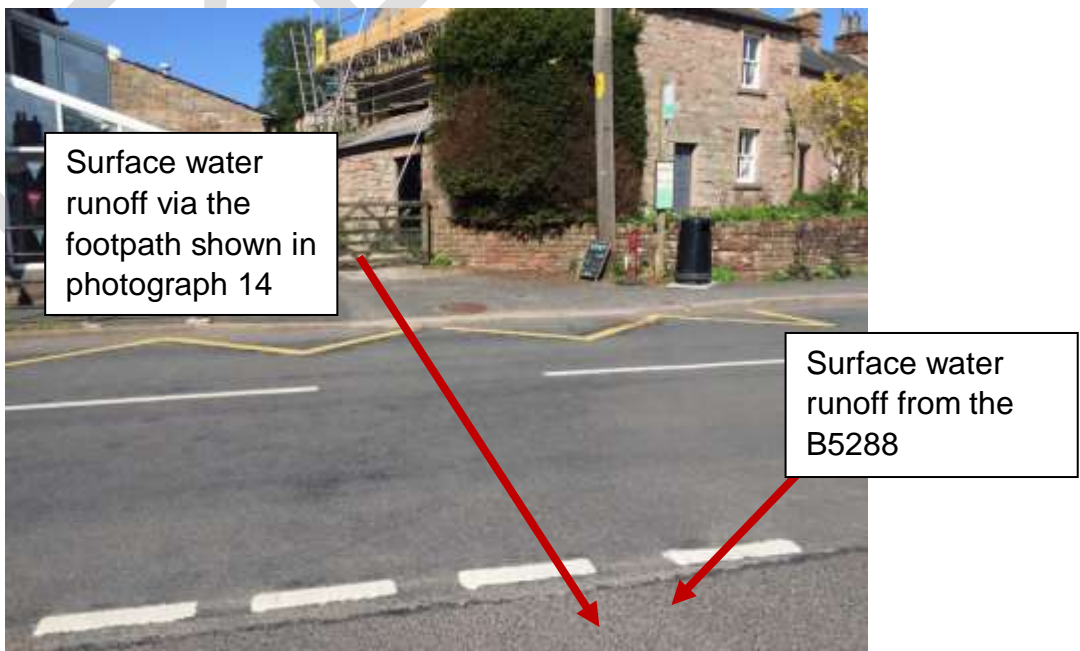
Photograph 16: Footpath exit onto the B5288 in Greystoke

Photograph 16 above depicts the exit of the footpath which runs parallel to Greystoke School. The surface water flows from the Ashburn Croft area flow from the footpath which acts as a

channel which transports water into the centre of Greystoke. Once the water is within the footpath it contributes towards the flooding of properties and then flows onto the B5288. This water is then joined by surface water runoff from the B5288 as explained within Photograph 15. The flood water then flows from the B5288 along Church Road before flowing to join the North Petteril.

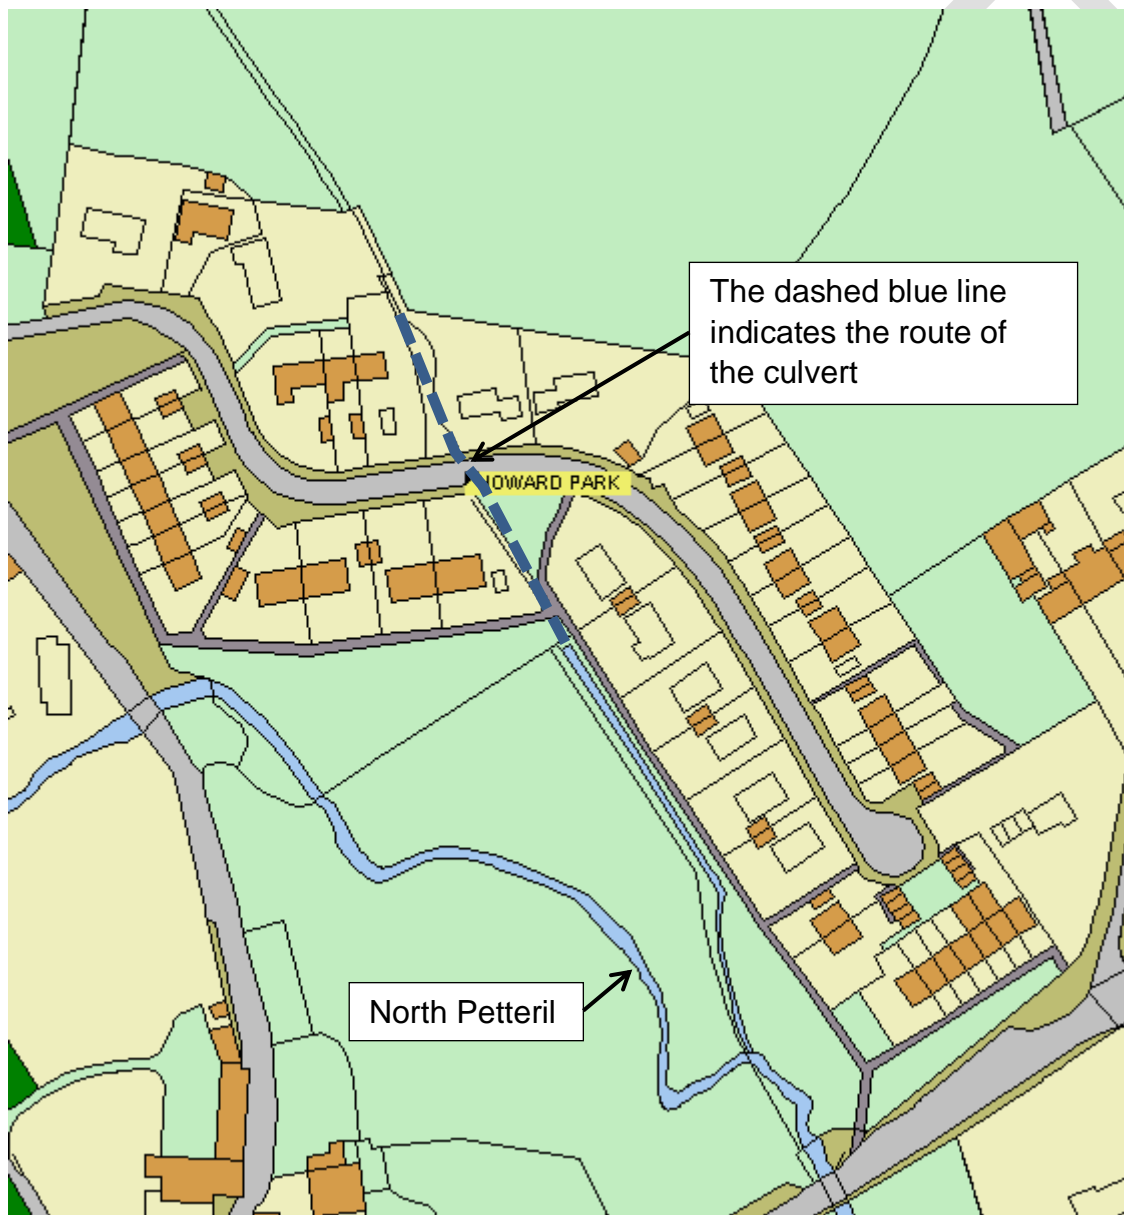
Figure 9: Plan identifying the culvert through Howard Park

After the rainfall event, the most significant factor of the flooding was the restriction caused by the culverted section that runs through Howard Park. The culverted section is identified in the following plan.

The culvert runs through private land, under highway and then through open space before it discharges into an open section of the watercourse. It is apparent that the culvert changes in size as it runs through Howard Park. Further investigations of the capacity of each section is

required to determine if there is only a restriction on one section of the culvert or if it is the total culvert that is causing the restriction. Residents have reported that the grid at the entrance to the culvert is also an area where debris is often trapped.

Cumbria Flood Partnership Theme	Action by	Recommended Action	Timescale
Maintenance	LLFA	Howard Park - CCTV the culverted section of watercourse and associated gullies and drainage	Autumn/Winter 2016
	LLFA	Howard Park - to assess the capacity of the culverted section of watercourse	Completed
	MSfWG	Howard Park - investigate the possibility of de-culverting the watercourse under Howard Park and replacing the road culvert with a bridge (and / or upsizing the culvert)	Unknown as this will depend on landowner permissions and budget provision
	MSfWG	Howard Park – Investigate options to prevent surface water flowing into Howard Park from the Johnby / Blencowe road.	Unknown as this will depend on landowner permissions and budget provision
	LLFA	Ashburn Croft / Stone Garth area – CCTV survey culvert in the fields to the south of Ashburn Croft	Autumn/Winter 2016
	LLFA	Ashburn Croft / Stone Garth area – following the CCTV survey LLFA to assess the capacity of the culverted section of watercourse.	Winter 2016

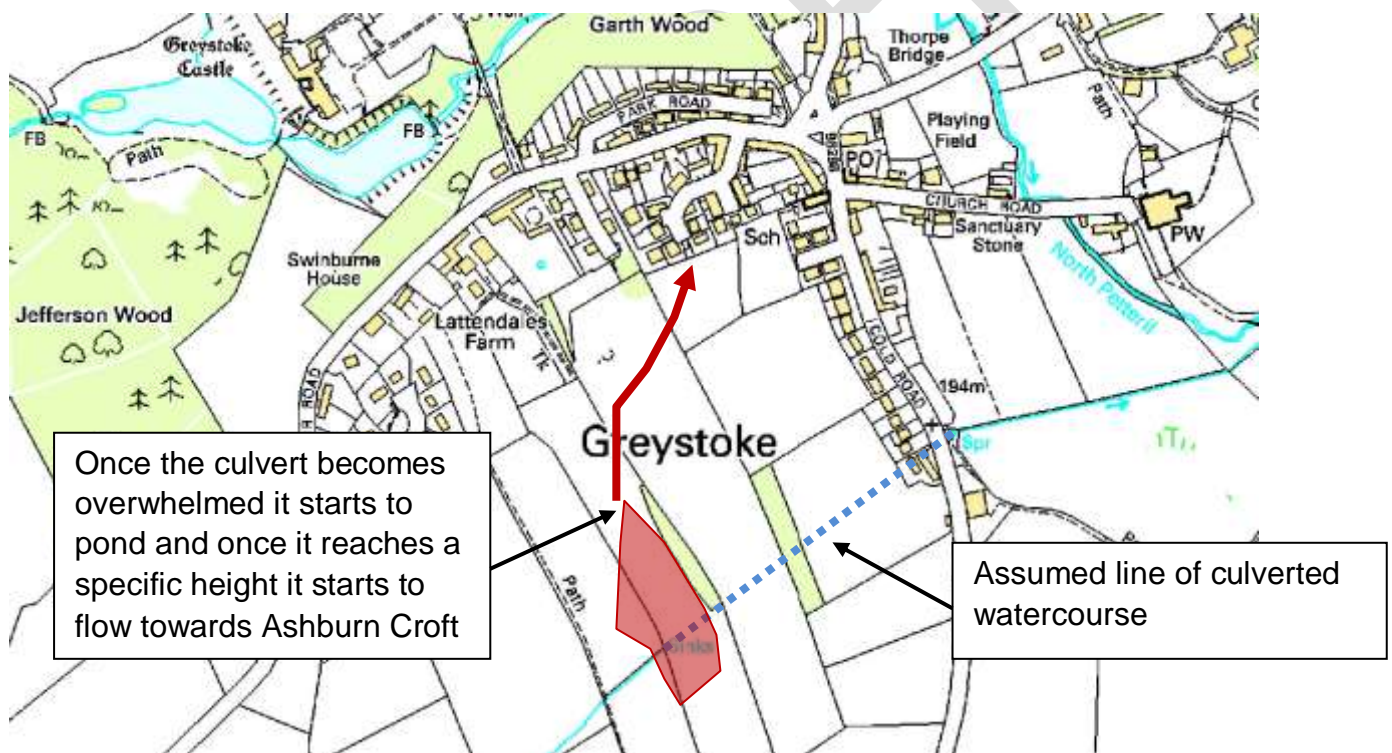
Figure 10: Location of culvert in fields south of Ashburn Croft

The major cause of the flooding in the Ashburn Croft, Stonegarth, Smithy Court and Church Road area is the either the lack of capacity or a blockage in the culvert that runs through the fields as indicated in figure 10. In normal circumstances the culvert is able to cope with any flows from the catchment above but during the two extreme events this became over whelmed. An action of this report is to CCTV survey the culvert to ensure it is not damaged or blocked.

The other surface water route from the rear of Lattendaes Farm also contributes to flood water entering Ashburn Croft.

LLFA	Ashburn Croft / Stone Garth area - investigate the possibility of de-culverting the watercourse	Unknown as this will depend on landowner permissions and budget provision
	LLFA	Investigate ground water flooding in Smithy Court area	Ongoing
	LLFA	Monitor ditch created to protect	Ongoing

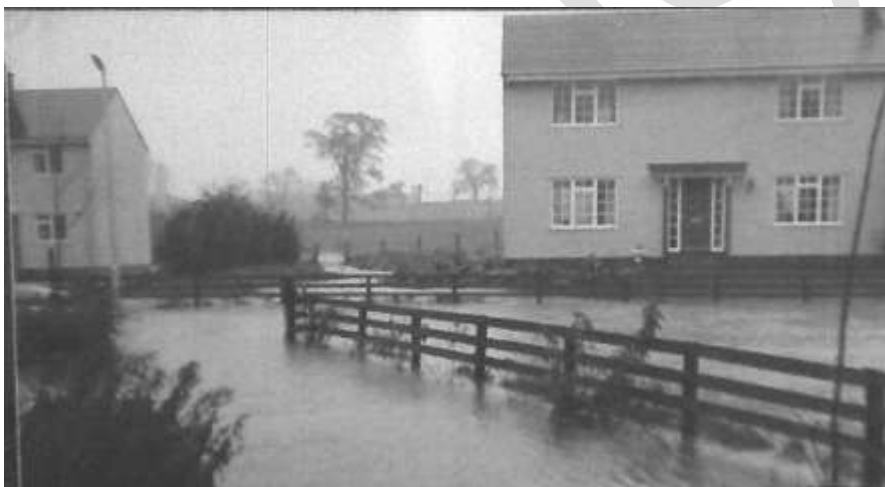
Photograph: Flooding during 1977 in Howard Park

There is a long documented history of flooding within the Howard Park estate. The estate was constructed during the 1970's with the first flood being reported in December 1977. Normally approximately 3 floods per year occur with it being estimated that flooding has occurred approximately 117 times since 1977.

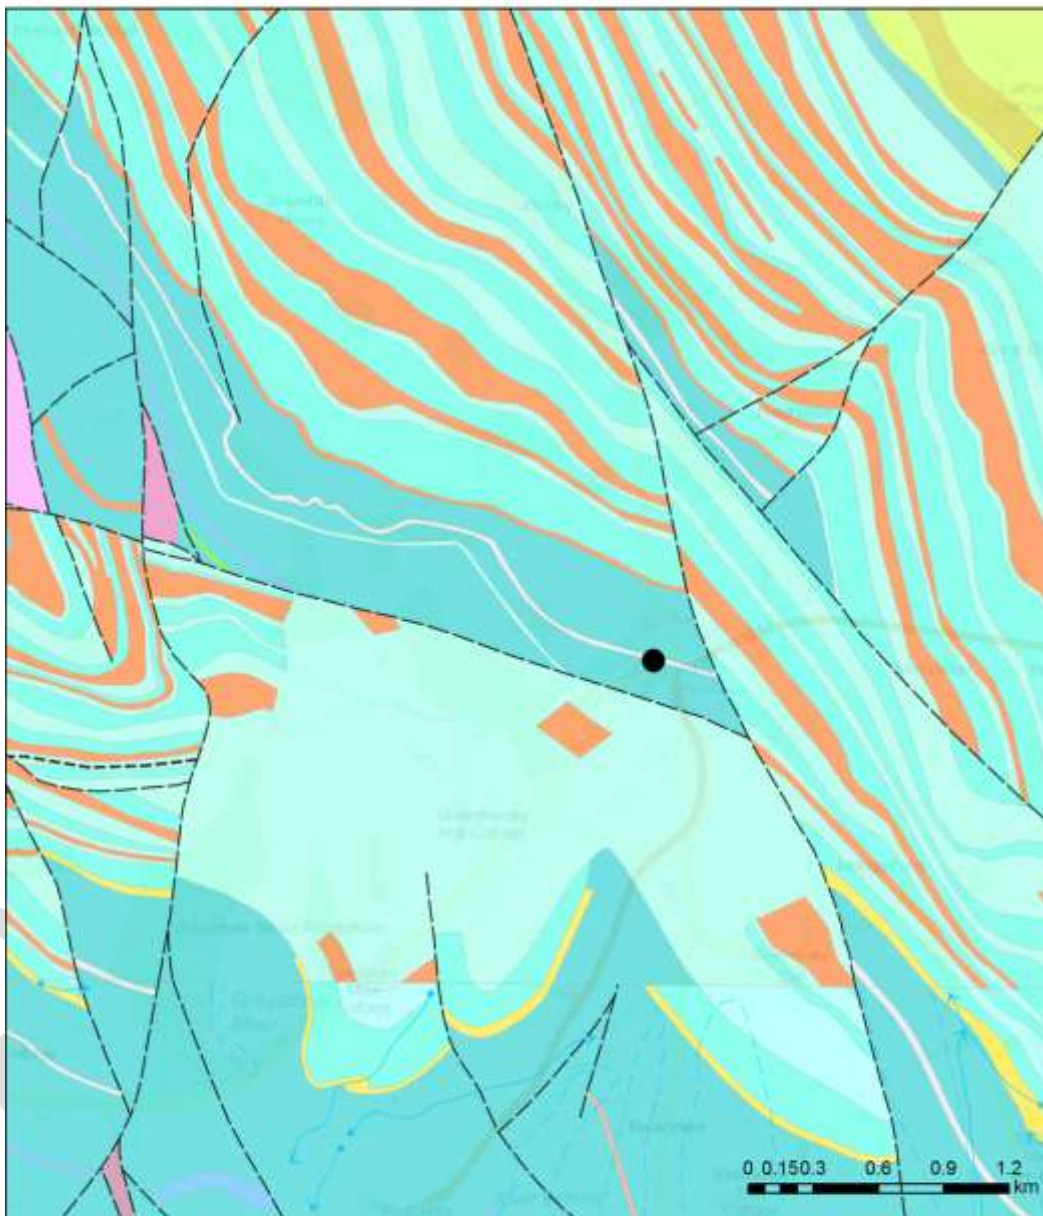
The following information is taken from the BGS data. The Smithy Court area is represented by the black dot.

Some properties in this area also experienced groundwater flooding. At the time of writing this report it is unclear what the cause of the flooding is but the properties affected are in an area of limestone and there is a fault very close by. Further investigations are required to identify the cause of the flooding but the geology of the area is complex. The BGS geology map is included as part of Appendix 4. Further information may come to light once the CCTV survey of the drainage in the area is complete.
