Shap

Flood Investigation Report

Flood Event 5th December 2015

This flood investigation report has been produced by Cumbria County Council as a Lead Local Flood Authority under Section 19 of the Flood and Water Management Act 2010.

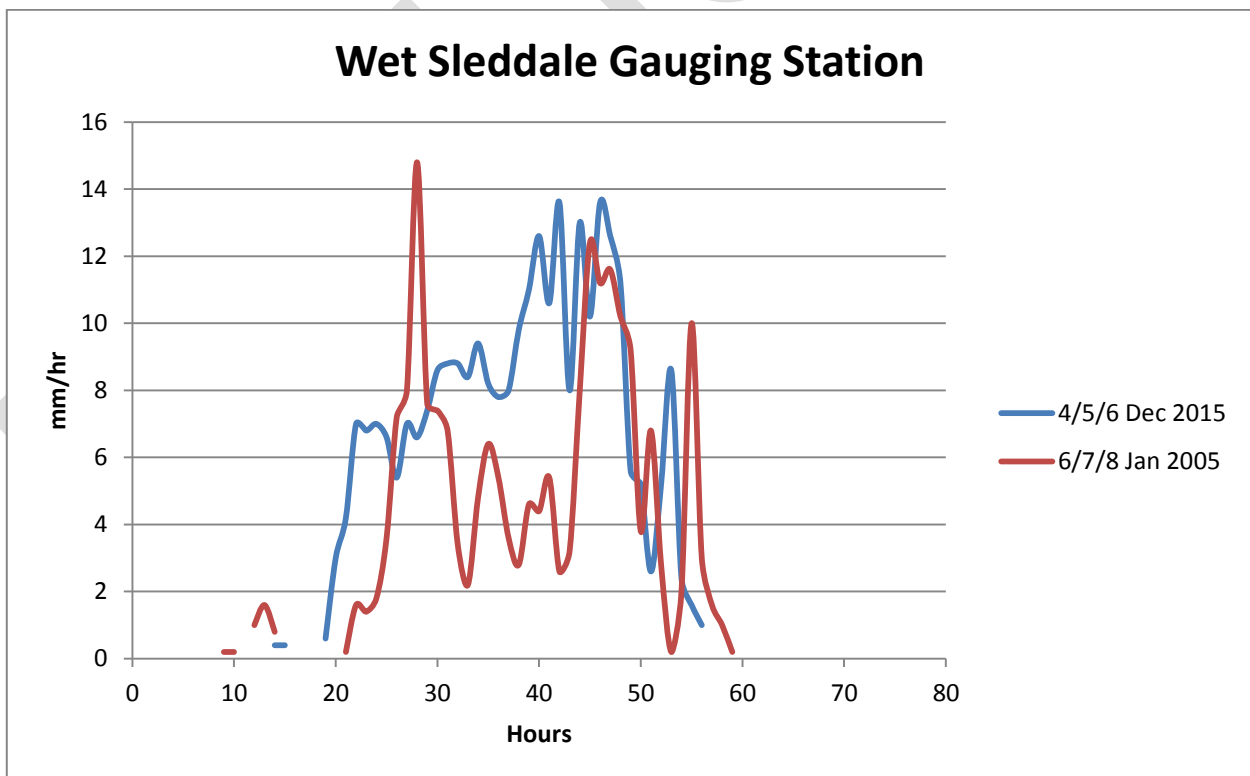
Graph 1: Comparison of rainfall for December 2015 and January 2005 flood events

On average during the month of December Shap is estimated to have a rainfall of 215.6mm with an average of 1,779mm per year. The Environment Agency has 2no rain gauges near to Shap at Burnbank (5.5km) and Wet Sleddale (3.8km). The following total rainfall was recorded at each one during Storm Desmond. The rainfall data from the January 2005 event is also included for comparison. It can be seen from the table that 283mm of rainfall fell within 36hrs which is well above the average rainfall expected for the whole of December.

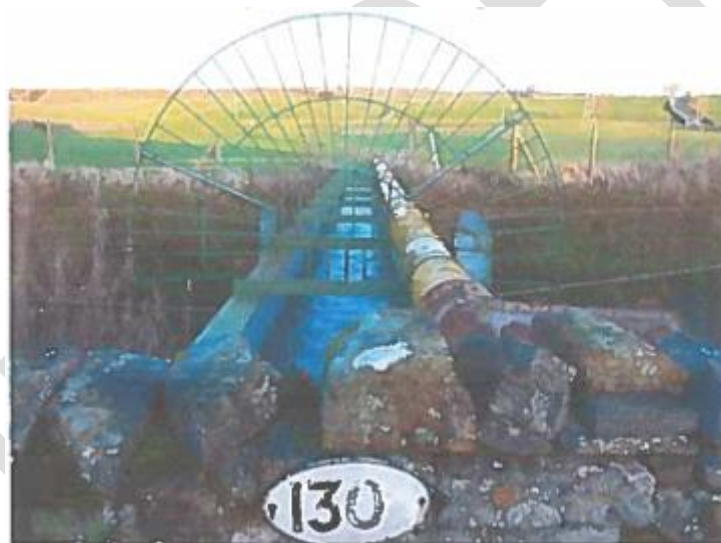
Photograph 1: Aqueduct across railway line

Shap is located within a valley with higher land to the east which is intercepted by the railway line. The land to the west is also higher than the village but not as high as the east side of the village. Shap Beck which flows through the village of Shap originates to the east of the village before crossing the railway line in an aqueduct.

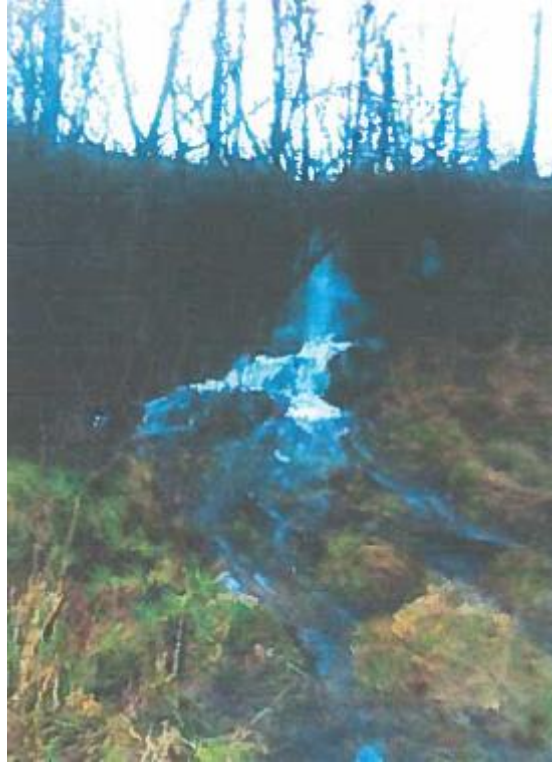
Photograph 2: Runoff from the railway line onto Memorial Park on 26th January 2016

The residents identified a further source of flood water which came from the railway line which was observed discharging into the playing field area next to the Village Hall. Meetings and correspondence with Network Rail Engineers have confirmed that they are aware that this is a low area in their network drainage system and this is a natural place that surcharging of the system is likely to occur when rainfall events exceed the drainage capacity. Network Rail has stated that they are aware that their drainage system has limits due to the capacity of the receiving surface water systems and watercourses downstream of their discharge points.

However, Network Rail is willing to co-operate with the other authorities involved in the flood investigation in order to reduce the risk of flooding to properties within Shap. (See action table for further information). The following photograph shows the excess runoff from the railway line on to Shap Memorial Park on 26th January 2016.

| Strengthening Defences | CCC (LLFA) / Network Rail / United Utilities | To co-ordinate drainage information to assess capacity of surface water drainage systems within Shap and identify feasible improvement options. This will require funding through the FCERM GiA process to facilitate the assessment. | Apply for funding via FCERM GiA process – project to be identified in submission to EA/Defra by March 2017 |

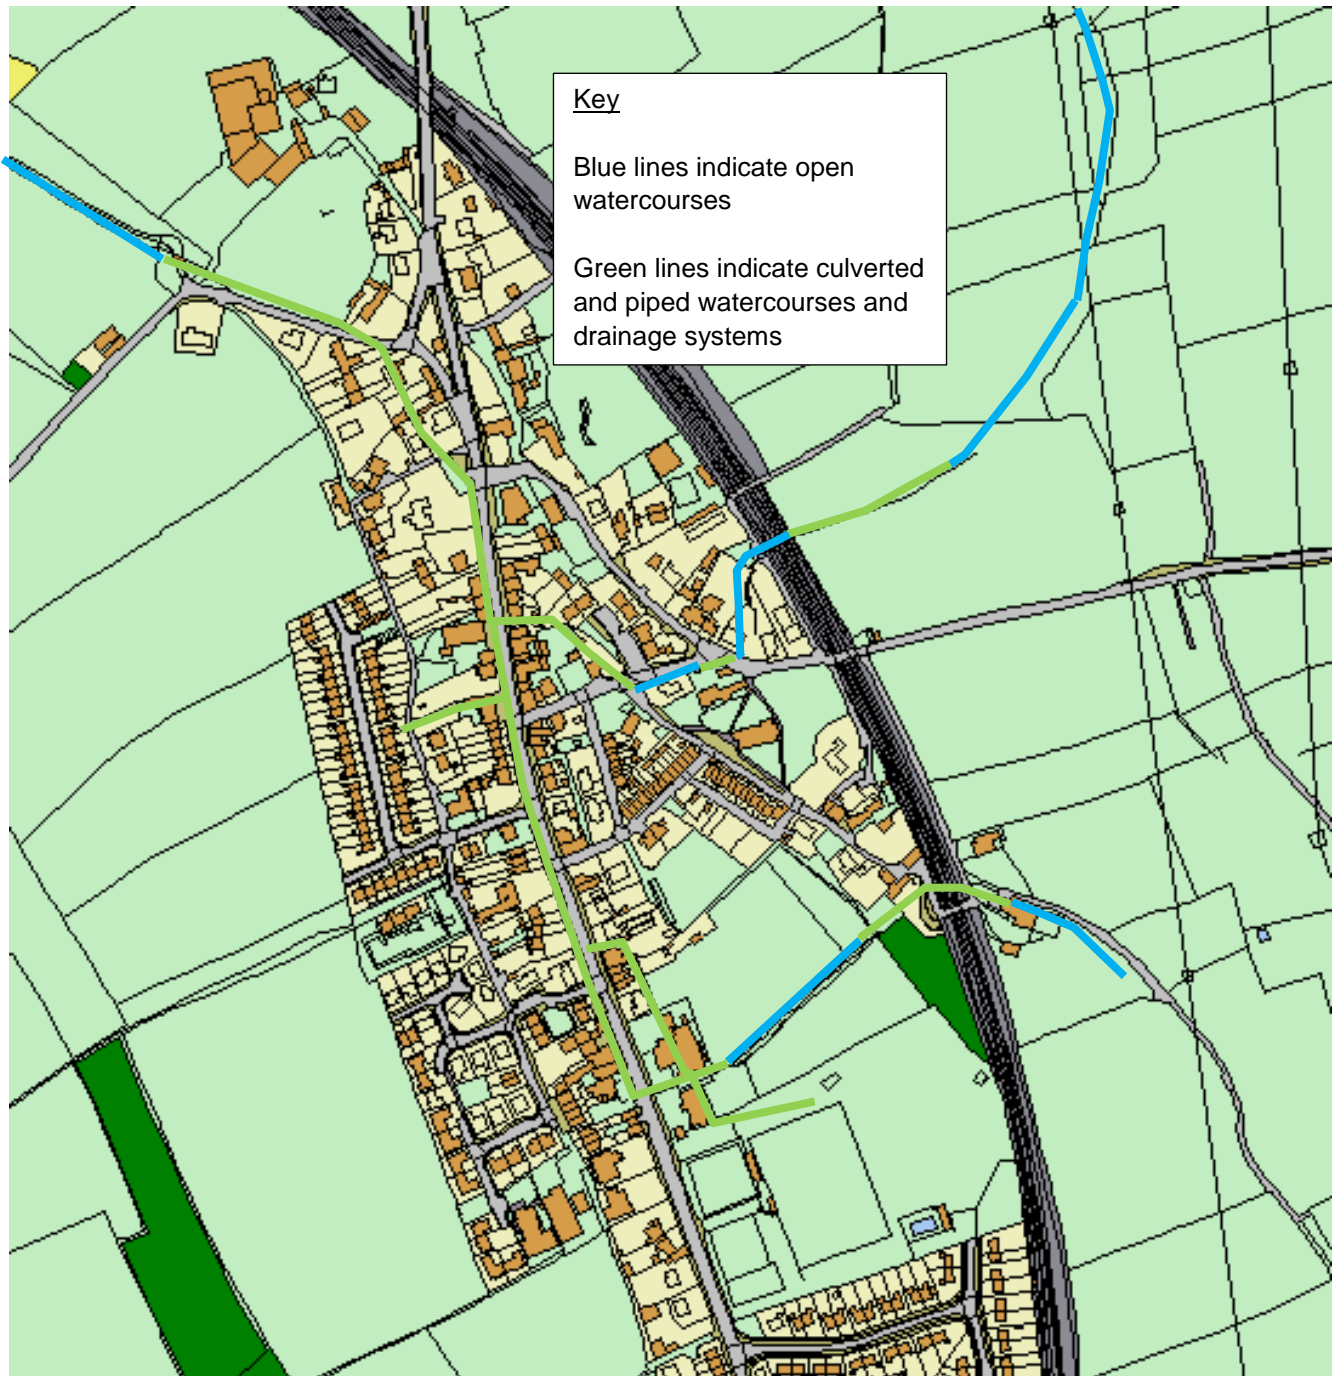
Figure 6: Plan indicating extent of culverted watercourses and drainage systems in the north and central area of Shap.

The Parish Council provided CCC's LLFA team with plans indicating the locations of the drainage systems and watercourses within Shap. CCC had very little knowledge of these systems with regard to their construction or current condition and commissioned a CCTV survey of the systems considered to be significant in the cause of the flooding. Although the survey is not complete it has indicated that the drainage systems within Shap are made up of various construction methods from concrete pipes to stone culverts with flagged soffits. From information gathered from old maps it is apparent that some of the older stone culverts could have been in place since the mid-1800s. A large proportion of the drainage systems are located within the highway boundary but there are also reaches of Shap Beck and other watercourses that run through private ground. The map on the following page is a simplification of the approximate location of the drainage systems within the north and central parts of Shap.

Following the event CCC have begun a survey of the drainage and watercourse systems. Initial CCTV investigations have indicated that in some areas two or three pipes run together to convey water. Appendix 4 includes the plan of the surveys completed to date.

| Cumbria Flood Partnership Theme | Action by | Recommended Action | Timescale |
|---|---|--|---|
| | CCC (LLFA) | Commission CCTV survey of significant culverted water course and surface water drainage systems within the north and central areas of Shap. This will also involve clearing of any debris identified in the culverted or piped sections. | 1st part of survey completed April 2016. Further survey planned for Winter 2016 to complete the investigation |

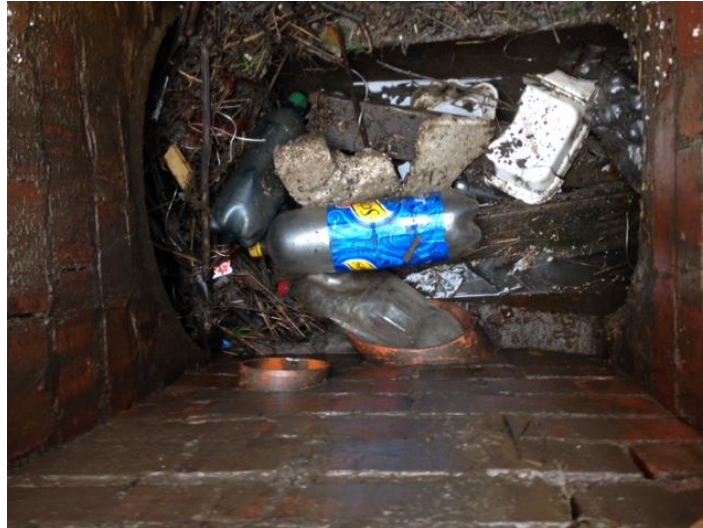
Photograph 3: Debris in one of the manholes in the culvert

During the survey it was established that in some areas of the system there was significant debris and rocks within the drainage systems. The debris included rocks, a spade, tennis racket, wheel trim and plastic bottles as well as vegetation. The following photograph indicated the volume of debris within parts of the system.

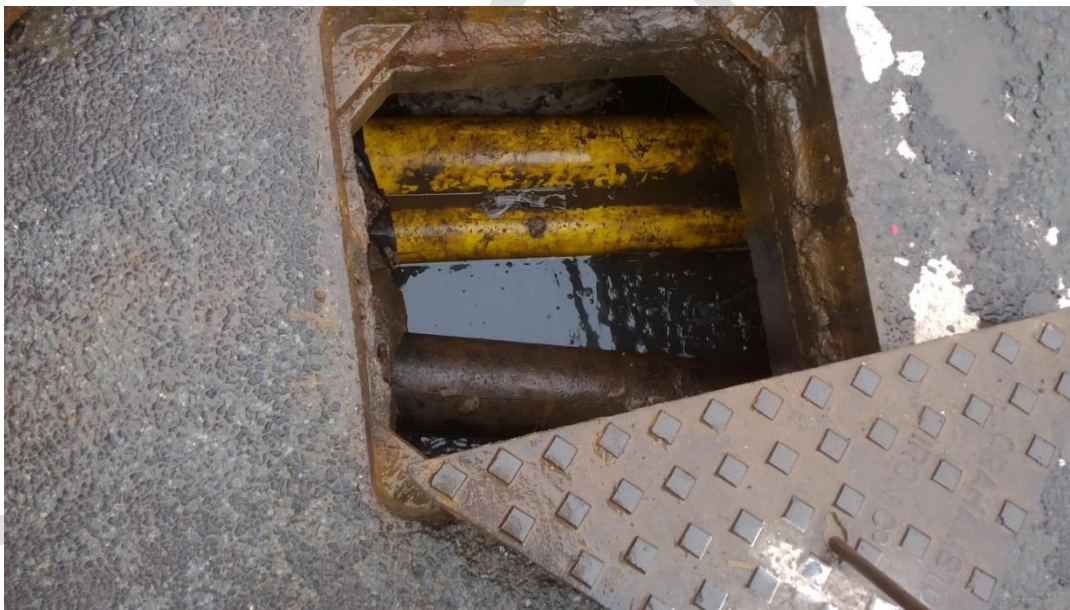
Photographs 4: Services through the drainage systems

A further contributing factor to this was due to services being installed through the surface water and watercourse systems which created snagging points for debris to get caught on. On one particular manhole a sewer connection, two gas supply pipes and an electricity connection were observed. The following photographs indicate some of the connections through the systems.

Following the initial survey discussions have taken place with the highway engineer that was involved in the upgrade of the section of drainage system in Main Street. It has been confirmed that the upgrade was difficult due to the number and the level of the services within the location of the drainage system. It was not possible to carry out the upgrades without incorporating some of the services within the drain particularly the existing public sewer connections. Therefore, at the time of the drain upgrade manholes were constructed at the major intersections with the services to enable extra capacity around the services that had to be incorporated and to allow for access to remove debris that may catch on the services within the invert of the drain.

| Cumbria Flood Partnership Theme | Action by | Recommended Action | Timescale |
|---|---|--|---|
| | CCC (LLFA/Highways) | Work with service providers and landowners to remove as many obstructions as possible, however, this may not be possible for many of the services particularly the sewer connections | Ongoing as and when identified by the CCTV surveys |
