# Grasmere

## Flood Investigation Report

**Flood Event 5-6<sup>th</sup> December 2015**

This flood investigation report has been produced by the Environment Agency as a key Risk Management Authority under Section 19 of the Flood and Water Management Act 2010 in partnership with Cumbria County Council as Lead Local Flood Authority.

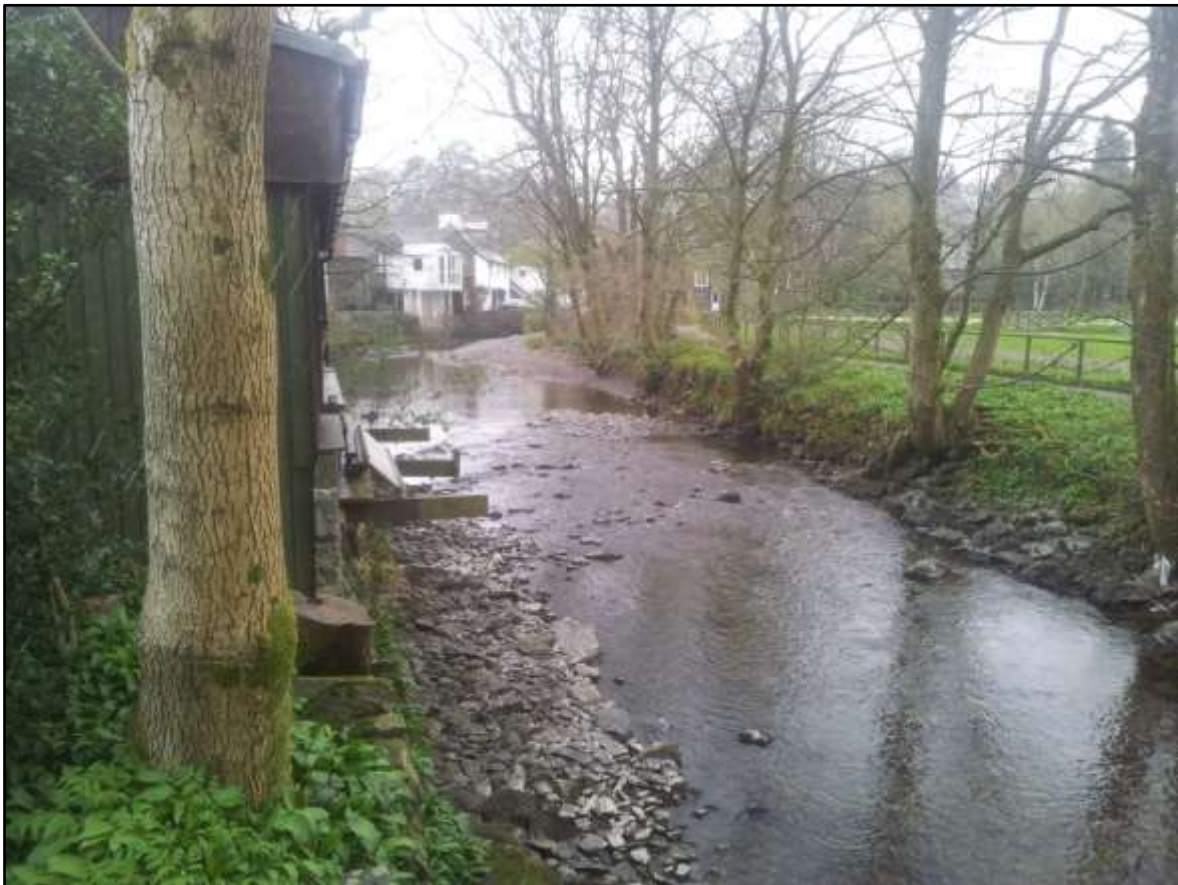
There are currently no formal flood defences in Grasmere. Along the banks of the River Rothay there are some areas of raised ground, made from deposits of excavated channel material that have vegetated over time, however these features are not structurally designed to offer a formal standard of flood protection. Other informal flood defences in the village are made up of privately-owned retaining walls and property boundary wall structures adjacent to watercourses. These structures have not been designed as engineered structures to manage flood risk. Figures 7, 8 and 9 show typical examples of informal flood defences along the River Rothay in Grasmere.

**Figure 7 - Typical Informal Flood Defences on the River Rothay**

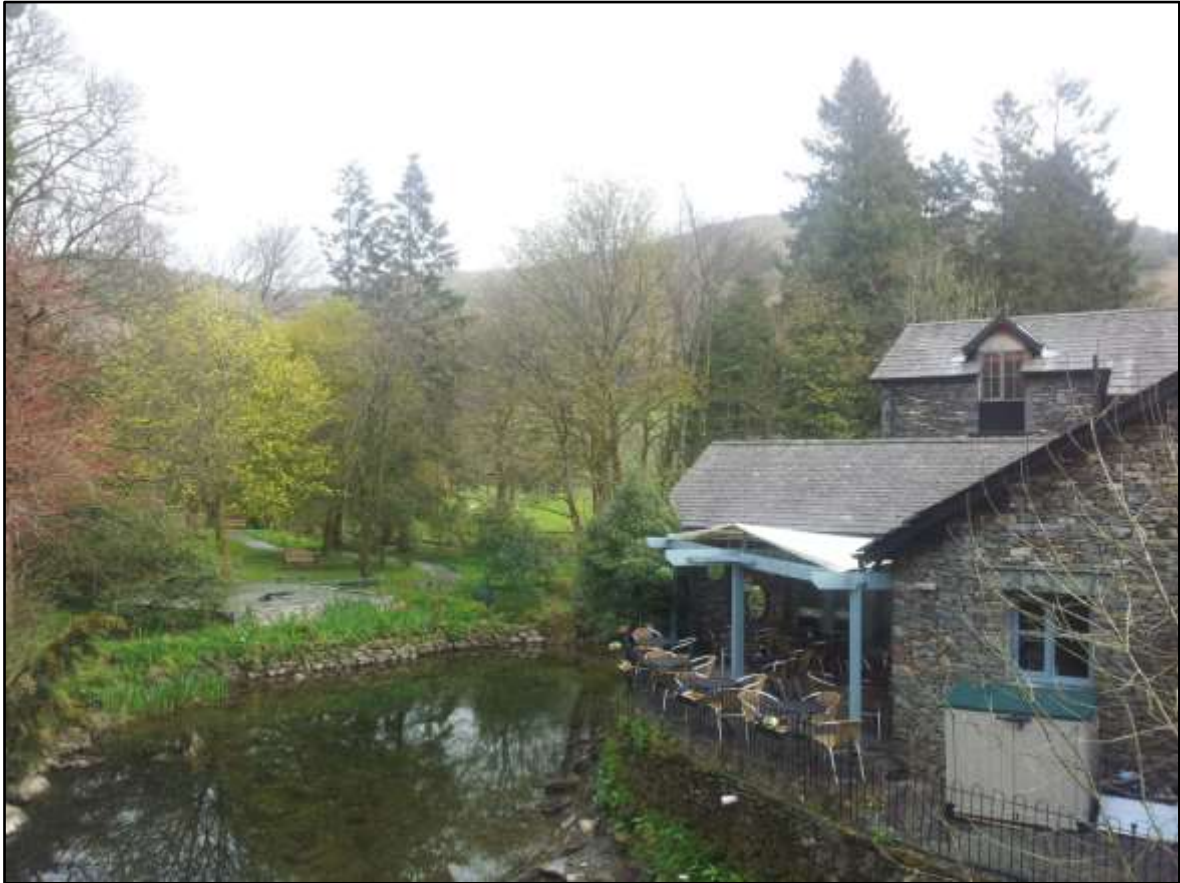
Figure 8 – Looking Upstream from Church Bridge at Riverside Retaining Walls on the River Rothay

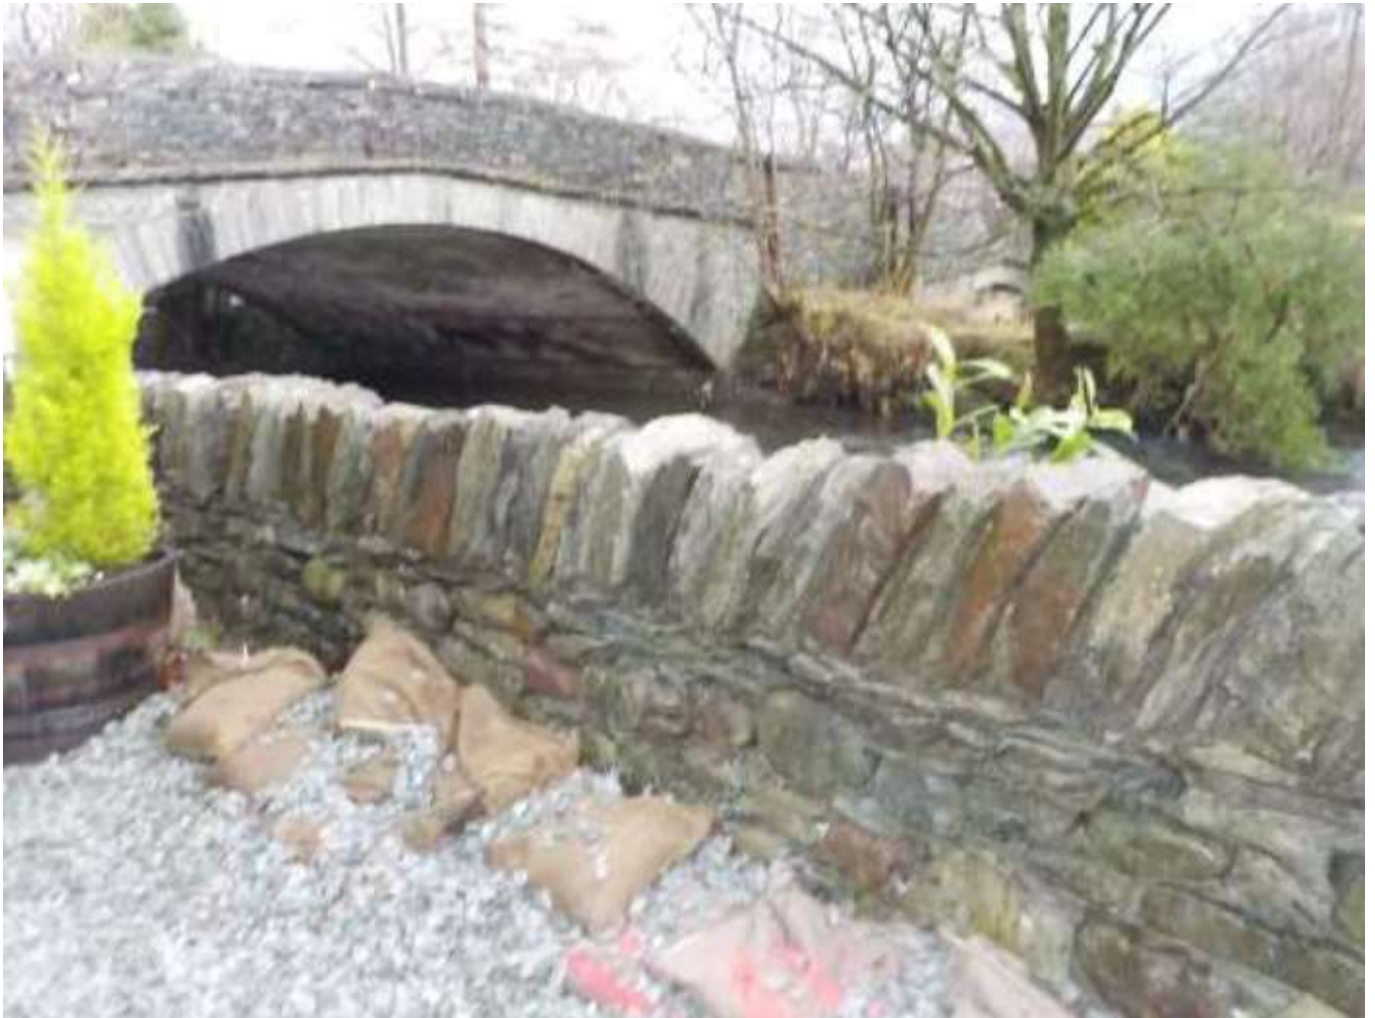
**Figure 9 – A privately-owned, informal flood defence downstream of White Bridge (photo taken looking upstream). The wall apparently overtopped during the December 2015 flooding. (Note that the arch in White Bridge just visible on the right of the photo is for a mill race and watercourse that flows from Greatcross Cottages).**

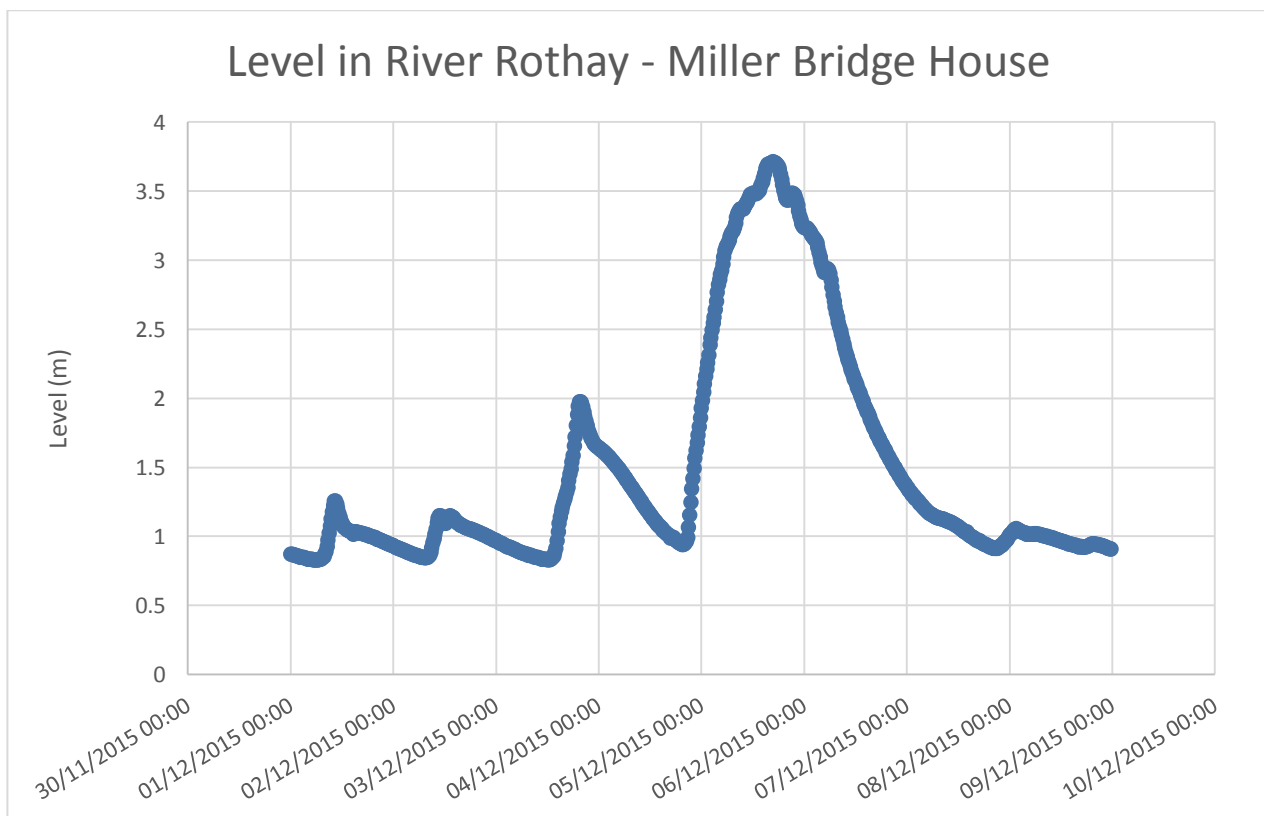
A peak level of 3.714m (44.148mAOD) was recorded at Miller Bridge House on the River Rothay during 5<sup>th</sup> December 2015. This exceeded the previous highest recorded level of 3.517m (43.951mAOD), recorded during the November 2009 flood event. Table 2 shows the highest recorded peak flood levels at the Miller Bridge House gauge.

Figure 11 shows the levels recorded by the Miller Bridge House river monitoring gauge. This shows the time and duration of the flood event on the 5<sup>th</sup> and 6<sup>th</sup> of December, and illustrates the magnitude of the flood event.

**Figure 11 - Levels Recorded at Miller Bridge House Gauging Station on the River Rothay from 01/12/2015 to 08/12/2015**

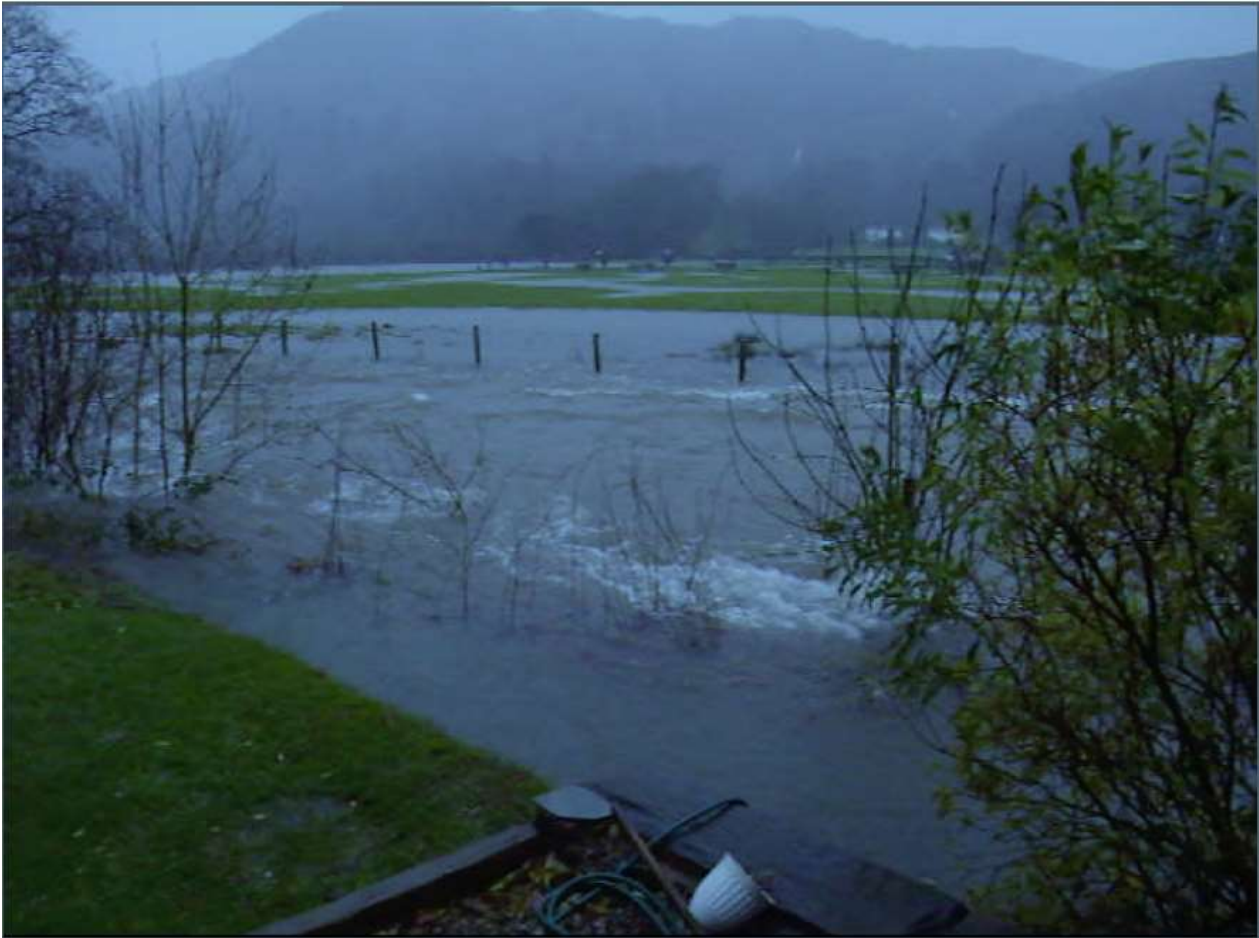
Figure 15 shows a photo taken from Victoria Cottage at 10:46am on 5<sup>th</sup> December 2015. Taken several hours before the peak of the River Rothay, the photo clearly shows that the River Rothay has exceeded its channel capacity and is spilling onto the floodplain downstream of the village, merging with the rising waters of Grasmere lake. The lake level can clearly be seen in the top left-hand corner of the photo.

**Figure 15 – Photo taken from Victoria Cottage at 10:46am on 5<sup>th</sup> December 2015.**

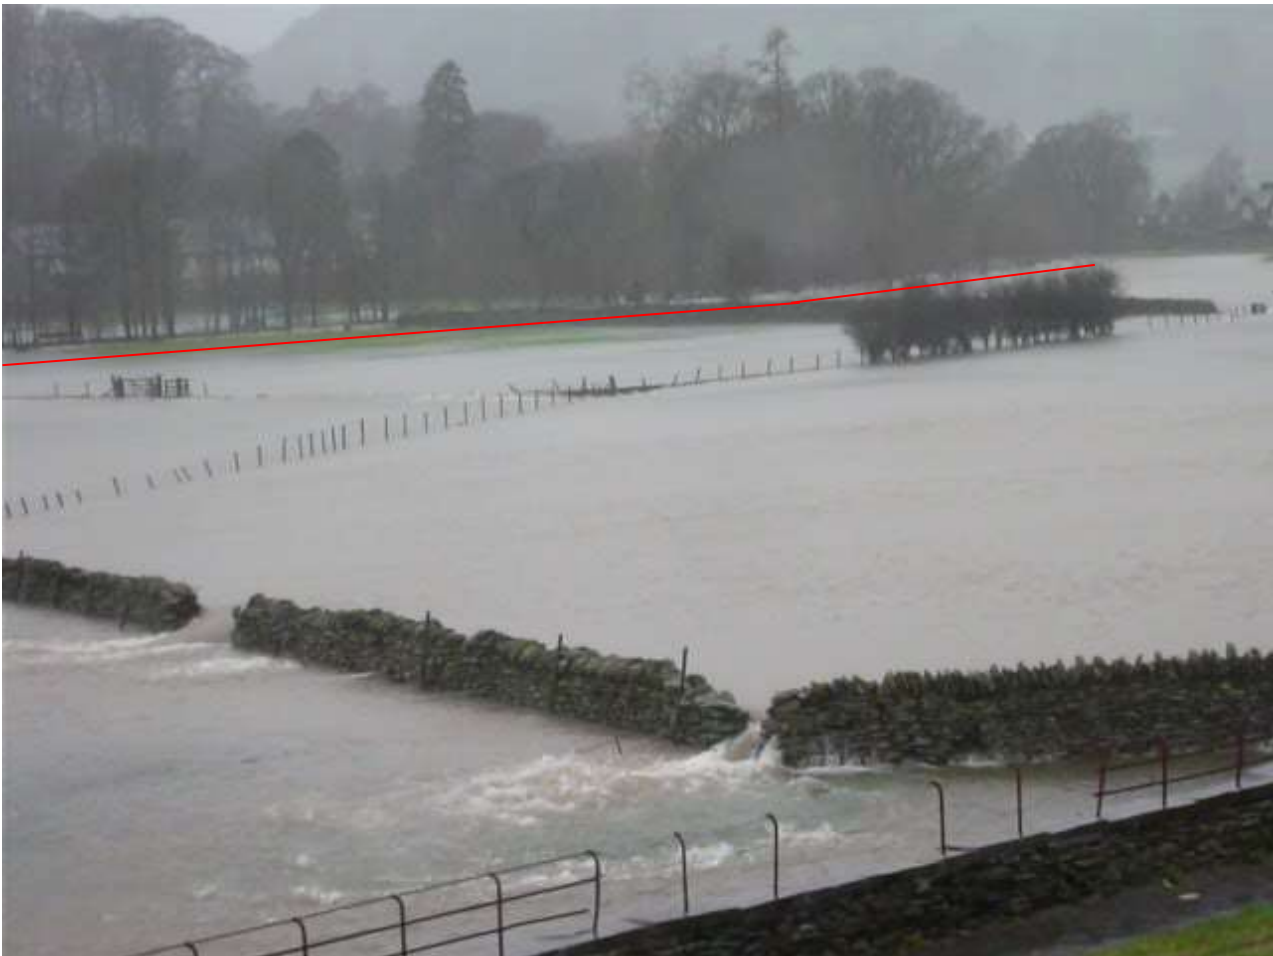
Figure 17 provides a graphic illustration of the significant floodplain flows on the left bank of the River Rothay. The photo was taken at 13:00 on 5<sup>th</sup> December 2015, with evident damage to field boundary walls due to the velocity of flows. The depth of water can also be seen at the boundary

wall breaches. The photo shows water flowing in a southerly direction on the floodplain, towards the Grasmere Sports Field and the B5287 Stock Lane. This flow route is illustrated further in Figure 19. Once the floodwater reached Stock Lane, it flowed in a westerly direction towards Lake View Drive and the area around Church Bridge due to the local topography - this is illustrated in Figure 20. Some floodwater was conveyed through Stock Bridge, which is situated to the eastern end of Stock Lane near the roundabout on the A591, which then joined floodwater in the 'Lake' sub-area downstream of Stock Lane.

**Figure 17 – Floodplain flows on the left bank of the River Rothay. The river channel is shown by the red line. © Mary & David Bass**

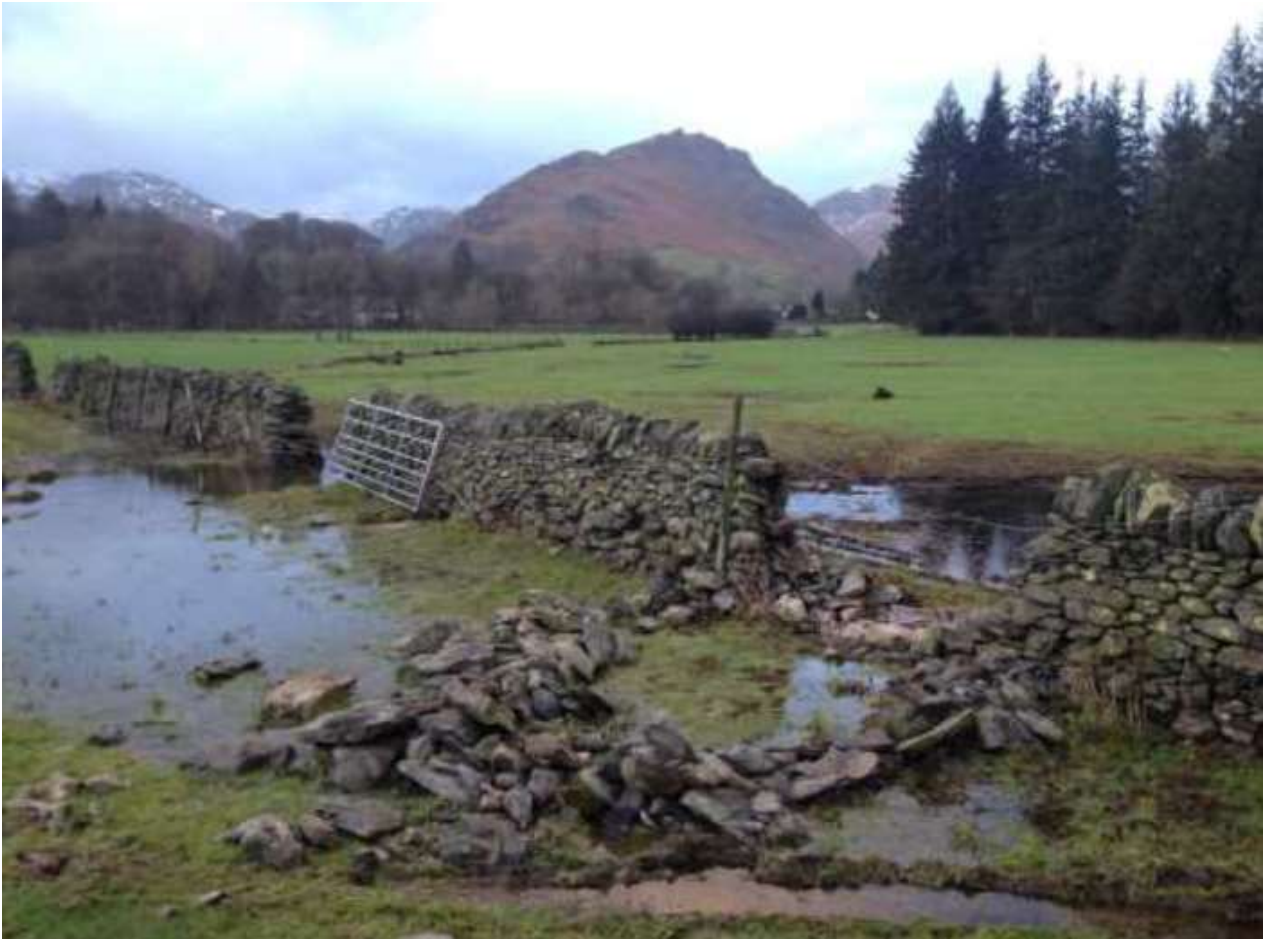
**Figure 18 – Damage to dry stone walls on left bank floodplain of the River Rothay due to flood water.**

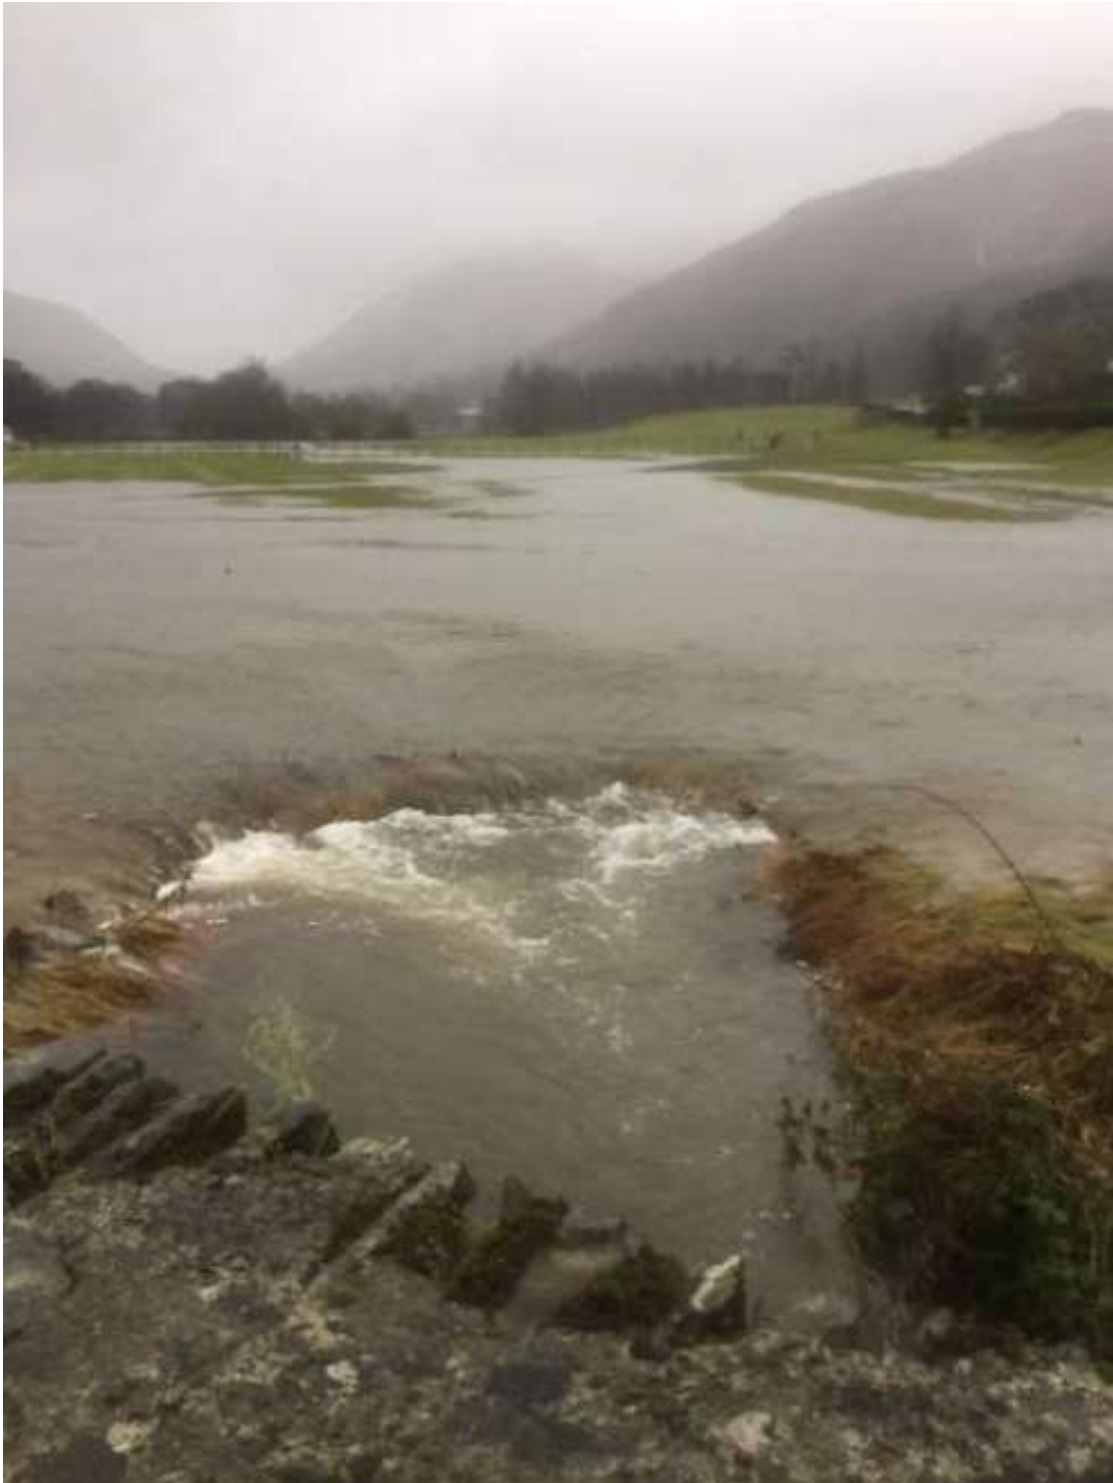
**Figure 19 – Overland flow route across the floodplain towards Stock Bridge.**

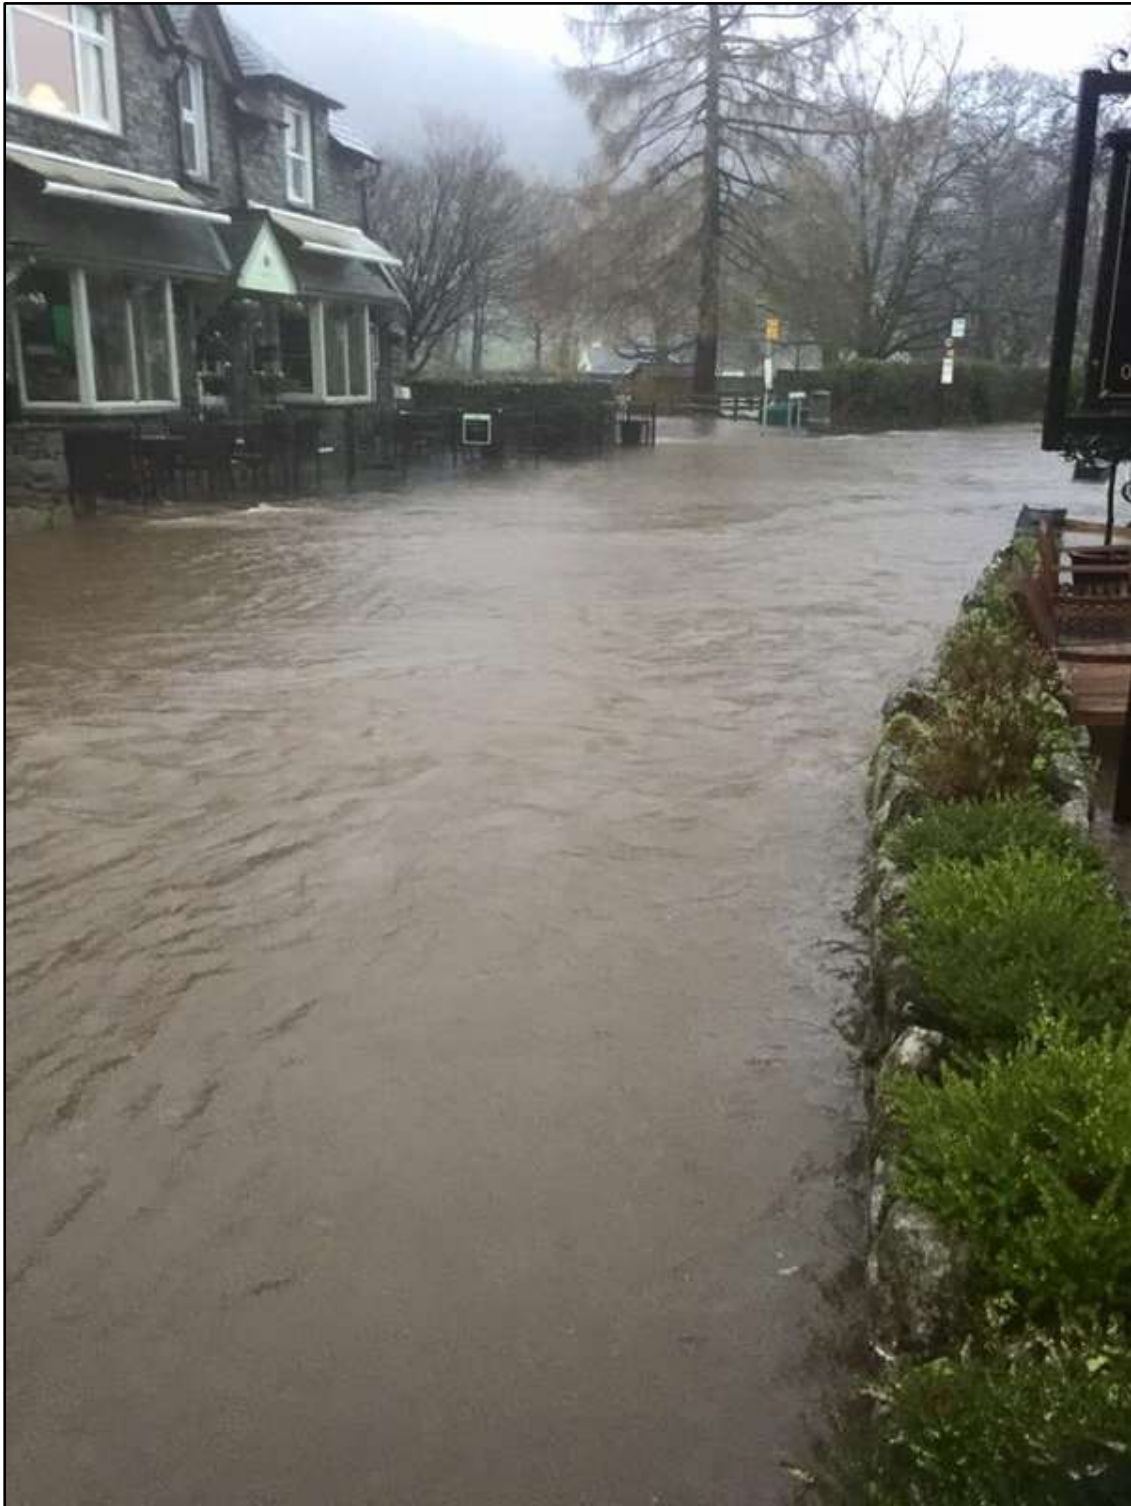
**Figure 20 – Flow down Stock Lane towards Church Bridge.**

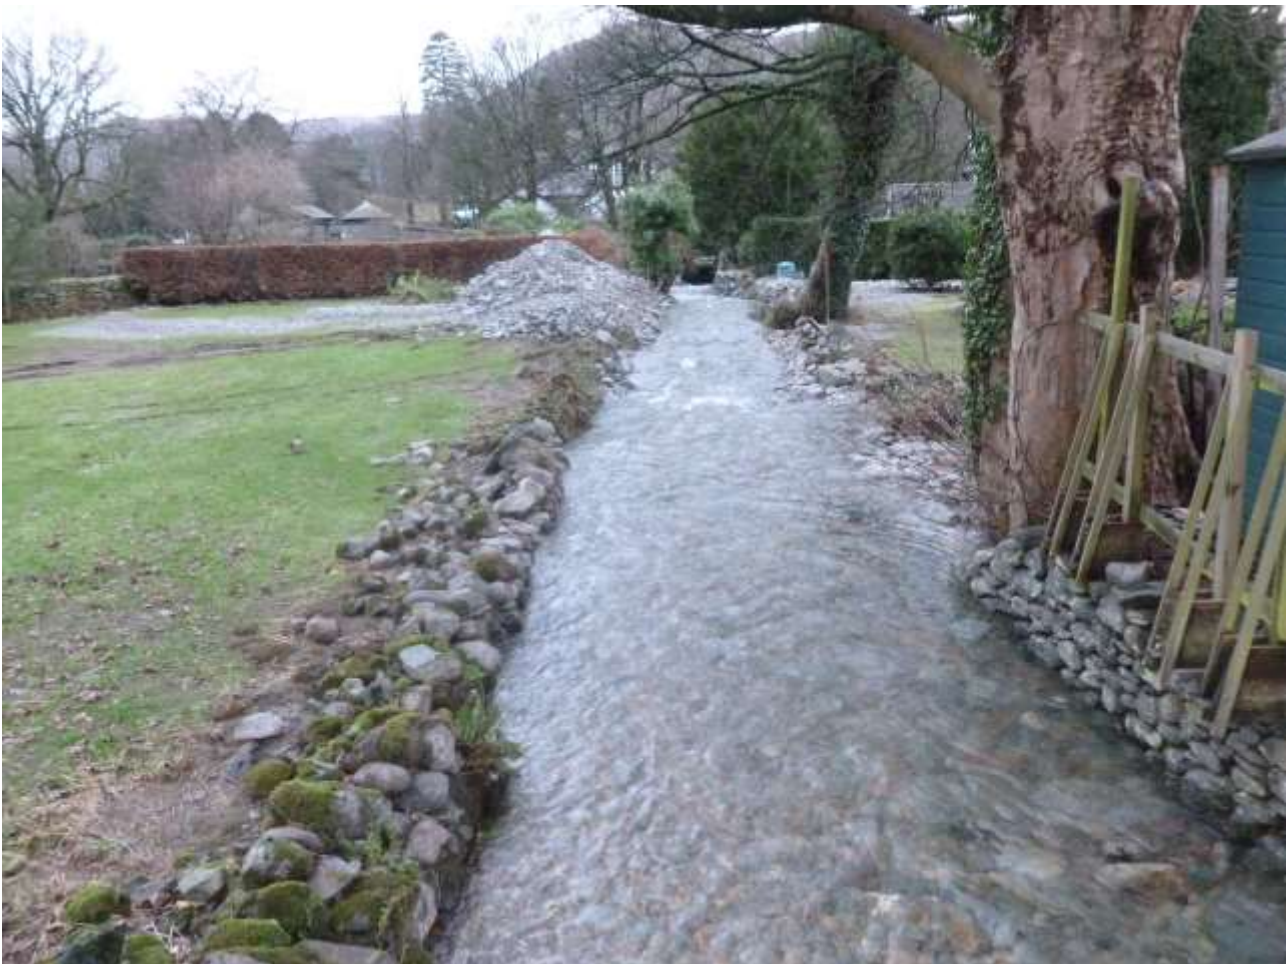
Properties situated alongside Greenhead Gill, which is an ordinary watercourse that flows from the hillsides to the north east of the village and joins the River Rothay on its left bank downstream of White Bridge, were affected by a combination of erosion, deposition of material from landslides upstream and flooding. Due to the steep gradient of Greenhead Gill and the landslides that occurred in the upper catchment, the resulting high flow velocities experienced on the watercourse transported a significant amount of gravel and larger bed material into the lower reaches of the watercourse, filling the existing shallow river channel. In the immediate aftermath of the flood event, the Environment Agency excavated the deposited material from the lower reach of Greenhead Gill to re-establish the river channel. An example of these excavations in the lower reach of Greenhead Gill can be seen in Figure 22.

**Figure 22 – Excavations in the lower reaches of Greenhead Gill**

In the immediate aftermath of the flood event the Environment Agency removed gravel and debris that had accumulated in the lower reach of Greenhead Gill. This was undertaken as emergency works to re-establish the river channel of Greenhead Gill, which had been in-filled by the extensive deposition of gravel and debris.

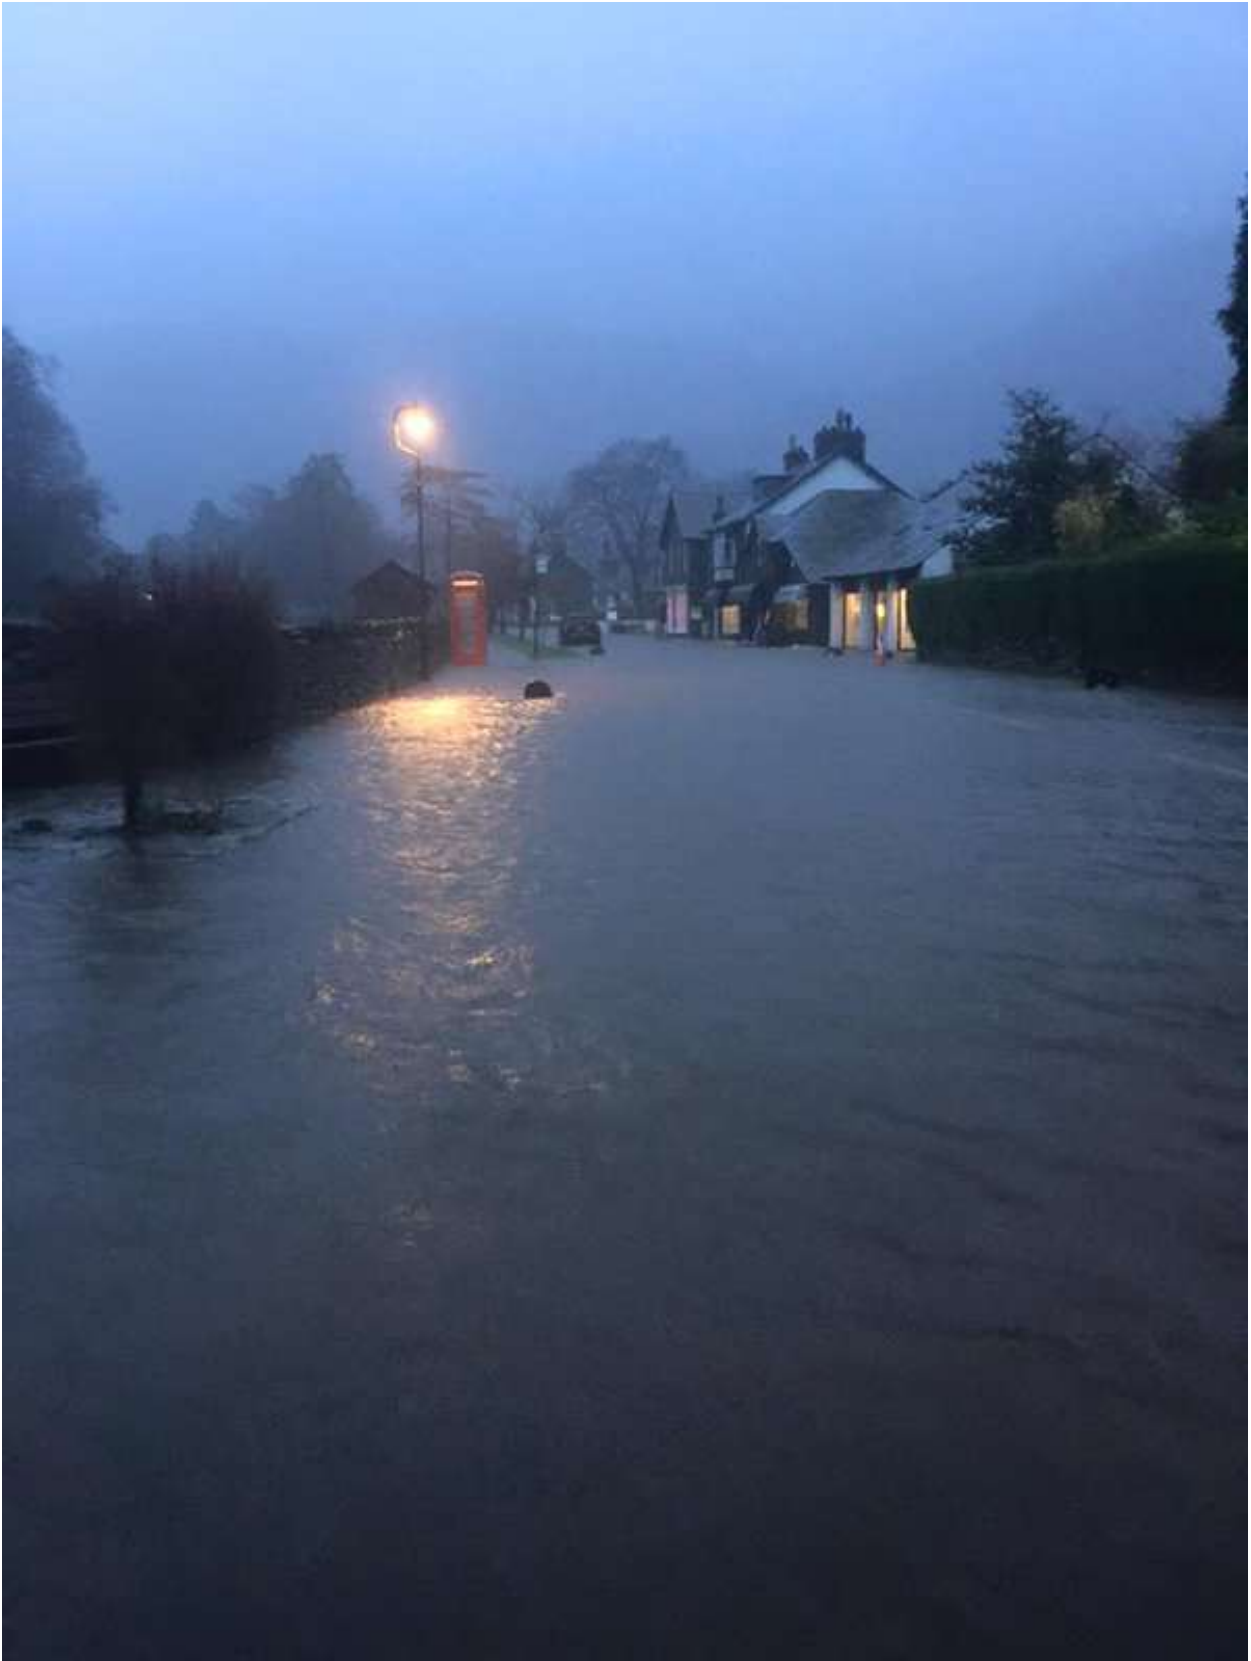
Downstream of White Bridge, the River Rothay overtopped its right bank and flooded onto Broadgate, with water then flowing in a southerly direction towards the College Street and Church Stile areas in the centre of the village. Figure 23, taken looking in a northerly (upstream) direction on Broadgate during the flood event, clearly shows this flood mechanism.

**Figure 23 – Flooding on Broadgate, 5<sup>th</sup> December 2015. Photo taken looking north (upstream).**
