Windermere

Flood Investigation Report

Flood Event 5-6th December 2015

This Flood Investigation Report has been produced by the Environment Agency as a key Risk Management Authority under Section 19 of the Flood and Water Management Act 2010 in partnership with Cumbria County Council as Lead Local Flood Authority.

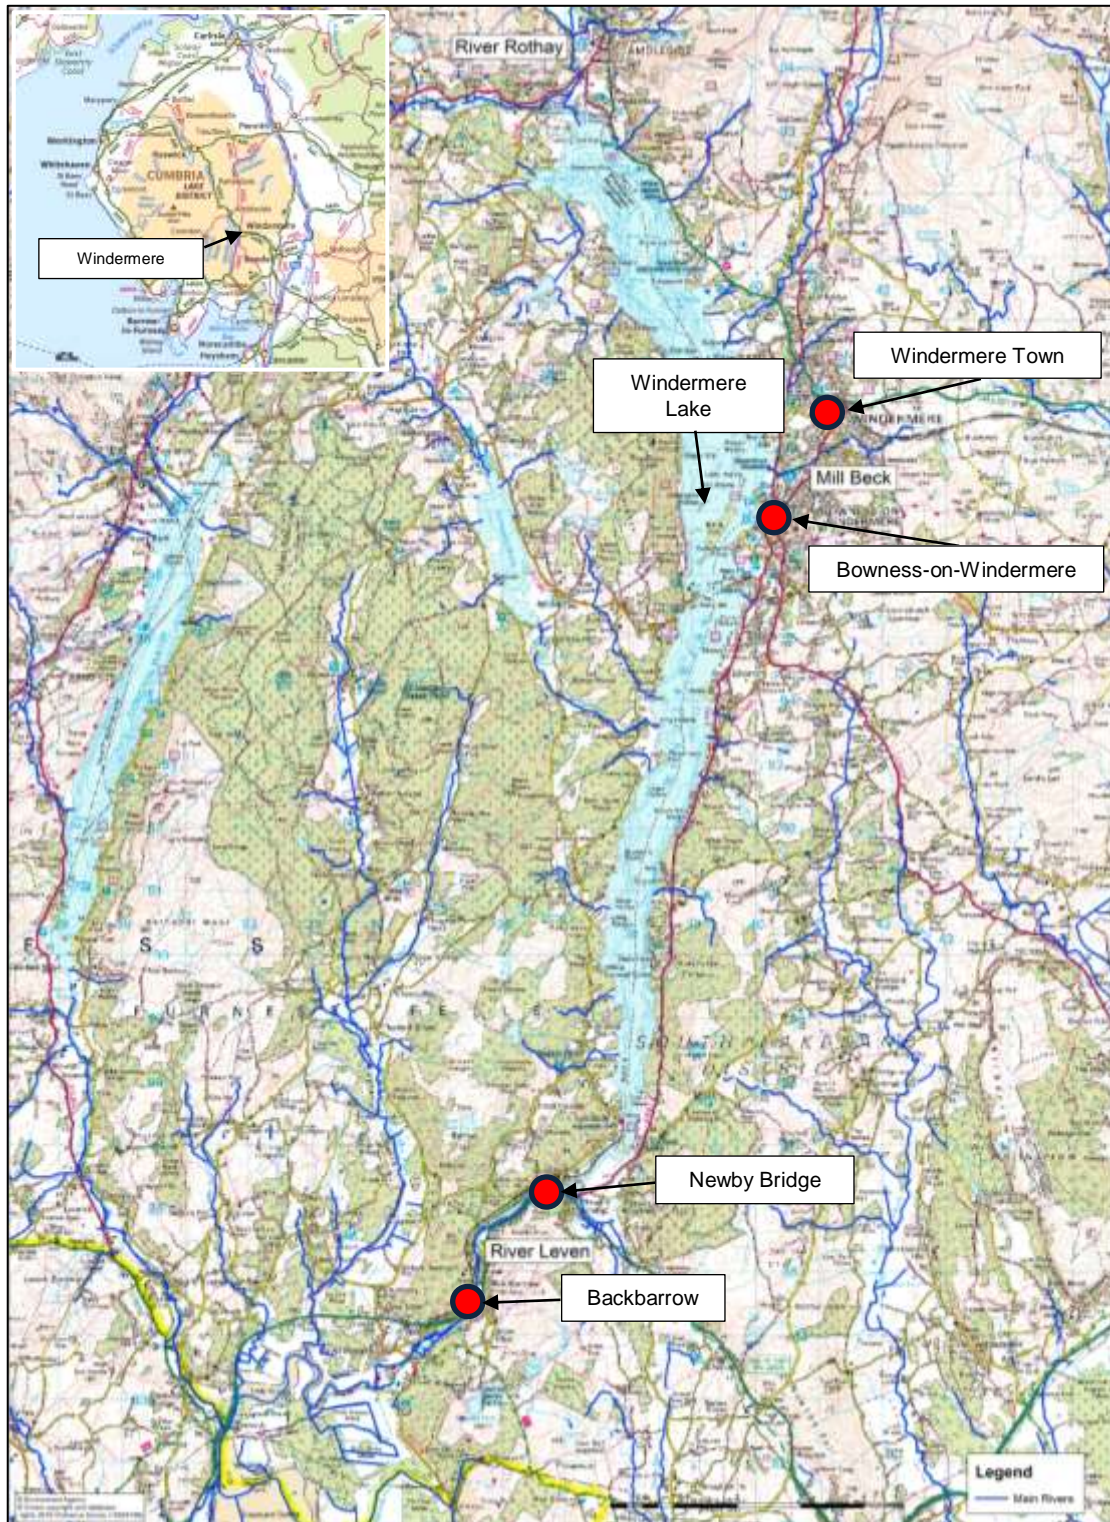
Figure 1: Overview of the Windermere area detailed in the report

Windermere Lake is the largest natural lake in England, stretching 16.9 kilometres in length and reaching a maximum depth of 66.7 metres at its deepest point. It is located within the Lake District National Park, in the county of Cumbria, North West England. The Lake is drained by the River Leven at its southern tip, which discharges into Morecambe Bay. **Figure 1** provides an overview of the Windermere area.

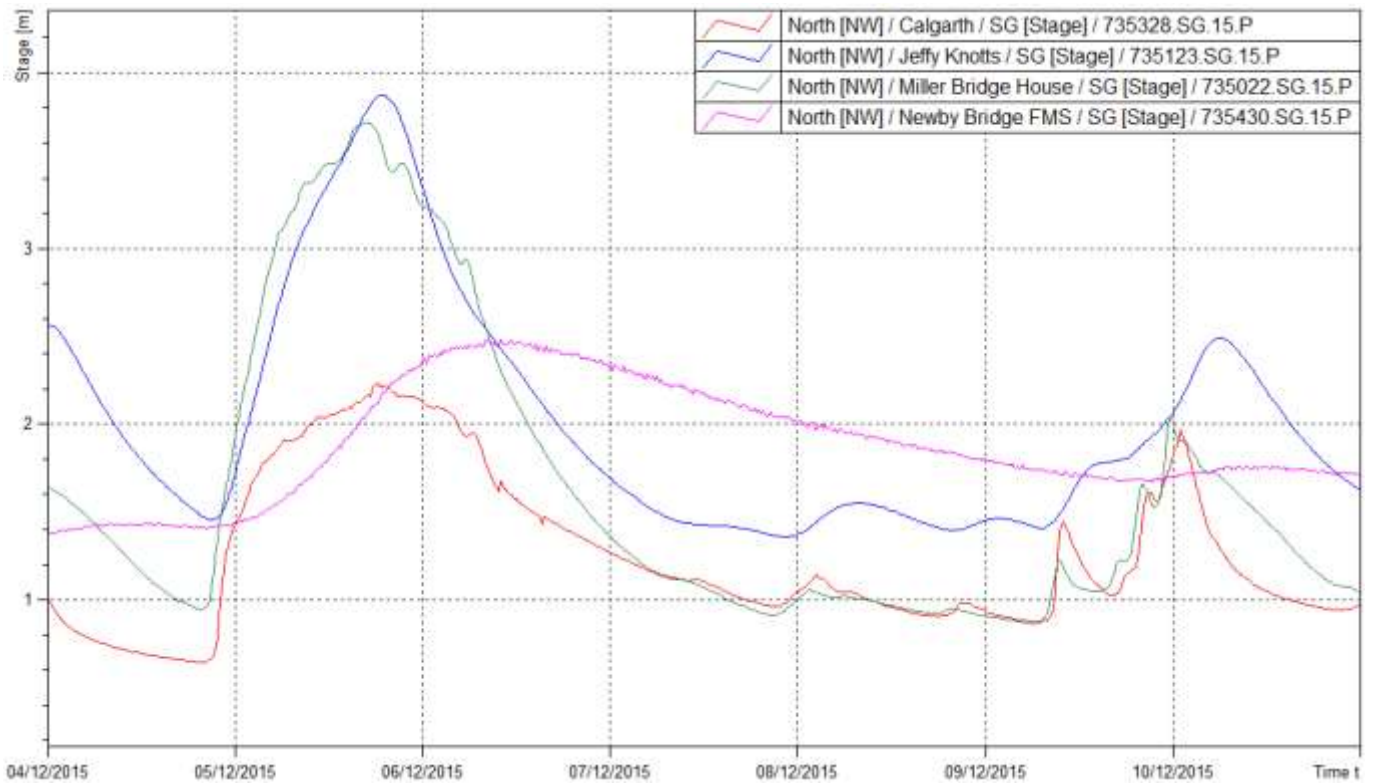
Figure 3 shows changes in the river levels at the gauging stations around Windermere Lake during the December flood event.

Figure 3: River levels recorded at the gauging stations

Table 5 shows lake levels for Windermere Lake recorded at the Far Sawrey gauging station. The maximum level recorded during the December 2015 flood event was 84mm lower than the record lake level, reached during the flooding of November 2009. This can be correlated with the flows draining the lake recorded at Newby Bridge gauging station on the River Leven, recording a peak level 61mm lower in 2015 than in 2009.

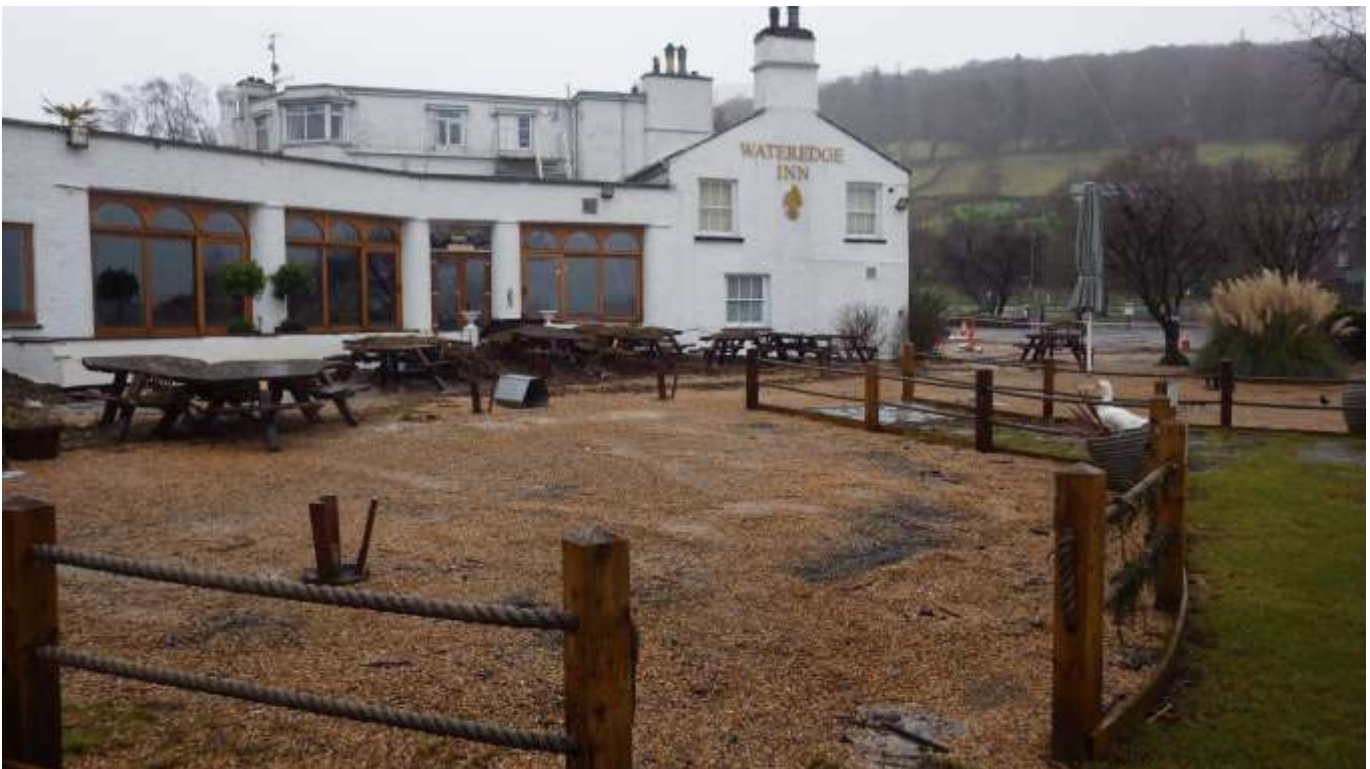
Several commercial properties and boat houses were affected in this area, as illustrated in **Photograph 1**. The locally recorded water level was about 10mm lower than in November 2009, shown in **Photograph 2**.

Photograph 1: Debris near the Wateredge Inn shortly after flooding

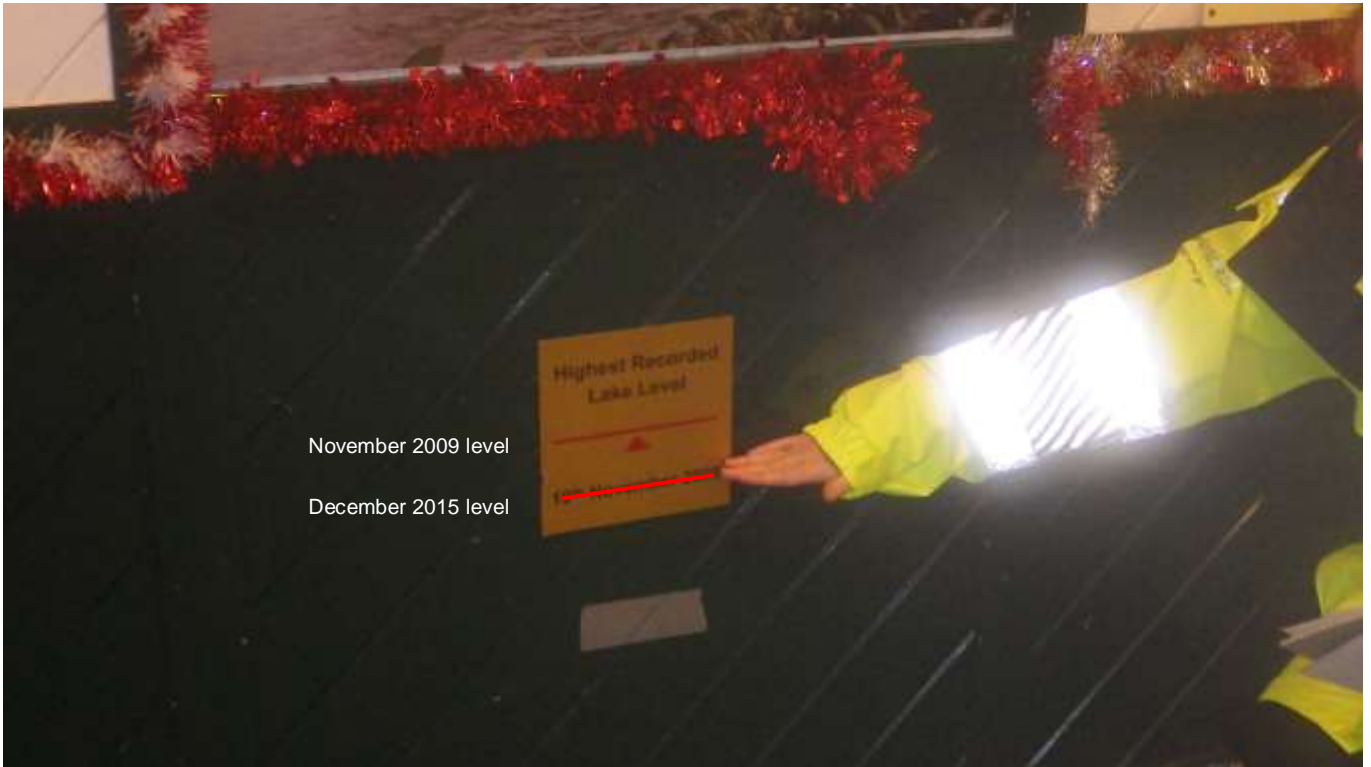
Photograph 2: Water level in 2015 in comparison with the flooding in November 2009

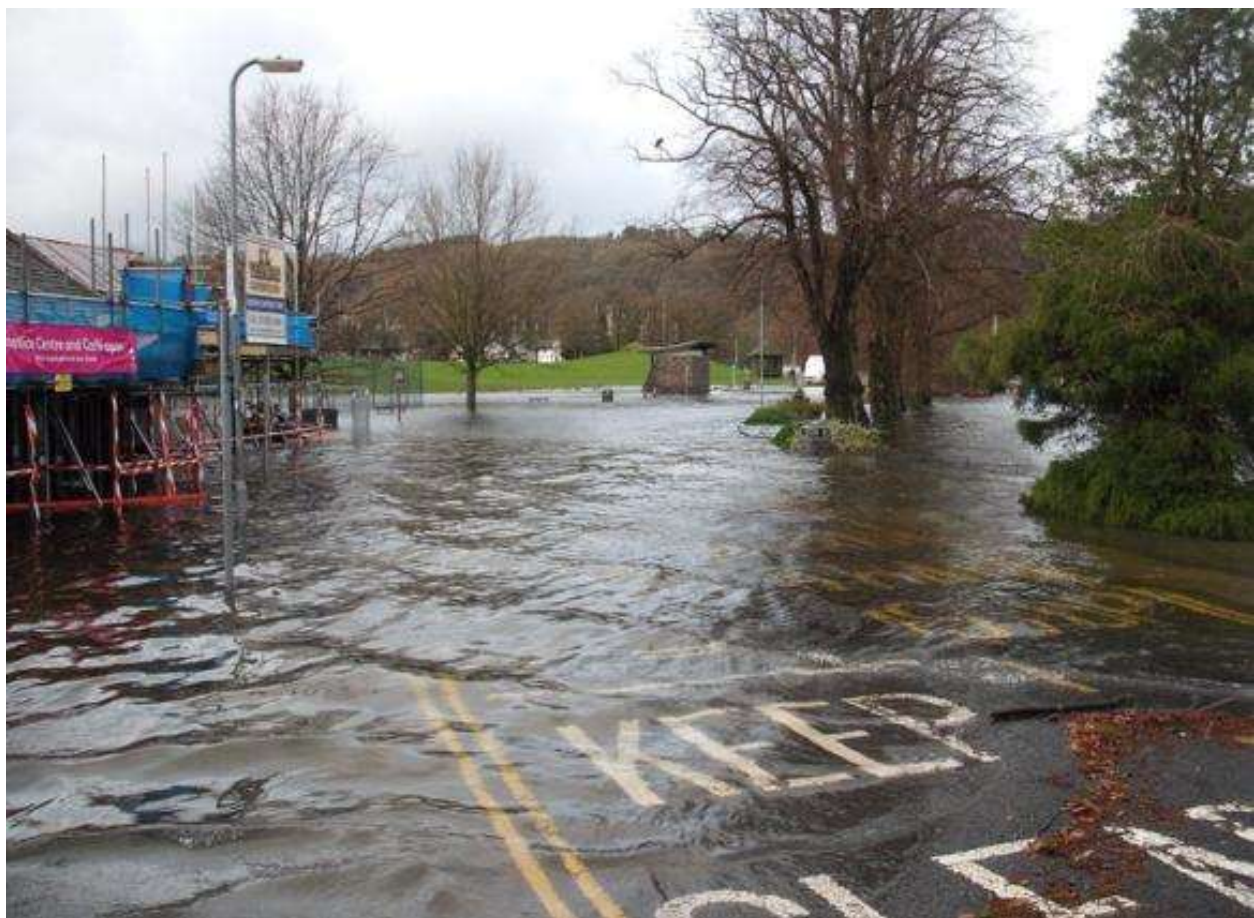
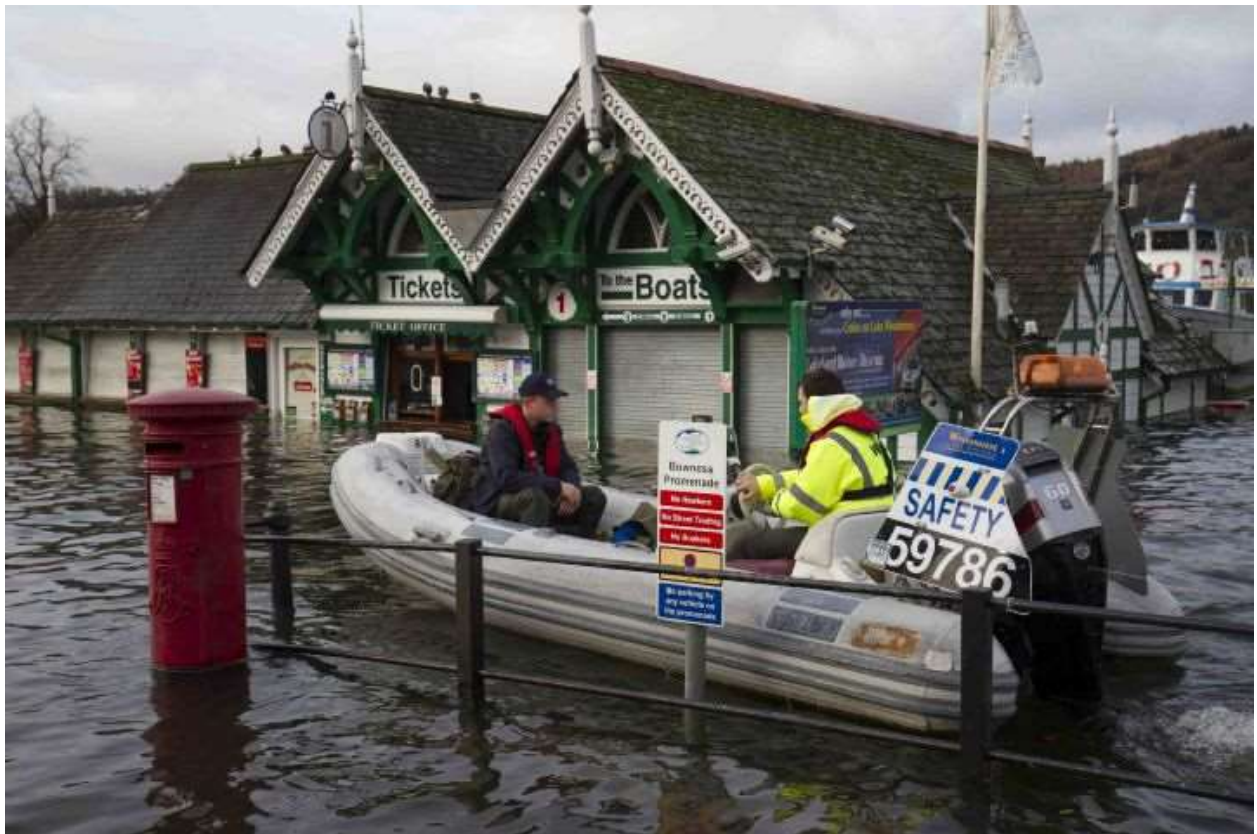
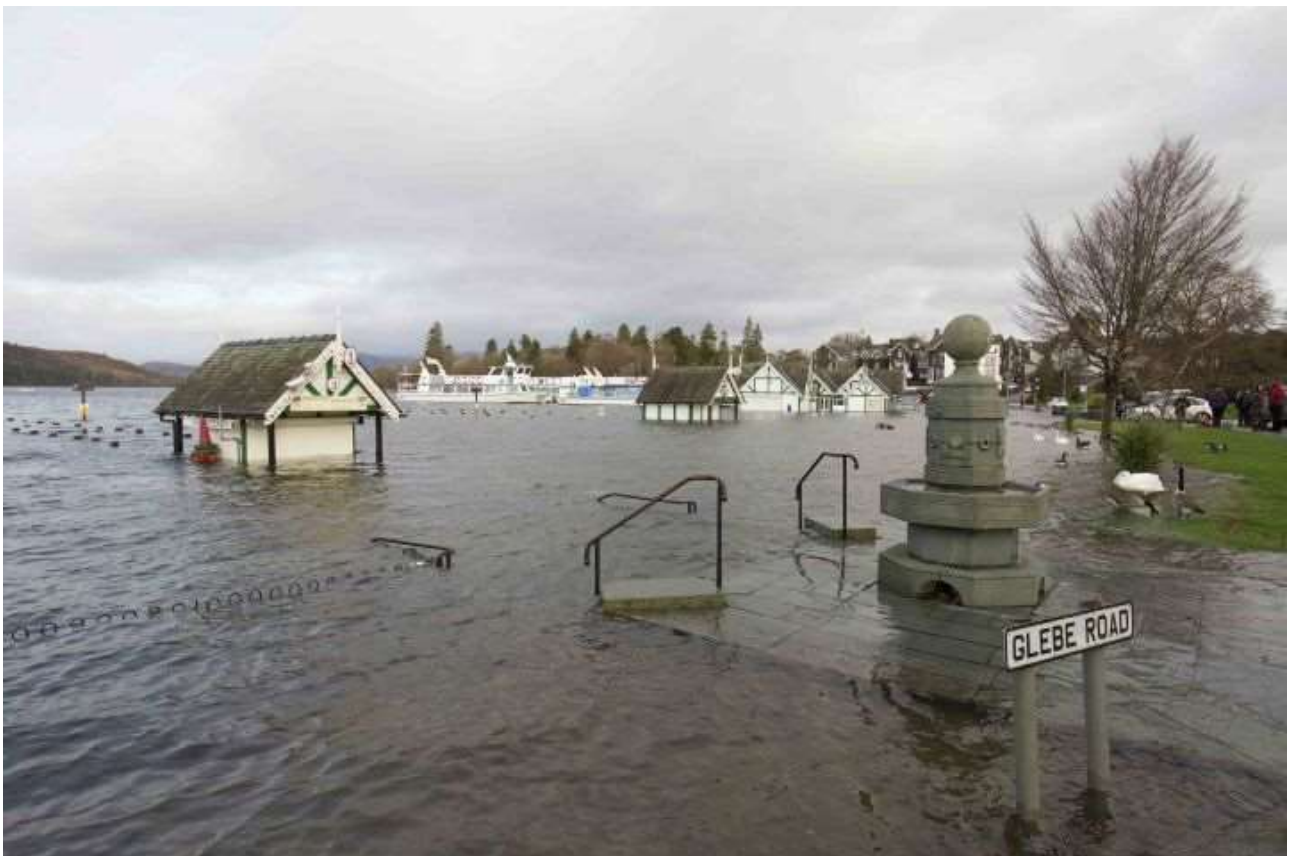
Photograph 3, Photograph 4, and Photograph 5 show flooding in the Glebe Road area on Sunday 6th December 2015.

Photograph 3: Glebe Road – picture by Allan Winrow (The Westmorland Gazette)

Photograph 4: Windermere Lake Cruises – picture by Gordon Shoosmith (Alamy Live News)

Photograph 5: The Promenade and Glebe Road on 6th December 2015 – picture by Gordon Shoosmith (Alamy Live News)

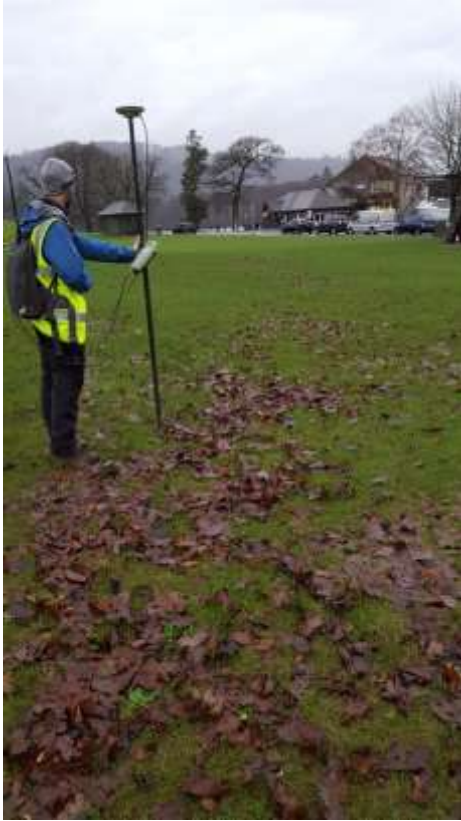
Photograph 6: Debris line on the area adjacent to Glebe Road

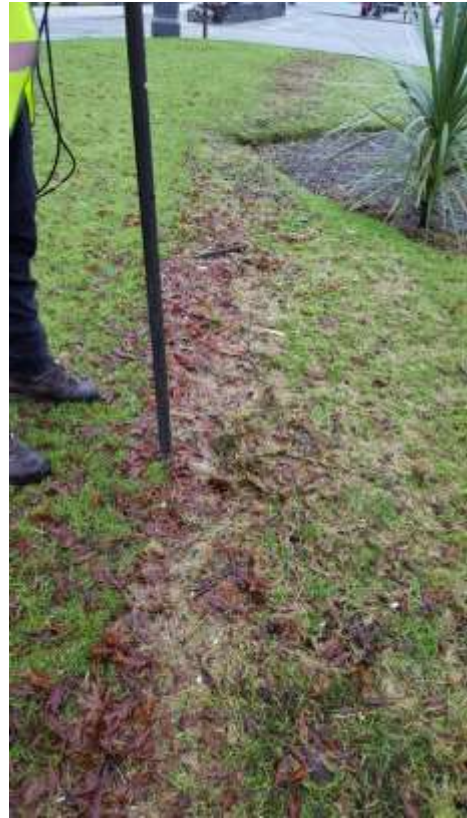
Photograph 7: Debris line on the grass area at junction of Glebe Road and The Promenade

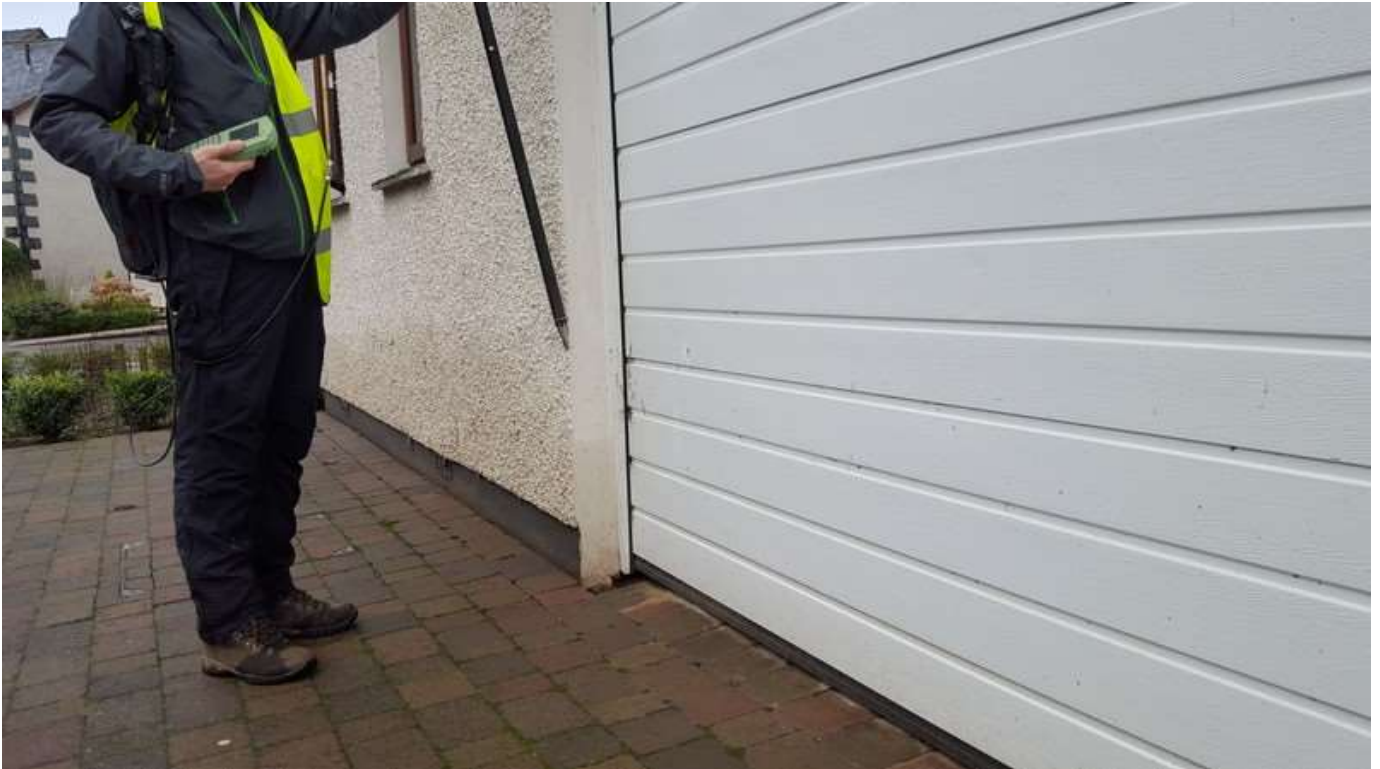
A further 10 residential properties, located a short distance to the south of this investigation area, were also flooded. Reportedly, water levels in these properties were 100 mm lower than recorded in November 2009.

Photograph 8: Flood level on one of the buildings in The Marina

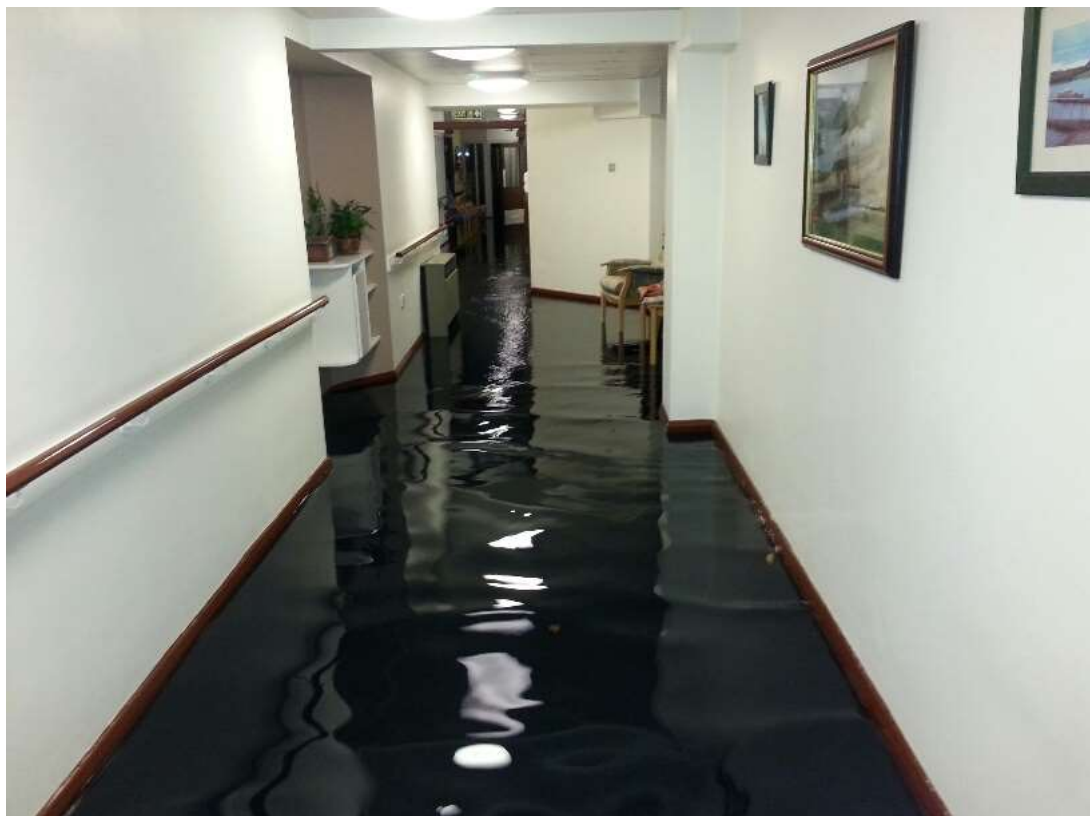
To the north of the A591 on Church Street, the Windermere Hotel and a group of adjacent properties were affected by flooding from overland surface water flows from the fellsides to the north. **Photograph 9** shows a hallway on the ground floor in Birthwaite Flats sheltered housing on 5th December, where eight flats were reportedly flooded by surface water. Local residents reported that the surface water flow route from the fellsides to the north of the Windermere Hotel continued in a westerly direction along the A591 Church Street before flowing south along Phoenix Way towards Birthwaite Flats.

Photograph 9: Hallway on the ground floor of Birthwaite Flats

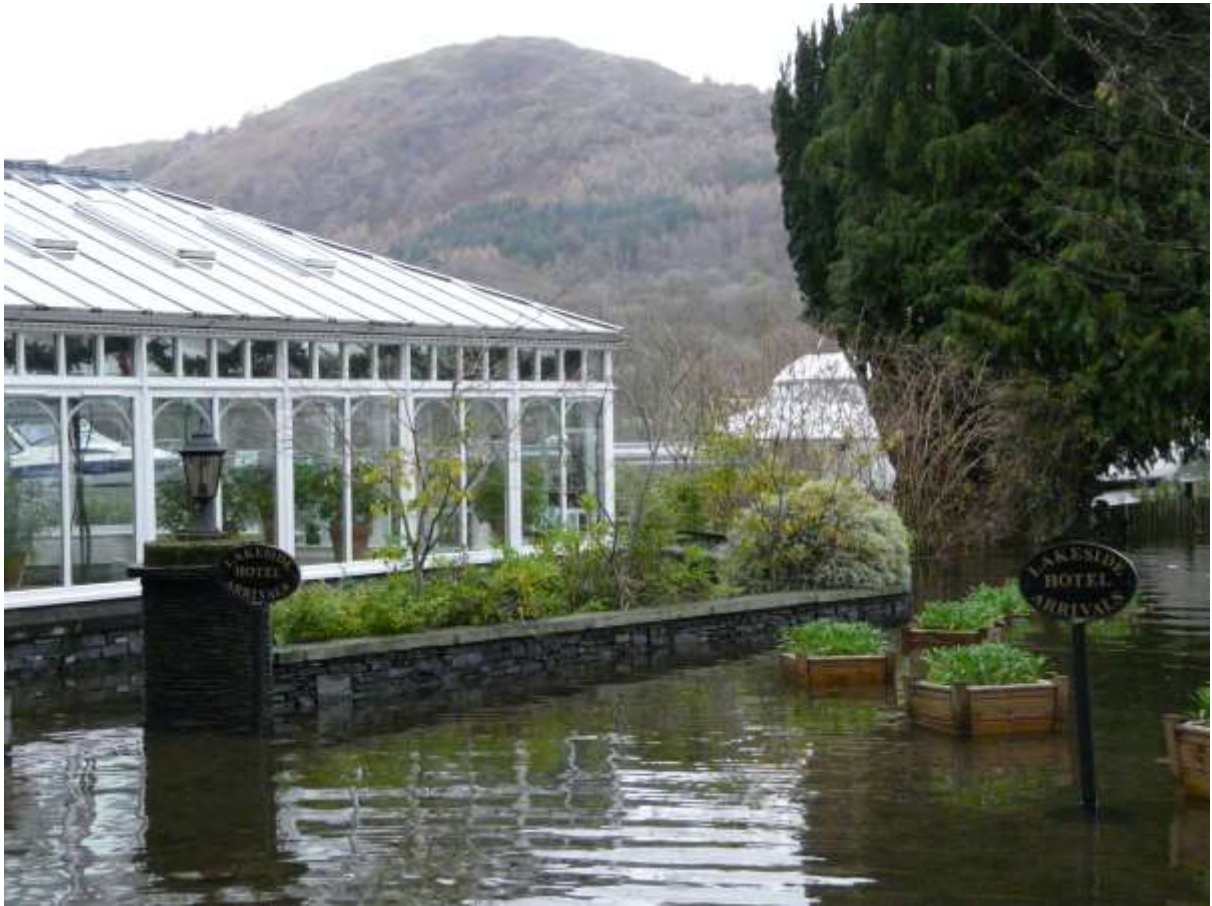
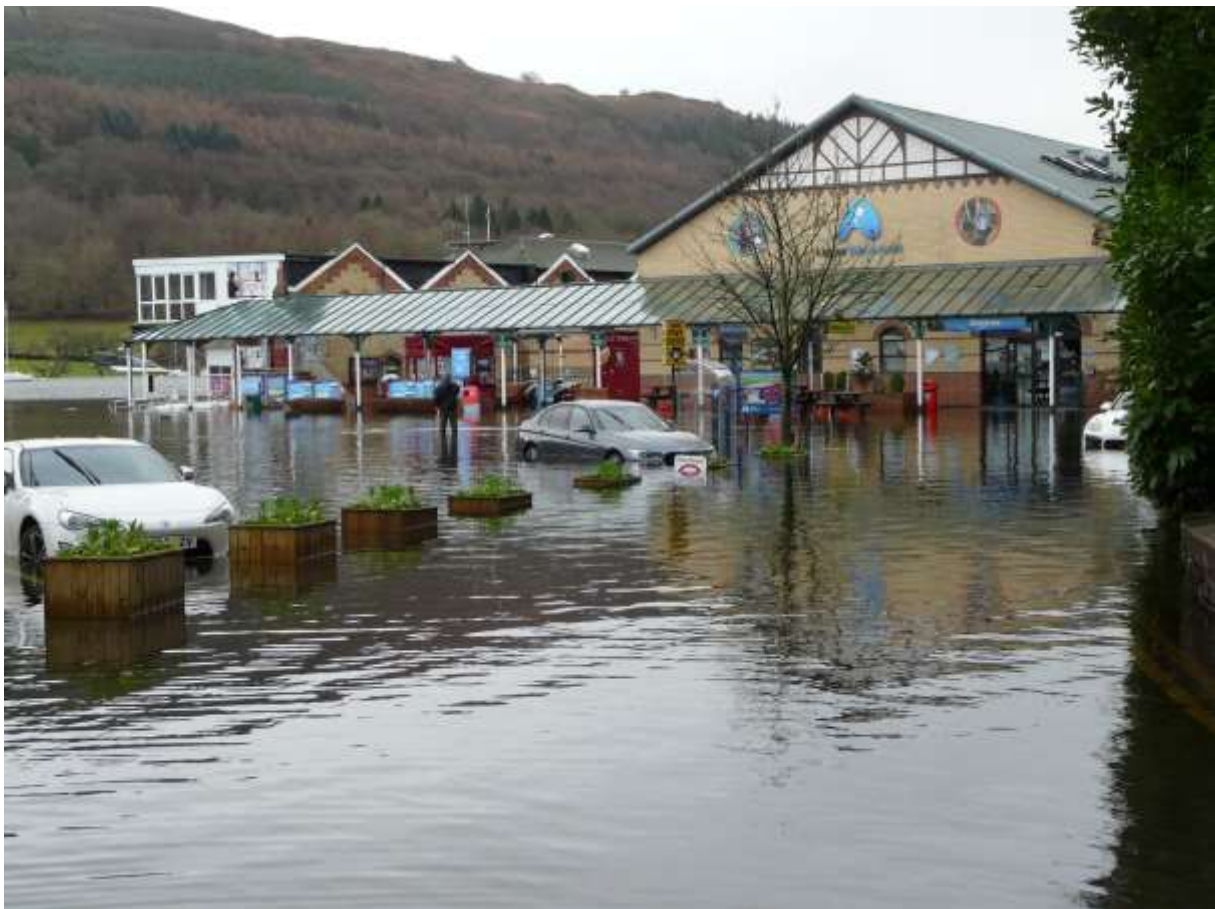
Photograph 10 shows the Lakeside Hotel and Photograph 11 shows the Lakes Aquarium and its car park. Both of these properties were flooded due to the high water level in Windermere Lake.

Photograph 10: Lakeside Hotel (Photo courtesy of Zan Fell)

Photograph 11: Lakes Aquarium (Photo courtesy of Zan Fell)

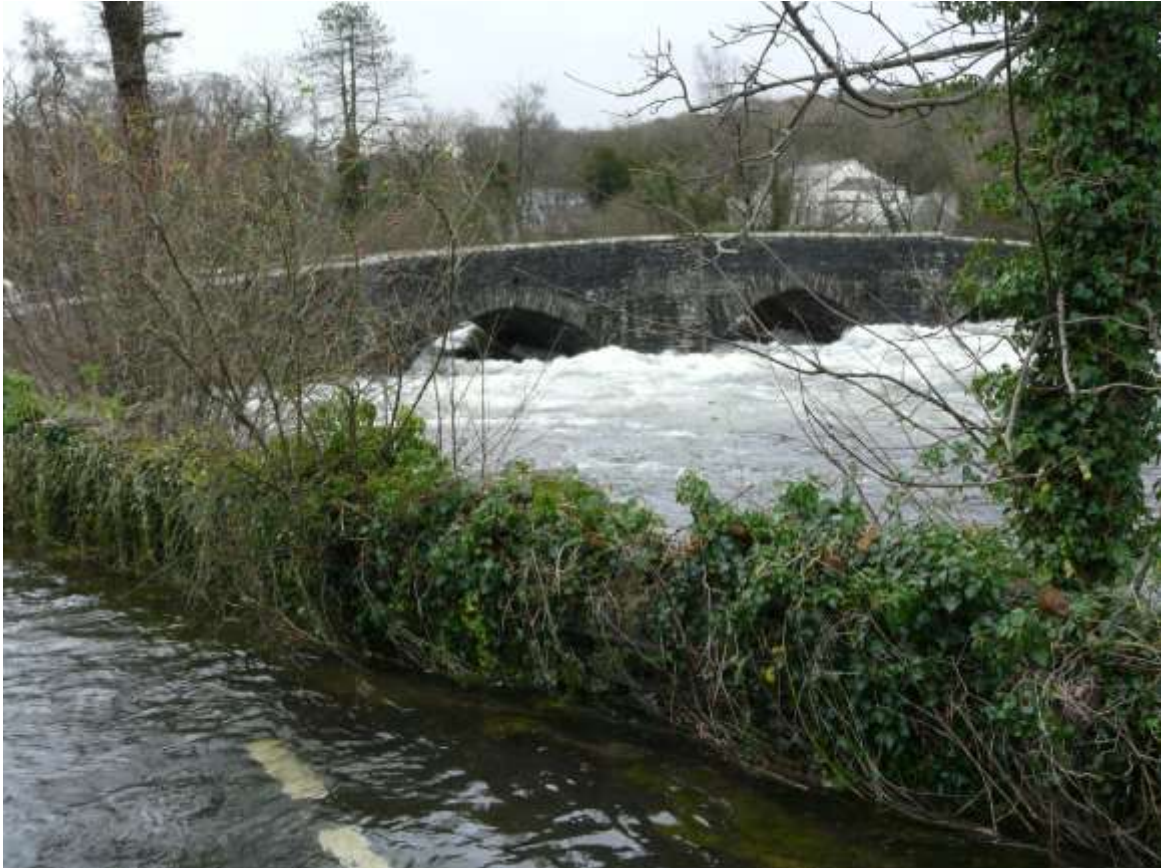
It was observed by local residents that as the water level in the River Leven rose, water swept round the side of the bridge parapet and onto the road. **Photograph 12** shows the water level in the bridge section. At the same time, water came through a gap between the bridge wall and a property boundary wall, located on the left bank of the River Leven, causing flooding to the road and to properties on the left bank.

**Photograph 12: Newby Bridge, looking upstream from the right bank
(Photo courtesy of Zan Fell)**

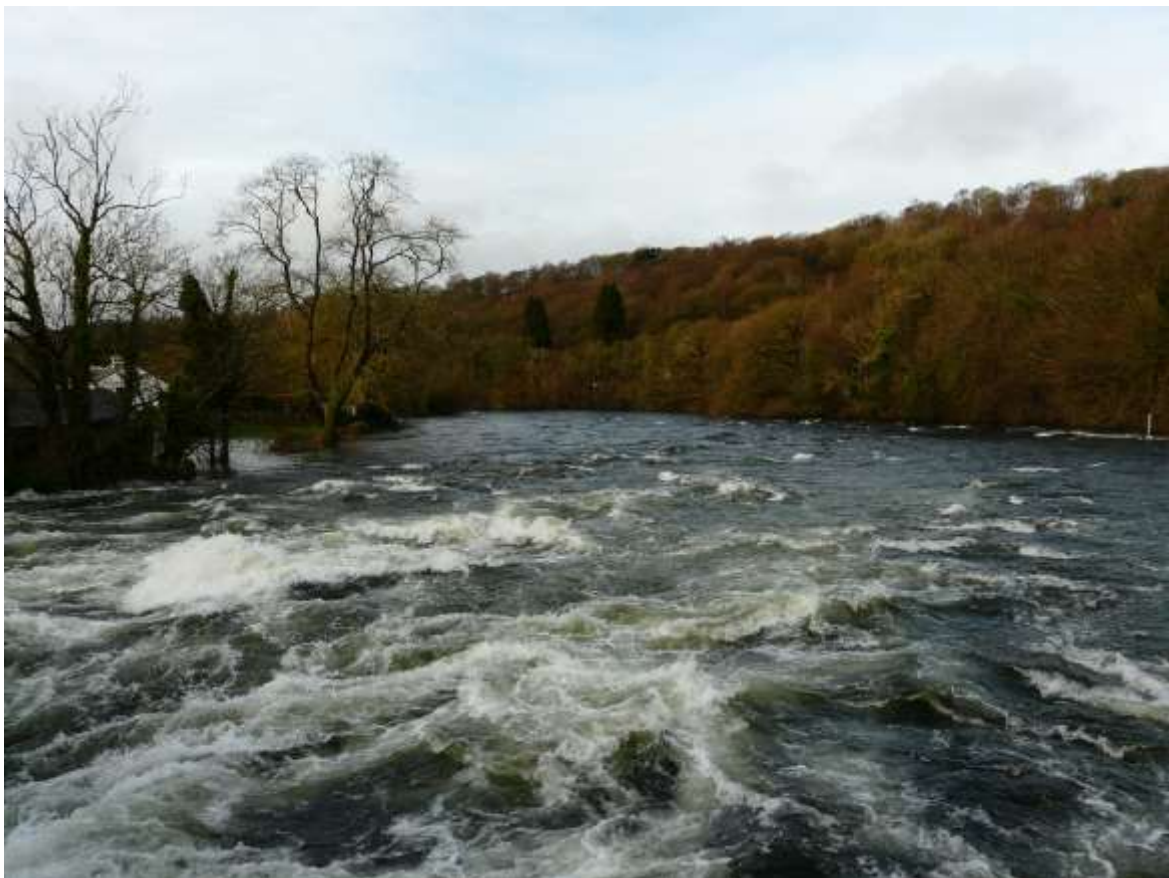
**Photograph 13: Looking downstream at Newby Bridge Weir from Newby Bridge
(Photo courtesy of Zan Fell)**

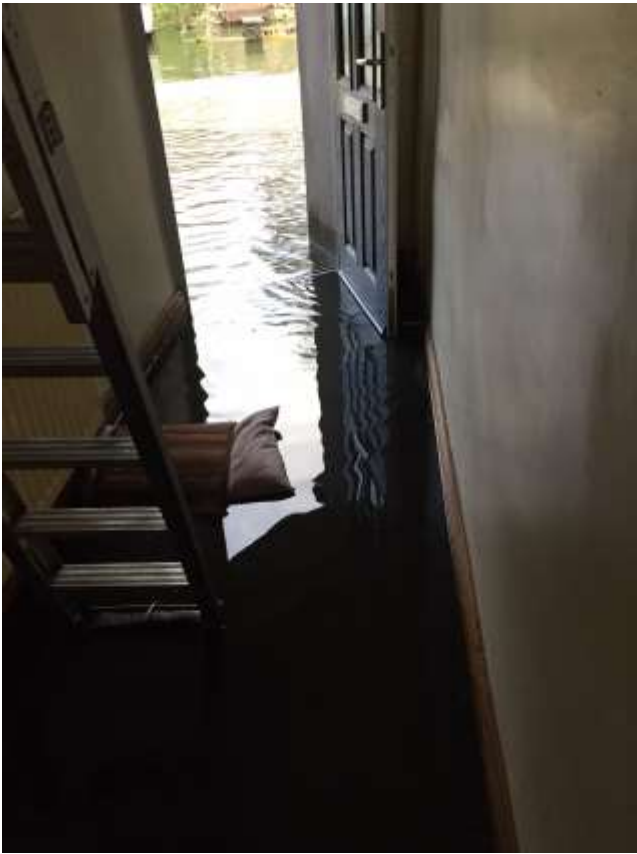
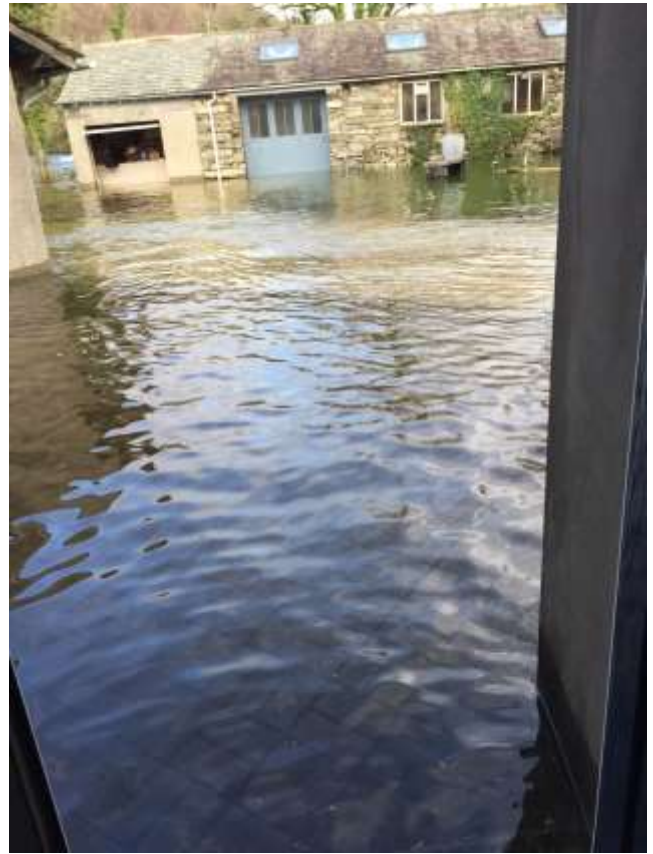
Flooded properties are shown in **Photograph 14** and **Photograph 15**. The Swan Hotel, shown in **Photograph 16**, was flooded to ankle depth on the ground floor. Local residents reported that water came up through the drains before floodwater inundated properties from the river.

Photograph 14 and Photograph 15: Flooded properties in Newby Bridge

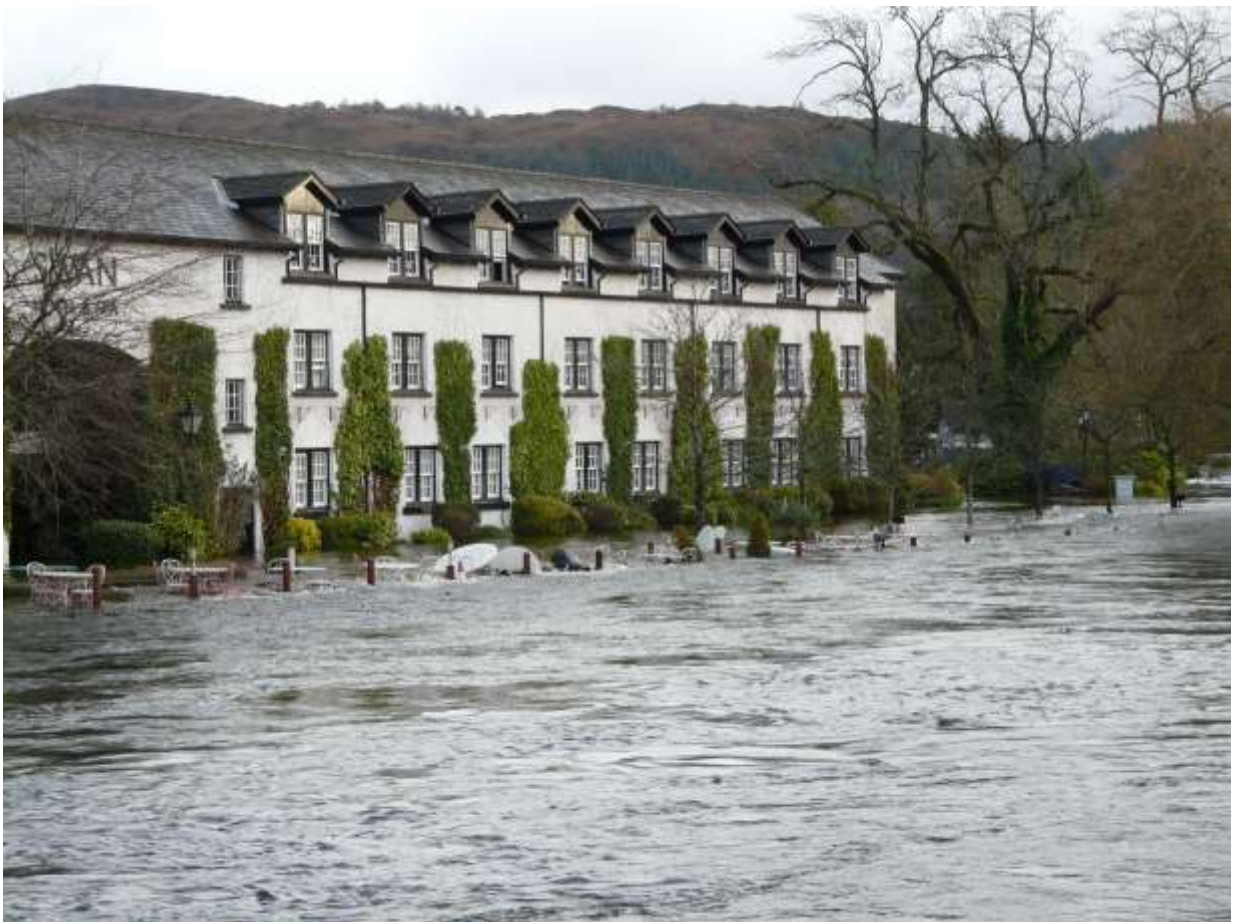
Photograph 16: The Swan Hotel, Newby Bridge

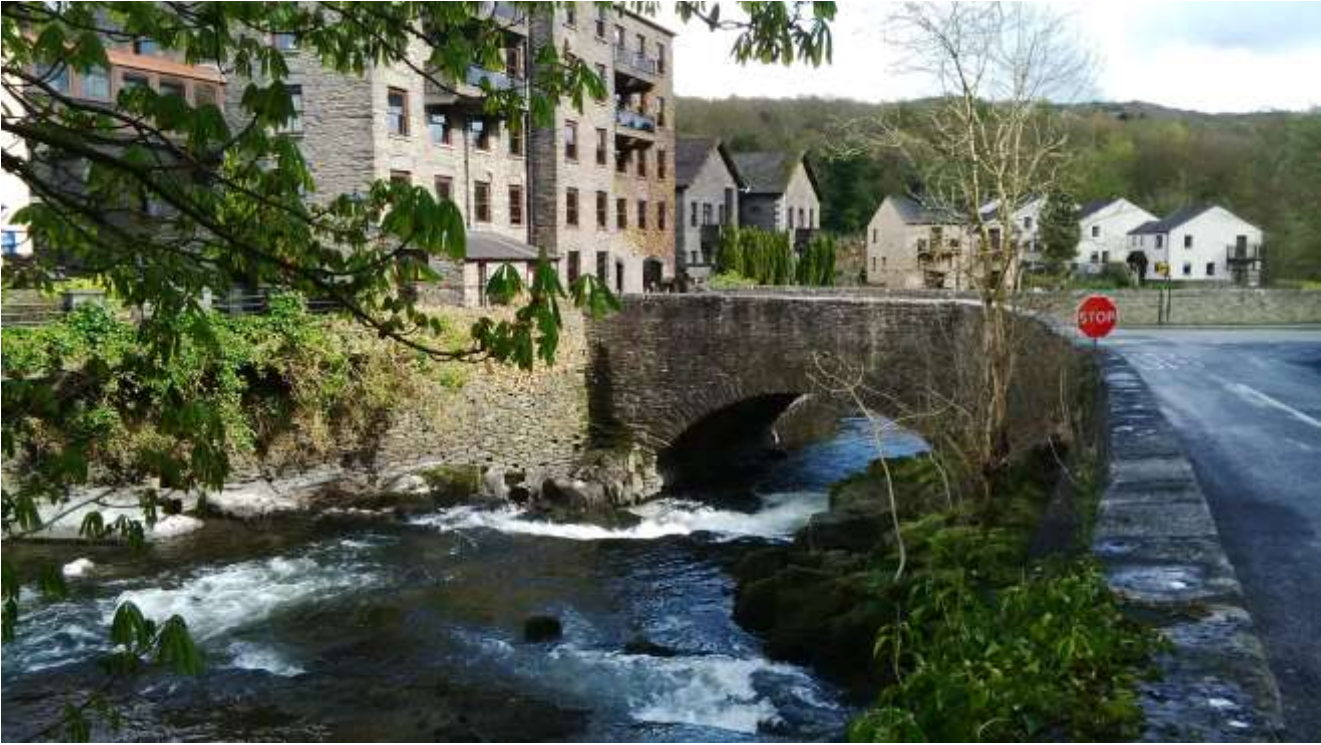
During the 2009 flood event the parapet walls on Backbarrow Bridge were seriously damaged and washed away by water overtopping the bridge. The bridge parapet walls were subsequently repaired by Cumbria County Council.

Backbarrow Bridge is a typical traditional stone built Lakeland bridge, and is shown in **Photograph 17**. The bridge was built many years ago, and with that comes many challenges in how best to maintain and adapt the structure to meet the modern day needs of vehicle access, public safety and flood risk. The capacity of Backbarrow Bridge to convey significant flood flows is widely recognised as being one of the main flood risk problems affecting the Lakeland Village, the Whitewater Hotel and residential properties located close to the bridge. Flood flow routes are shown in **Figure 14**. The bridge is a restriction to large flood flows, and in combination with the bridge parapet walls, prevents flood water from overtopping the bridge leading to higher flood levels affecting adjacent properties. The December 2015 flood event replicated the November 2009 flooding, with the bridge causing flood water to back up, submerging the bridge and overtopping river walls causing flooding to properties, illustrated in **Photographs 18 to 22**. The bridge parapet walls remained in place during the December flood, which was said by the local community to have made the flooding worse. A stone wall to the south east of Backbarrow Bridge failed over about five metres, leading to the loss of foundations to the electricity transformer immediately downstream. This resulted in the loss of power locally until the foundations had been repaired.

Photograph 17: Backbarrow Bridge

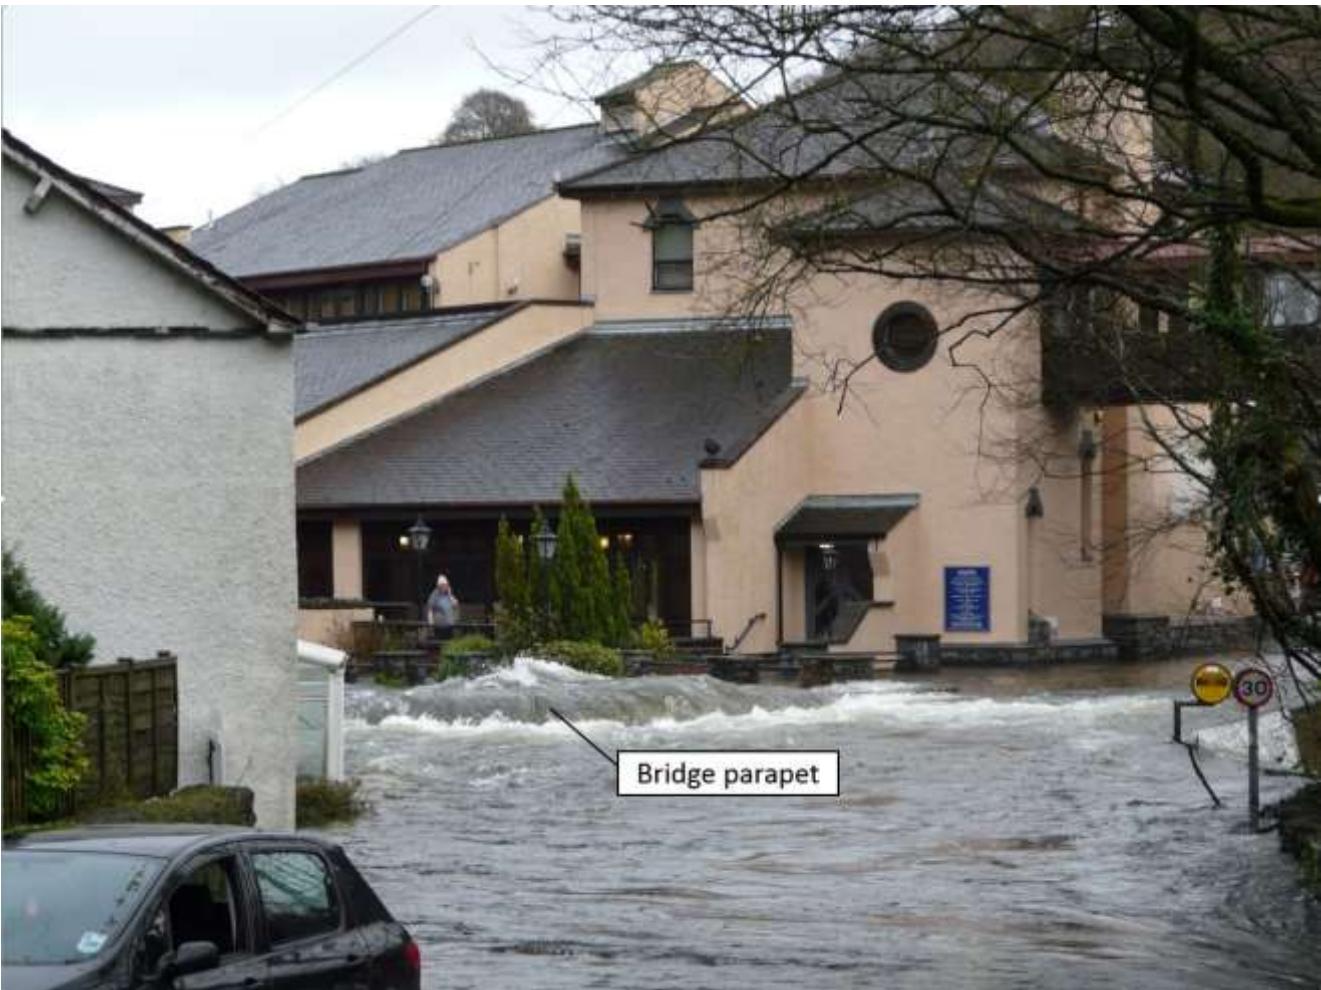
**Photograph 18: Backbarrow Bridge – Water overtopping the bridge parapets
(Photo courtesy of Zan Fell)**

The Whitewater Hotel, shown in **Photographs 18 and 20**, as well as a number of timeshare properties at The Lakeland Village, shown in **Photographs 21 and 22**, were flooded on the left bank of the River Leven. The recorded water levels in these properties ranged from between approximately 120mm to 1000mm.

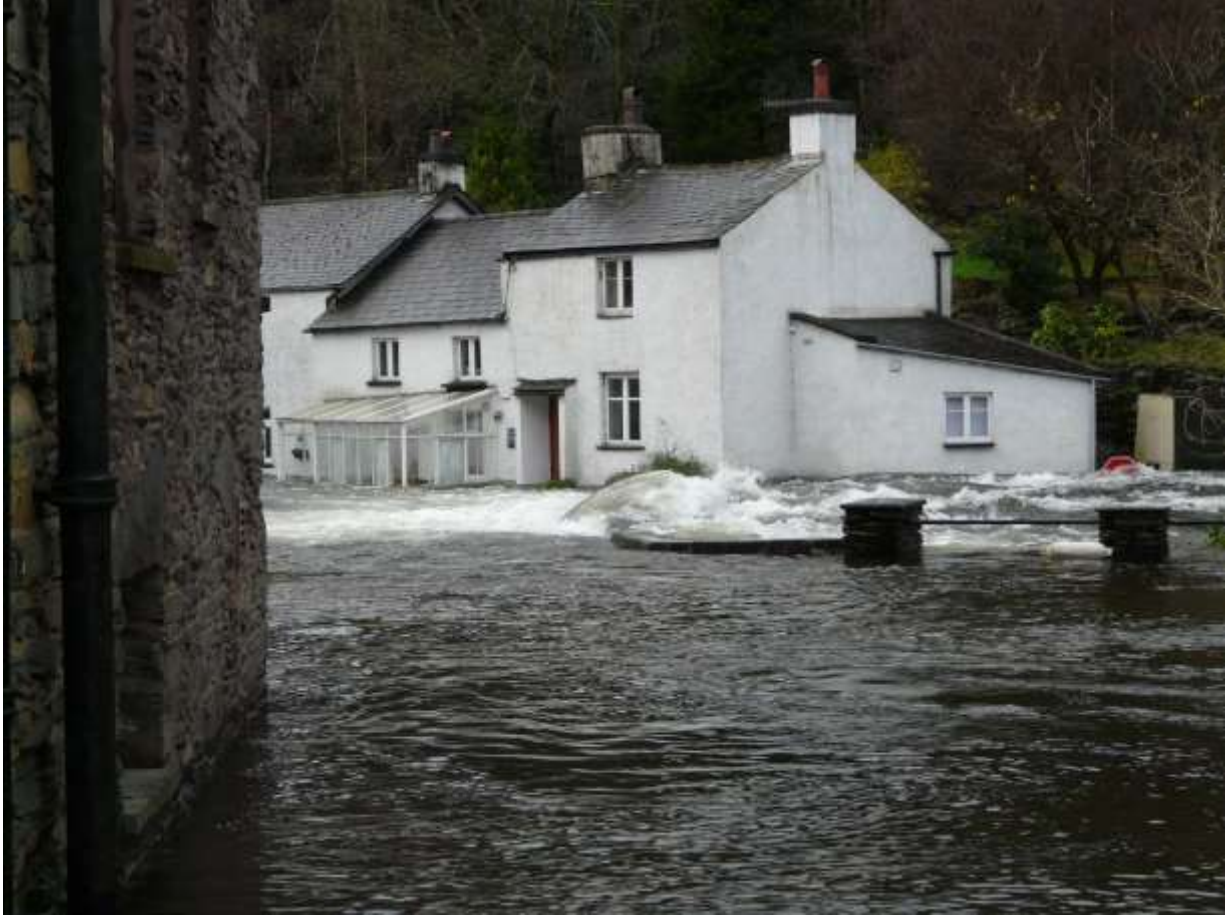
On the right bank of the River Leven at Backbarrow Bridge, Bridge House and Bridge Cottage were affected by flooding, shown in **Photograph 19**.

**Photograph 19: Backbarrow – Water affecting Bridge House and Bridge Cottage
(Photo courtesy of Zan Fell)**
