Windermere

Flood Investigation Report

Flood Event 5-6th December 2015

This Flood Investigation Report has been produced by the Environment Agency as a key Risk Management Authority under Section 19 of the Flood and Water Management Act 2010 in partnership with Cumbria County Council as Lead Local Flood Authority.

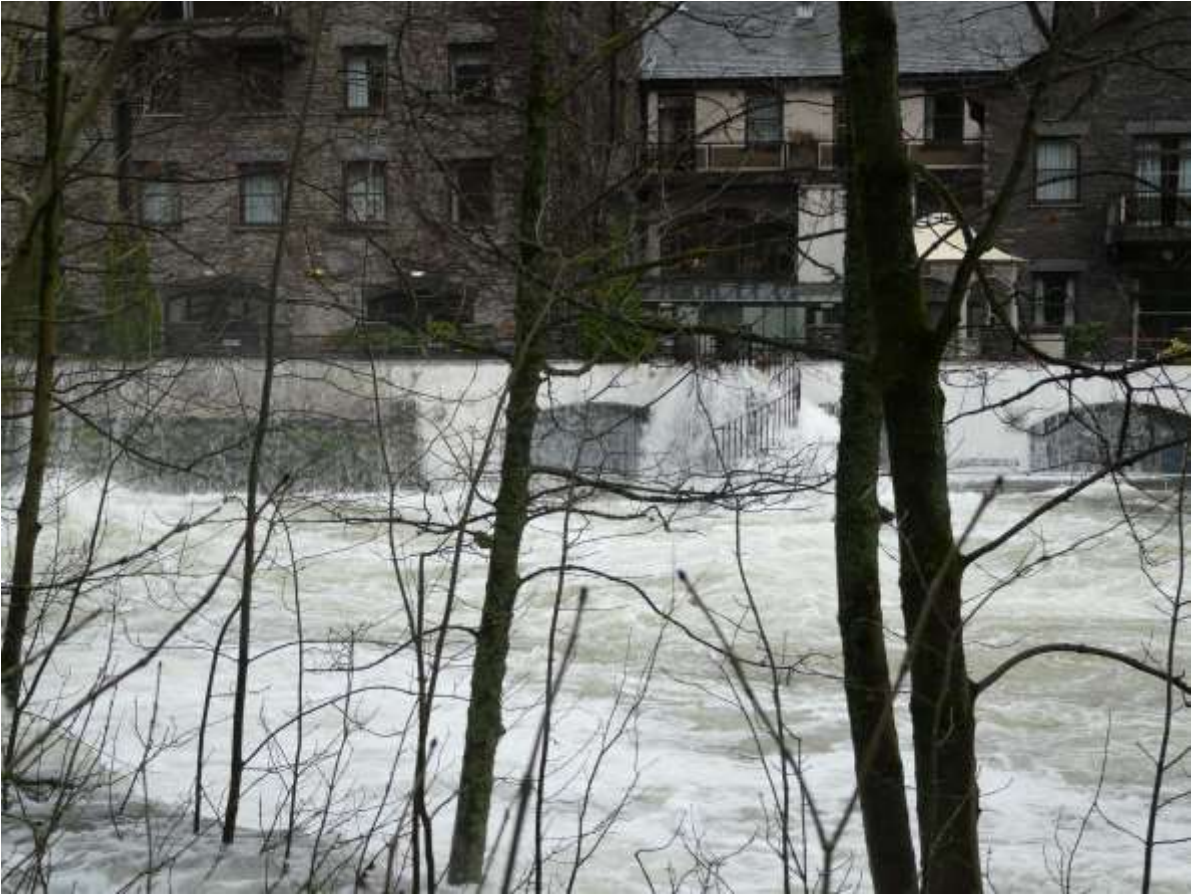
The Whitewater Hotel, shown in **Photographs 18 and 20**, as well as a number of timeshare properties at The Lakeland Village, shown in **Photographs 21 and 22**, were flooded on the left bank of the River Leven. The recorded water levels in these properties ranged from between approximately 120mm to 1000mm.

**Photograph 20: Backbarrow – Whitewater Hotel
(Photo courtesy of Zan Fell)**

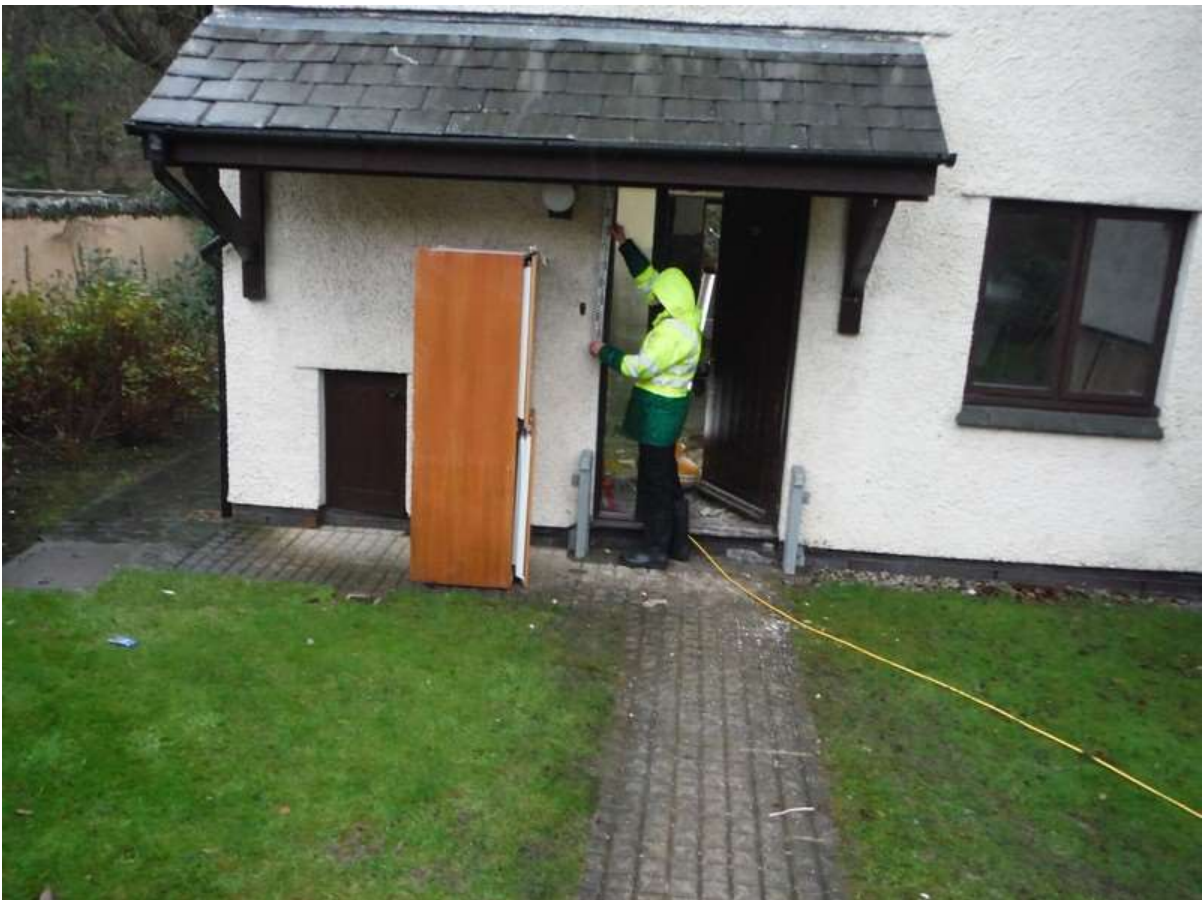
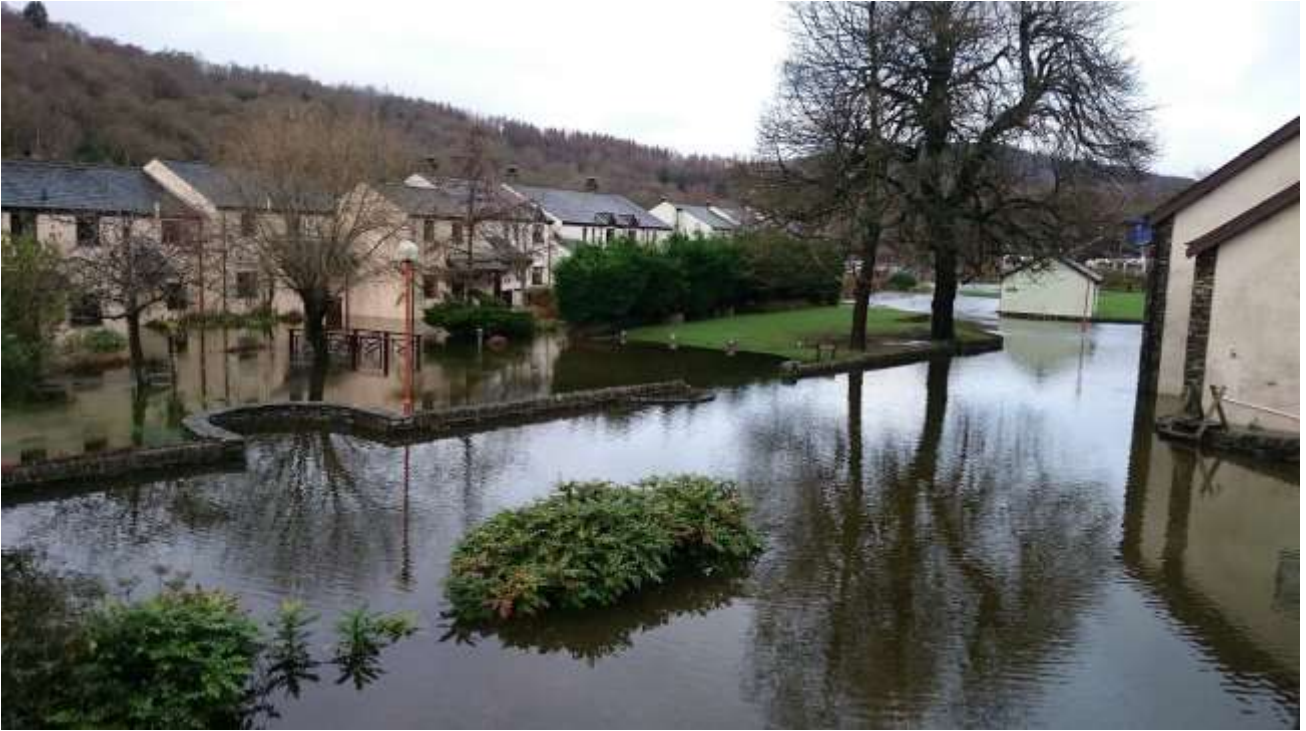
Photograph 21: Backbarrow – Lakeland Village timeshare estate with water mark

**Photograph 22: Backbarrow – Lakeland Village timeshare estate
(Photo courtesy of Richard Guzinski)**
