# Burneside

## Flood Investigation Report

## Flood Event 5-6<sup>th</sup> December 2015

This flood investigation report has been produced by the Environment Agency as a key Risk Management Authority under Section 19 of the Flood and Water Management Act 2010, in partnership with Cumbria County Council as Lead Local Flood Authority.

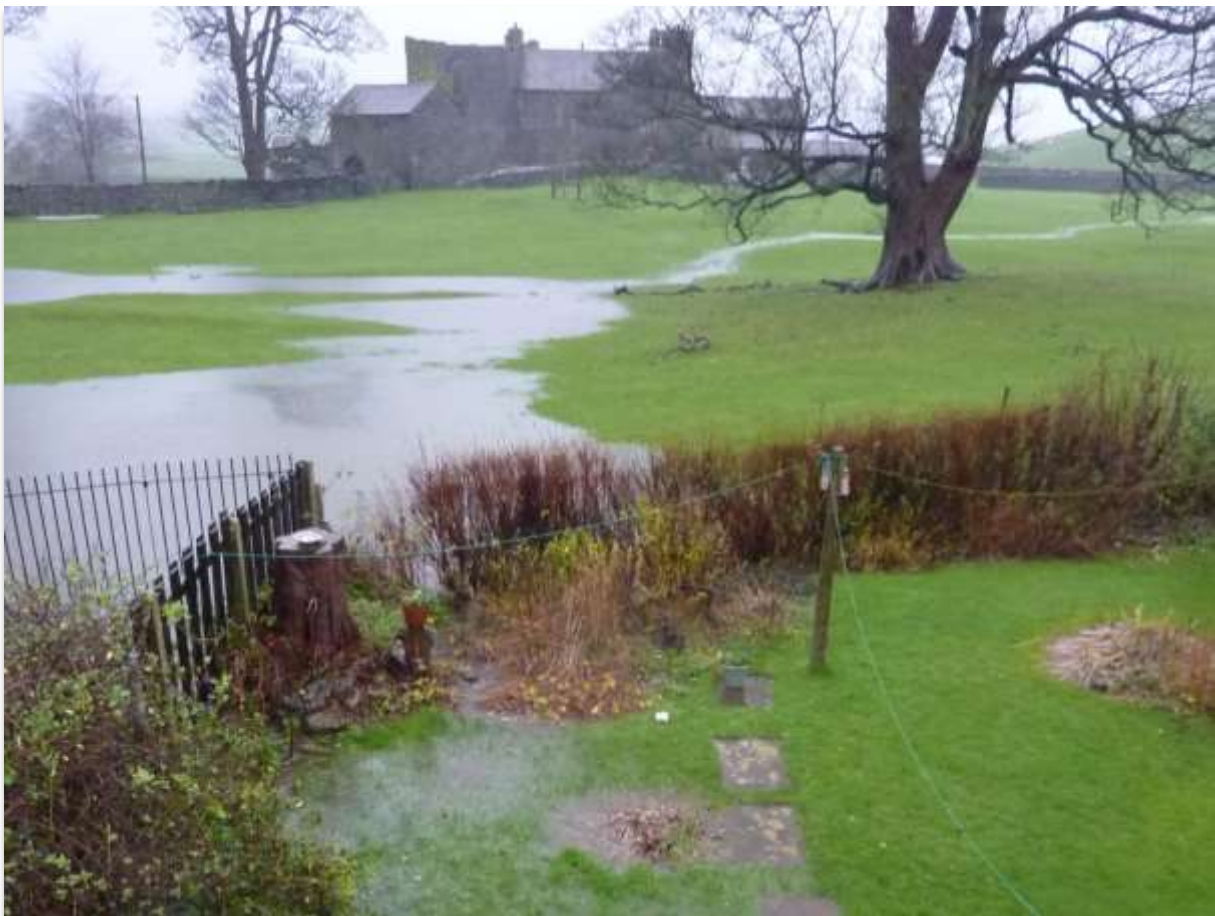
Surface water flooding at Hall Park on the 5<sup>th</sup> December 2015

Surface water run-off from Burneside Heads flooded part of the rear garden of 110 Hall Park, where the owner had to dig a drainage trench around the boundary of the property to drain standing water into the surface water drainage systems serving Hall Park. Figure 21 shows the extent of the surface water flooding at 110 Hall Park.

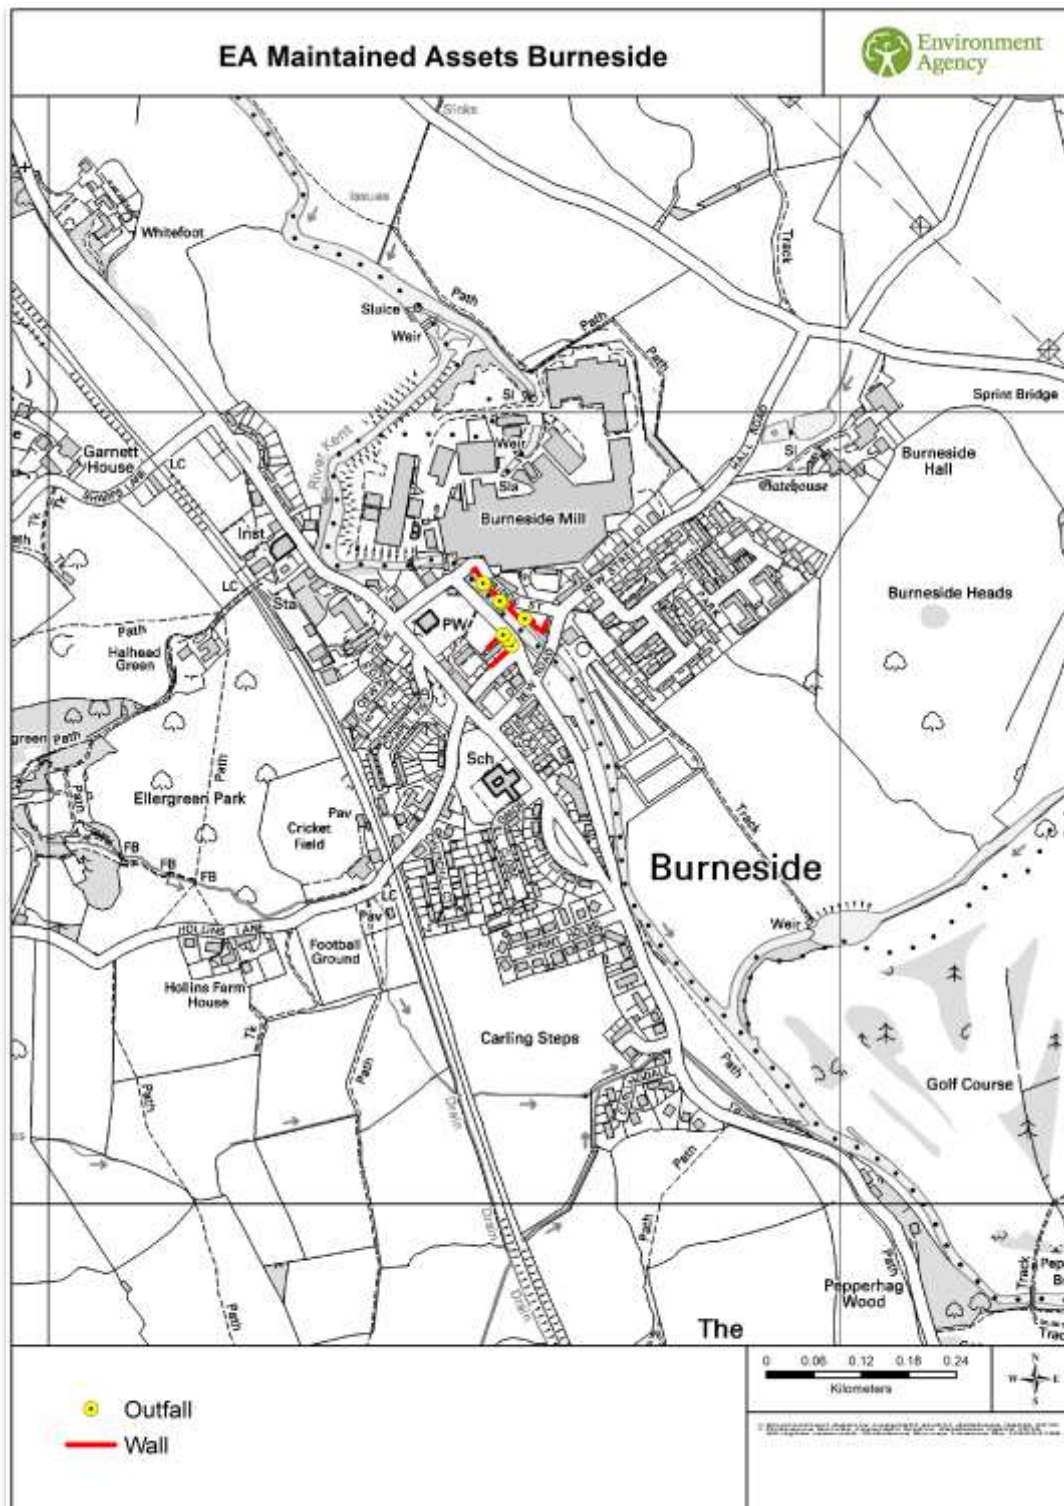
Figure 5: Existing flood defences in Burneside

There are a small number of formal raised flood defences within Burneside. A defence wall on the left river bank runs along Bridge Street between the James Cropper Paper Mill and Ford Bridge. There is also a defence wall that runs around a terrace of properties on Steeles Row. These walls incorporate flap valves, which allow water gathered on the 'dry' side of the defence wall to drain once river levels fall.

A map of existing flood defences and other flood risk management assets serving the village is shown in Figure 5.

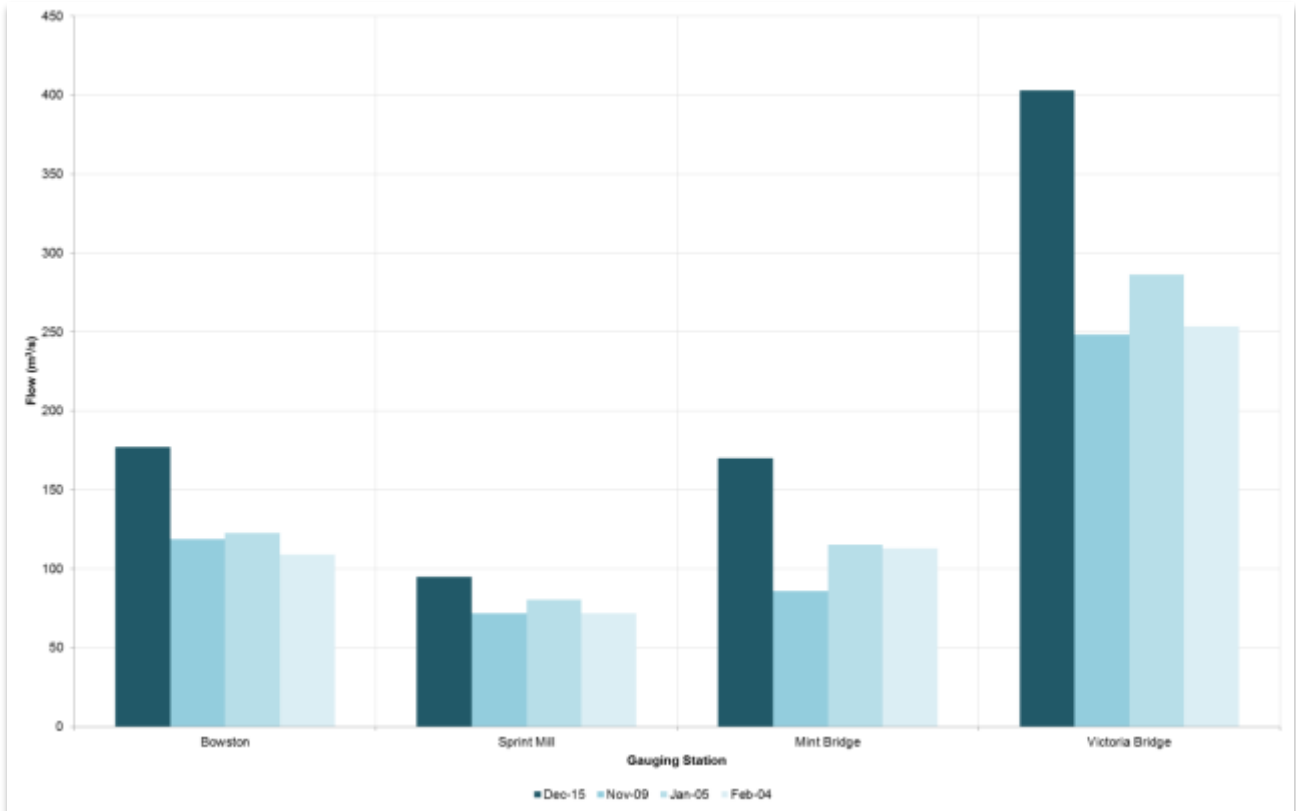
Figure 7: Recorded peak river flows in the River Kent catchment for recent flood events

Five principal flow gauging stations are located within the catchment of the River Kent<sup>1</sup> (see Figure 6). One of the stations is located upstream of Burneside on the River Kent at Bowston, which replaced Burneside gauging station (now closed) in 1999. Sprint Mill gauging station gauges flow on the River Sprint and is located approximately 1km north-east of the village. Further downstream on the River Kent, Victoria Bridge gauging station is located in the centre of Kendal, while Sedgwick gauging station is located approximately 6km downstream of Kendal town centre. In addition to these, Mint Bridge gauging station gauges flows in the River Mint, which joins the River Kent downstream of Burneside in north Kendal. Together, these stations recorded the fluvial event caused by Storm Desmond, and the recorded data is presented in Table 4, Figure 7 and Figure 8.

Gauging Station	River	Peak flow (m <sup>3</sup> /s)	
		Dec 2015	Jan 2005
Bowston	Kent	177.0	122.5
Sprint Mill	Sprint	94.8	80.5
Mint Bridge	Mint	170.0	115.4
Victoria Bridge	Kent	403.0	286.5
Sedgwick	Kent	526.8	347.0

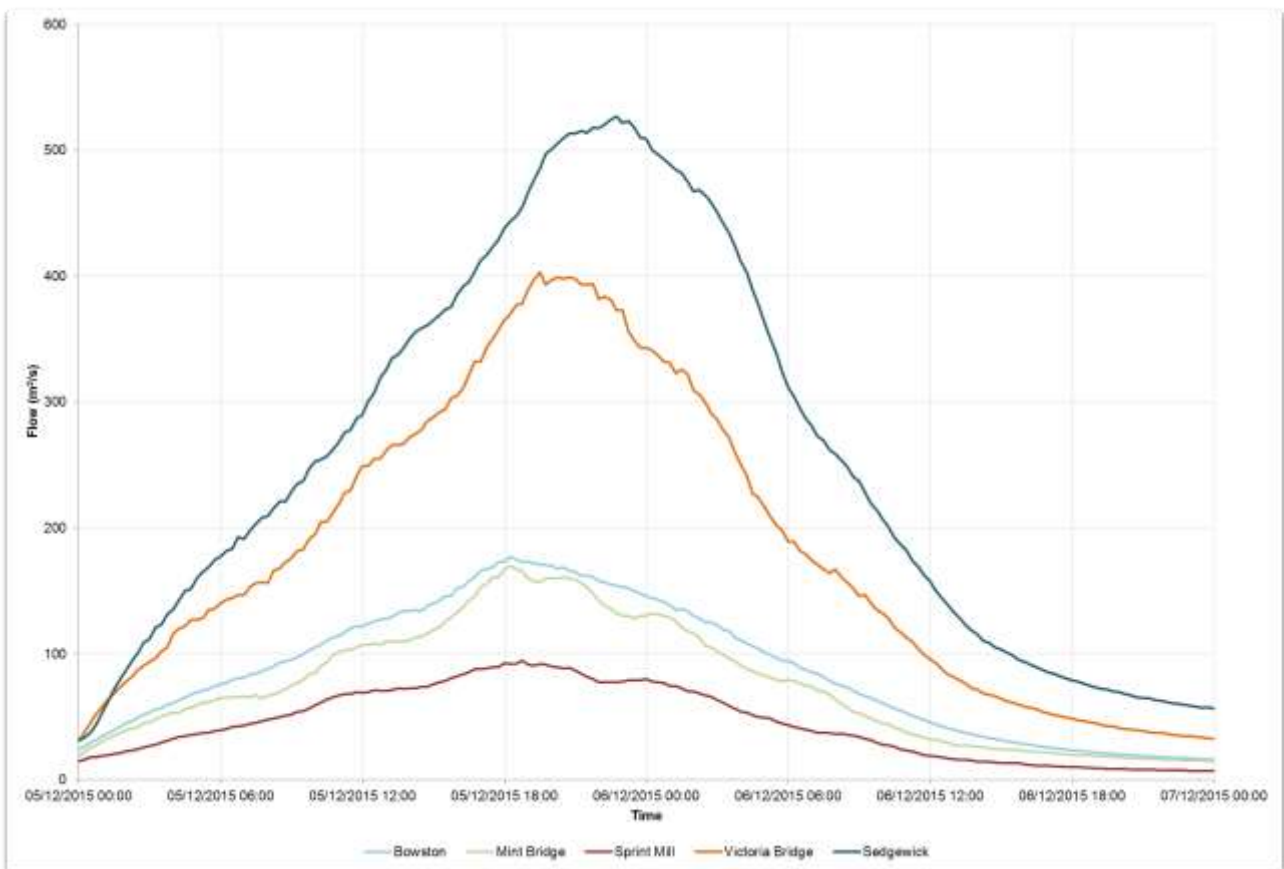
Figure 8: Gauged river flows at various locations in the Kent catchment on the 5<sup>th</sup>-6<sup>th</sup> December 2015

At Bowston gauging station, the level of the River Kent peaked at 60.0m AOD at 18:15 on Saturday 5<sup>th</sup> December. This was the highest river level ever recorded, and exceeded the previous record level of 59.6m AOD (January 2005).

The recorded peak flow at Bowston gauging station is greater than any flow previously recorded at this location on the River Kent, and initial analysis of this data suggests that the December 5<sup>th</sup> event had a 0.4% probability of occurring in any given year (0.4% Annual Exceedance Probability or AEP). The magnitude of the flood event was greater than the size of event that the existing flood defences within Burneside were designed to defend against. Therefore, river levels would be expected to be higher than the flood defence level, and overtopping of the defences would be expected to occur.

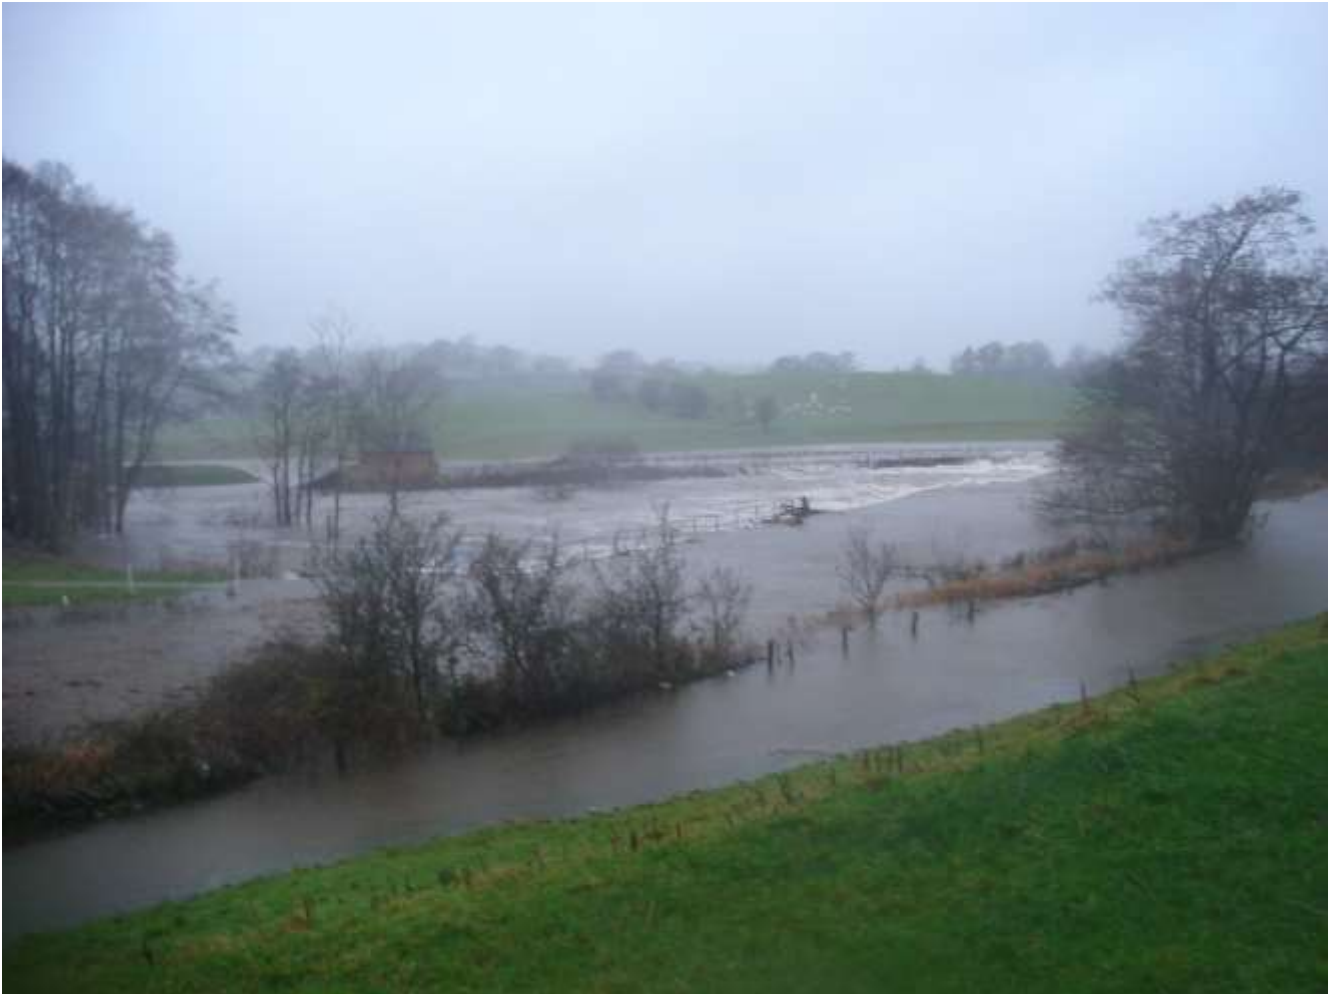
On 5<sup>th</sup> December 2015 the principal source of fluvial flooding in Burneside was the River Kent. As it enters the village, the river flows through a bifurcation structure (splitting the river channel), which provides a feed to the James Cropper paper mill. Immediately downstream of this structure, the River Kent overtopped its banks, flooding part of the paper mill site and affecting buildings within the mill complex. Figure 10 shows the bifurcation structure during the flood event, whilst Figure 11 shows Burneside Bridge adjacent to the James Cropper paper mill complex.

**Figure 10: The bifurcation structure on the River Kent upstream of the James Cropper paper mill at 13:55 on 5<sup>th</sup> December**

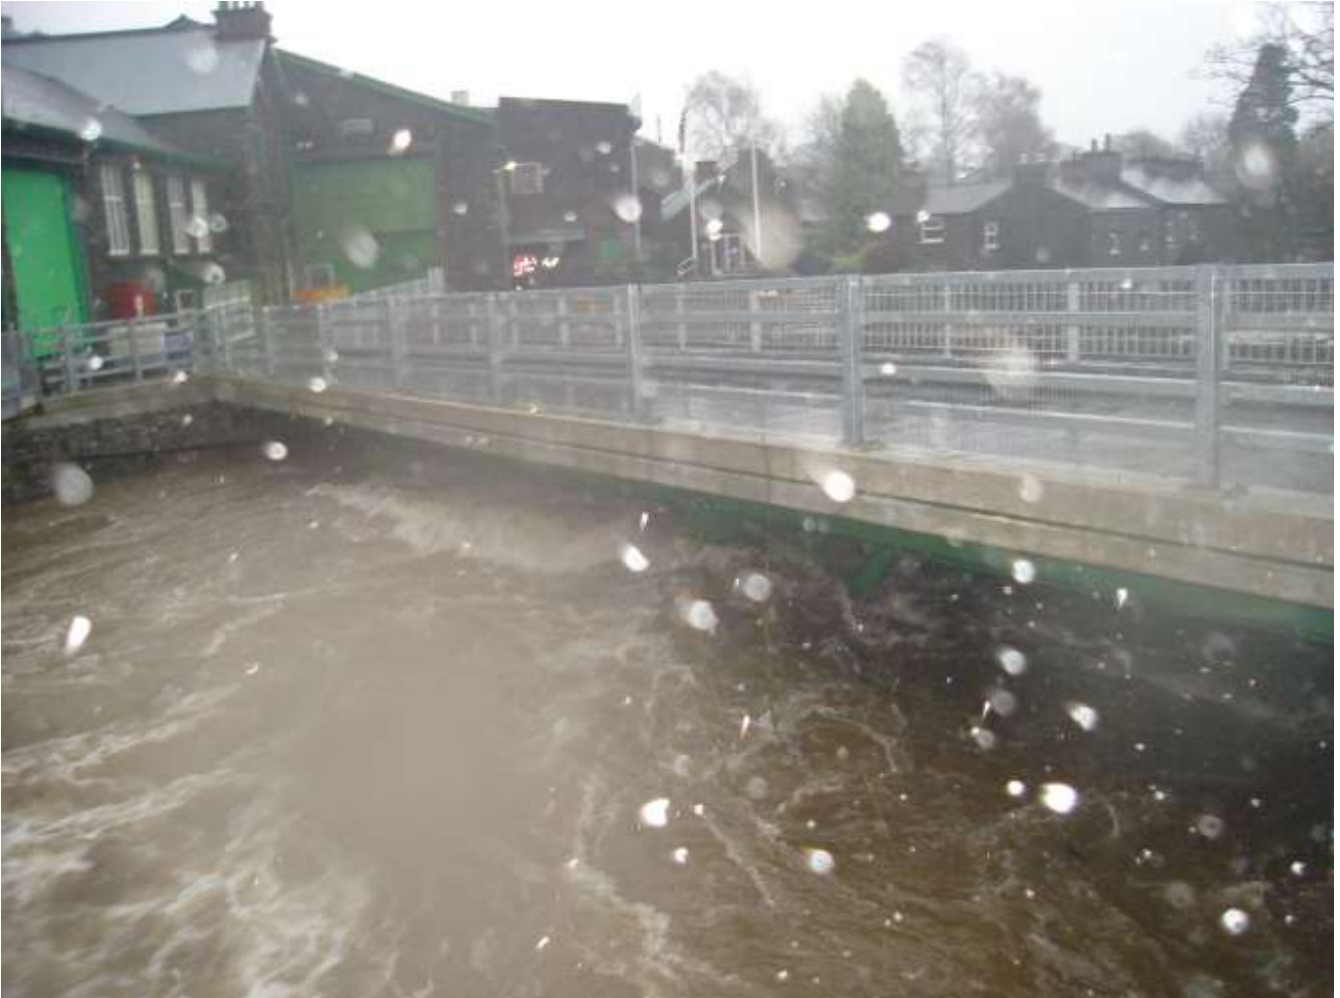
**Figure 11: Burneside Bridge at 14:27 on 5<sup>th</sup> December**

Cumbria Flood Partnership Theme	Action by	Recommended Action	Timescale
Strengthening Defences	Cumbria County Council & Environment Agency	Assess the impact of the road bridges and footbridges in Burneside on flood flows and investigate options to increase their flood capacity, taking into account the potential effects on flood risk downstream.	2016-2017
	Environment Agency & Cumbria County Council	As part of the appraisal of options to improve the existing Standard of Protection in Burneside, investigate improvements required in the Bridge Street and New Street areas to manage the floodwater flowing to the area down New Street.	2016-2017
	Cumbria County Council in partnership with the Environment Agency and United Utilities	Conduct a detailed assessment for Burneside (including Staveley and Kendal) under the Surface Water Management Plan process and identify solutions to mitigate surface water flood risk in high risk areas that will integrate with fluvial flood risk mitigation options as part of a joined up approach.	2016-2017

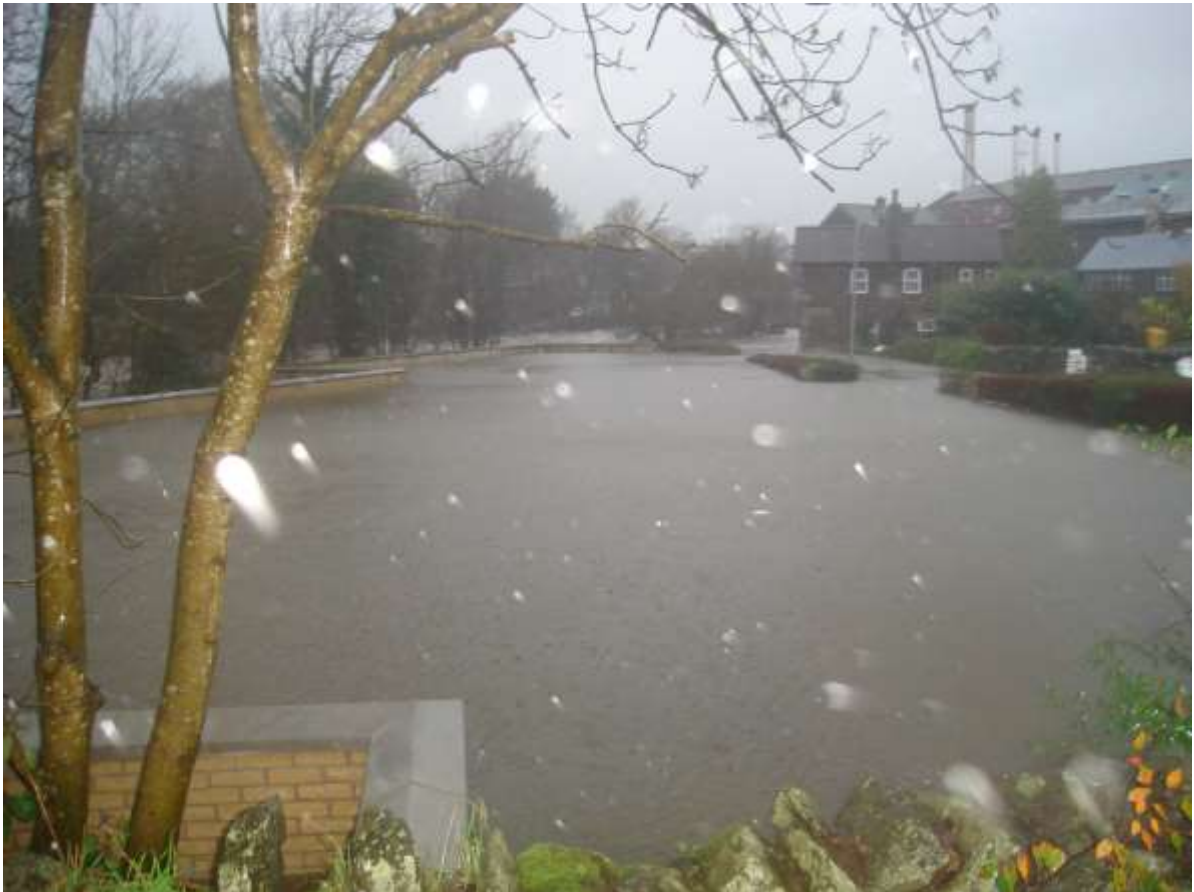
Significant overtopping of the river banks on both sides of the River Kent occurred in the centre of Burneside. In particular, properties on Bridge Street were affected as floodwater overtopped doorway flood barriers, causing internal flooding (see Figures 12 and 13).

**Figure 12: Bridge Street, Burneside at 14:20 on 5<sup>th</sup> December**

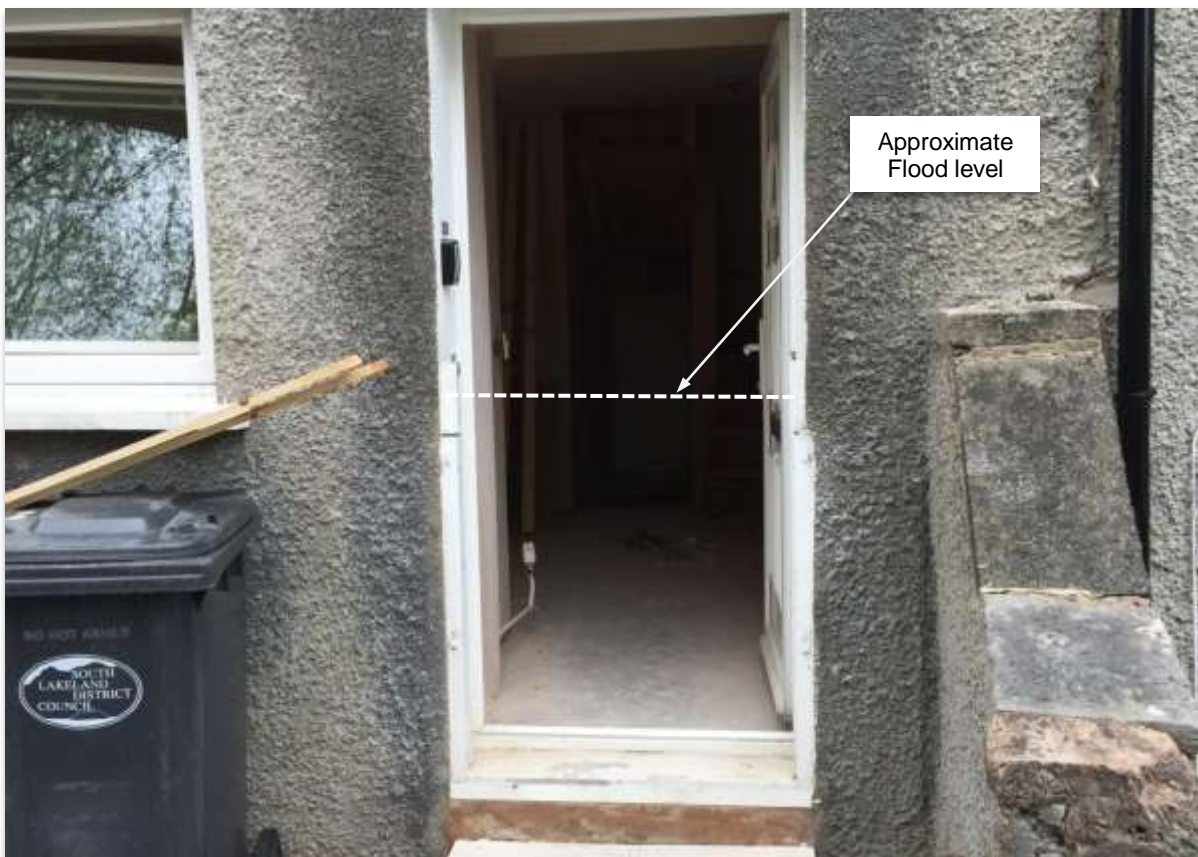
**Figure 13: Affected property on Bridge Street, Burneside**

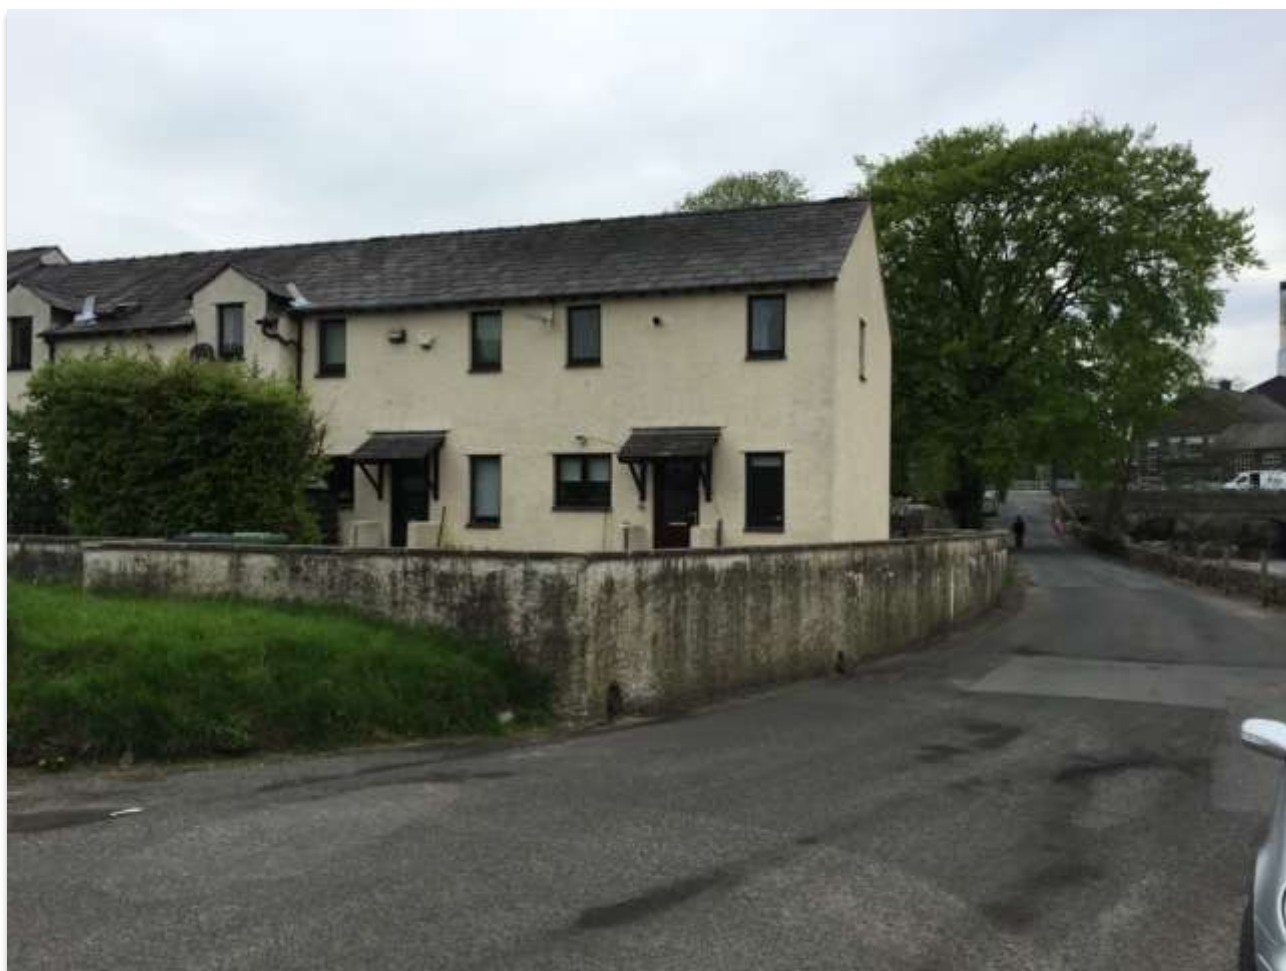
On the right bank of the river, properties at the east end of Steeles Row closest to the river were initially prevented from flooding by the existing flood defence walls. Reports from residents indicate that prior to the flood defence walls overtopping, initial flooding occurred from a combination of groundwater, flooding through utility pipes and sewer flooding. As the River Kent continued to rise and flow further up Steeles Row to the west, the flood defences were outflanked, before eventually being overtopped, resulting in further internal flooding.

**Figure 14: Steeles Row, Burneside, showing existing flood defence wall around properties**

The Environment Agency has undertaken repairs to the flood defence wall which provides protection to properties on Steeles Row. No other Environment Agency flood defence assets were damaged as a result of the flood event.

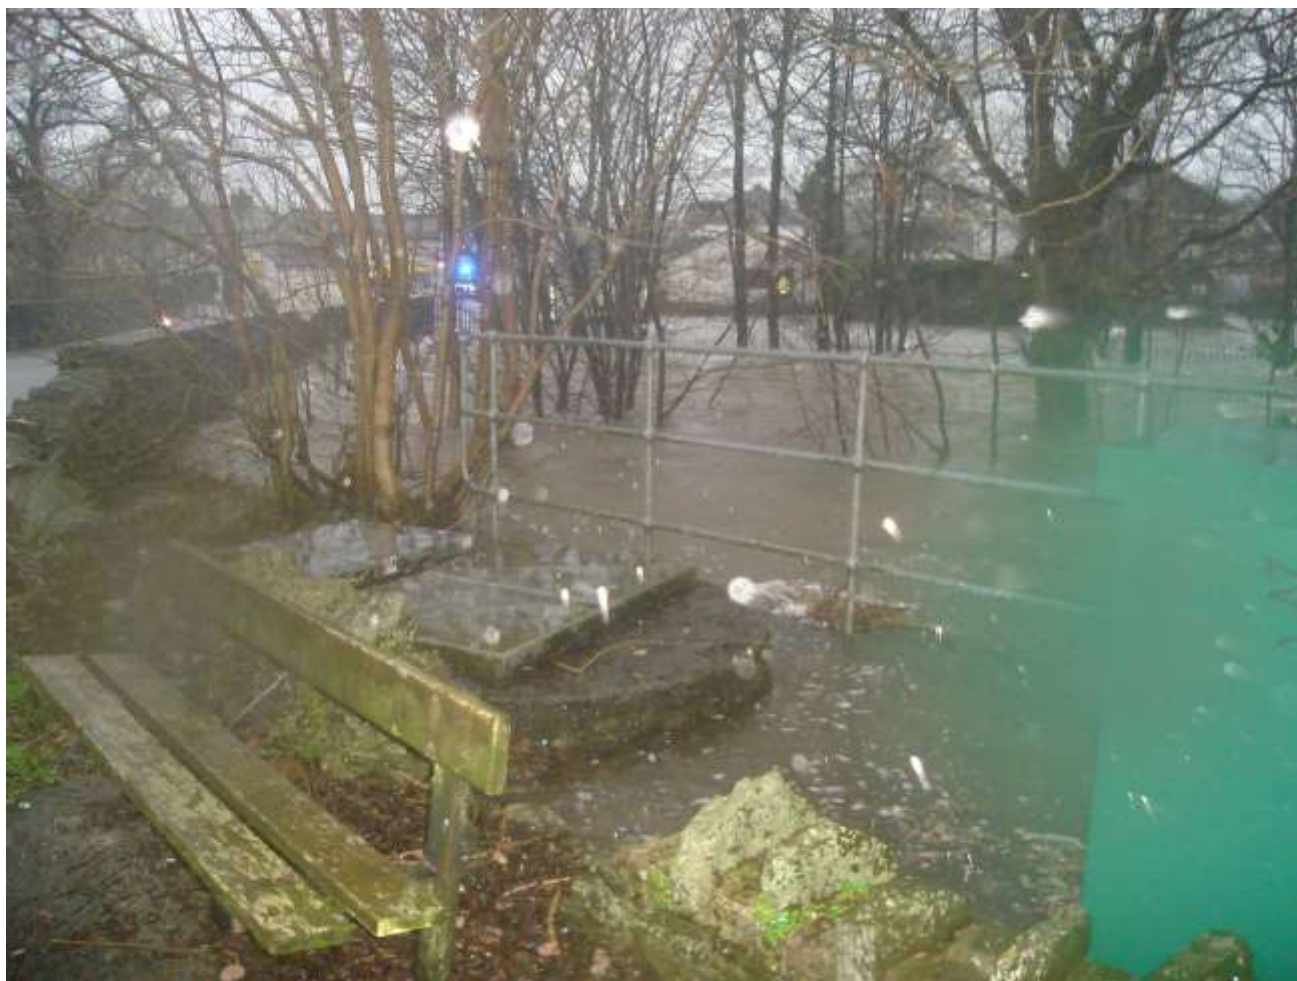
The fluvial flooding in the Bridge Street and Steeles Row area appears to have been exacerbated by Ford Bridge, which restricted flows in the river channel and caused the river to back up (see Figure 15). The bridge itself suffered structural damage, and was closed to Heavy Goods Vehicle (HGV) traffic, with all other traffic restricted to single lane operation following the event.

**Figure 15: Ford Bridge, Burneside, at 14:20 on 5<sup>th</sup> December. Note the capacity of the bridge has already been exceeded four hours ahead of the flood peak at Bowston gauging station**

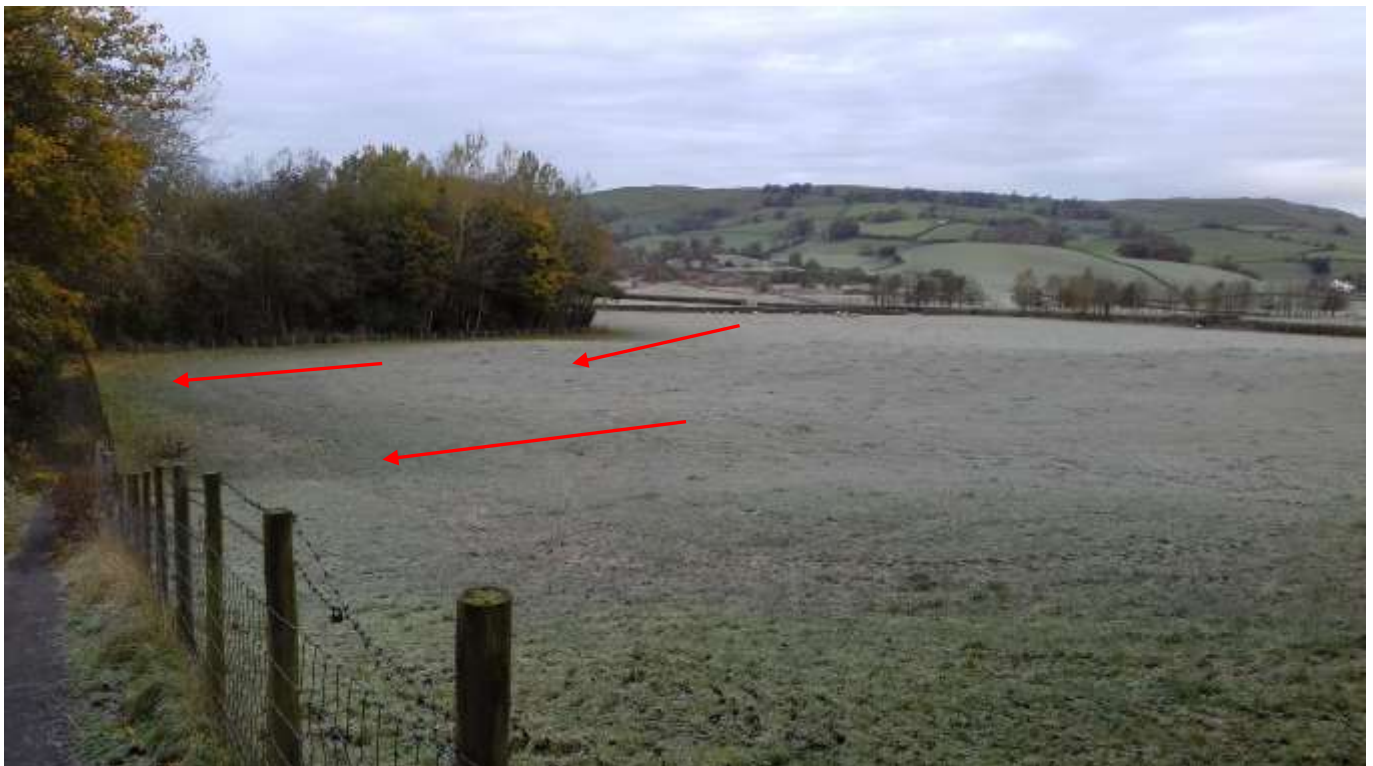
Two long-term local residents, who formerly worked at the James Cropper paper mill, believe two culverted watercourses that flow through this field will have contributed a significant volume of the flow observed in this area. One of these watercourses is known locally as the Barnsdale Runner, and originates from Barnsdale to the north east of Burneside. The watercourse is culverted from the north east of the Mill Flats field, and is believed to flow in culvert along the alignment of the northern field boundary wall before discharging into the mill race within the James Cropper paper mill site. The other referenced watercourse possibly contributing flows in this area is culverted from the outlet of the pond at Burneside Hall, and follows a course flowing in a south-westerly direction under Hall Road and to the rear of properties on New Street. The outlet of the culvert at its confluence with the River Kent is visible on the left bank of the River Kent immediately upstream of Ford Bridge, and is visible in Figure 20.

During the flood event, local residents observed flow from the Mill Flats field flowing in a south-westerly direction into the eastern extent of the James Cropper paper mill complex, as illustrated in Figure 16, which reportedly flooded the loading bay area and despatch warehouse. Due to the nature of the local topography, flow continued through the complex towards the rear of the three properties located at the top of New Street. The residents of these properties reportedly took action to protect their properties, which prevented internal flooding, however the properties were surrounded by water. Water flowed between these properties onto New Street, before flowing down the hill towards Bridge Street, as illustrated in Figures 17, 18 and 19. Residents of the properties along New Street reportedly placed makeshift barriers in their entrance gates along the road, which prevented their properties from flooding and channelled the water down the road.

**Figure 16: Looking north across Mill Flats, located to the north east of the James Cropper paper mill complex. The arrows indicate the reported direction of flow across the field**

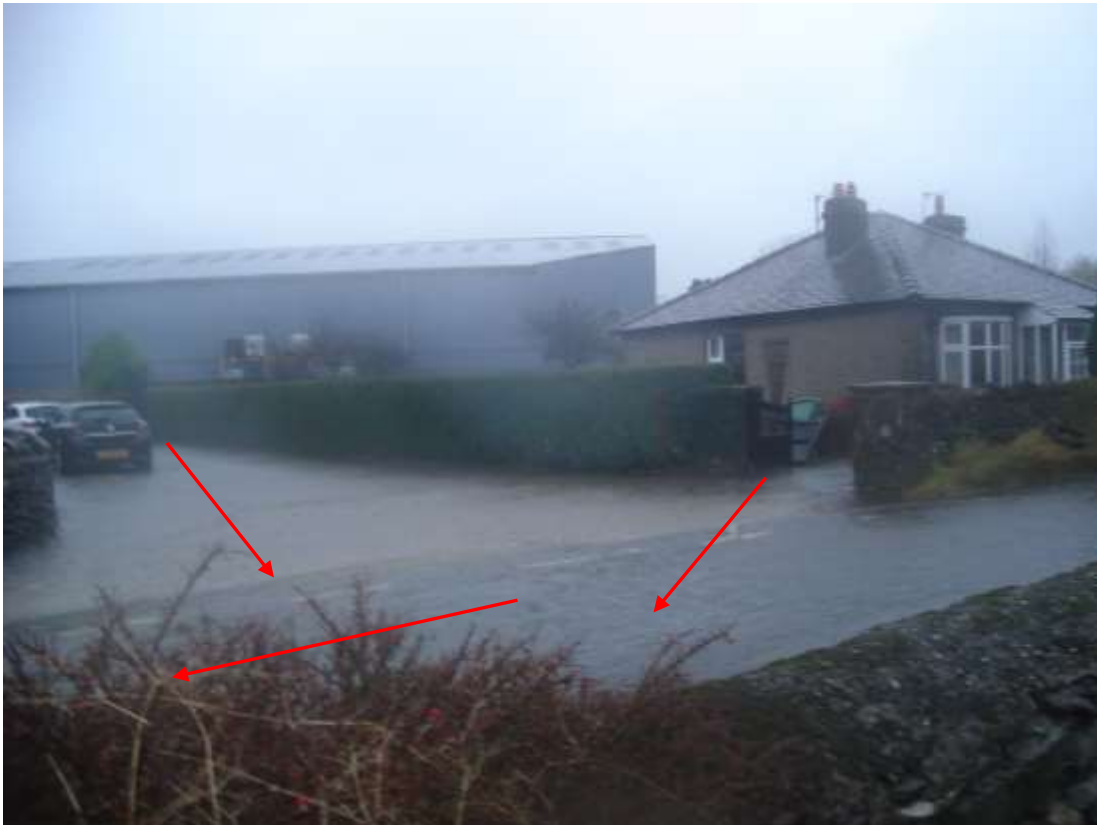
**Figure 17: Flow route from the James Cropper paper mill complex between properties at the top of New Street, at 14:13 on 5<sup>th</sup> December**

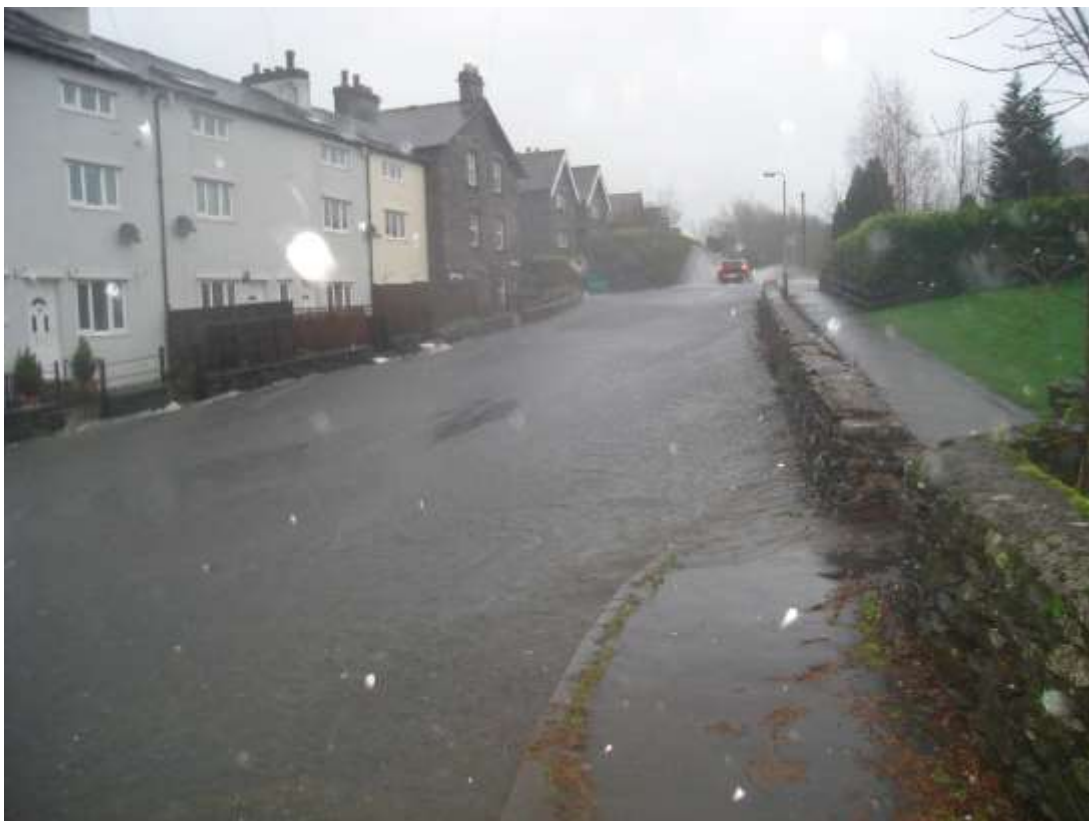
**Figure 18: Flow route down New Street at 14:15 on 5<sup>th</sup> December**

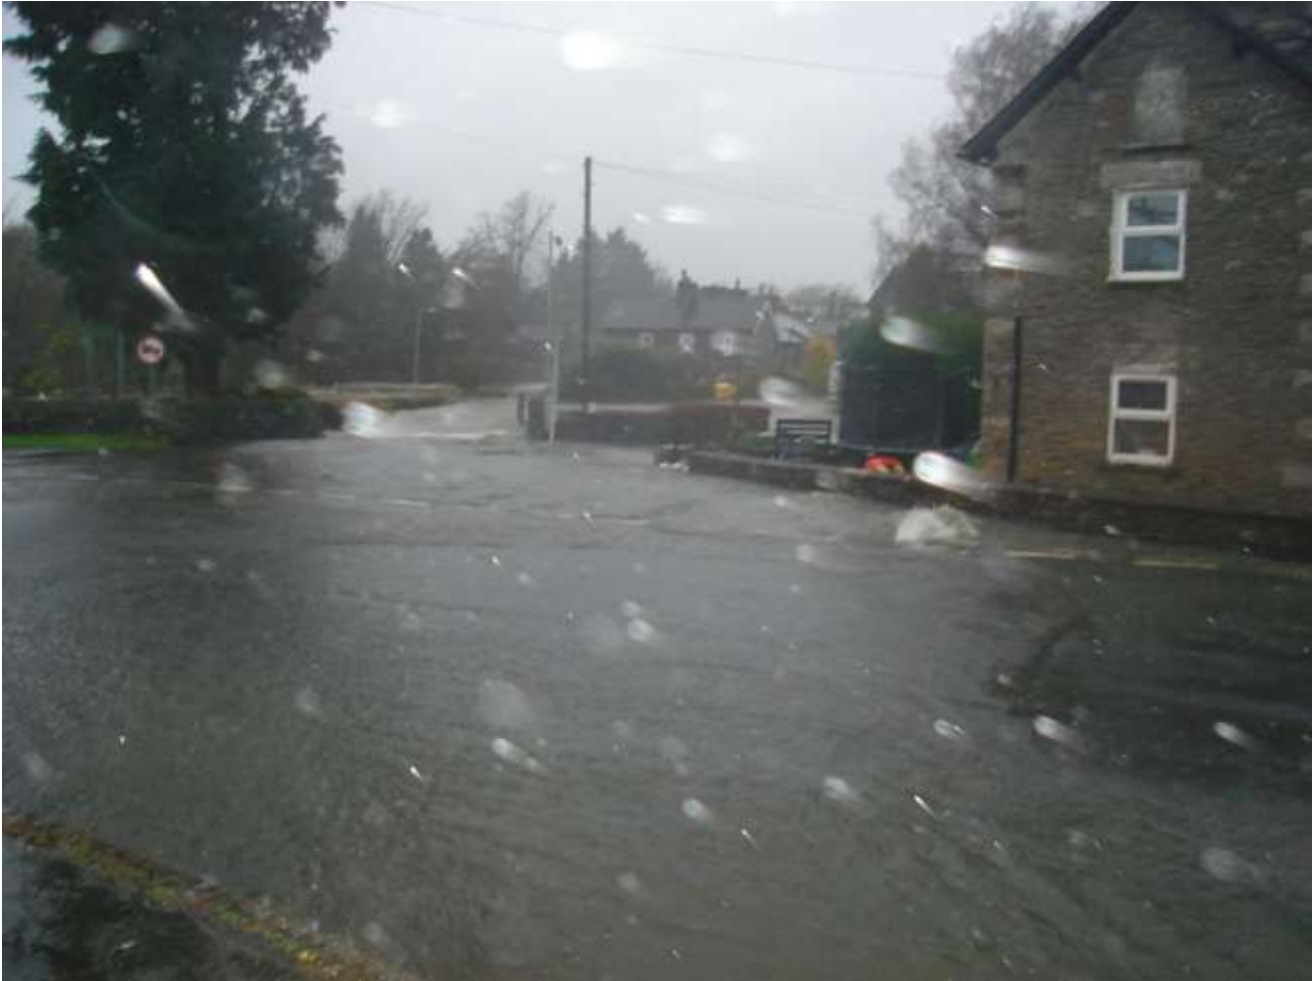
**Figure 19: Flow down New Street towards Bridge Street and Ford Bridge, at 14:15 on 5<sup>th</sup> December**

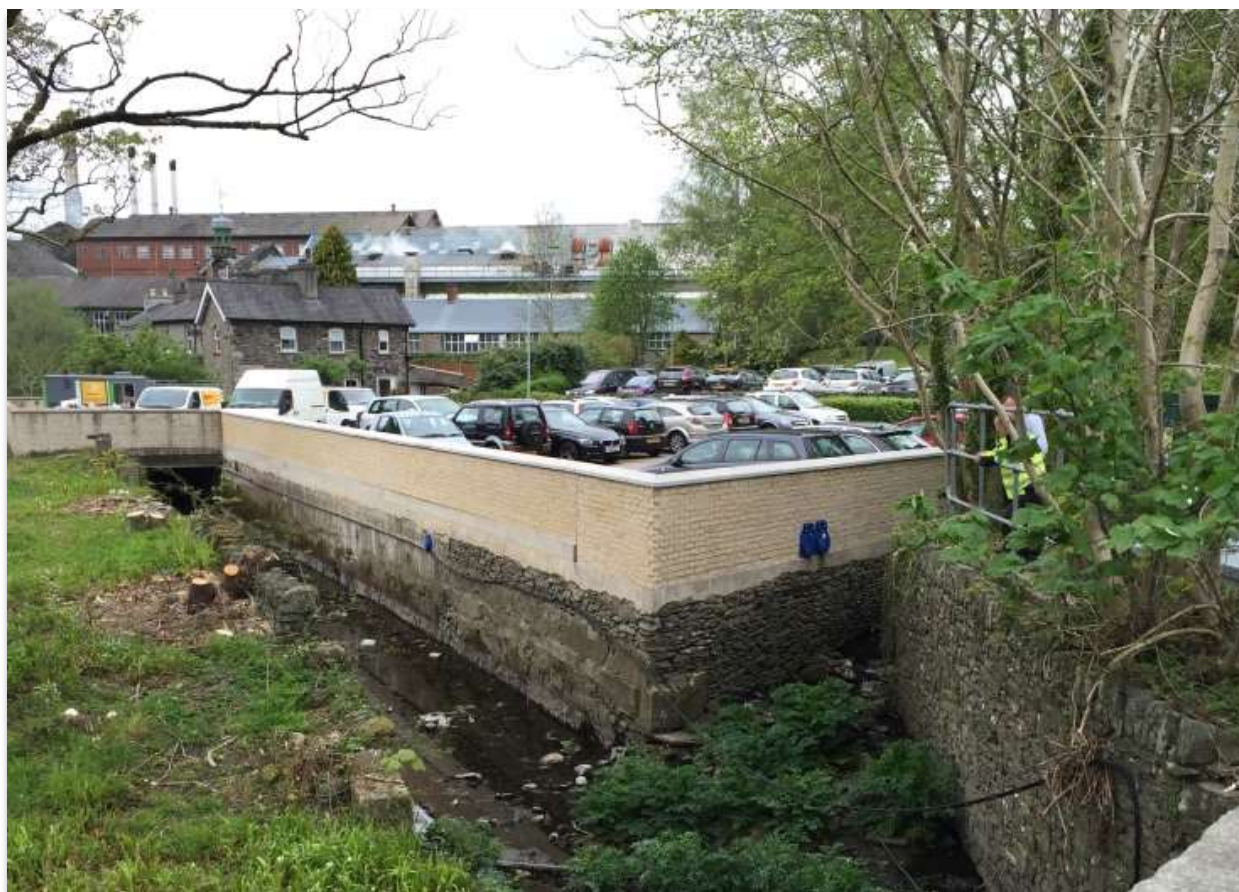
The flow route down New Street described and illustrated above resulted in water being trapped on the 'dry' side of a flood defence wall. Whilst this wall incorporates flap valves to allow water to drain out (see Figure 20), these were surcharged by the River Kent and so prevented the car park area from draining freely. The impact of this was that properties in this area were initially flooded from water trapped behind the flood defence wall. Later in the flood event, as the River Kent continued to rise, the flood defence wall was overtopped, further exacerbating the flooding in this area.

**Figure 20: Properties on Bridge Street and New Street flooded initially as a result of water being trapped on the 'dry' side of the flood defence wall**

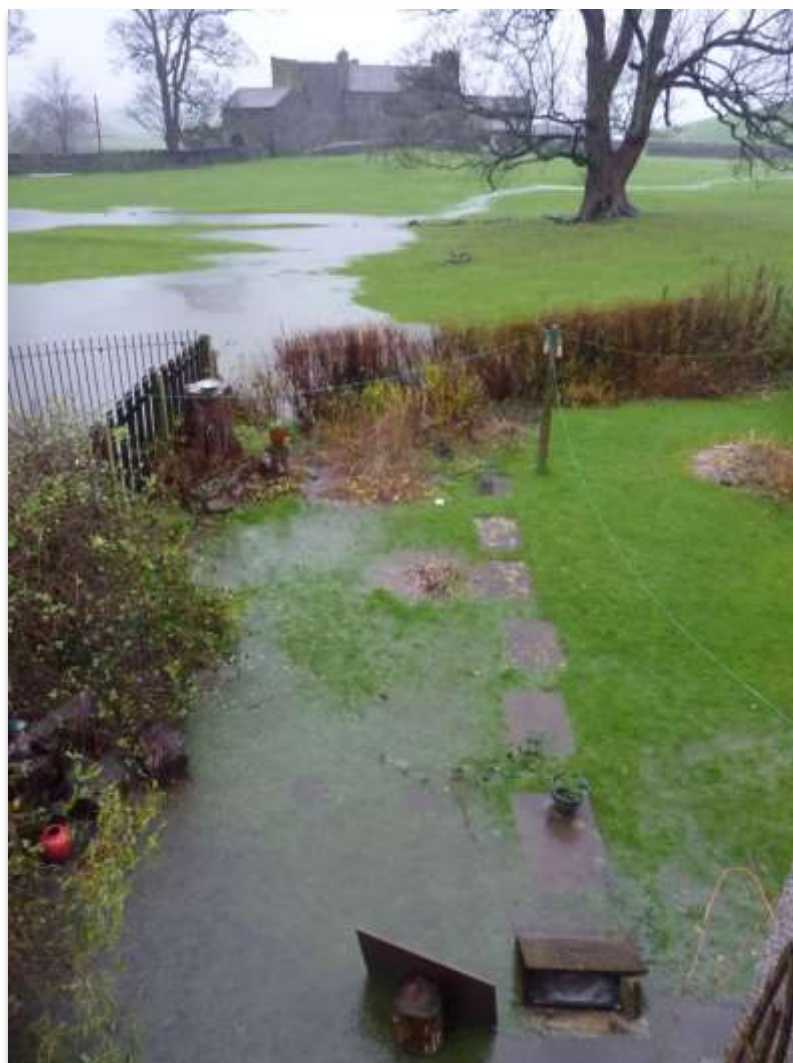
**Figure 21: Surface water flooding at 110 Hall Park**
