Staveley and Ings

Flood Investigation Report

Gowan Bridge, Staveley

Flood Event 5-6th December 2015

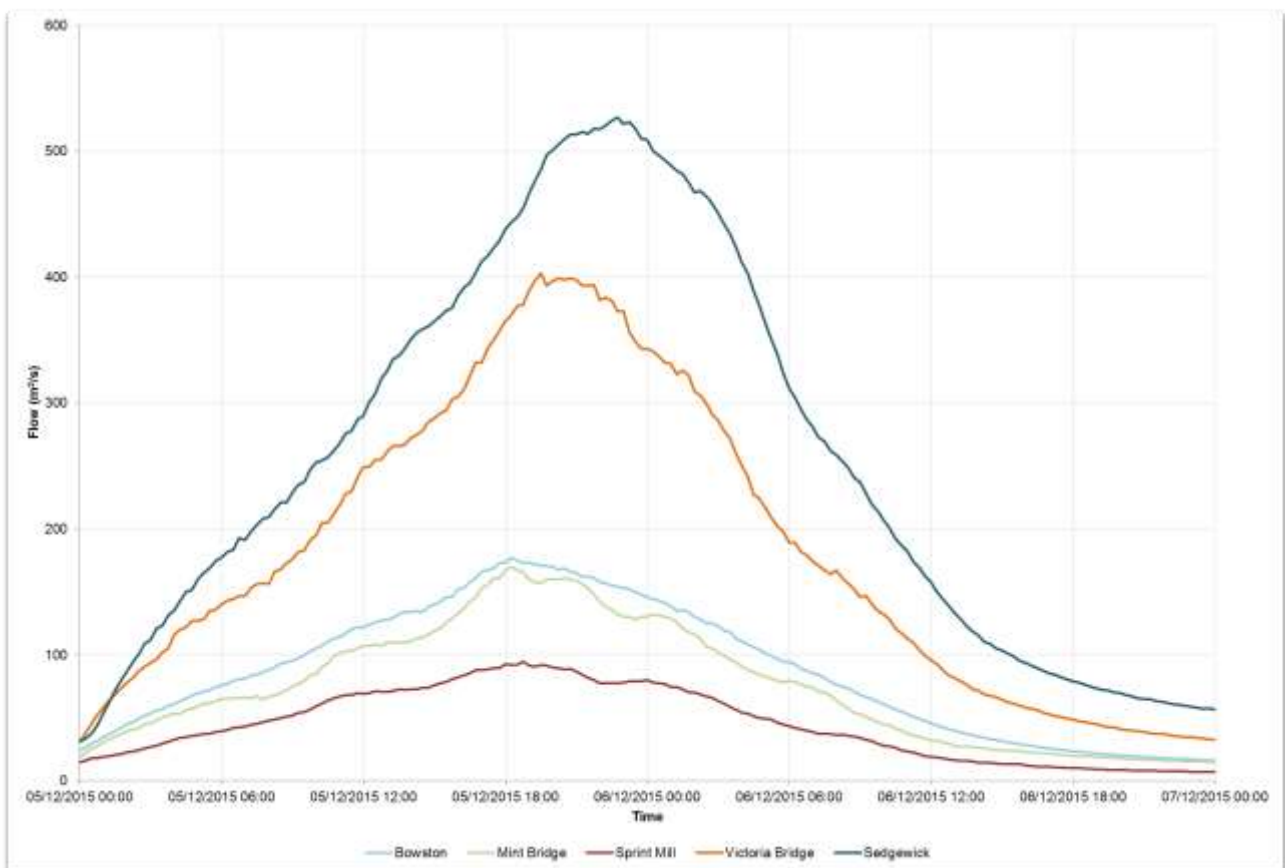
Figure 6: Gauged river flows in the Kent catchment during the December 5th and 6th flood event

The recorded peak flow at Bowston gauging station is greater than any flow previously recorded at this location on the River Kent and initial analysis of this data suggests that the December 5th event had a 0.4% probability of occurring in any given year (0.4% Annual Exceedance Probability or AEP). However, it should be noted that this assessment is based on recorded data at a river level gauge approximately 4km downstream of Staveley, and provides only a limited guide to the severity of local rainfall and river flows in and around Staveley and Ings.

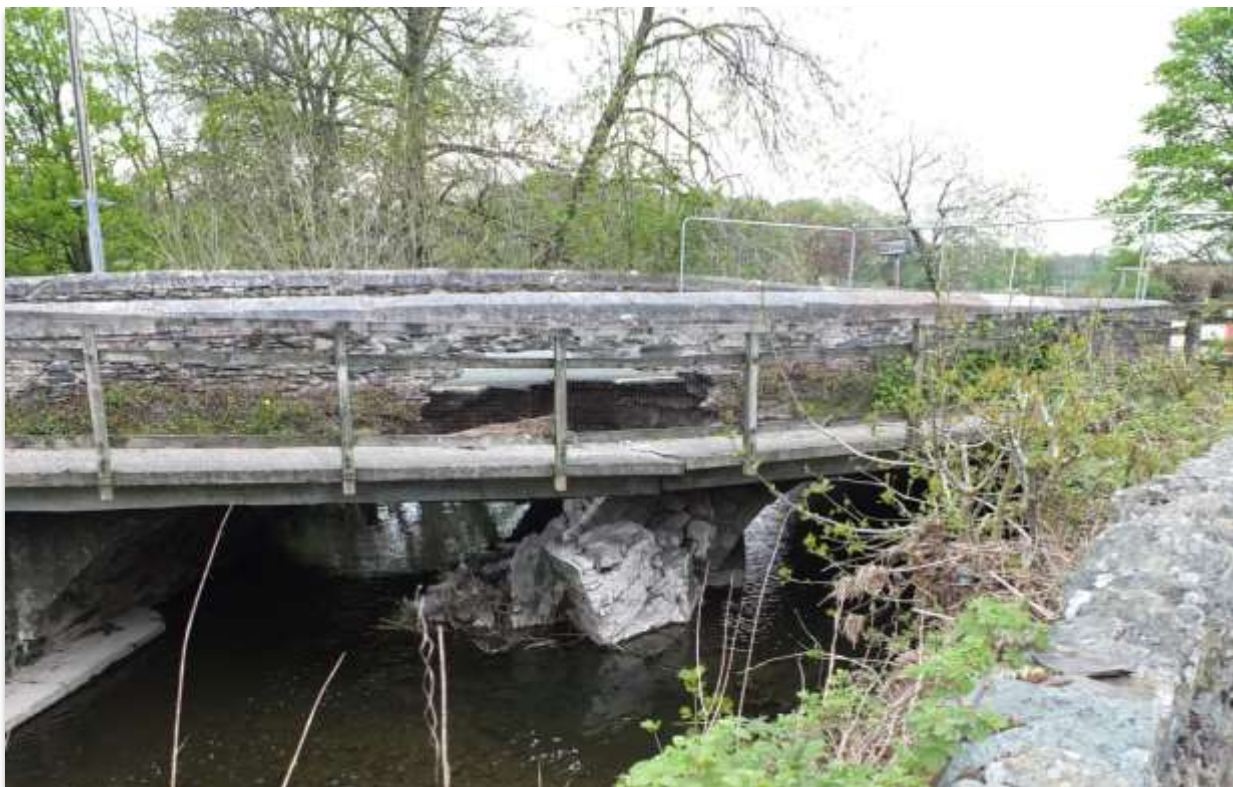
Figure 7: Structural damage to Gowan Bridge

Gowan Bridge, spanning across the River Gowan near the Eagle and Child Inn, suffered major damage, including displacement of the central pier (illustrated in Figure 7). The damaged bridge was subsequently demolished, with a new structure due to be constructed in Spring 2017.

Cumbria Flood Partnership Theme	Action by	Recommended Action	Timescale
	Agency and United Utilities		
Strengthening Defences	Environment Agency in partnership with Cumbria County Council and South Lakeland District Council	Develop options to improve the existing Standard of Protection in Staveley and Ings as part of a wider appraisal of flood risk management improvements in the Kent catchment (including Kendal and Burneside). Defence options to be appraised are likely to include upstream storage, improvements to flood channel conveyance, raised flood defences and natural flood management.	2016-2017
	Cumbria County Council & Environment Agency	Assess the impact of the road bridges and footbridges in Staveley on flood flows, and investigate options to increase their flood capacity, taking into account the potential effects on flood risk downstream.	2016-2017
	Cumbria County Council	Complete works to replace Gowan Bridge near the Eagle and Child public house. The replacement structure should be designed taking into account possible effects on flood risk.	Replacement Gowan Bridge due Spring 2017
