# Tebay

## Flood Investigation Report

**Flood Event 5 December 2015**

This flood investigation report has been produced by Cumbria County Council as a Lead Local Flood Authority under Section 19 of the Flood and Water Management Act 2010.

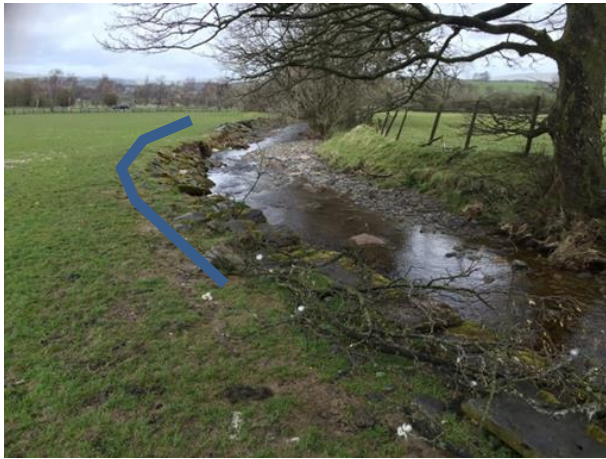
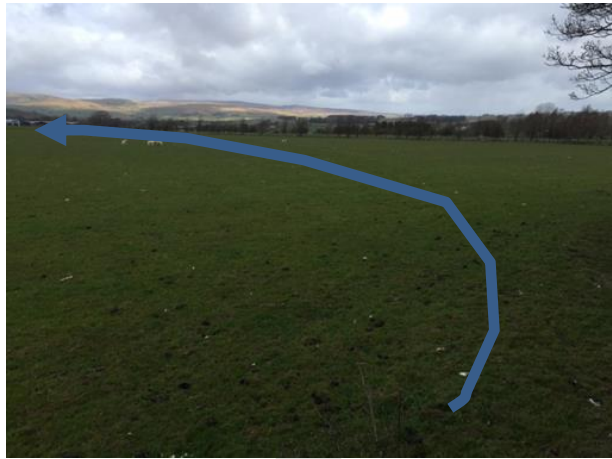
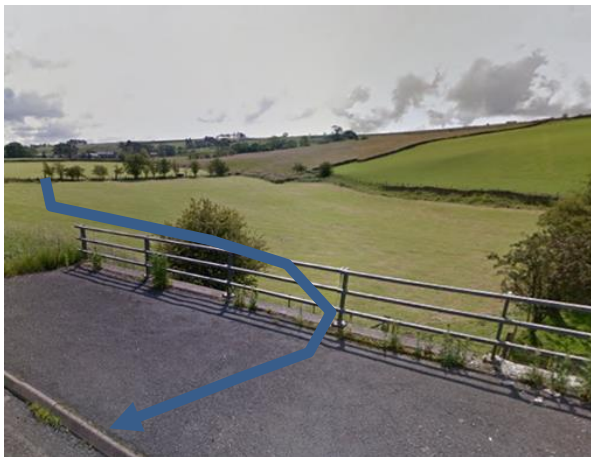
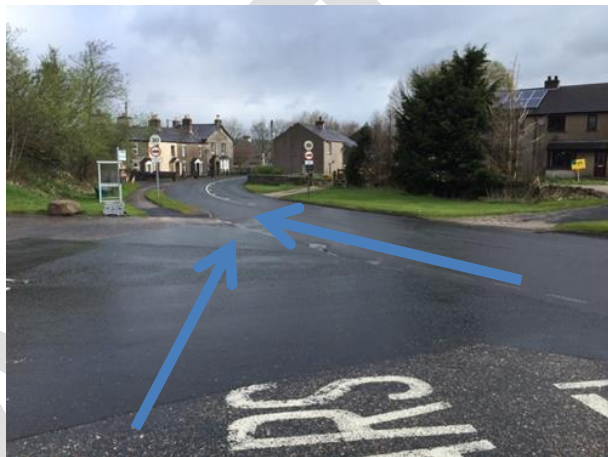
**Photographs 1 – 4: Various Flow Routes**

It is evident from the information gathered that the primary cause of the flooding was the rainfall event which created large volumes of surface water that overwhelmed the watercourses and soils in the area. The overtopping of Tebay Gill Beck created flow routes through the field adjacent to the A685 along the bottom of the road embankment, underneath the A685 carriageway and then through the field and into Old Tebay.

To compound this source of flooding, the outfall for the surface water drainage systems is into the River Lune which also overtopped river banks. The highest ever level on the River Lune was recorded during Storm Desmond. This caused surface water drainage on the B6260 to surcharge back into the Orton Road area. It is also likely that the gullies along the A685 and B6260 could have been blocked due to organic material which could increase surface water flows flowing through Old Tebay. Residents also reported that the continuation of vehicles to use the B6260 also increased the problems of the flooding due to the bow waters caused by the vehicles passing through the flood water.

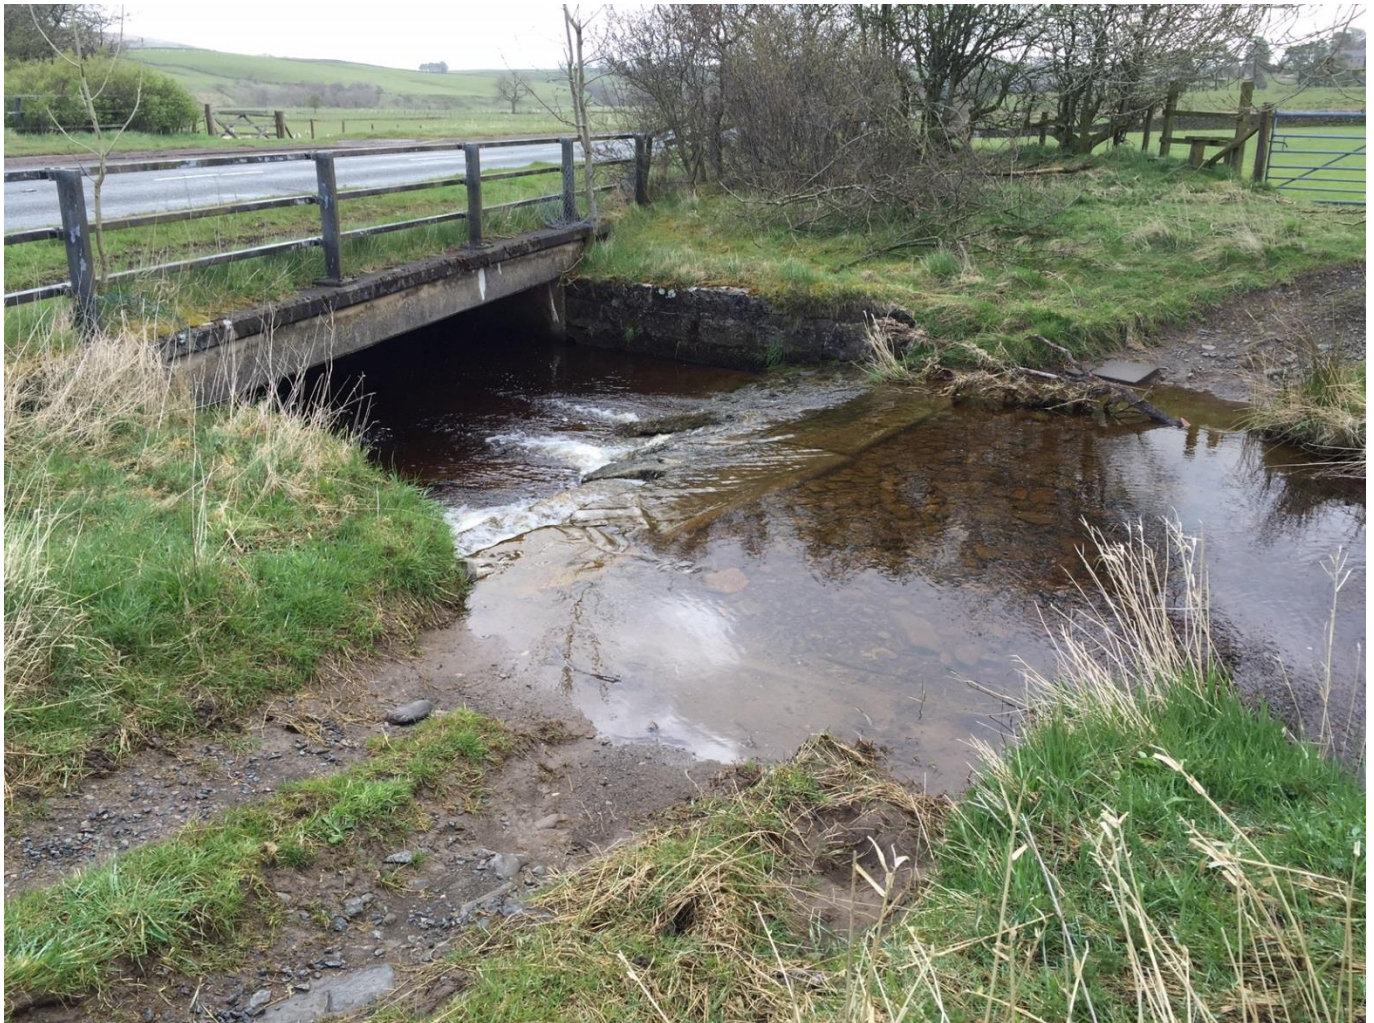
**Photograph 5: Entrance of Tebay Gill Beck under the A685 carriageway**

Photograph 5 above depicts the entrance of Tebay Gill Beck into a culvert beneath the A685 carriageway via a weir. The photograph was taken on 3 May 2016 and was during a period of low water flows through the watercourse. In light of this, the height between the surface of the watercourse and the bottom edge of the culvert beneath the carriageway is approximately 1 metre. This has the potential to cause a restriction to the watercourse during extreme precipitation events and could cause water to back up from the restriction and increase the height of the watercourse upstream. The banks of the watercourse are of equal height either side of the watercourse (1 metre) and at the entrance to the weir is a ford for farm machinery. The access tracks either side of the ford appear to direct flood water away from the carriageway and into neighbouring fields. The only evidence of a severe flood at this location is that the vegetation on the western bank of the watercourse is flattened and pointing downstream of the watercourse. The carriageway at this location is not known to have flooded during the event, but it is a severe restriction of the watercourse.

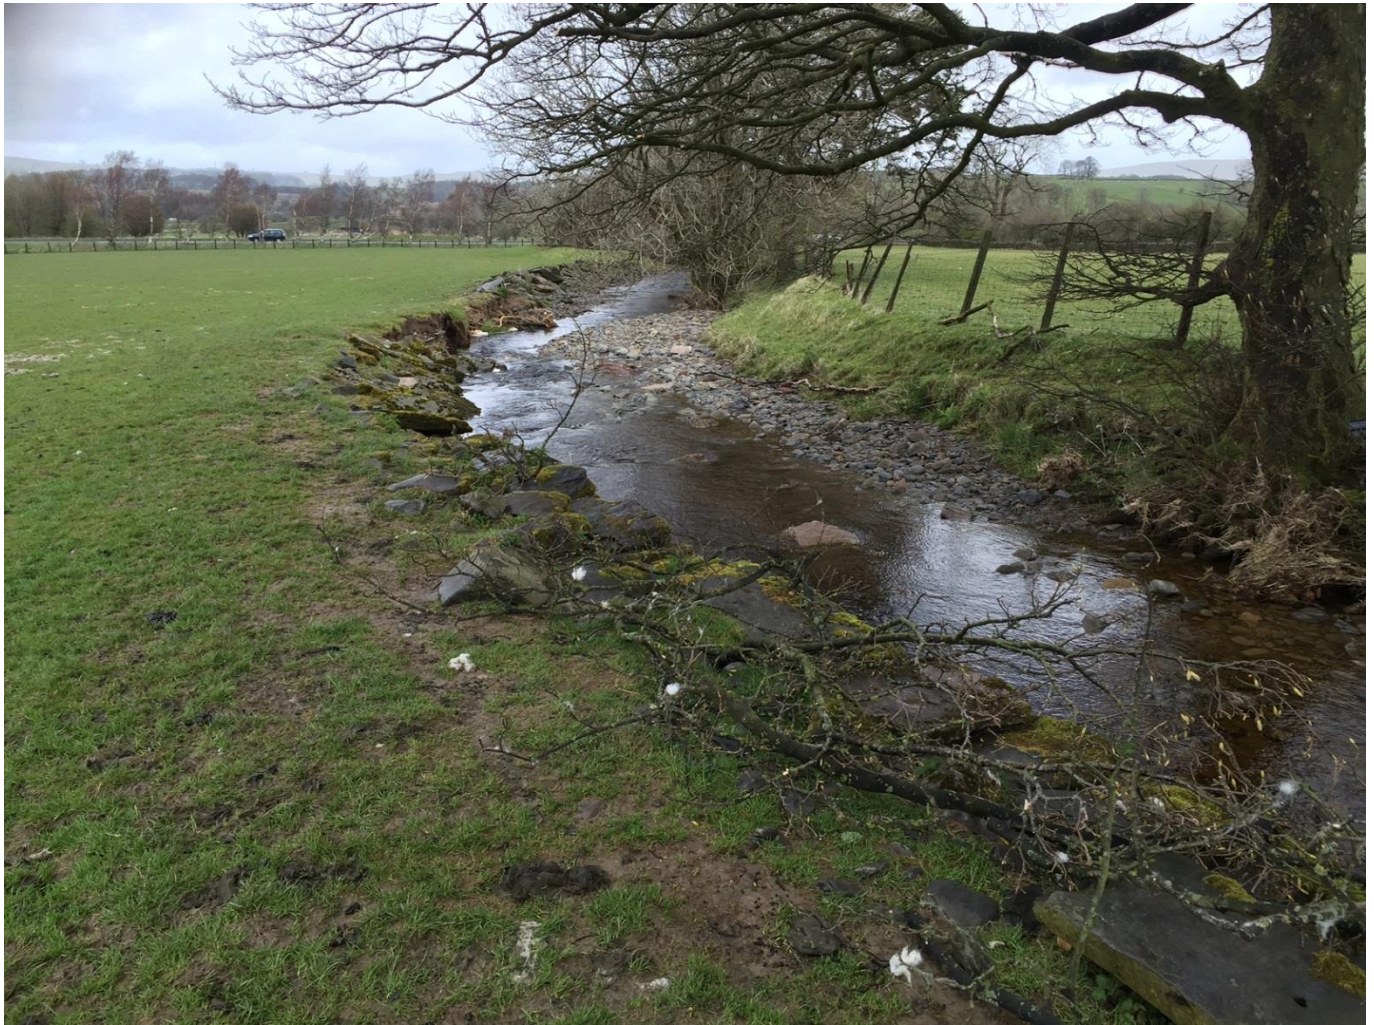
**Photograph 7: Raised embankment on the eastern bank of Tebay Gill Beck downstream of the minor road bridge**

Photograph 7 above depicts Tebay Gill Beck downstream of the second major restriction of the road bridge facing towards the A685. It can be seen that the western bank is approximately 0.5m below the level of the eastern bank. This will mean that during watercourse bank full conditions that any flooding is likely to spill out of the watercourse and into the flood plain to the west. This section, prior to the earth embankment on the western bank, spans approximately 40m of the watercourse and is the likely source of flooding which affects Old Tebay.
