Seascale

Flood Investigation Report 31

Flood Event 30/8/2012

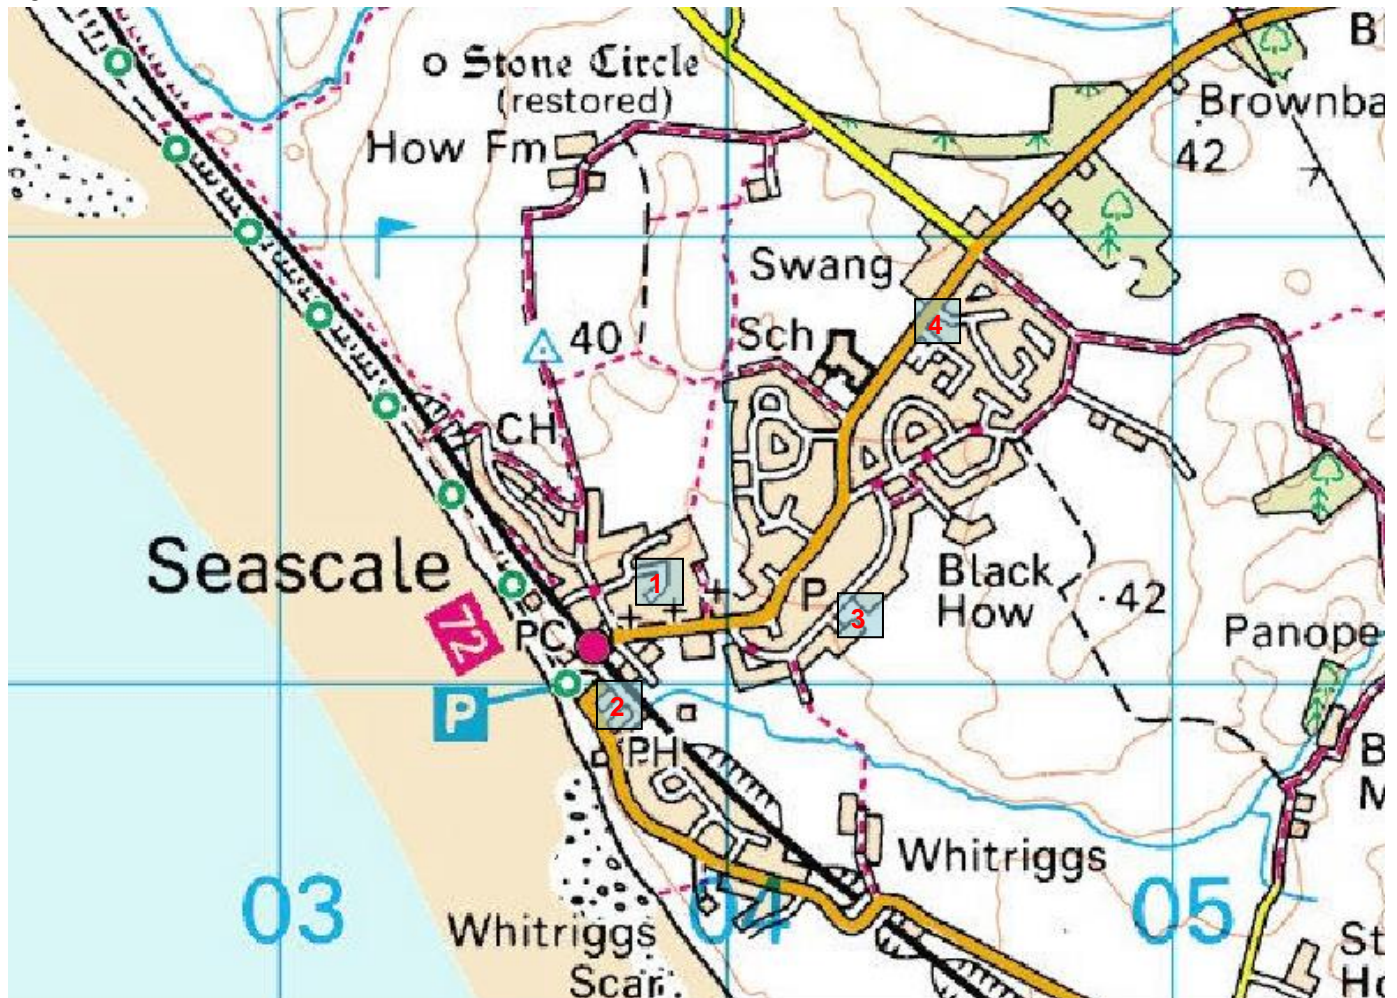
Figure 1. Map showing the location of the flood areas.

Figure 1 illustrates the locations affected during the heavy rain that occurred on the 30th August 2012.

1. The Fairways
2. Railway Terrace
3. Santon Way
4. Swang Farm

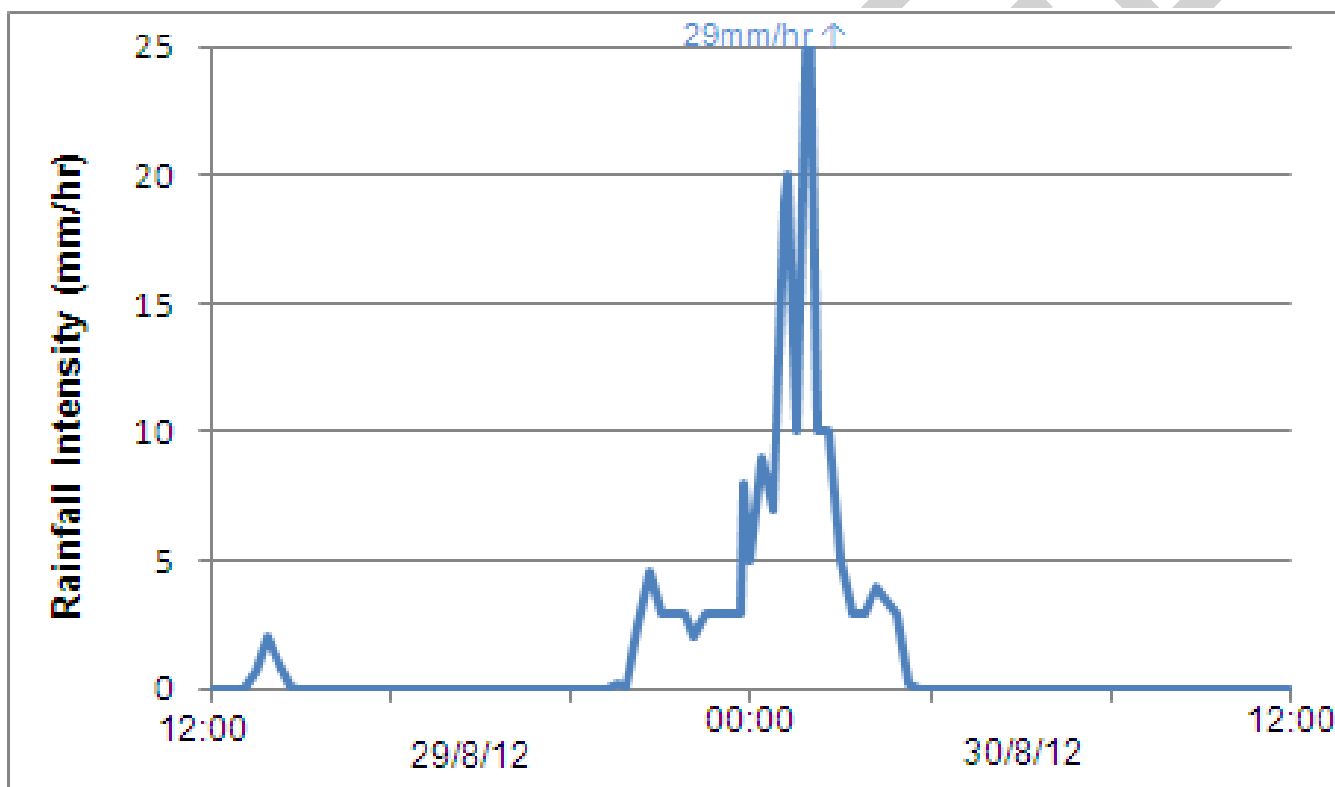
Figure 2. Radar rainfall data from 29-30 August 2012

According to radar data taken from a weather records provider, peak rainfall was 29mm/hr and occurred at about 1:15am. The rain started at 9:00pm and finished at 3:30am with a total of 37mm in 6hrs 30mins.

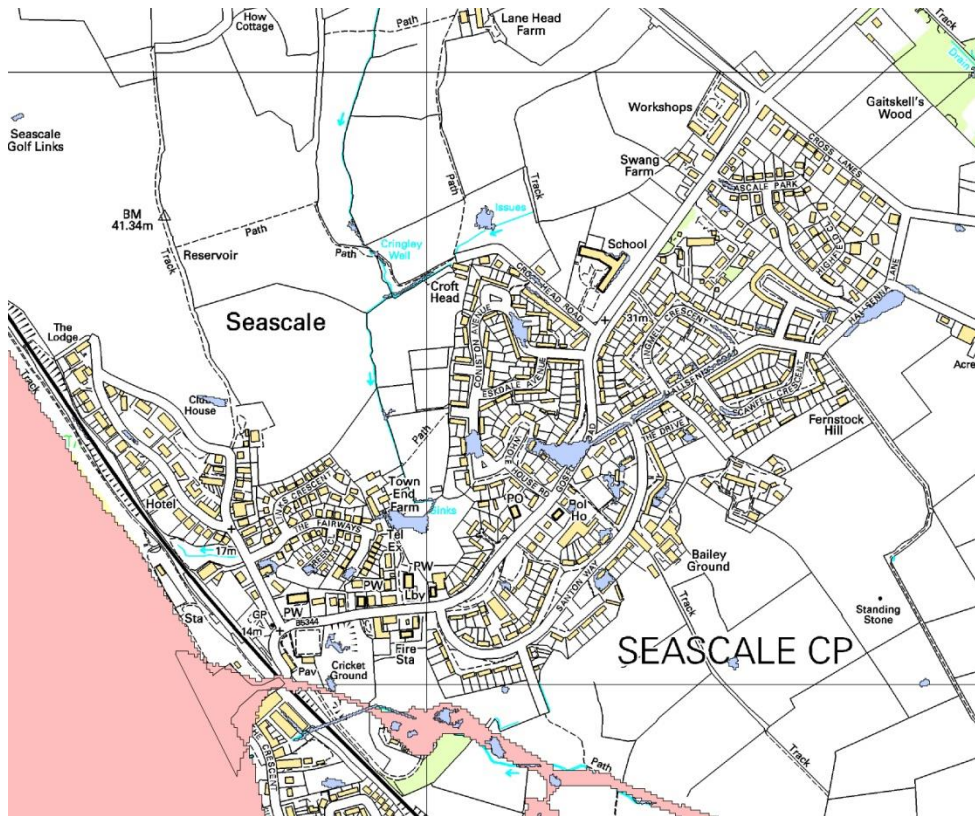
Environment Agency flood mapping: Zone 3 and surface water flooding from a 1 in 100 year rainfall event.

Pink hatching shows Flood Zone 3 where rivers have a greater than 1% chance of flooding in any one year. The dark blue zone indicates susceptibility to surface water flooding from a 1:100 year rainfall event. Parts of The Fairways, Santon Way and Railway Terrace all fall within the more severe and frequent surface water flooding zones.
