St Bees

Flood Investigation Report 37

Flood Event 30/8/2012

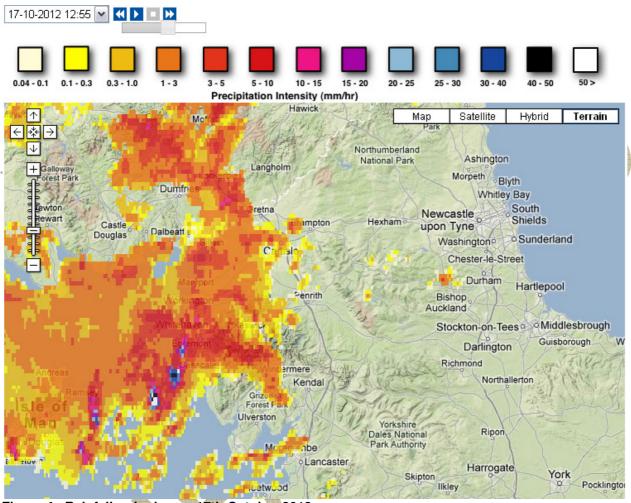
The figures for the 17/10/12 storm at St Bees show that that it was even more severe, with 43.7mm over the day, 38.mm from 11:30 to 18:45, caused by the thunder storms that were moving across the area. These included three 20mm/hr plus bursts just after midday and 35mm/hr at 16:50.

Figure 4. Rainfall radar image 17th October 2012
