Millom and Haverigg

Flood Investigation Report

30th September 2017

This flood investigation report has been produced by Cumbria County Council as a Lead Local Flood Authority under Section 19 of the Flood and Water Management Act 2010.

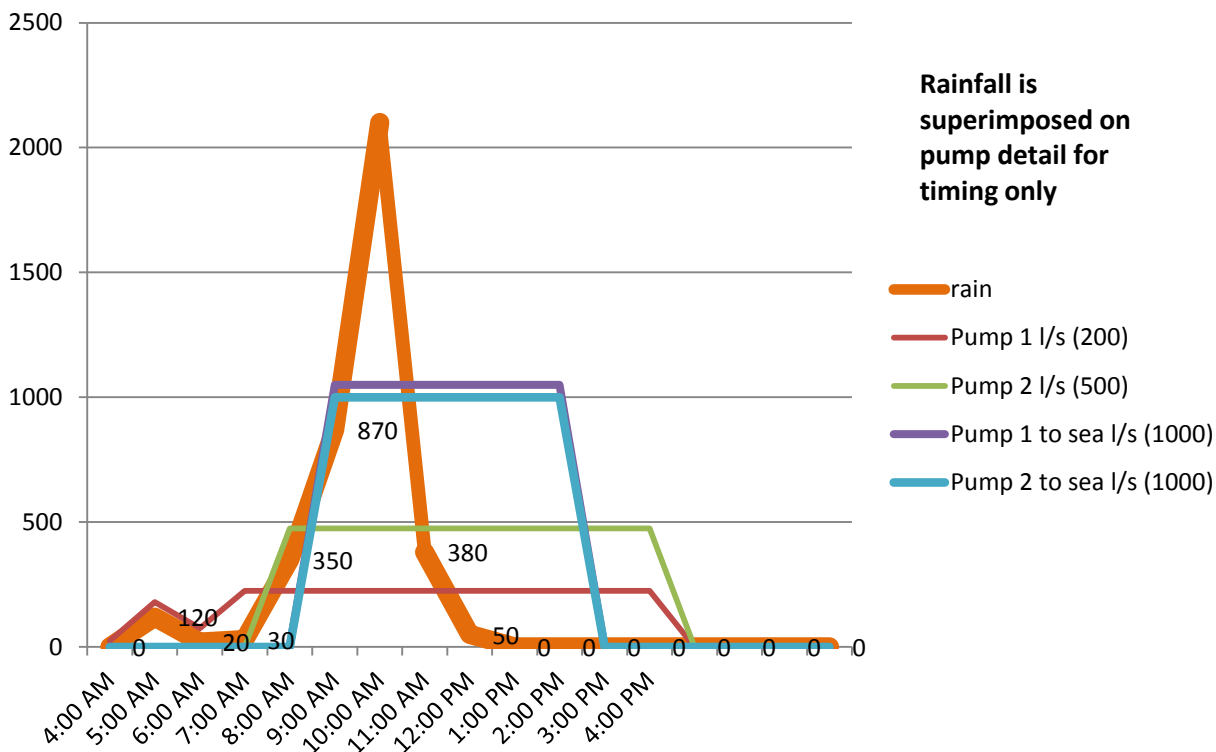
Figure 20: Rainfall totals against King Street Pumping Station operations

Several residents refer to this valve as a tidal gate and were concerned that it was not open during the event. The graph under figure 20, demonstrates this was not the case.

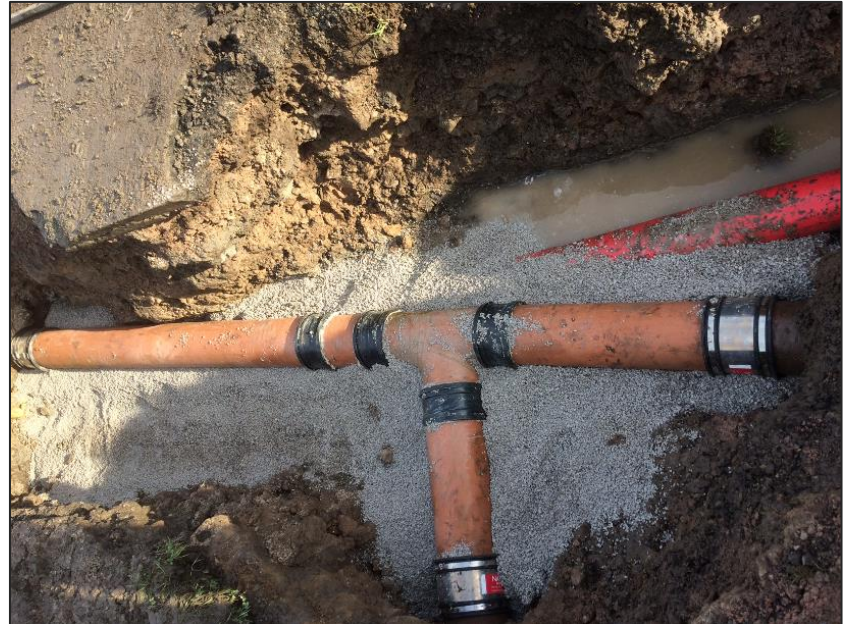
Photograph 2: Highway drainage reinstated on Mainsgate Road. Photo courtesy of Electricity North West

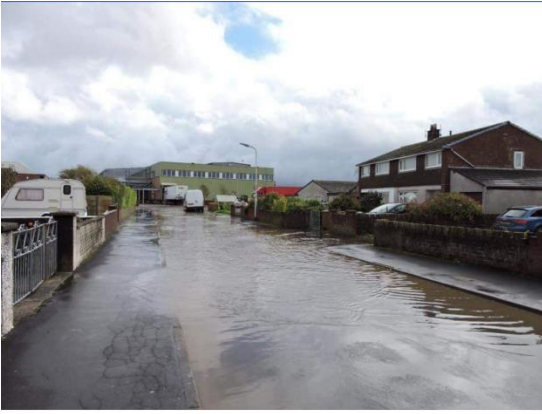
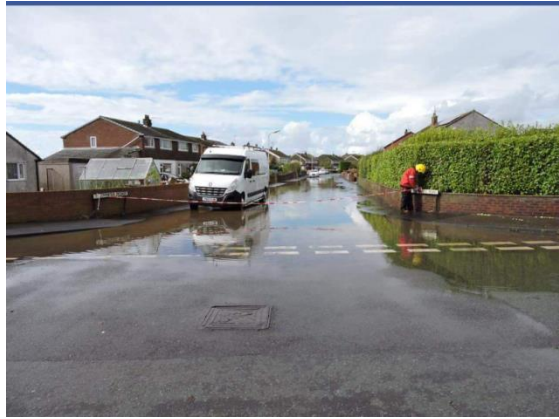
Photographs 3: Photographs of the flooding in the Bowness Road area

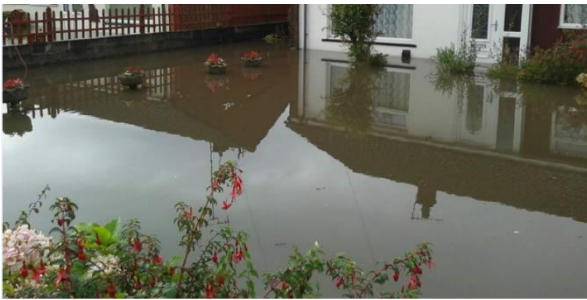
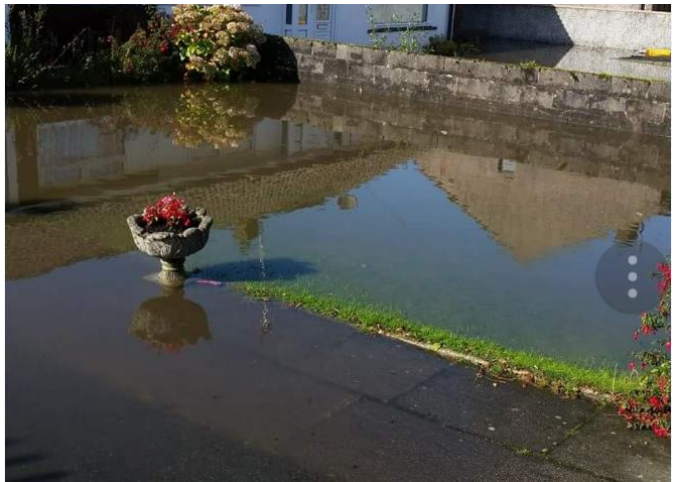
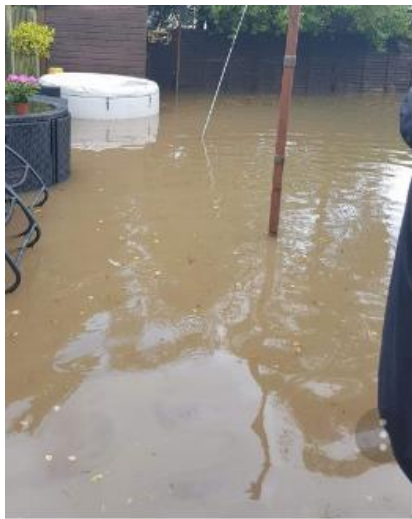
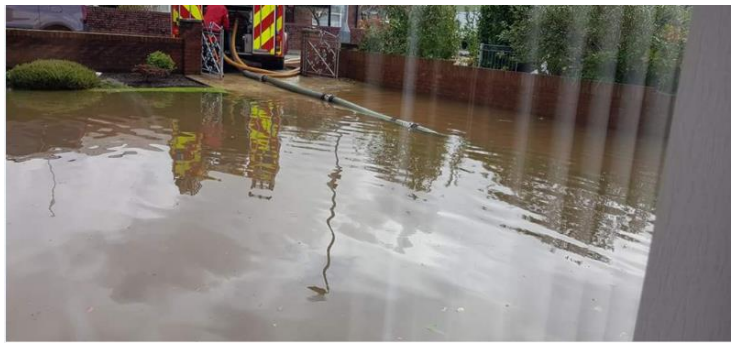
Photographs 4: Photographs of the flooding in the Mainsgate Road area

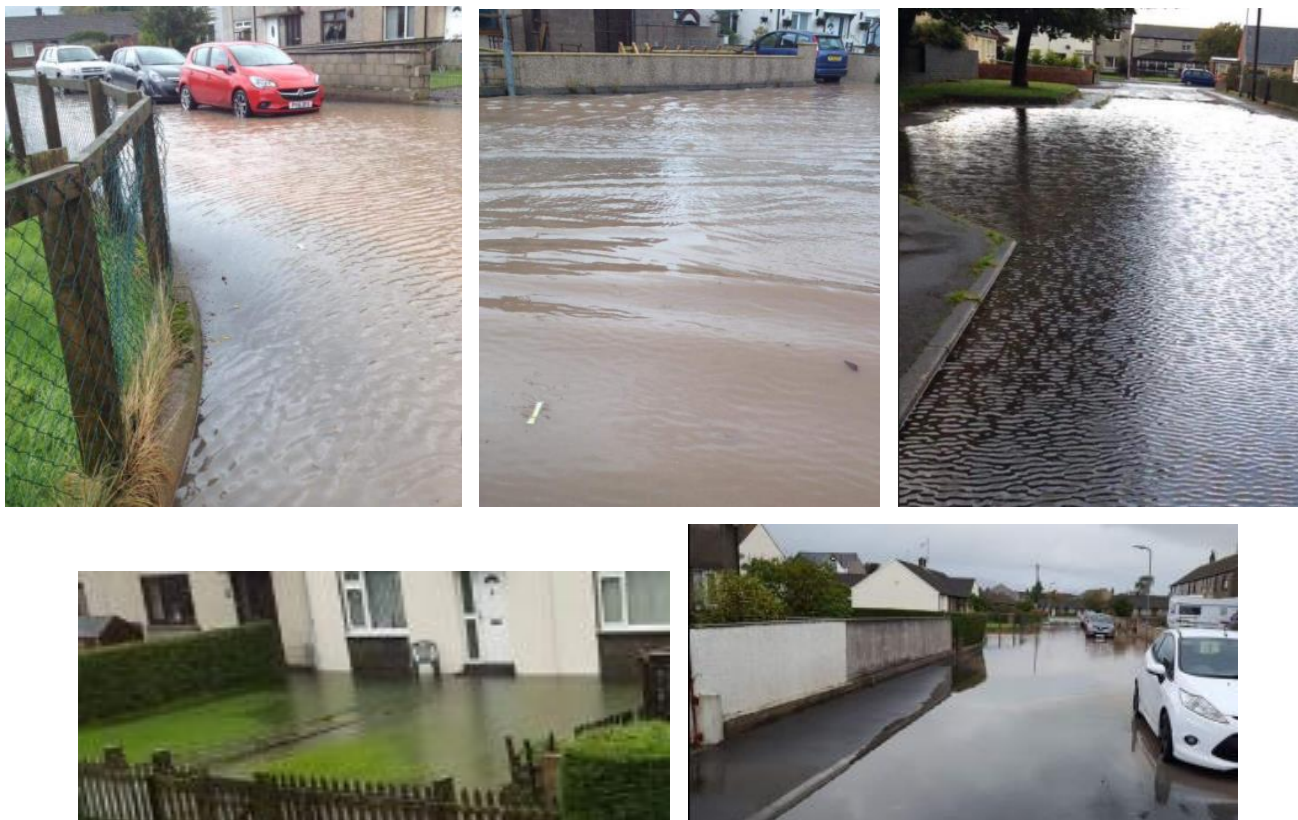
From information gathered regarding this area it is concluded that the likely cause of the flooding is the extreme rainfall event exceeding the design capacity of the drainage systems available.

Photographs 5: Photographs of flooding in Wasdale Road, Cook Road and Park Road

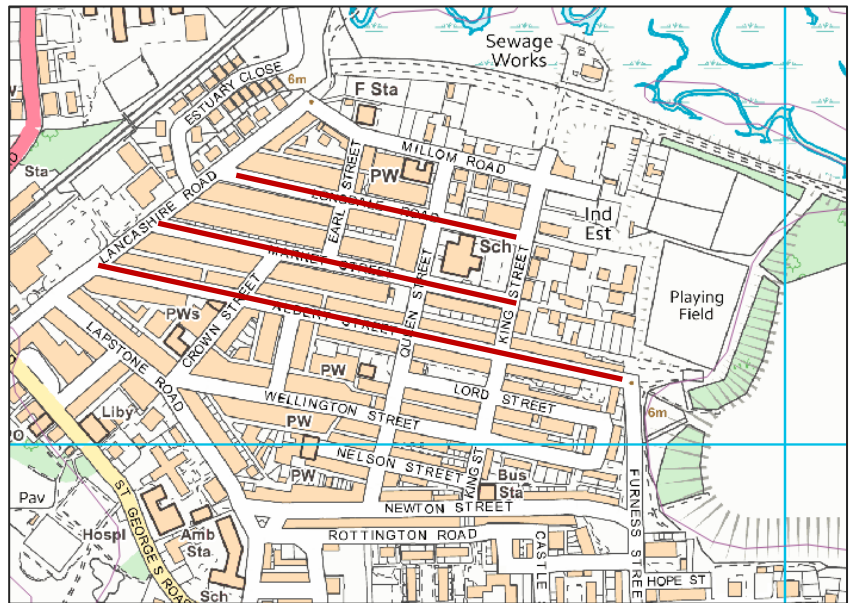
Figure 25: Lonsdale Road/ Market St / Albert St etc.

The feedback information from the residents do not suggest that there were problems with the flushing of toilets during this event and information from UU suggested that there appeared to be limited sewage within the flood water which suggested that the flooding was likely to be caused by inability of the heavy rainfall to enter the highway and combined sewer system.

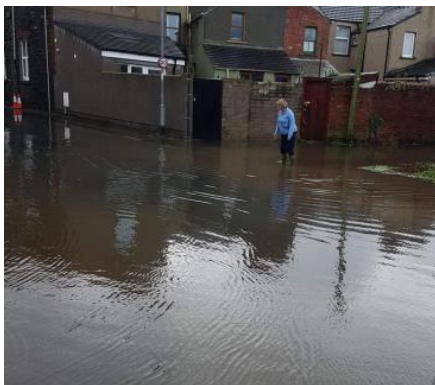
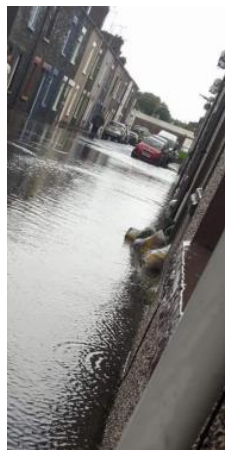
Photographs 6: Photographs of flooding in Albert Street

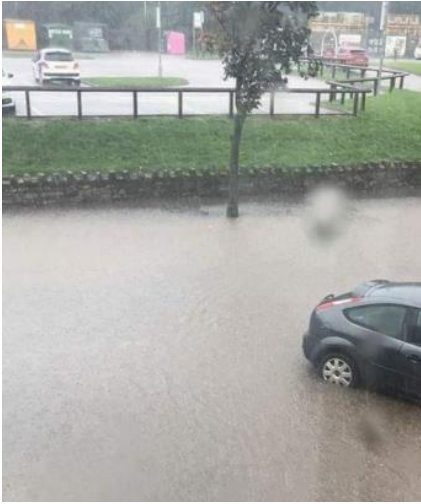
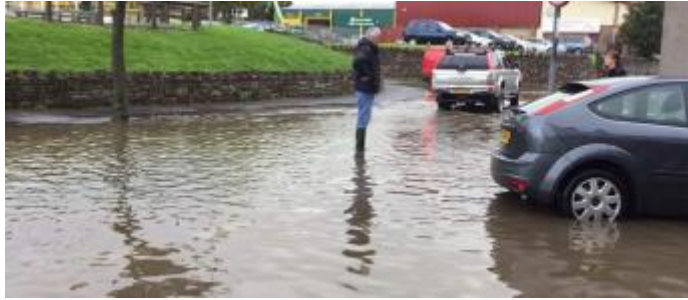
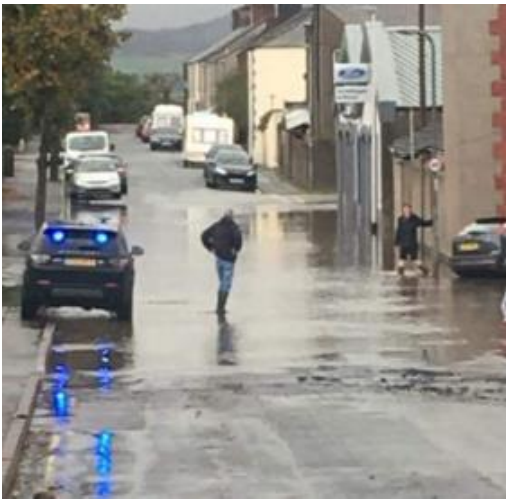
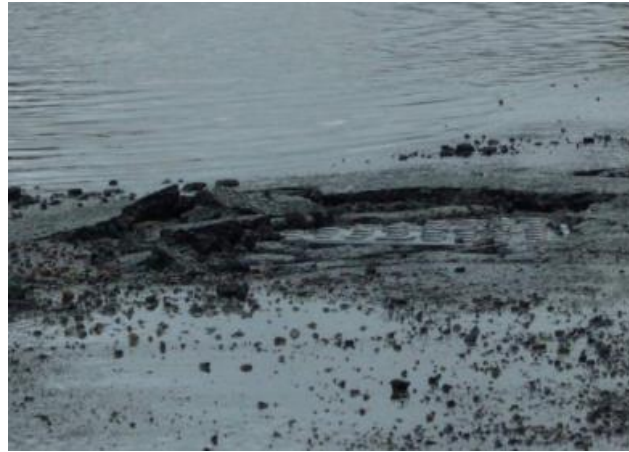
Photographs 7: Photographs of flooding in Lancashire Street

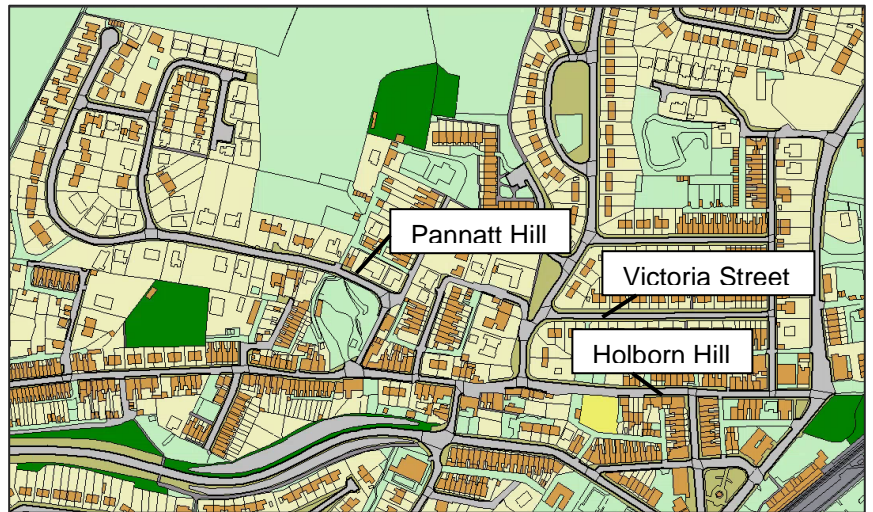
Figure 26: Holborn Hill / Victoria St / Pannatt Hill

The combined sewer has been visually inspected, surveyed by CCTV and dye tested where necessary. The system runs effectively during downpours however there was one area of damage which blocked a single highway gully on the corner of

Finch St/Holborn Hill, see below for more detail. The cause of flooding in this area was due to vast quantities of surface water, once the drainage system was at capacity any precipitation ran from the surrounding high ground and pooled at the low point of Holborn Hill. Once the drainage system 'caught up' the surface water cleared.

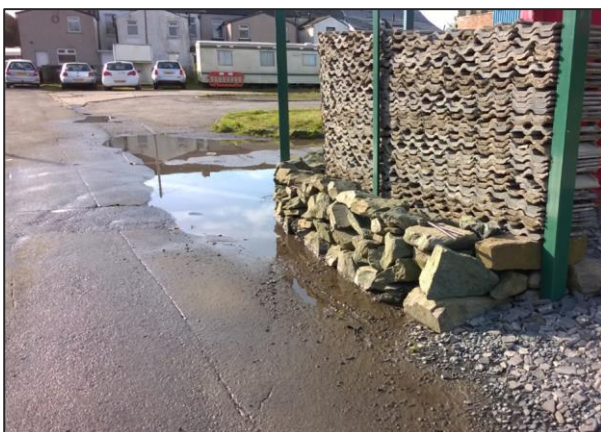
- Number 1 was heavily silted. This has since been cleared and is now in full working order.
- Number 2 was covered by a sheet, presumably to protect the drain from gravel (see **photograph 11**). The sheet has been removed and the gully is fully functional.
- Number 3 has partially collapsed, severing the link between the gully and the combined sewer. This has now been repaired and reconnected.

Photograph 11 (left): Standing water on collapsed chamber

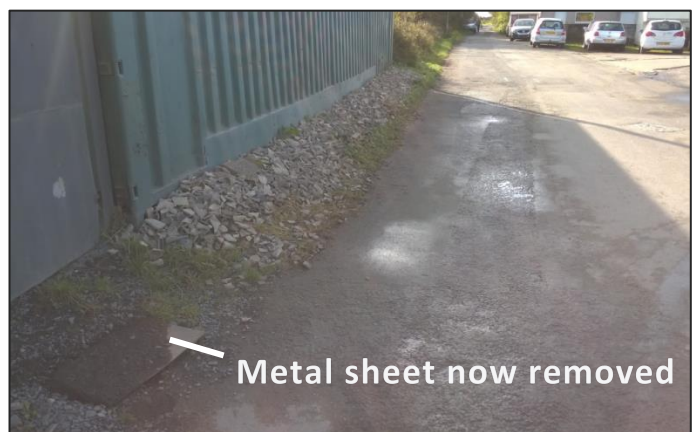
Photograph 12 (right): Metal sheet over highway gully

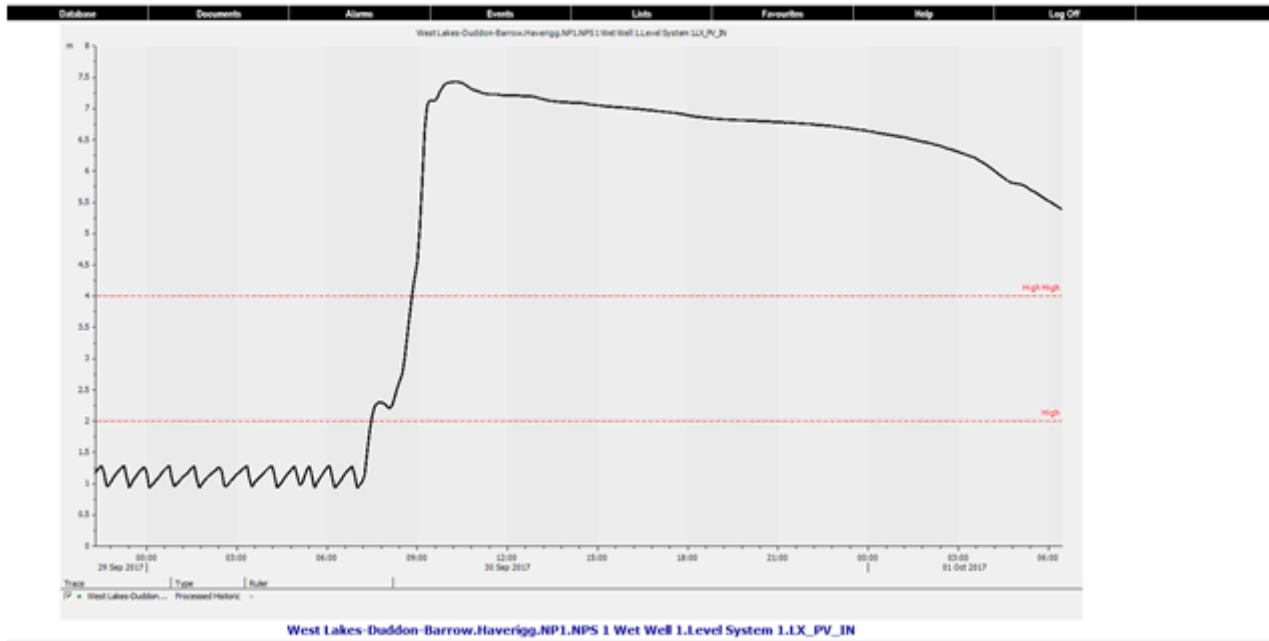
Haverigg pumping station wet well level 30th September 2017

- 07:16 Pump no 2 starts running
- 07:32 Wet well from normal to high
- 08:54 Wet well goes from high to high high
- 09:04 Wet well reaches back up pump control so pump 2 stops and pump 1 starts
- 09:10 CSO Starts to spill into watercourse
- 10:33 Pump no 1 trips and Pump no 2 starts running right away
- 14:16 Pump no 1 is reset by controller and starts running right away and Pump no 2 stops

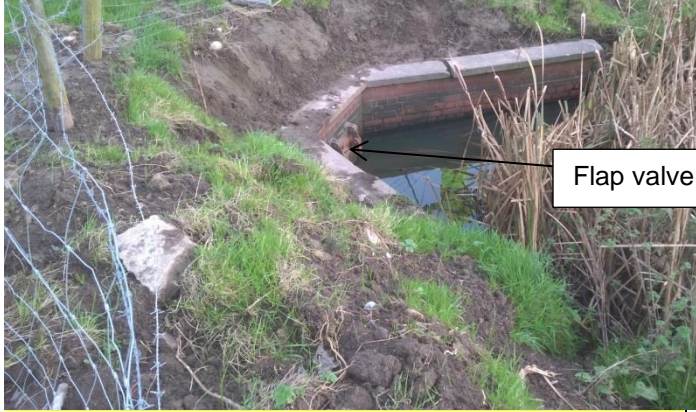
<p data-bbox="1369 1464 1549 1525">Flap valve</p>

<p data-bbox="847 1173 1123 1234">Downstream outlet</p>
Outfall 1	IL 3.275	Concrete pipe 675mm dia.	Flap valve corroded and fixed in one position – needs attention

Cumbria County Council	Remove flap valve at the end of the culverted water course into Crook Pool	Completed
	Copeland Borough Council	Inspect flap valves at Crook Pool exit / old ironworks	Ongoing
	Cumbria County Council/United Utilities	Investigate replacement drain system at Bank End Haverigg	Completed

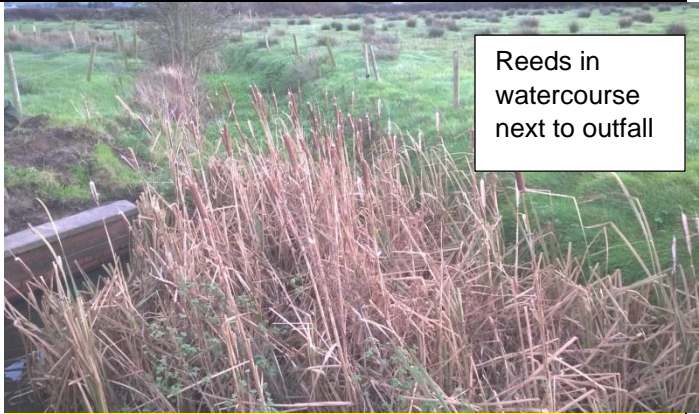
<p>Reeds in watercourse next to outfall</p>
Crossing 2	U/S IL 3.351 D/S IL 3.362	Concrete pipe 1100mm dia.

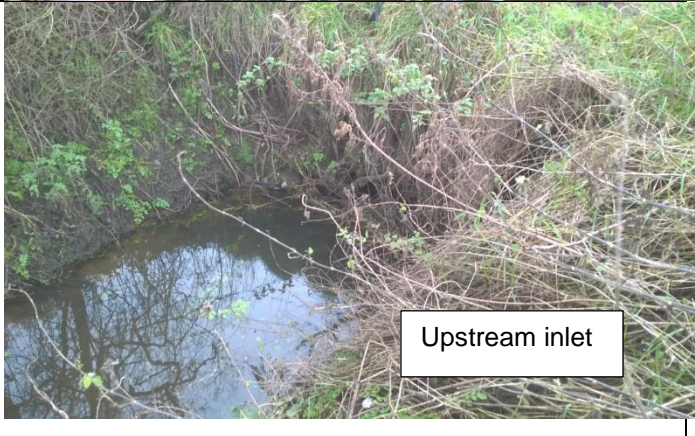
<p>Upstream inlet</p>
<p>Crossing 6</p>	<p>U/S IL 2.478 D/S IL 2.184</p>	<p>Stone culvert U/S 850mm high x 850mm wide D/S 900mm high x 800mm wide</p>

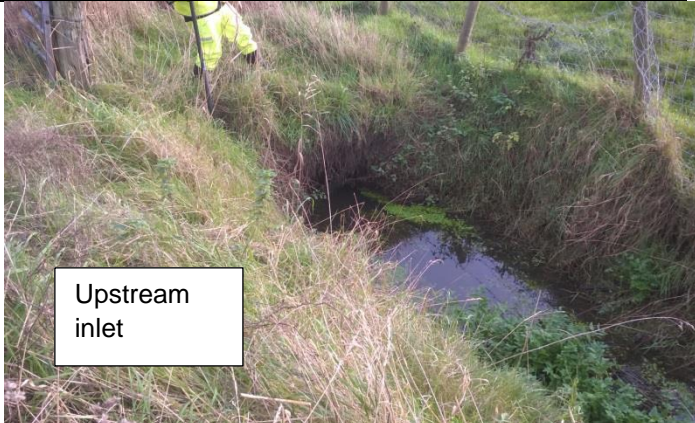
<p>Upstream inlet</p>
<p>Crossing 7</p>	<p>U/S IL 2.264 D/S IL 2.134</p>	<p>Stone culvert U/S 1100mm high x 1000mm wide D/S 1200mm high x 900mm wide</p>

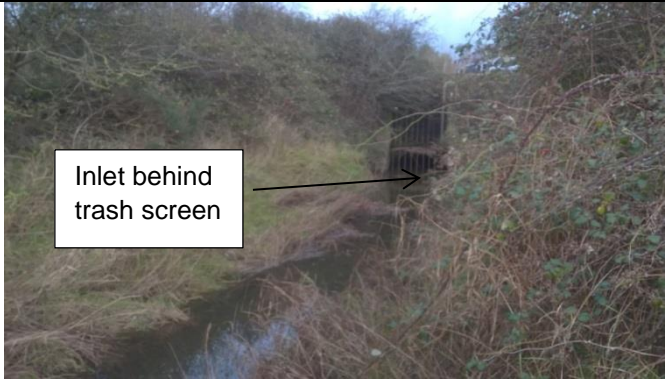
Inlet 1	IL 2.212 (this is approximate as it was not possible to access the invert due to the grid)	Concrete pipe with sluice gate and grid Inlet approach 2000mm wide culvert approx. 1300mm dia but unable to measure accurately

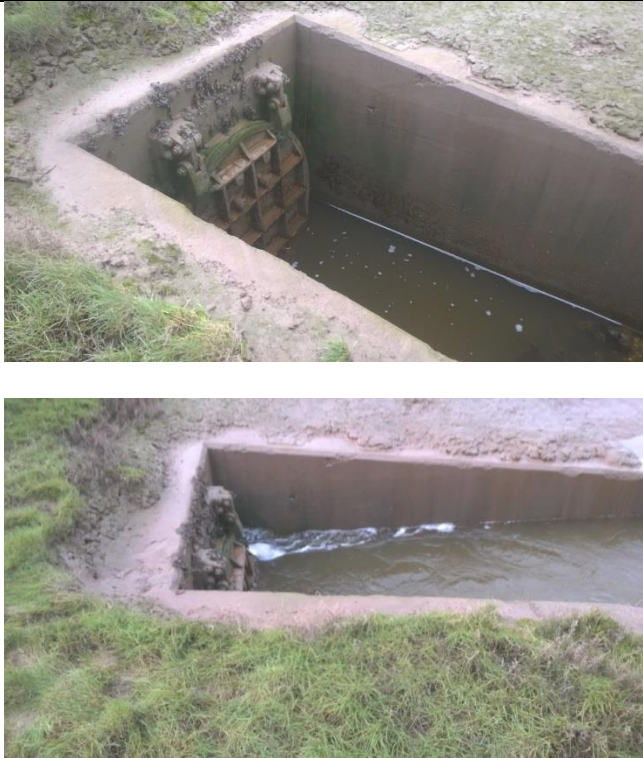
Outfall 2	IL 1.023	Concrete pipe 1500mm

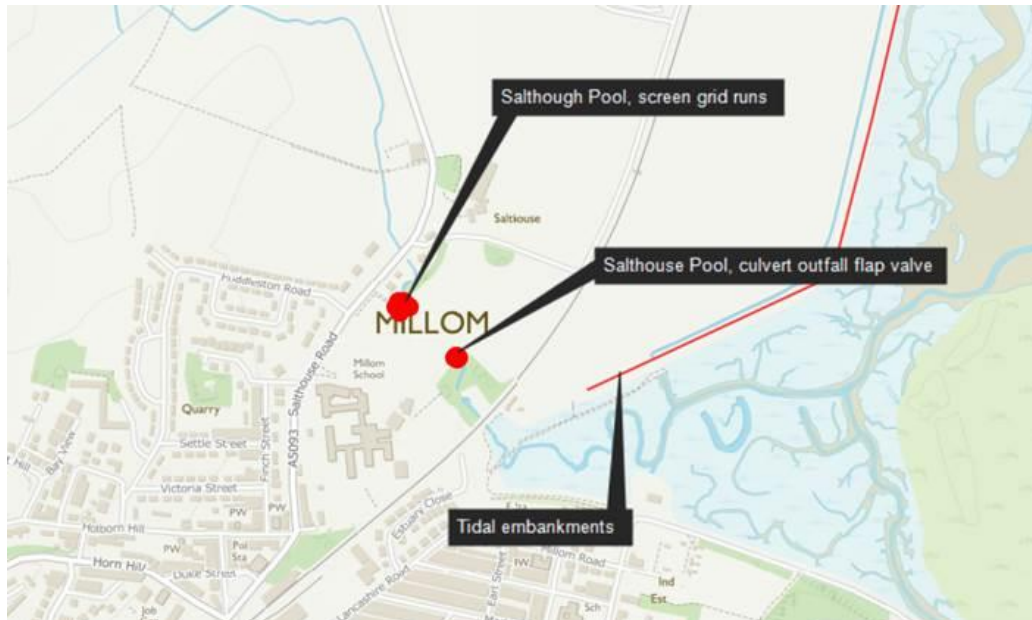
Figure 19: Assets maintained by EA in Millom

- Salthouse Pool, Screen clearance on regular grid runs and ahead of forecast heavy rainfall (NGR: 317417, 480667)
- Salthouse Pool, Culvert outfall – flapped (NGR: 317503, 480585)
- There are also tidal embankments and flaps that are EA maintained to the north-east

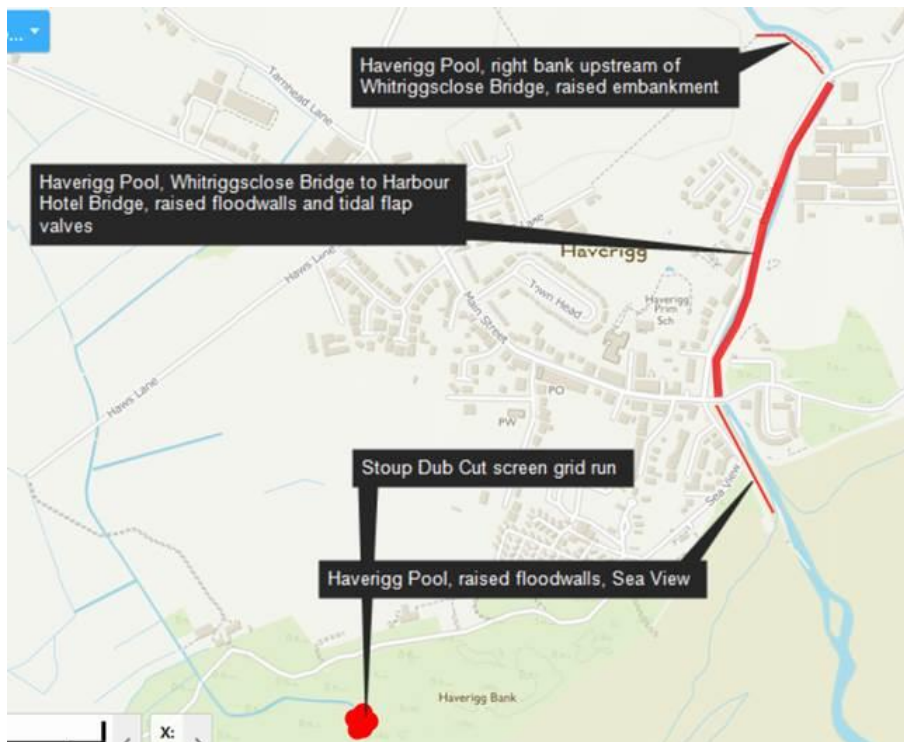
Figure 20: Assets maintained by EA in Haverigg

- Stoup Dub Cut, Haverigg Bank, screen clearance on regular grid runs and ahead of forecast heavy rainfall (NGR: 315548, 478204)
- Haverigg Pool, right bank upstream of Whitriggsclose Bridge, raised embankment (NGR: 316194, 479226)
- Haverigg Pool, Raised Floodwalls both banks and tidal flap valves, from Whitriggsclose Bridge to Harbour Hotel Bridge
- Haverigg Pool, Raised Floodwalls right bank and tidal flap valves, along Sea View

It is considered that the EA assets performed well during the event and there have not been any reports of any back flow from the sea side of the defences during the event. It is therefore considered that the main rivers within both the Millom and Haverigg catchments did not have an impact on the flood event.

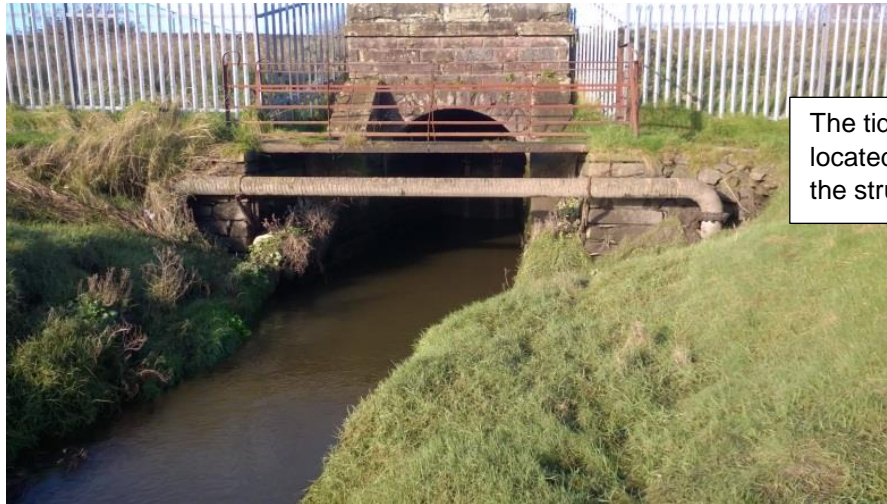
Photograph 2: Cumbrian Coast Railway Line river crossing

The Cumbrian Coast Railway Line runs from Barrow-in-Furness to Carlisle passing through Millom. As it passes through Millom it crosses the main river known as Salthouse Pool. In this location there is a river crossing with a tidal flap as indicated in the following photograph.

There is no evidence that any drainage systems close to flooded properties interact with the Salthouse Pool watercourse and, therefore, it is considered that the Network Rail asset has not had any impact on the flooding that occurred on the 30th September 2017.
