Gamblesby

Flood Investigation Report No 62

Flood Events:
28th June 2012
26th November 2012
18th May 2013

This flood investigation report has been produced by Cumbria County Council as a Lead Local Flood Authority under Section 19 of the Flood and Water Management Act 2010.

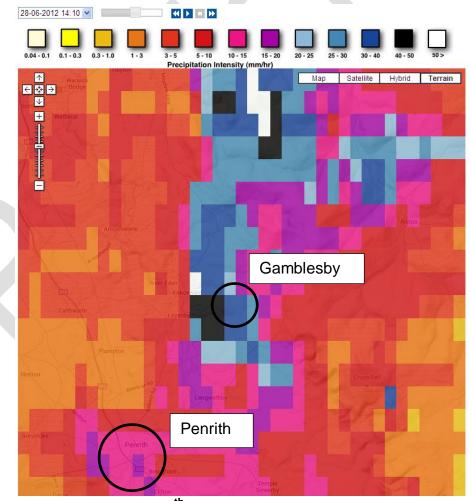
Figure 4: Radar information from 28th June 2012

The surrounding catchments experienced showers during the morning of the 28th June of low intensity. The intense rainfall event occurred between 13.00 and 14.30 with two peaks at approximately 13.10 and 14.10 where rainfall intensity reached between 30-40mm per hour. The diagram below shows the radar data for 14.10 on 28th June 2012.

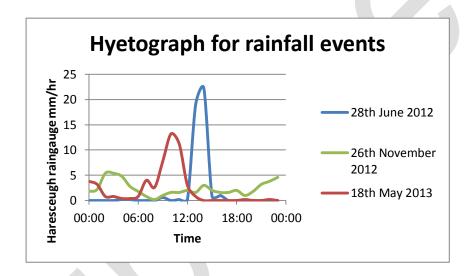
Figure 4: Rainfall hyetograph

The rainfall event began on 17th May 2013 at approximately 23.00 with low intensity rainfall of up to 3mm per hour. This increased to intensities in the order of 5mm per hour around 09.00 on 18th May 2013 and lasted until 13.00 with rainfall completely clearing by 14.00. However, during this event there were three peaks which occurred at approximately 10.00 (intensities 30-40mm), 10.30 (intensities 15-20mm) and 11.35 (intensities 20-25mm).

The Environment Agency (EA) also has a rain gauge located at Haresceugh Castle which is located approximately 3.8km from Gamblesby. The rainfall information obtained from the EA is illustrated in the following hyetograph.

The above hyetograph and table indicate the variation in rainfall totals and intensities that have caused flooding in the village of Gamblesby. From the flooding events that have occurred it can be seen that the catchments discharging to Gamblesby are susceptible to both very intense summer events as well as prolonged winter events.
