Kirkby Stephen

Flood Investigation Report

Flood Event 5th December 2015

This flood investigation report has been produced by Cumbria County Council (CCC) as the Lead Local Flood Authority under Section 19 of the Flood and Water Management Act 2010.

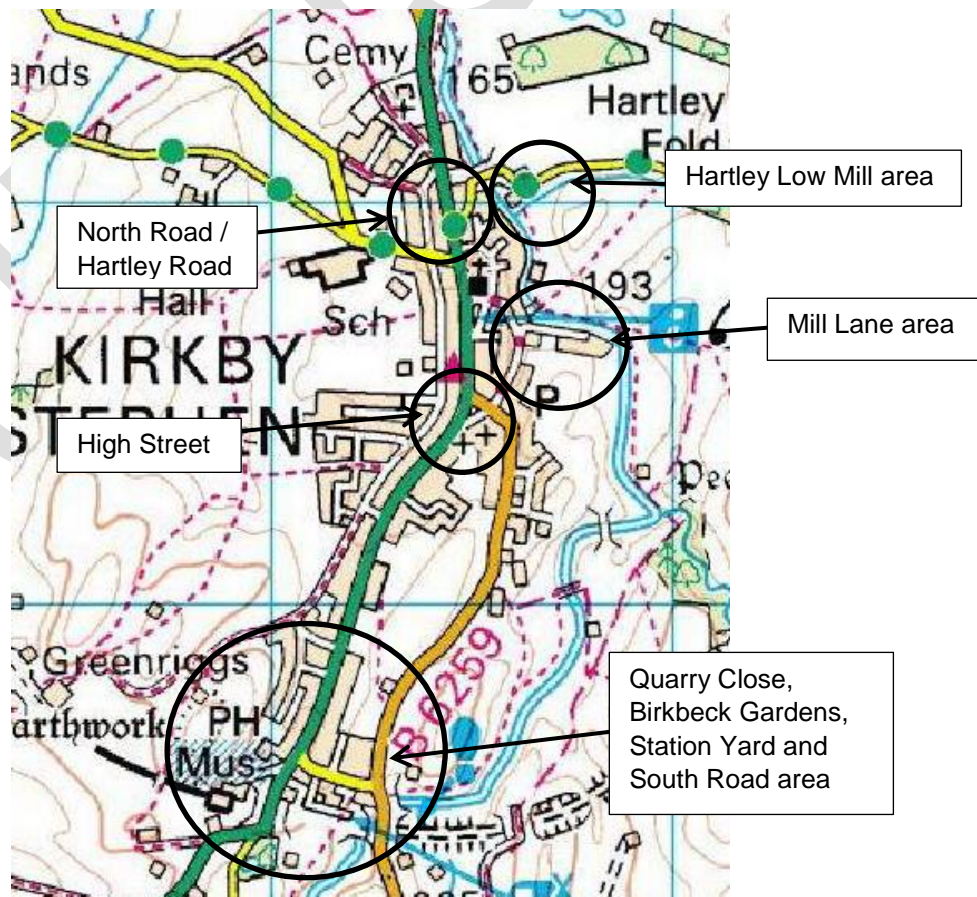
Figure 2: Location of areas affected by flooding in Kirkby Stephen

During the event five areas of Kirkby Stephen are known to have been affected by flooding as follows:

1. Quarry Close, Birkbeck Gardens, Station Yard and South Road – 7 properties are known to have suffered from internal flooding with up to 10 other properties avoiding internal flooding by the actions that were taken.
2. High Street - 3 properties were known to have suffered internal flooding with 5 known to have been protected from flooding by either the actions of the fire service or sandbagging.
3. North Road / Hartley Road – 4 properties are known to have been affected by flooding by ground water seeping up through the floors of the properties.
4. Mill Lane area – 6 properties are understood to have been affected by the flooding.
5. Hartley Low Mill area – The flooding in this area caused a particular issue on the highway which could have led to flooding of properties if action had not been taken by the residents.

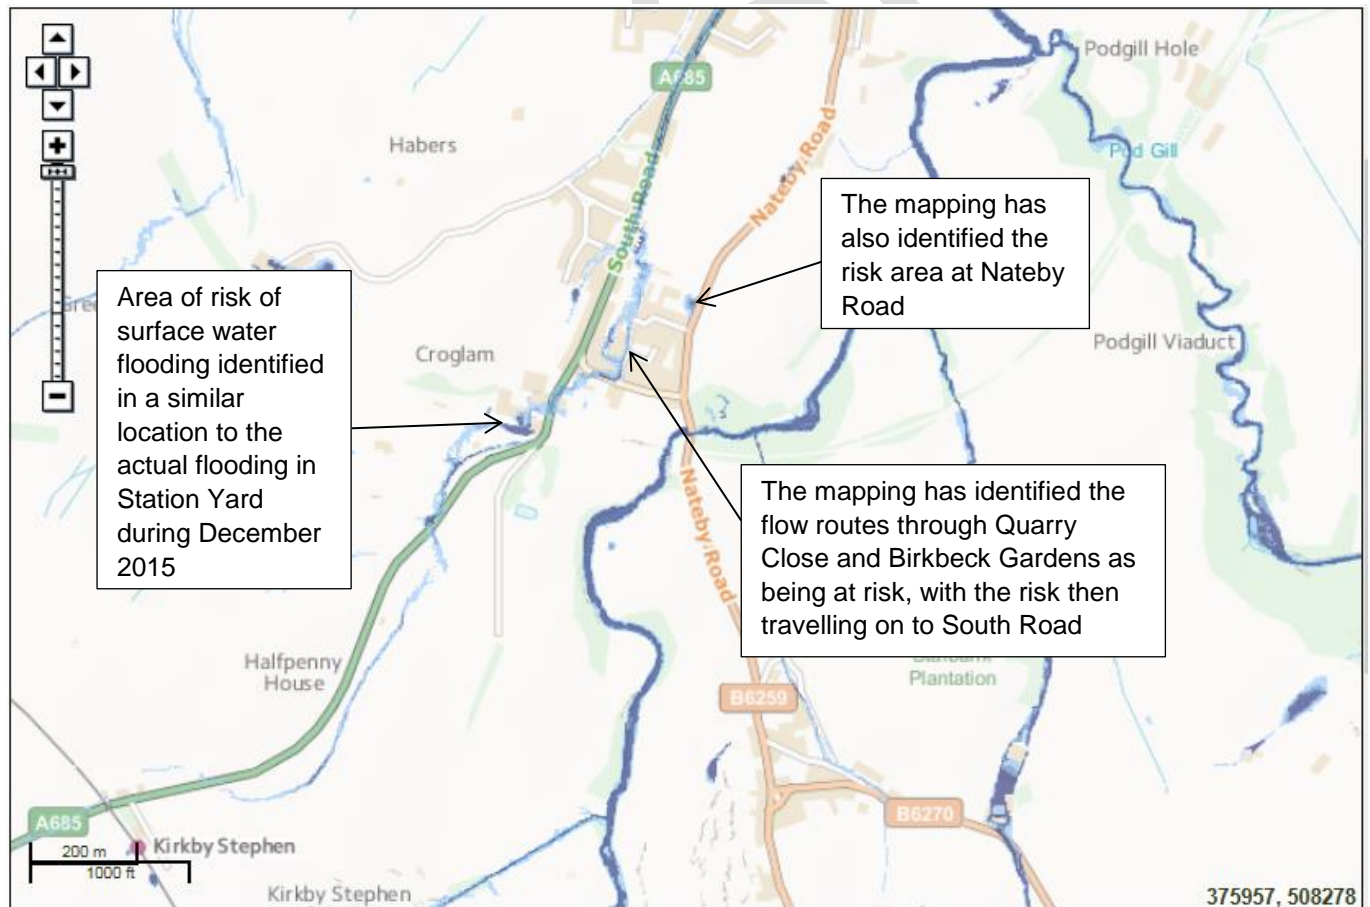
Figure 3: Extract from Environment Agency's Surface Water Mapping for the Station Yard, Quarry Close, Birkbeck Gardens and South Road area

From the Environment Agency mapping it can be seen that many of the areas that have flooded during the December 2015 event were already identified as being at risk of flooding as is demonstrated on the extract from the Surface Water Map detailed below.

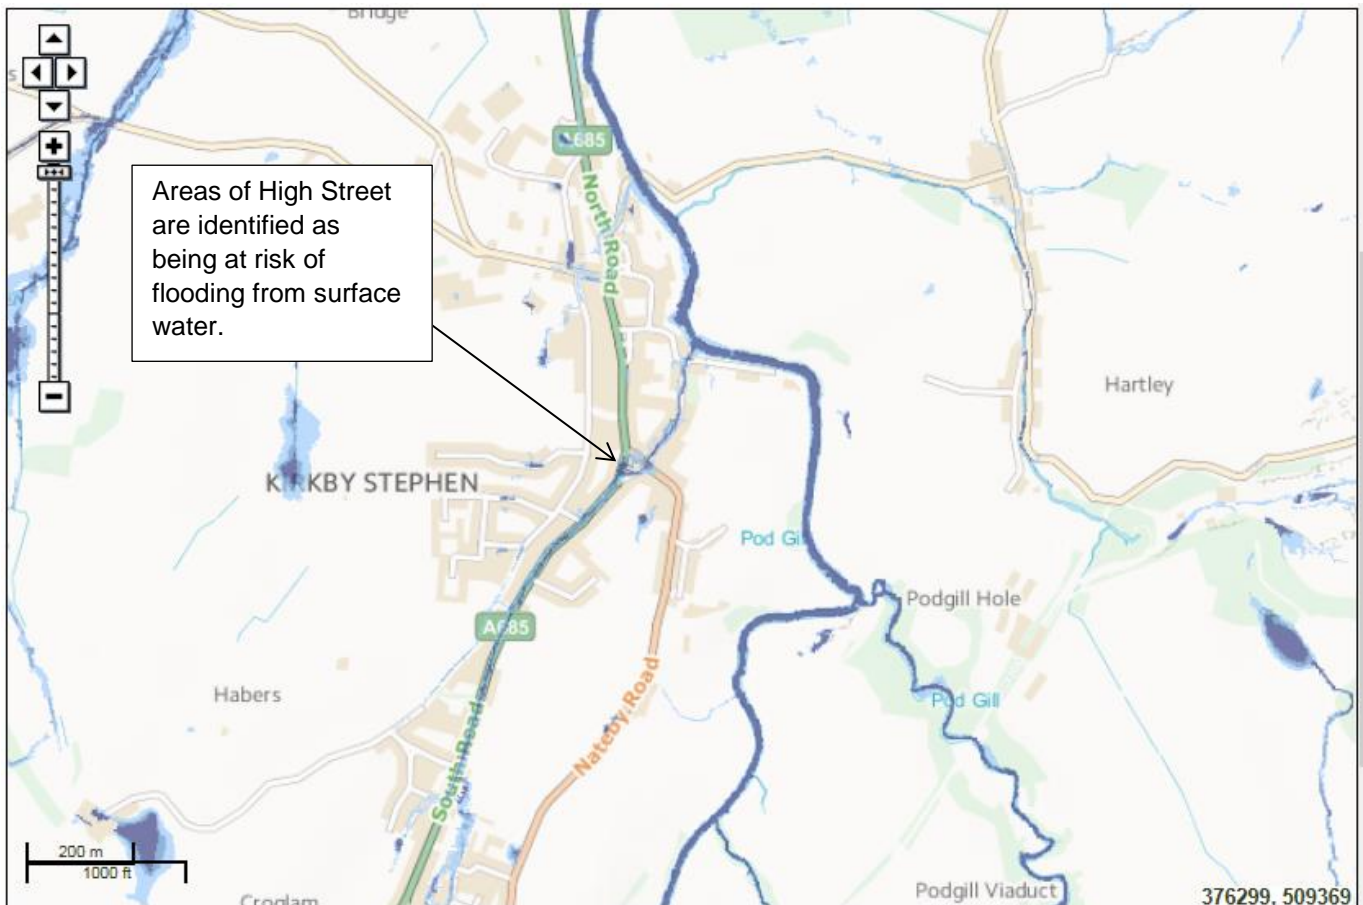
Figure 5: Extract from Environment Agency's Surface Water Mapping for the High Street area

From the Environment Agency mapping it can be seen that many of the areas that have flooded during the December 2015 event were already identified as being at risk of flooding as is demonstrated on the extract from the Surface Water Map detailed below.

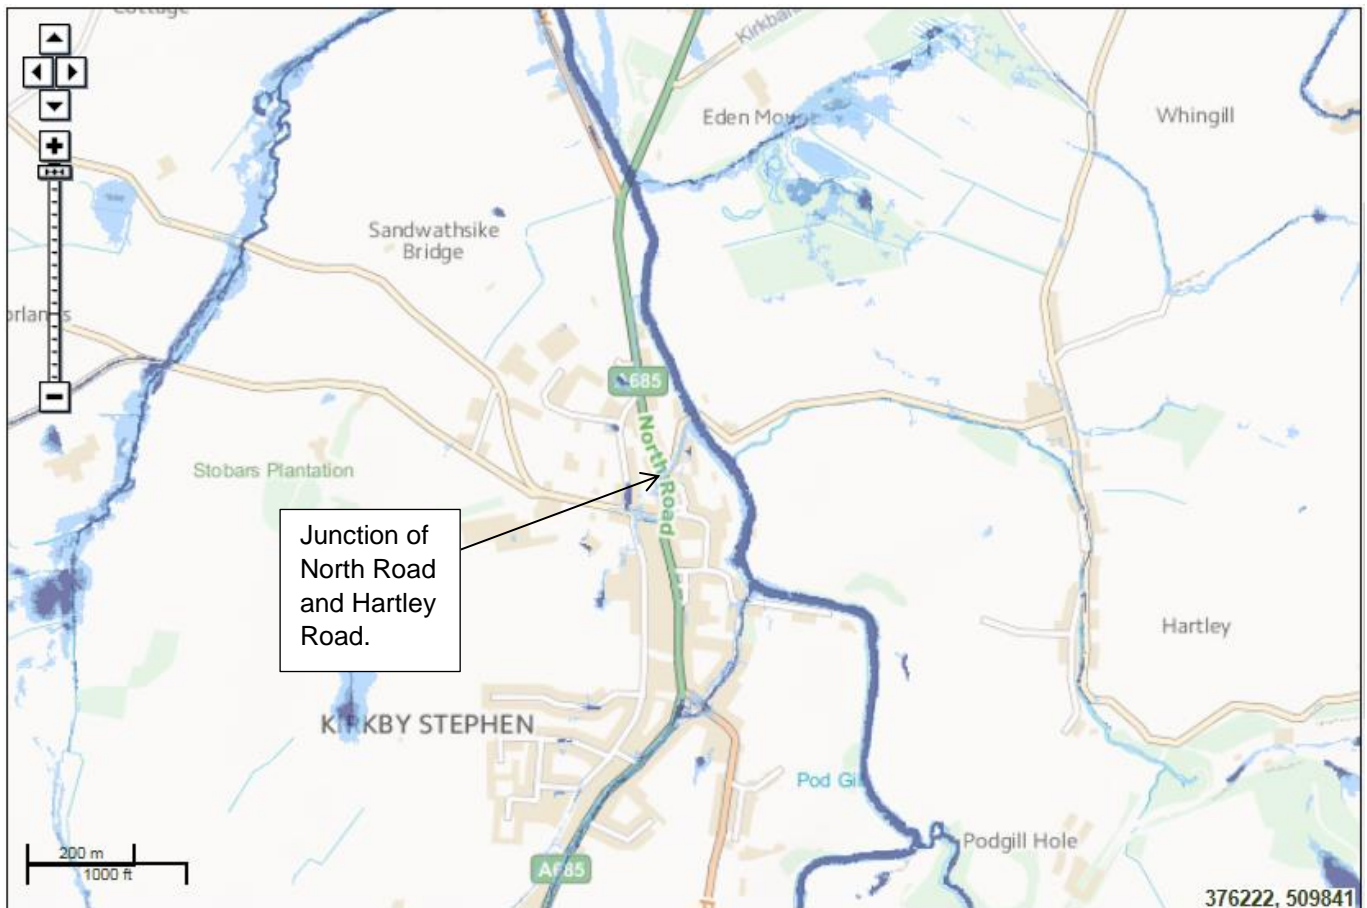
Figure 7: Extract from Environment Agency's Surface Water Mapping for the North Road and Hartley Road area

From the Environment Agency mapping it can be seen that many of the areas that have been flooded during the December 2015 event were identified as being a low to medium risk of flooding as is demonstrated on the extract from the Surface Water Map detailed below.

At the time of writing this report it is understood that 4 properties were affected by flooding. Information that has been provided to CCC suggests that flooding was caused by ground water seeping up through the floors and some residents have suggested that there is a high-water table in the area.

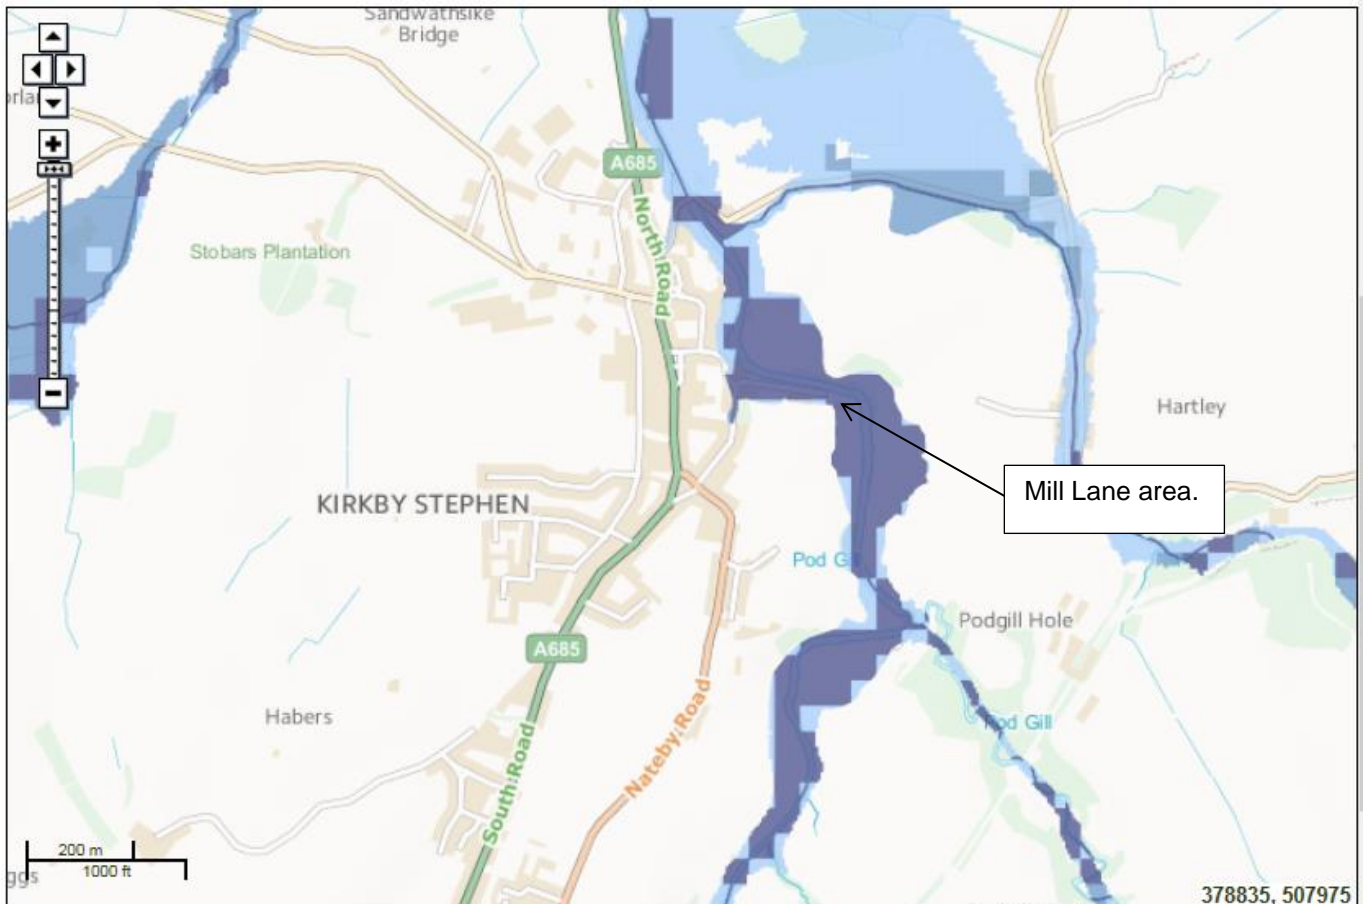
Figure 8: Extract from Environment Agency's River and Sea Flood Mapping for the Mill Lane area

From the Environment Agency mapping it can be seen that the areas affected by the flooding in the December 2015 event were already identified as being at risk of flooding as is demonstrated on the extract from the Rivers and Sea flood mapping.

The flooding to five of the properties was caused by the River Eden when it breached its banks following the heavy rainfall and then overtopped at low garden/retaining wall to affect the properties. The following plan indicates the proximity to the River Eden.

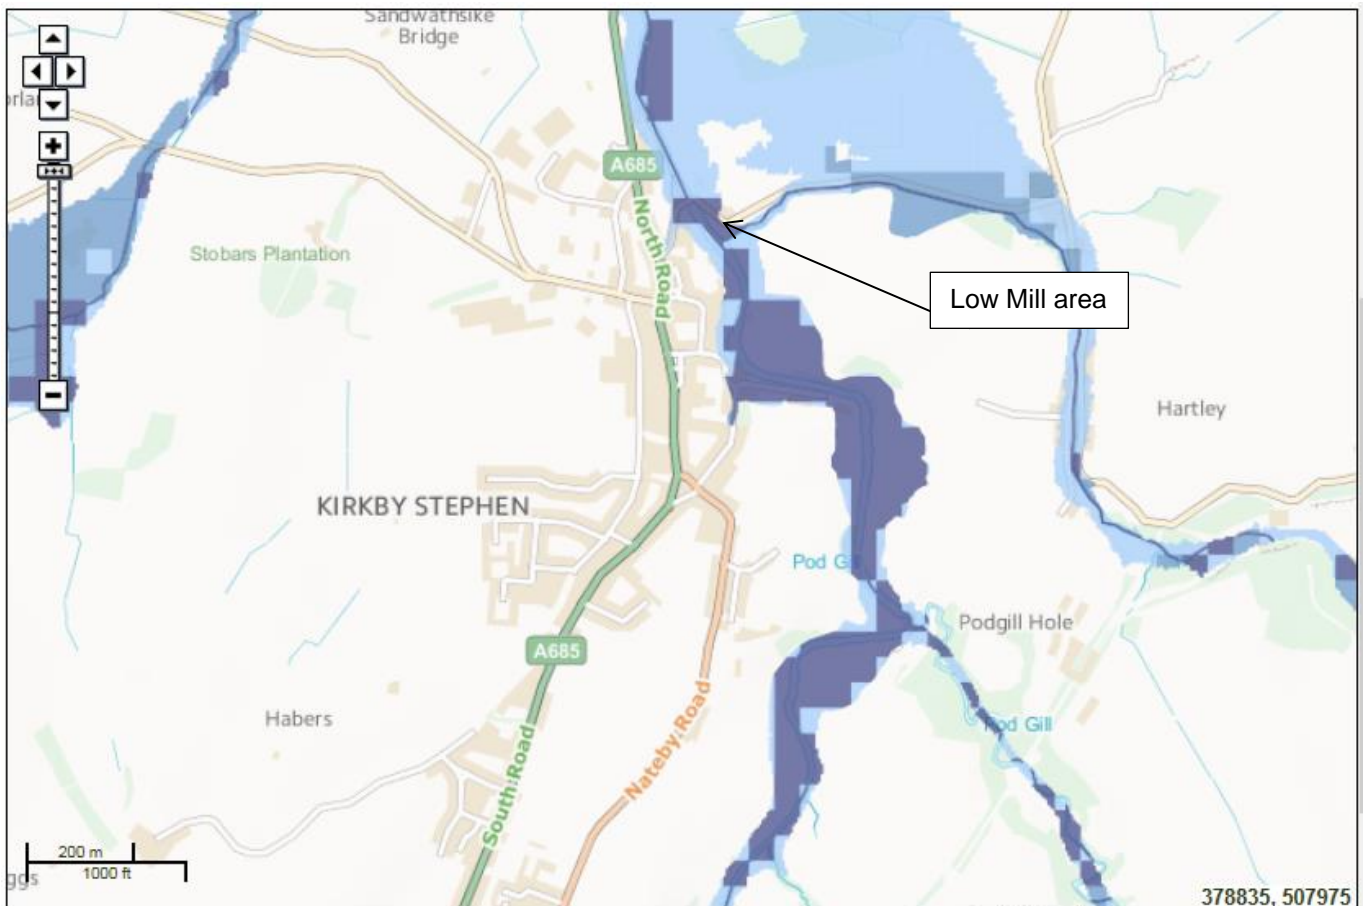
Figure 10: Extract from Environment Agency’s River and Sea Flood Mapping for the Mill Lane area

From the Environment Agency mapping it can be seen that the areas affected by the flooding in the December 2015 event were already identified as being at risk of flooding as is demonstrated on the extract from the Rivers and Sea flood mapping.
