Kendal

Flood Investigation Report

Sandylands and Mintsfeet on the 6th December 2015

Flood Event 5-6th December 2015

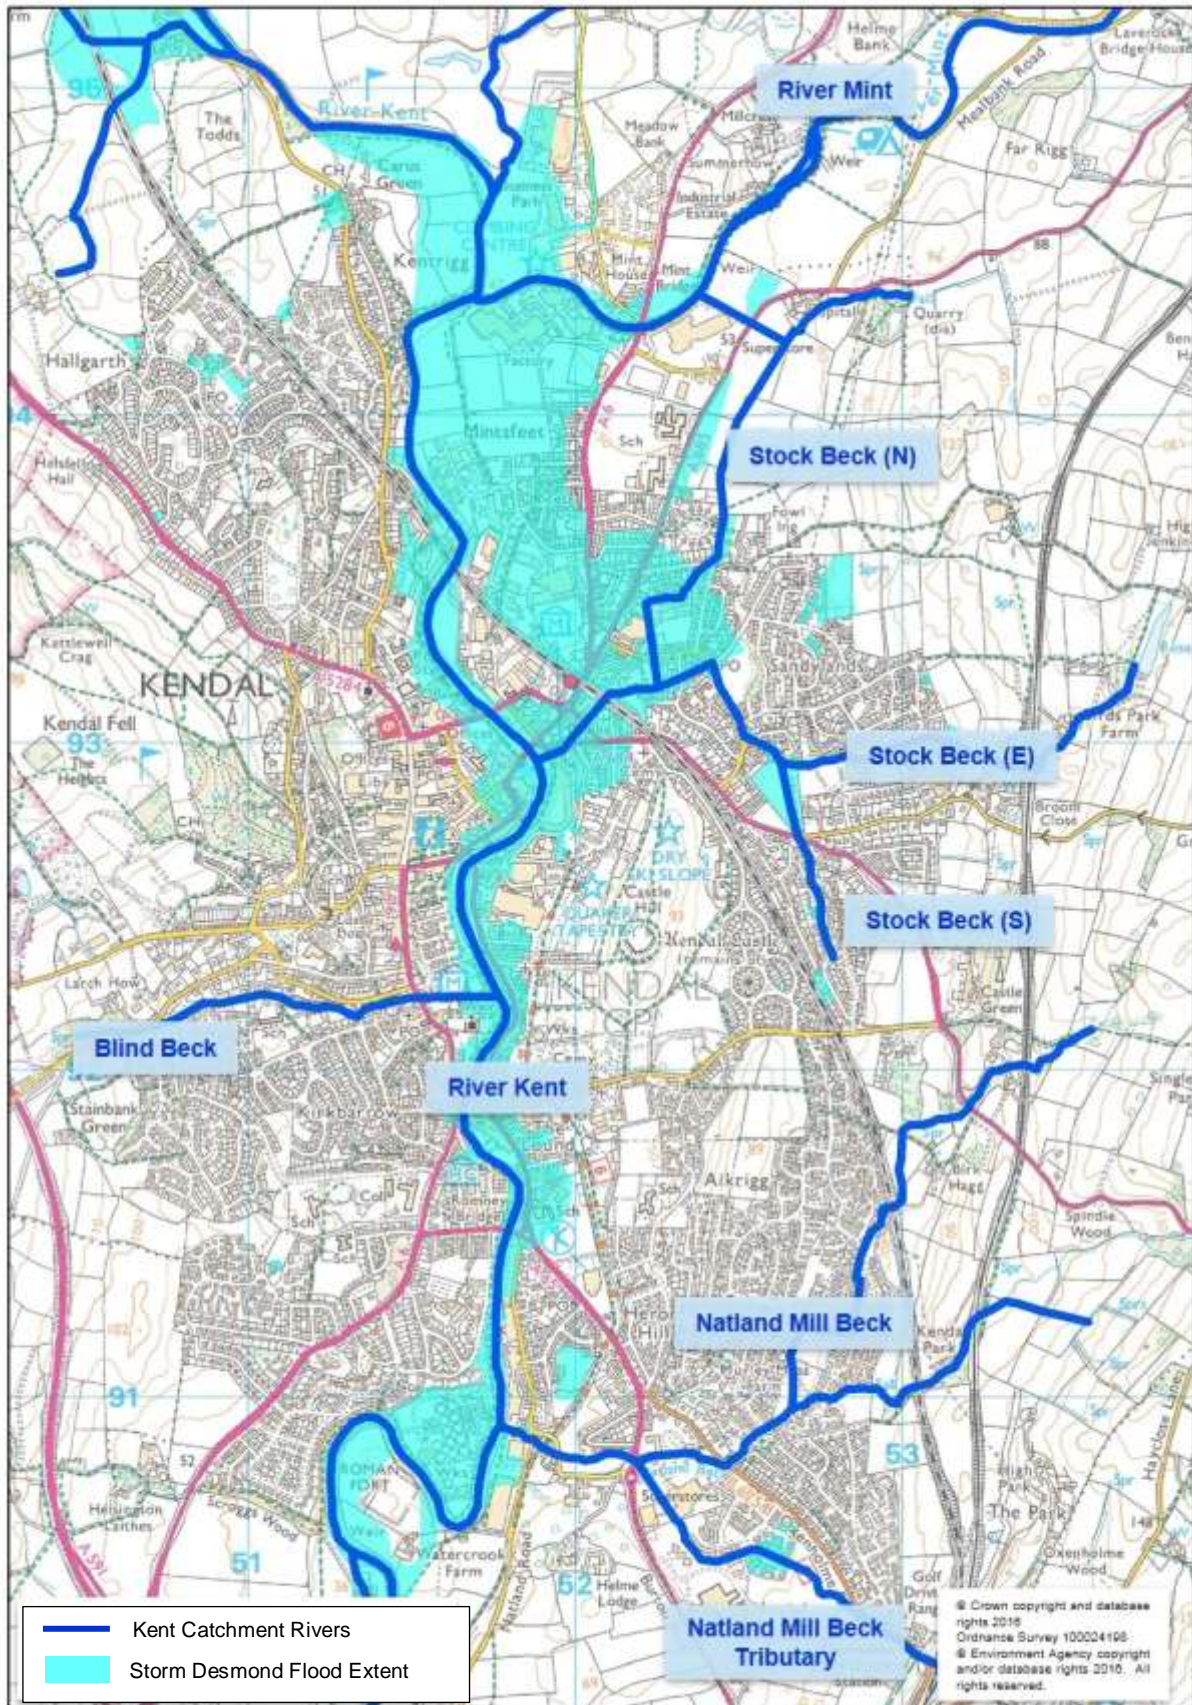
Figure 4: Extent of flooding in Kendal on 5-6th December 2015

On the 5th and 6th December 2015, approximately 2,150 properties in Kendal suffered significant flooding as a result of Storm Desmond, which caused record breaking rainfall over Cumbria and other parts of north-west England. The storm led to widespread river and surface water flooding across Cumbria, with significant flood events occurring on the Eden, Derwent and Kent catchments.

In Kendal, the main source of flooding was from flood water overtopping the left banks of the Rivers Mint and Kent in the Mintsfeet area, located due north of Kendal town centre where the River Mint joins the River Kent. This caused significant flooding to commercial properties in the Lake District Business Park, with overland flood flows then continuing due south across playing fields before flooding commercial and residential properties located between the Oxenholme-Windermere railway line (situated on an embankment) and the A6 Shap Road, including the Mintsfeet Industrial Estate. This overland flow then continued to spread east towards Appleby Road and combined with overland flow from Stock Beck to cause flooding to properties east of Appleby Road in the vicinity of Sandylands Road. Flood water then continued to flow through the railway overbridge at Longpool, which crosses the A6, where further flooding occurred in the Ann Street and Castle Street area.

River flooding also occurred in the immediate vicinity of the River Kent where it flows through the centre of Kendal, with properties on both banks affected. This flooding extended to the southern part of the town, where Kendal Wastewater Treatment Works (WwTW) suffered damage as a result of sewer surcharging and a blocked outfall.

Flooding from other sources, including groundwater, surface water run-off, and artificial drainage systems was also reported. Figure 4 indicates the extent of the flooding that occurred in Kendal from all sources following Storm Desmond.

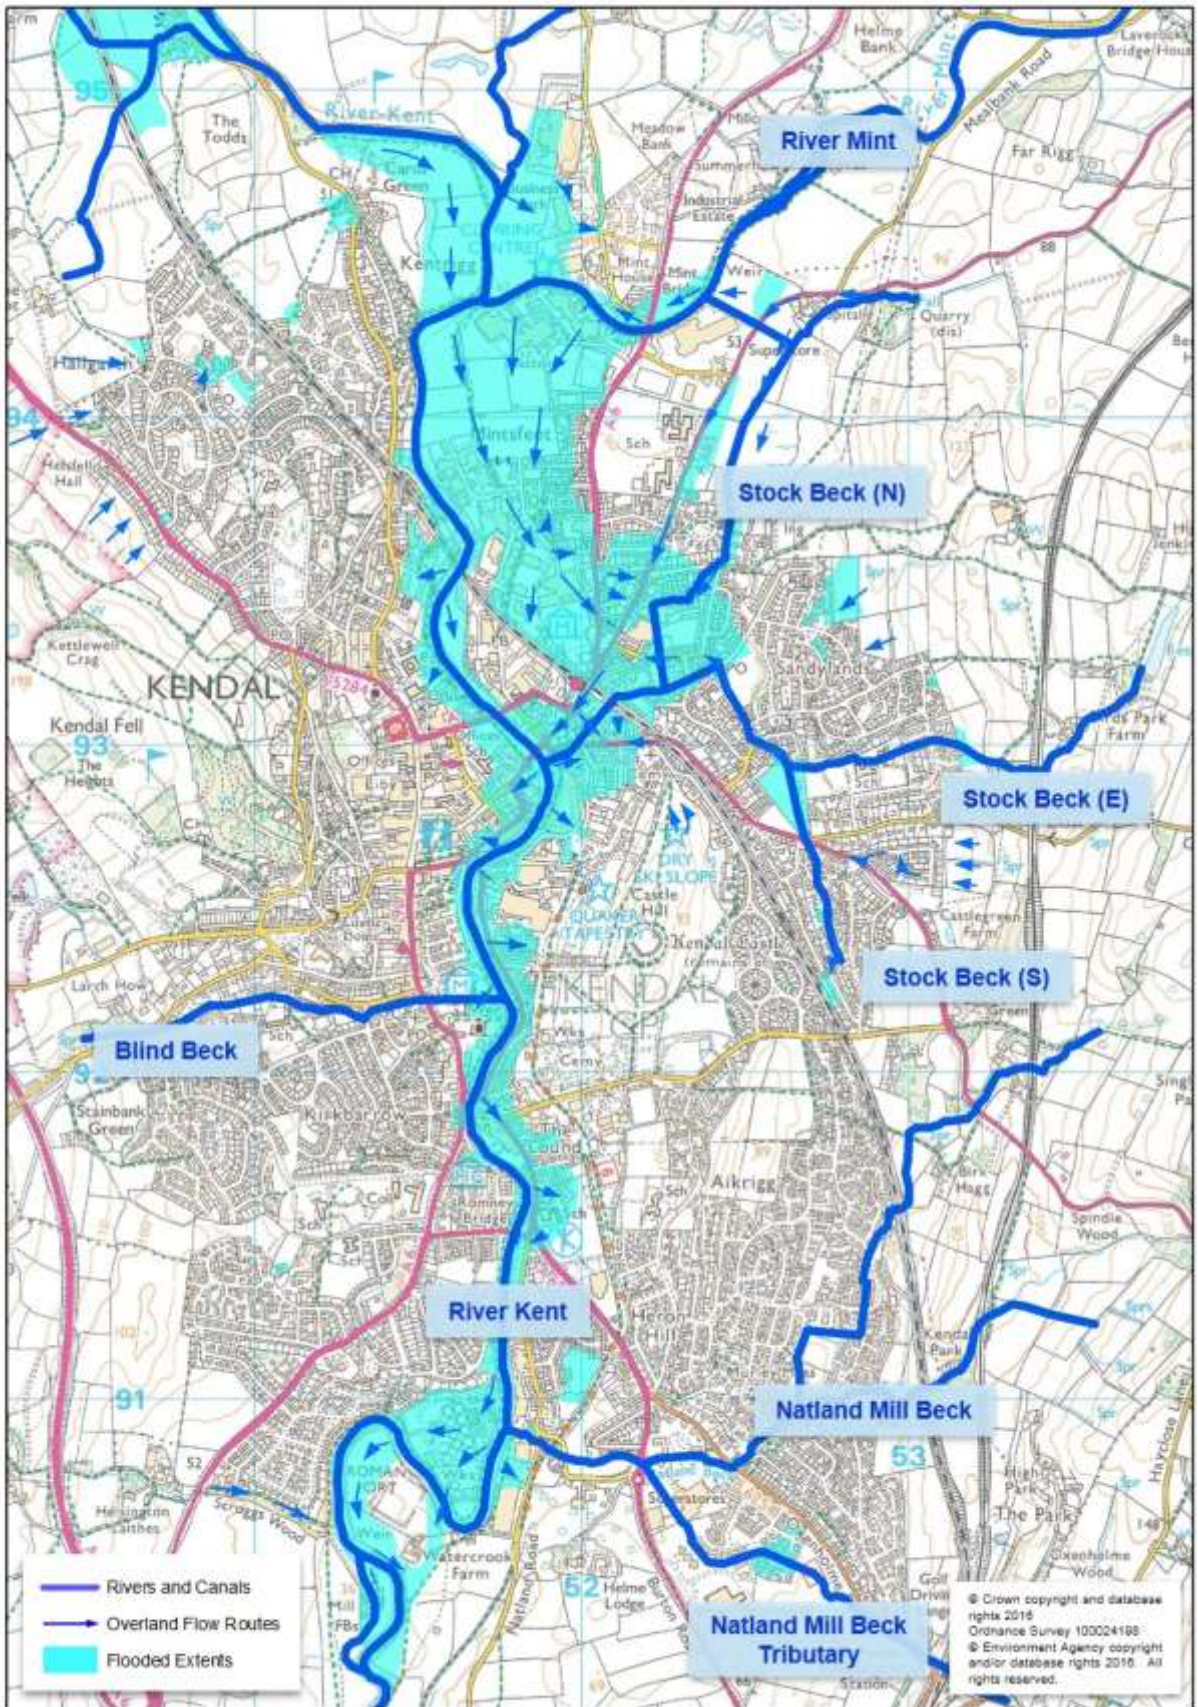
Figure 10: Principal overland flow routes through Kendal

The overland flood flows that caused the flooding in Kendal on the 5th and 6th December 2015 were complex and derived from multiple sources. From the data and evidence obtained both during and after the flood event, it is clear that river, surface water, drainage systems, and groundwater sources of flooding all contributed to the devastation across the town. Generally speaking, the principal source of flooding in Kendal may be attributed to the River Kent, Mint and Stock Beck river flooding. However, in specific areas, the evidence suggests that surface water flooding, groundwater flooding, and flooding from drainage systems played a critical role. In view of this, the sources of flooding in each of the areas identified in Figure 5 are discussed on an area by area basis in the Likely Causes of Flooding section of this report.

Detailed flow routes are also identified in the Likely Causes of Flooding section of this report. However, an overview of the principal flood flow routes through Kendal is presented in Figure 10. This figure shows the dominant flow paths within the town, but there is evidence that these changed over the course of the event as different sources of flooding came into play and flood waters in some areas began to recede.

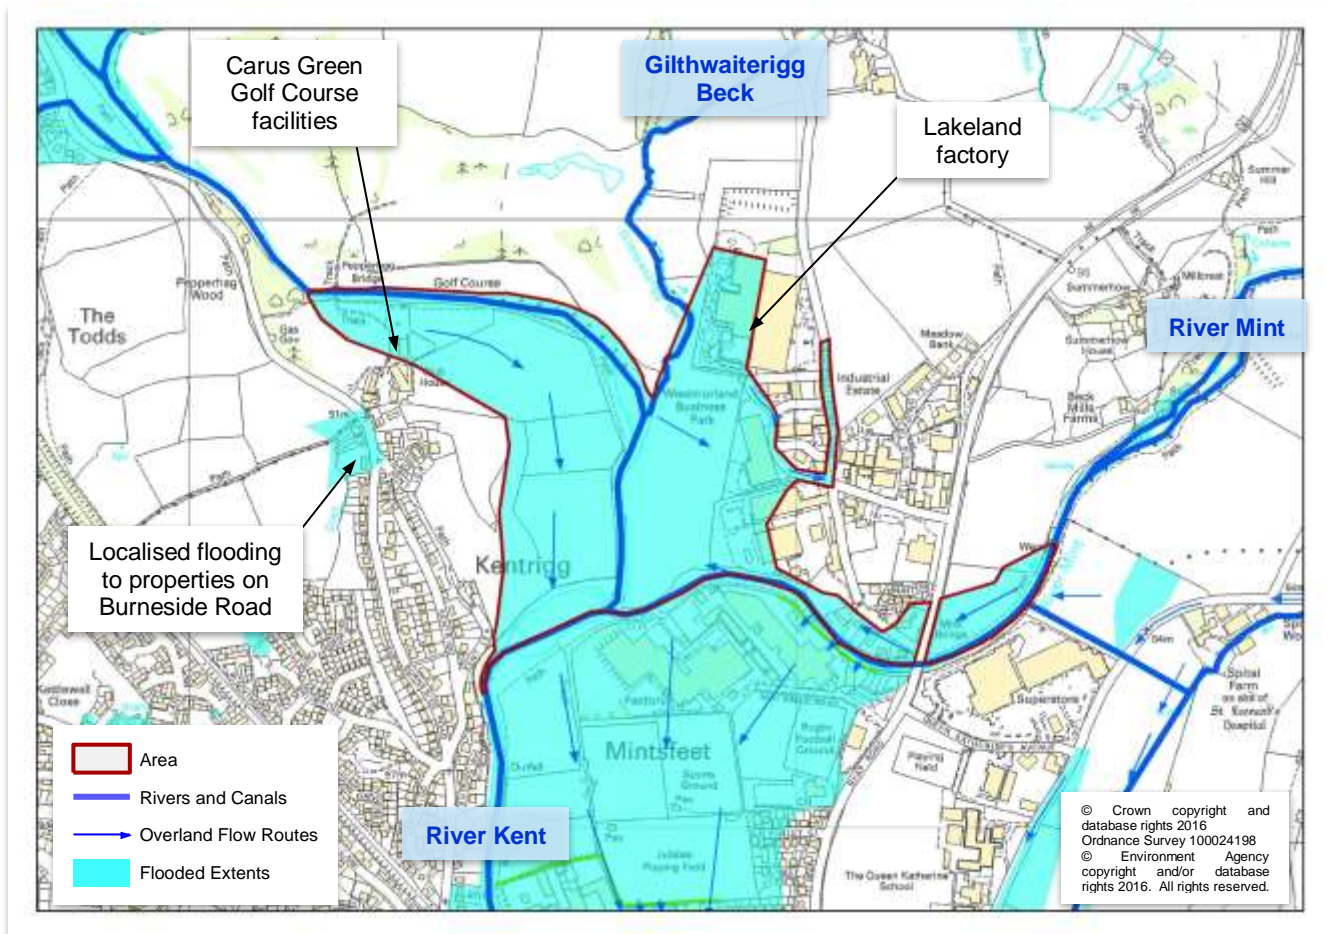
Figure 11: Overland flow routes in the Kentrigg and Carus Green area

Kentrigg is located in the north of Kendal on the River Kent and close to its confluence with the River Mint. Flooding in this area was predominantly caused by the fluvial event on the River Kent, with parts of the Westmorland Business Park on the left bank of the River Kent also affected by flooding from Gilthwaiterigg Beck.

For the most part, the areas of land that flooded are green field areas, including part of Carus Green golf course, where substantial damage was reported on the left bank of the River Kent. Flooding also affected facilities at the golf club (on the right bank of the River Kent), where the depth of water reached 0.6m.

The Westmorland Business Park, within which is a factory for the Lakeland homeware brand, suffered flooding. The Lakeland factory itself was flooded and it is believed that this was caused by groundwater flooding. Flooding to a depth of circa 20mm was reported in an extension built to the north of the site. The shallow depth of water meant that staff were able to clean the premises relatively quickly

Fluvial flooding from an ordinary watercourse resulted in five properties on Burneside Road, opposite Kent Lea, being affected. Investigations suggest that this was caused by an obstructed culvert.

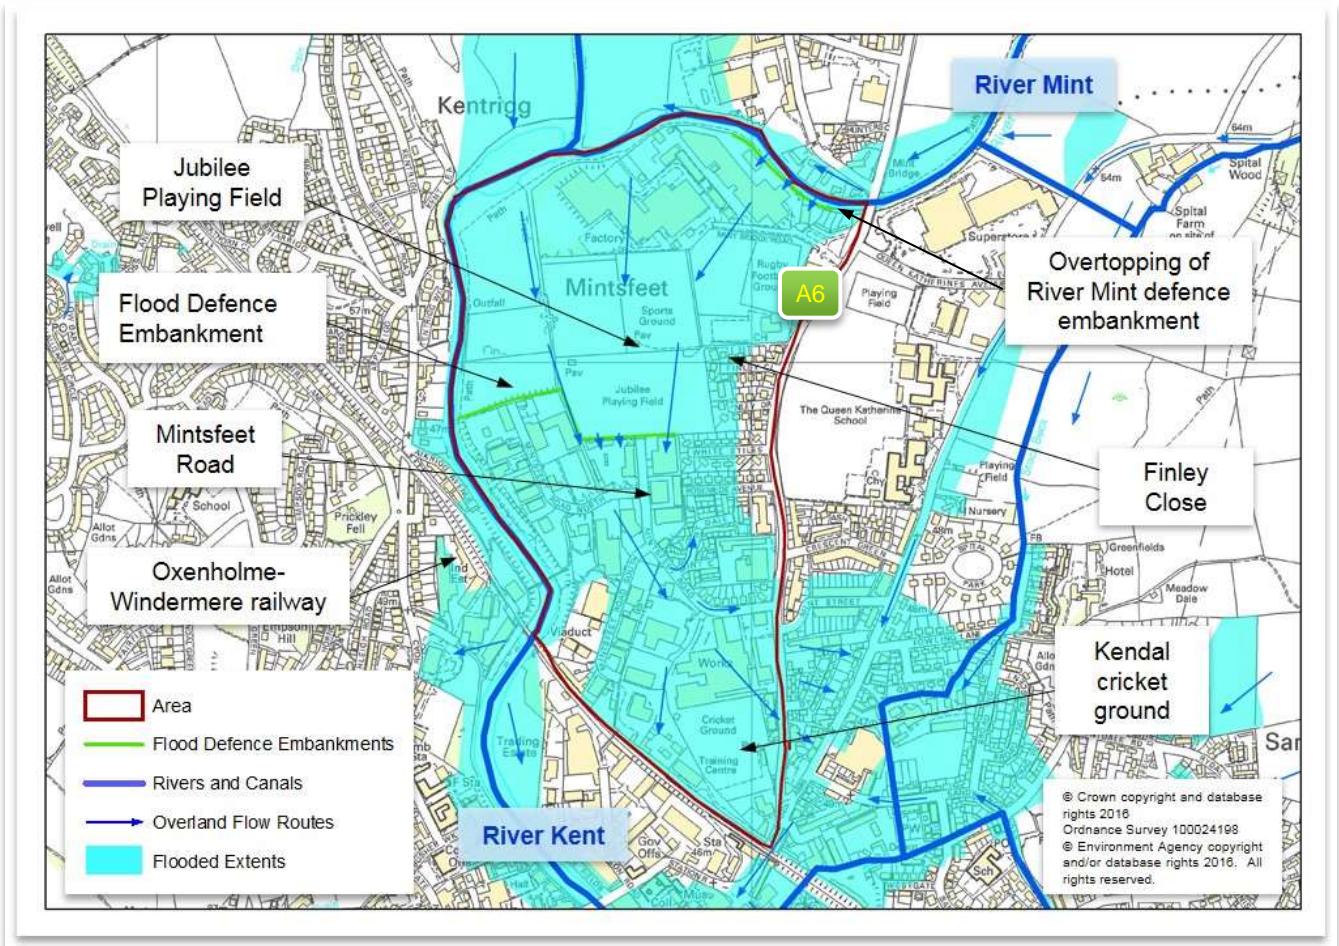
Figure 12: Overland flow routes in the Mintsfeet area

The Mintsfeet area, enclosed by the Rivers Mint and Kent to the west of the A6 Shap Road and north of the Oxenholme – Windermere railway line, comprises a mixture of residential, commercial, and green field land uses. The area was badly affected and the principal source of flooding was from the fluvial event on the Rivers Mint and Kent. Residential and commercial properties on and around Mintsfeet Road suffered significant damage and commercial property in the Lake District Business Park was also affected. The principal flood mechanisms and overland flow routes are shown in Figure 12, with a timeline of the key events given in Table 7.

Floodwater from these sources was then able to flow through the business park and across the Jubilee Playing Fields to the south, where it was initially impounded against the existing flood defence embankment highlighted on Figure 12 and shown in Figure 13.

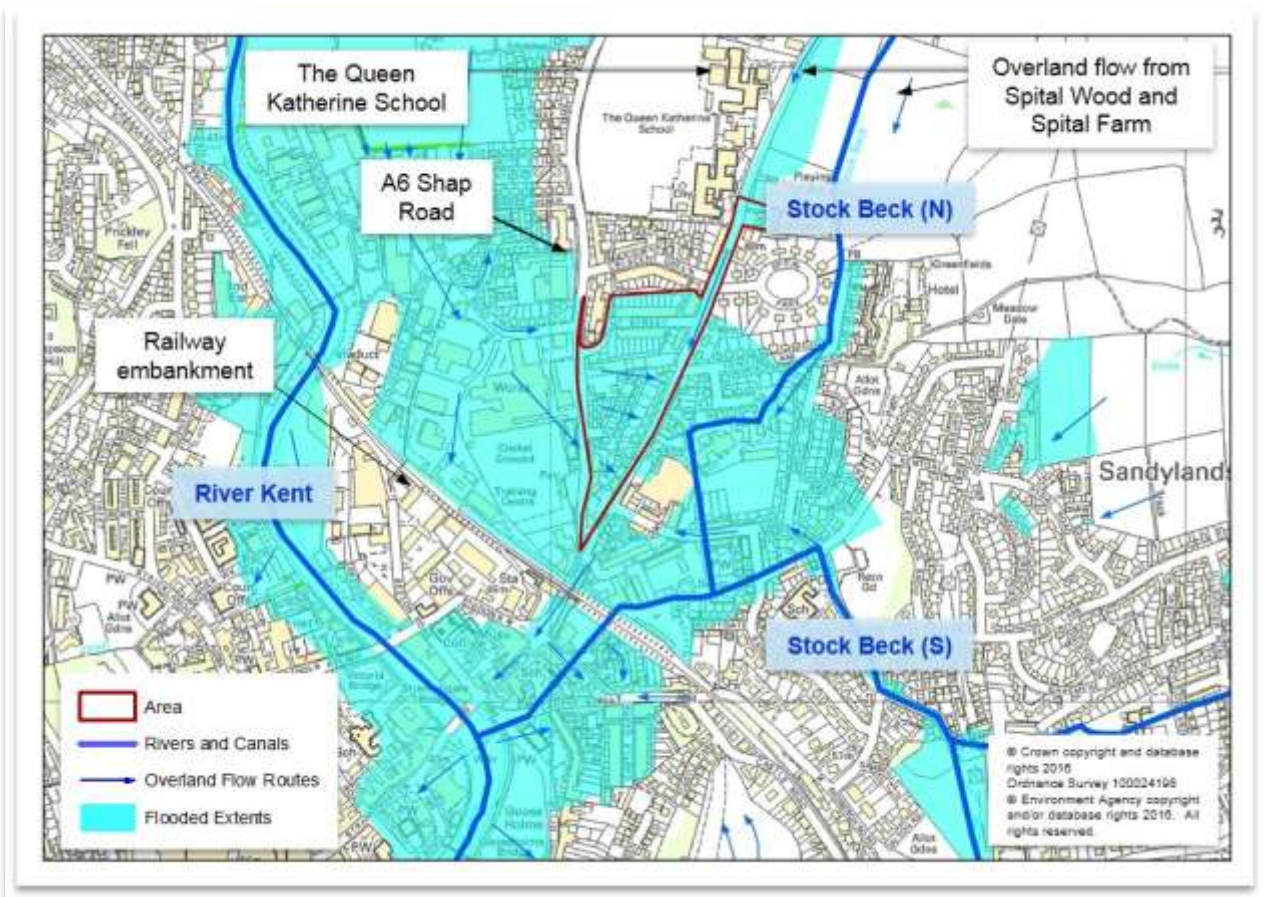
Figure 15: Overland flow routes in the Shap Road and Appleby Road area

Overland flow from the north tributary of Stock Beck formed a significant flow path down Appleby Road. This flow path originated upstream of the Morrison's superstore at Spital Wood, with out-of-channel flows conveyed down Appleby Road and past the Queen Katherine School before flooding properties on and around Mint Street. The Stock Beck culvert opposite the Morrison's store at Spital Farm surcharged (reached capacity and therefore overflowed) during the event and at this location, much of the in-channel flow was diverted to the River Mint via the Stock Beck overflow. Flow that was forced out-of-bank at this point formed a secondary flow path over open fields that then contributed to flooding on Fowling Lane and Broad Ing.

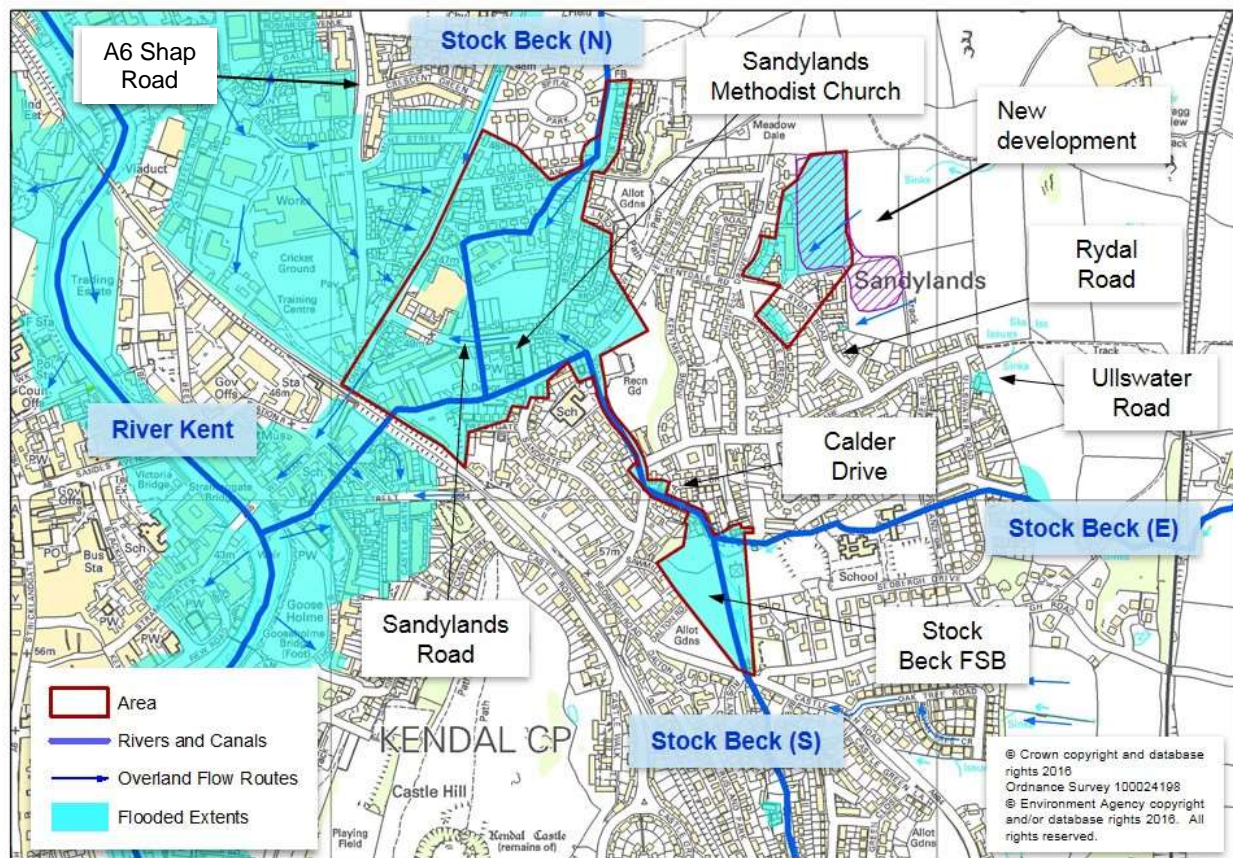
Figure 17: Overland flow routes in the Shap Road, Appleby Road and Sandylands areas

Situated on the east side of Kendal, the Sandylands area has limited coverage within the existing Environment Agency flood warning areas. With the exception of the area in the immediate vicinity of Sandylands Road, it is predominantly outside of Flood Zones 2 and 3, hence the lack of flood warning area coverage. However, on the 5th December 2015, the vast majority of the area between the A6 Shap Road and Jenkin Rise was badly affected by flooding. The area to the east of Sandylands has a number of sinks and springs and is also influenced by the West Coast Mainline, which sits on a raised embankment running north to south. The northern, eastern and southern Stock Beek tributaries all converge at various locations within Sandylands, as illustrated in Figure 17. It should also be noted that prior to being developed, areas of Sandylands were previously swampy land that often became ponds in winter. As a result of development, much of this natural flood storage has been lost.

Reports and evidence suggest that the flooding in this area was caused by multiple mechanisms. The area is situated immediately adjacent to Mintsfeet, and so was affected by flood flows from the Rivers Mint and Kent as per Area 2. In addition to this, the Stock Beek system, which comprises three tributary watercourses, flows through the area and is culverted for much of its length. Flooding was reported from a number of manholes associated with this culvert on Sandylands Road and damage was caused to part of a footpath on Eastgate, where the culvert roof was lifted up by the water pressure. Furthermore, overland flow was observed from the 'north' Stock Beek tributary down Appleby Road, affecting properties on Appleby Road and in the Longlands View and Fowling Lane areas (see Area 3: Shap Road and Appleby Road).

As the event progressed, properties on Calder Drive were affected by overland flow caused by problems associated with the performance of Stock Beck FSB. This storage basin is located upstream of Calder Drive and on the confluence of the southern and eastern tributaries to the Stock Beck watercourse system (see Figure 6). It is an online flood storage basin and immediately downstream of the confluence, the watercourse discharges through the water-retaining embankment via a flow control structure. This flow control comprises an orifice/penstock (principal control) and a high level weir and spillway (secondary control and auxiliary overflow).

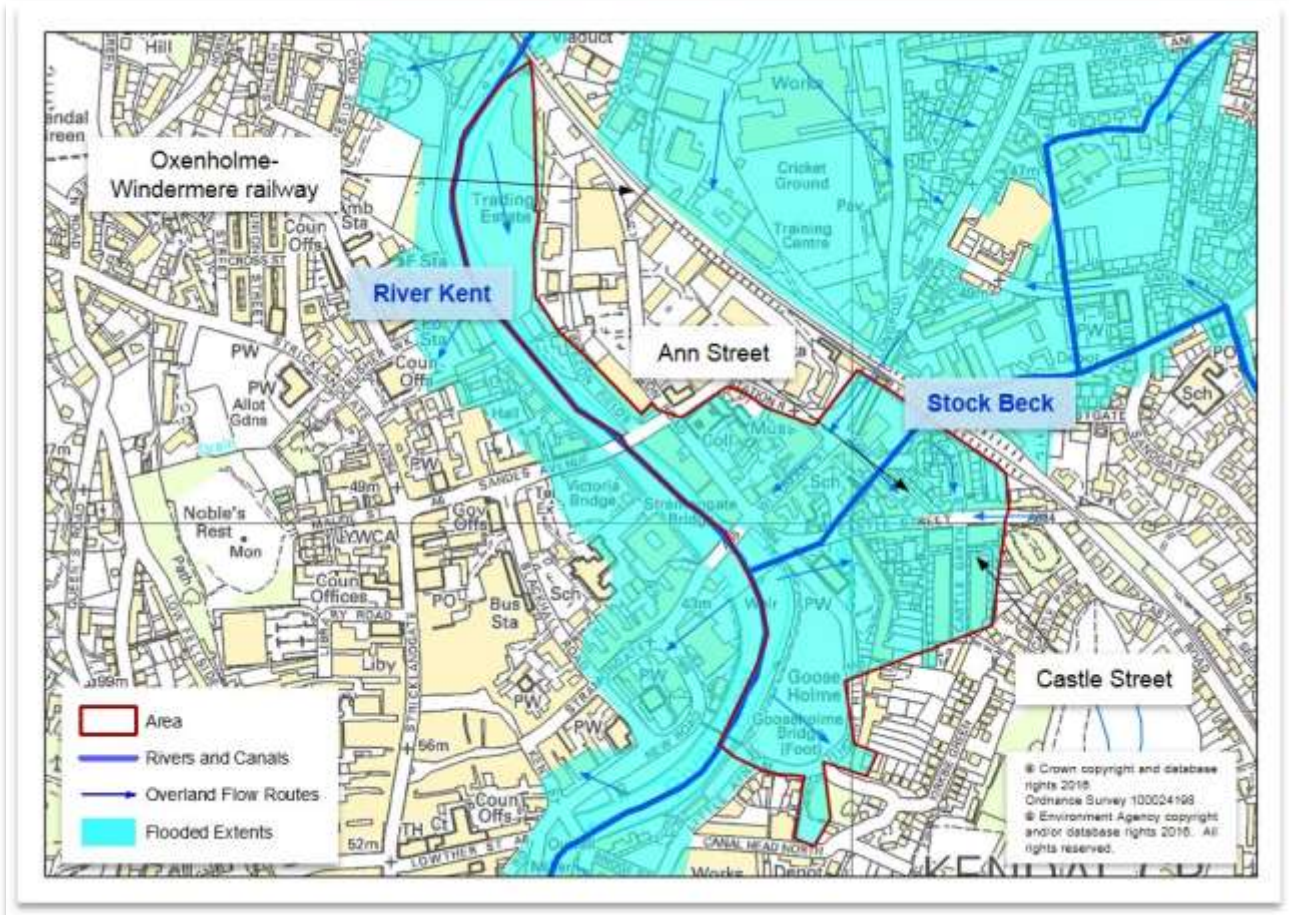
Figure 22: Overland flow routes in the Wildman Street, Ann Street and Castle Street area

Flooding occurred in the Wildman Street, Ann Street, and Castle Street area from a variety of sources, with initial reports of flooding from drainage systems and groundwater, as well as fluvial flooding from Stock Beck, the River Mint, and the River Kent. Whilst the area is situated on the left bank of the River Kent, it was the other sources that initially caused flooding in the area before the River Kent burst its banks in the centre of Kendal.

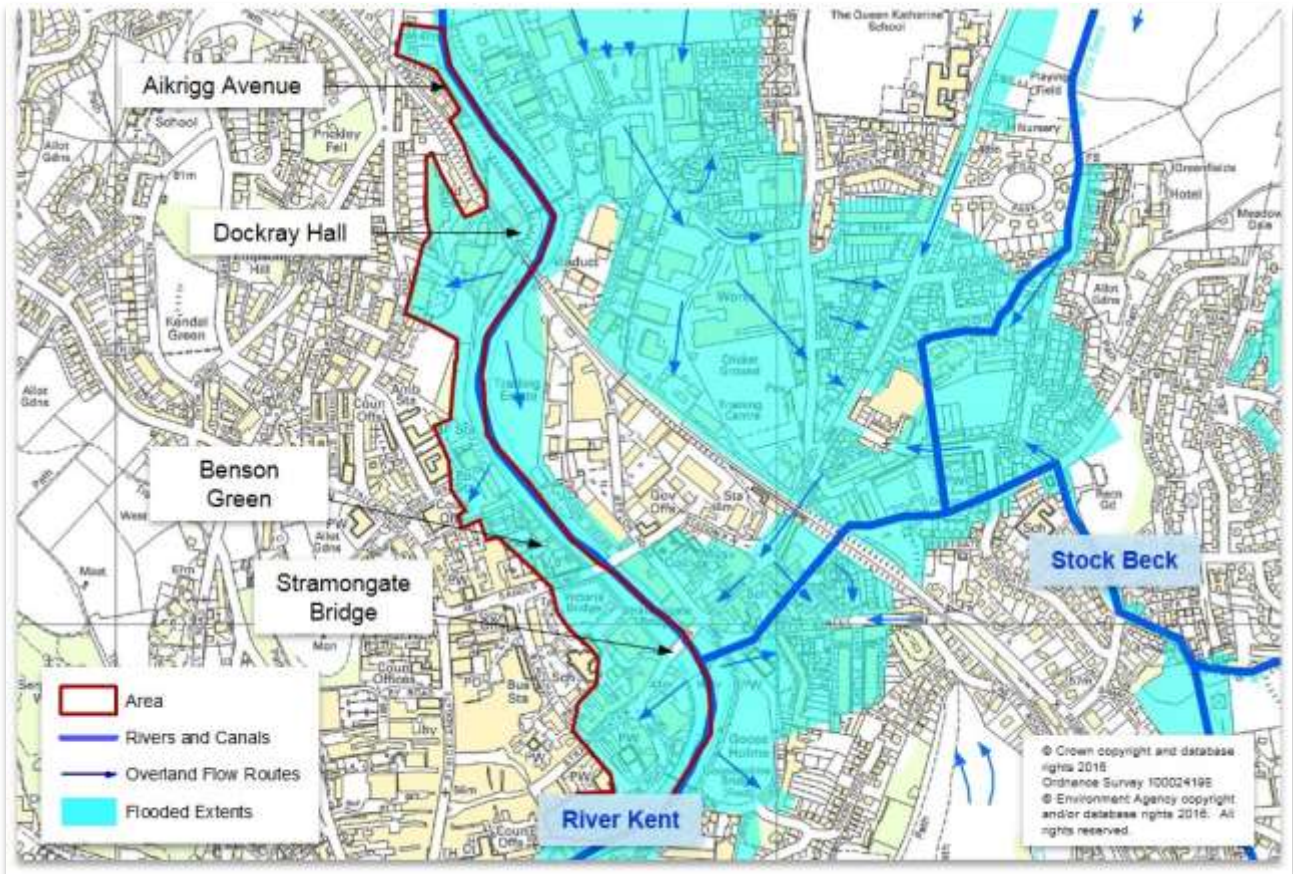
Figure 237: Overland flow routes in the centre of Kendal

In the centre of Kendal, commercial properties on Stramongate and New Road suffered flooding from the River Kent. Overtopping of the right bank of the river downstream of Stramongate Bridge was observed at 17:00 on the 5th December, with the peak river level occurring some four hours later.

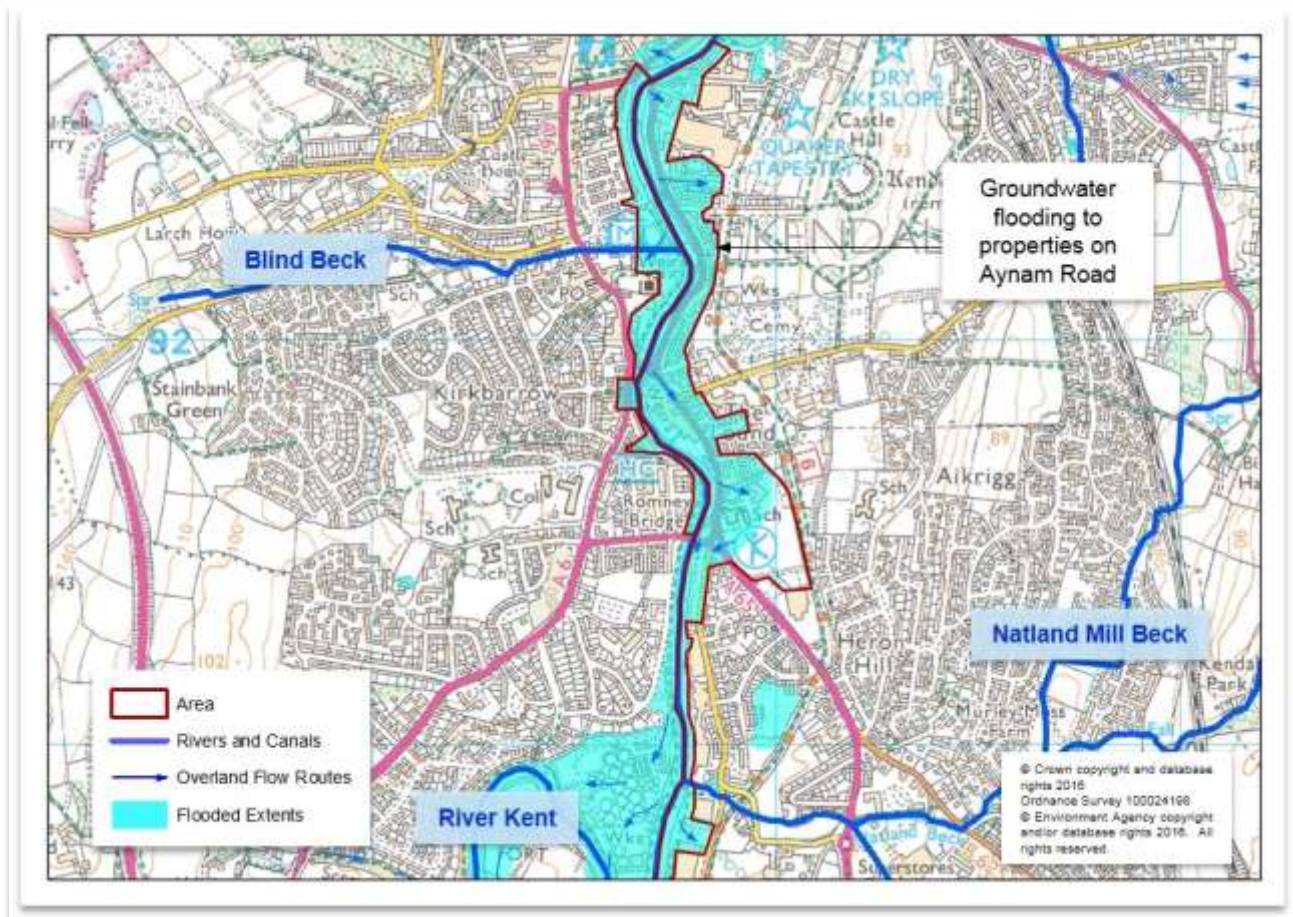
Figure 248: Overland flow routes on the left and right banks of the River Kent through Kendal

'A local resident on Brigsteer Road, in the upper Blind Beck catchment, reported flooding to garages from local springs at The Ghyll, Hylands and other garages further down towards Greenside. There was also localised flooding observed on Brigsteer Road at the junction of the Underwood Estate, where flood depths were reportedly 60cm.'

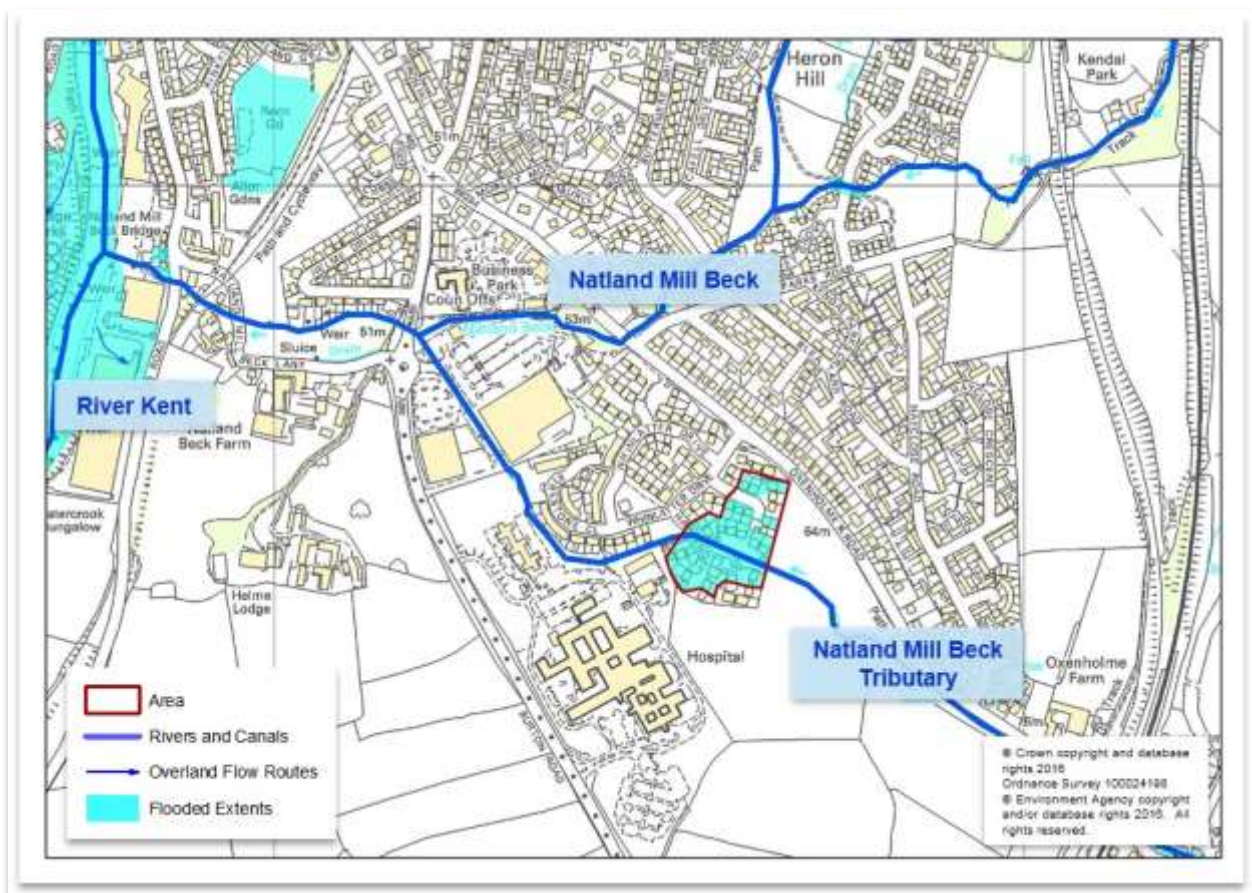
Figure 3026: Affected areas around Natland Mill Beck and Natland Mill Beck Tributary

Natland Mill Beck and Natland Mill Beck Tributary drains a small catchment that includes the south-east of Kendal and discharges to the River Kent opposite Kendal WwTW. The watercourse system comprises three tributaries and localised fluvial flooding from the southerly Natland Mill Beck Tributary affected properties on Blencathra Gardens and Hardknott Gardens. This watercourse flows in open channel to the rear of properties on Hardknott Gardens and Blencathra Gardens before passing beneath Hardknott Gardens in culvert.

Reports from local residents who observed the flooding mechanisms were that the Natland Mill Beck Tributary exceeded its channel capacity in the fields upstream and flowed out of bank across the fields towards Blencathra Gardens and Hardknott Gardens. There were also observations of a blockage where the watercourse flows underneath a fence line at the eastern extent of the estate. The blockage at the fence line was caused by debris - including bed material from the watercourse that had been scoured by the velocity of the water - becoming trapped on the fence. This blockage resulted in flow leaving the watercourse channel on the right bank, flowing through properties on Blencathra Gardens and Hardknott Gardens before re-joining the channel. The affected area is shown in Figure 30.

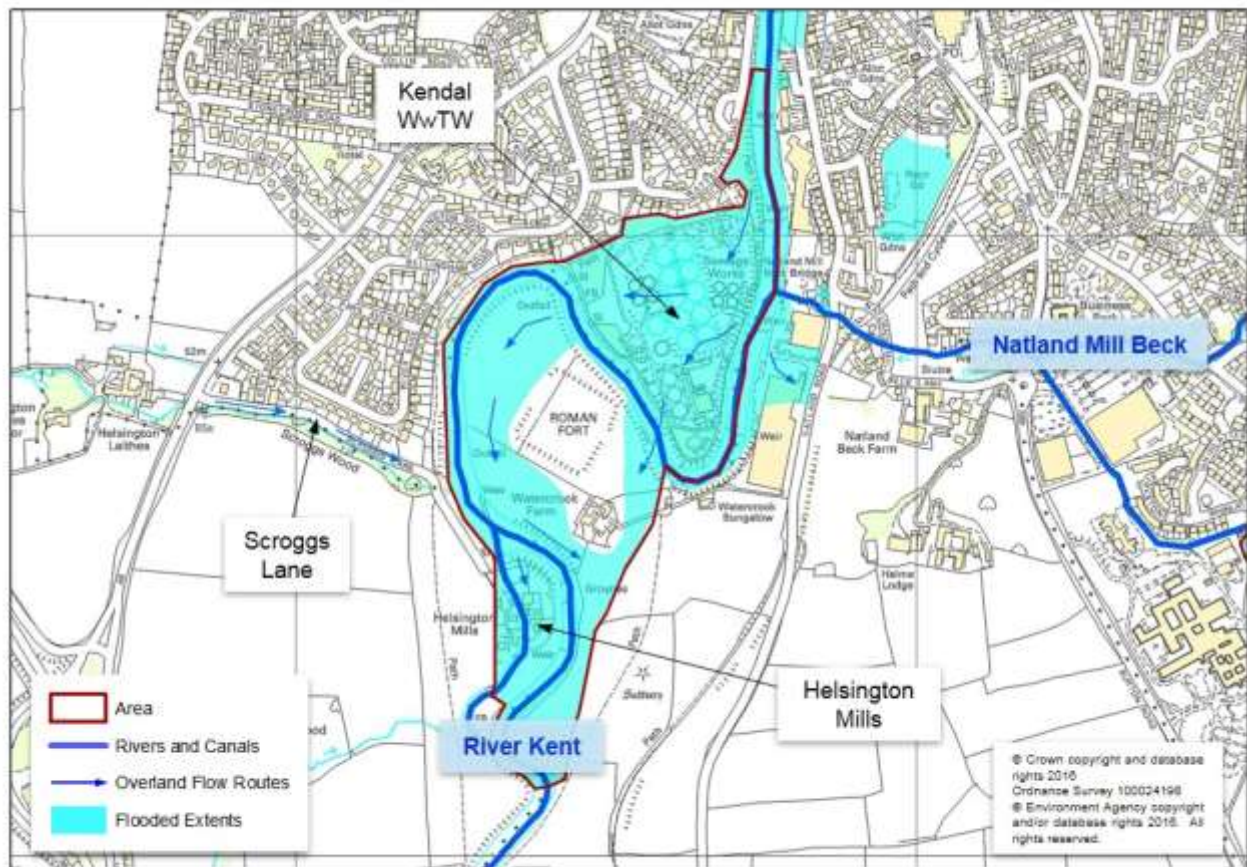
Figure 31: Overland flow routes at Kendal WwTW and Helsington Mills

Further downstream on the right bank of the River Kent, there was a flow route caused by surface water run-off and flow from an ordinary watercourse along Scroggs Lane, which provides access to properties in Helsington Mills. Here, water depths were reported as being 0.6-0.9m. This overland flow combined with fluvial flooding from the River Kent to flood properties in the Helsington Mills development to a depth of 0.9-1.2m. 'A resident of Helsington Mills, Phil Chaplow, provided the following details of the flooding that affected the area on the 5th and 6th December. The first property to be affected by flooding in Helsington Mills was Mr Chaplow's property, Mill House, which is the lowest lying property in the development. Flooding reportedly began at Mill House around 15:00 on 5th December. By 16:30, a water depth of 0.9m was observed at the access bridge at the bottom of Scroggs Lane. The peak water level was reached at around 23:30, with Mill House reportedly flooded to a depth of 2.0m. At 08:00 on 6th December, Mr Chaplow reported that water levels remained at around 0.9m, and that it was necessary to wade through water to access properties. It wasn't until about 15:00 later that afternoon when all of the flood water had left the lowest property.'

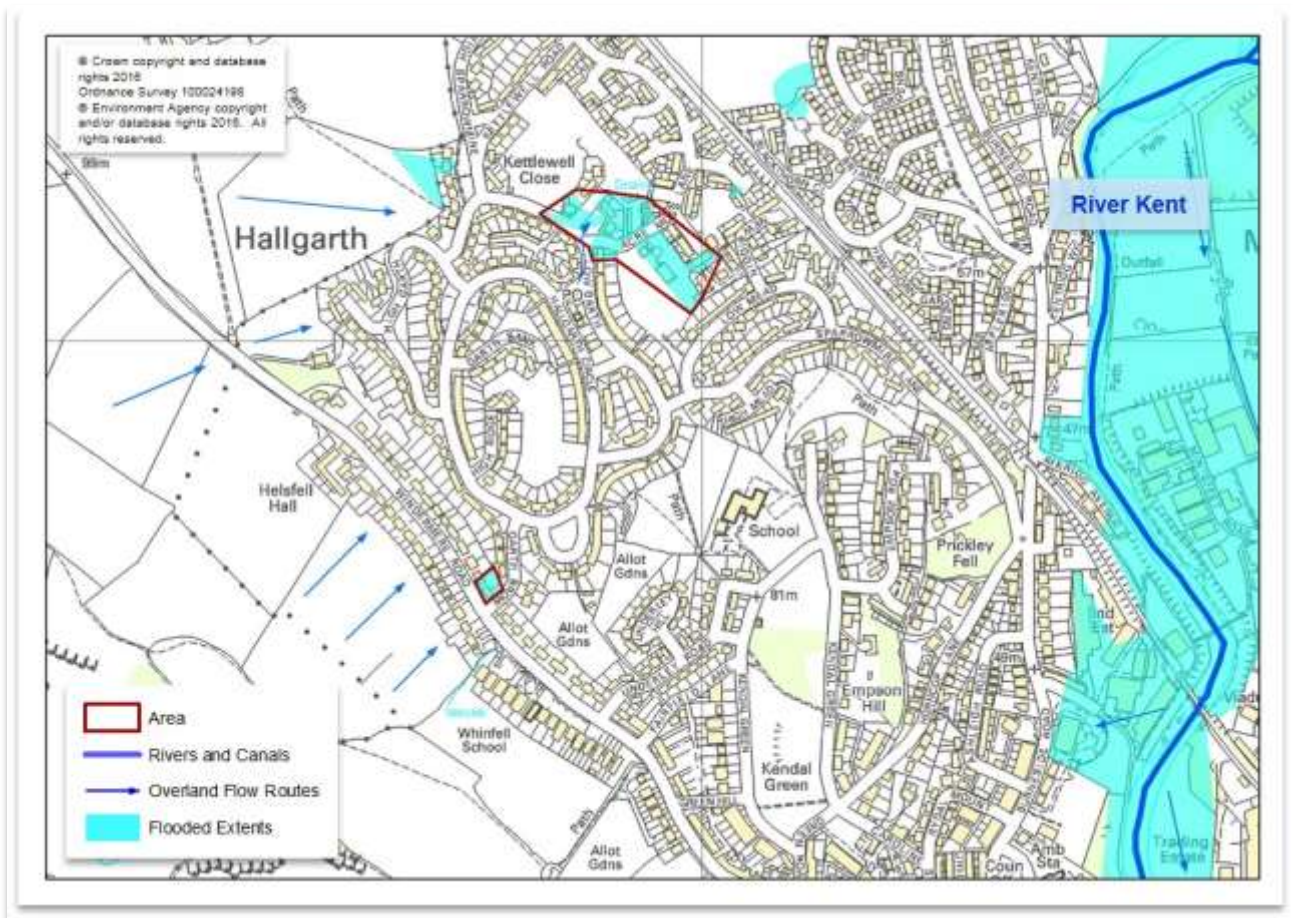
Figure 33: Overland flow routes in the Hallgarth area

Whilst the area was unaffected by the river flooding that affected the north and central areas of the town, parts of the area were affected by surface water flooding. In a similar mechanism to that experienced by properties on Ullswater Road and Rydal Road in Area 3, some properties on the junction between Low Garth and Acre Moss Lane suffered from localised surface water flooding. Other overland flow routes were observed in the area, with surface water run-off from areas upstream of the A5284 Windermere Road channelled down the road itself to an observed depth of 100mm at around 19:00.

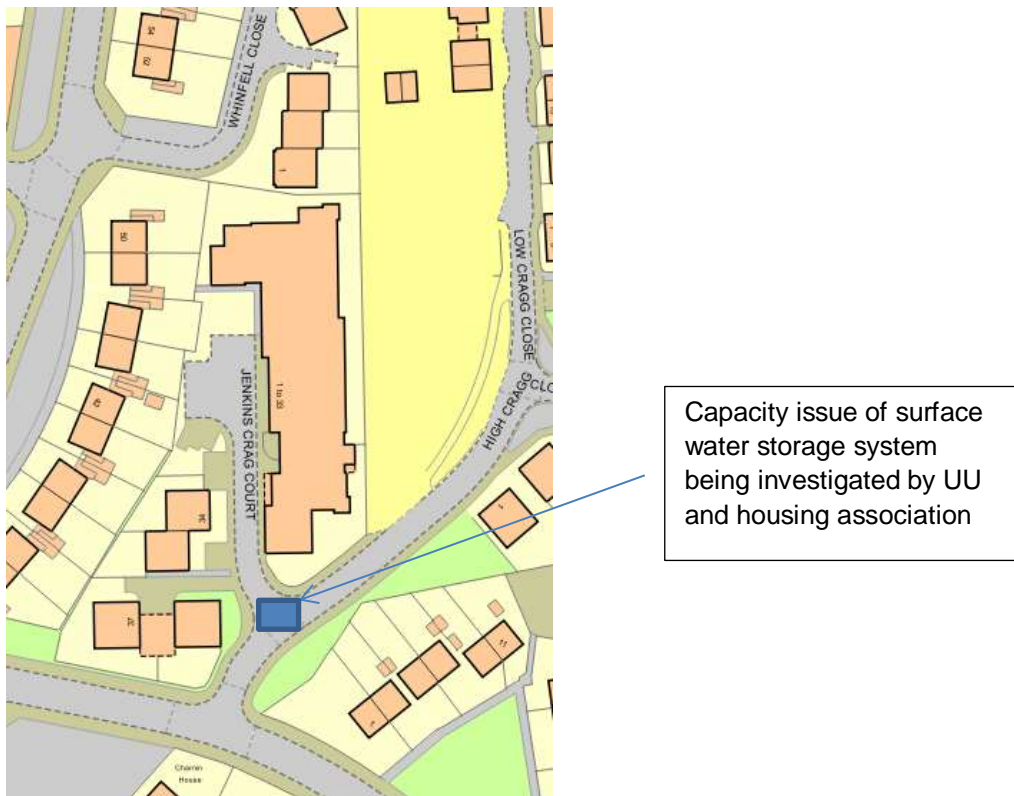
6. Jenkins Crag Court

- 2) During the flood event, residents on Rydal Road, and in Jenkins Crag Sheltered Housing complex at Jenkins Crag Court, observed the drainage systems in the car park to the west of the Sheltered Housing surcharging at 13:30 on 5th December, with the water then flowing towards the rear of properties on Whinfell Drive. Two properties flooded to approximately 600mm in spite of several hours of pumping by the fire service.

- 7) Residents on Rydal Road observed the drainage systems in the car park at the Sheltered Housing complex at Jenkins Crag Court surcharging at 13:30 on 5th December, with the water then flowing towards the complex.
