# Sedbergh

## Flood Investigation Report

**Flood Event 5-6<sup>th</sup> December 2015**

This Flood Investigation Report has been produced by Cumbria County Council as a key Risk Management Authority under Section 19 of the Flood and Water Management Act 2010 in partnership with Cumbria County Council as Lead Local Flood Authority.

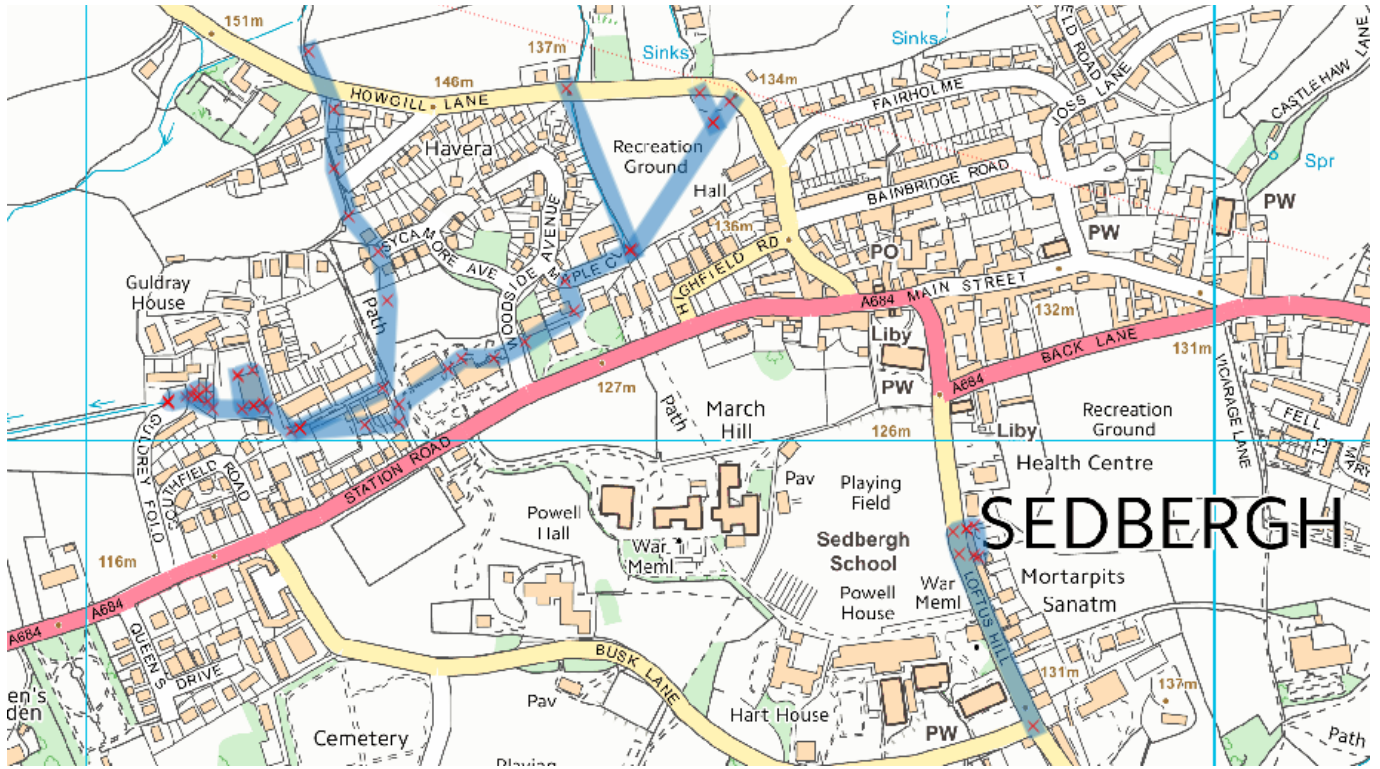
**Figure 4 - Identification of Areas Flooded**

On the 5<sup>th</sup> and the 6<sup>th</sup> of December 2015, approximately 5 properties in Sedbergh were affected by flooding. This flooding can be attributed to a record-breaking rainfall event from Storm Desmond. This led to flooding from the nearby ordinary watercourses indicated with in figure 2 below.

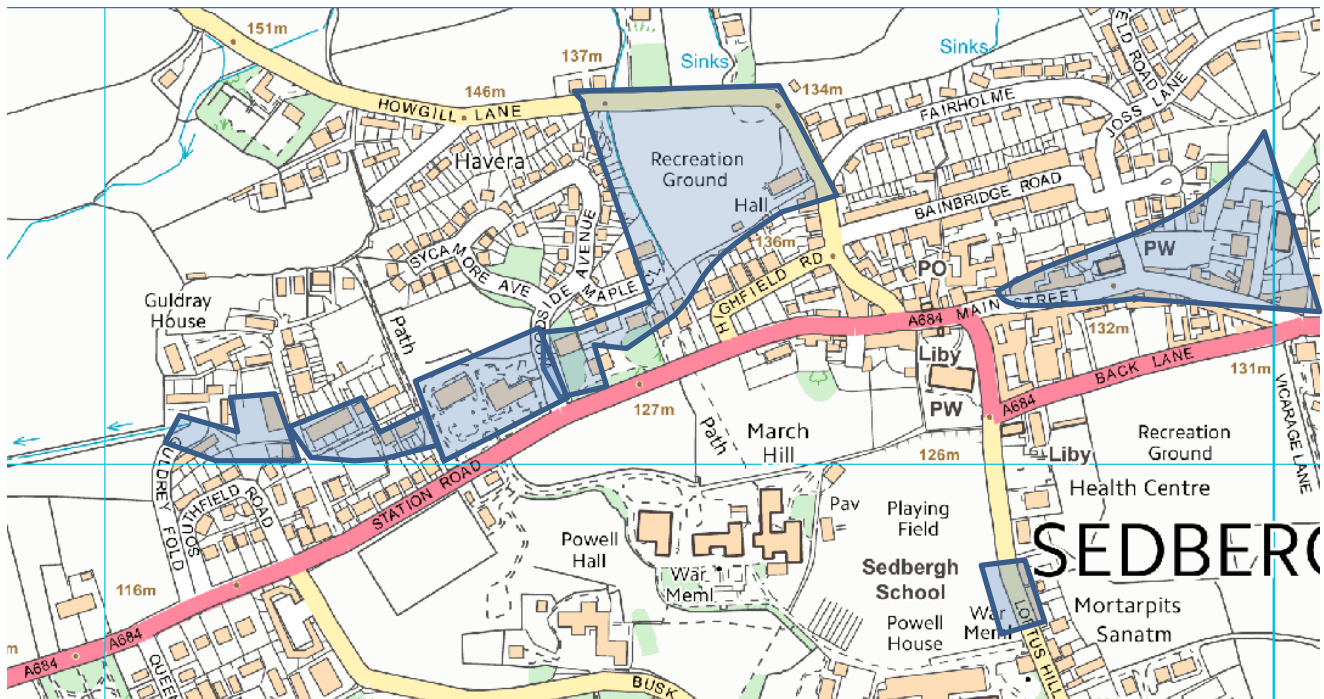
**Figure 5- Indicates the location of the 6 sub-areas**

There were a number of different flood flow routes during this event. For this report, the flooded area has been divided into 6 sub-areas, as shown below.

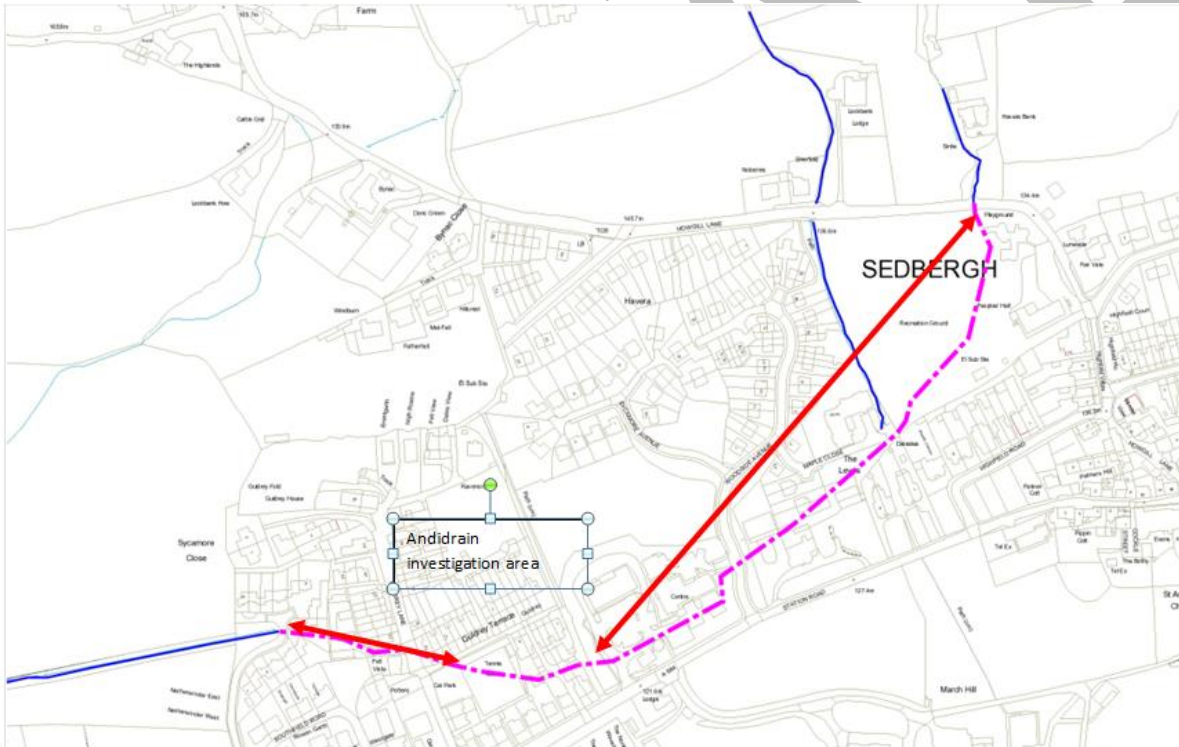
### Location plan 1: Andidrain investigation area March 2016

During the original survey undertaken by Andidrain the camera unit was unable to pass through the garden area at the rear of “The Nook” and was also unable to proceed from the downstream access on Guldrey Lane past a mass of roots located in the front gardens of Guldrey Terrace. There were no other obstructions within the culverted watercourse system.

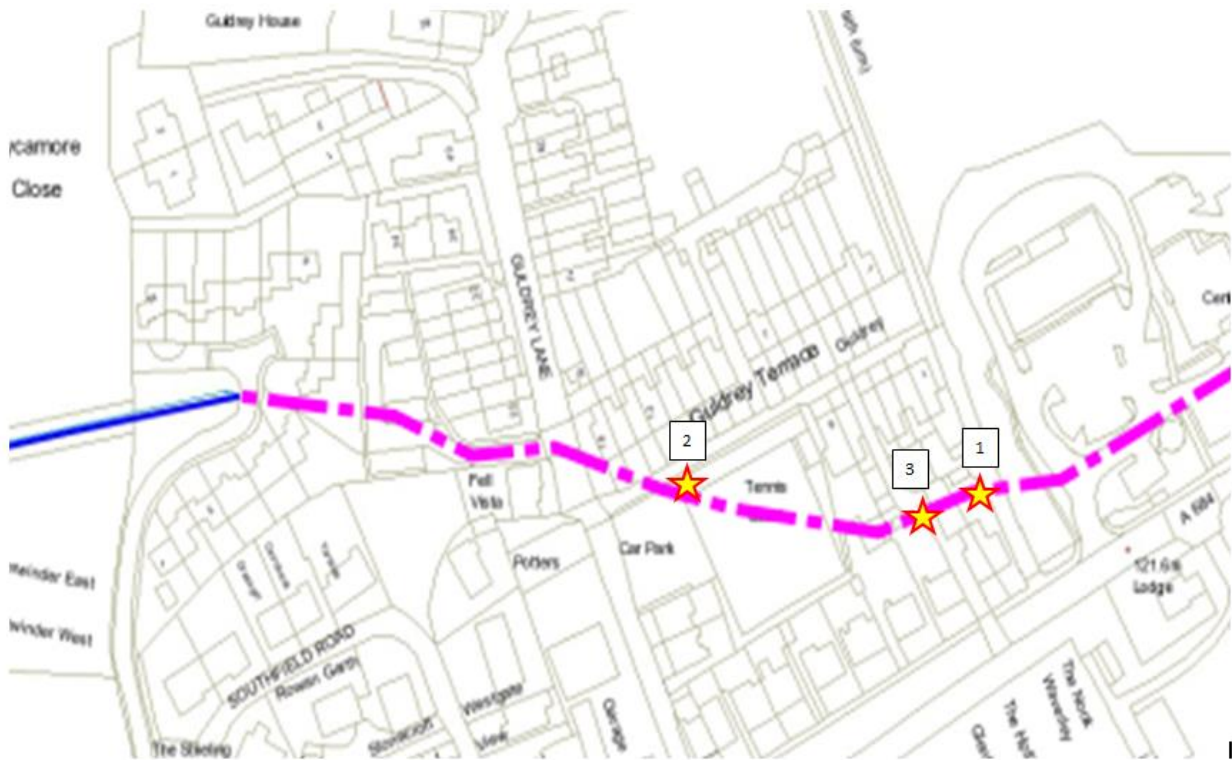
**Location plan 2: Sapphire Access excavation locations**

The works started with an attempt to clear the debris blocking the culvert in the rear garden of The Nook (Location 1) see location plan 2.

It was soon evident that although large stones had blocked the culvert and reduced the capacity to as little as 10-15% there was a significant amount of smaller sediment behind this which also reducing the capacity of the stone culvert to between 70% near Guldrey Terrace and 30% at the rear gardens of Waverley and The Nook . Image A below shows the size of stones removed by hand from the access chamber in the rear garden of The Nook.
